historic structure report  
appomattox manor

october 1982

HISTORIC STRUCTURE REPORT  
PHYSICAL HISTORY AND ANALYSIS SECTION  
APPOMATTOX MANOR  
CITY POINT UNIT  
PETERSBURG NATIONAL BATTLEFIELD  
VIRGINIA

By  
Richard G. Turk  
and  
G. Frank Williss

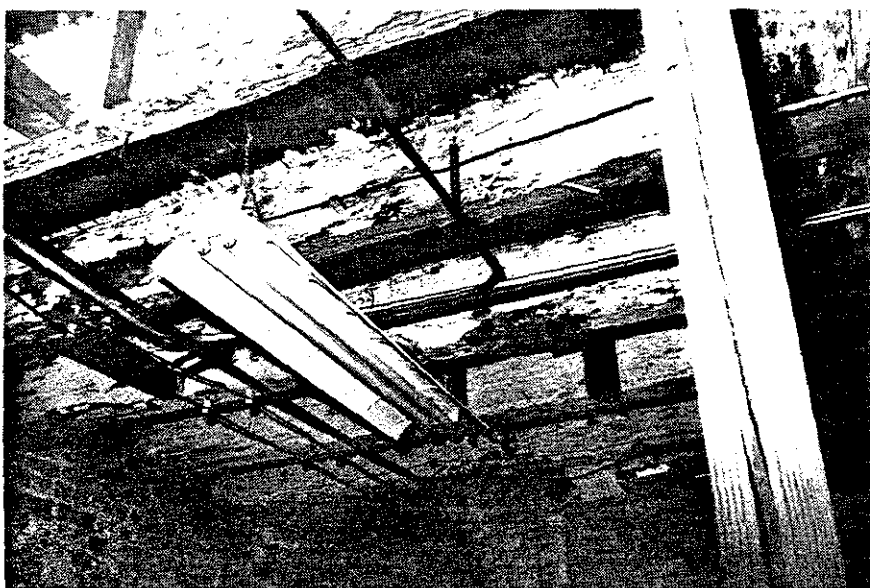
Illustration 64 1981  
 Manor House, basement  
 Interior, Room B-05  
 Detail first floor framing

Note: Insect damaged members

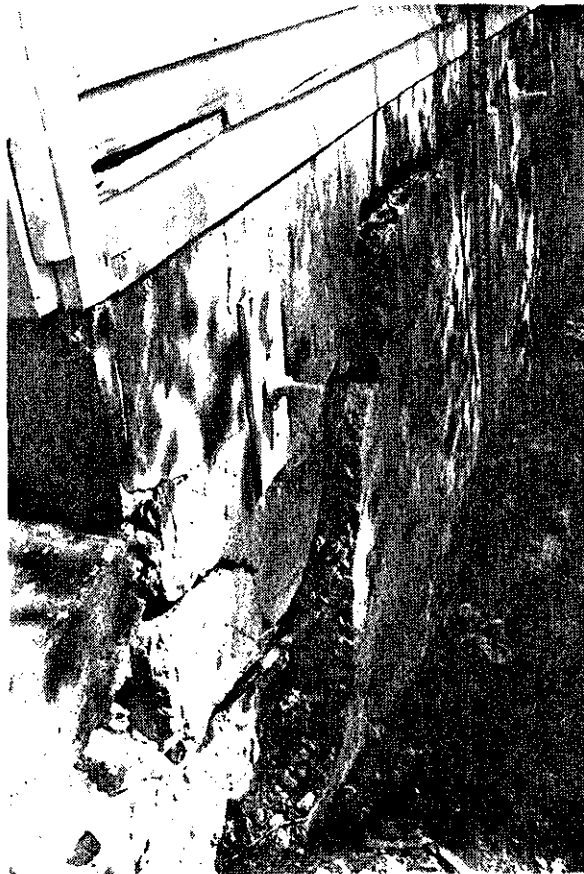
Illustration 92  
Carriage House  
West elevation  
Foundation failure

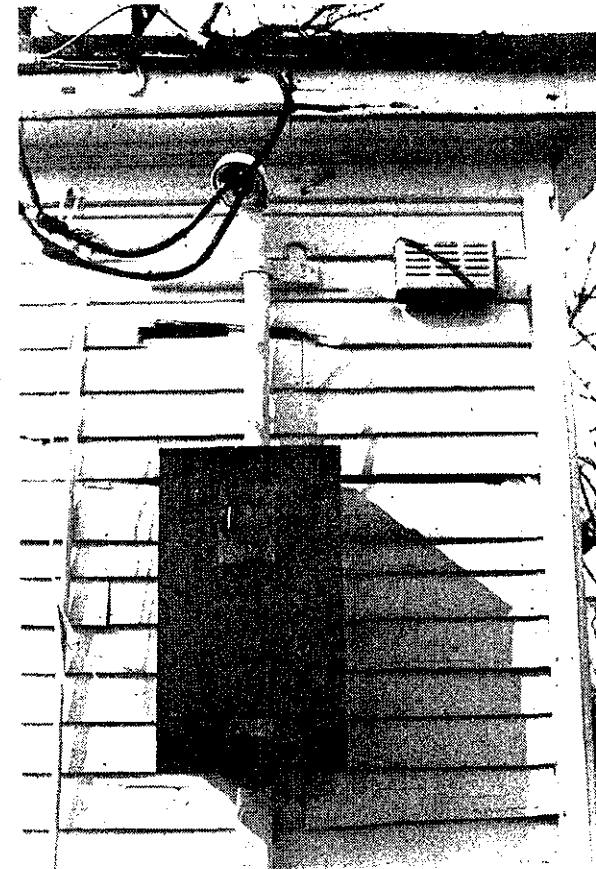
Illustration 93  
Carriage House  
East elevation  
Damaged weatherboarding

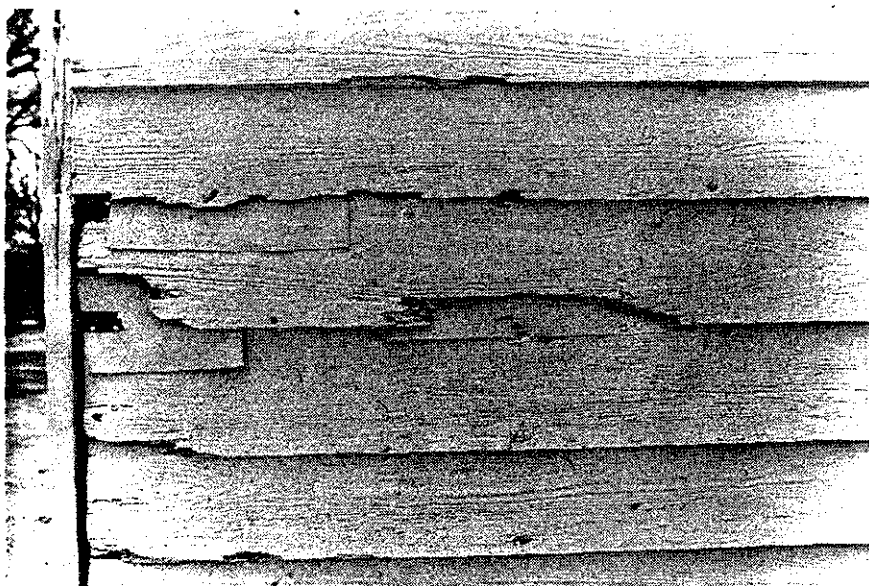
Illustration 102  
Old Smokehouse  
North elevation  
Detail of damaged weatherboards

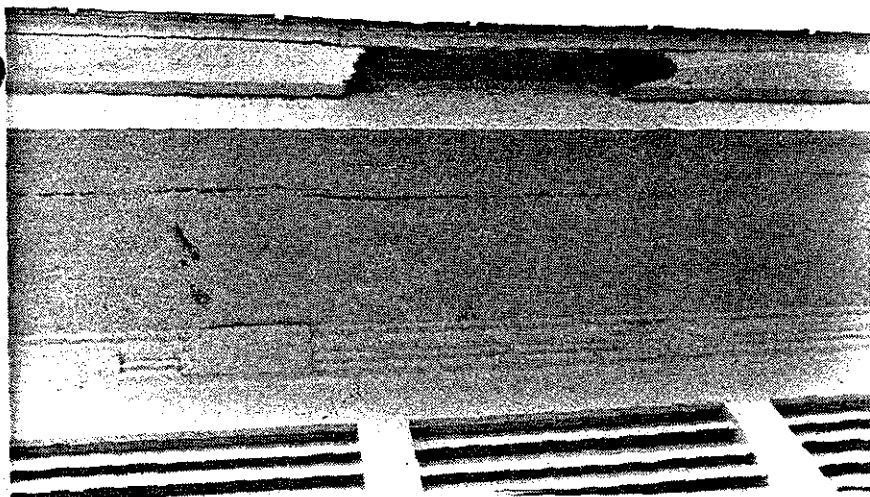
Illustration 122

North elevation

Damaged cornice moulding

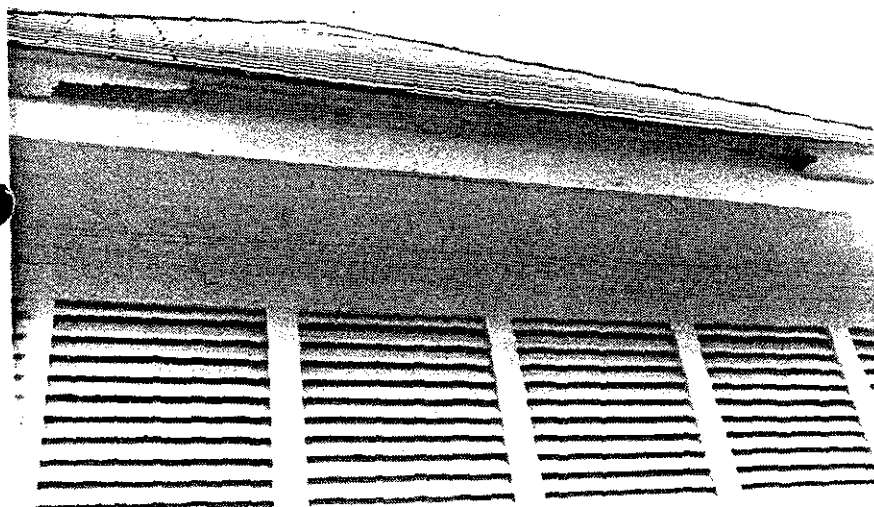
East elevation

Damaged cornice moulding

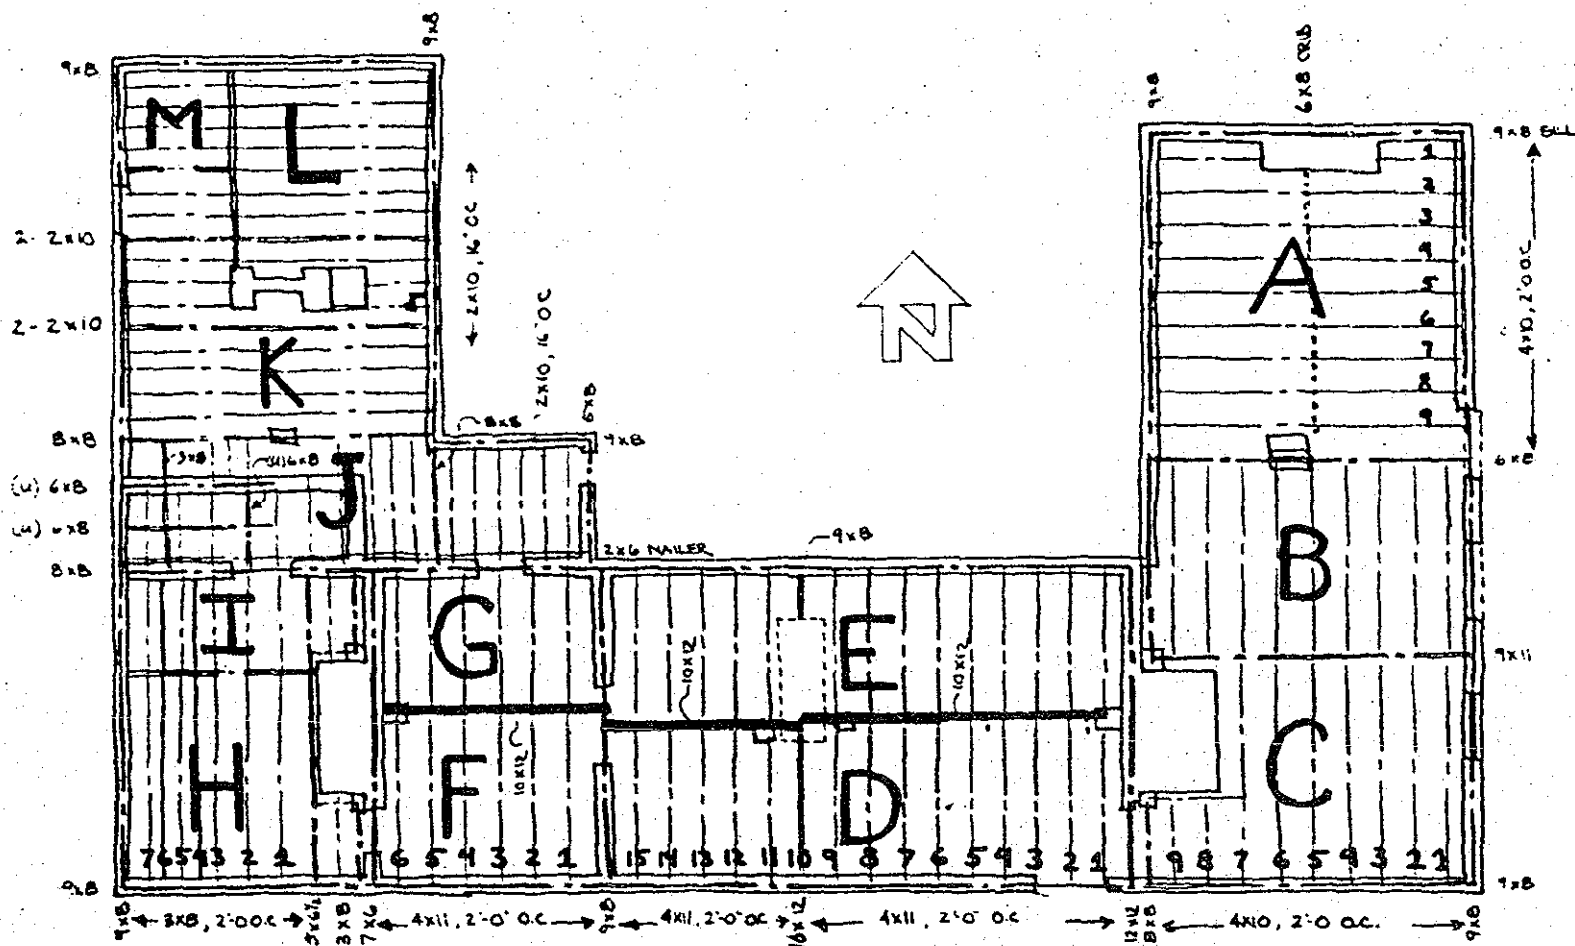
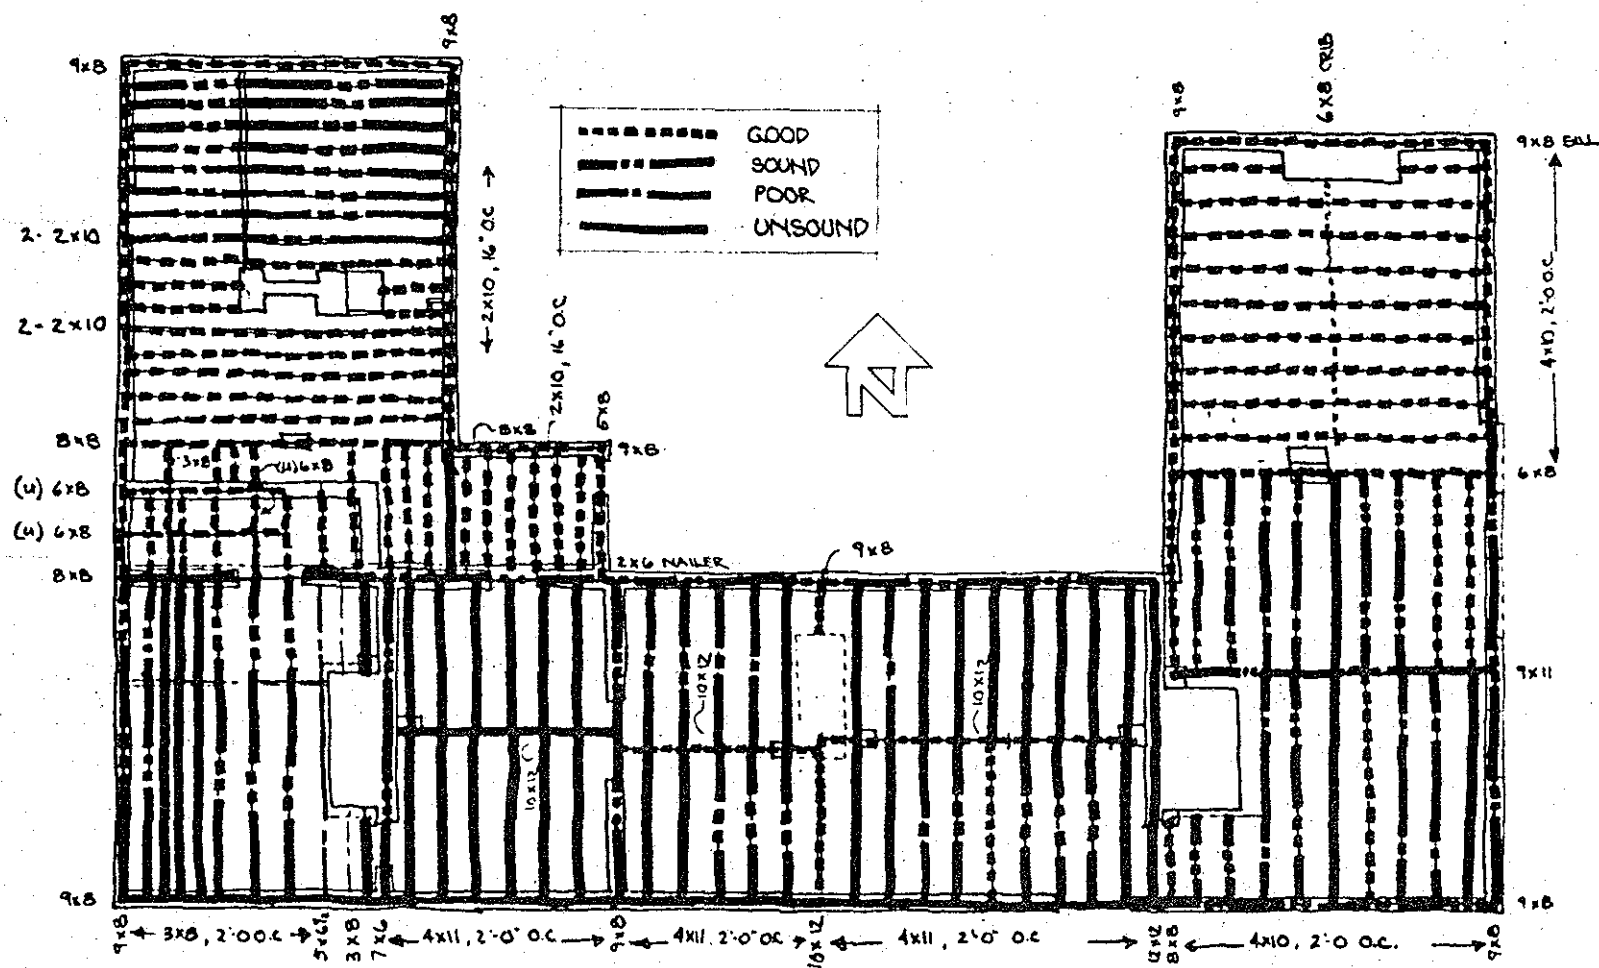
Joist B2 - Powder post beetle damage, good material.

Joist B3 - Powder post beetle damage, sound material.

- Joist B4 - Powder post beetle damage, sound material.
- Joist B5 - Powder post beetle damage, termite damage at south end, unsound material.
- Joist B6 - Heavy powder post beetle damage at south end, poor material.
- Joist B7 - Heavy powder post beetle damage at south end, poor material.
- Joist B8 - Powder post beetle damage, sound material.
- Joist B9 - Powder post beetle damage, sound material.
- 9" x 11" Summer beam between areas "B" and "C" in sound condition.

Throughout basement areas "E", "D", "F", "G", and an occasional joist in area "C", deteriorated joist have been supplemented by a new 2" x 10" nailed along side. This new joist structurally improves the framing system, but in no way provides adequate support. In most cases, this new member is merely nailed or toenailed to badly deteriorated fabric.

It is our recommendation that all joists and framing members identified as in either poor or unsound condition be removed and replaced with CCA pressure treated southern yellow pine dimensionally similar to the existing framing. All joists and framing identified as sound should be supplemented by new 2" CCA pressure treated joist spaced 1" off the existing framing. All material identified as good should be brush treated with a copper naphthenate base wood preservative. It is also recommended that all new and existing mortise and tenon joints be additionally supported by mechanical connection, such as - angle iron, joist hangers, etc.
