HISTORIC STRUCTURES REPORT

PART I

BUILDING NO. 2 - MEMORIAL SHAFT

Perry's Victory and International Peace  
Memorial National Monument

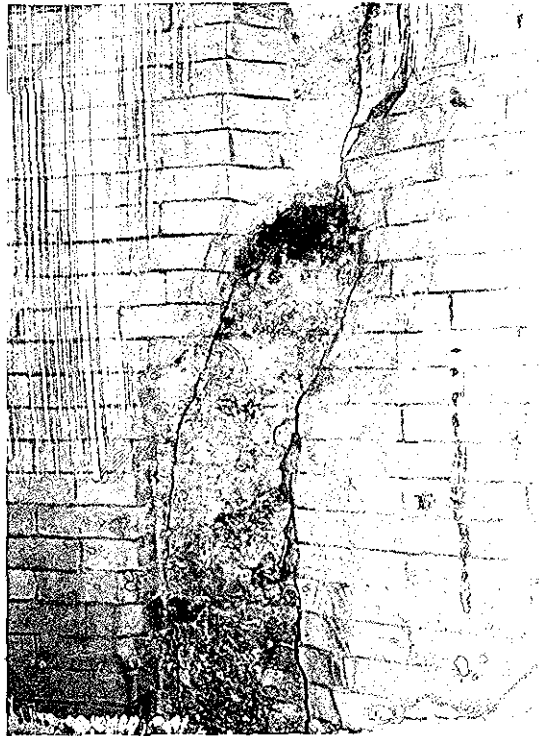
Northwest Wall (Inside)

This crack extends from

top of shaft to  
elevator landing

Note Plucking

Crack  
extends  
from middle  
to bottom  
of Shaft
