december 1976

## PERRY'S VICTORY AND INTERNATIONAL PEACE MEMORIAL MEMORIAL COLUMN AND PLAZAS

Historic Structure Report  
Memorial Column and Plazas  
Administrative and Architectural  
Data  
Perry's Victory and International  
Peace Memorial  
Ohio

DALTON-DALTON-LITTLE-NEWPORT

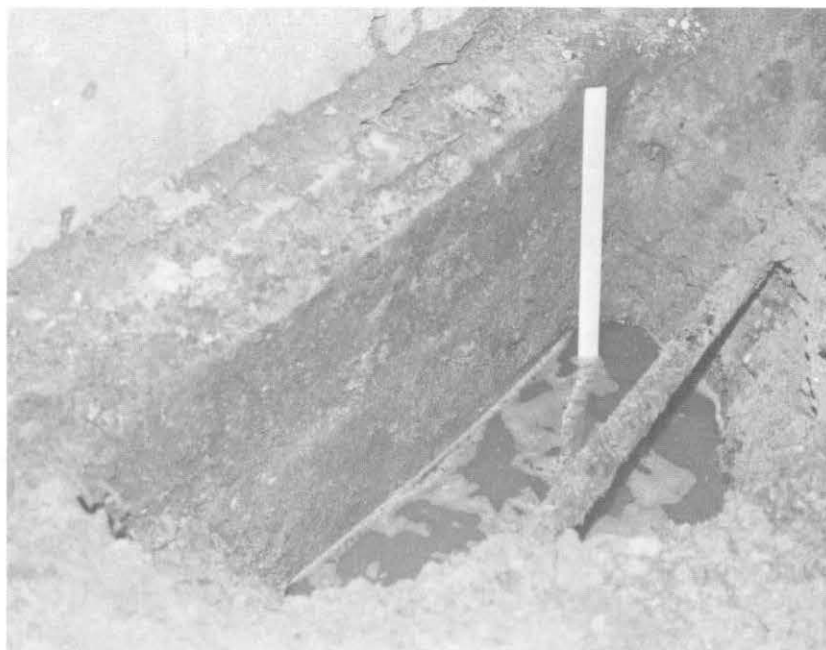
ILLUSTRATION 24. Top of column foundation at approximately southeast side, just below upper plaza.

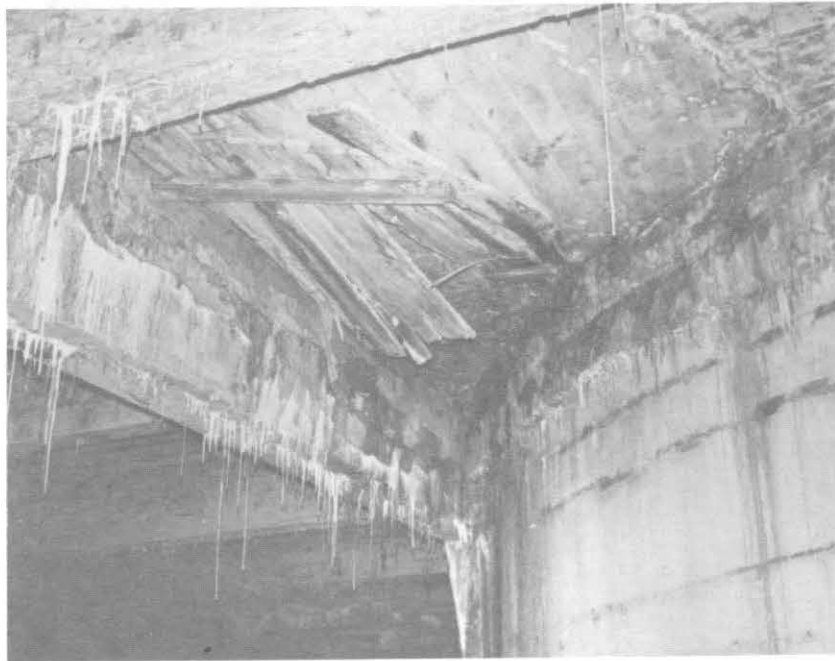
ILLUSTRATION 25. Bottom of column foundation at approximately southeast side, just below grade.

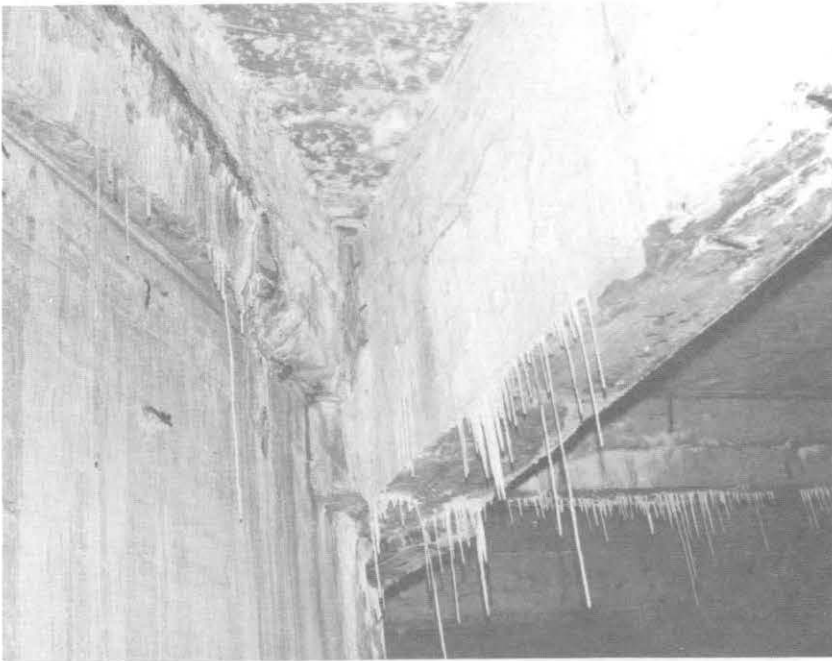
ILLUSTRATION 26. Top of column foundation at approximately northwest side, just below upper plaza.

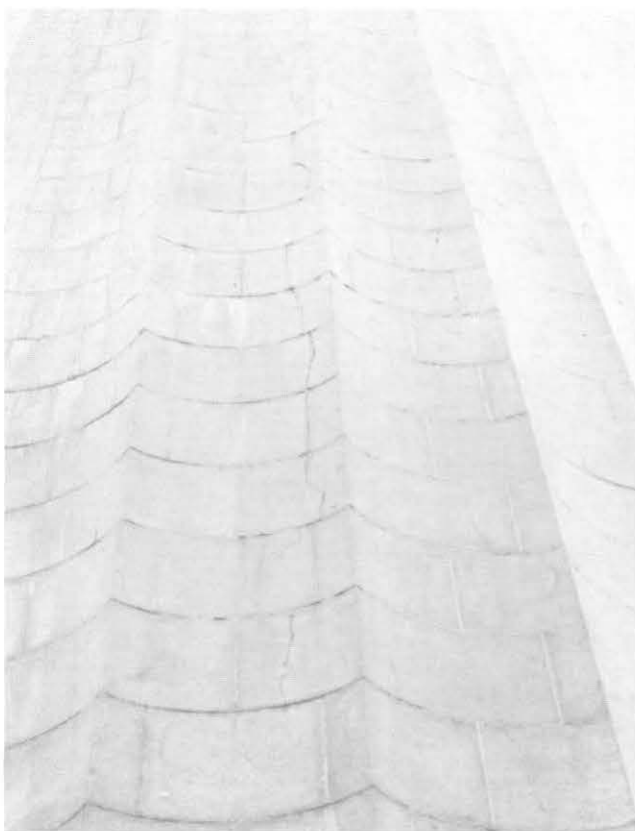
ILLUSTRATION 30. Detail of major crack on lower part of southwest side of column and some typical efflorescence.

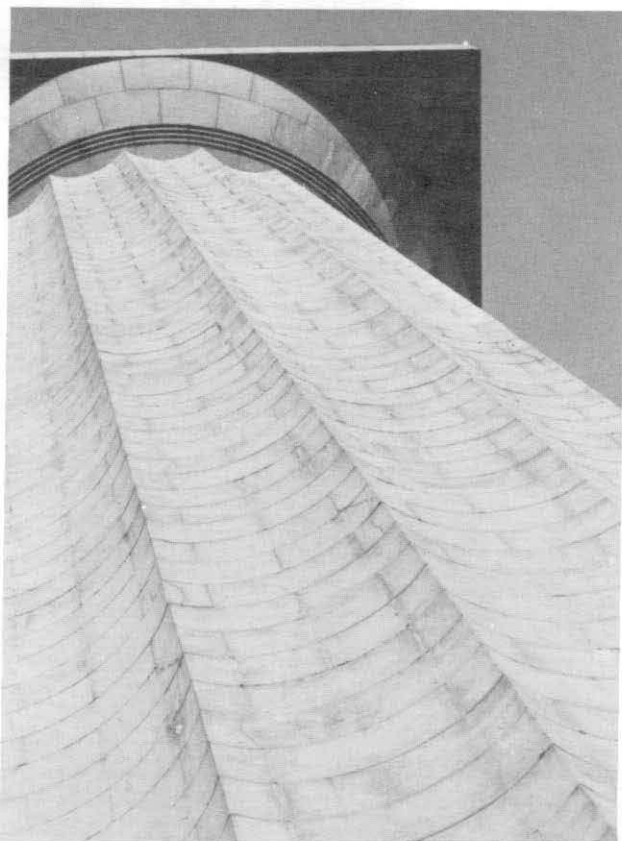
ILLUSTRATION 32. Typical detail of efflorescence and improperly sealed joints.

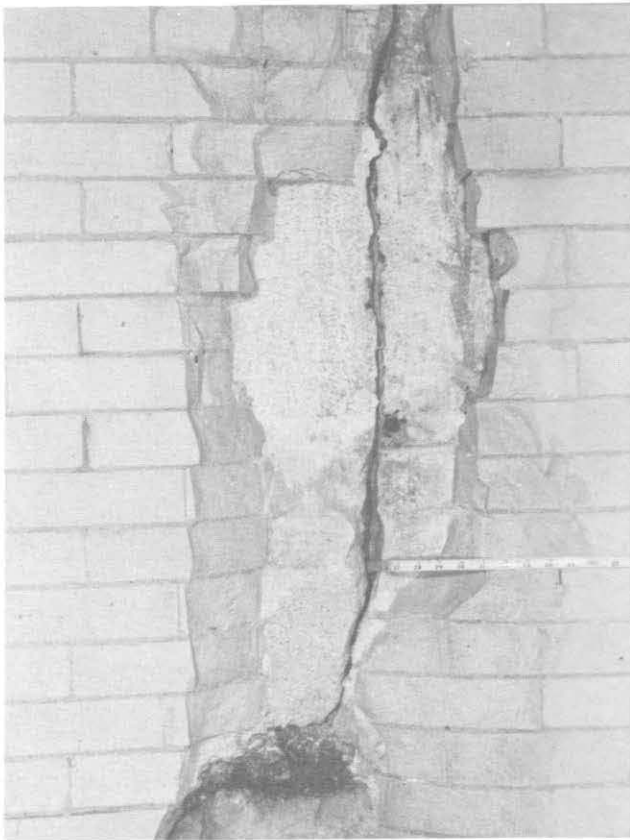
ILLUSTRATION 47. Detail view showing structural concrete with major crack; brick and mortar with wire loop, minimum depth of crack.

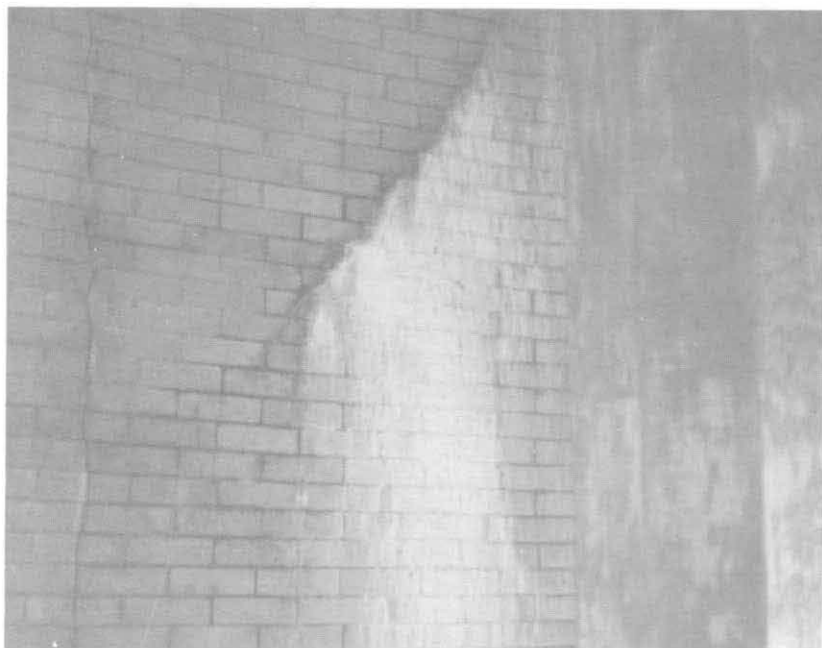
ILLUSTRATION 49. Typical efflorescence and brown stains which occur throughout shaft.

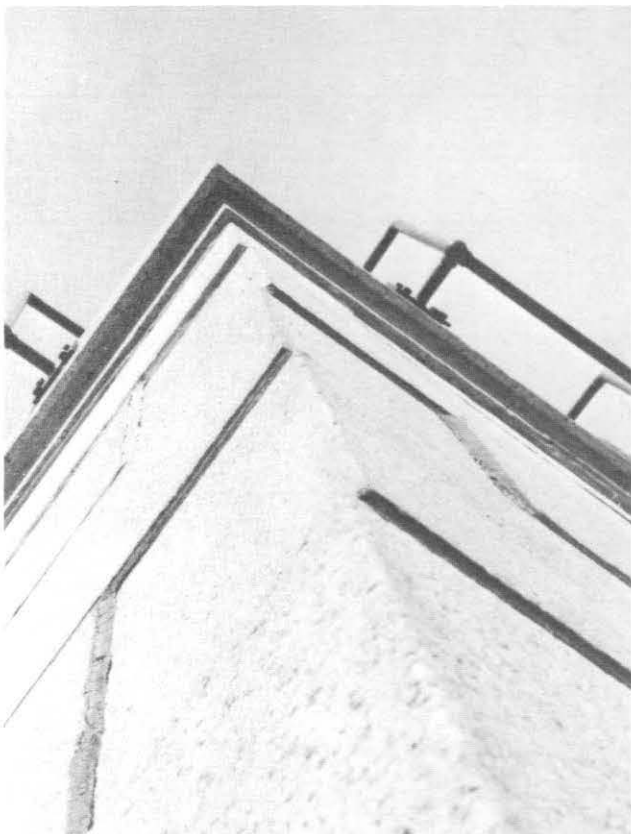
ILLUSTRATION 76. View of exterior of northeast corner of penthouse cornice showing shifted granite blocks, extra wide sealant joints and handrails from navigational lights.

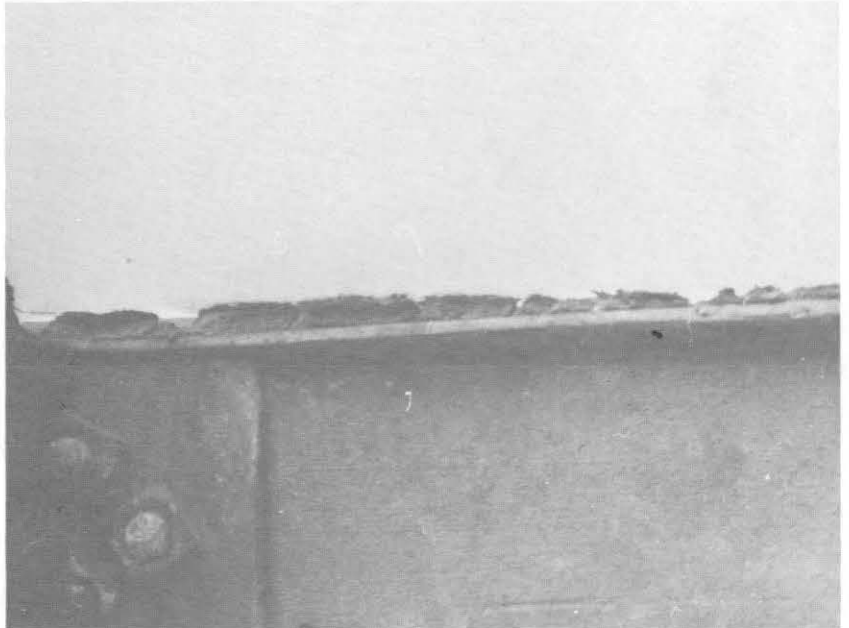
ILLUSTRATION 101. Detail of steel bracing inside of bronze lantern.

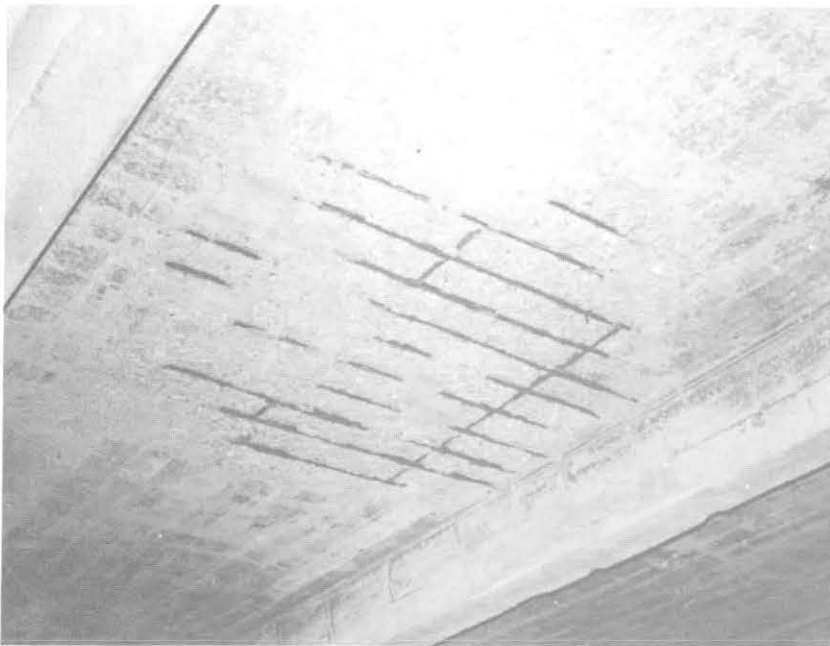
ILLUSTRATION 110. Photo from NPS file showing reinforcing steel in slab and beams.

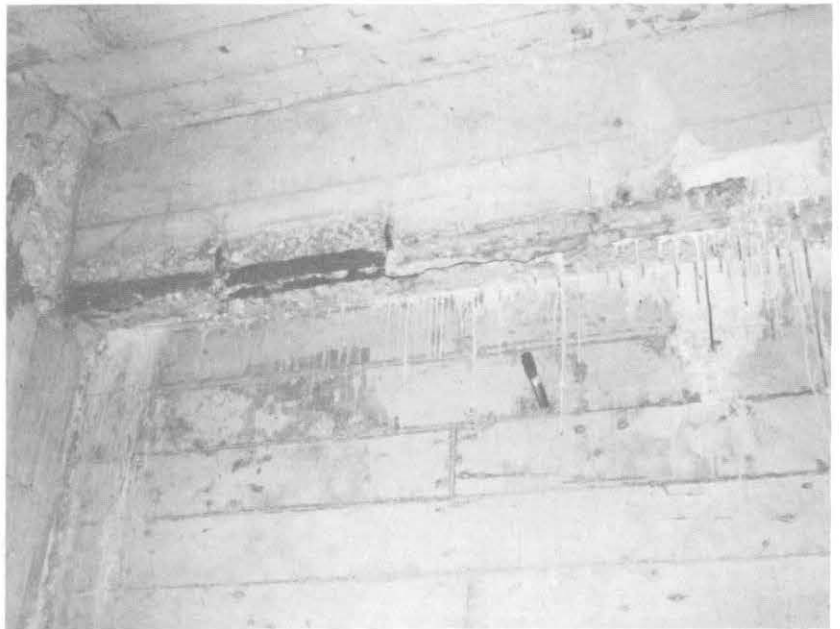
ILLUSTRATION 125. Detail of typical beam with rusting bars and spalled concrete.

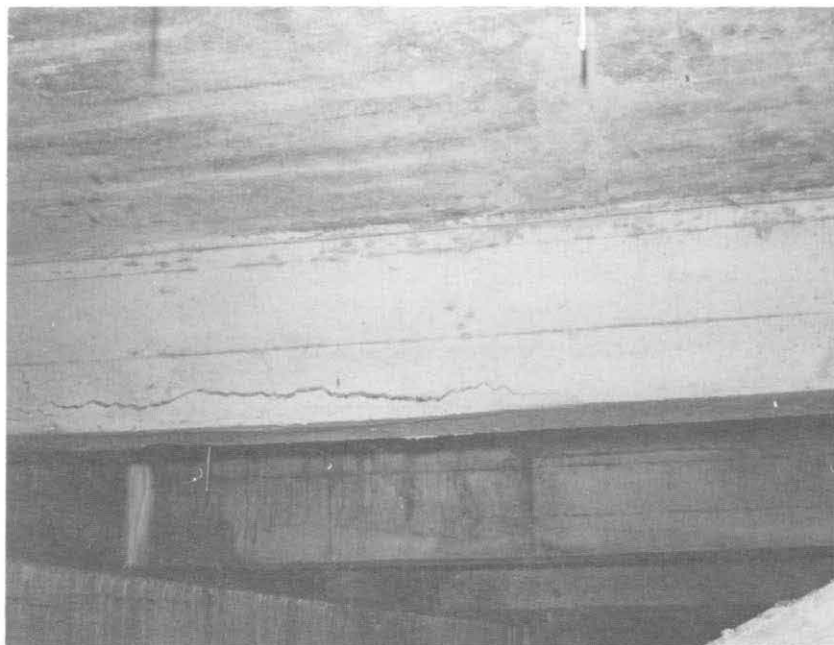
ILLUSTRATION 126. View of beam at outer wall showing rusting bars, spalled concrete and cracks of concrete about to spall from rust buildup behind.

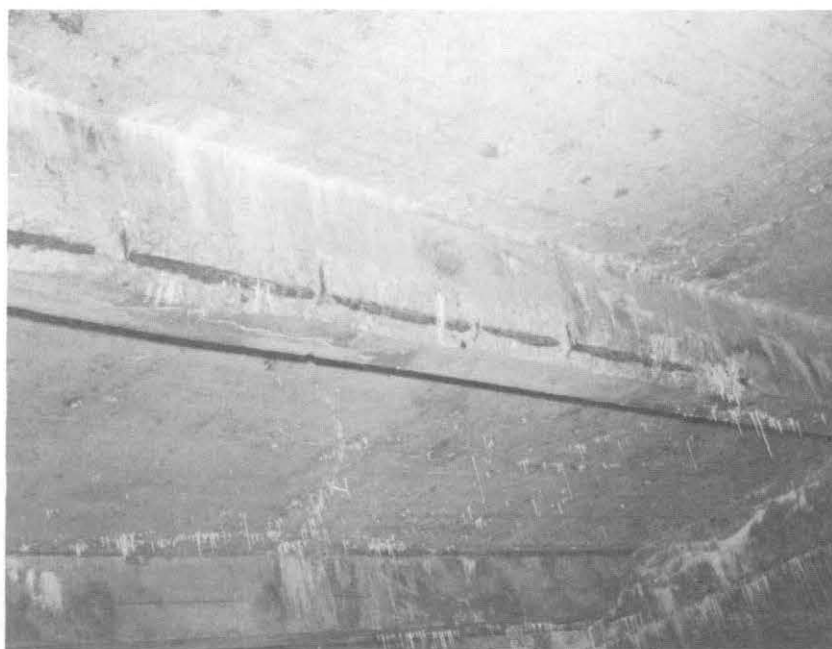
ILLUSTRATION 127. View of a typical beam with crack formed by rusting steel bars behind.

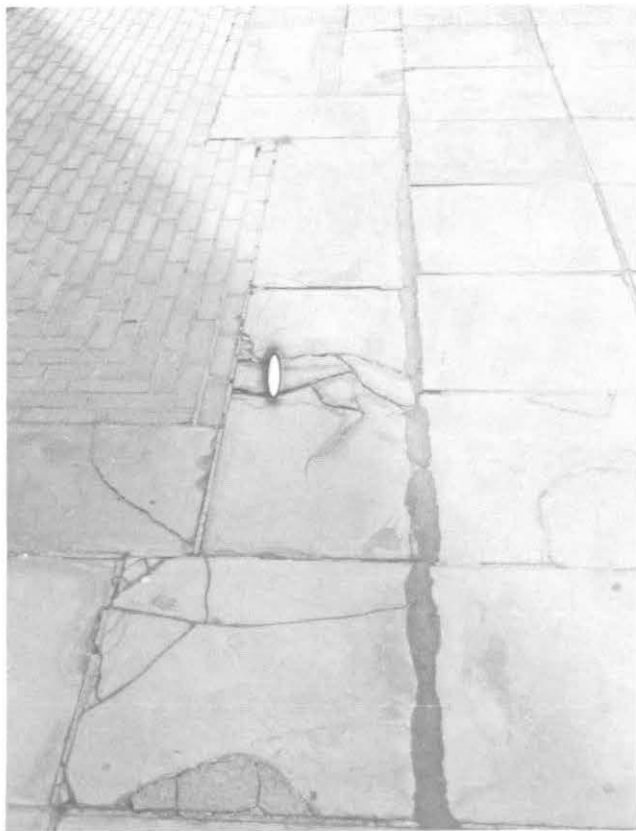
ILLUSTRATION 129. Detail view of condition of concrete fill slab and setting bed below sandstone and brick pavers of upper plaza.

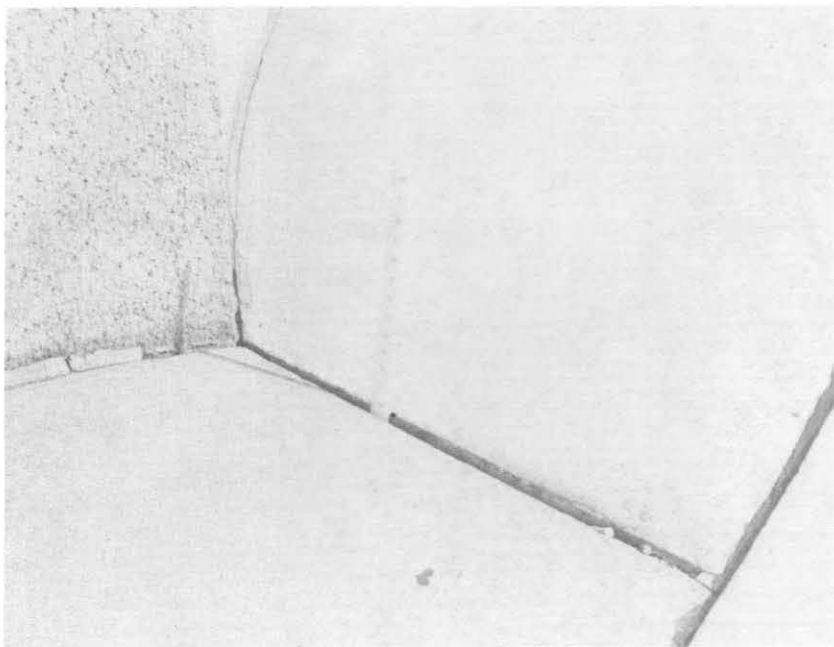
ILLUSTRATION 130. General view at northeast quadrant of upper plaza showing deteriorated joints, cracked and spalled sandstone pavers and brick paving inlay pattern.

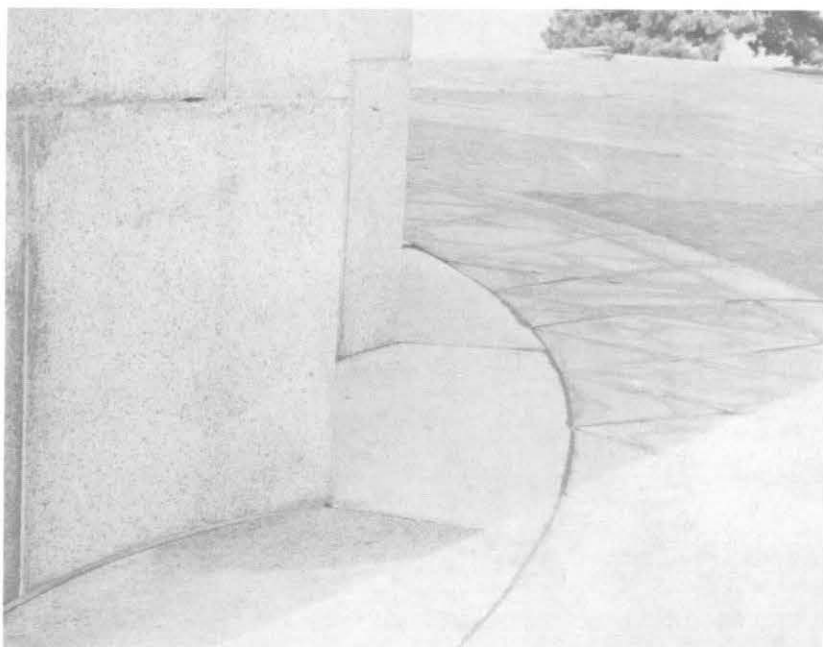
ILLUSTRATION 137. View of sloped concrete ramp at north entrance door.

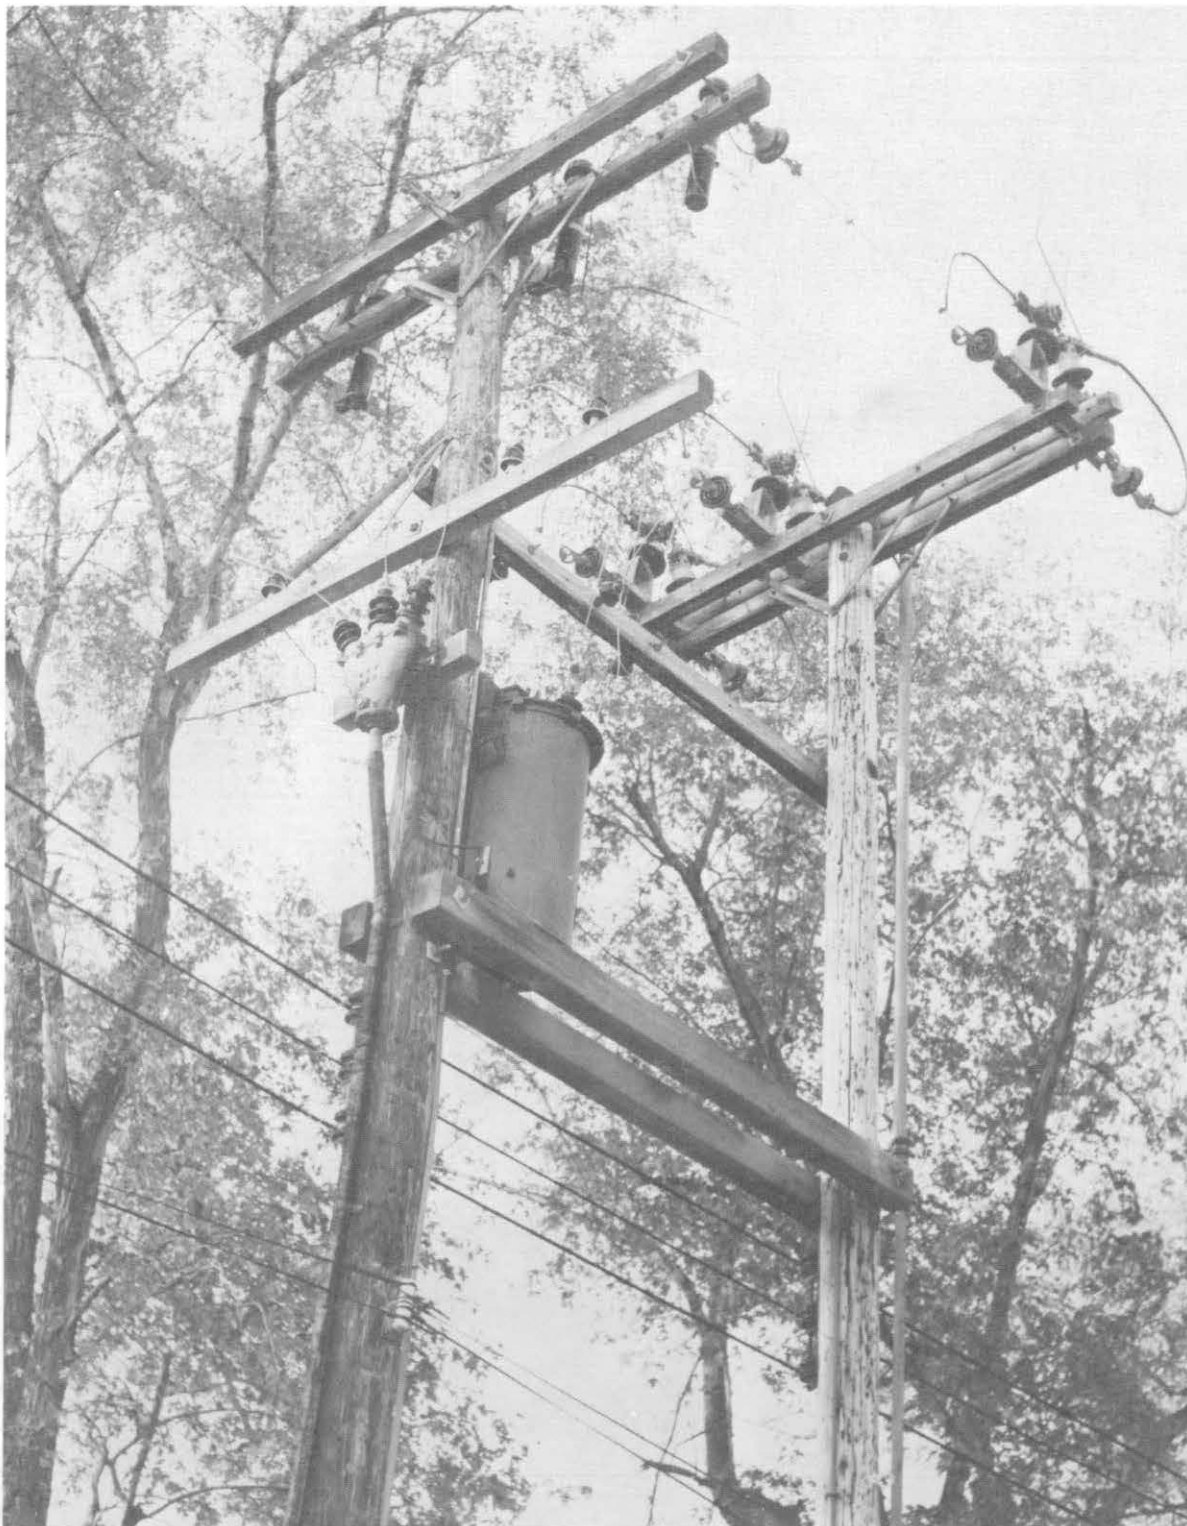
1. OHIO EDISON SERVICE The pole farthest from the transformer is in poor condition and should be replaced.

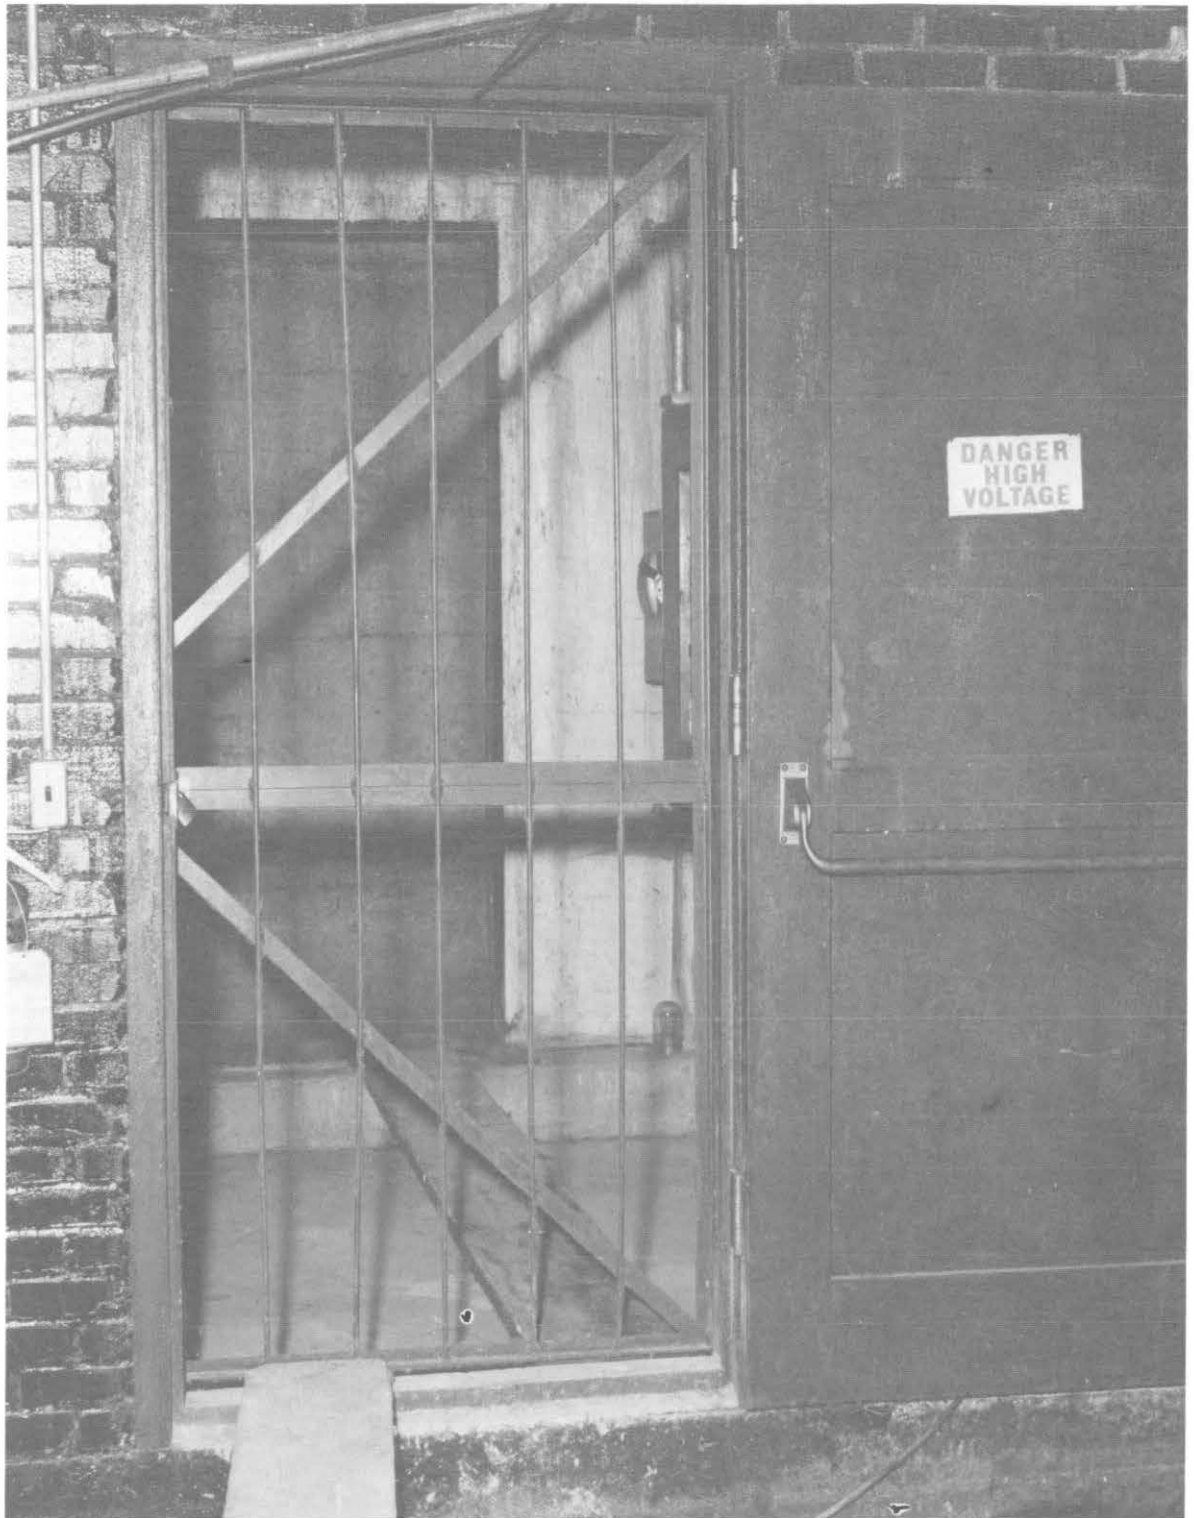
2. BASEMENT TRANSFORMER & SWITCHROOM This room serves as a ventilating corridor for the extremely damp basement. This door should be closed, and the basement should be separately ventilated to prevent rusting and possible arc over on the bus, panelboards, and switchgear.

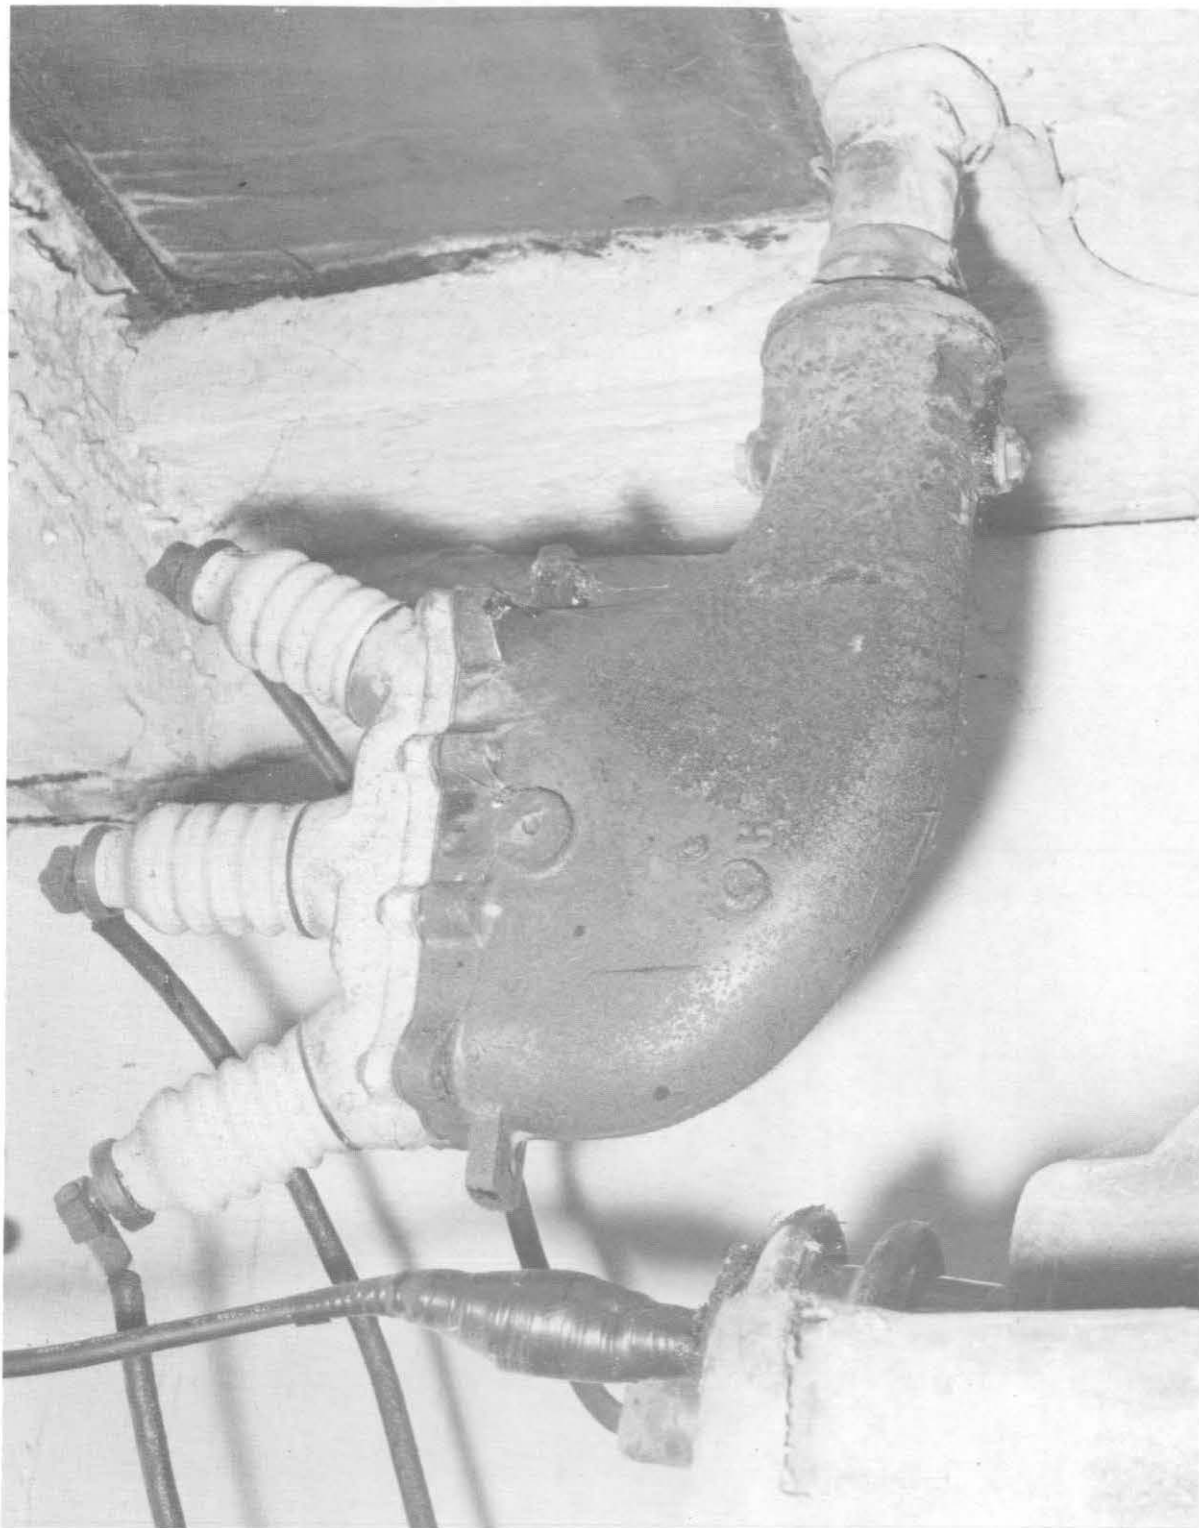
3. SERVICE ENTRANCE POTHEAD This service entrance pothead should be cleaned, and the connections should be taped to prevent birds or rodents from causing an arc over.

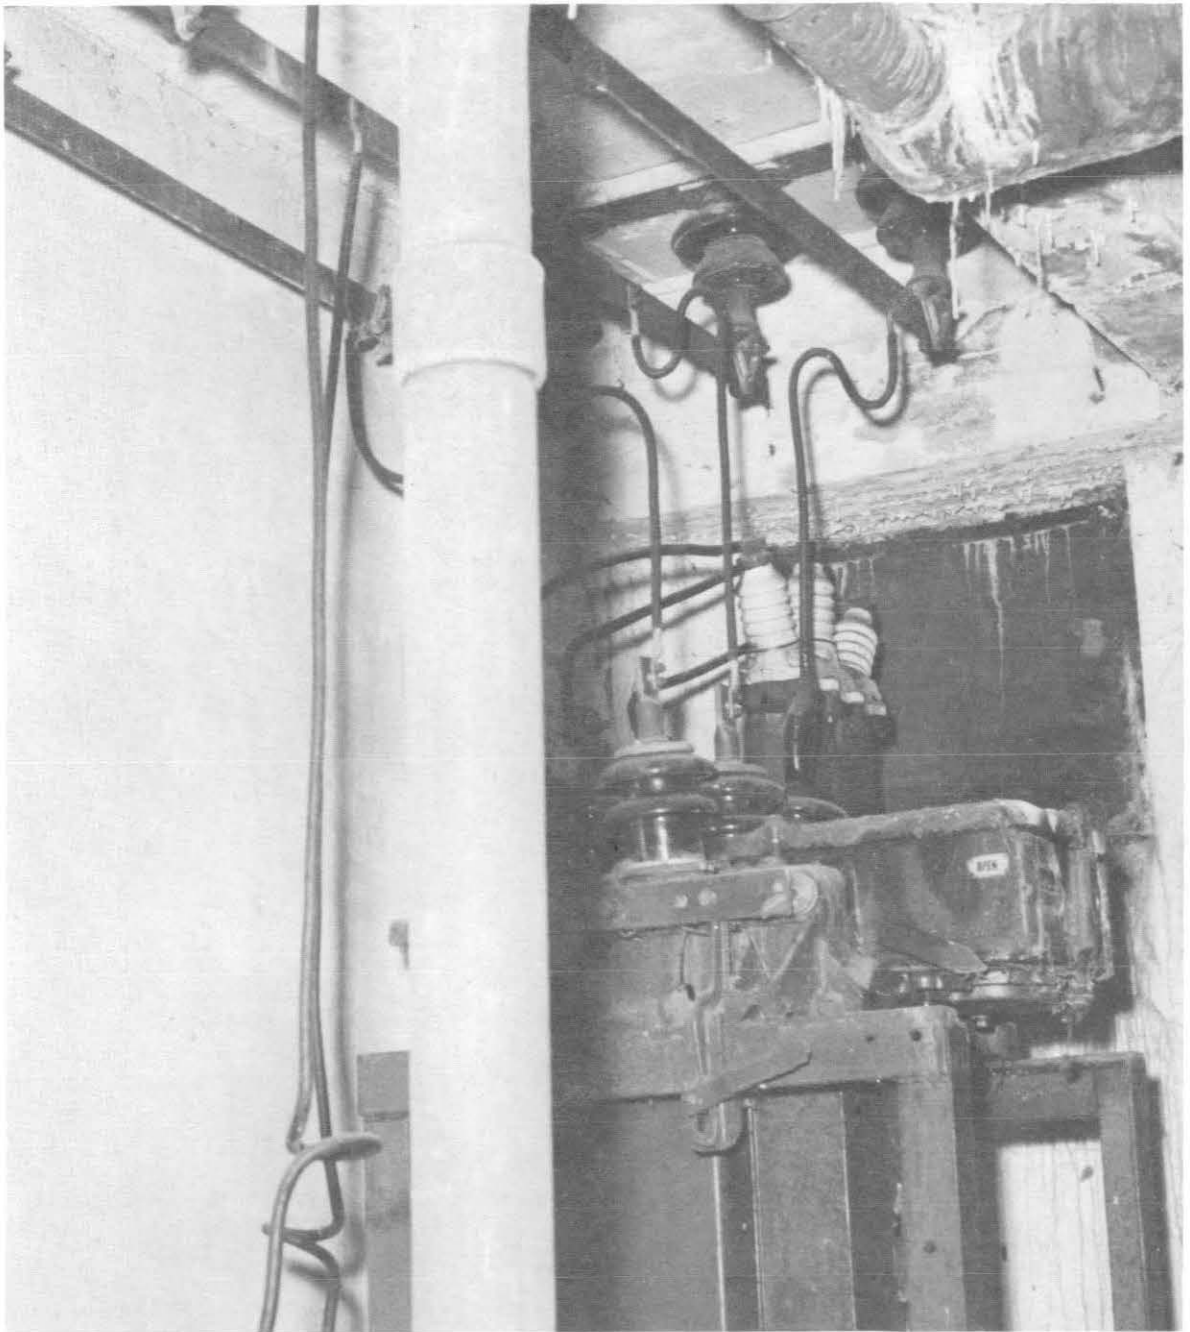
4a. MAIN SERVICE OIL CIRCUIT BREAKER This oil circuit breaker is in extremely dirty condition externally. The operating mechanism did not work due to rusting; we loosened the mechanism to permit proper tripping. This unit requires a complete mechanical and electrical cleaning and overhaul. The ceiling mounted bus and bus insulators should be cleaned and all connections tightened.

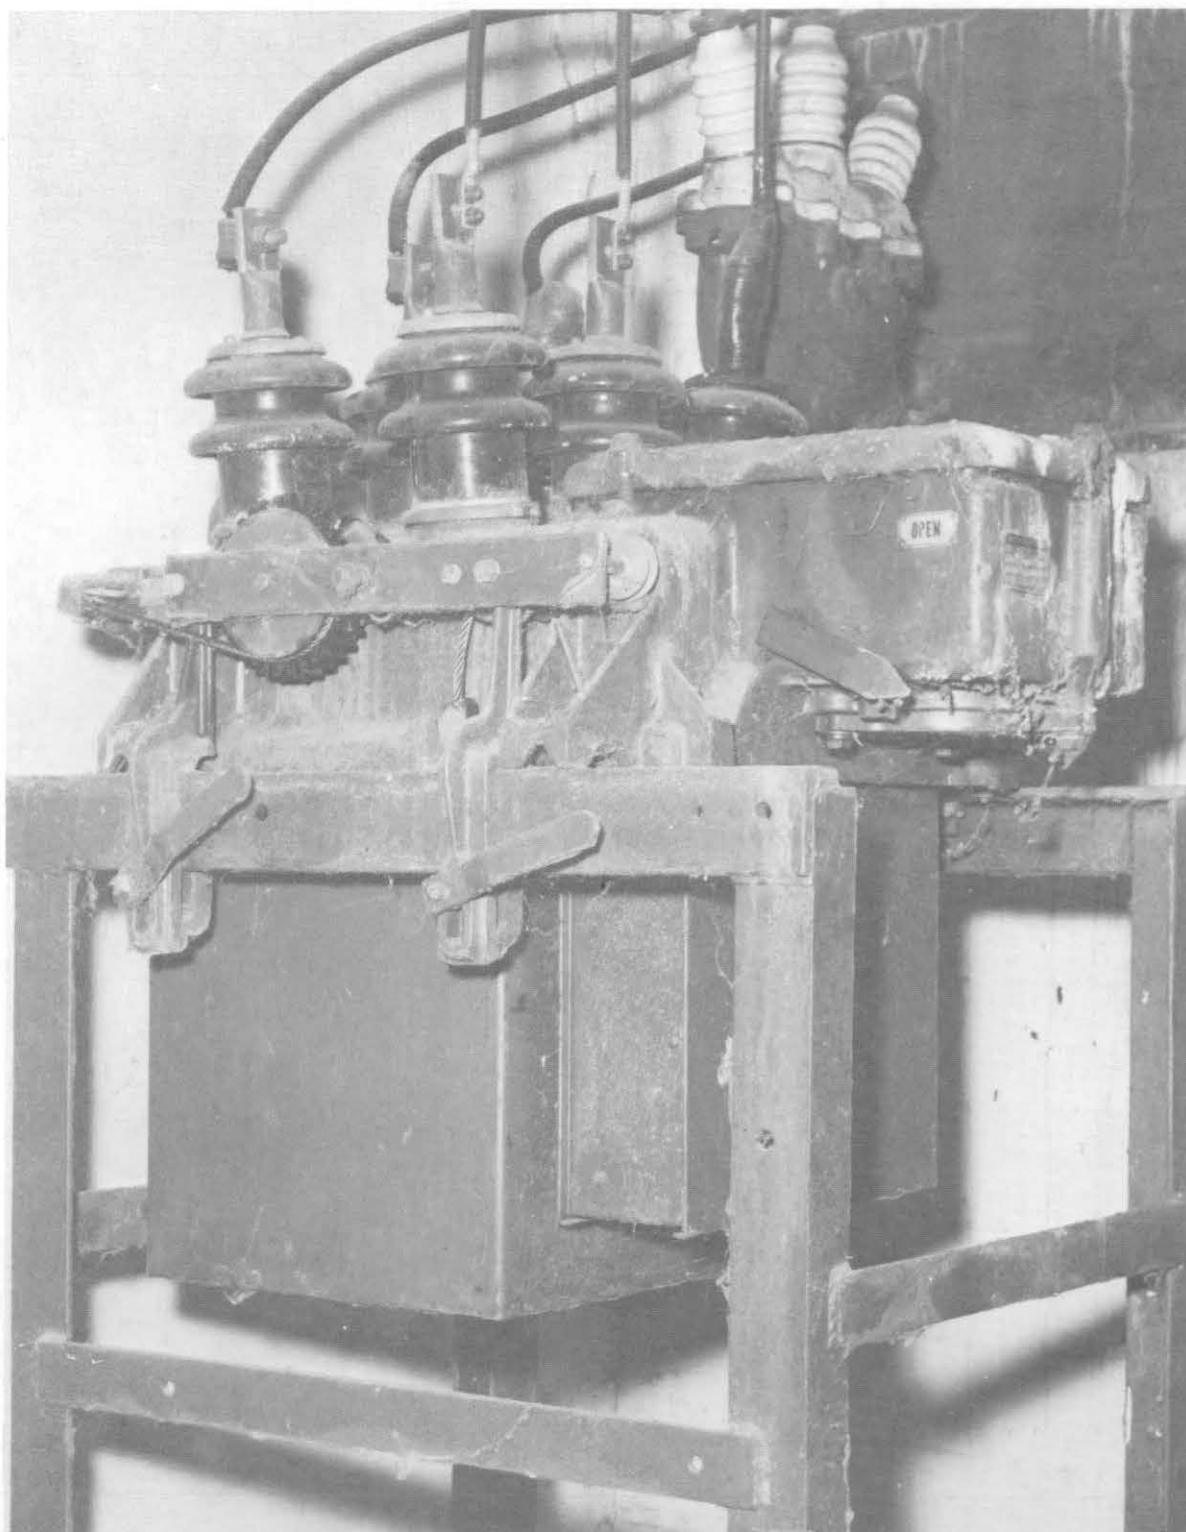
4b. MAIN OIL CIRCUIT BREAKER The line and load terminals of this oil circuit breaker should be taped to prevent bird or rodent arc over.

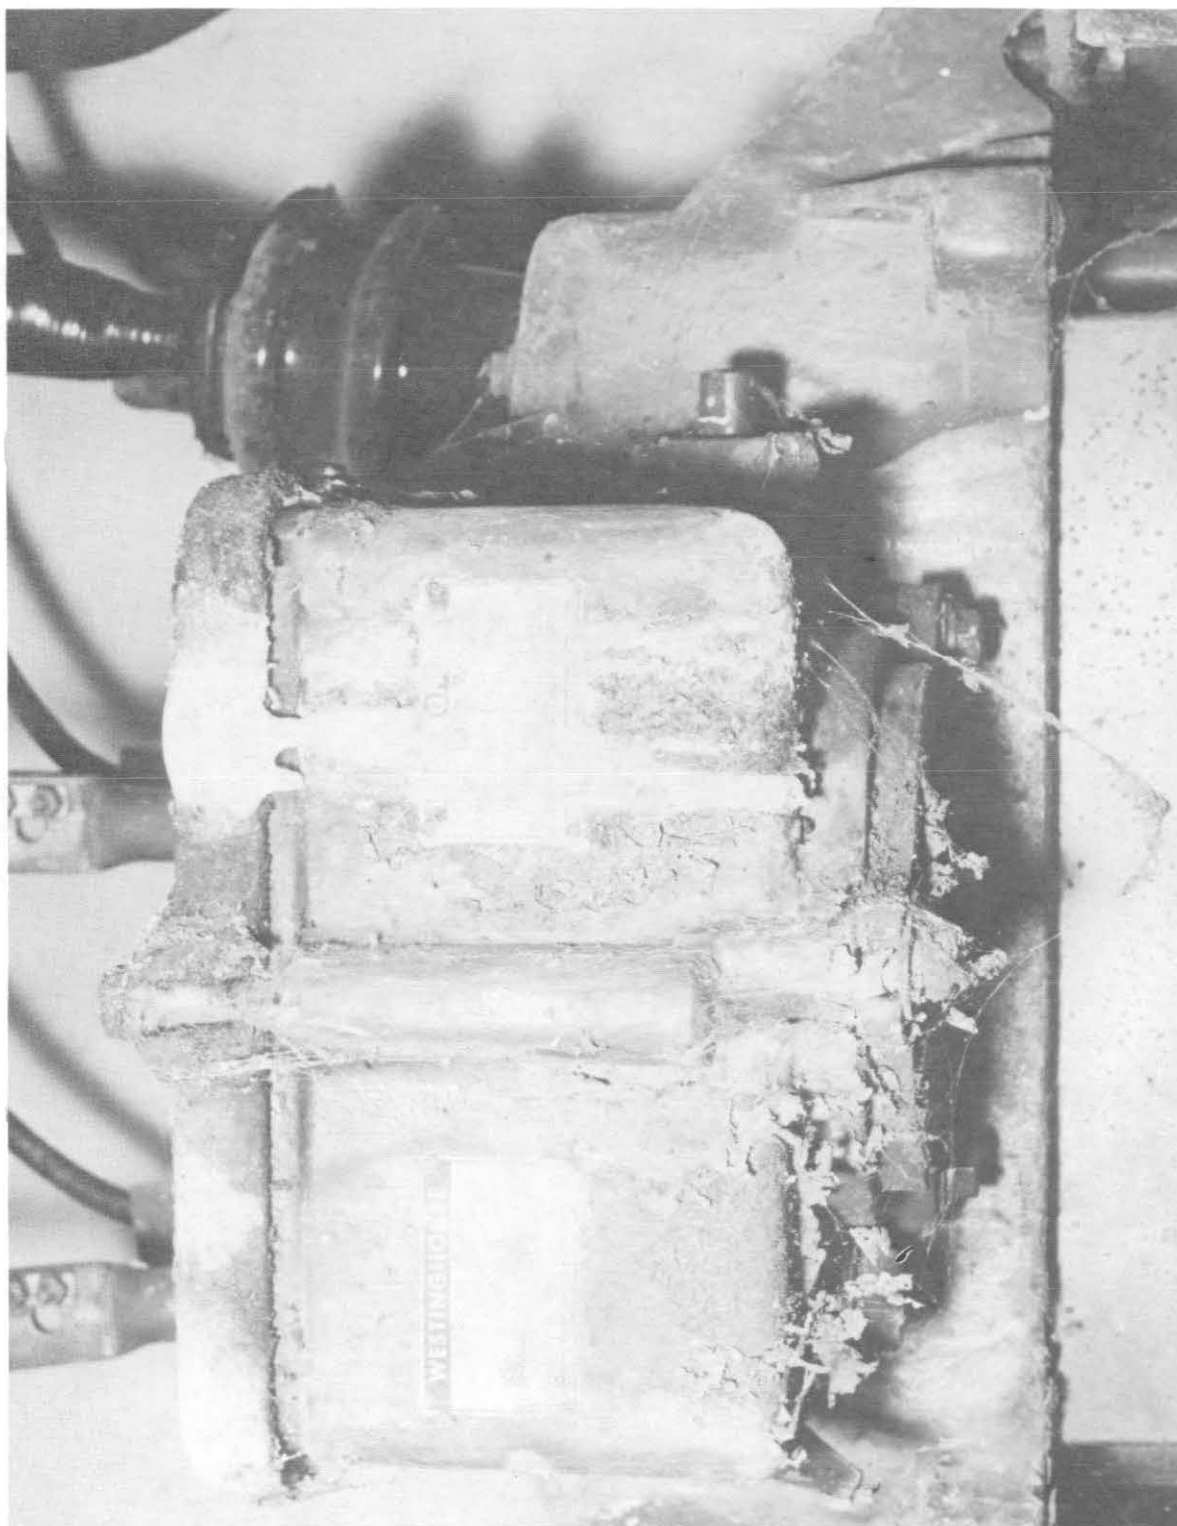
4c. MAIN OIL CIRCUIT BREAKER The entire housing and support framework of this oil circuit breaker should be cleaned and painted with a rust resistant paint.

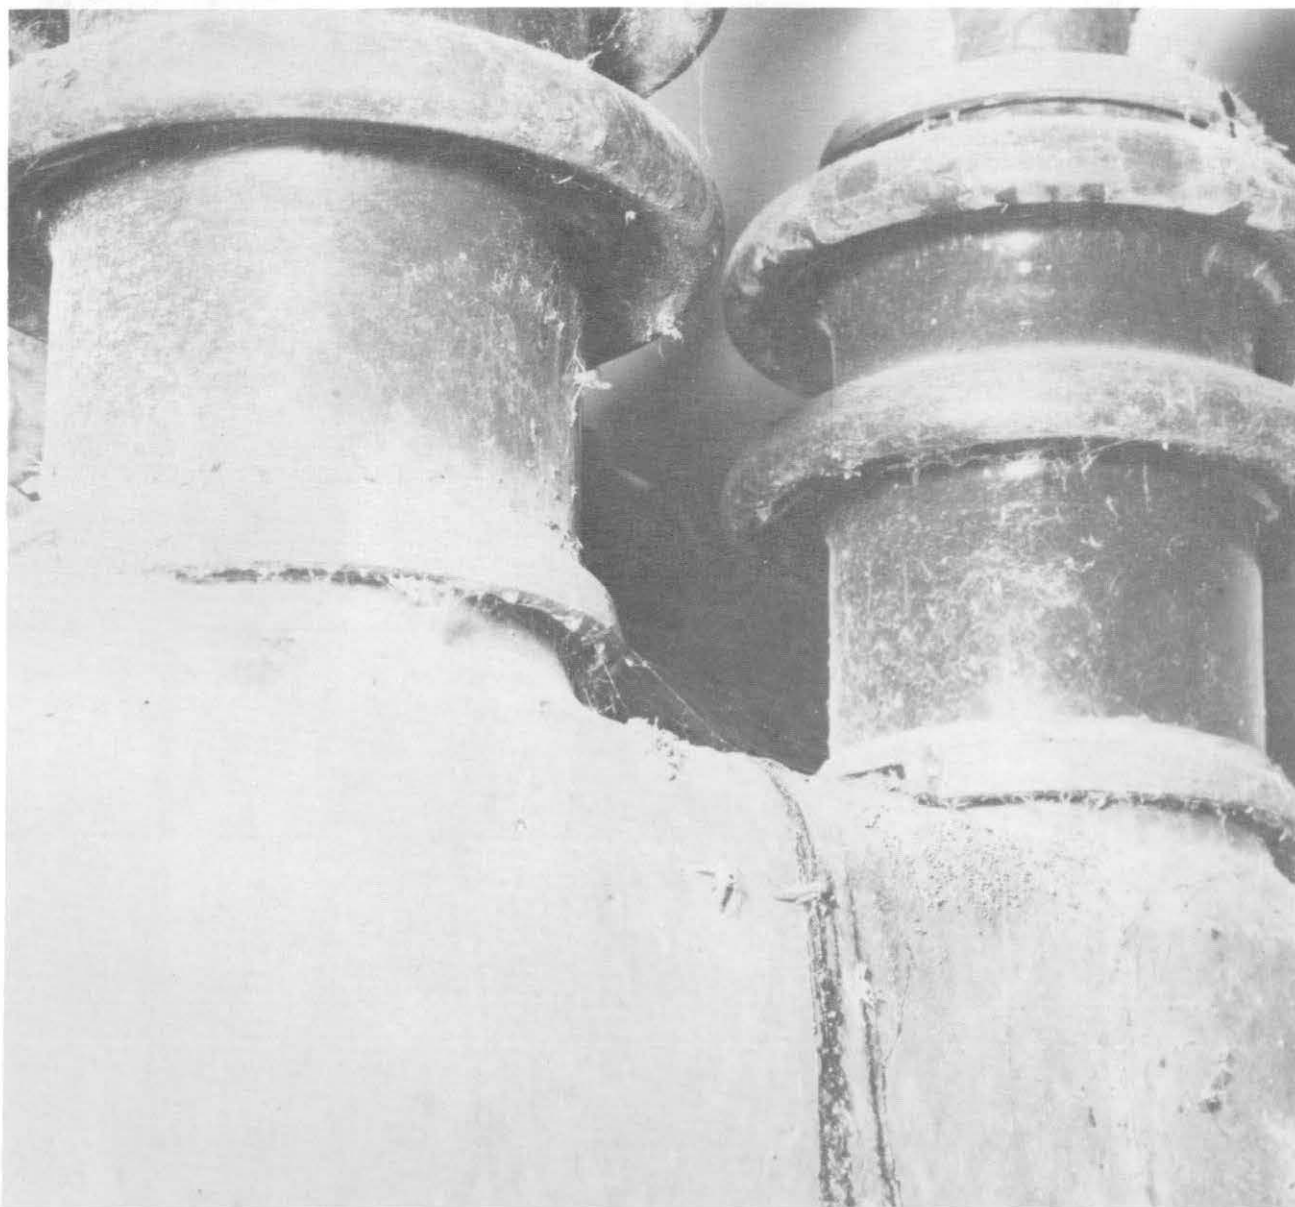
4d. MAIN OIL CIRCUIT BREAKER The extremely dirty bushings should be cleaned, and the connections tightened and insulated.
