december 1976

## PERRY'S VICTORY AND INTERNATIONAL PEACE MEMORIAL MEMORIAL COLUMN AND PLAZAS

Historic Structure Report  
Memorial Column and Plazas  
Administrative and Architectural  
Data  
Perry's Victory and International  
Peace Memorial  
Ohio

DALTON-DALTON-LITTLE-NEWPORT

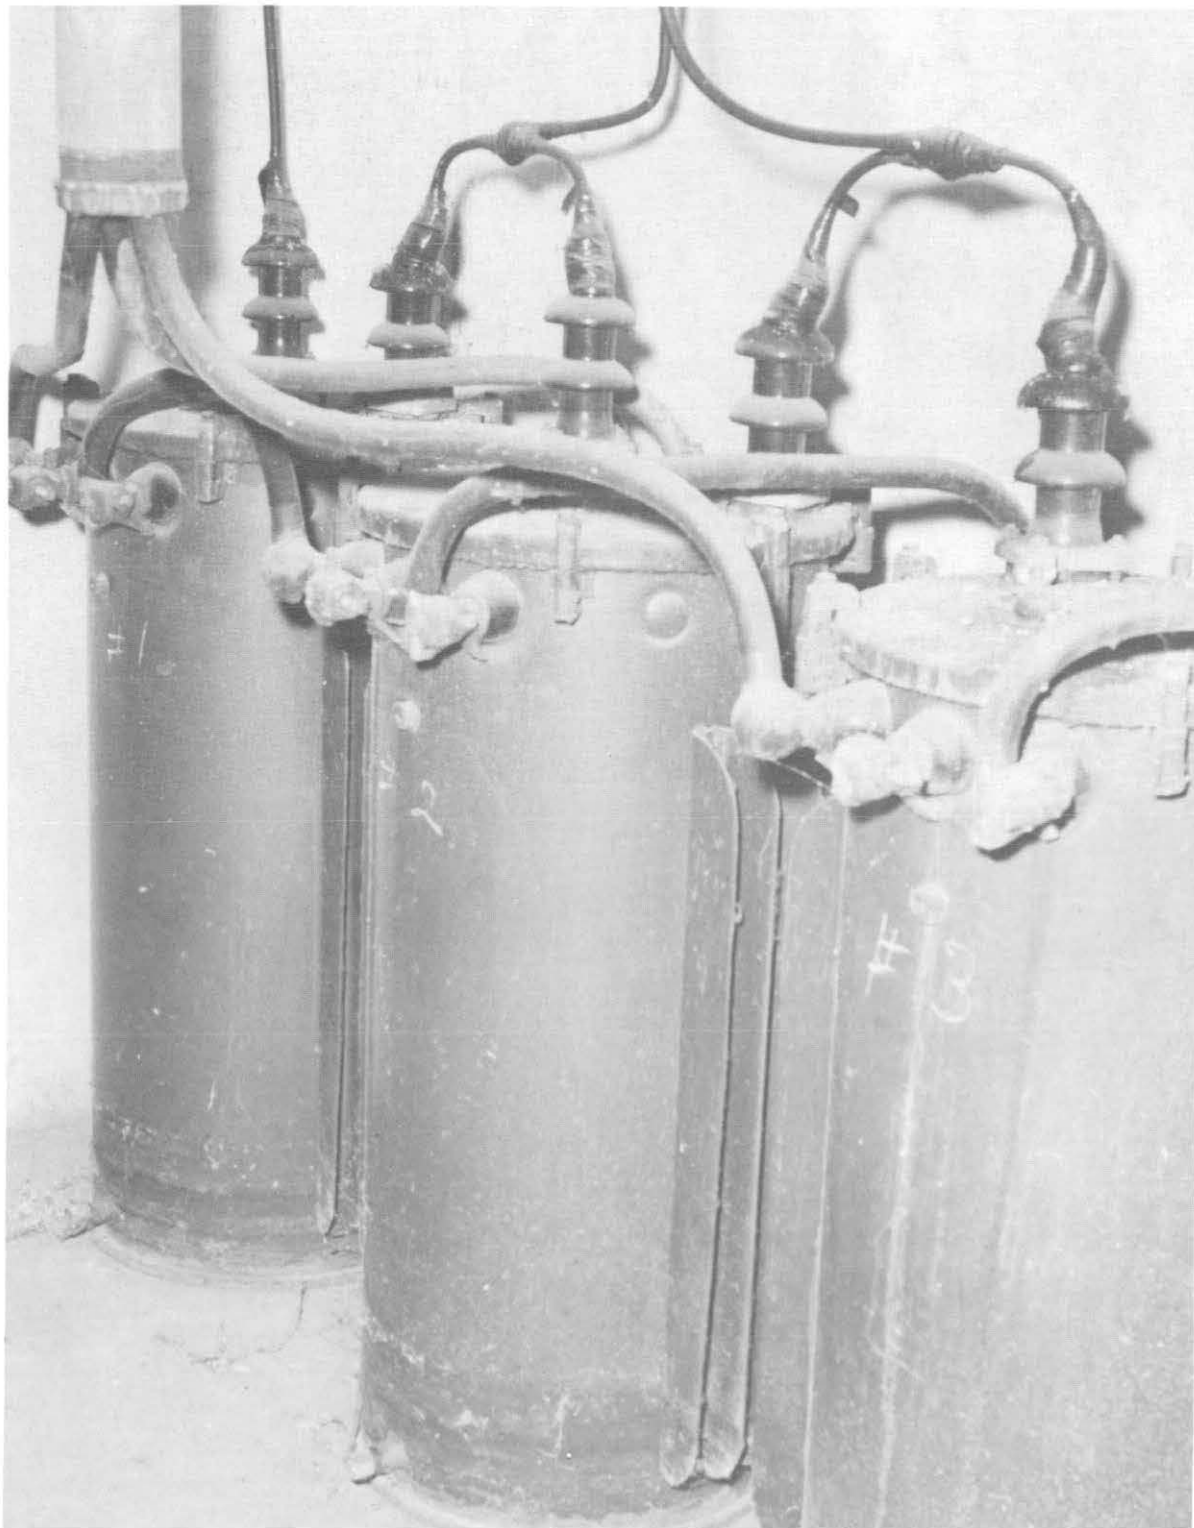
5a. 3-PHASE TRANSFORMER BANK These transformers should be cleaned, rust removed, and painted with a rust resistant transformer paint. The right side transformer tested fair. We recommend a re-test in one year.

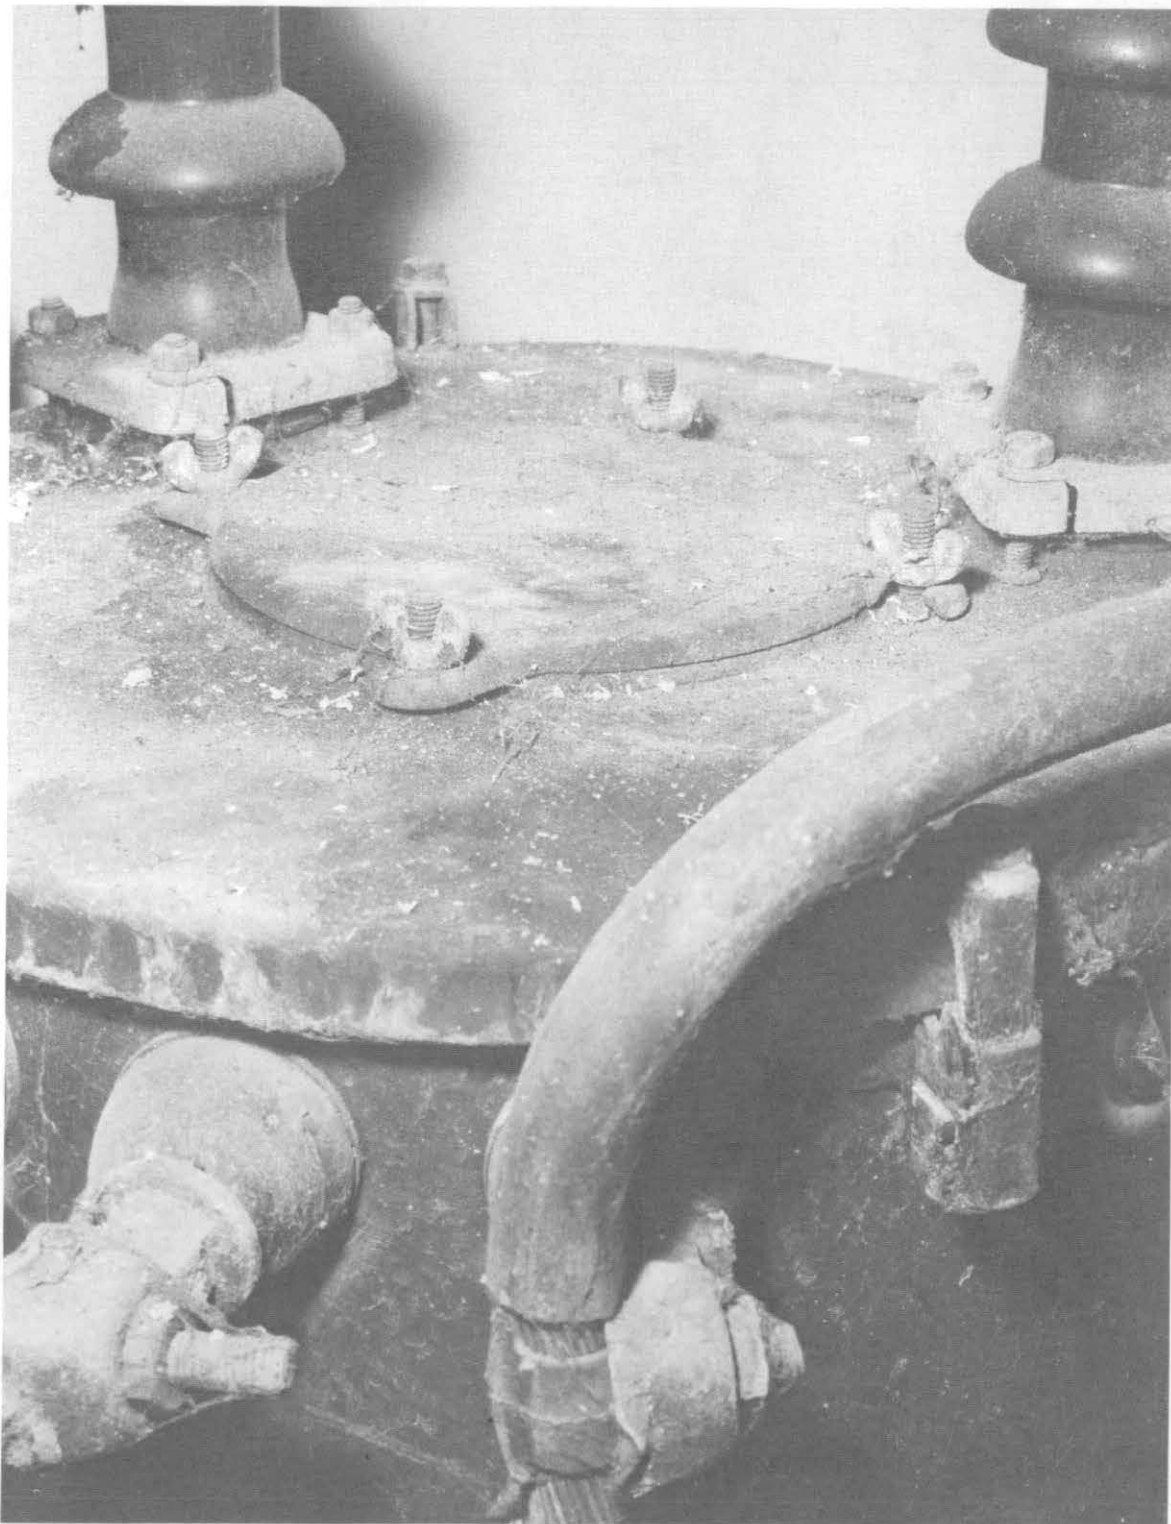
5b. TRANSFORMER The high voltage transformer bushings should be cleaned, and the connections should be reinsulated. (NOTE WET BUSHINGS FROM INSULATING MATERIAL LEAKAGE.) The low voltage bushings should be cleaned and tightened.

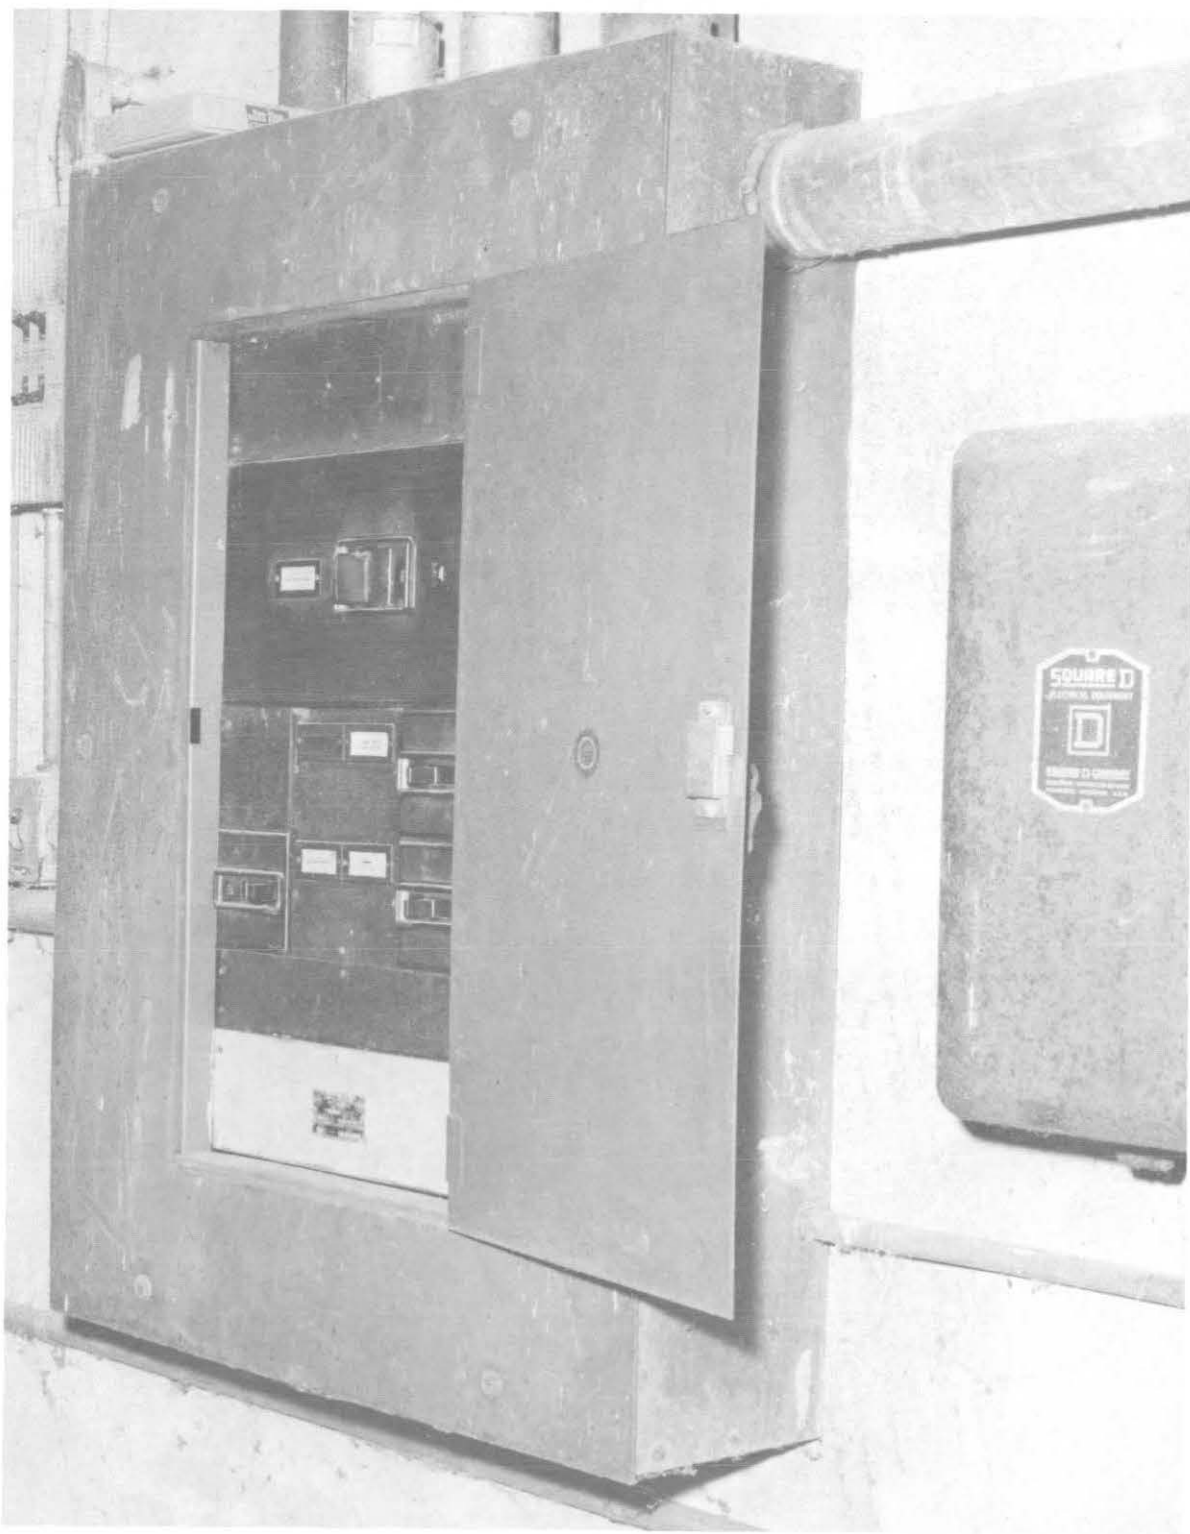
6. MAIN 208-VOLT 3-PHASE PANELBOARD This panel board should be vacuum cleaned internally, all cable connections should be tightened, and the cabinet should be dismantled and cleaned of rust inside and outside and painted with a rust resistant panelboard paint. All bus connections should be dismantled, cleaned, lubricated with conducting grease, and torqued for proper connection tightness. The Boiler Room 100-AMP, 3-pole, circuit breaker is bad and should be replaced.

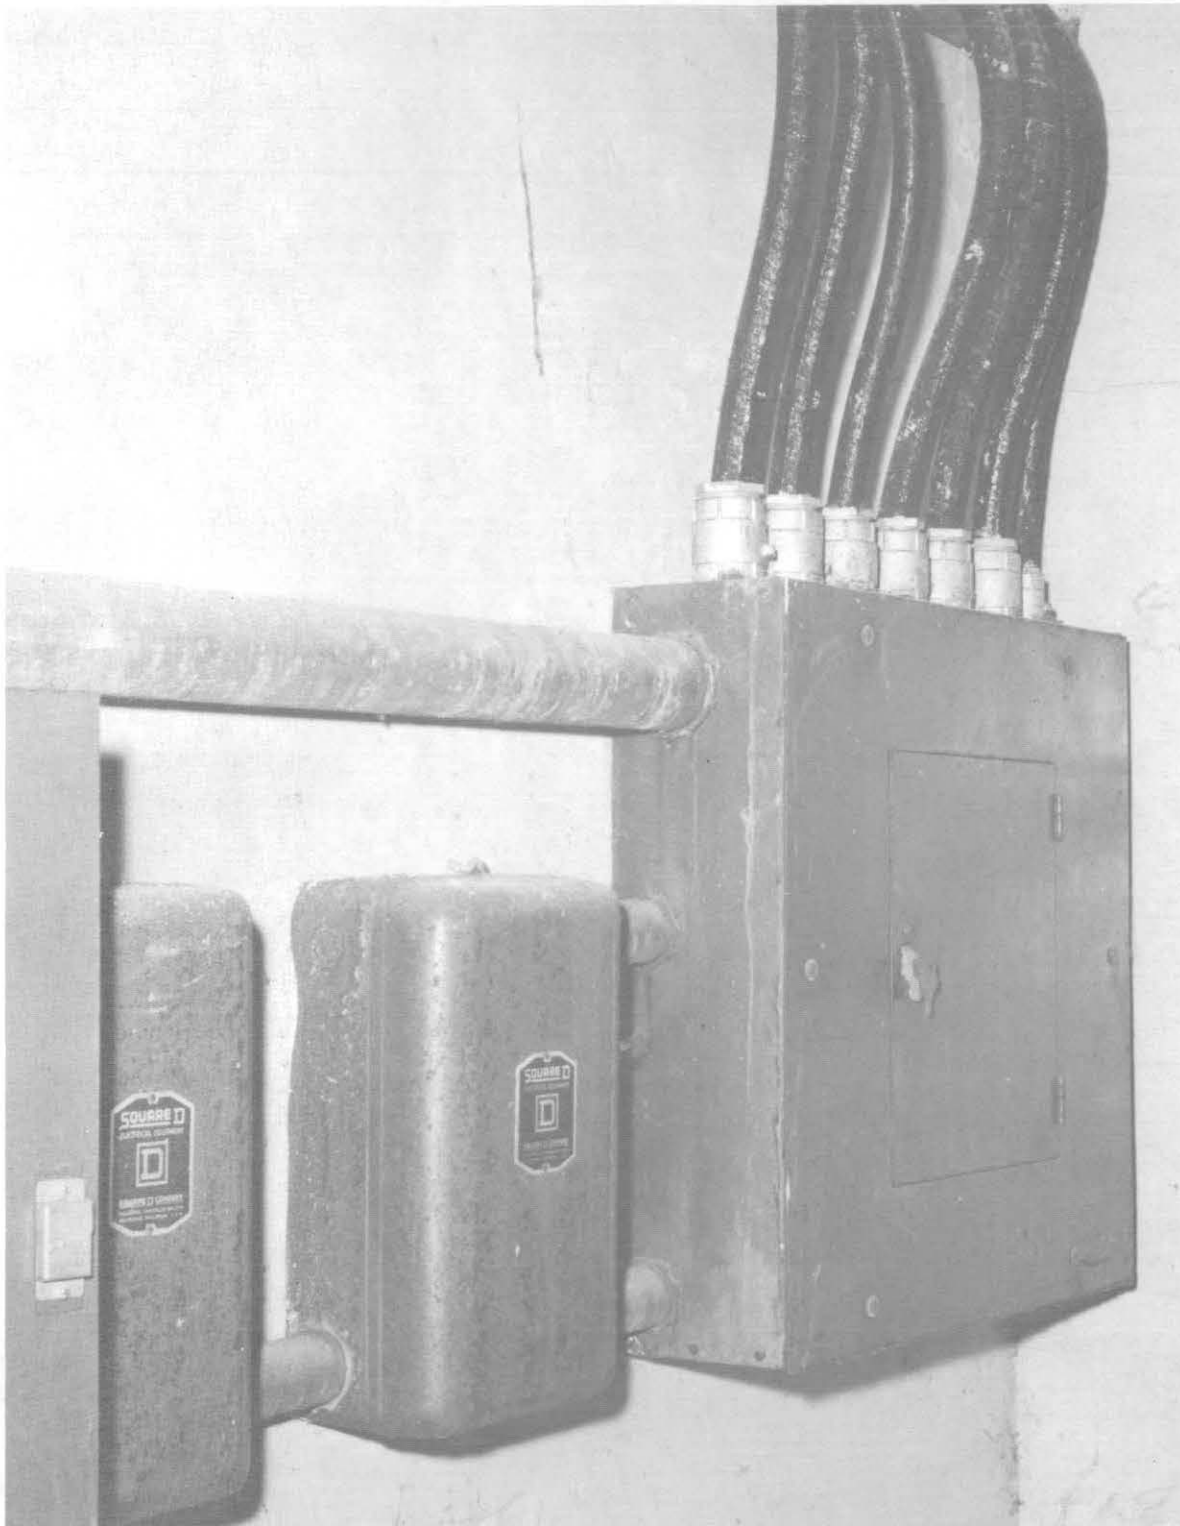
7. MAIN 120-VOLT PANELBOARD This panelboard should be vacuum cleaned internally, all cable connections should be tightened, and the cabinet should be dismantled and cleaned of rust inside and outside and painted with a rust resistant panelboard paint. All bus connections should be dismantled, cleaned, lubricated with conducting grease, and torqued for proper connection tightness.

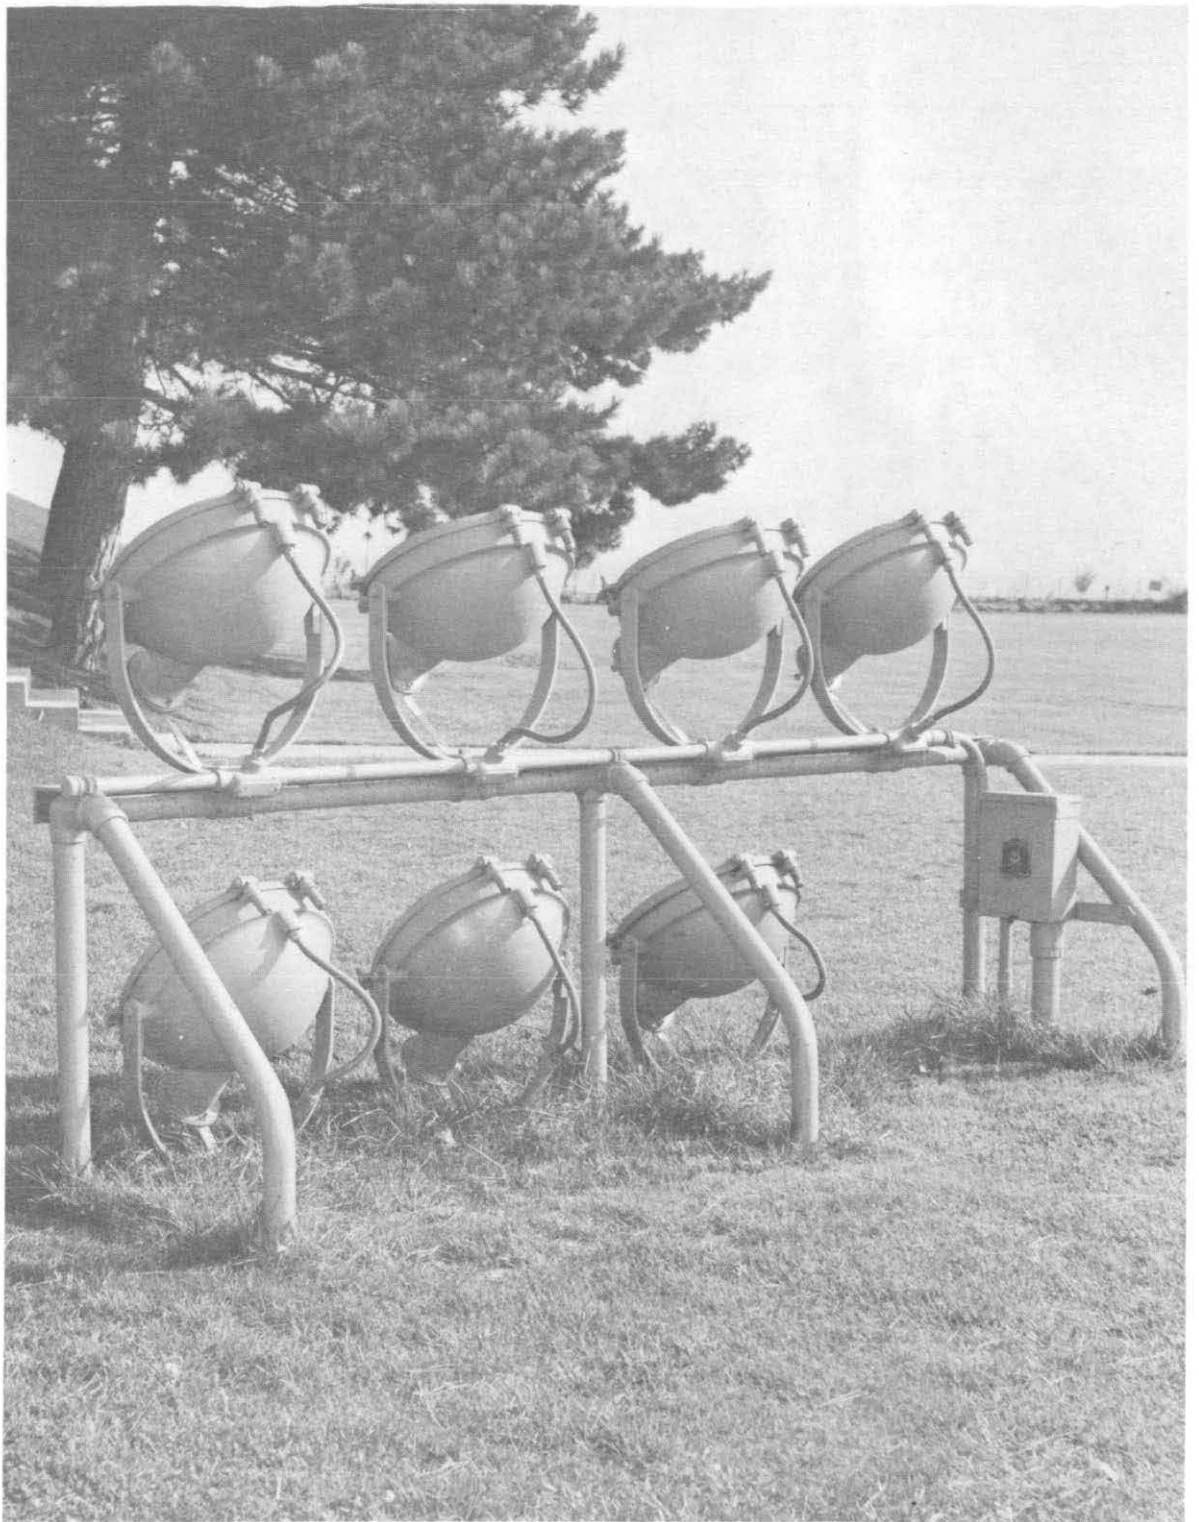
8a. OUTDOOR FLOODLIGHTING The outdoor floodlighting distribution panel-board should be replaced with a heavy-duty outdoor enclosure type panel-board. The existing panelboards are severely rusted. (SEE PHOTOGRAPH 8b.) The northeast floodlight feeder tested bad. All other floodlight feeders tested marginal or fair.

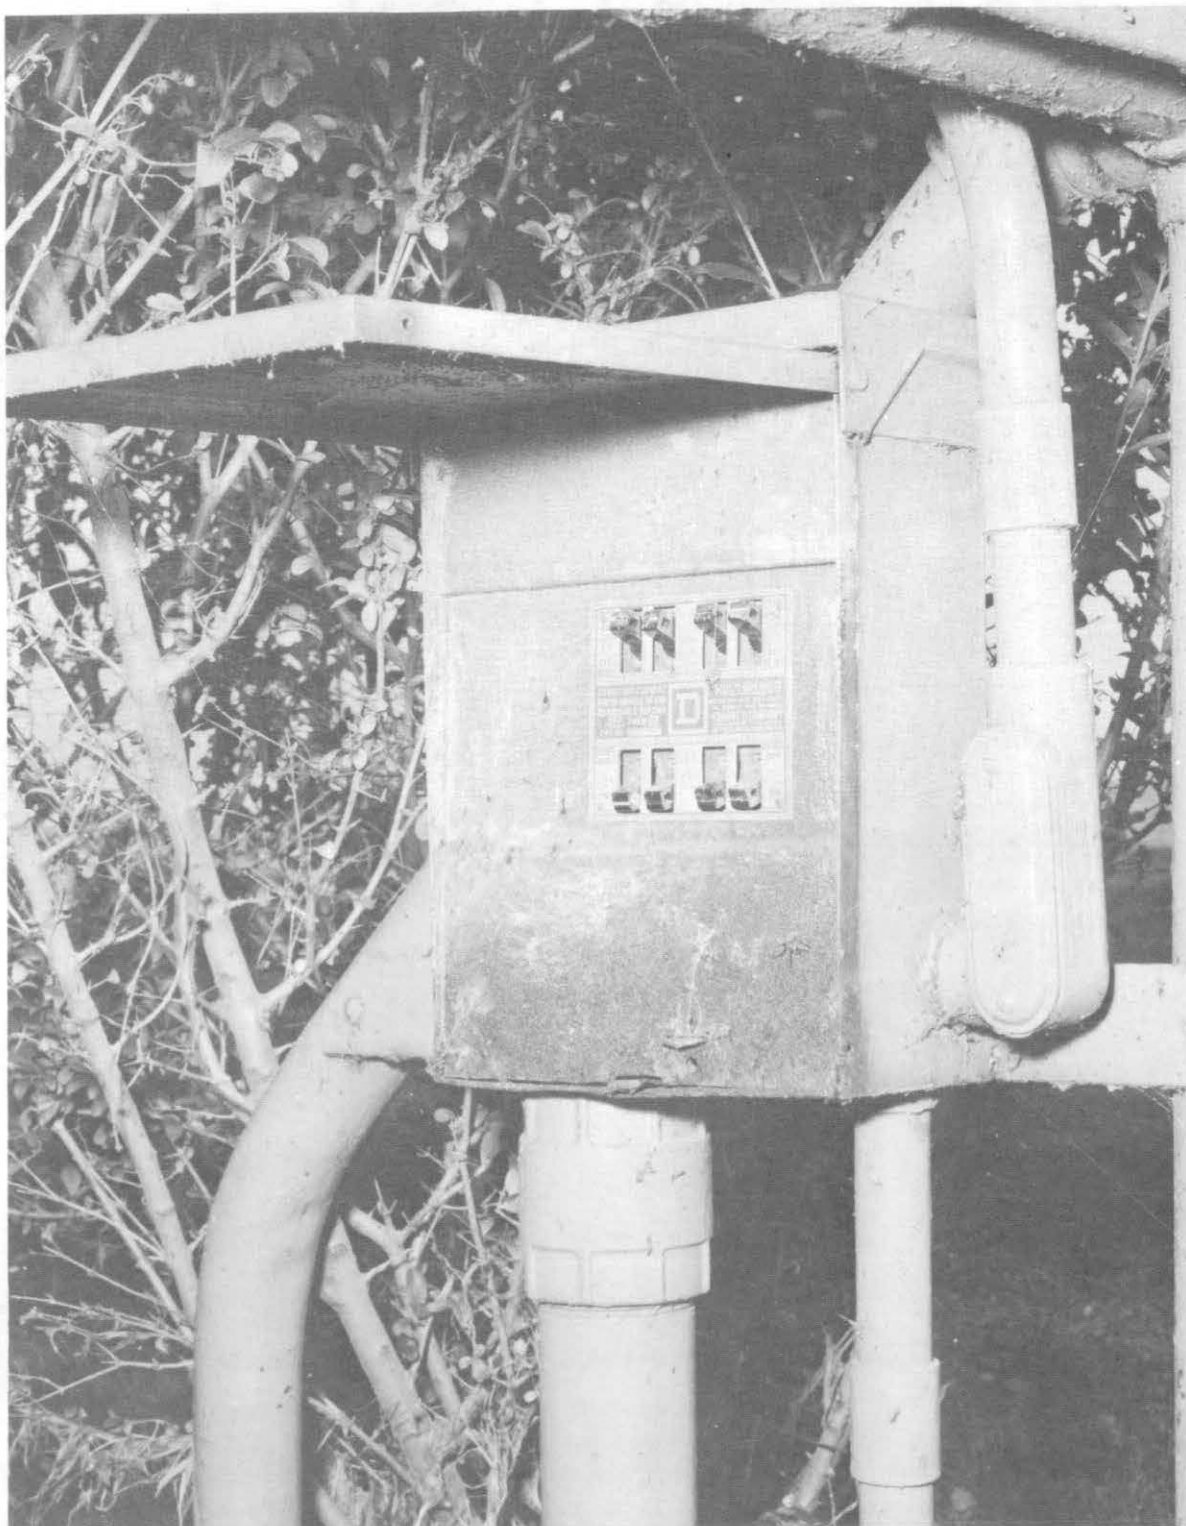
8b. OUTDOOR FLOODLIGHTING PANELBOARD The extremely rusted condition of this panelboard warrants its replacement as noted in comments on photograph 8a.

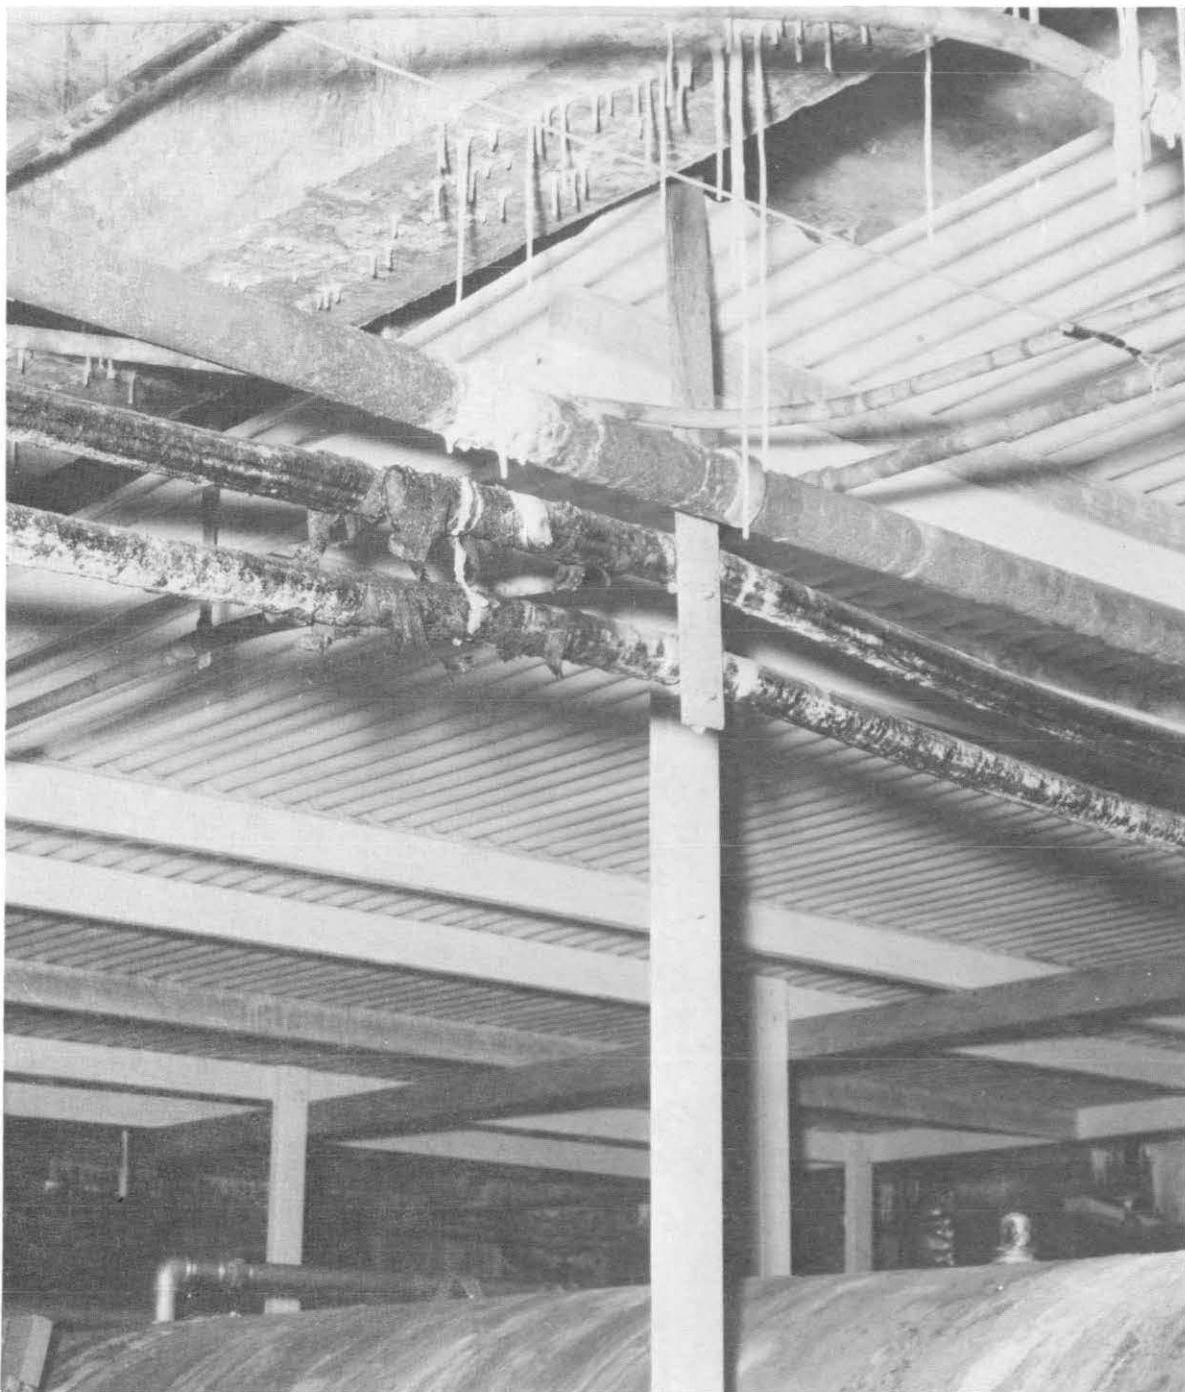
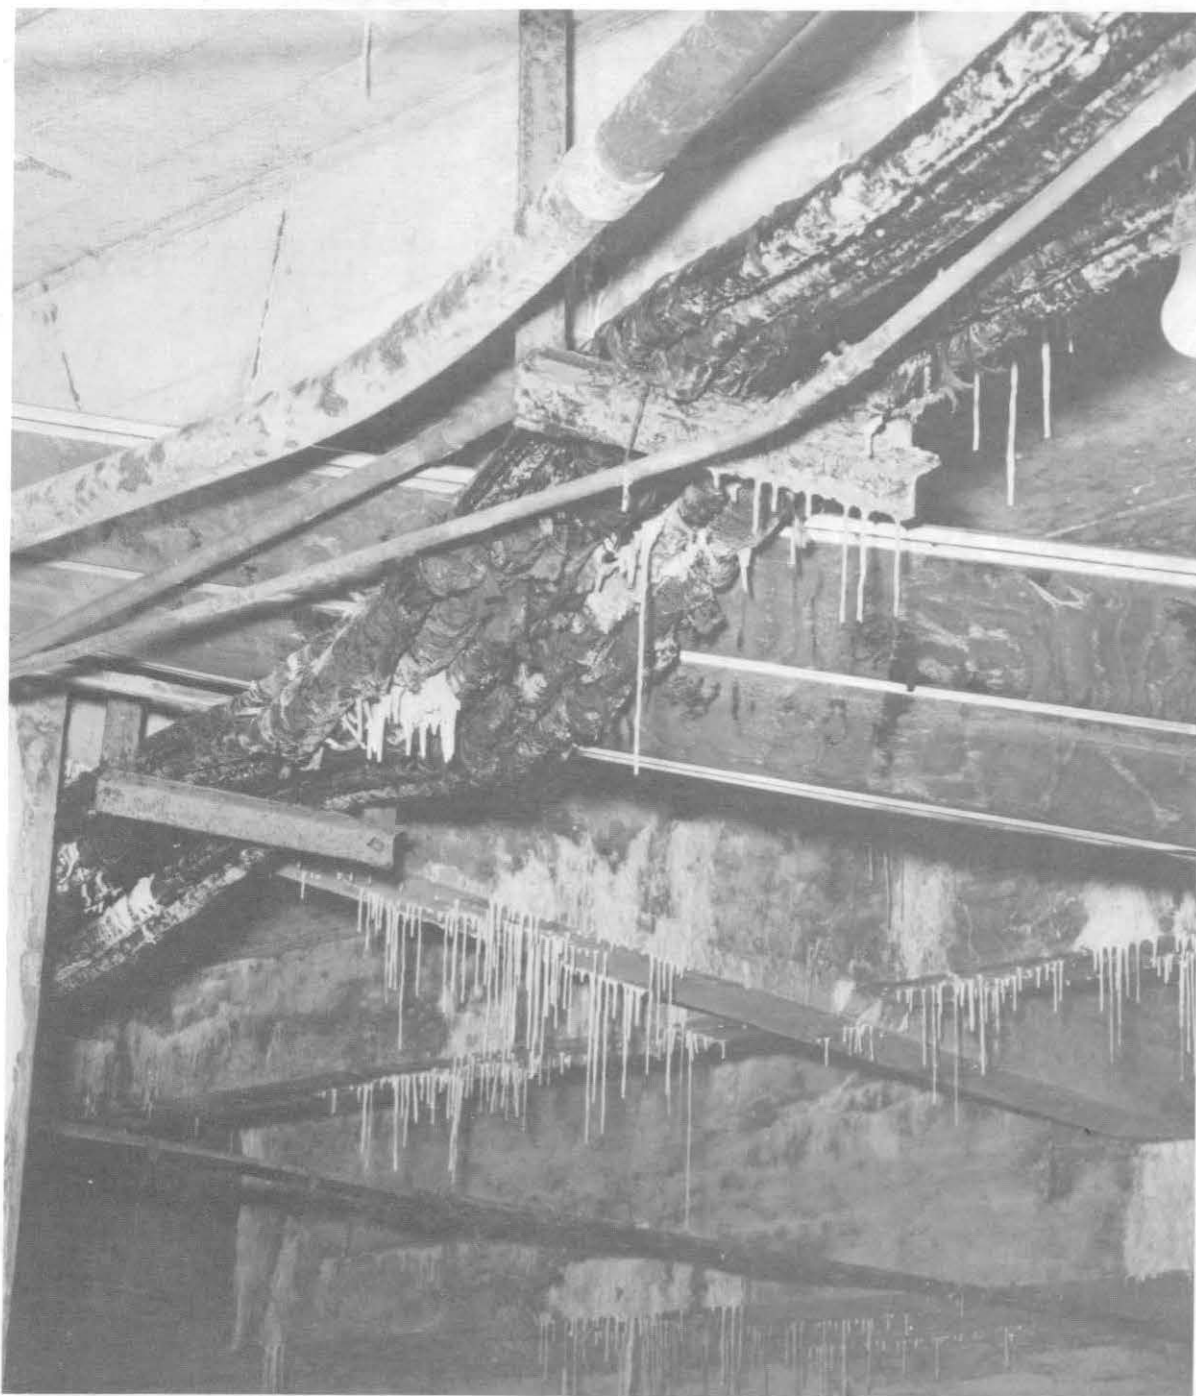
9a. BASEMENT CABLE The cables for floodlighting, elevator, and interior lighting are inadequately supported and exposed to damage and high stress concentrations at the support point. A cable tray and conduit system should be installed to continuously support these circuits. As an alternative, a stress spreading support plate should be installed at all attachment points. The outer jacket should be repaired with vinyl type tapes where the severe jacket damage and rotting are noted.

9b. BASEMENT CABLE See 9a.

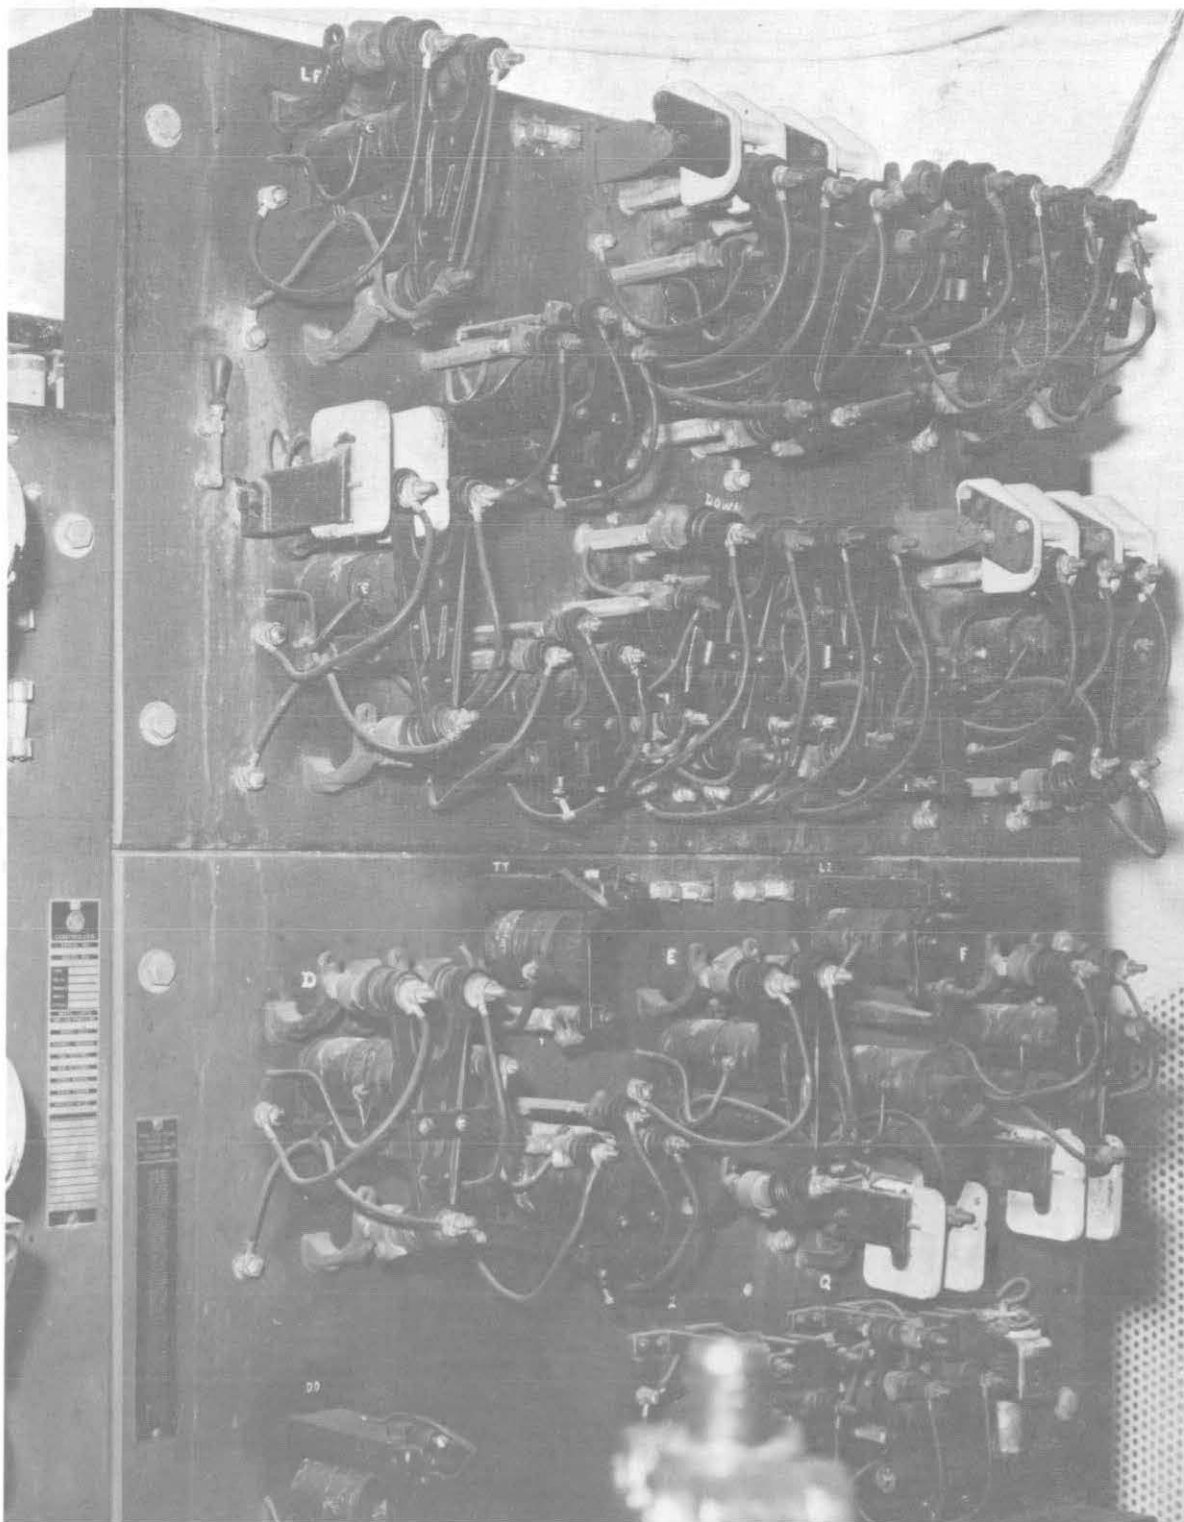
10a. ELEVATOR CONTROL PANELBOARD The elevator control panelboard should be cleaned, all contacts burnished, and all connections tightened. All solenoid and contactor coils should be painted with an insulating paint, and all inter-connecting control wiring with brittle or damaged insulation should be replaced. All backboard connections should be cleaned and tightened. A complete inventory of replacement parts should be developed, and a spare parts locker should be installed at the panelboard location.

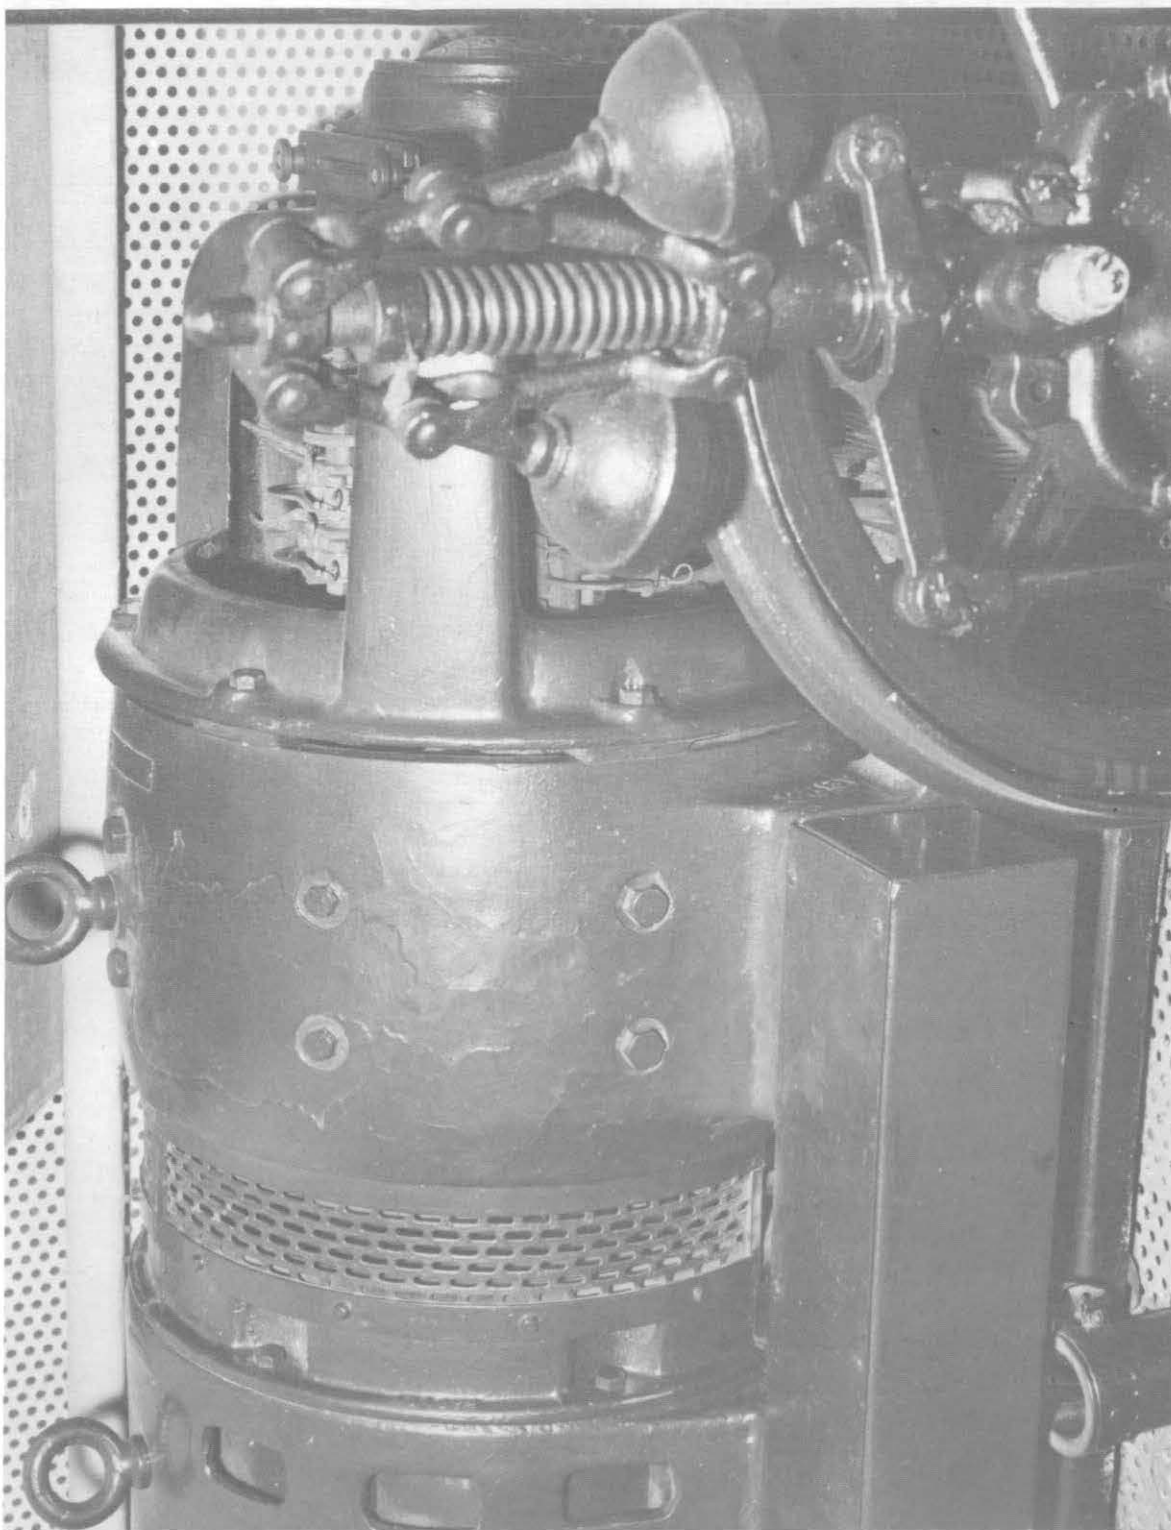
10b. ELEVATOR MOTOR GENERATOR SET This motor generator set should have the commutator section vacuumed, the brush holder boxes and connections cleaned, and the brush shunt connections checked.

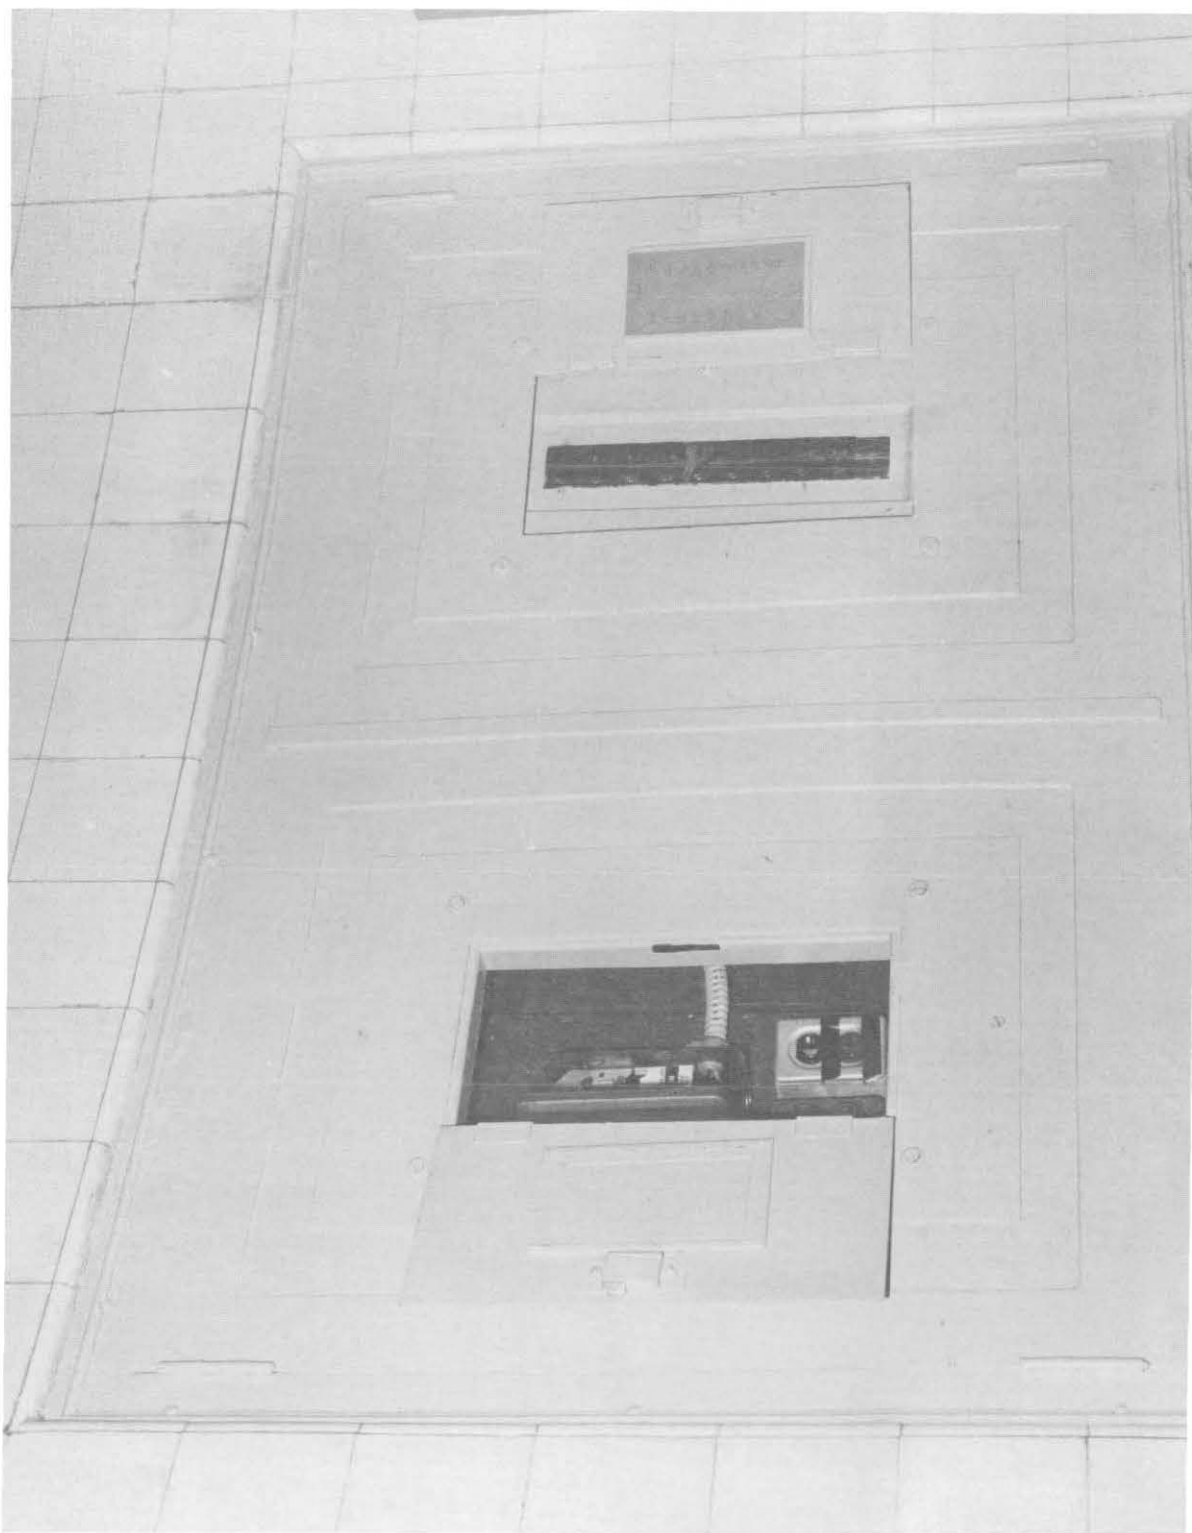
11. LIGHTING PANELBOARD This lighting panelboard is adequate for its present use. Possible future parts replacement problems may suggest the installation of a new panelboard during any present electrical modernization program.
