Point Reyes Lightstation  
Conditions Assessment Report

Conditions Assessment Report  
Point Reyes Lightstation  
Point Reyes, California

ARCHITECTURAL RESOURCES GROUP  
Architects, Planners & Conservators, Inc.

November 10, 1999

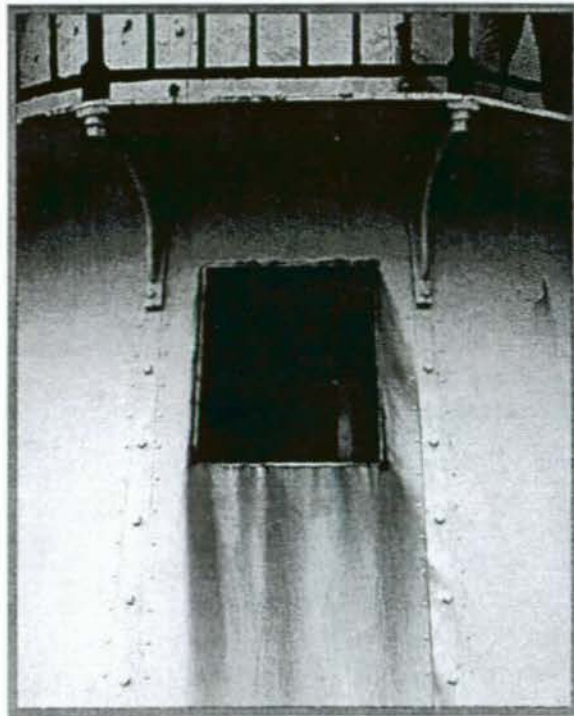
Ground level paint coating failures are limited to small areas of loss around the perimeter of the base. There is heavy rust staining under the two ground level windows (see Figure 1 at the end of lighthouse section). A consistent loss of paint is occurring on all sides of the first gallery level deck. This coating failure is occurring at a height of approximately 4'-0" and below and it is marked by random areas of the primer coat showing through the top coat (Figure 2). Slightly discolored areas of white paint reveal previous patches. Rust staining is occurring under each of the base plate on the first gallery level. Light organic growth exists under the second gallery deck on the north-east elevation.

The rust staining under the windows on the ground level suggests that water is penetrating the glazing caulking. There are a few occurrences of graffiti and there is rust staining at 10% of the cast iron bolt connections. The loss of paint on the first gallery level is the result of impact from visitor bags and equipment. There is rust staining on the cleats and astragals on the second gallery level and evidence of corrosion on the cast iron cornice (Figures 3 & 4).

There is heavy rust staining on the single light plexiglass windows on the ground level (Figure 1). The ground level windows are set flush in the cast iron panel without frames and sealed with caulking.

The caulking which was used to seal the glazing into the recessed frame of the cast iron plate has dried out and is allowing water to enter. The cast iron is reacting with the oxygen and water and forming rust.

Figure 1. Rust staining under the ground level windows.

The pattern of rust staining on the lighthouse suggests that concealed metal surfaces surrounding the windows on the ground level, and in the window frame assemblies of the lantern level are corroding. These surfaces must be exposed for preparation and painting. This will require removal of the glazing cleats and glazing prior to painting and their subsequent reassembly. An enclosure should be temporarily erected to protect the exposed metals during the paint applications from the marine environment.

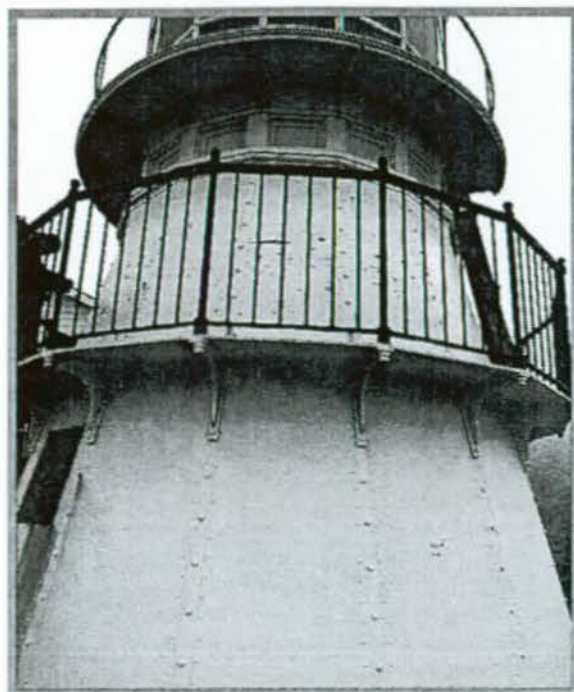
Figure 2. Through the railing, the 4'-0" and lower areas of paint loss are evident.

All of the lighthouse metals should be sandblasted to white metal and repainted. The cuprous metals should be primed with an epoxy coat followed by a second epoxy coating, then a colored urethane topcoat applied over the epoxy coatings and finished with a final acrylic clear coat. A zinc based primer coating followed by two epoxy coats, a colored urethane topcoat protected by an acrylic clear coat is recommended at this time to insulate the ferrous metals.

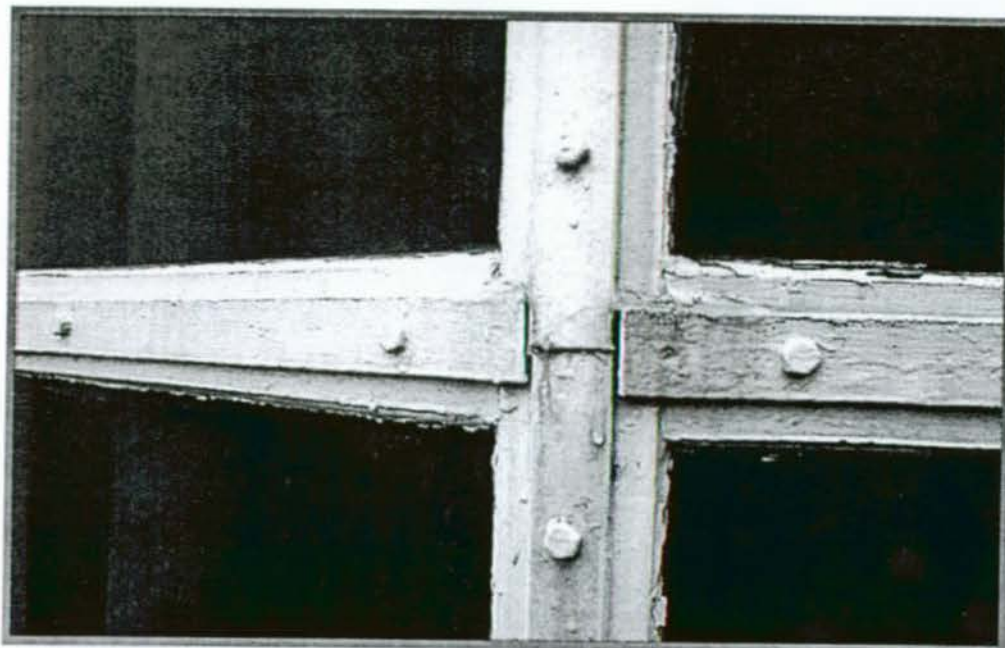
The cracks in the cast iron cornice may be caused by water entering through leaks, perhaps in the glazing sealant, and corroding the metal components of the joints (Figure 3.) Consequently, the metal components of the joints would then be rusting and expanding and their increased cross sectional diameters creating an upward pressure on the cornice thereby causing it to crack. The glazing sealant may also not be capable of accommodating movement of the plastic sheeting due to thermal expansion. A 30° temperature differential can cause a 1/2" expansion of the plastic sheeting. This expansion must be absorbed either by the sealant or by air space. If either of these allowance details are unable to accommodate the expansion force, then the sealant can fail and water will enter the frame assembly. Leaks in the glazing assemblies are evident by rust stains which run down the interior and exterior mullions (Figure 4). Another potential cause

Figure 3. Rust or rust staining on mullion & muntin joint.

In order to determine which process is causing the cracks in the cornice, it will be necessary to pull a section of the top transom cleat away to observe the condition of the joint connection between the cornice and the glazing. If it is evident that water is entering through the joint and corroding the rabbet assembly materials, then re-sealing the joint after painting with silicon may prevent further corrosion. Additionally, existing rust should be removed from the assembly materials. Rust which remains provides a source of further corrosion. Cracks in the cast iron may be repaired by welding, filling with metal filled epoxy or with sealant. If forces of thermal expansion seem to be responsible for the leaks and cracks, then the glazing detail may need to be studied or replacing the panel material may need to be explored. The selection of the repair technique will be made after the mechanism of failure is understood.

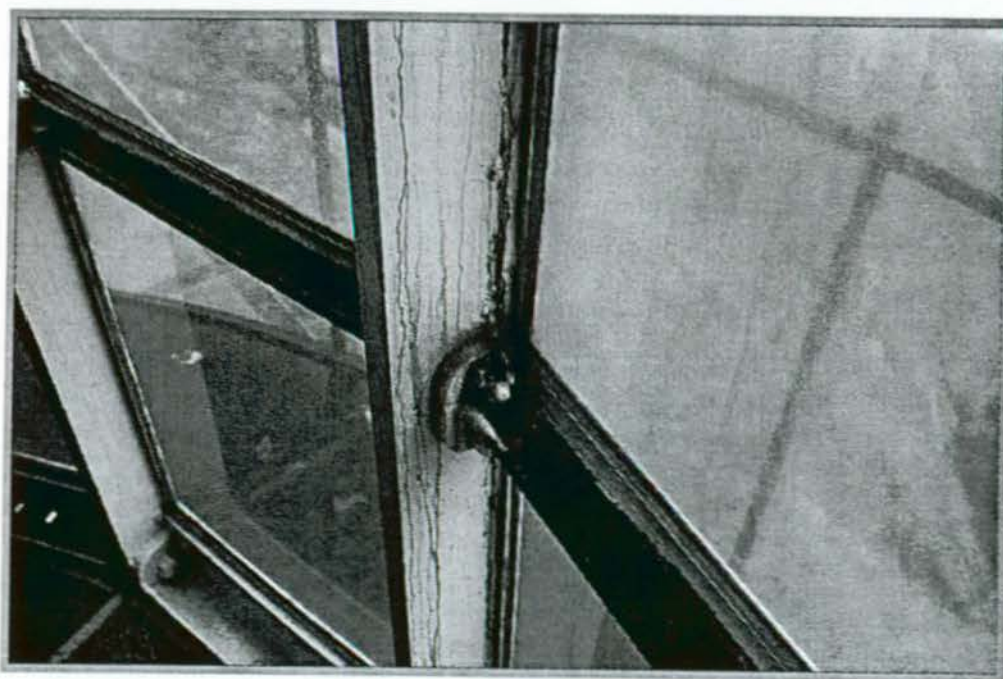
Figure 4. Rust stains and collected water on interior astragal and water trough.

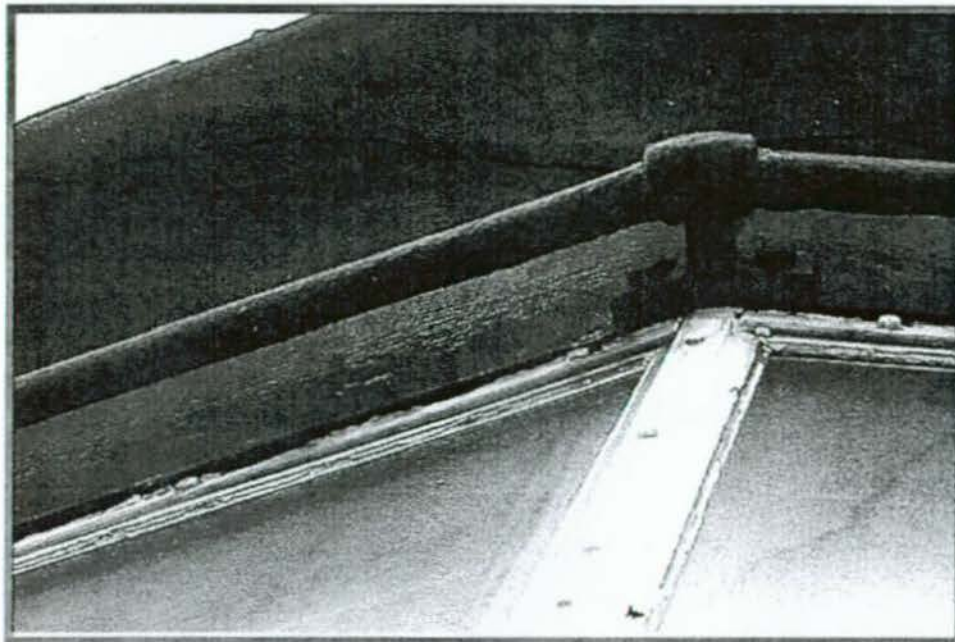
A large (1/8"- 1/4" wide) crack was observed in the iron cornice directly above the head of a glazed panel on the south elevation (Figure 5). In addition, hairline cracks in the cornice span above three of the windows to the far right on the south elevation (Figure 6). Corrosion in the form of rust surrounds these cracks and is staining the plexiglass panels below where the cracks occur.

for the cracks is corrosion due to galvanic action. The screws, bolts and transom components of the glazing frames are a copper alloy whereas the cornice is cast iron. In the presence of water, ions from the iron will flow to the nobler copper metal to protect it from corroding. In the process of sacrificing ions to the copper, the cast iron is subjected to corrosion.

Figure 5. Large crack in cornice on south elevation.

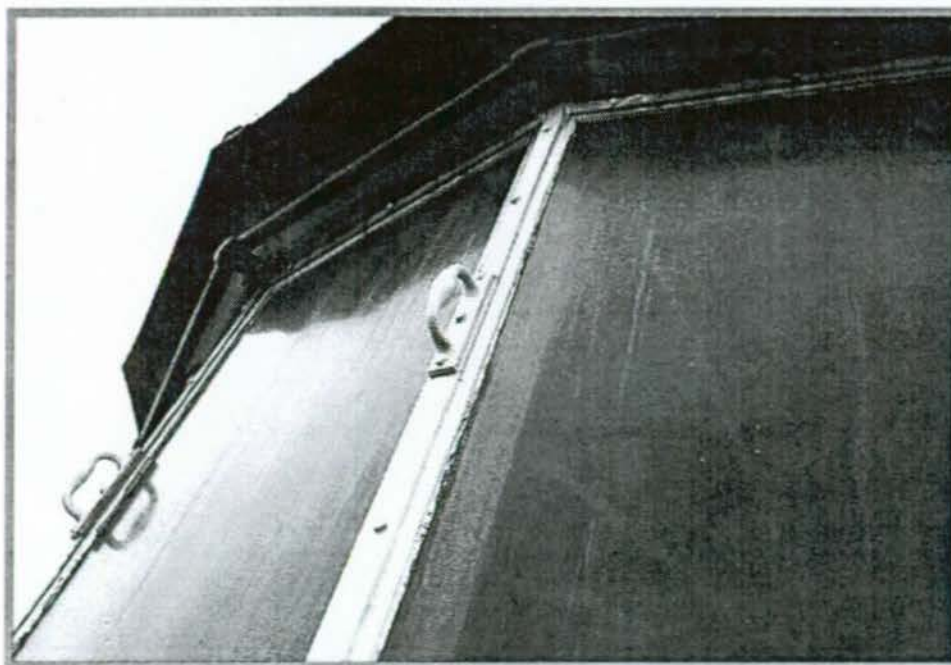
Figure 6. Hairline cracks in cornice above pipe connections, note rust stains on plexiglass sheeting.

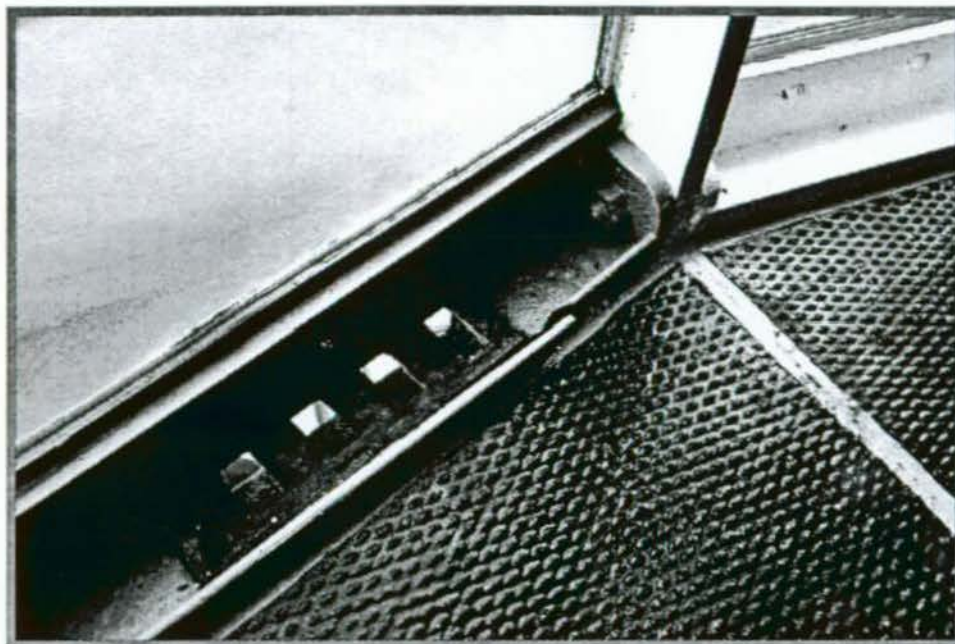
The base gutters located on the interior deck of the second gallery level have corroded to the point that it is difficult to slide the vent plates. Consequently, some of the vents are sealed and condensation is no longer vented out of the lantern.

The corrosion of the base plates is likely due to galvanic action between two dissimilar metals. The baseplates, which are a copper alloy, are bolted to the cast iron window base plate with copper alloy bolts. In the presence of an electrolyte (water) the copper will corrode the iron. The result of this corrosion is rusting of the cast iron. The rusting causes the cast iron to expand and put pressure on the base plate yielding it difficult for the vent plate to slide evenly. In addition, sections of the cast iron are splitting under the pressure of corrosive forces (Figures 7 & 8).

Figure 7. A base plate in the second gallery level interior decking. The cast iron sill plate has been sheared due to corrosion.

Historically, the bolt and screw heads were caulked with a white lead paste or were separated with gaskets to prevent galvanic action from corroding dissimilar metals. This detail needs to be replaced wherever there are copper screws which connect the lantern base plates to the cast iron and the hinges of the entry door to the cast iron door. Stainless steel fasteners sunk through rubber washers should replace the copper alloy fasteners and neoprene gaskets should be installed between the dissimilar metals to insulate them from each other in order to prevent further galvanic corrosion.

The base and vent plates should be cleaned of all existing rust and reinstalled. The functioning of the vents is necessary to vent heat and condensation out of the lantern. The cast iron doors on the ground and first gallery levels should be repaired to operate smoothly and not scrap the jambs. The operation of the bronze lock mechanism should be restored and covered with new paint coatings as specified above to protect the metals from exposure.

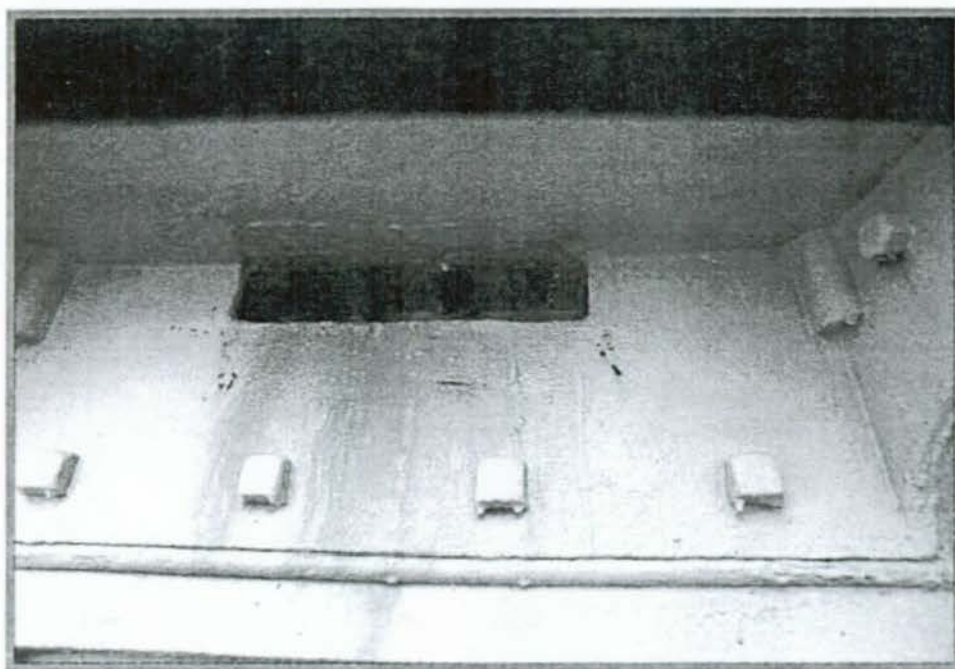
Figure 8. Rust stains caused by the corrosion of the base plates on the first gallery level.

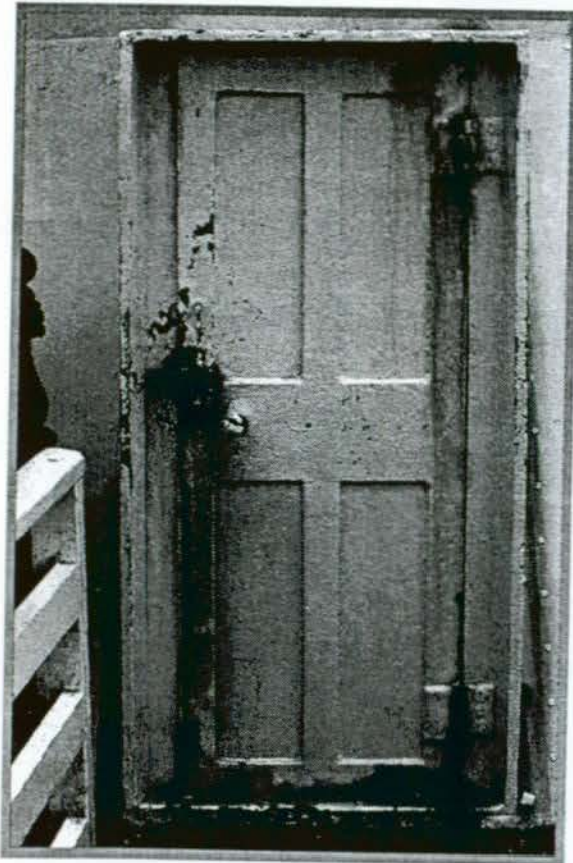
There is heavy rust and rust staining at the hinges and most of the perimeter of the cast iron entry door on the first gallery level (Figure 9). The original bronze lock mechanism no longer functions. In its place, a latch has been added to secure the door. There is paint loss on the strike side of the door and on the edges of the hood.

The corrosion at the hinges appears to be due to galvanic action. The door is cast iron and the hinges and pins are a copper alloy. Copper, being the more nobler metal, will corrode the cast iron. The corrosion along the perimeter of the door may be a subsequent result of the corrosion occurring at the hinges. The door does not hang flush in the frame due to the loss of surface metal in the hinges, and so is scraping within the frame. The resulting abrasion has removed the cast iron's protective surface and is

Figure 9. Signs of corrosion on the hinges, edges, and locking mechanism on the first gallery level entry door.

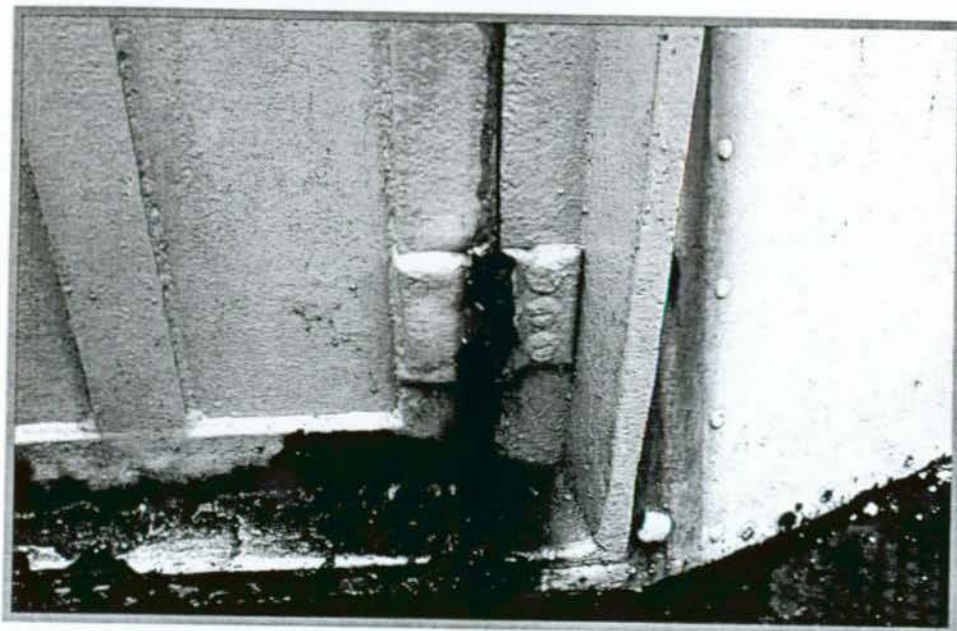
allowing the door's edges to corrode (Figure 10). Similarly, because the door does not close easily within its frame, the latch does not fit comfortably either. The scraping of the latch is causing paint loss on the neighboring surfaces.

Figure 10. Rust on the bottom hinge of the first gallery entry door.

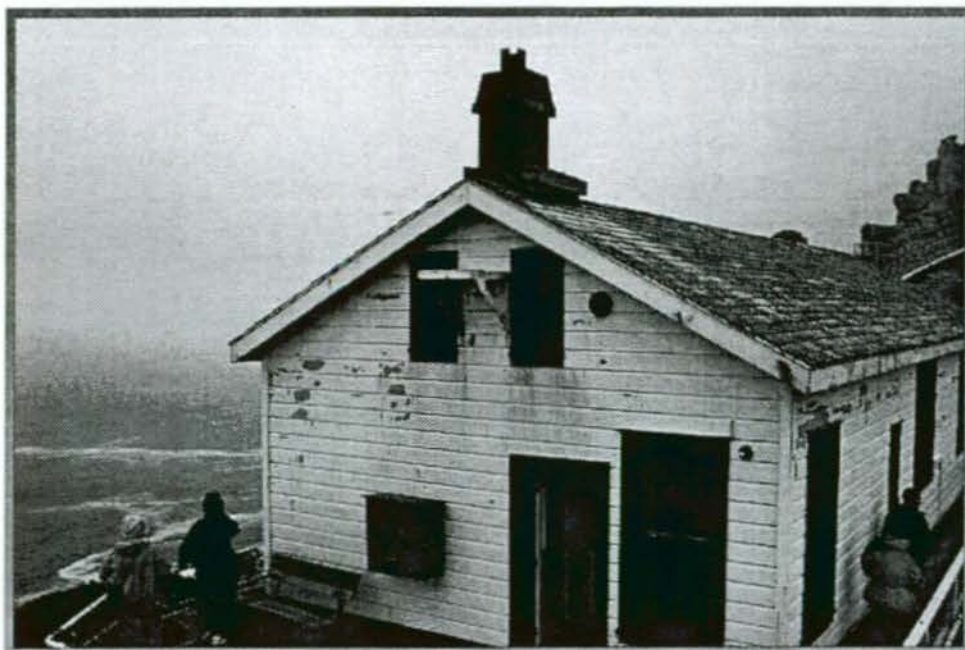
There are areas of paint loss on the north and west elevations (see Figure 11 at the end of this section). There is some minor rust staining on the gutters, north and west walls, and under metal conduit (Figure 12). The flashing at the chimney has fallen away and is allowing water to enter at the roof joint (Figure 13). A section of the conduits on the west elevation has broken off the handrail (Figure 14). All of the window sashes have been replaced.

The paint coatings are failing principally on the south and west elevations. These elevations suffer the most exposure to wind and moisture. Metal components throughout the building are rusting, revealing evidence of paint coating failure in these locations.

Figure 11. The west elevation of the Equipment building showing coating failure.

All surfaces of the Equipment buildings should be repainted. The owner should determine if any lead based coatings are present and provide this information to the painting contractor. The chimney flashing should be repaired to prevent water infiltration through the open roof joint. In addition, the broken conduit should be repaired and secured to the handrail.

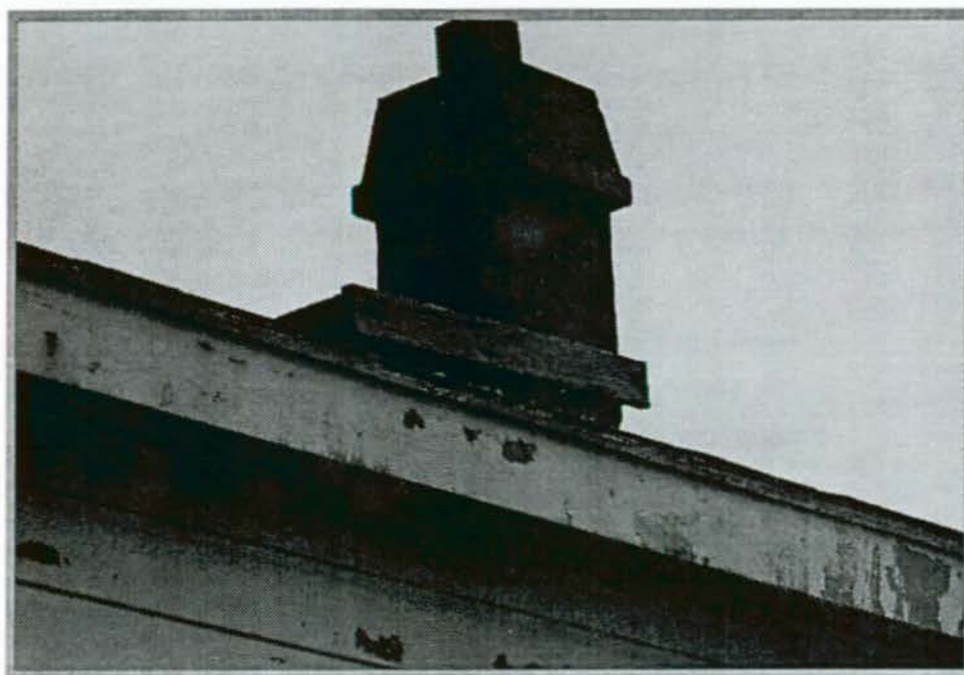
Figure 12. Coating failure at the gutters on the Equipment building.

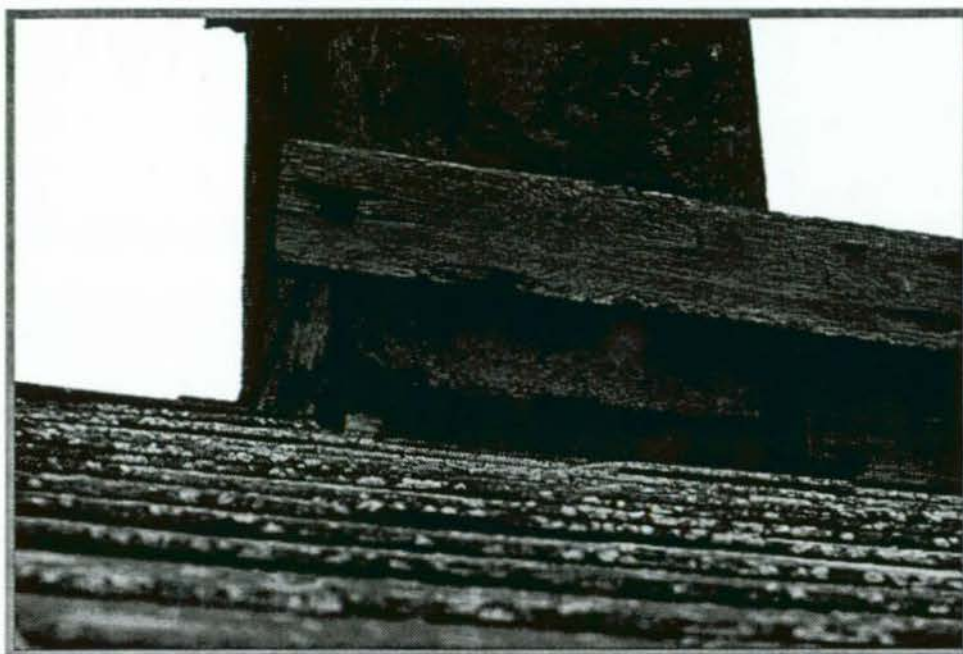
Figure 13. Joint at chimney where water flashing has fallen away.

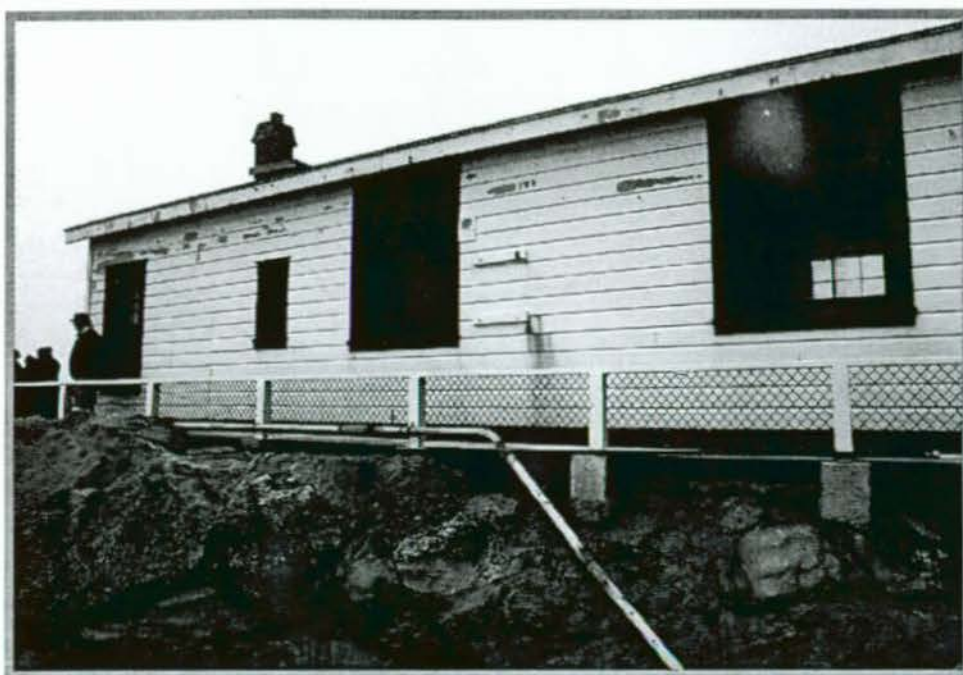
Figure 14. The west elevation of the Equipment building showing paint loss and the broken conduit.

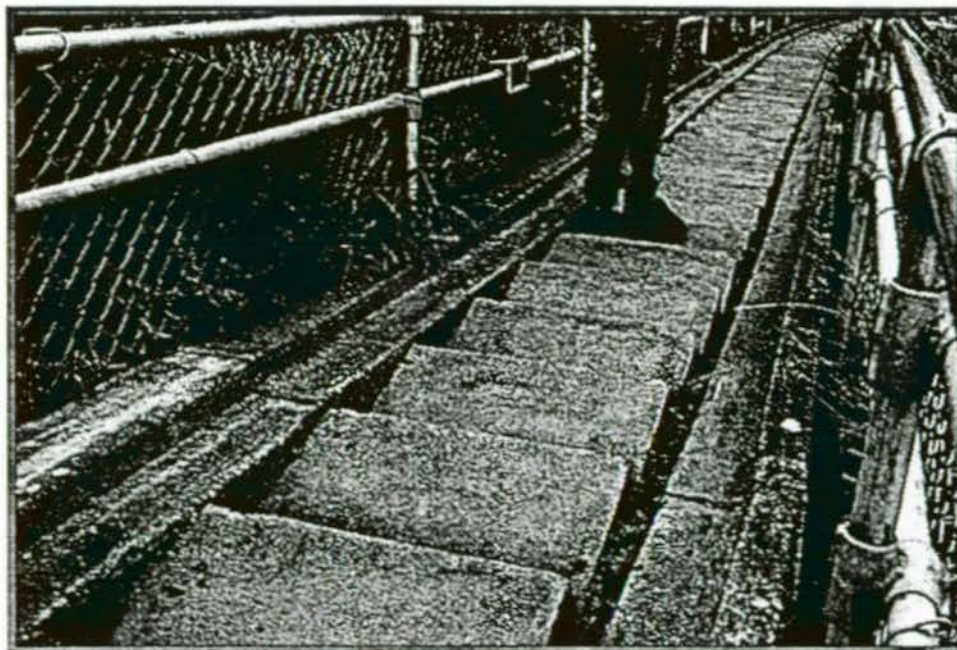
The most prevalent occurrence of deterioration on the concrete stairs leading to the light-house and equipment buildings is the separation of the concrete curbs from the stairs (see DW-1). The joint between the curb and the stairs has opened and widened from 1/8" to 1 1/2" depending on location. This condition exists on 90% of the stair run (see Figure 15 at the end of this section). Adding to the deterioration, plants have invaded the separation space between the stairs and the curbs. Trench drains occur approximately every 100 stairs and are filled with dirt (Figure 17). Approximately 50% of the concrete curbs are missing or have top cracks (Figure 16).

Table 1 depicts the following conditions. The curb separation (curb separation) from the stairs appears to be the result of land on either side eroding outward from the stairway. This conclusion is supported by the fact that where there are outcroppings of rock bracing the stairway, there is negligible to no separation of the curbs. Missing curbs (missing curbs) are likely to be caused by erosion and impact from the Coast Guard's hauling cart. The cart is operated by a winch at the top of the stairs; deep scrapes mark the location where the cart is hauled over the top step. The wheels of this cart knock out sections of the curb as it rolls between the lower and upper curbs. The horizontal cracks (joint separation) are cold joints which form from thermal expansion forces.

Figure 15. A greater than 3/8" separation between the stair and curb.

Despite the separation of the curb from the stairs and cart damage, the stair assembly remains in good overall condition. For this reason, repair rather than replacement is recommended. The separation of the concrete curbs from the stairway can be arrested by bracing either side from slipping outward and away from the stairs. The existing gap separations should be plugged with a flexible, urethane sealant to match the color of the existing concrete. The section of curbs which are missing should be replaced and the areas that have deteriorated should be removed and replaced (Figure 17). New curbs should be detailed so that they can withstand impact damage from the cart. The trench drains should be cleaned so that water can drain away from the stair foundations. Water infiltration may be causing further deterioration due to corrosion of the concrete reinforcing bars.

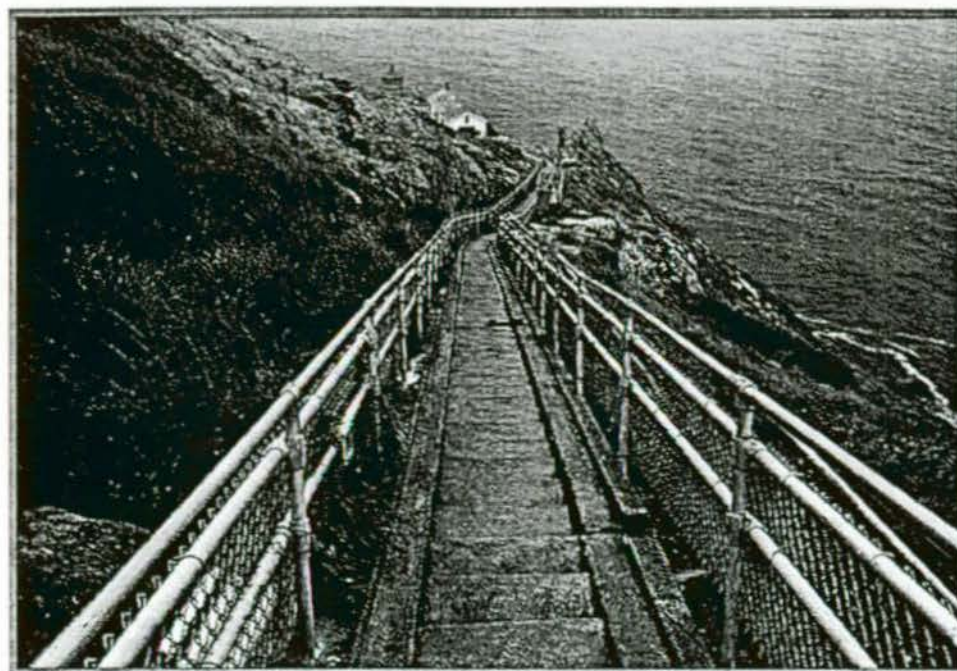
Figure 16. A missing curb section on the right side of the stairway.

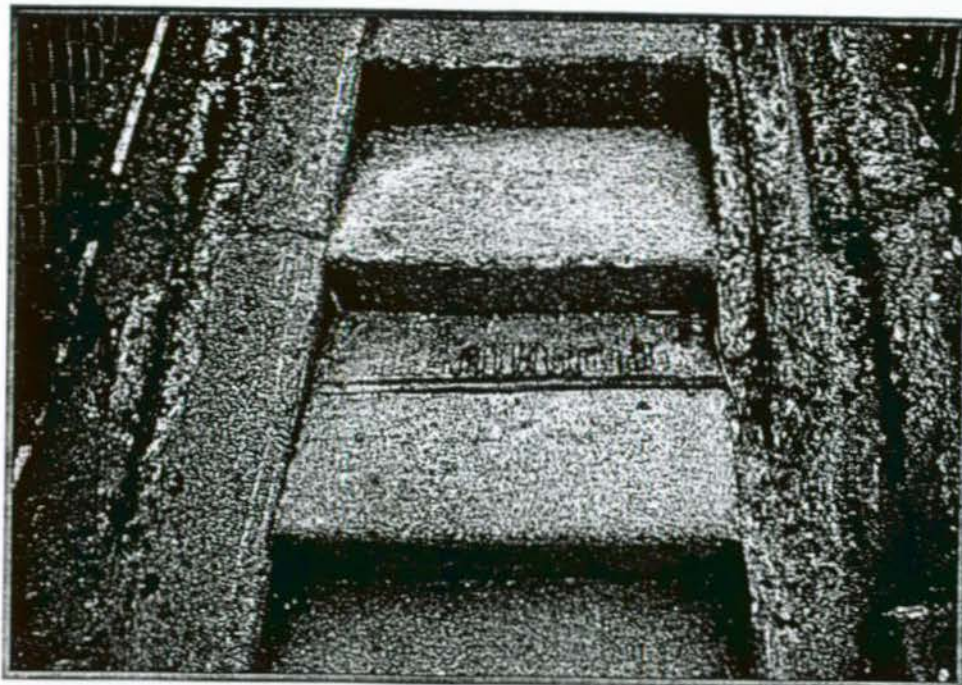
Figure 17. A filled trench drain, missing curb sections on both sides of the stairway, a horizontal cold joint, and exposed reinforcing bars.

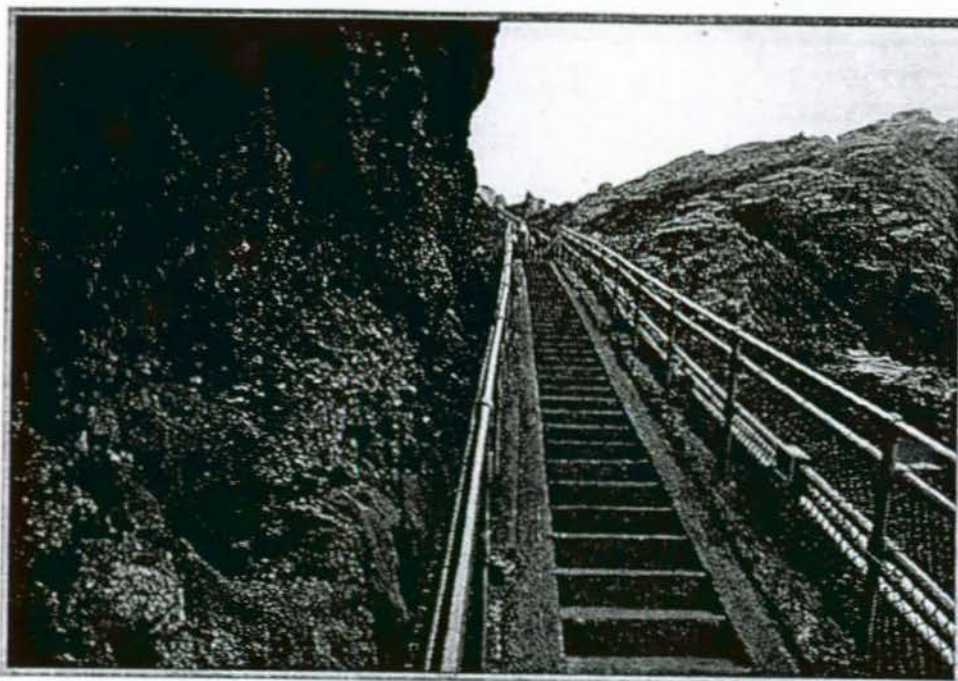
Figure 18. The rock cropping on the right (right side in direction of stairs) near stairs 201-250 appears to be preventing erosion and curb separation.

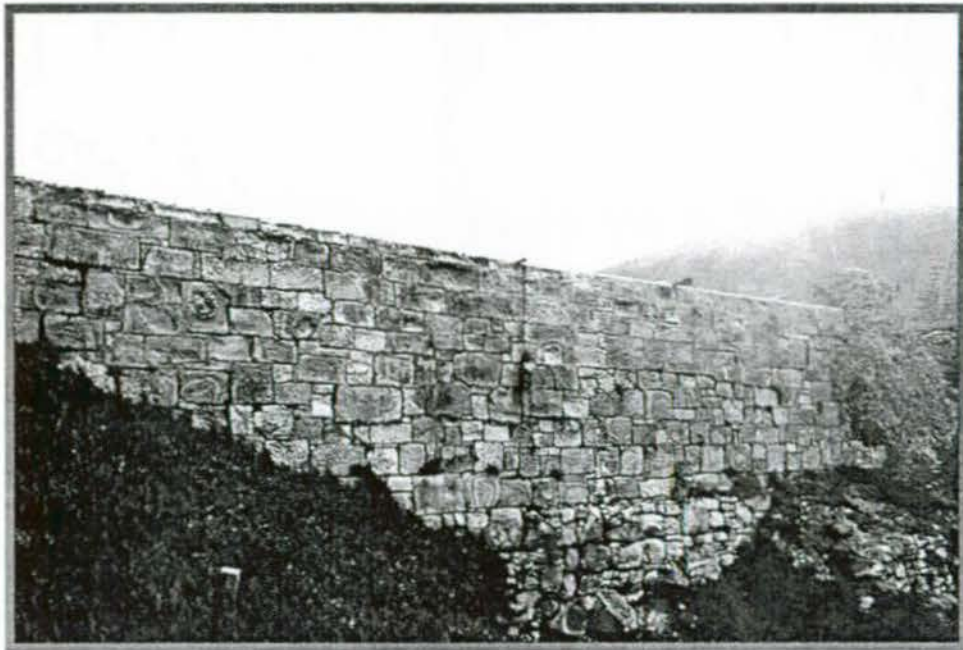
All of the mortar joints in this wall have deteriorated (Figures 19 & 20 at the end of this section). The absence of mortar has allowed water to infiltrate the wall and plants to invade the joints. The two feet of wall which rises above the surface of the watershed is parged with plaster (Figure 21). A large crack spans over half the length of this knee wall. Severe deterioration is occurring at the top edges of the wall where it meets the cliff side.

Water is the major factor in the deterioration of the wall. The large crack on the top of the knee wall is allowing water to enter and seep down the back side of the wall. Severe weathering has eroded the surface of the wall and caused erosion of the soil behind the wall (Figure 22). It is also possible that the cement that was used to patch the mortar joints is incompatible with the sandstone, prohibiting the sandstone from expanding without fracturing. The water that is entering through the crack is also draining around the side of the wall causing the stone and cliff to erode.

Figure 19. Full view of sandstone wall; deterioration of the mortar joints and stone faces is continuous along length of wall.

Architectural Resources Group will analyze the mortar. This survey is necessary to determine the original composition of the mortar and to ensure a compatibility with the sandstone. All mortar joints should be repointed. The crack on the top of the wall should be routed and cleaned to provide a good bonding surface, and then sealed with a polyurethane based elastomeric sealant.

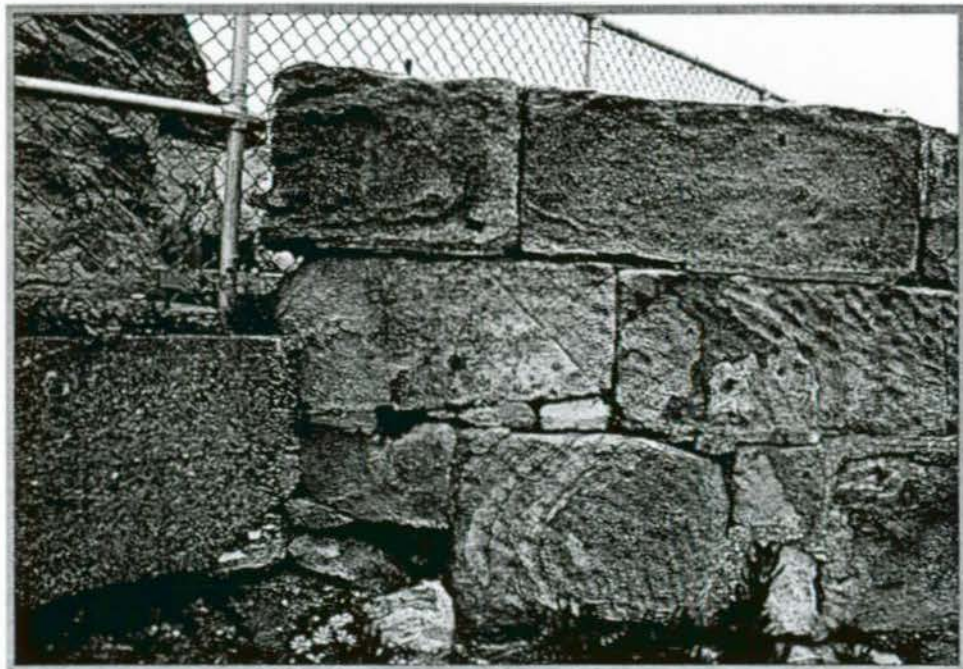
Figure 20. Far north edge of the wall illustrating where water is draining from behind and eroding edge.

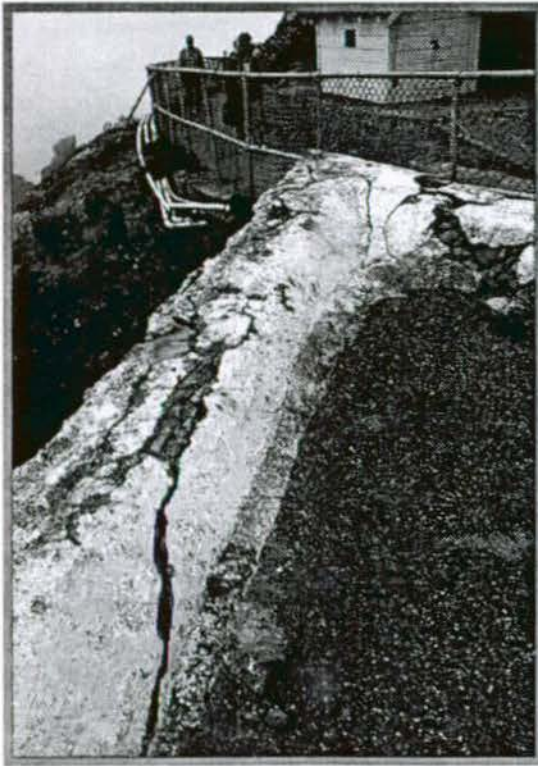
Figure 21. Crack on the top at the watershed and cistern where water is infiltrating from behind.

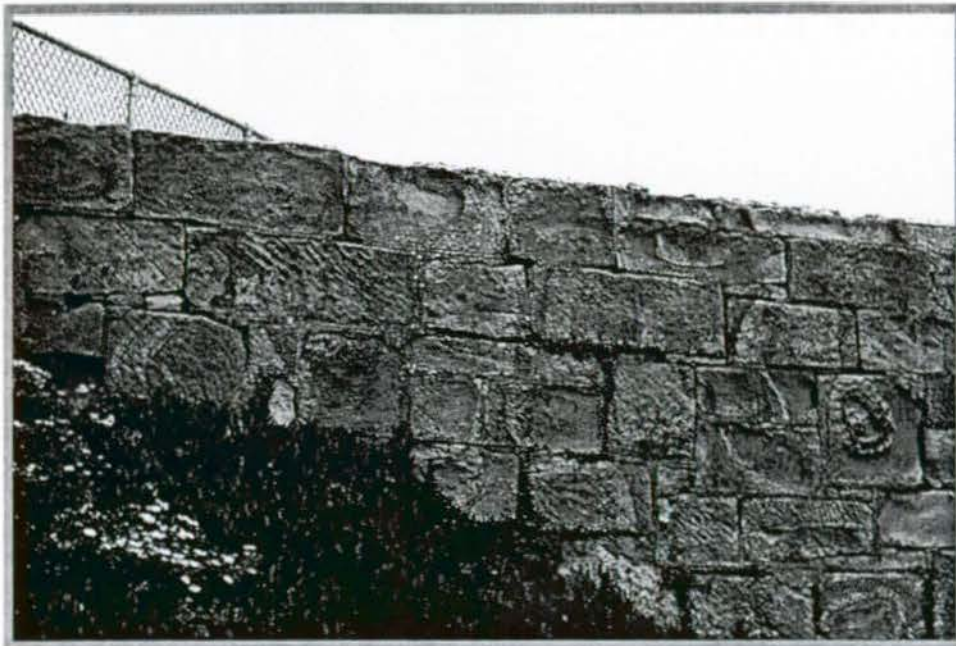
Figure 22. Previous patches are spalling along with original stone face.

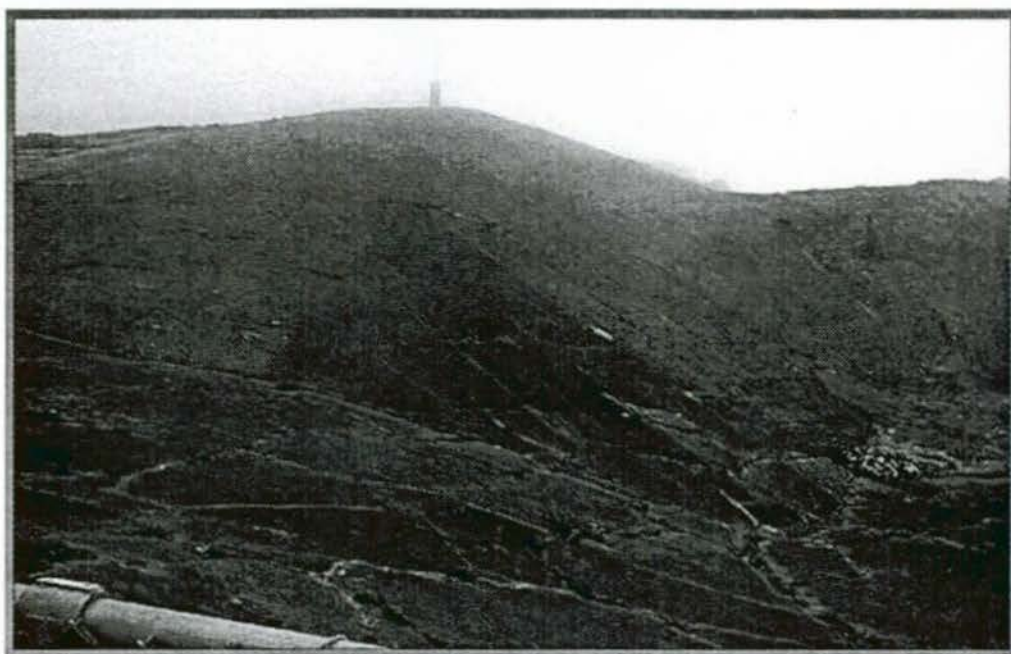
The watershed appears to be covered with a thin, unreinforced, concrete plaster. This covering appears to have been spread over the hill without expansion joints. Cracks have occurred throughout and plants have taken root in these cracks ( see Figures 22 & 23 at the end of this section).

The concrete of the watershed has cracked and deteriorated due to the age of the concrete and the thinness of the layer.

Figure 22. Southwest view of watershed illustrating severe cracking of concrete and plant invasions at cracks.

There are a few treatment options to consider for the cistern and watershed. The least intrusive option is to elect not to perform any kind of treatment on the watershed's concrete. In this case, ongoing maintenance would be required to keep the concrete free of plants and sitting water. Without continuous attention to plants and water, the watershed will continue to deteriorate. A second option is to seal the existing cracks with an elastomeric sealant. This treatment would provide a flexible material for the existing, thermal expansion cracks to move within, and yet prevent water from entering and causing further deterioration of the concrete. This solution is temporary since additional cracks are inevitably going to occur due the age, quality and thin layer of the original concrete. Additionally, this treatment may also change the character of this historic feature. Another option is to cover the existing concrete with a new layer of concrete. This treatment would permanently and irreversibly cover historic fabric, yet would maintain the original shape of the watershed for park visitors to interpret. Furthermore, this treatment would defer further treatment for a longer period than the other two options. Further discussions with the National Park Service and study of treatment options for the cistern is recommended.

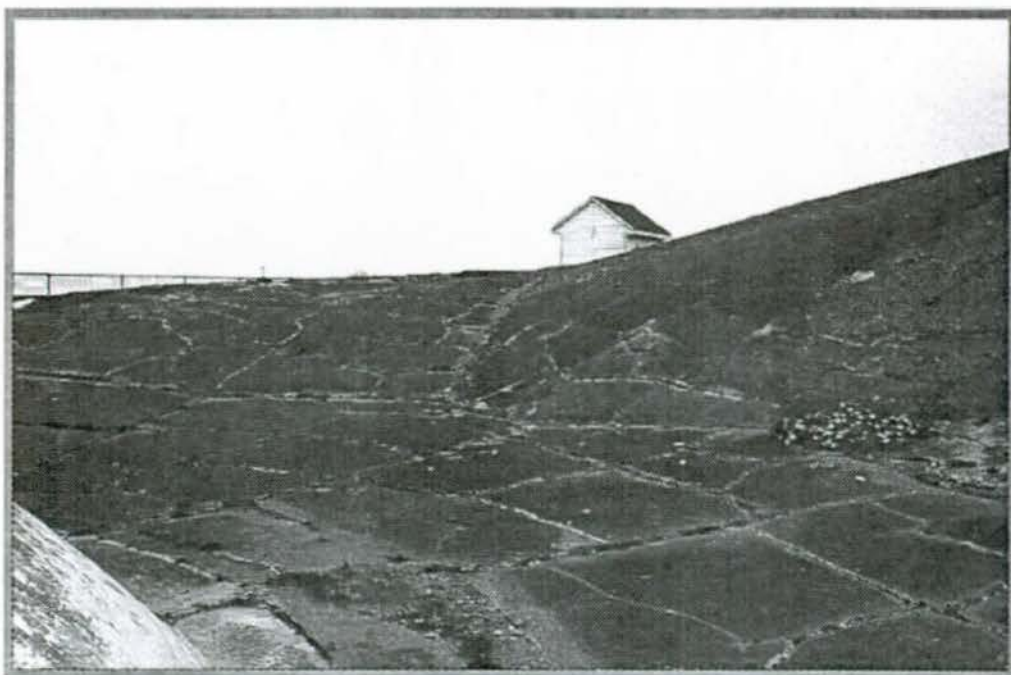
Figure 23. View of cistern, in lower left, and watershed showing severe cracking, elastomeric joints, and plant invasions.
