Preservation Case Studies

Improving Thermal Efficiency: Historic Wooden Windows

The Colcord Building
Oklahoma City, Oklahoma

Sharon C. Park AIA

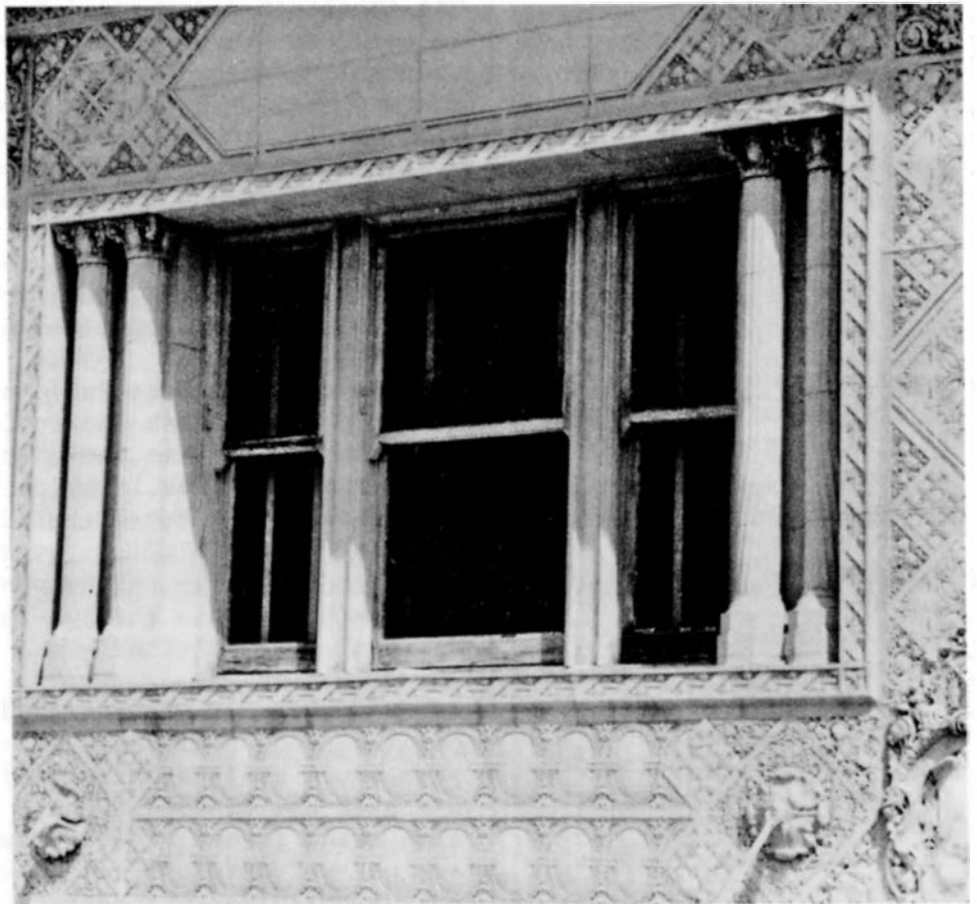
Figure 2. *Original second-floor wooden windows of the Colcord Building. Note the high degree of ornamentation with the composition of the triple windows, the deep setbacks, the paired Corinthian columns, and the Sullivanesque terra-cotta panels surrounding the windows. The windows on the upper floors are of a simpler composition being paired one-over-one double-hung windows.*
(Photo: Jack Graves, AIA)

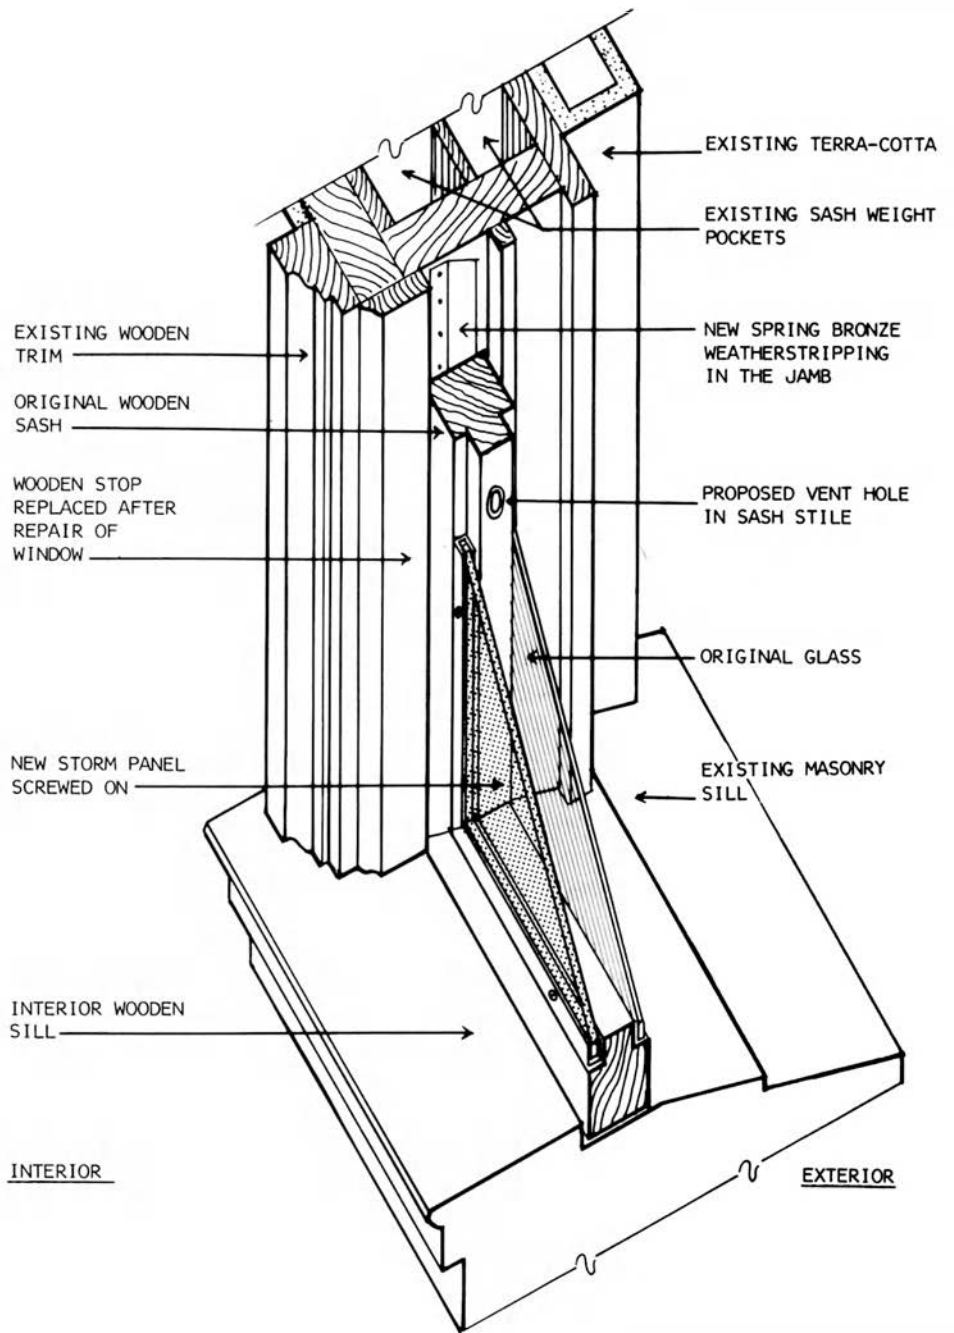
The architect's two concerns were the routing, or rabbeting, of the windows' wooden rails and stiles and the impact the additional weight of the storm panels would have on operating the windows. The cross-section of the sash rails and stiles was 1 7/8 by 2 inches of solid wood in good condition. The proposed rabbet of 1/2 by 3/8 inch was, therefore, not substantial enough to weaken the windows. This rabbeting would still allow a thermal cavity of a full inch between the glazing layers. The second concern was whether the existing sash weights could tolerate the additional weight of the storm panels. The Colcord Building windows vary from 22 by 66 inches to 48 by 66 inches and are composed of an upper and lower sash. The corresponding weight of the storm panels was approximately 3 to 8 pounds. The architect determined that the existing sash weights were adequate and specified that the pulleys of the sash chains be lubricated during the retrofitting to ease operating the heavier windows. (see figure 3)

moist air from penetrating into the cavity between the two layers of glazing. The vent holes, drilled laterally through the sash stiles, were to provide a minimum amount of circulation within the cavity to reduce condensation. (see figure 3)

Figure 3. Cutaway view of the window showing the proposed interior storm panel in place. Note the new weather stripping on the frame of the window and the proposed vent hole on the wooden sash stile.

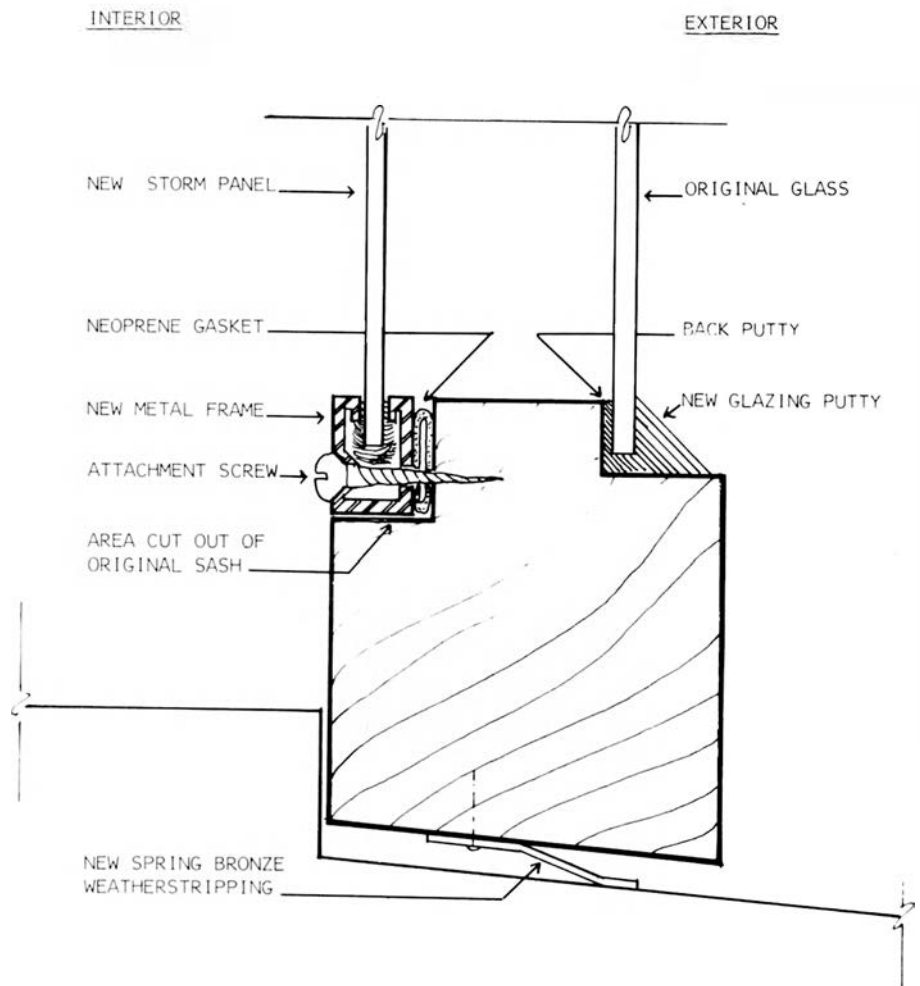
Figure 4. Detailed section through the wooden sash rail with storm panel in place. Note the small area of wood cut out to recess the new storm panel. The cavity left between the two glazing layers is 1 inch which is within the optimum range on 1/4 inch to 1 1/4 inch for insulated glazing. Note the neoprene gasket that acts to seal out moist air between the storm panel and the wooden window.

Each window sash was taken, in turn, to the workbench where it was prepared for the new storm panel. The glass was carefully removed and set aside. Then a 1/2 by 3/8 inch rabbet was cut from the inside surface of the wooden sash to receive the recessed storm panel (see figures 3 and 4). The loose paint and any remaining dry glazing putty was scraped and removed from the sash. The glass was then reinstalled with a modern glazing compound and a new piece of spring metal weatherstripping was applied to the underside of the lower sash rail before it was returned to its frame (see figure 5). The original window sash were equipped with sash locks at the head and sill, and the architect determined that these locks should be kept fastened at all times to insure that the windows would remain tight in their frames.

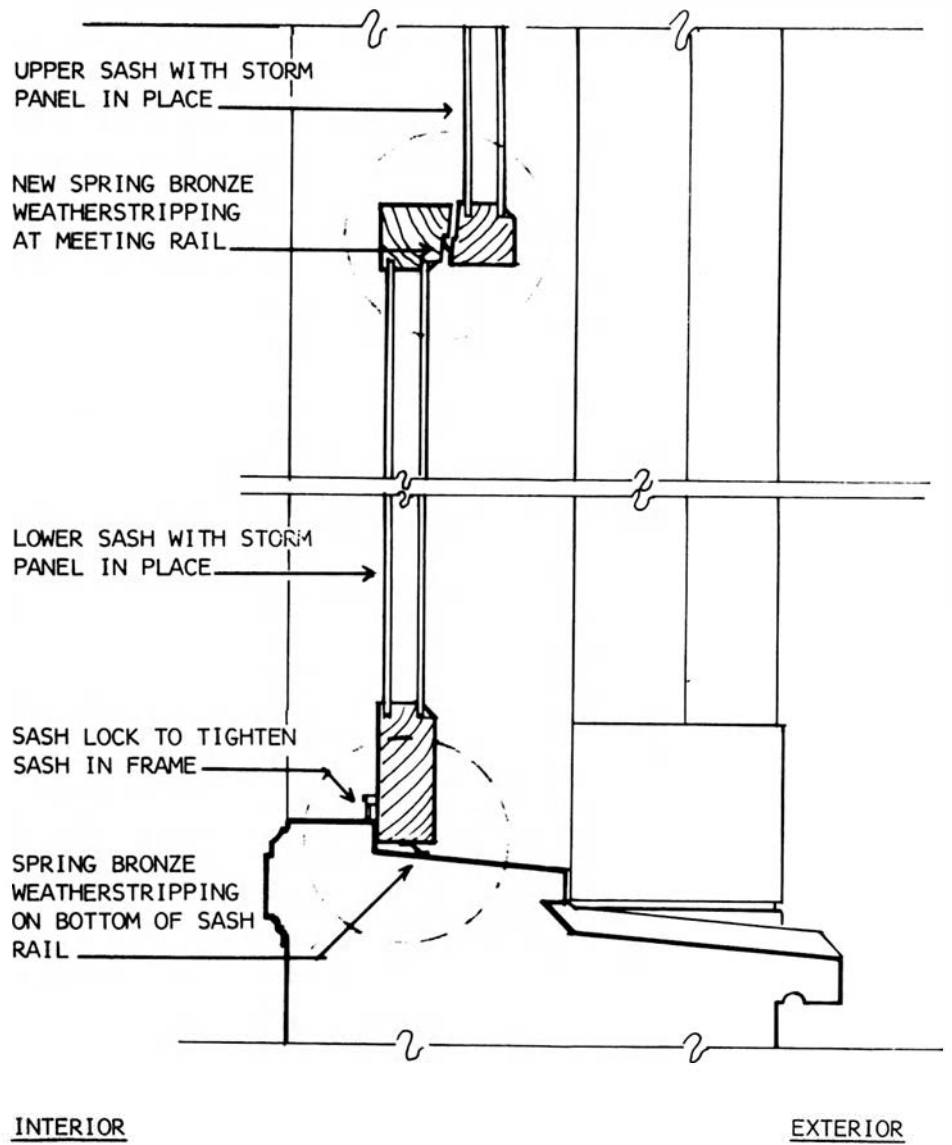
Figure 5. Section through the window showing areas of weather stripping. Note that new weather stripping was also added between the sash and the wooden frame, or jamb.

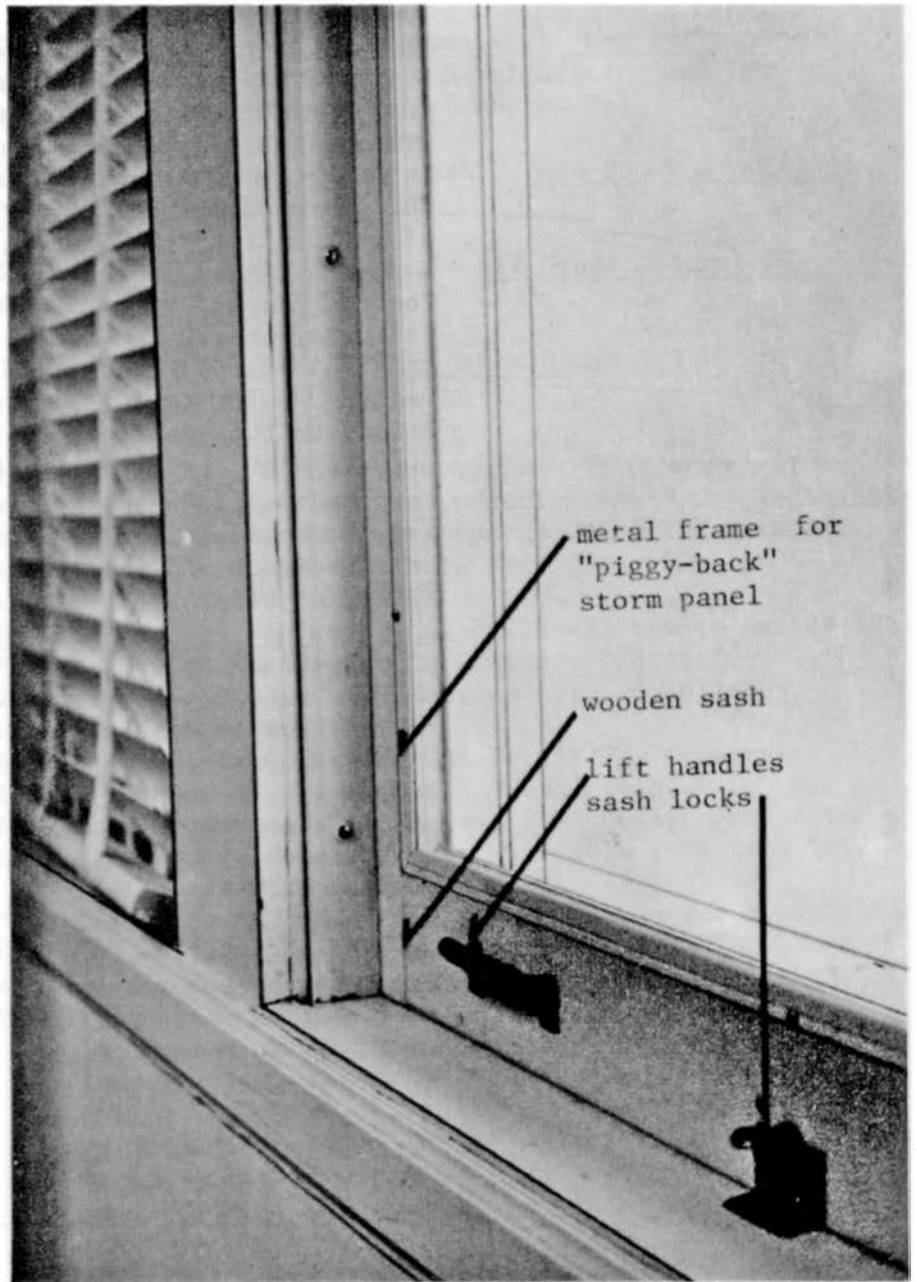
Figure 6. New interior storm panel in place. Note that the storm panel was recessed into the wooden sash. This allows full operability of the window as the lower sash is raised without hinderance from the storm panel on the upper sash. The interior storm panels were affixed with screws and will be removed only for maintenance. (Photo: Tamara Coombs)
