# Montgomery Co. Jail & Sheriff's Residence

## Condition Assessment and Treatment Plan

July 31, 2026

Seven Generations AE, Part of the Bodwé Professional Services Group

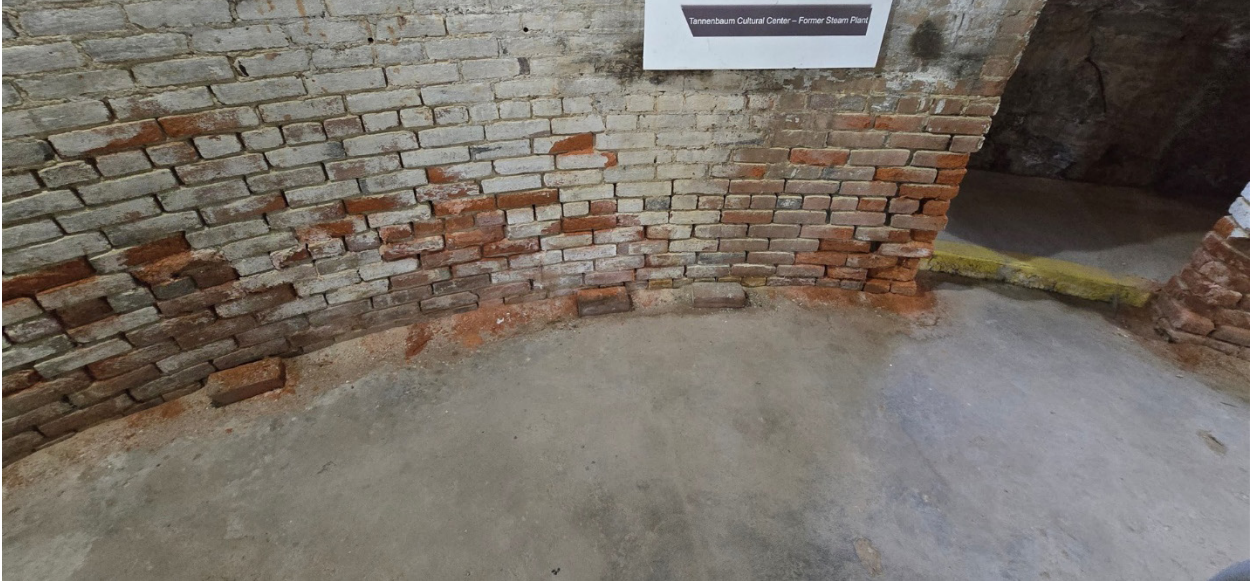
- The circular brick masonry wall beneath the mechanical jail equipment is in fair to poor condition.
  - Serious: The lower portion of the wall shows significant erosion related to rising damp.
- The limestone foundations walls visible within the interior of the jail are in fair to poor condition.
  - Serious: A number of cracks and spalls were observed within the limestone masonry.
- The mortar joints within the brick and limestone basement walls are in poor to fair condition.
  - Serious: Cracked or eroded mortar joints should be cut out and repointed with a suitable repair mortar that matches the original in strength, texture, and appearance.

**Figure 2.8:** The brick masonry wall beneath the rotary jail mechanism.

At interior basement walls of cellblock, repoint failed mortar joints. Construct short concrete wall to supplement eroded brick masonry in the circular wall beneath the rotary cellblock.

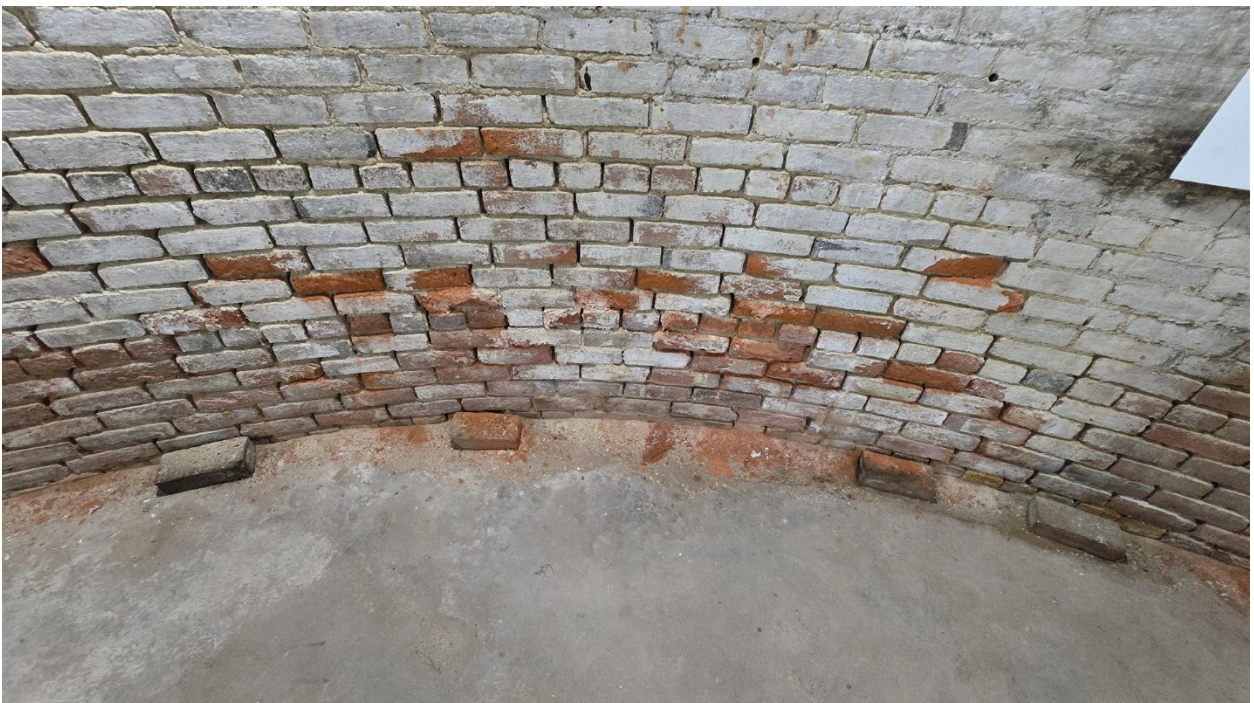
**Figure 2.9:** Damage is believed to be caused by rising damp.

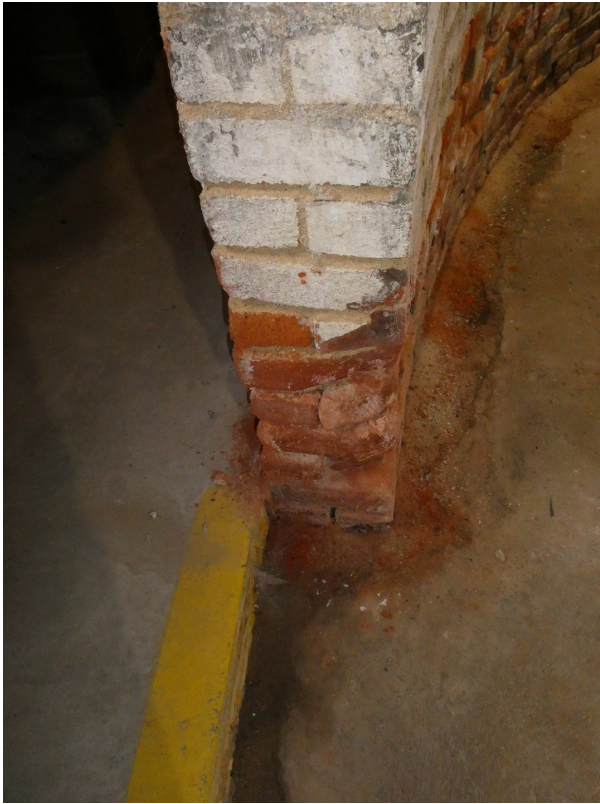
**Figure 2.10:** The wall is only two wythes in thickness.

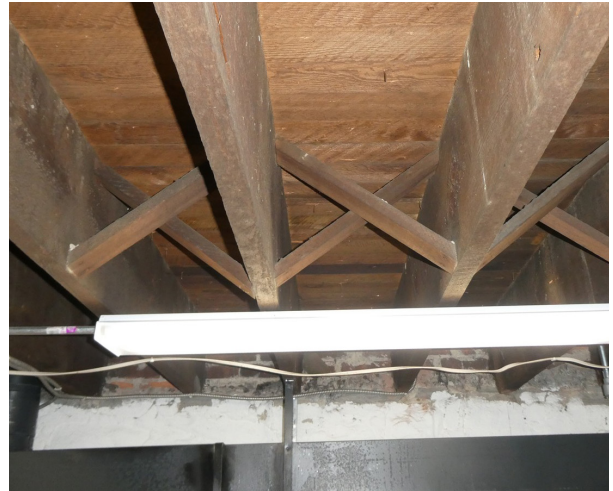
**Figure 2.13:** Cross bracing was observed within the first-floor framing.

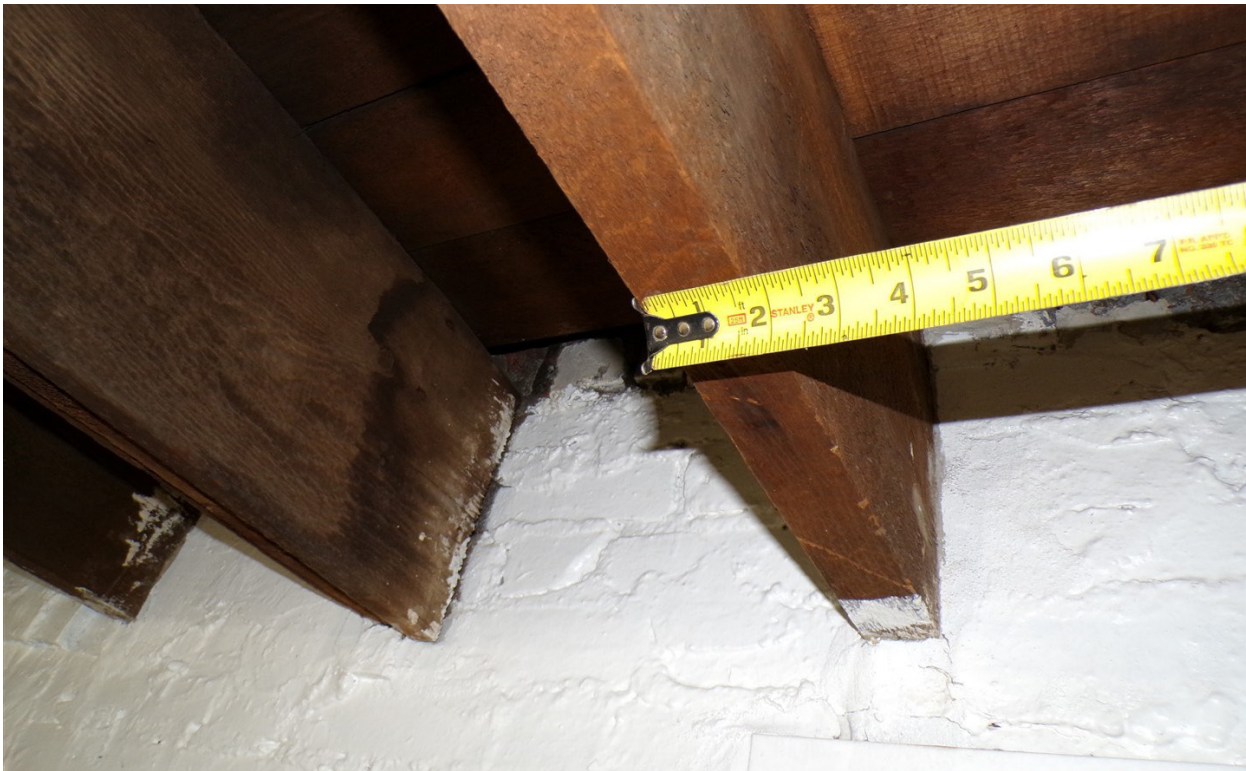
**Figure 2.14:** The joists were measured to be nominal 2x10 lumber in this location.

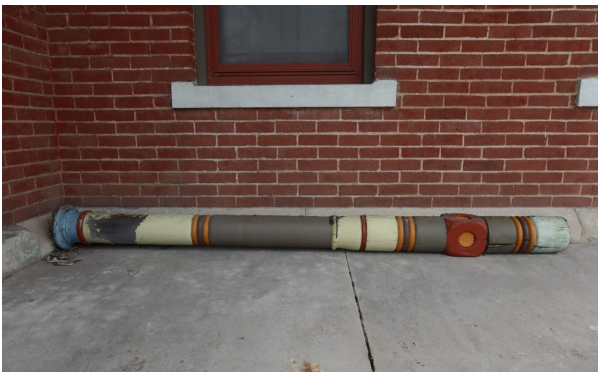
**Figure 2.18:** This porch post recently fell during a storm.

Reinstall fallen porch post.

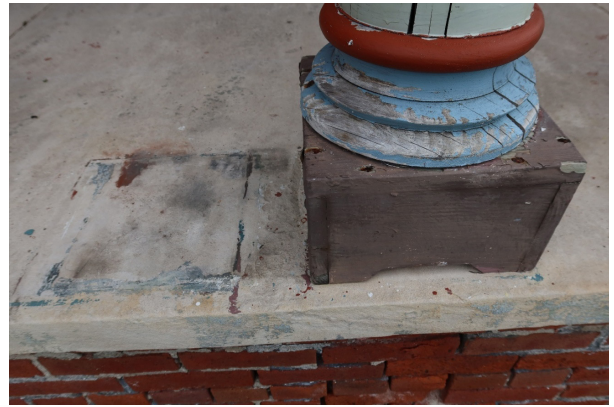
**Figure 2.19:** Typical deterioration to new-growth wood at replacement base of porch post.

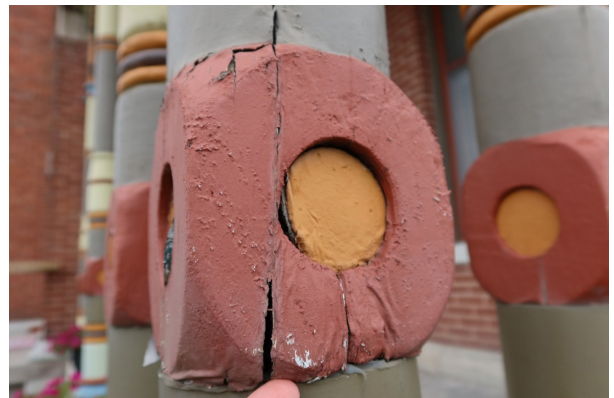
**Figure 2.20:** Deterioration at lower part of porch post.

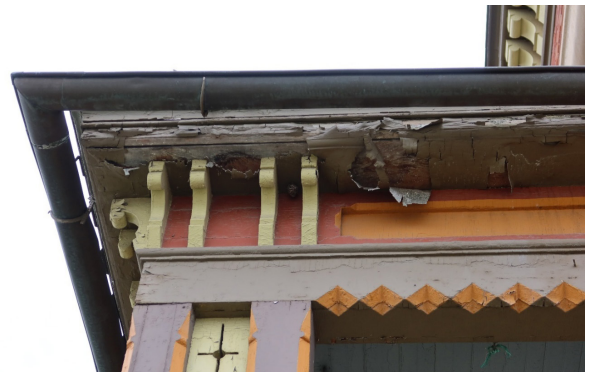
**Figure 2.21:** A leaking gutter is causing deterioration to the north end of the porch.

Repair leaking gutter.

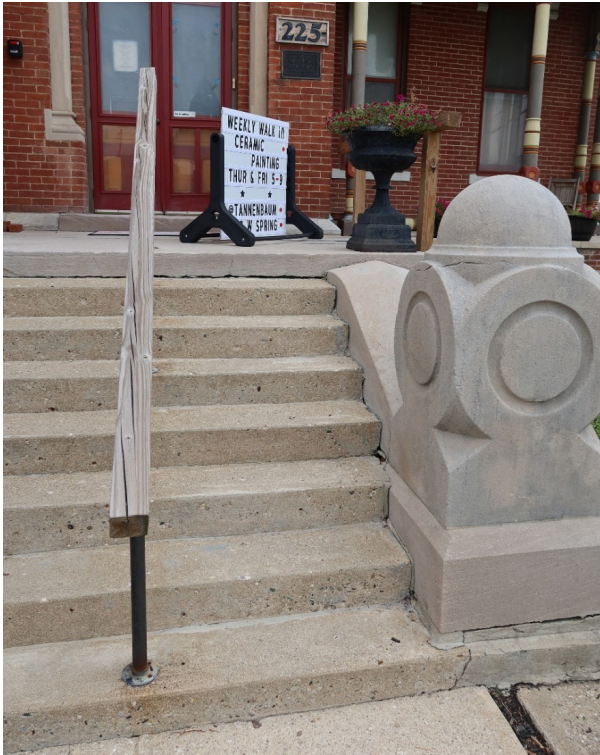
**Figure 2.22:** Critical: the present wood handrail is not a code-compliant handrail. It is too thick to meet the requirements for safe use. The wood is also cracking.

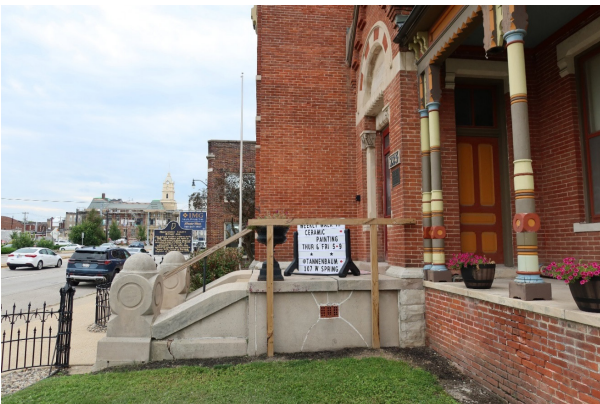
**Figure 2.23:** The museum's insurance provider required the addition of a handrail to the north side of the front porch. The handrail is bolted into the ends of the stone stoop slabs. This is likely to cause cracking and deterioration of the stone over time. Consider future replacement with a less intrusive metal railing.

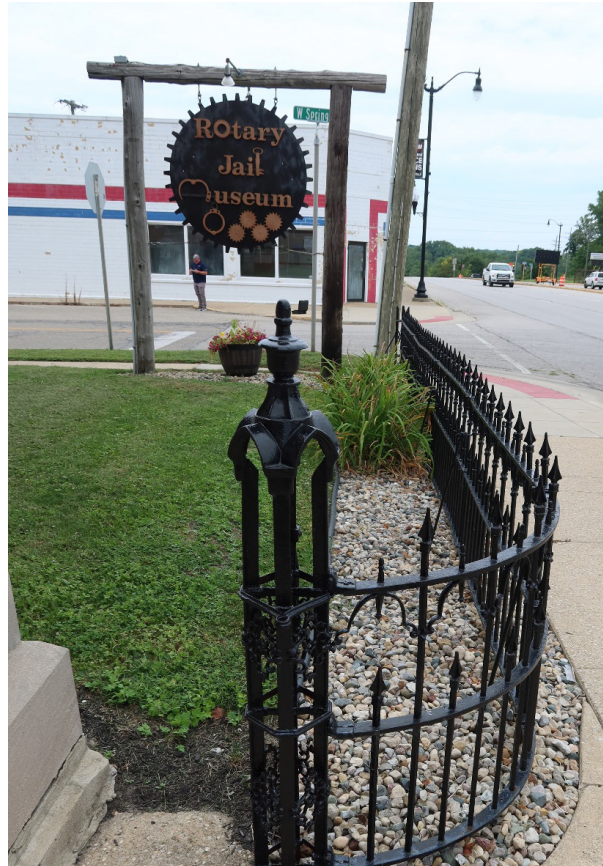
**Figure 2.24:** The iron fence was recently cleaned and painted and is in good condition overall. The cap of the north fencepost (far end of fence) recently broke loose and is stored inside the building.

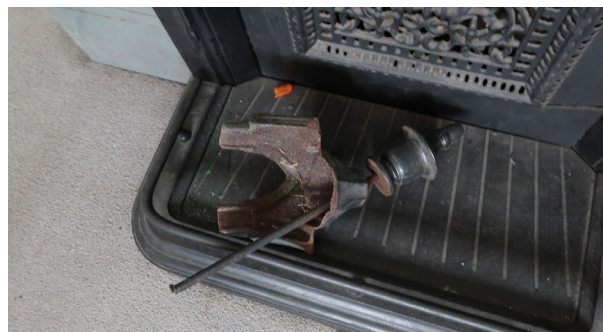
**Figure 2.25:** Broken cap from north fencepost, now stored inside the building.

Repair or replace damaged cap of  
north fencepost.

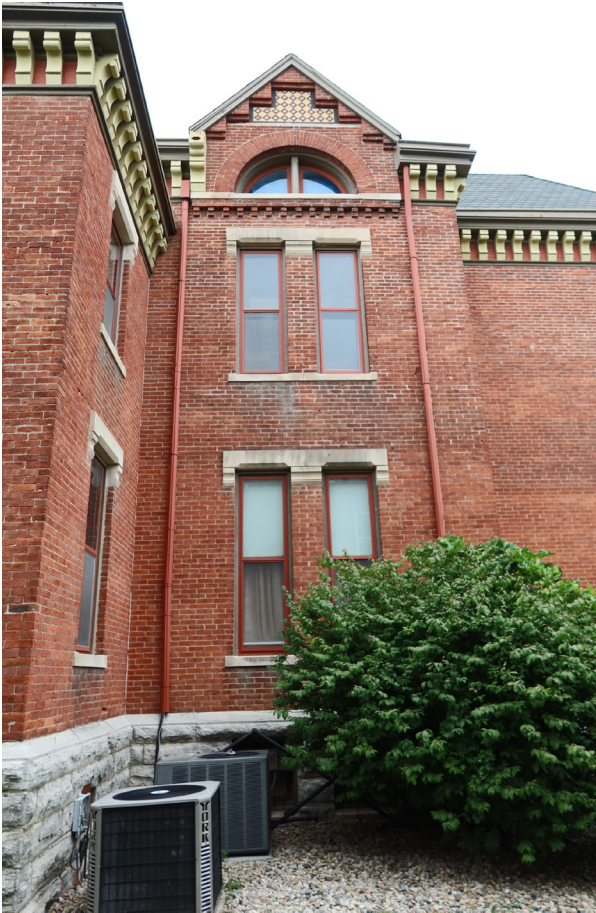
**Figure 2.26:** The east bracket (right) on the south gable of the residence has been missing for many years.

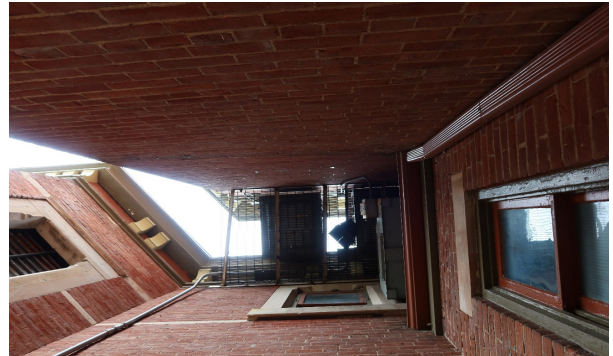
**Figure 2.27:** Missing brackets at notch between house and jail (left). These appear to have been salvaged to replace missing brackets in more visible locations.

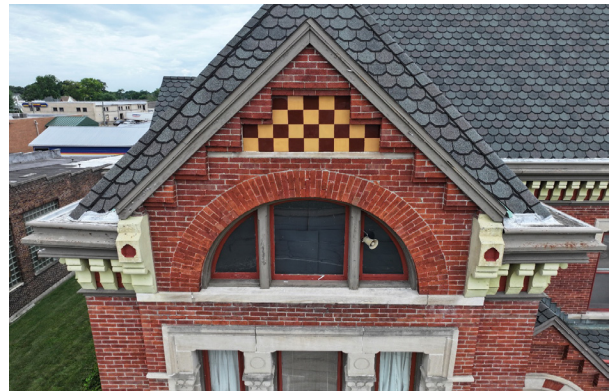
**Figure 2.28:** The cornice appears to be slightly displaced on either side of the east gable. (Drone photo by Arsee).

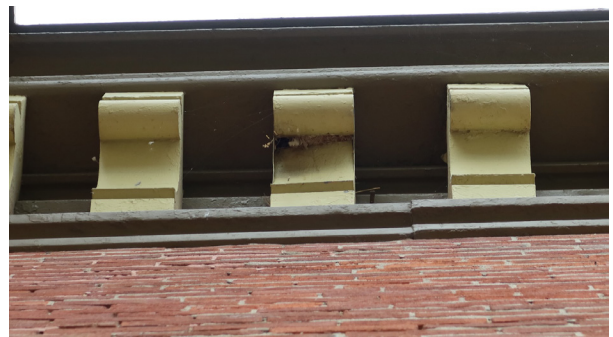
**Figure 2.29:** Minor damage to one cornice bracket with evidence of birds nesting inside bracket.

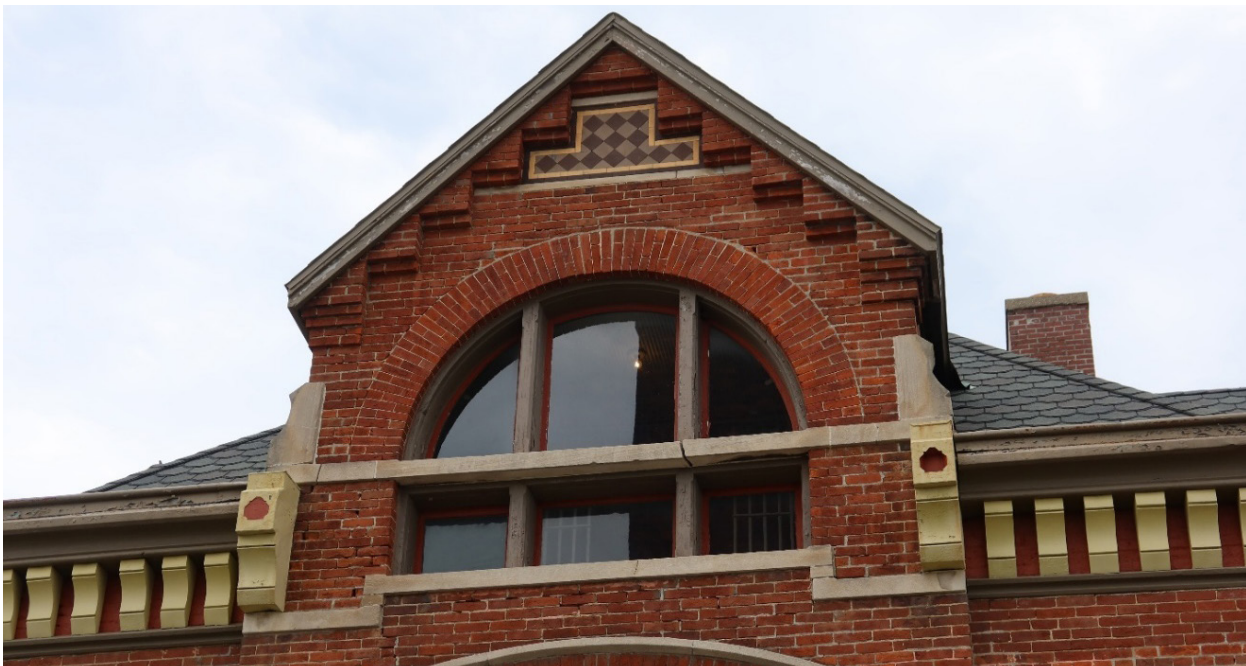
**Figure 2.30:** Historic wood windows at the residence and jail attic are in fair to good condition overall.

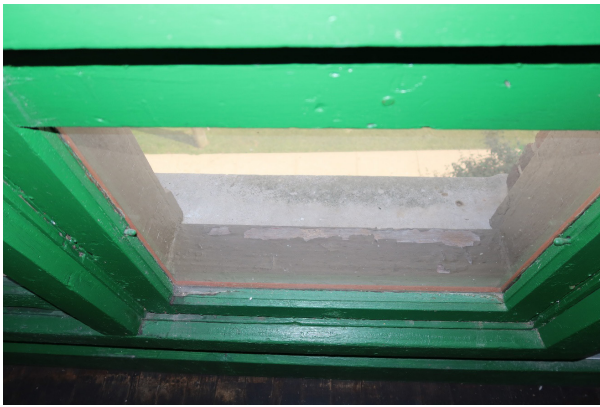
**Figure 2.31:** Typical historic wood window at jail attic showing overall condition. Note peeling paint on exterior sill.

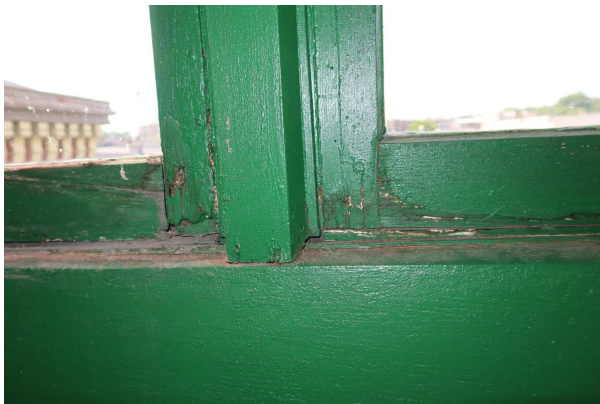
**Figure 2.32:** Typical jail attic window in fair condition.

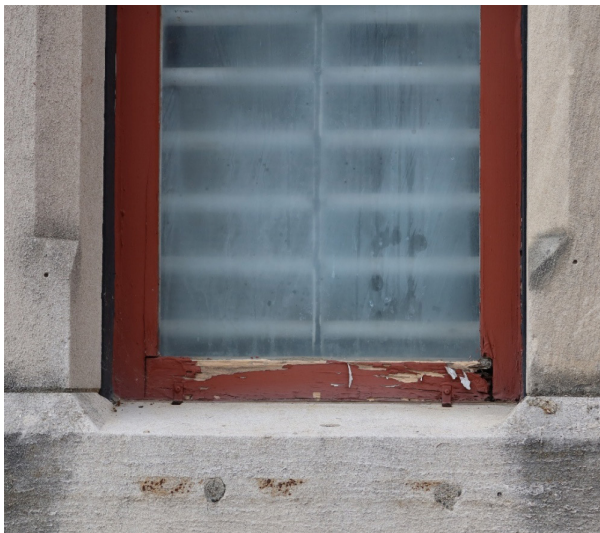
**Figure 2.33:** Typical deterioration of non-historic replacement windows at cell block.

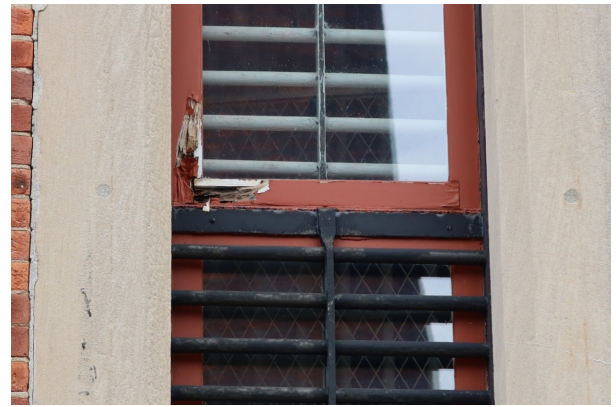
**Figure 2.34:** Typical deterioration of non-historic replacement windows at cell block.

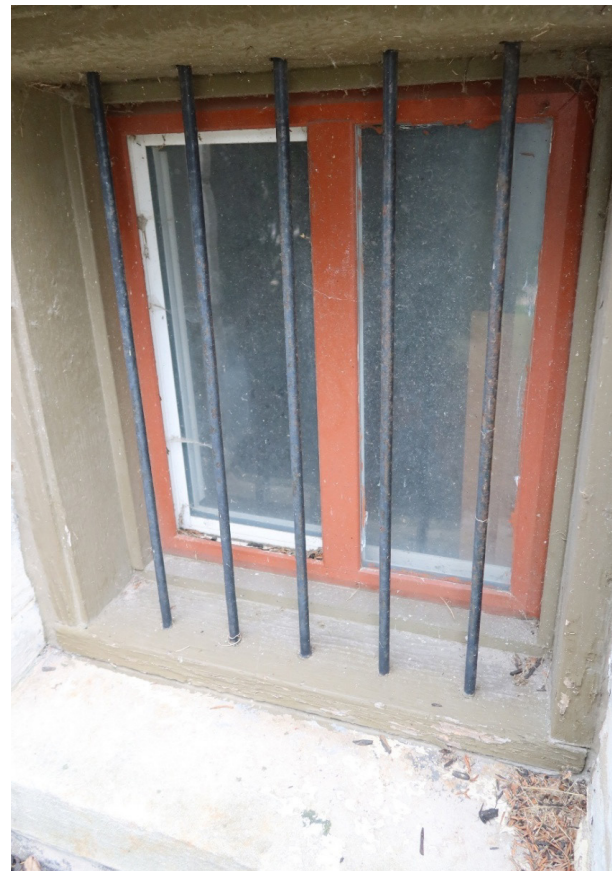
**Figure 2.35:** Non-historic basement window. This window is missing its screen (left).

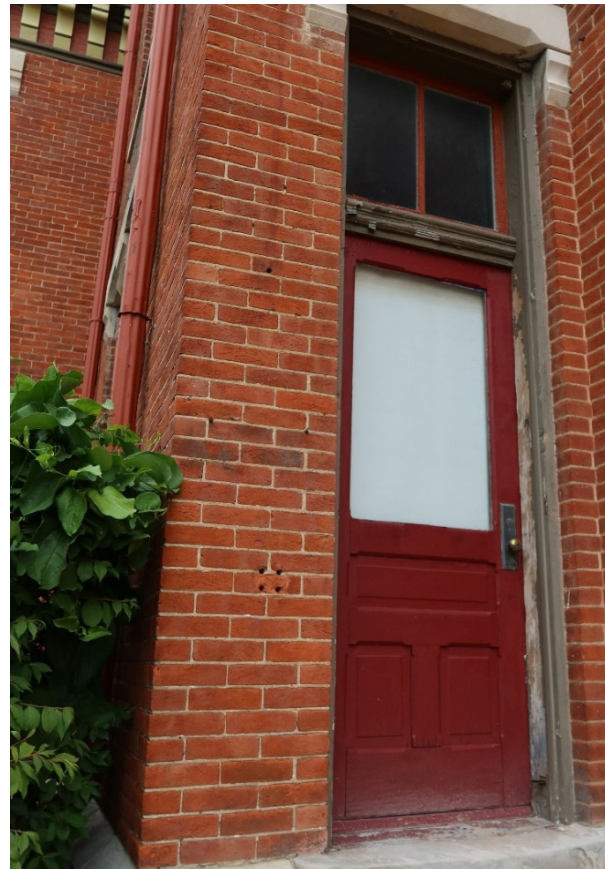
**Figure 2.37:** Dining room door. this door needs to be restored and should be fitted with a new storm door.

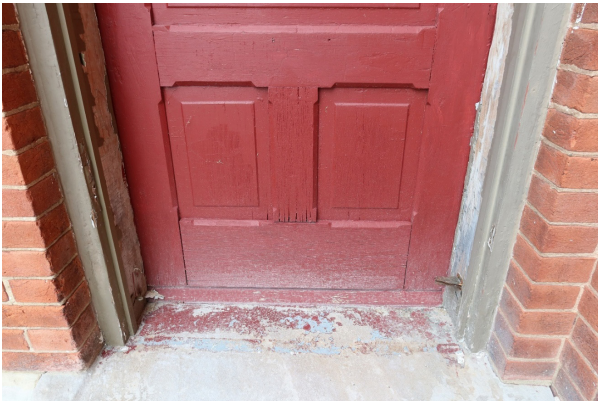
- Serious: The dining room door's storm door is missing. This storm door was falling apart in a 2005 photo and was removed c.2006. The door suffered significant weathering between 2007 and 2023 because the storm door was not replaced.

**Figure 2.38:** Dining room door showing paint failure and weathering since removal of storm door around 2006.

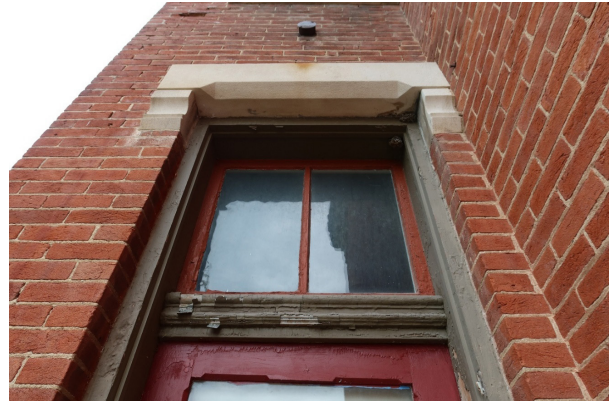
**Figure 2.40:** Paint failure at transom bar of dining room door.

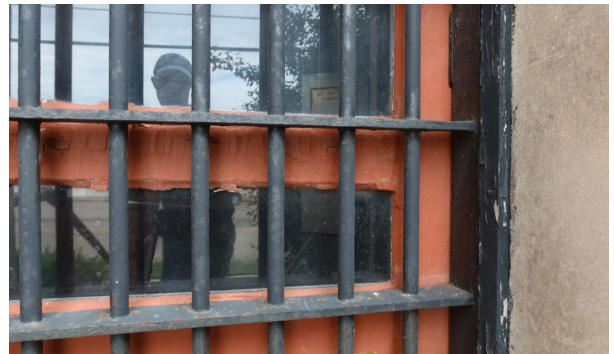
**Figure 2.41:** Typical deterioration of paint finishes at guard room door.

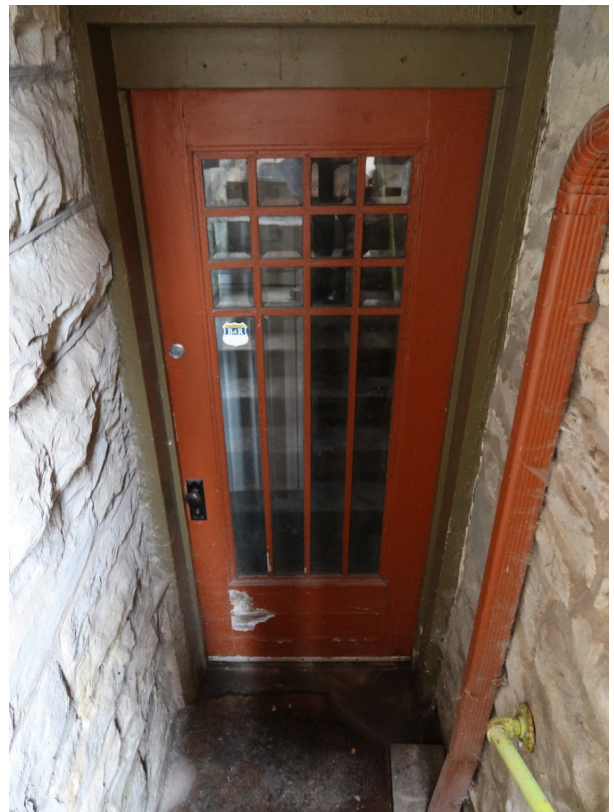
- The basement door appears to date from c.1925.
  - Minor: Some paint failure and deterioration evident at lower rail of door.

**Figure 2.42:** Basement door showing paint failure and damp conditions at areaway.

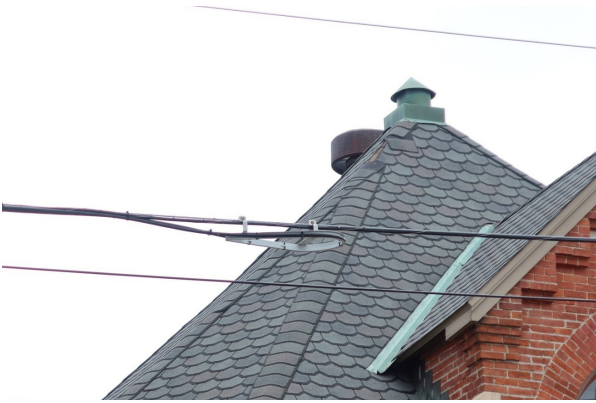
**Figure 2.43:** Roof of cellblock. Note loose and missing shingles at upper part of hip.

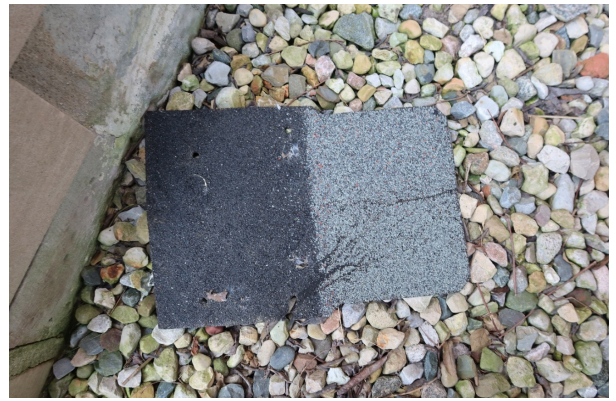
**Figure 2.44:** Loose shingle on the ground next to cellblock.

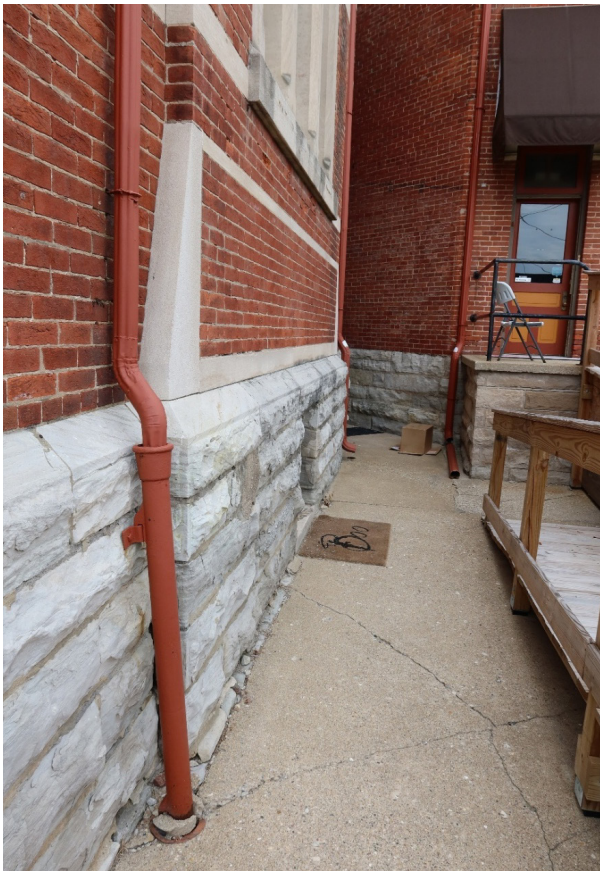
- Serious: Downspouts drain to the ground near the building or to subsurface drain tiles. This appears to be a likely contributor to water infiltration in the basement of the jail. Consider replacement of all sub-surface drain tiles with new piping conducting rainwater to the street or storm sewer.

**Figure 2.46:** Downspouts drain to the ground near the building or to subsurface drain tiles. This appears to be a likely contributor to water infiltration in the basement.

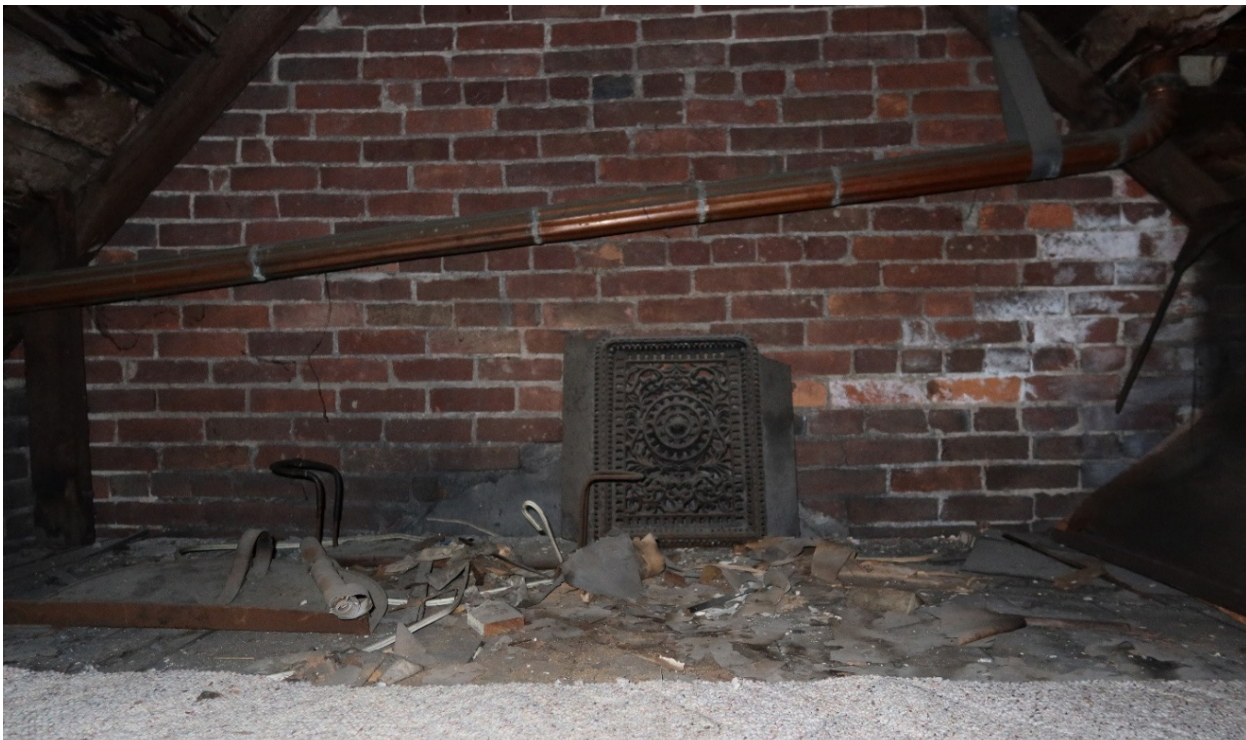
- Minor: The downspout draining the south face of the residence vestibule roof passes through the vestibule attic. This appears to be the original detail and does not show any signs of leaks. This attic should be inspected quarterly for signs of leaks.

**Figure 2.47:** Residence vestibule attic, facing east. The downspout draining the south face of the residence vestibule roof passes through the vestibule attic. This appears to be the original detail and does not show any signs of leaks. This attic should be inspected quarterly for signs of leaks.

Inspect vestibule attic quarterly for signs of leaks around interior downspout.

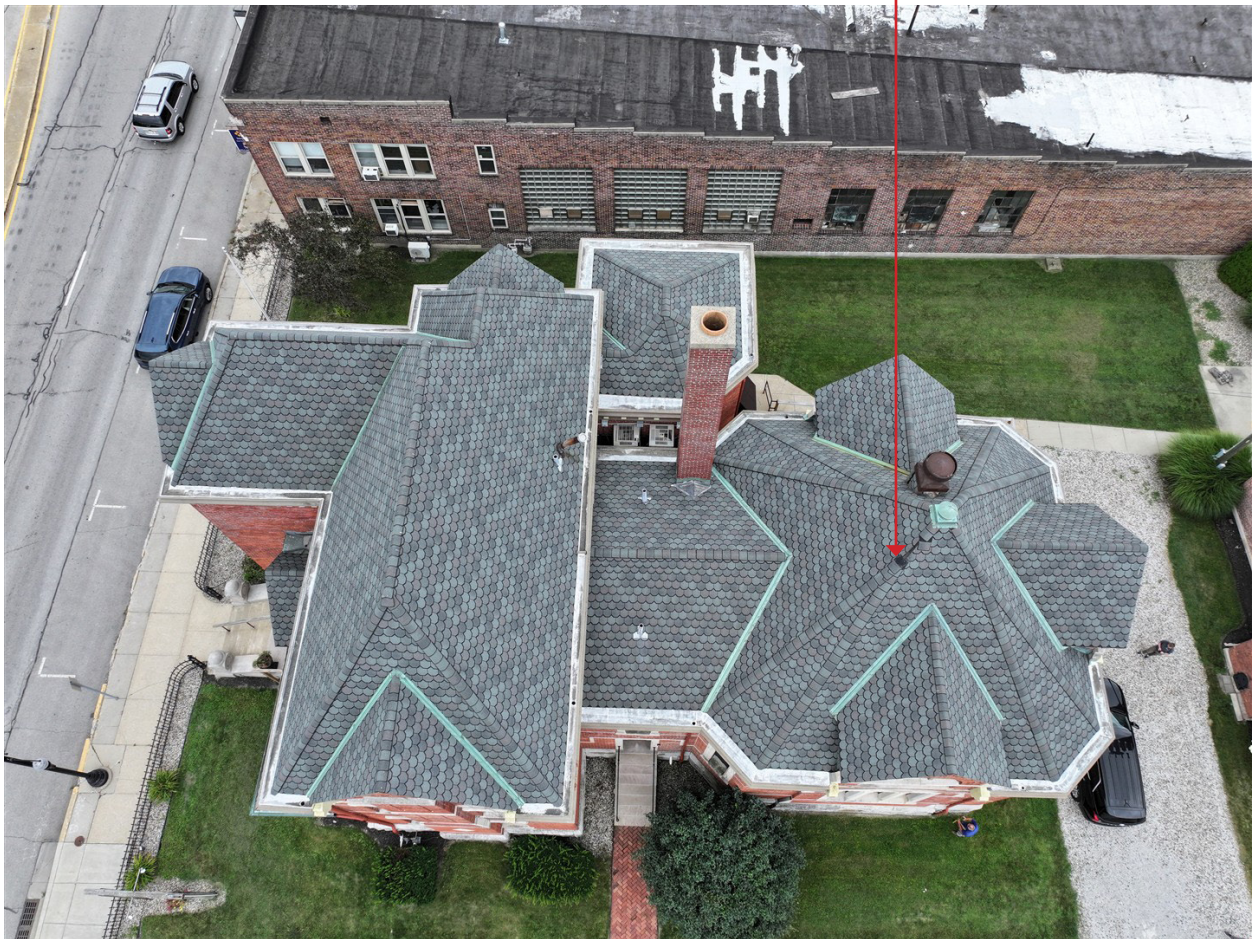
**AERIAL VIEW**

Missing shingles on the hip of the cellblock roof (dark areas to lower left of finial).
