## CULTURAL LANDSCAPE REPORT

### PRAIRIE CREEK FISH HATCHERY

REDWOOD NATIONAL AND STATE PARKS , CALIFORNIA

JUNE 2020

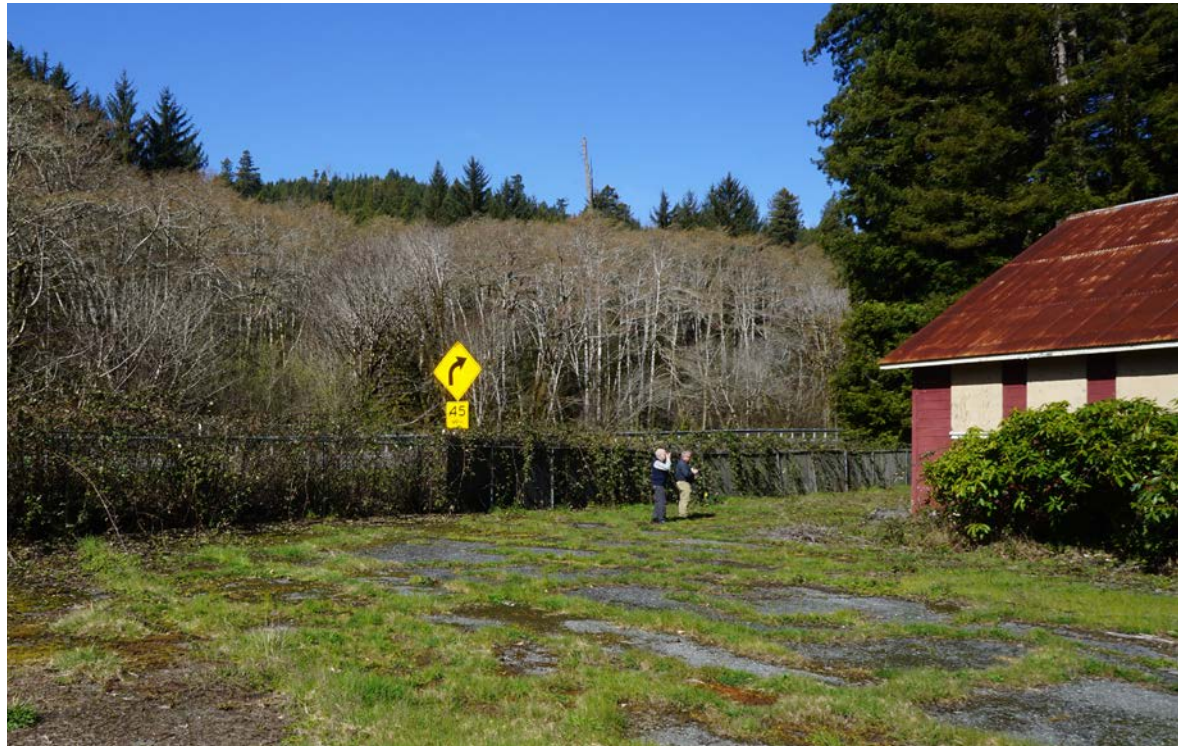
Northwest view:  
existing conditions  
(2020): Original  
Highway 101  
entrance fenced  
with chain link fence  
and Himalayan  
Blackberries (CLRG,  
2020).

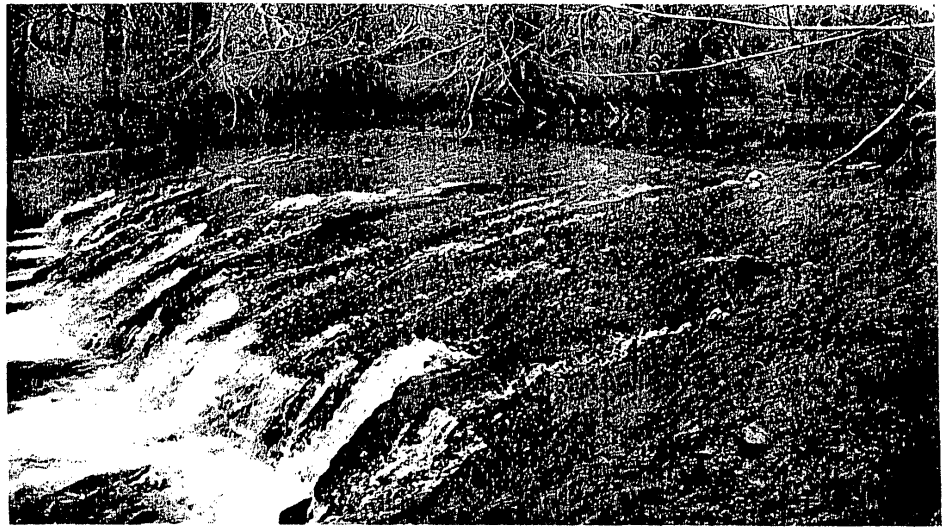
View north, across dam face. Note the north wing wall and deteriorating condition at bottom of dam face.
