RICHMOND NATIONAL BATTLEFIELD PARK

GARTHRIGHT HOUSE

HISTORIC STRUCTURES REPORT

ARCHITECTURAL DATA

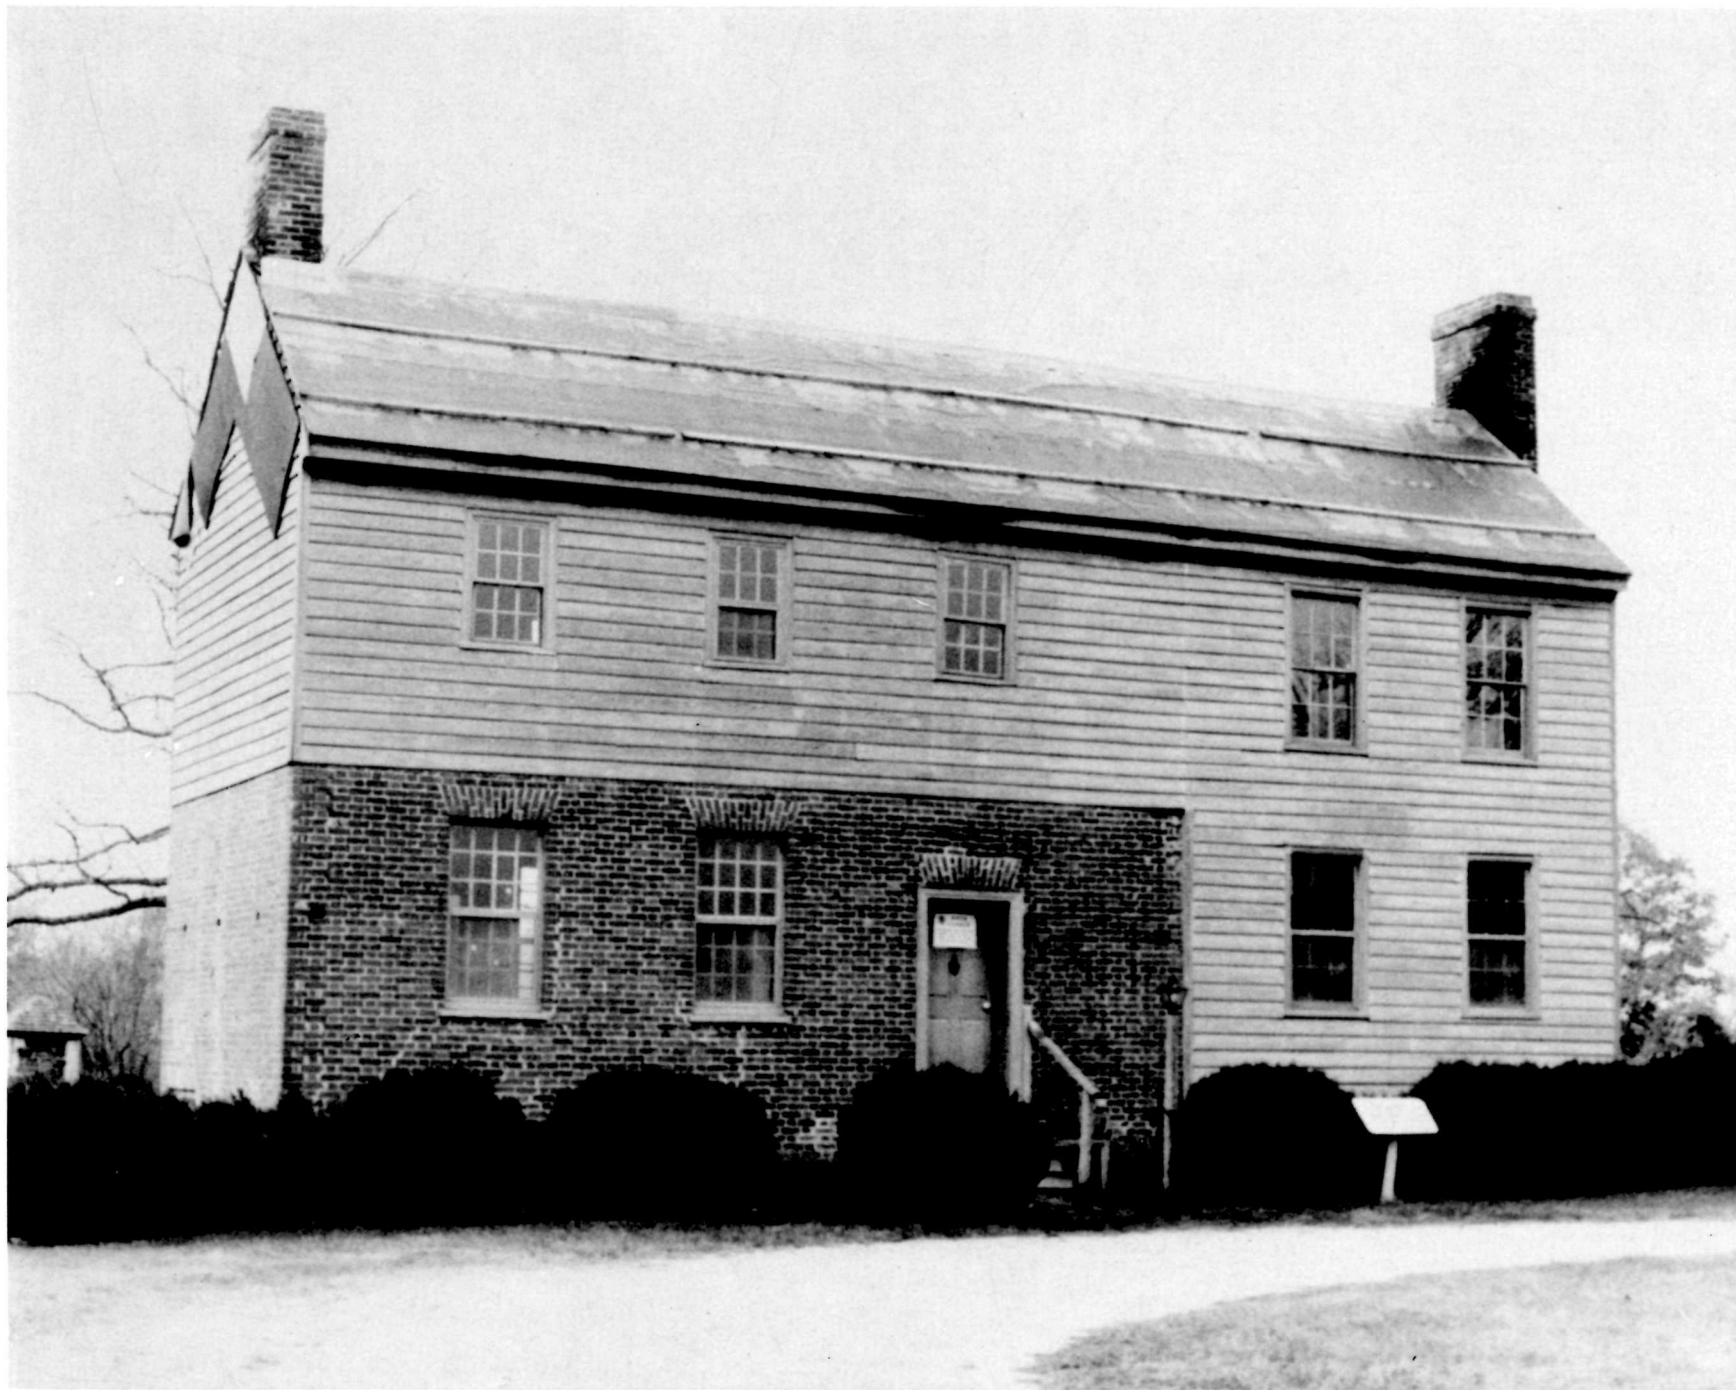
PLATE VII

Garthright House, Feb. 1971. Note temporary roof installed to protect the building after the fire of 1970.

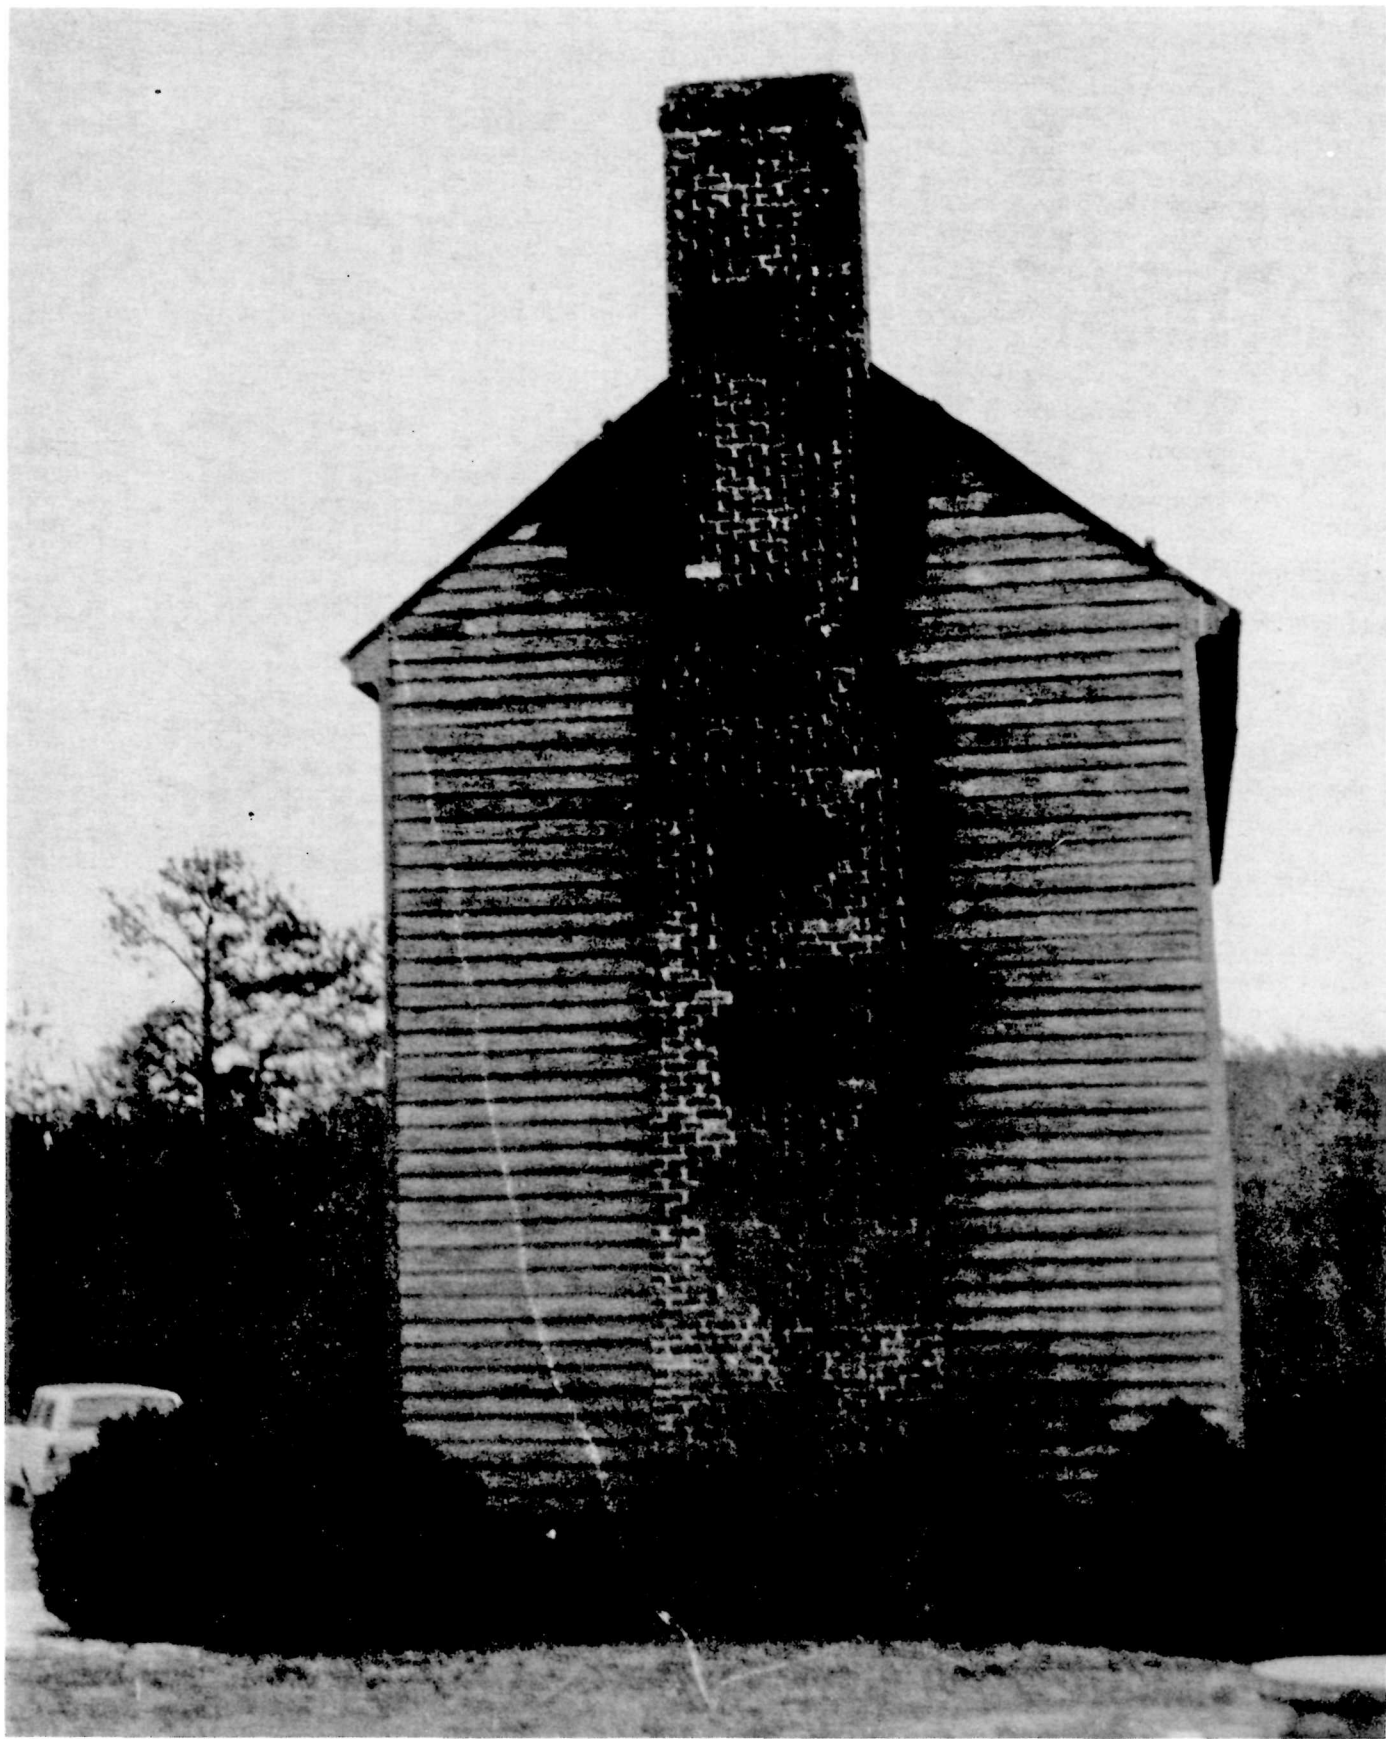
PLATE VIII

West elevation showing fire damaged gable
and condition of chimney.

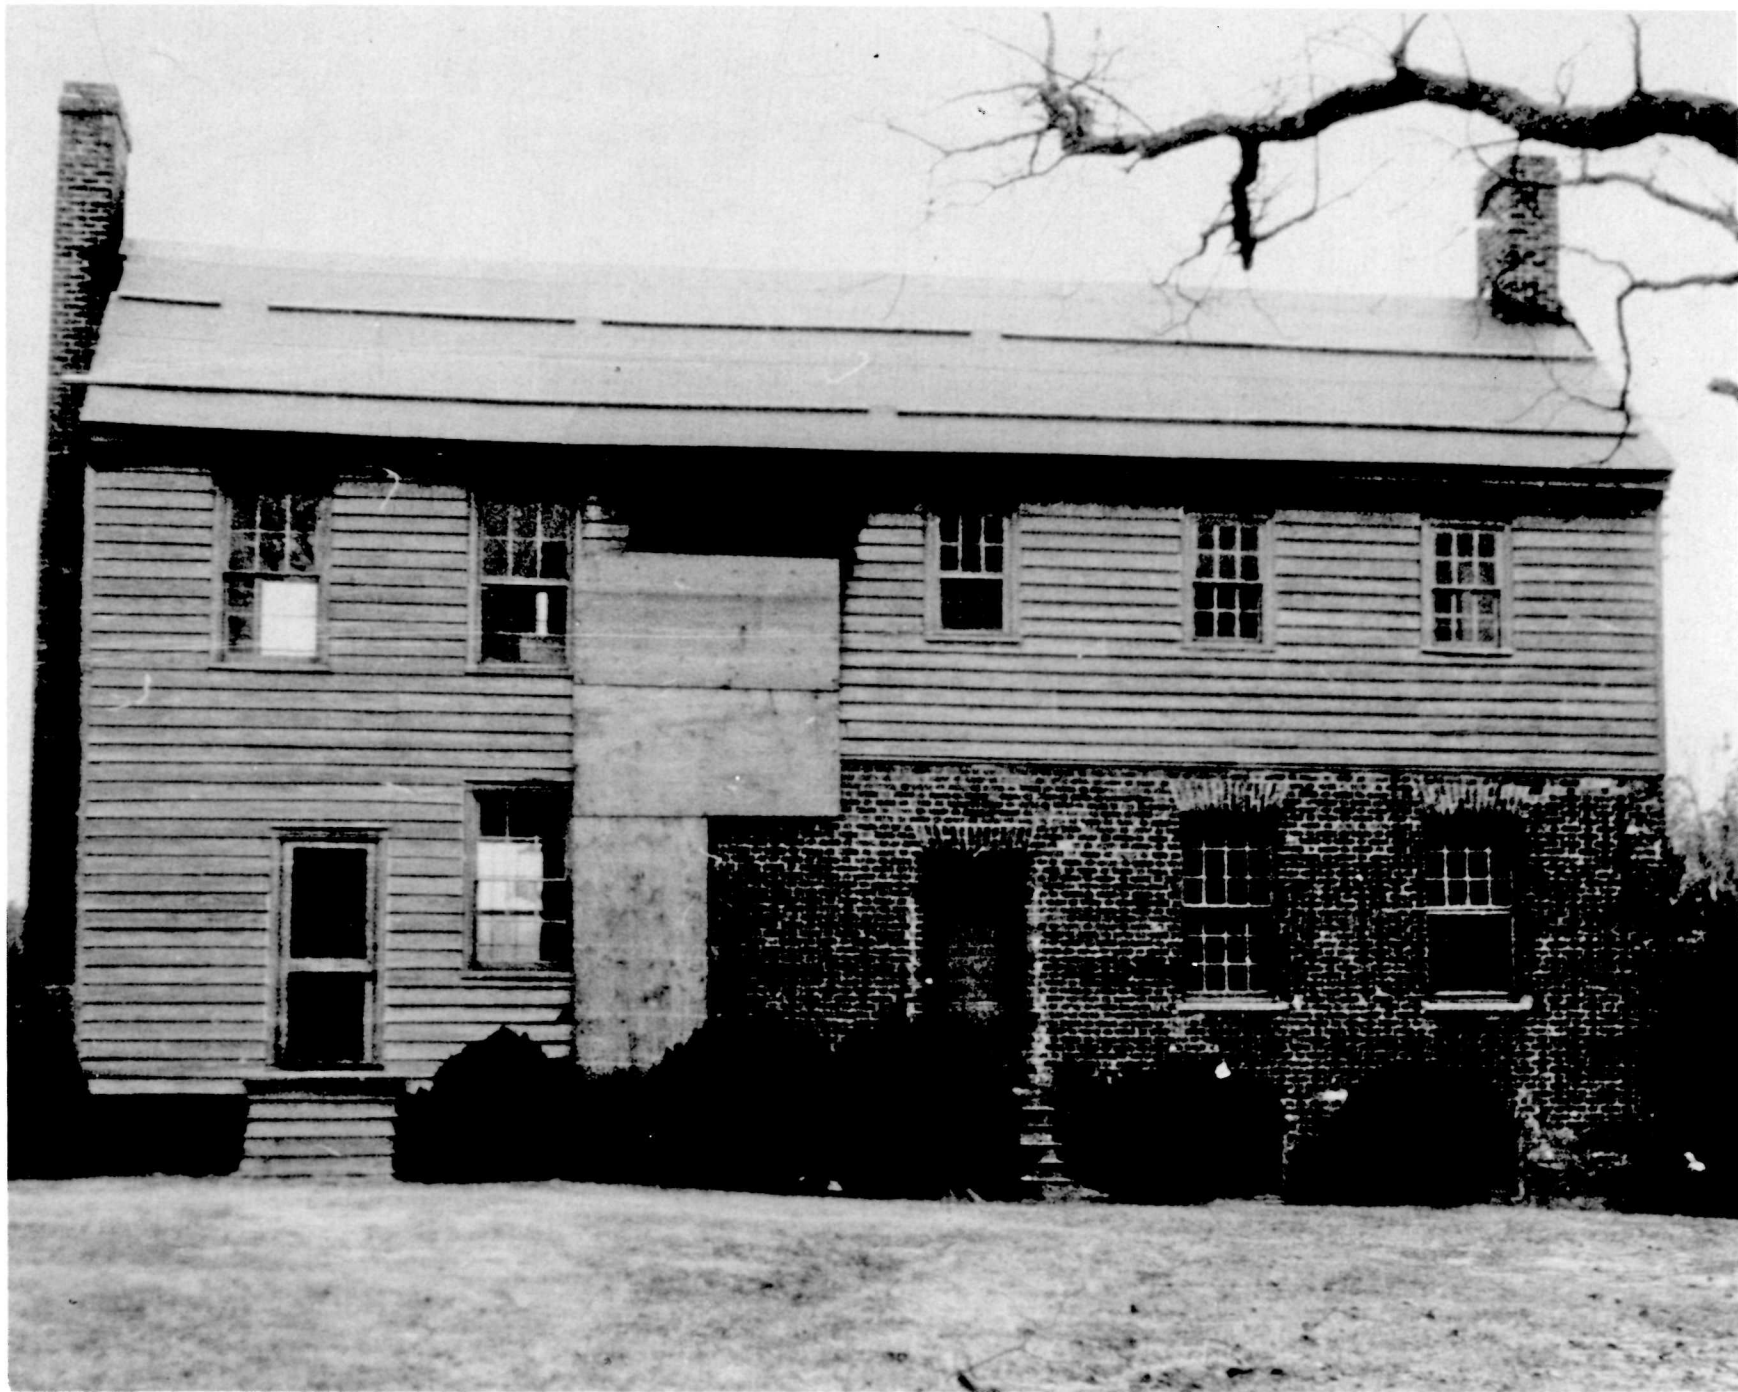
PLATE IX

Rear elevation showing extent of fire damage to this side.

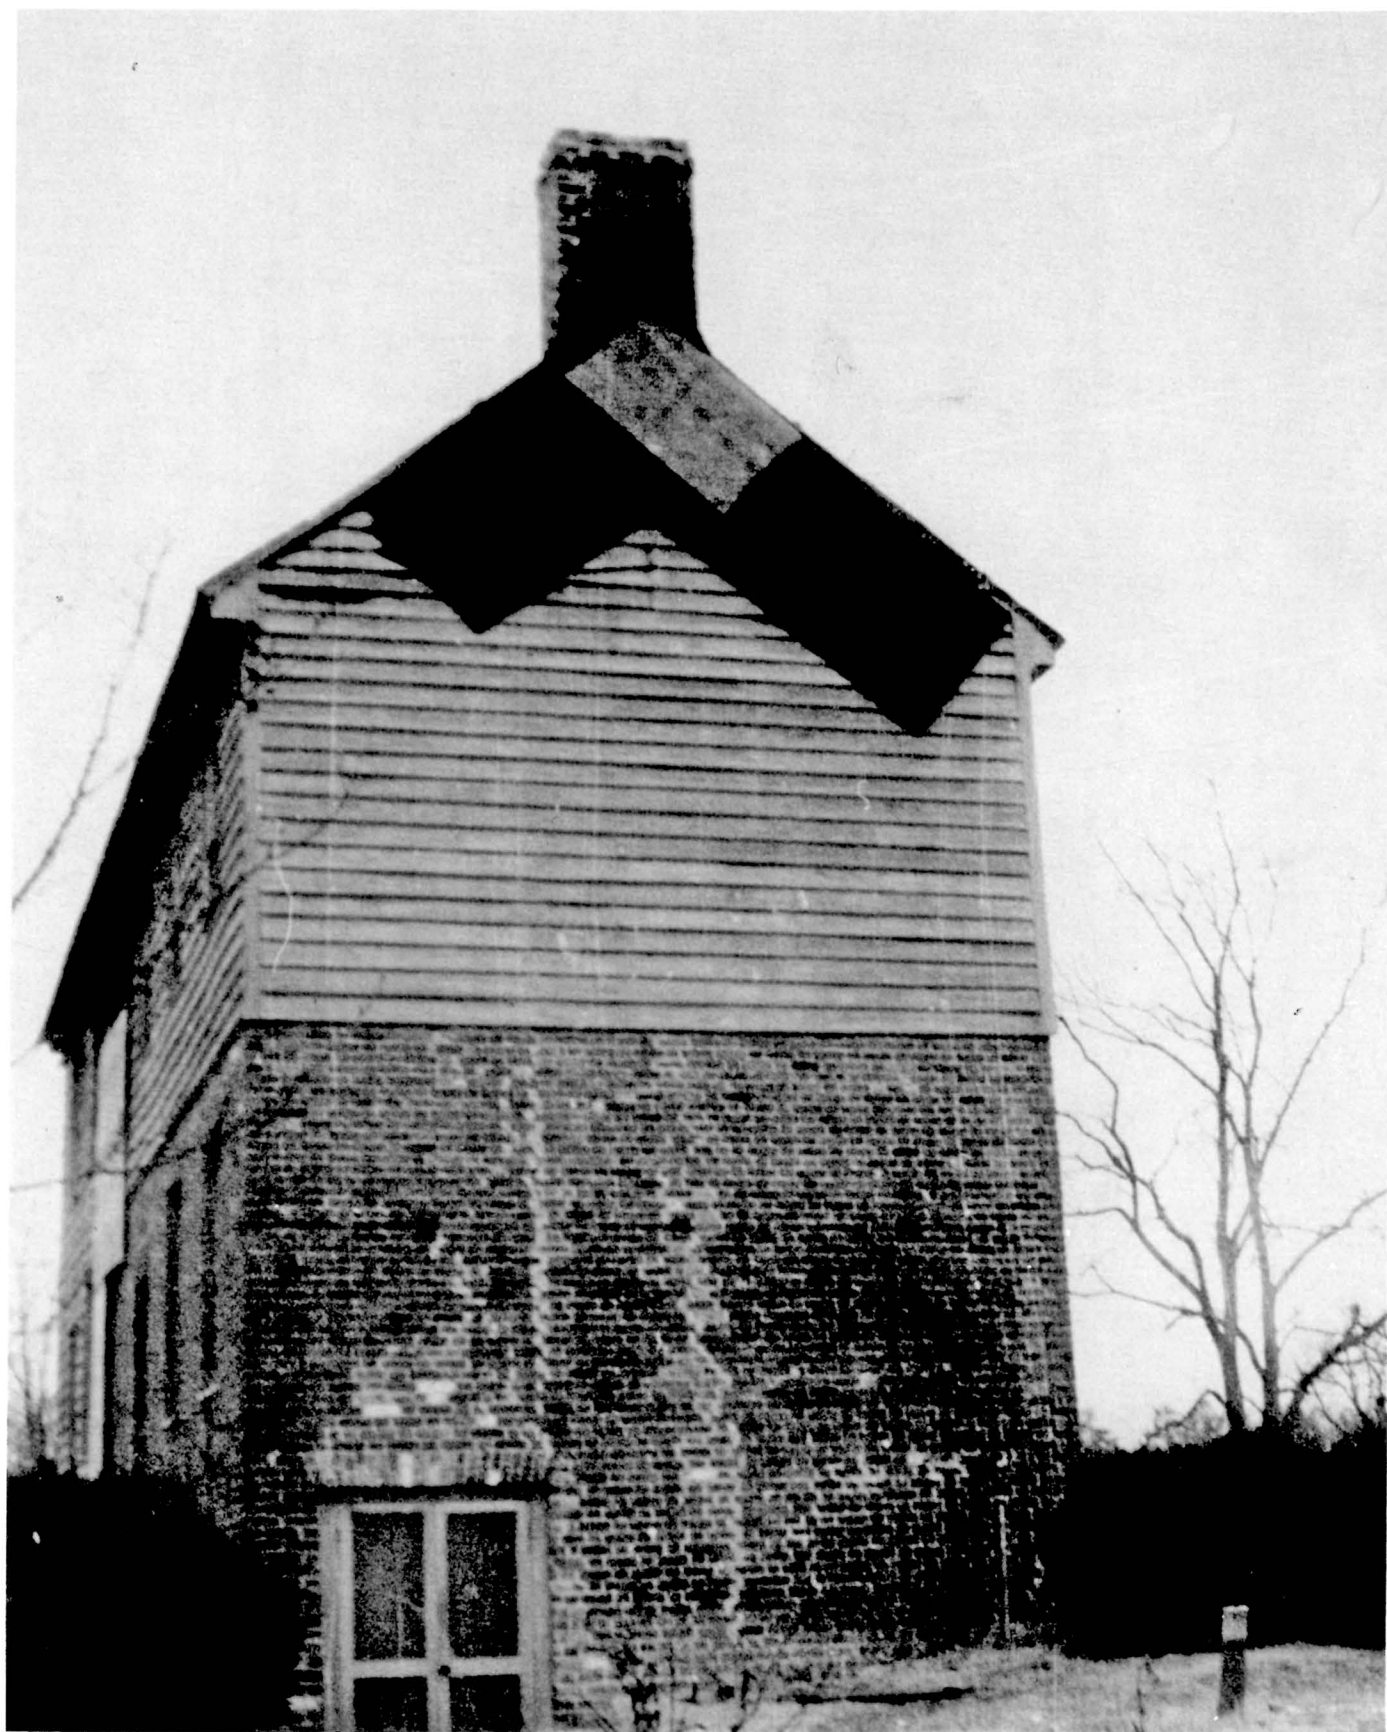
PLATE X

The gables were damaged more extensively by the fire than appears from the outside. Note the appearance of the masonry due to poor workmanship in repainting.

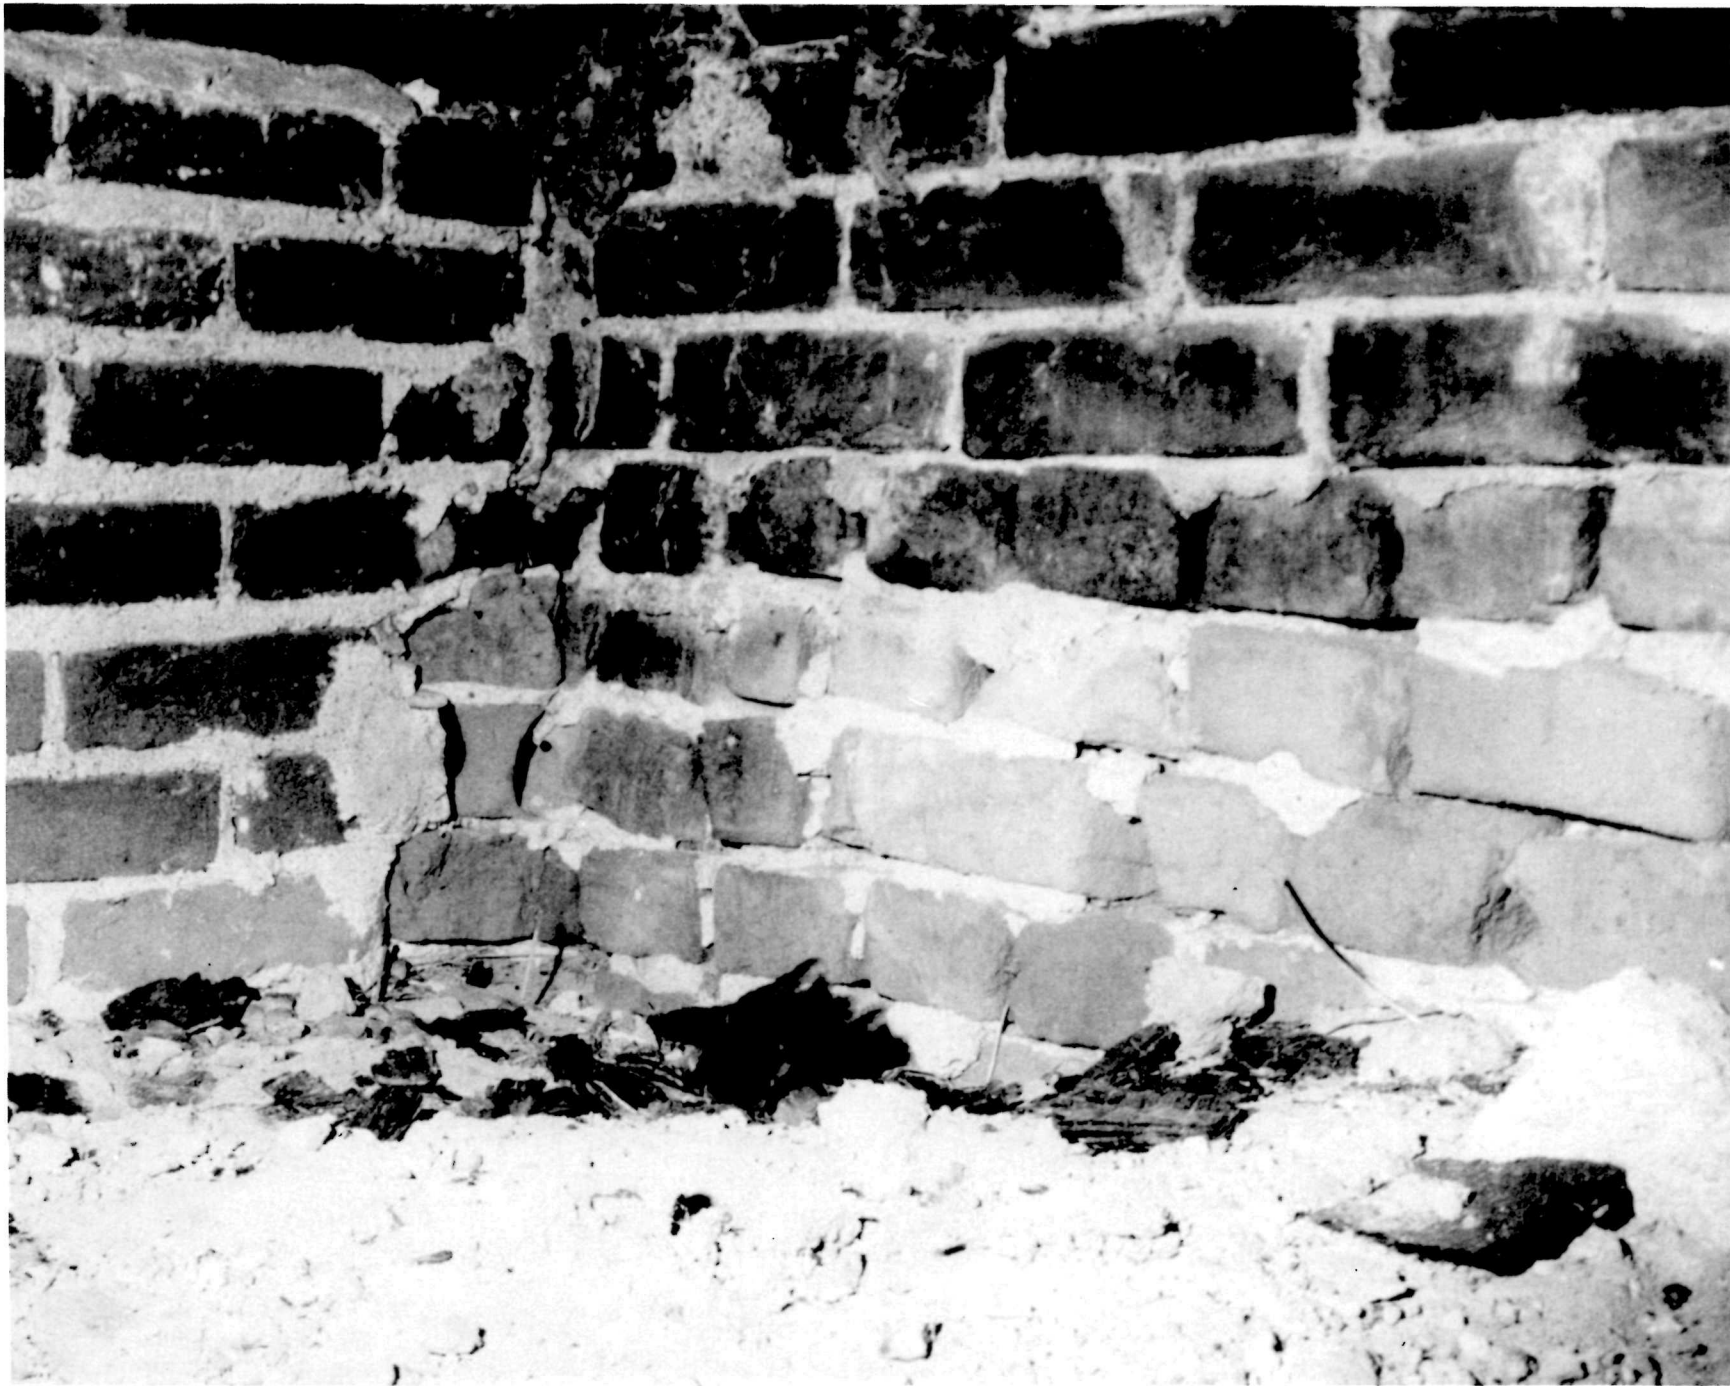
PLATE XI

View of the foundation showing lack of maintenance.

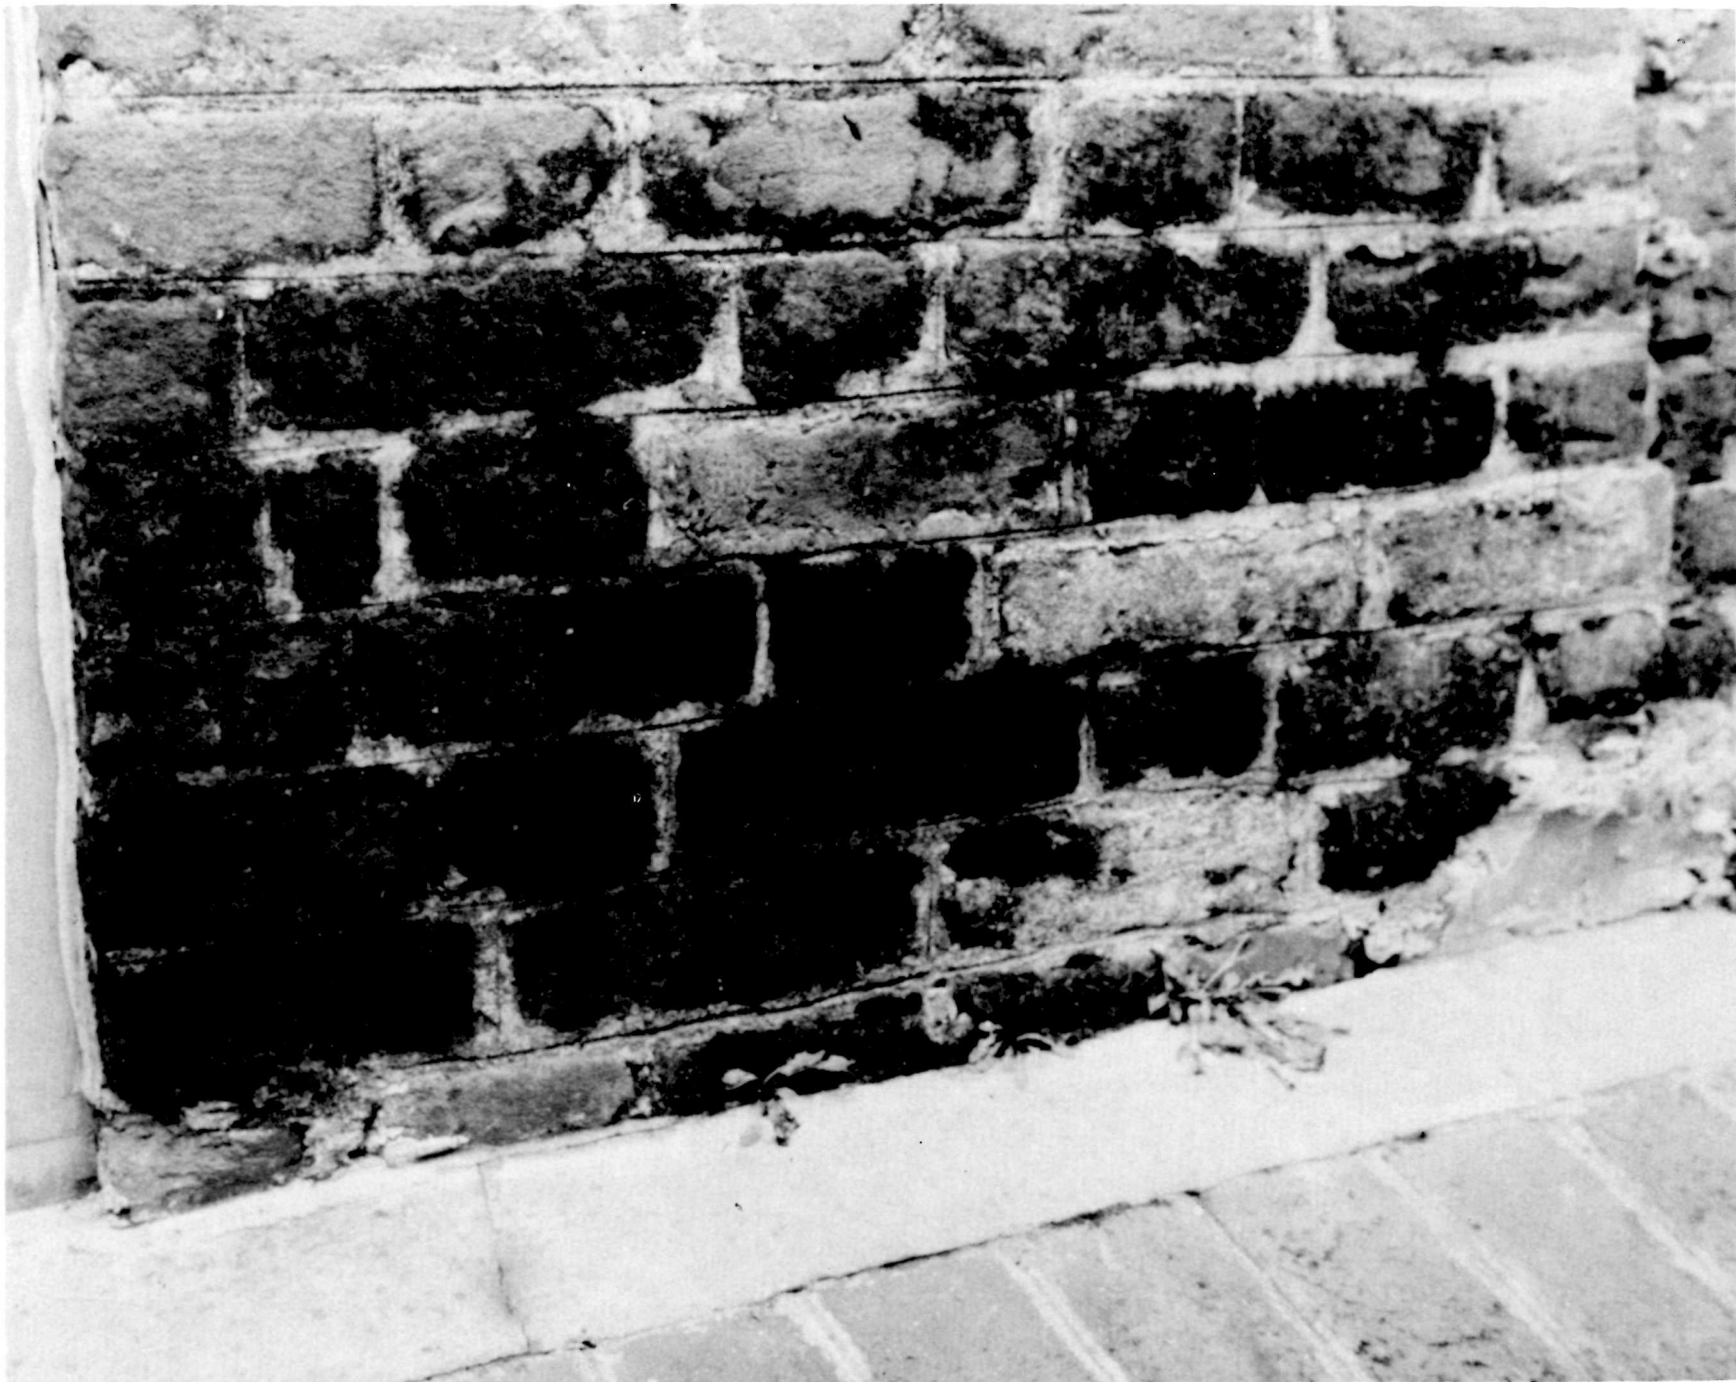
PLATE XII

The brick drains installed along the front and rear walls are not in character with a Virginia farmhouse and are causing serious damage to the wall bricks by splashing the water against the walls.

The weathering of the lower portion of the walls has been accelerated by water splashing from the brick drains.

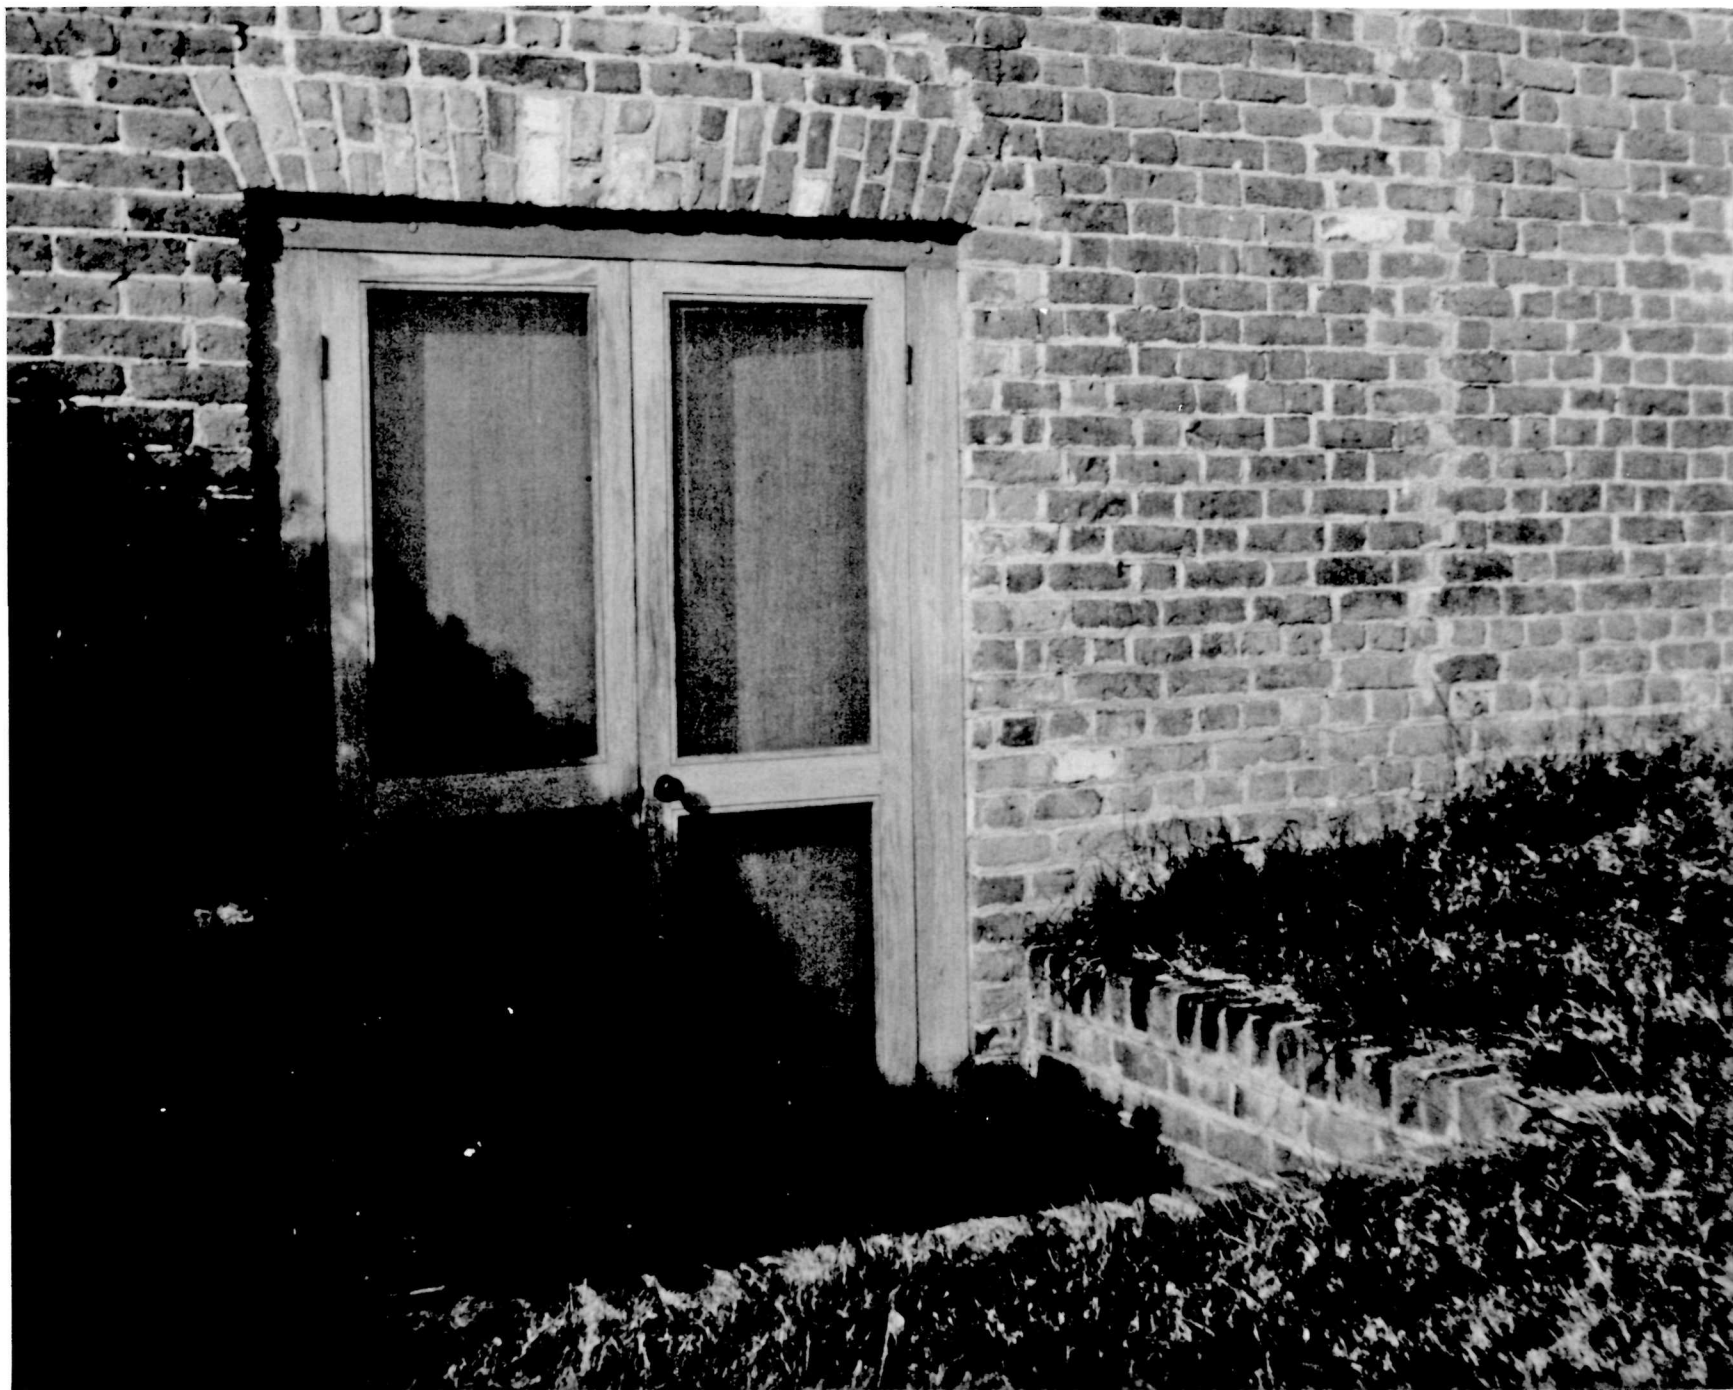
PLATE XIII

Outside basement entrance. This will be investigated during the restoration to determine its historic accuracy.

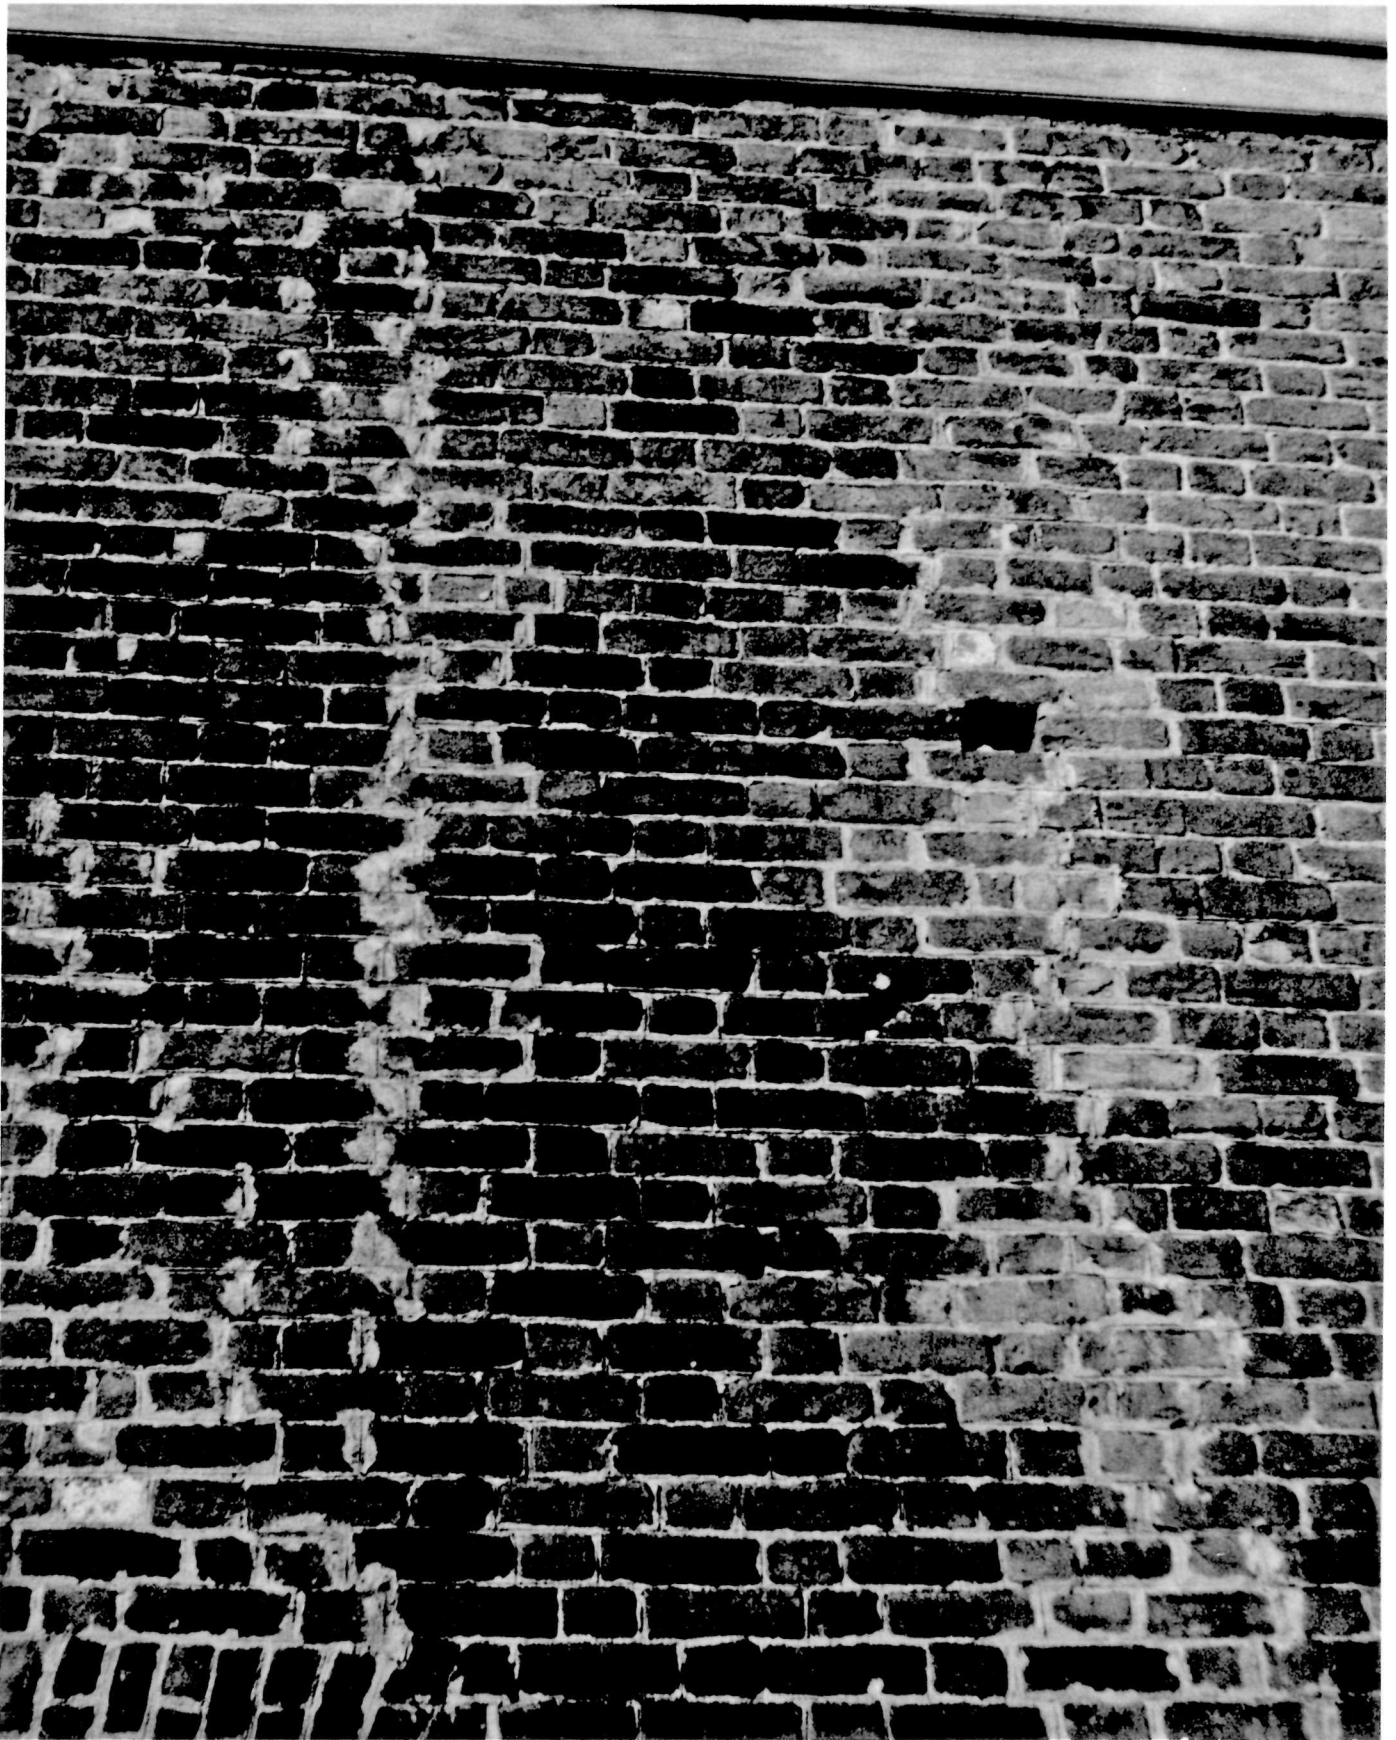
PLATE XIV

A close-up of the south elevation showing the general condition. Note "Pud Lock" hole to facilitate scaffolding during construction.

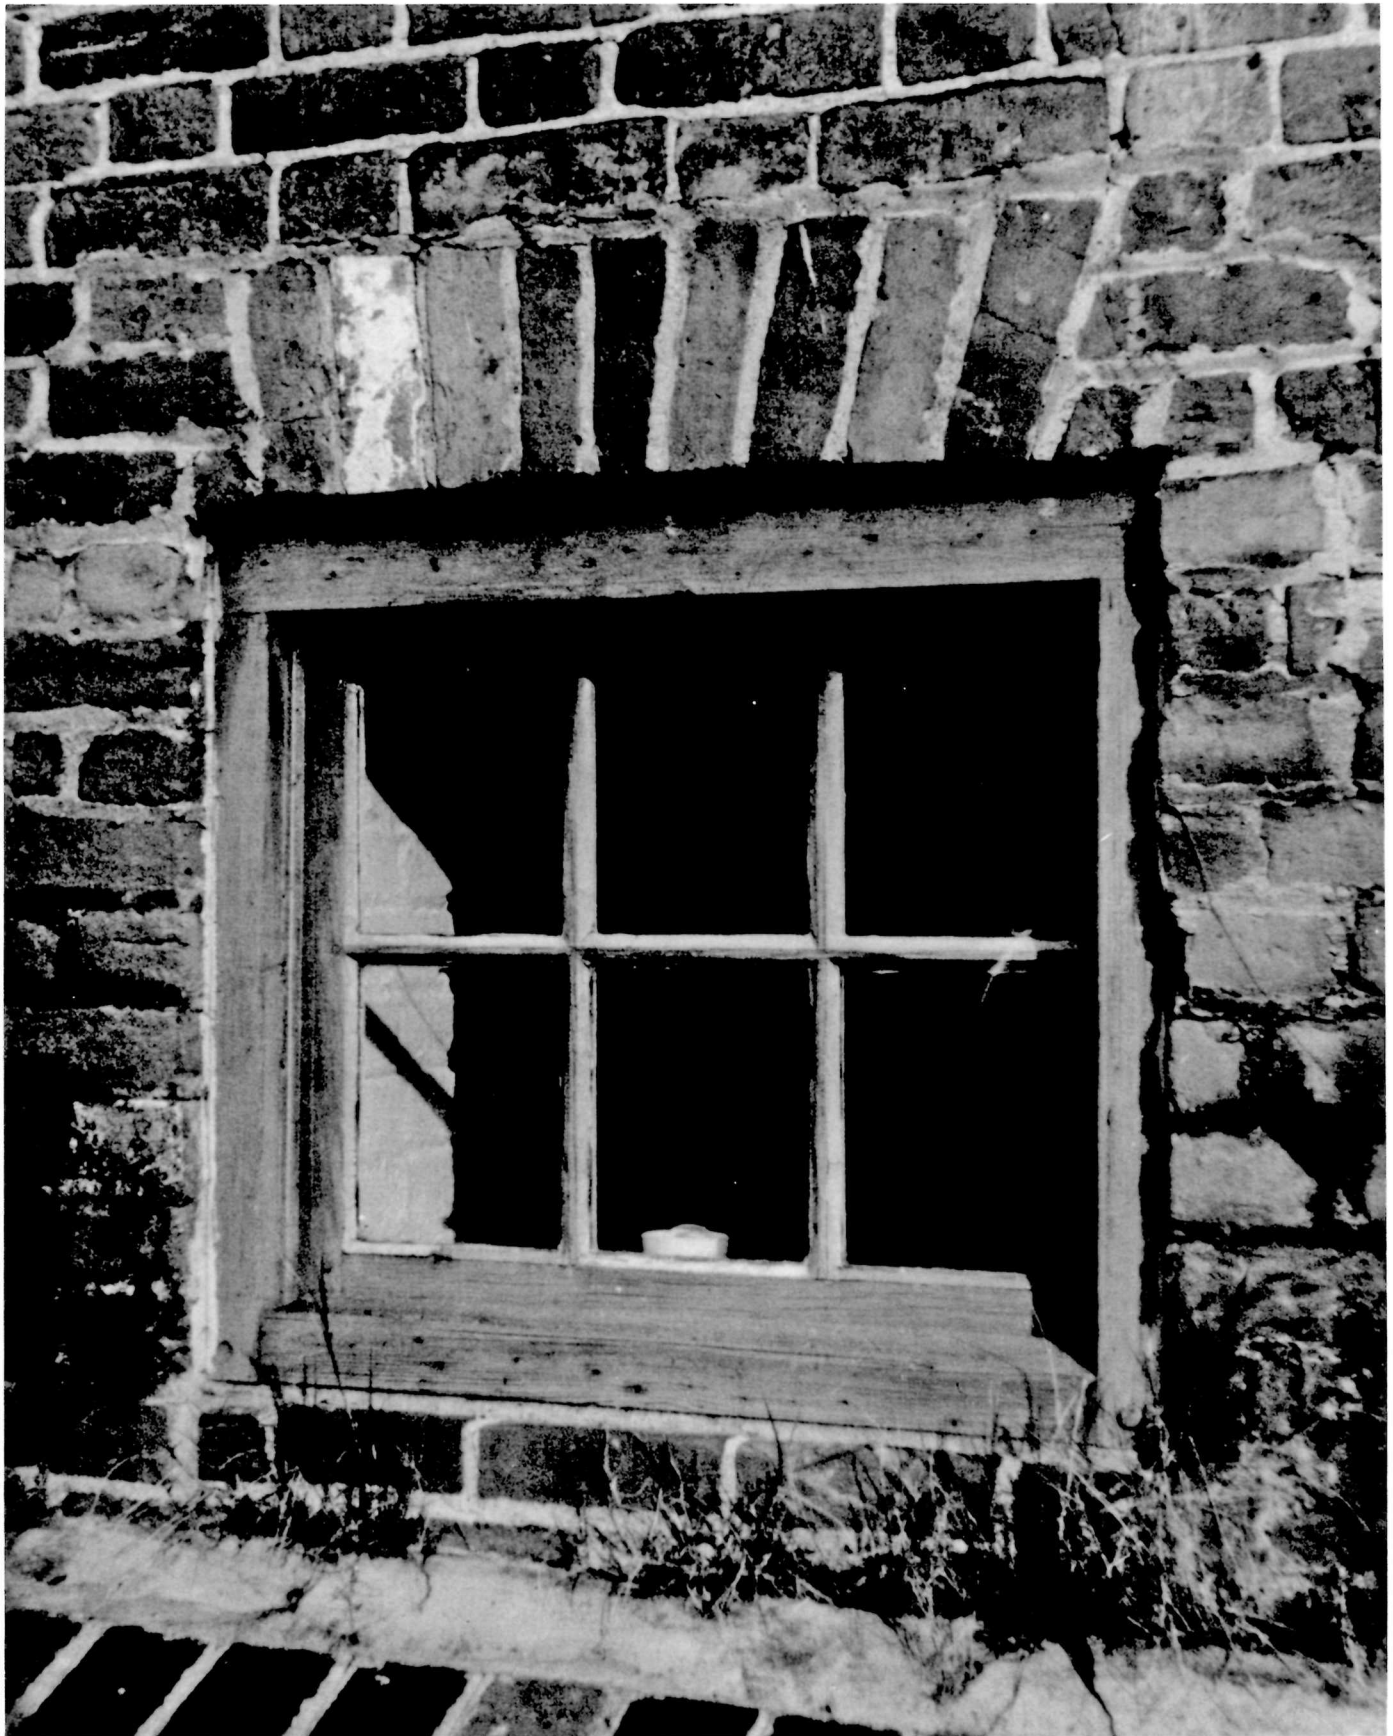
PLATE XV

While not historically accurate, the basement windows are in good condition and will not be replaced at this time due to limited funds. They should be corrected as soon as possible.
