RICHMOND NATIONAL BATTLEFIELD PARK

GARTHRIGHT HOUSE

HISTORIC STRUCTURES REPORT

ARCHITECTURAL DATA

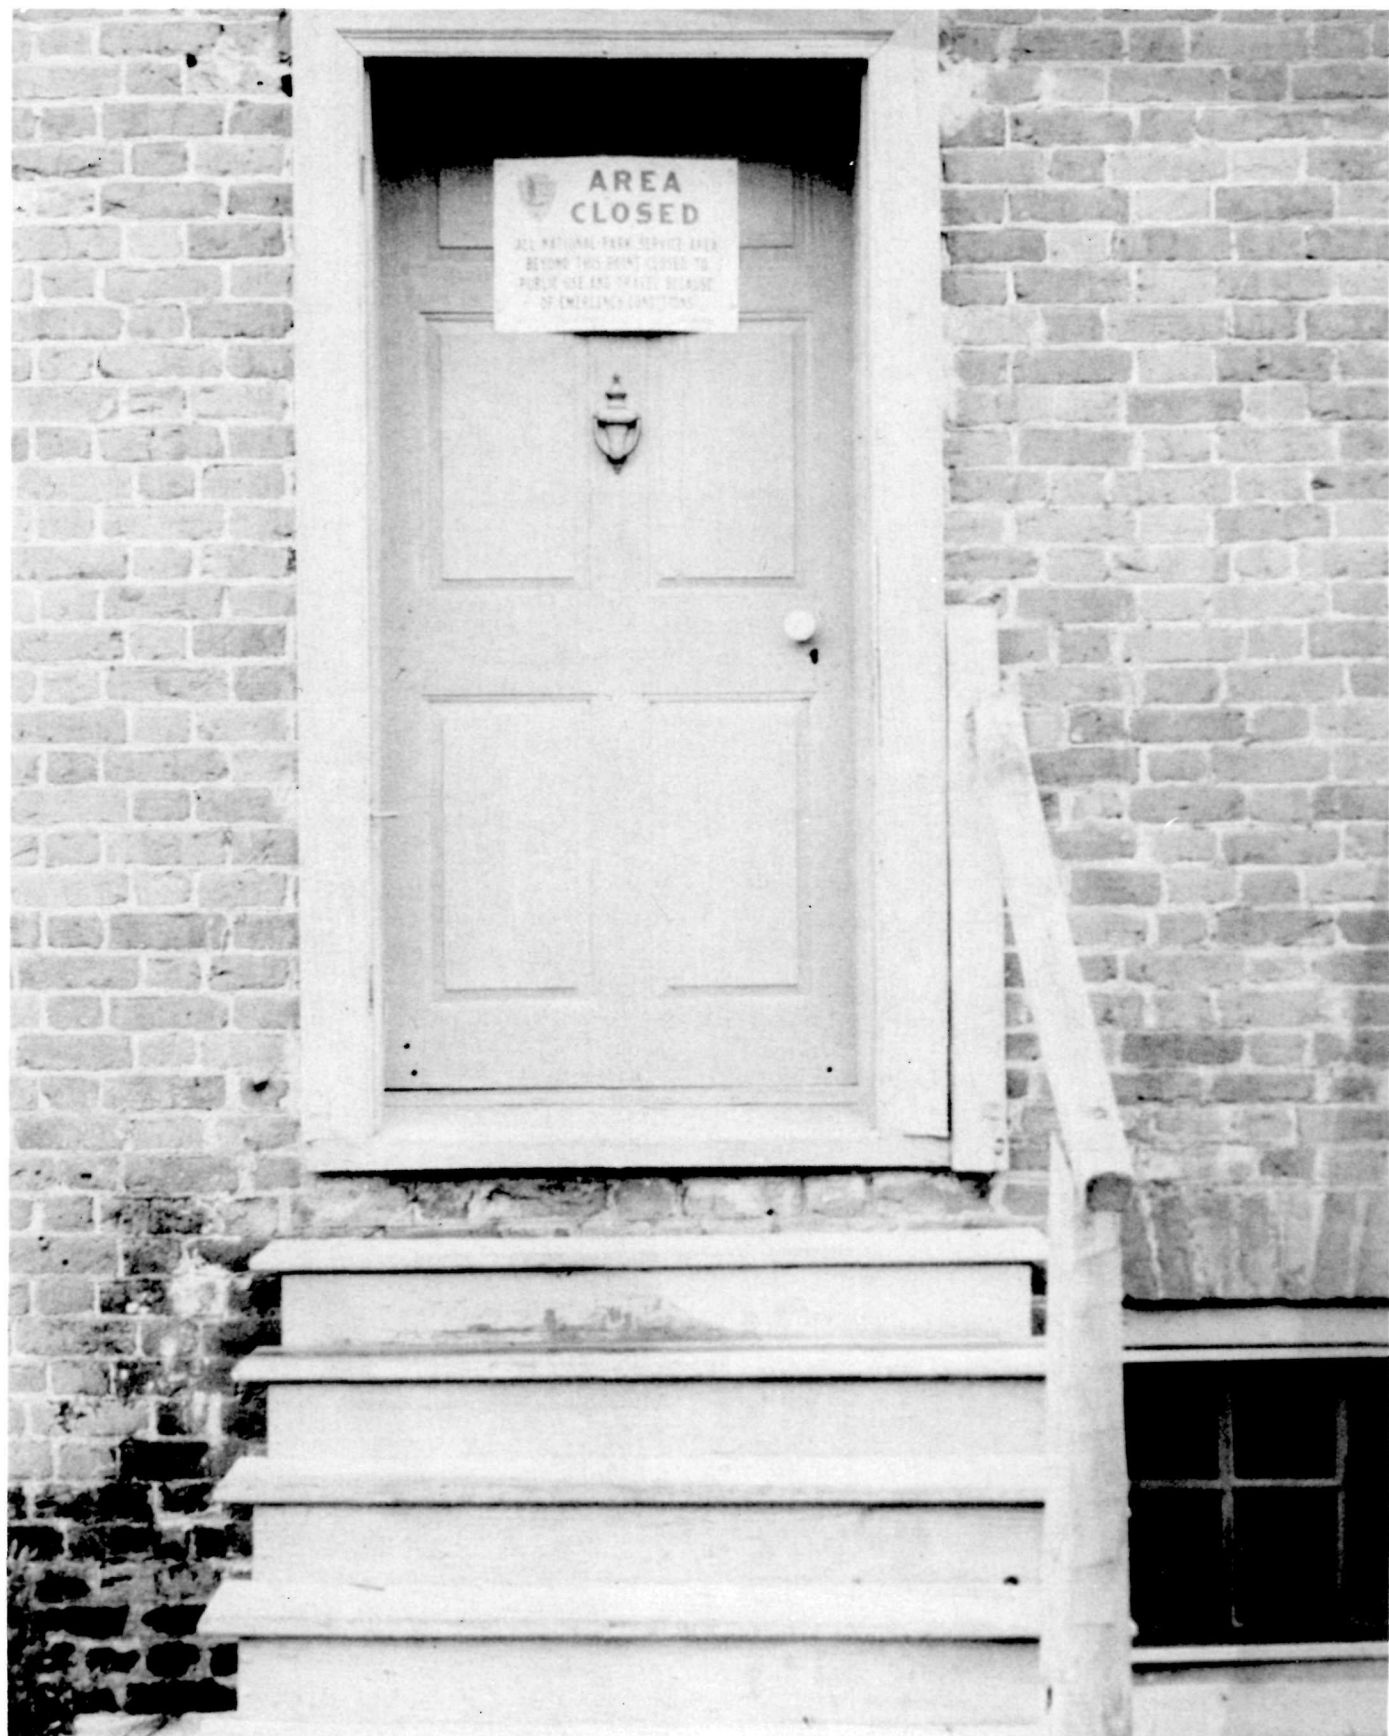
PLATE XVI

The open riser wood steps at the three exterior doors are not historically correct and are in very poor condition.

Front door and steps. The present steps will be replaced with a historically accurate reproduction.

Remove existing front steps and replace with open riser wood steps and brick pad.

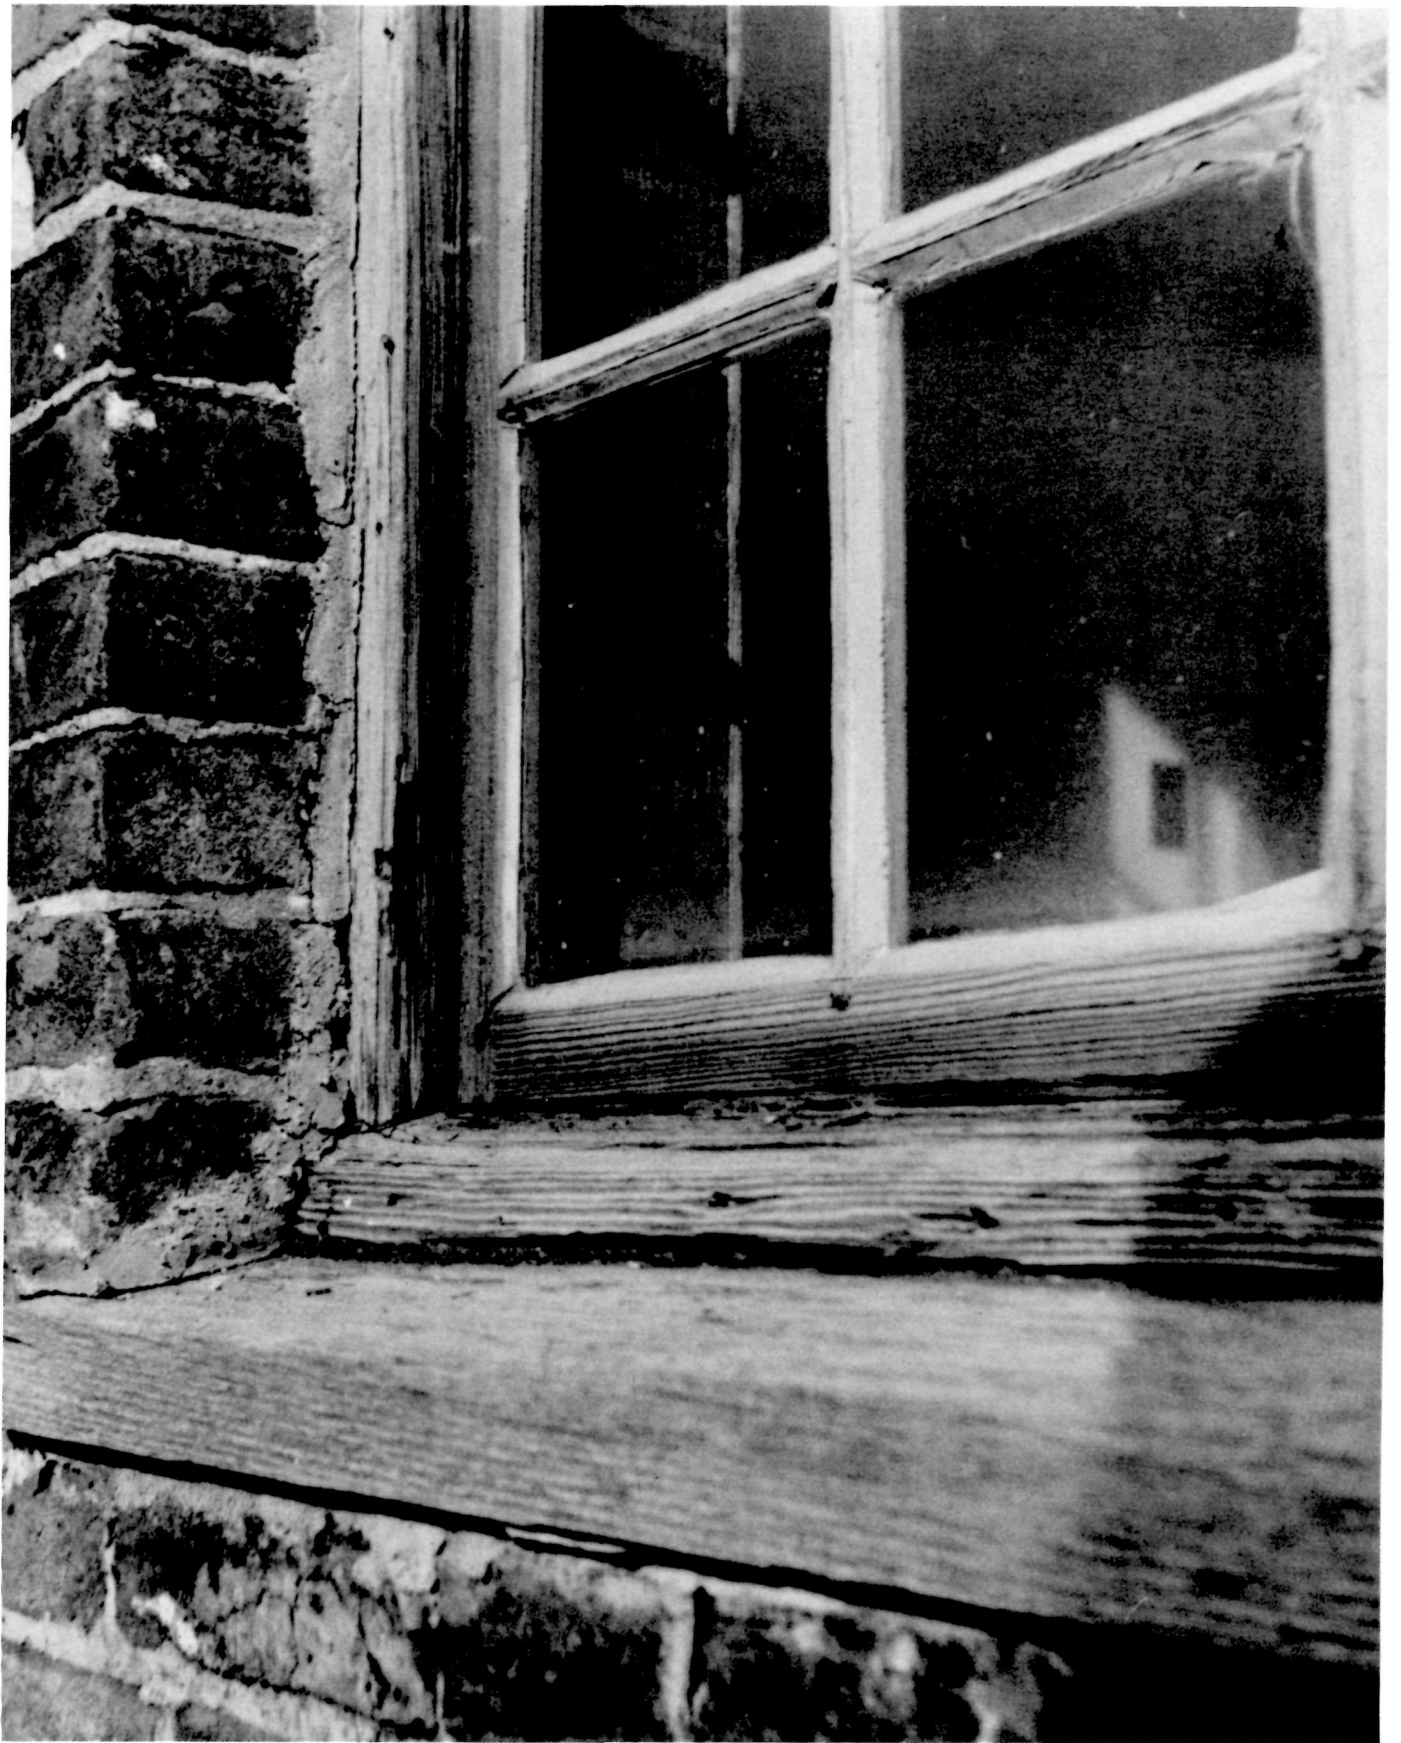
PLATE XVII

The sash, frames, sills and trim are deeply weathered and infected with rot. The sash need reglazing. A number of window panes are broken.

This close-up photograph of a window in the masonry portion of the building illustrates the extent of deterioration and repair necessary.

Repair or replace all sash, frames, sills and trim. Replace broken glass and reglaze all sash. Original sash trims, etc., shall be used as a model for the replacement items.

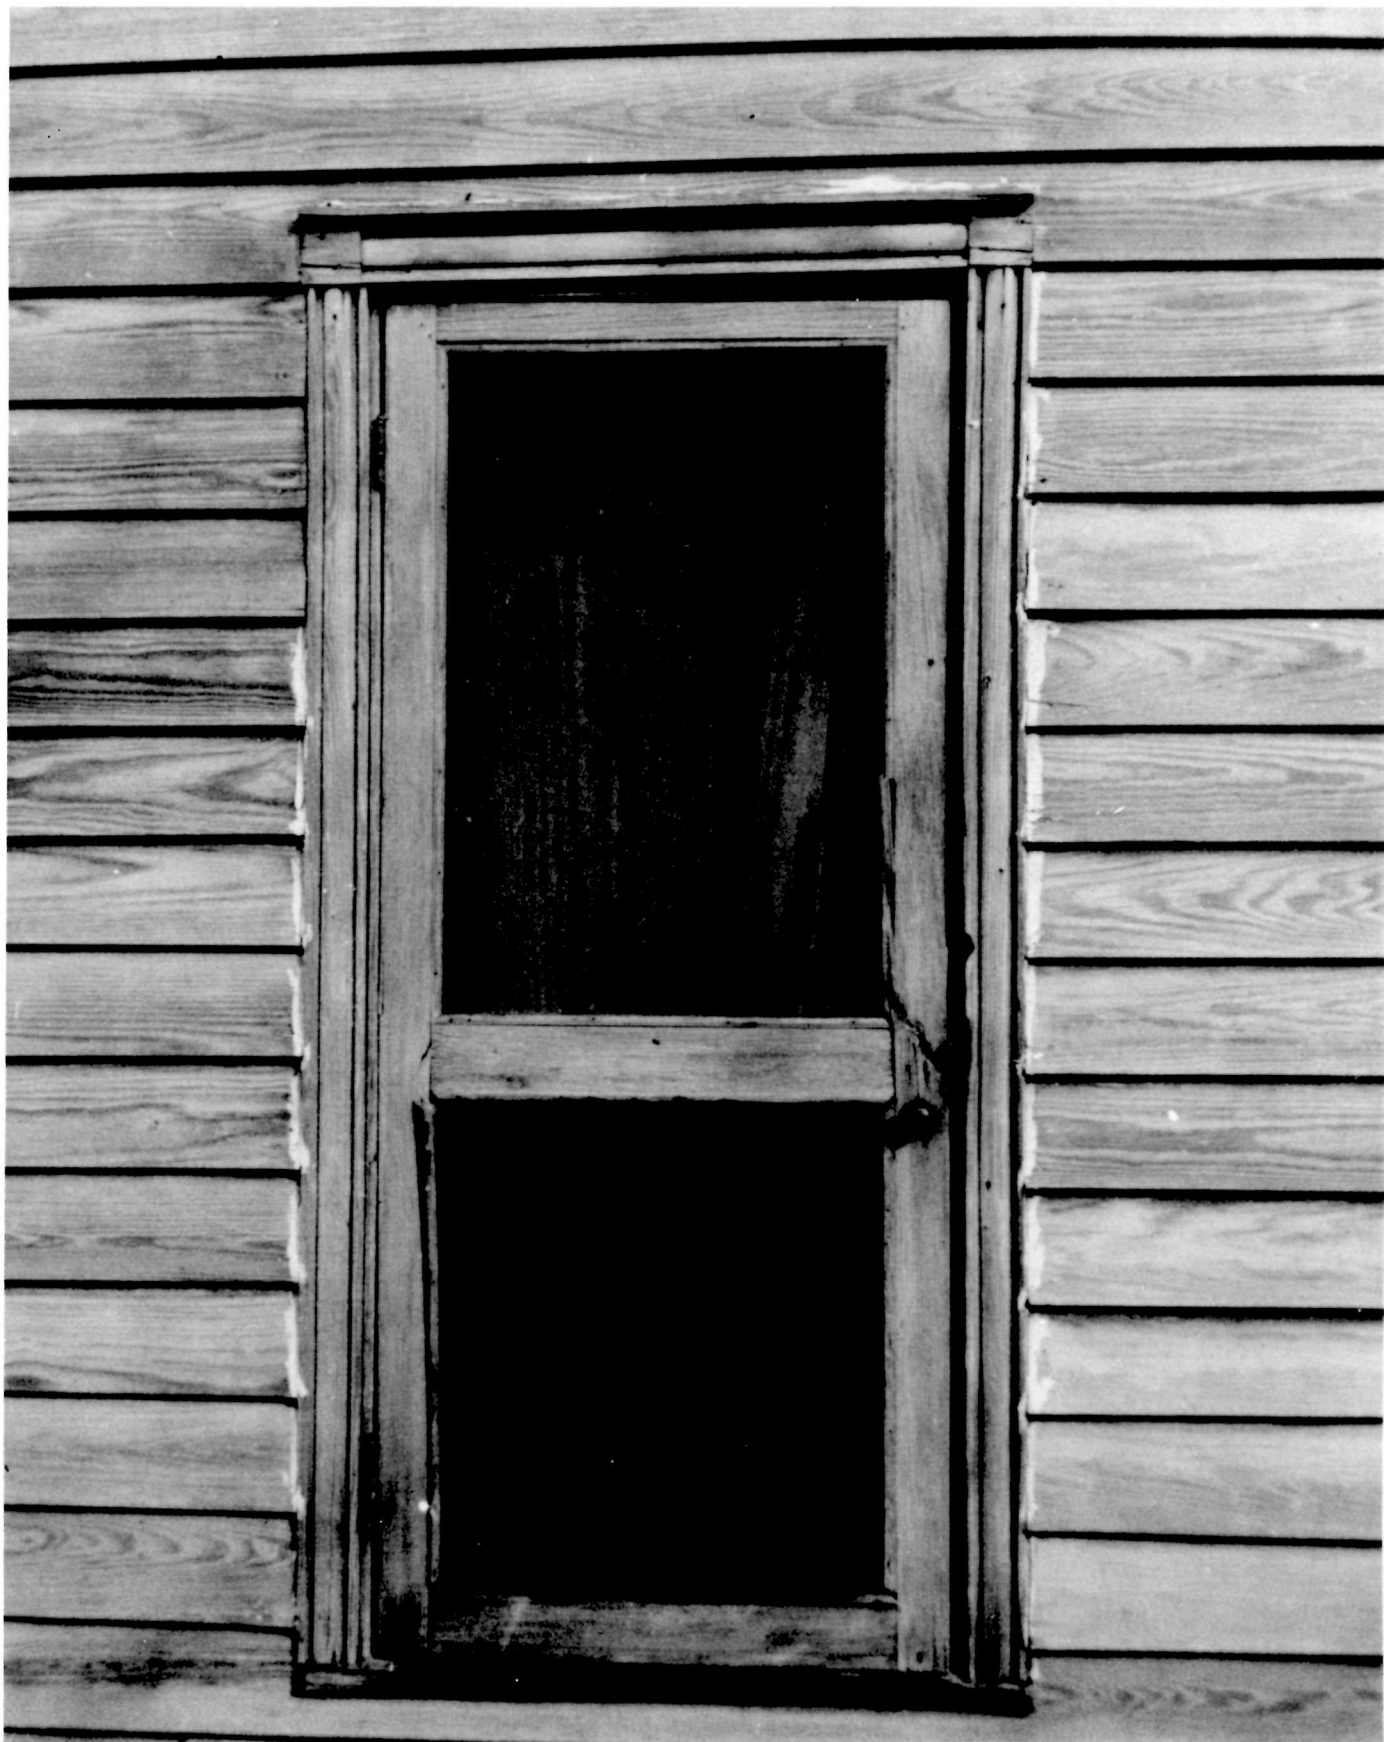
PLATE XVIII

One rear door was destroyed in extinguishing the fire. The other two doors are weathered. All door frames, sills and trim are in need of repair and replacement. Extensive damage has occurred in the trim due to the entrance of water at the door heads.

This rear door was damaged beyond repair during the fire. Note the condition of the trim and threshold and the attempt to seal the siding at the door frame. Flashing must be installed to correct this condition.

Replace one door. Repair other two doors. Repair or replace as required frames, sills, thresholds and trim. Install flashing at all doors and windows.

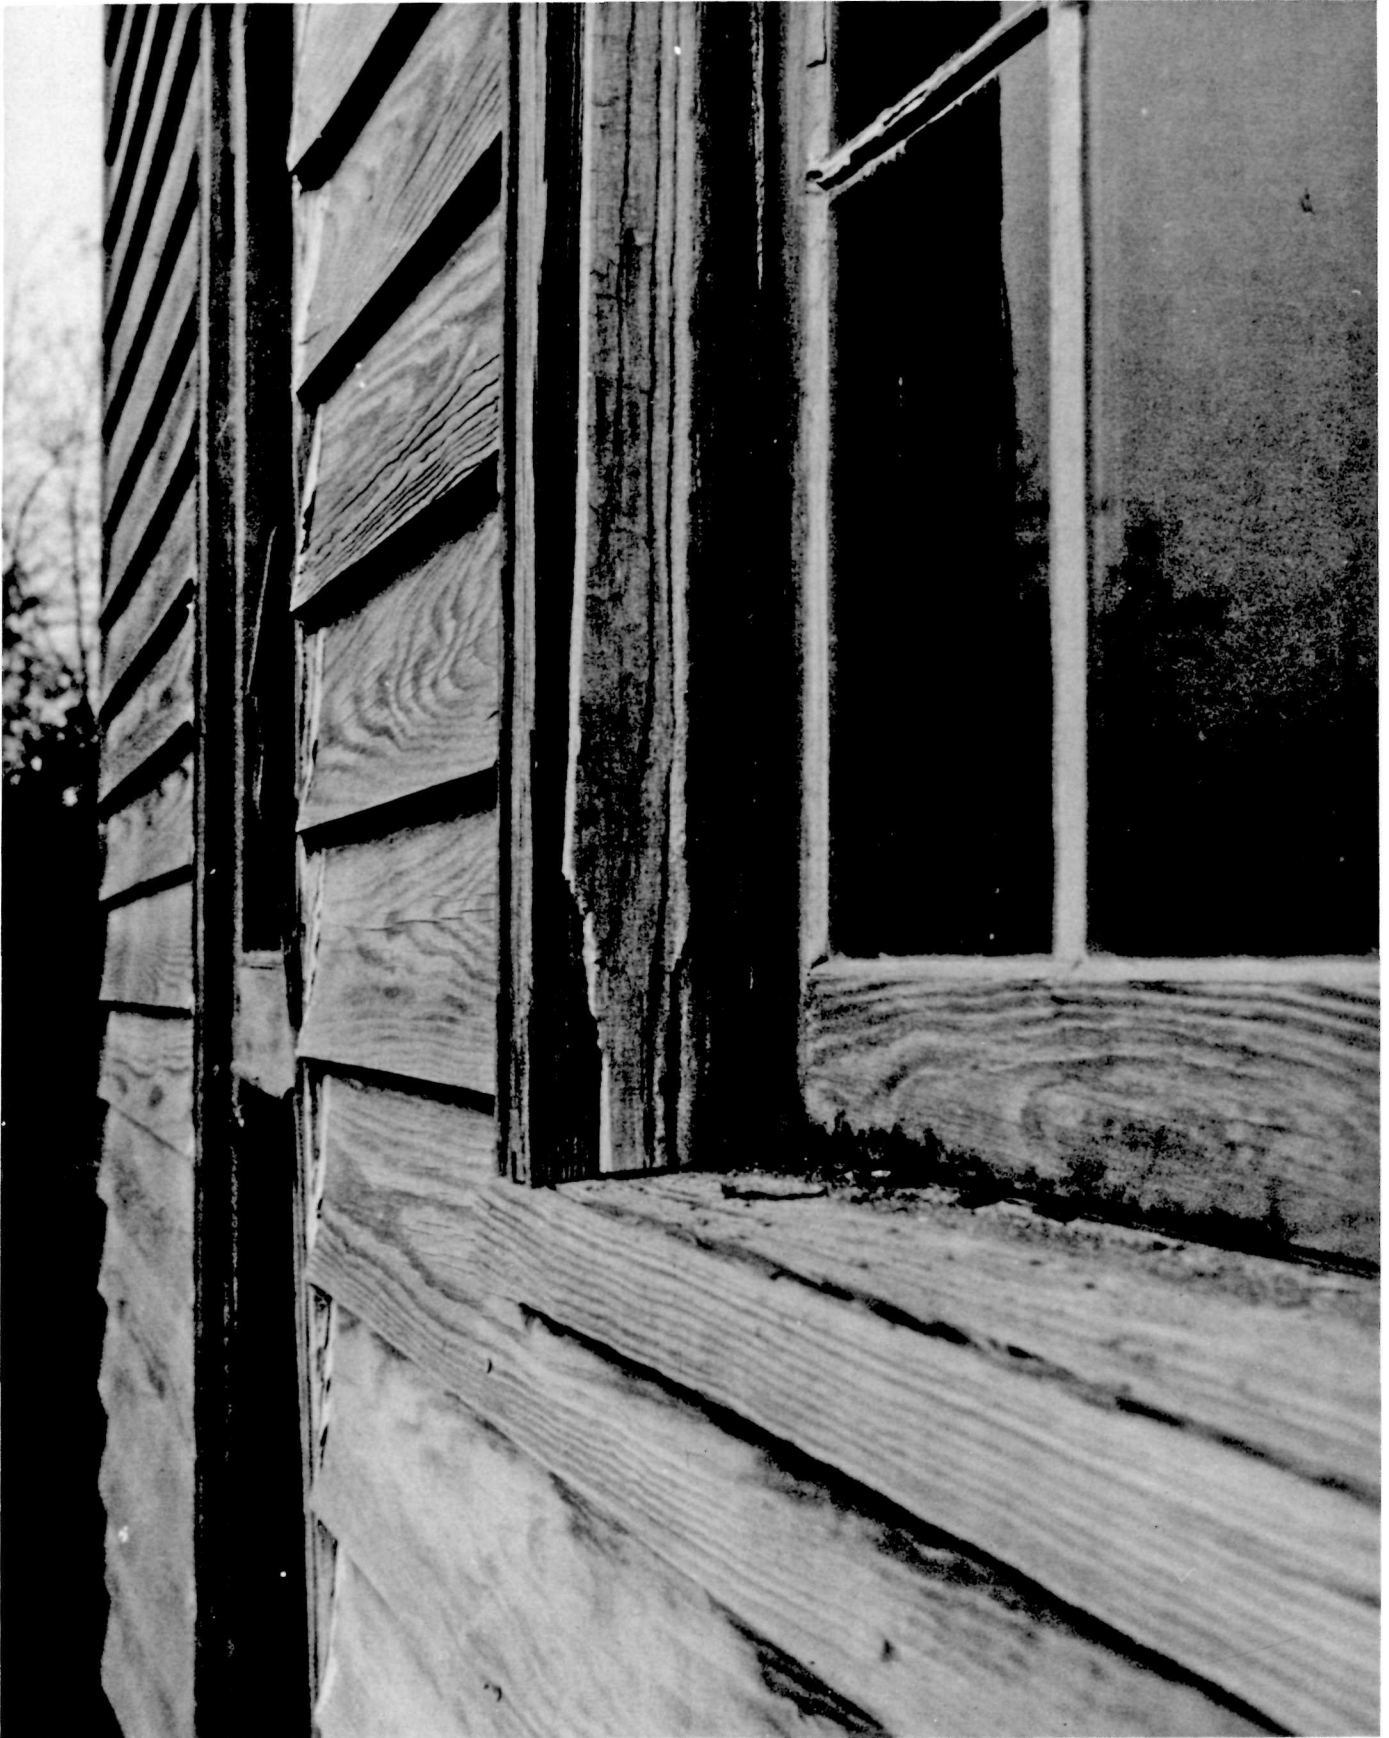
PLATE XIX

Window in frame portion of building showing
typical condition.

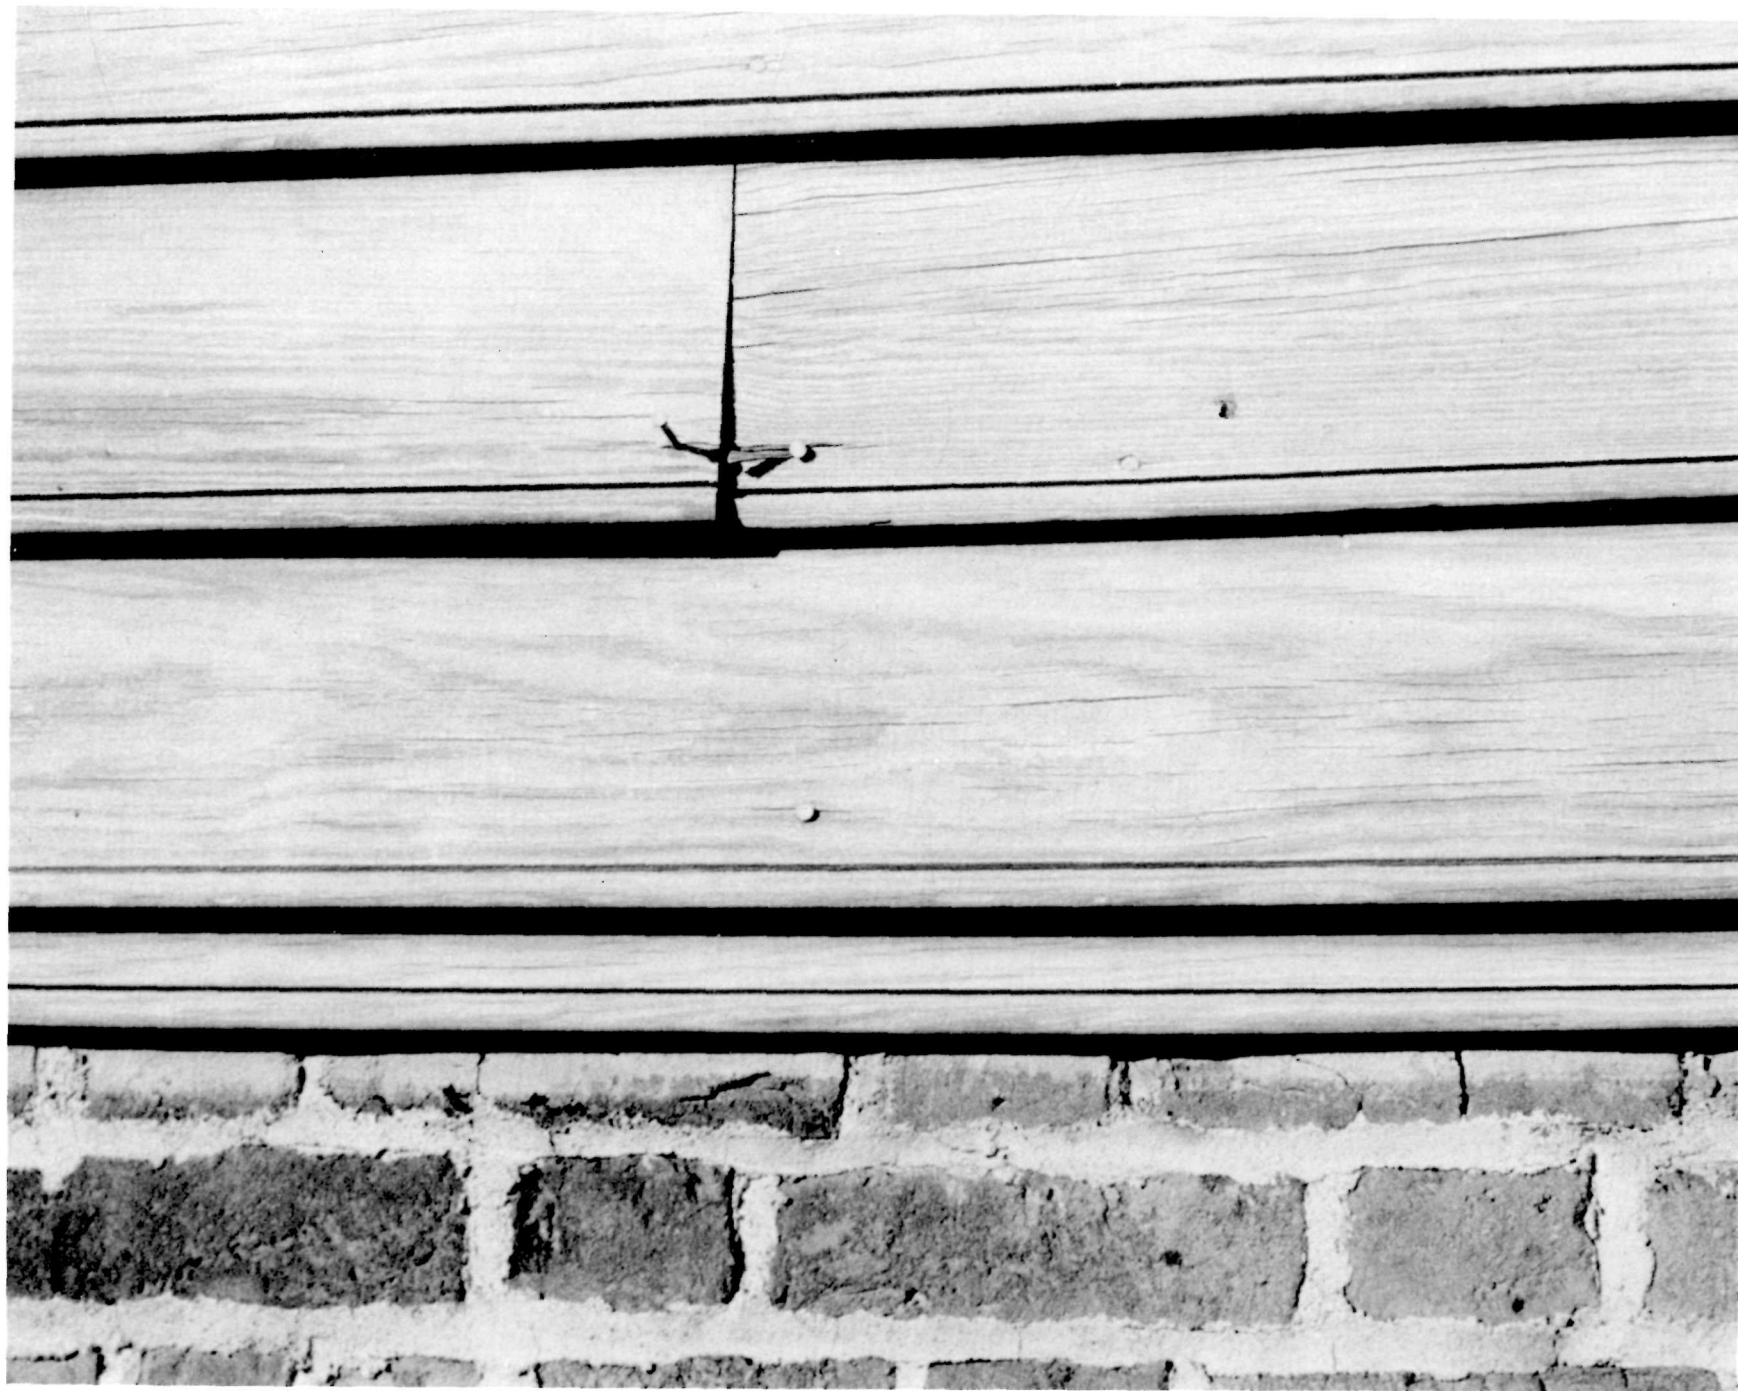
PLATE XX

The siding is in bad condition generally due to warping, splitting, and rot. The rear wall was damaged by the fire.

Much of the siding must be replaced and properly fastened to prevent this condition from recurring.

Replace all deteriorated and fire-damaged siding. The existing siding shall be used as a model for the new material. All sound existing material shall be reused.

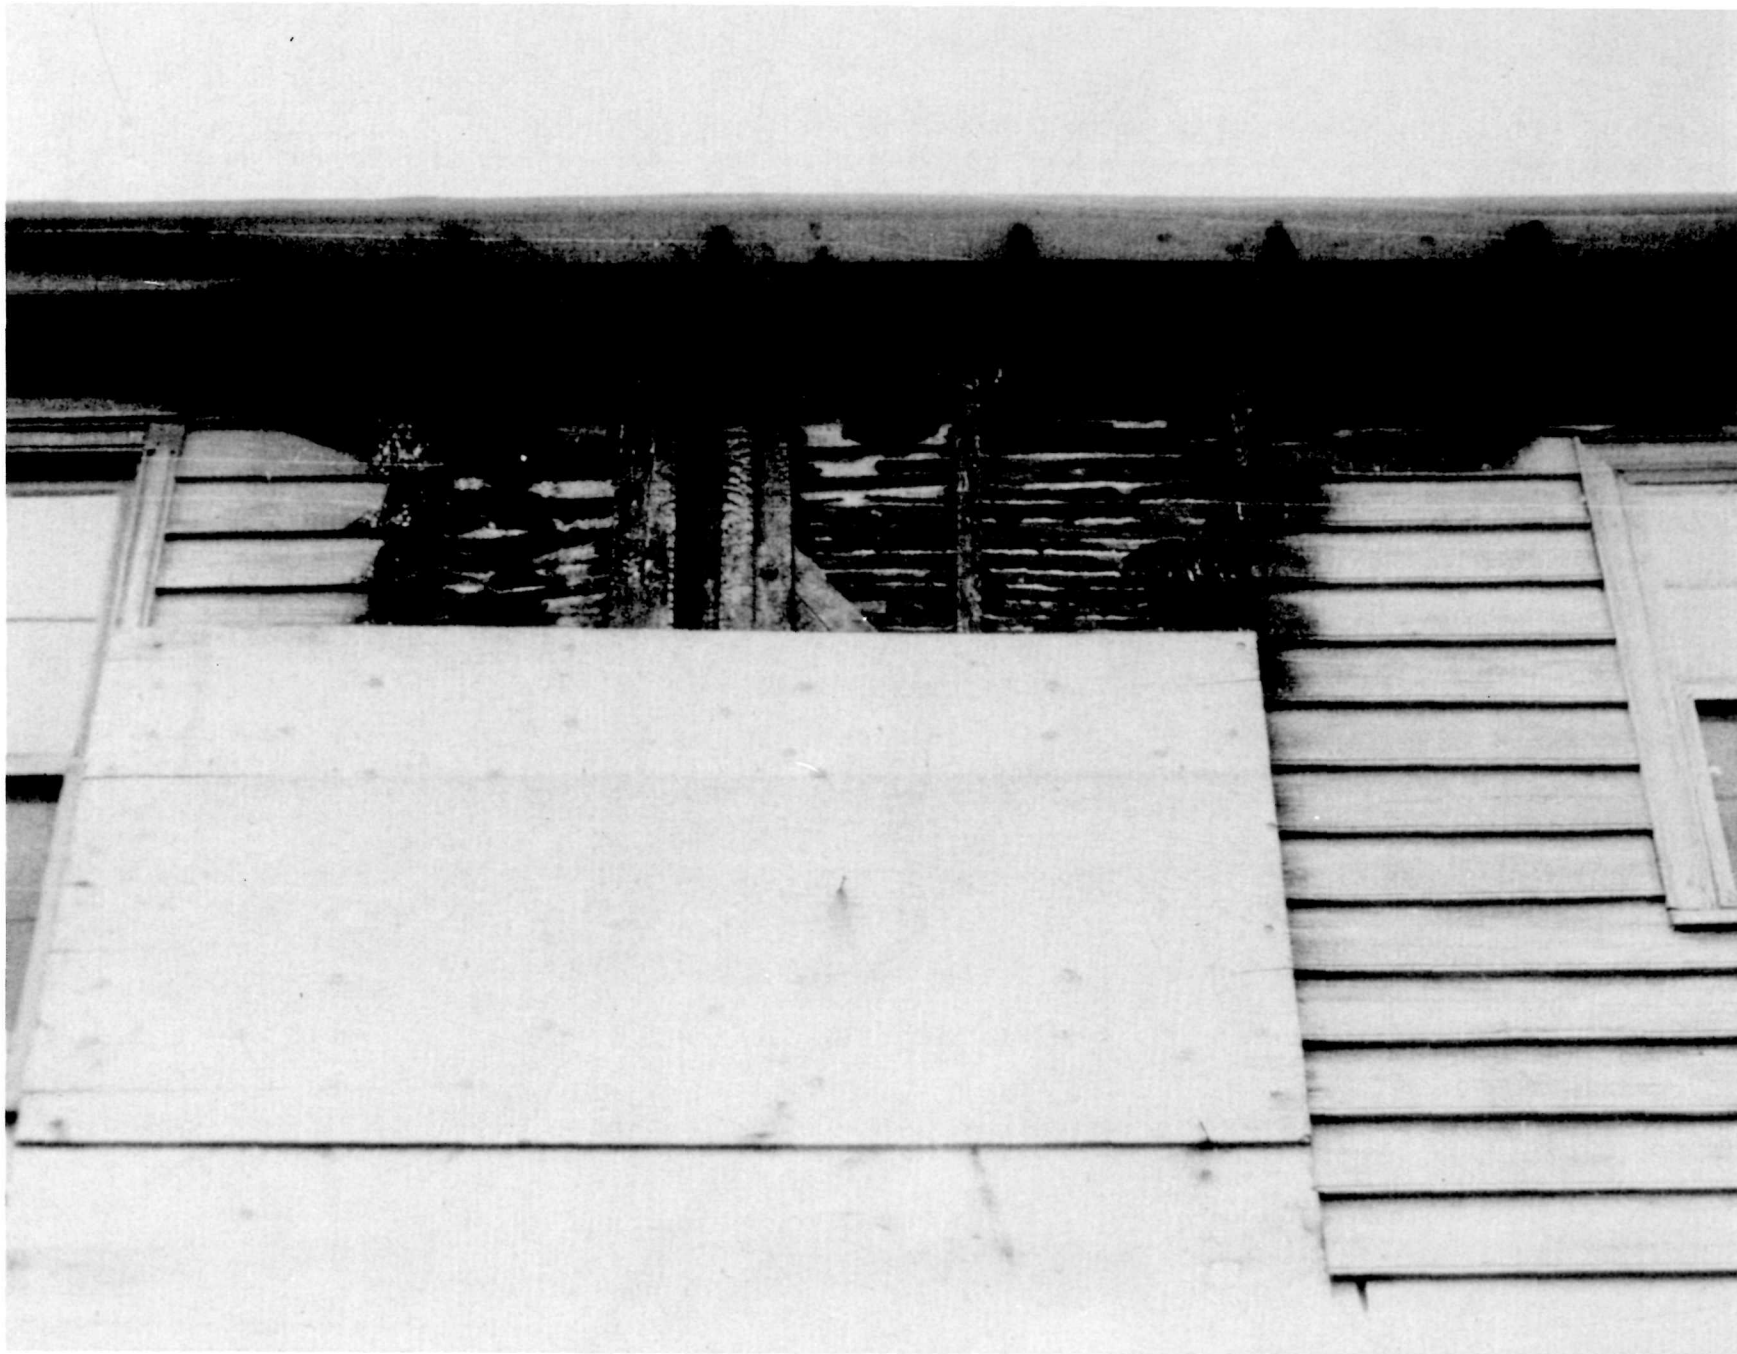
PLATE XXI

View showing fire damage at eaves, south (rear) wall.

Observe detail at junction of frame wall over masonry
portion and the abutting two story frame addition.

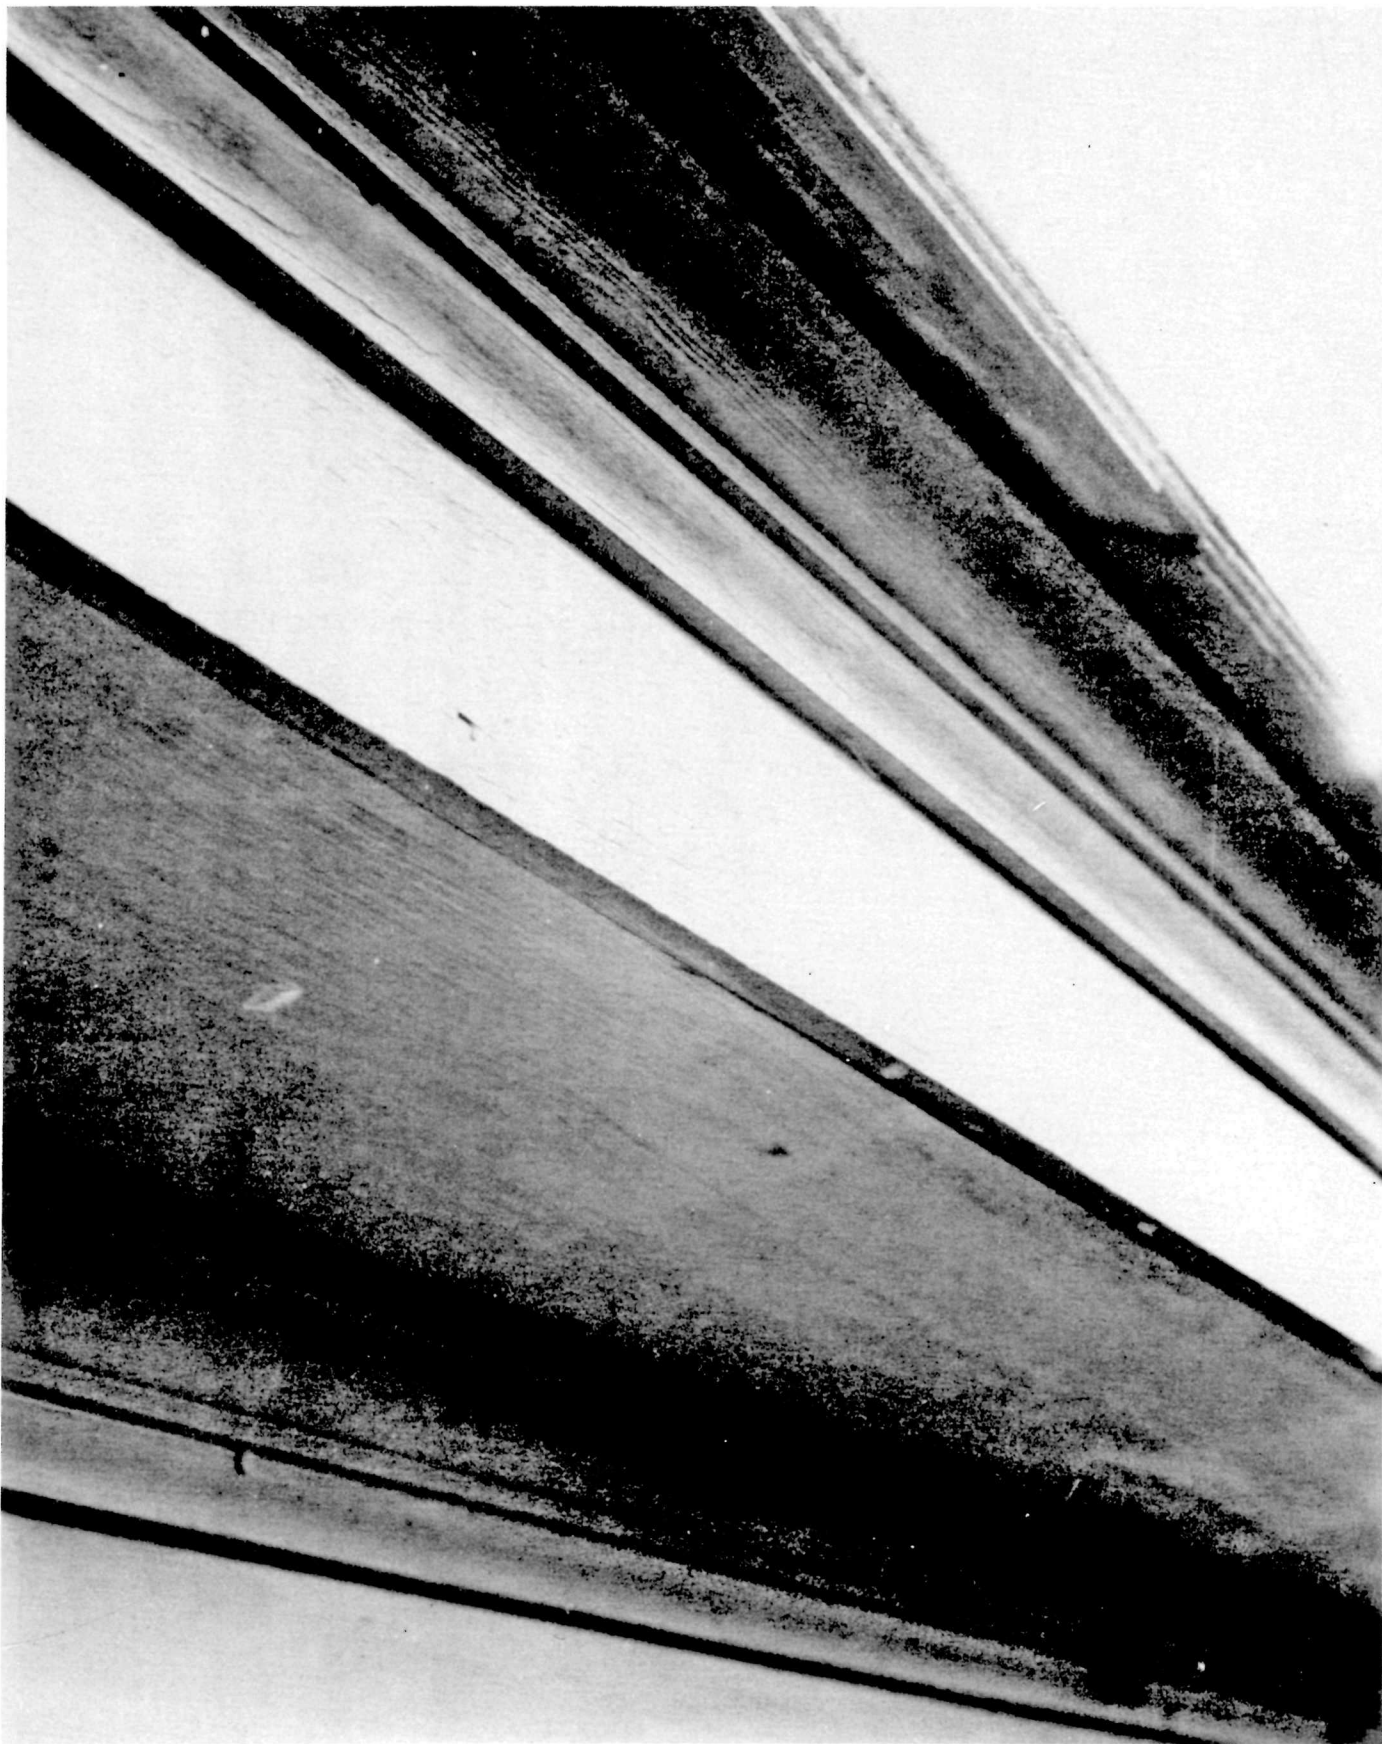
PLATE XXII

Although not evident when viewed from the ground, the cornice was damaged beyond repair by the fire.

This close-up photograph of the cornice does not reveal the extensive internal damage caused by the fire.

Reconstruct the entire cornice and all large boards. The replacement moldings shall duplicate the original items.

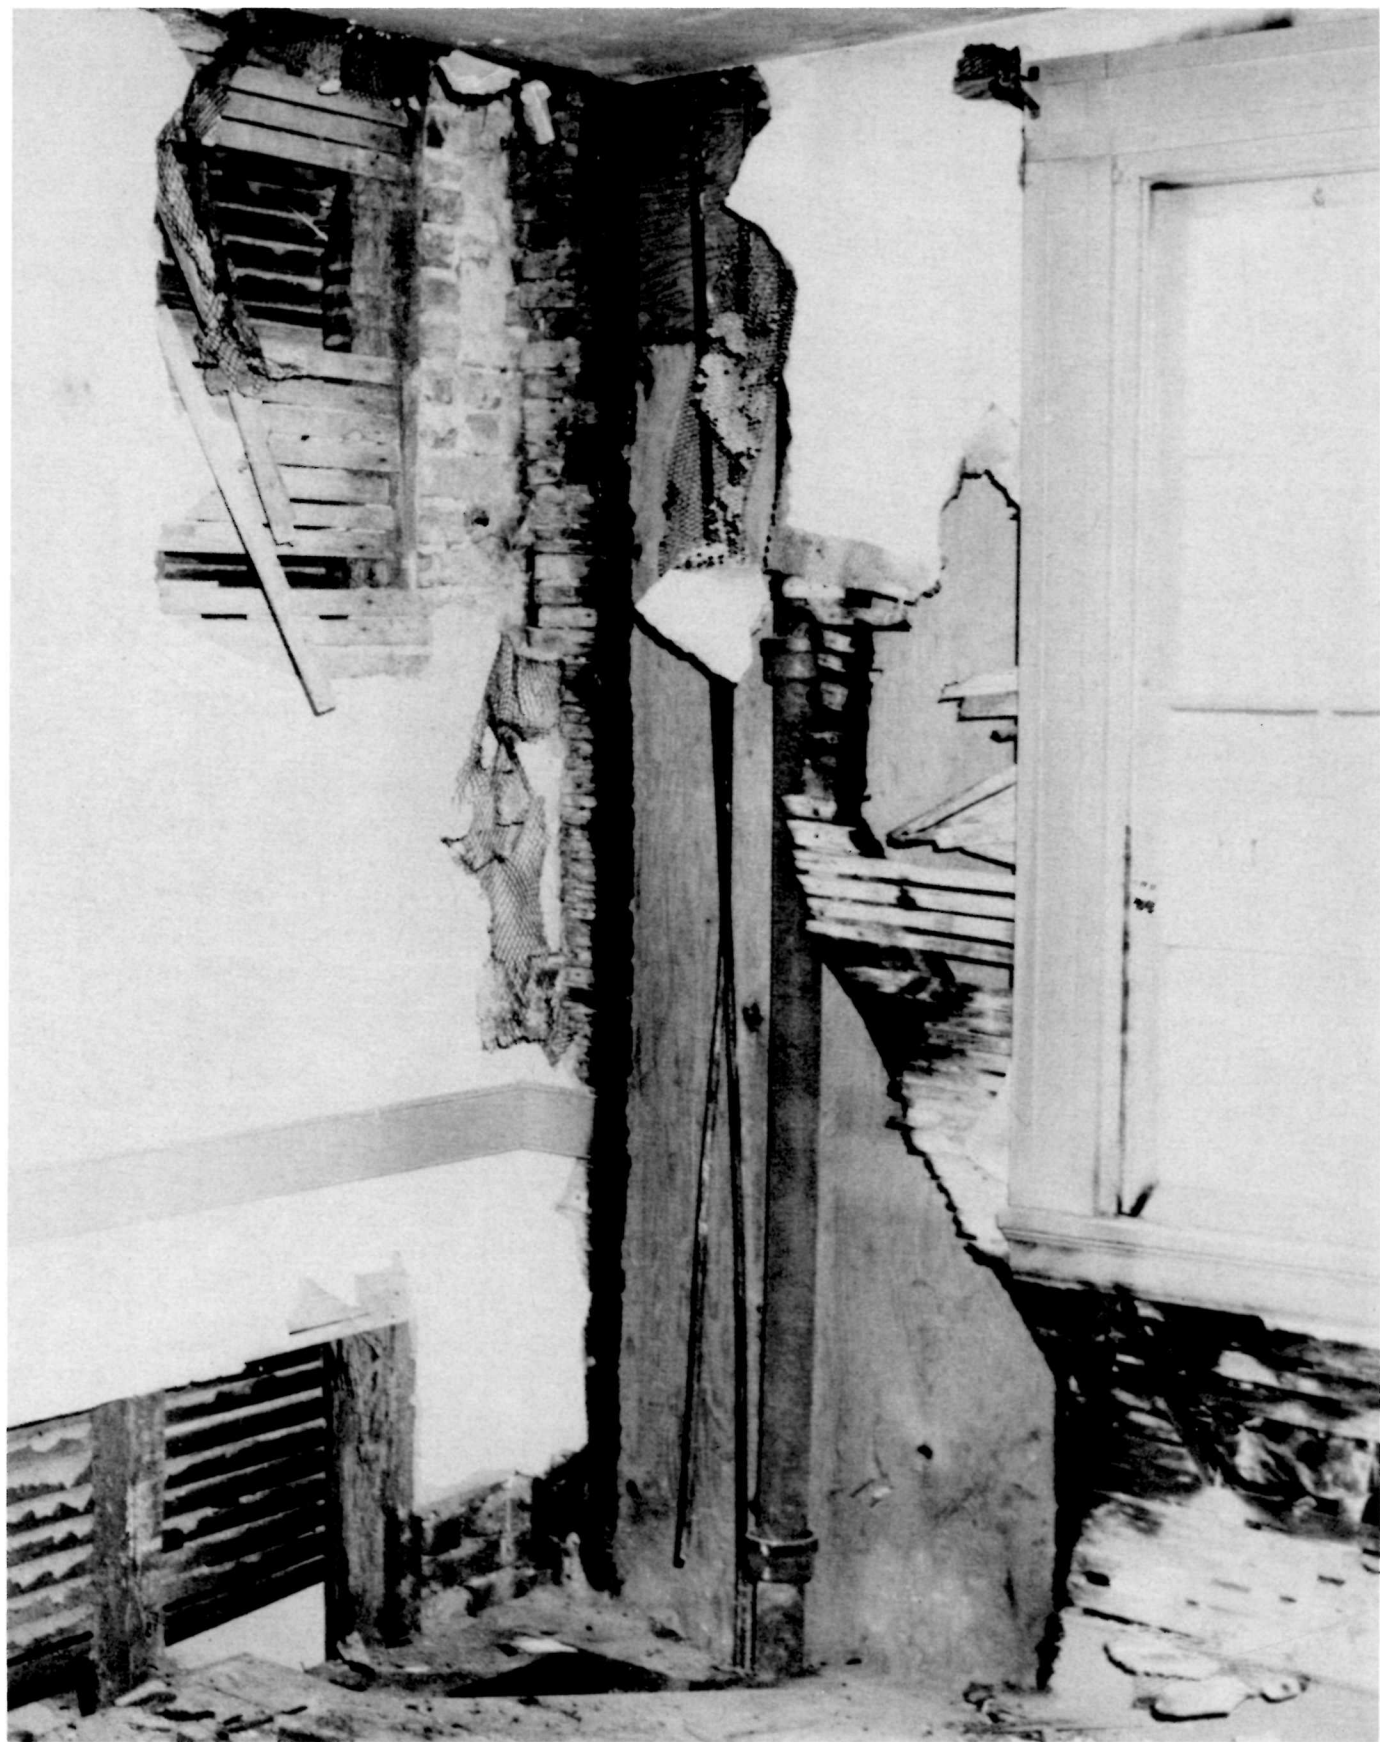
PLATE XXIII

Interior view of south wall and cross partition
first floor showing fire damage.

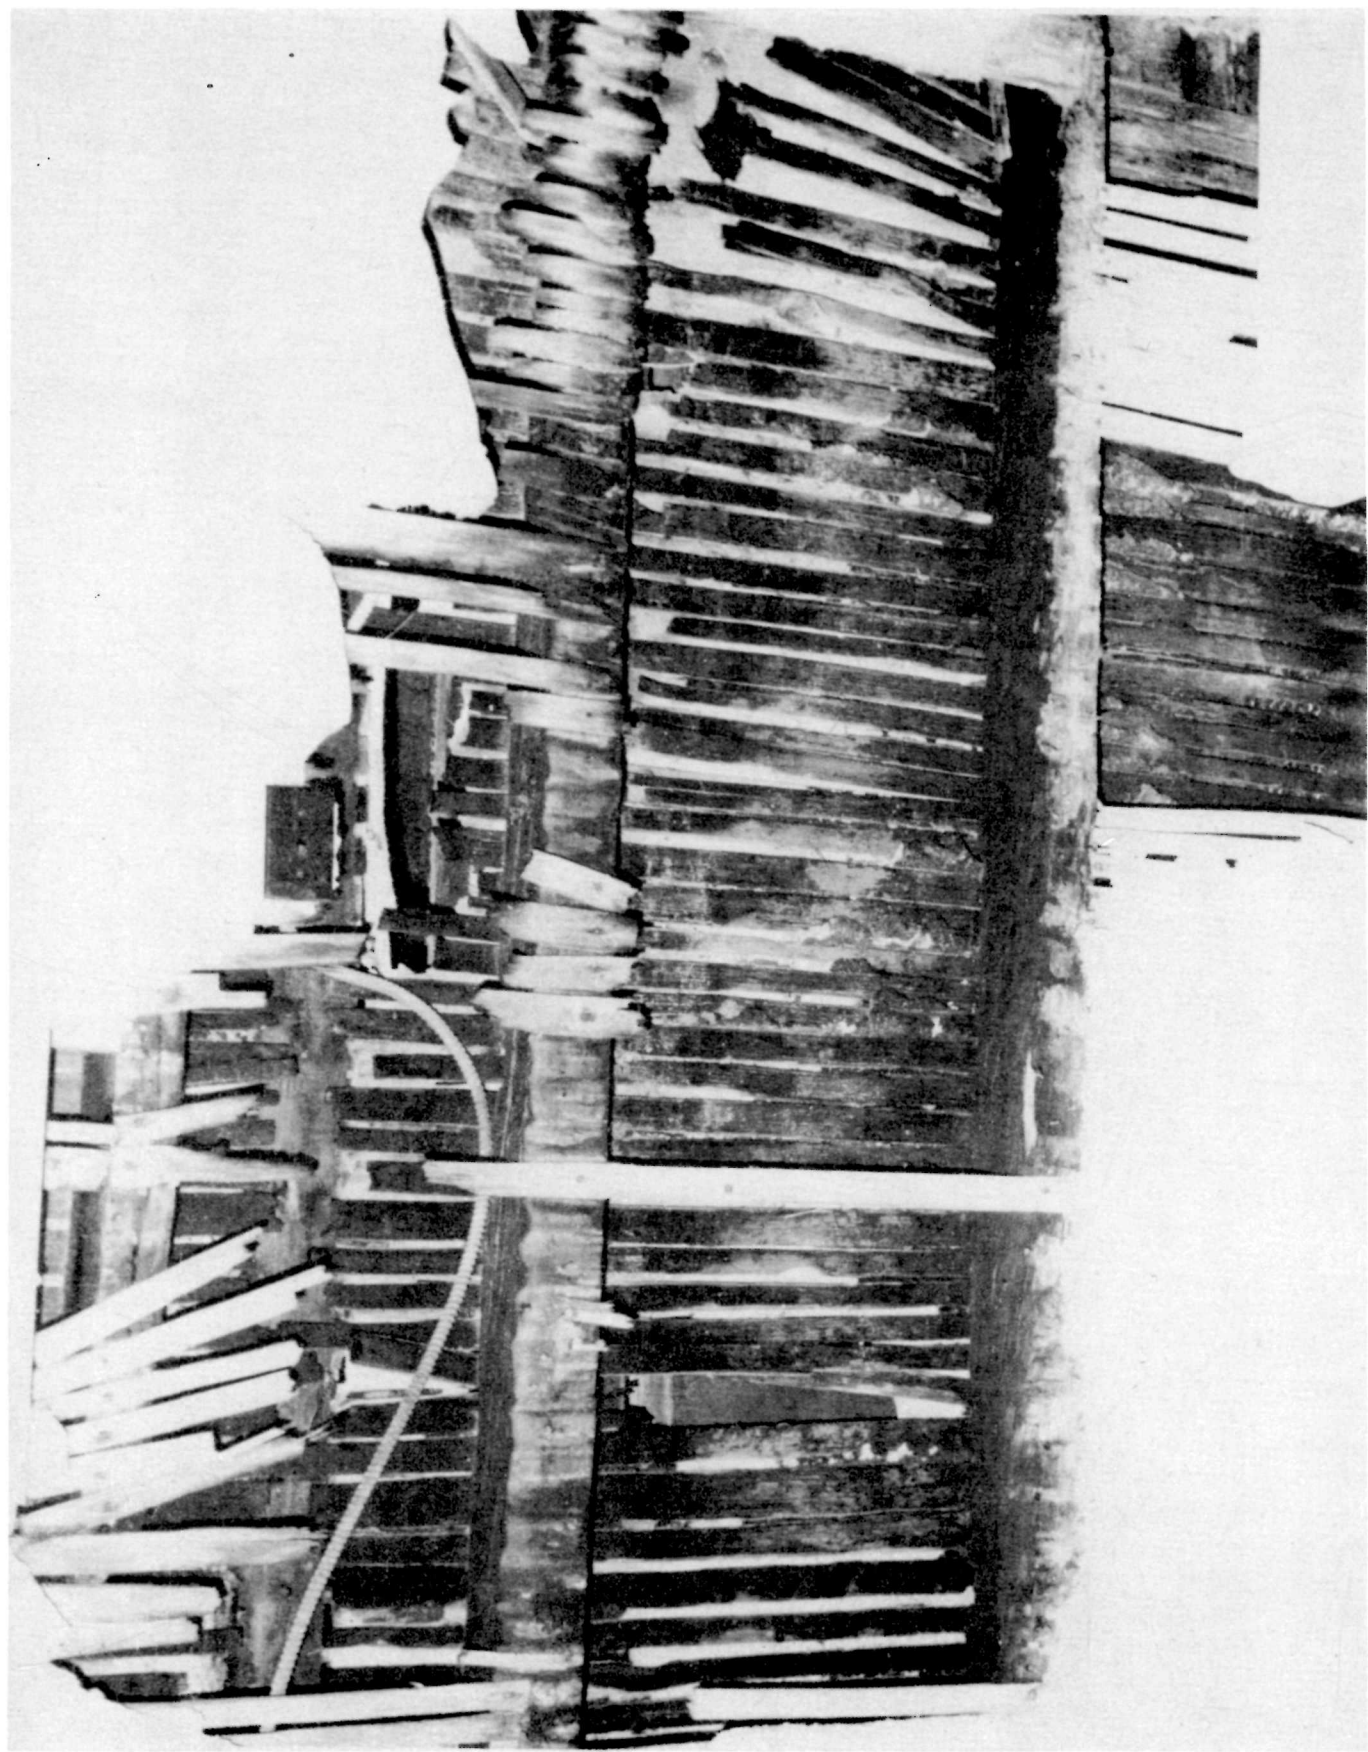
PLATE XXIV

Second floor fire damage
