RICHMOND NATIONAL BATTLEFIELD PARK

GARTHRIGHT HOUSE

HISTORIC STRUCTURES REPORT

ARCHITECTURAL DATA

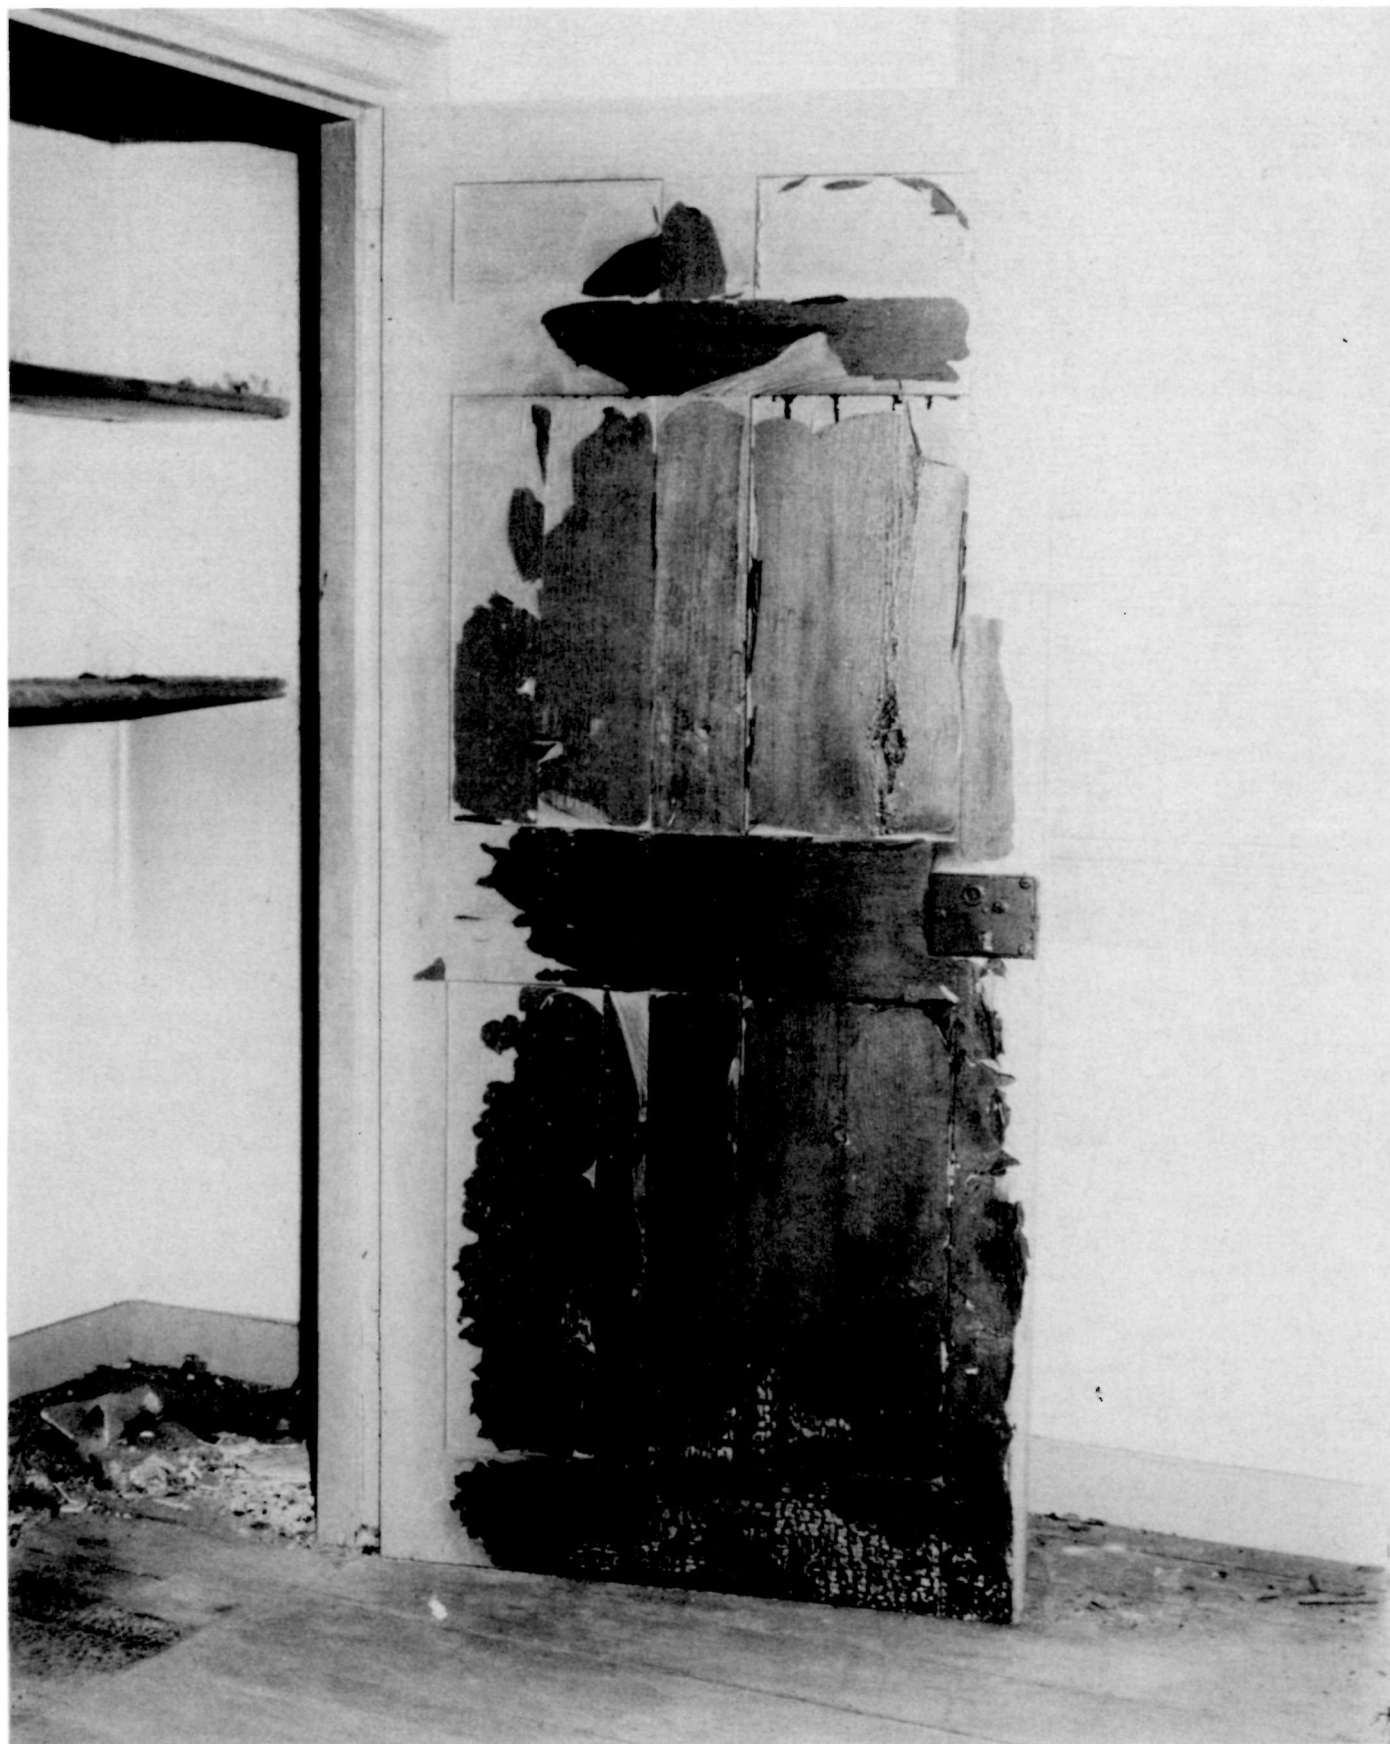
PLATE XXV

Fires do strange things. This is the inside face
of the closet door, south room, second floor.

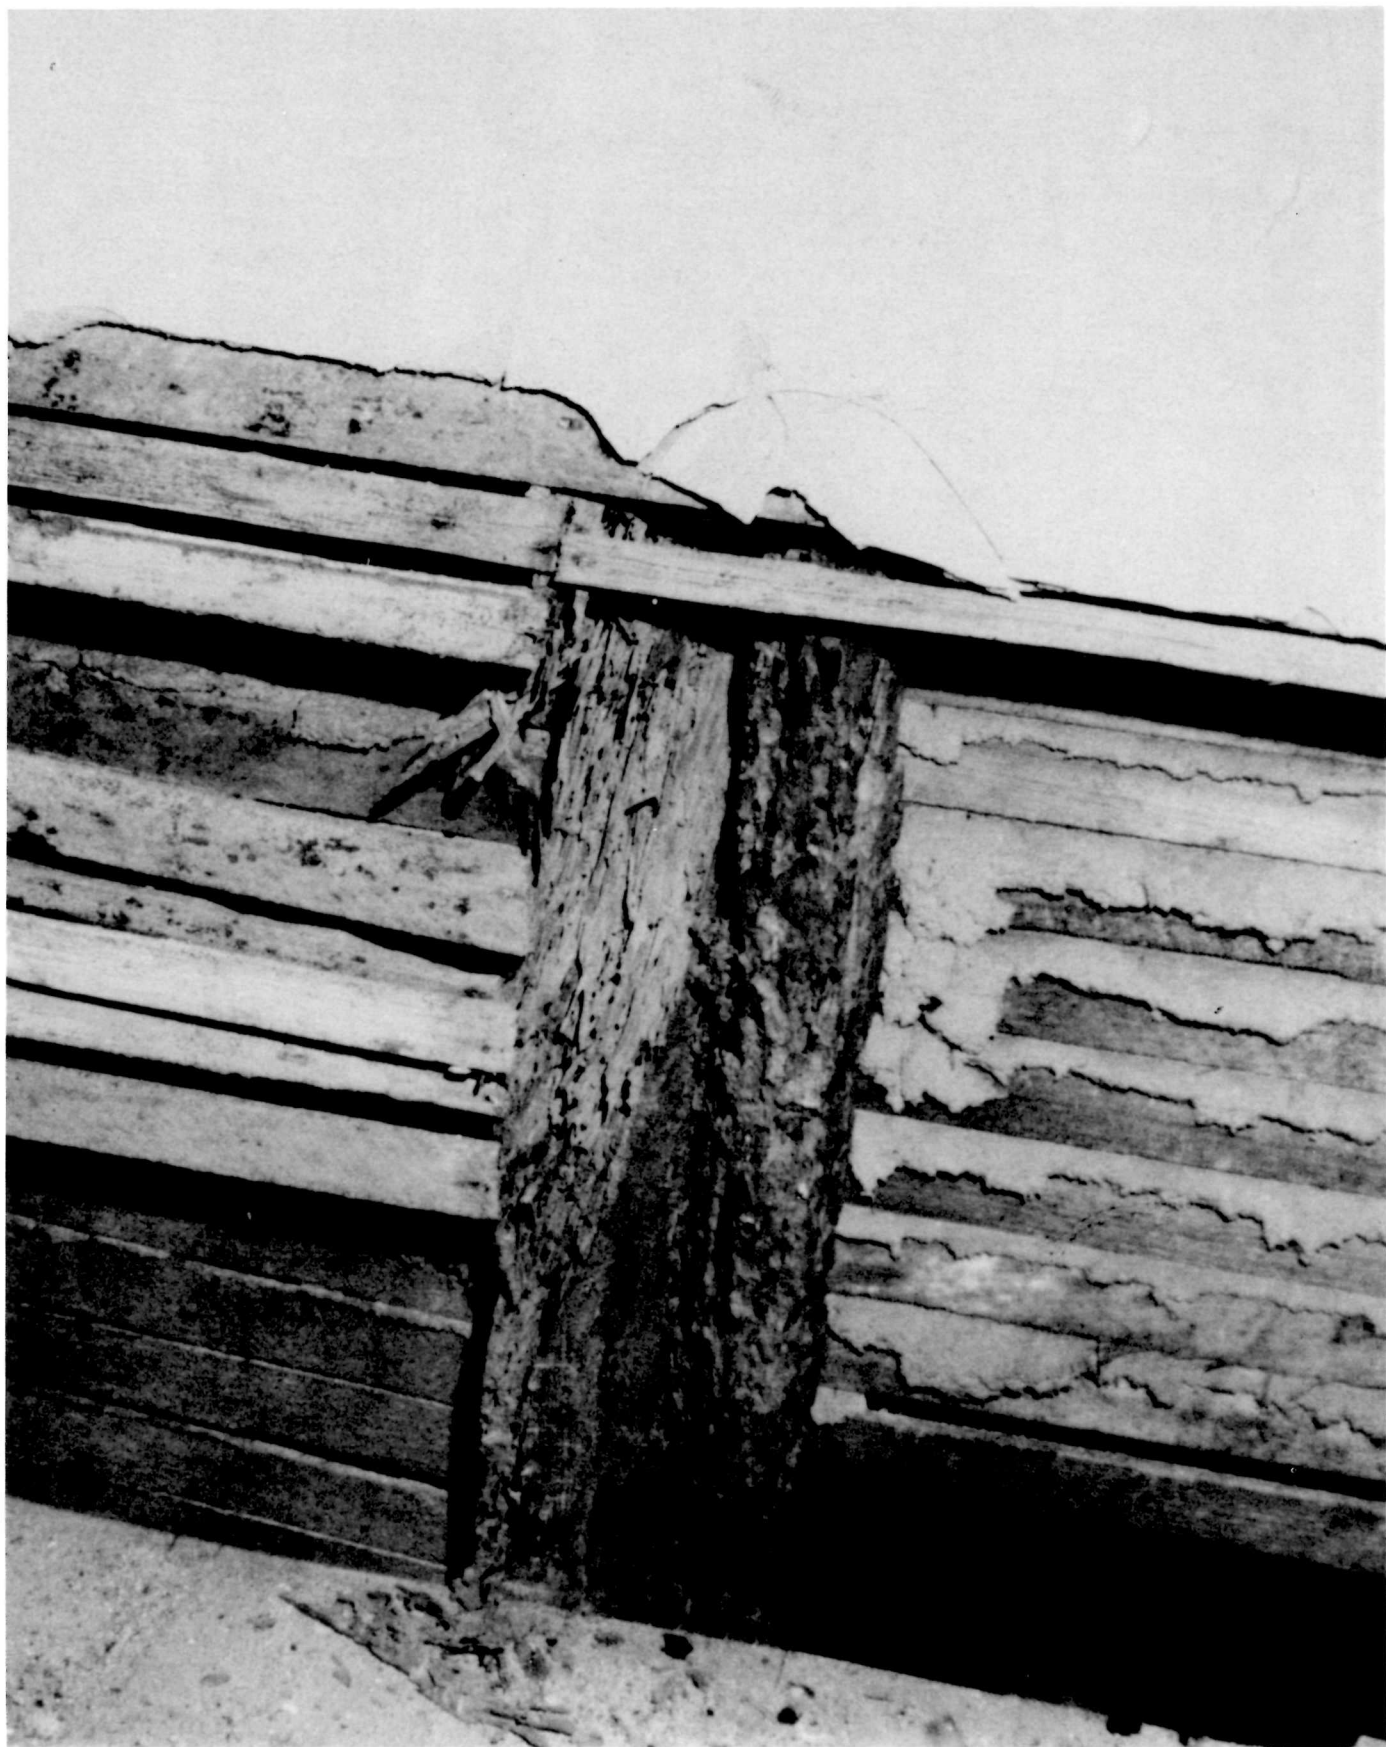
PLATE XXVI

Termite damage to first floor partition studs
was revealed during the investigation to determine
the extent of fire damage.

Replace all framing damaged by the fire. Replace all framing damaged by rot and termites. Install new second-floor ceiling joists. Install new roof and gable framing.
