SAN ANTONIO MISSIONS  
NATIONAL HISTORICAL PARK  
San Antonio, Texas

MISSION CONCEPCIÓN  
CULTURAL LANDSCAPE REPORT

Contract No. 1443CX700092007

May 1998

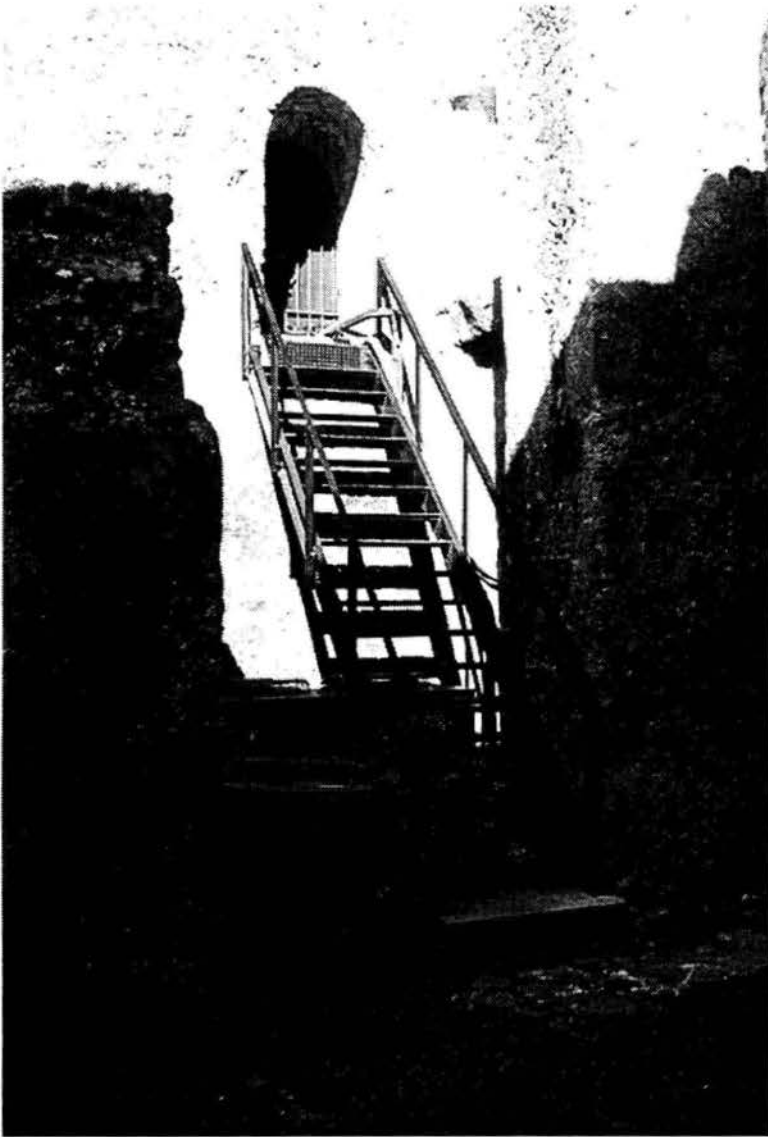
*Figure 87. A flight of steel stairs leads from the northwest corner of the courtyard to the second floor of the church's south tower; air-conditioning equipment is clustered at its base.*

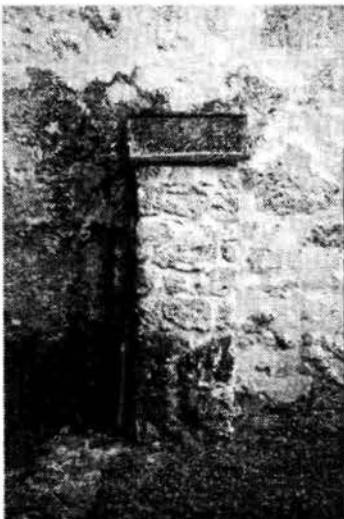
*Figure 88. This buttress-like structure conceals an electrical entry in the courtyard when seen from the plywood walkway.*

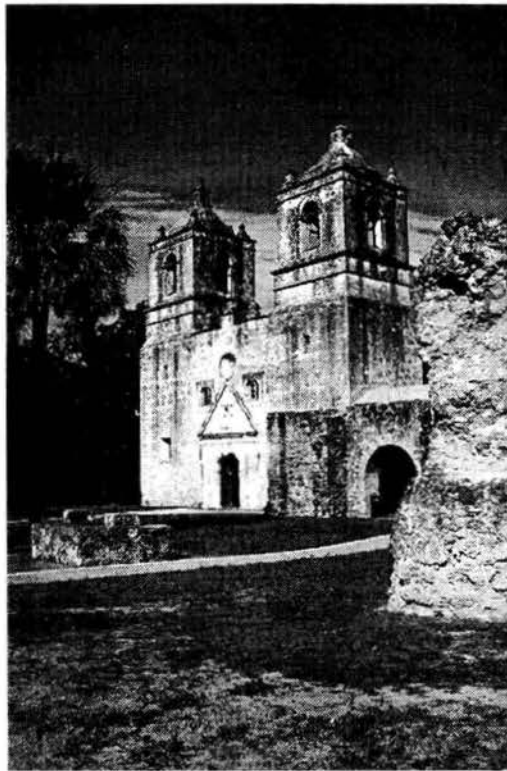
Figure 105b. In 1915, stone and wood edging was used to edge planting beds near the church, and the landscape west of the building consisted of hard-packed earth. By 1994, the planting beds have been removed and grass lawn has replaced the hard-packed earth.

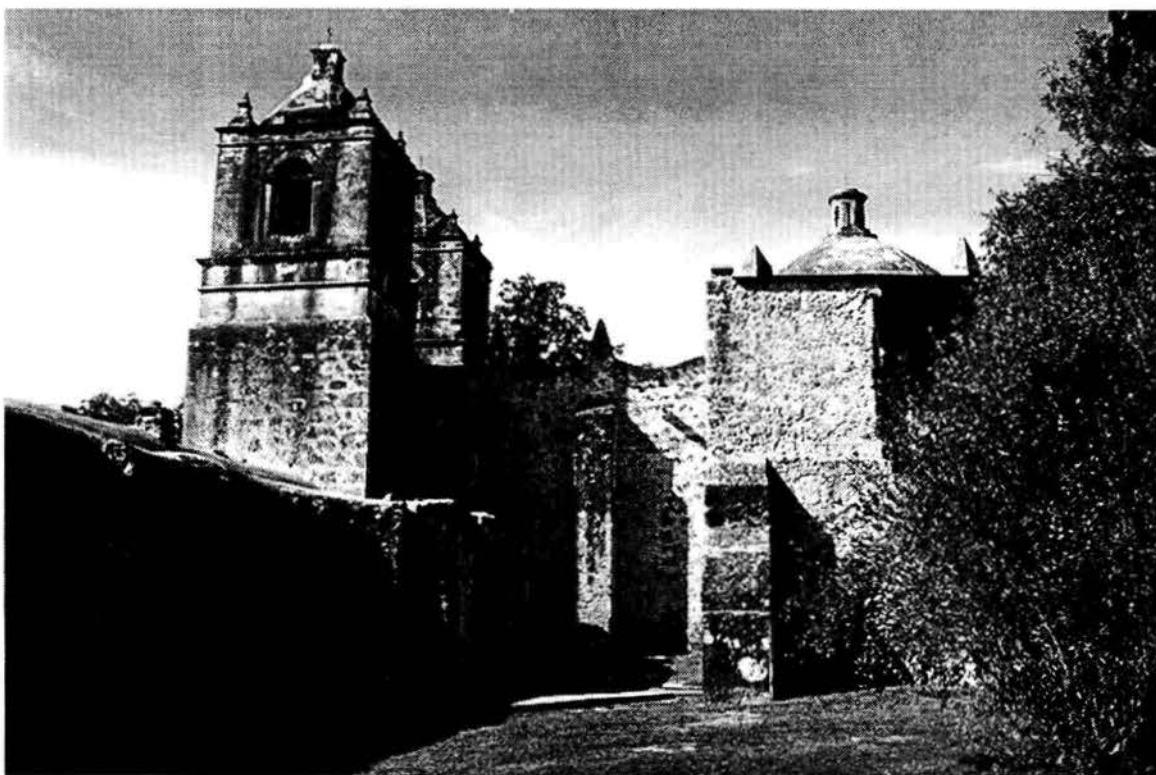
*Figure 108b. Changes to the landscape around the convento ruins and courtyard by 1994 include the replacement of hard-packed earth with grass lawn, the removal of stone-lined planting beds at the base of the buildings, the removal of some plant materials, and the addition of others.*

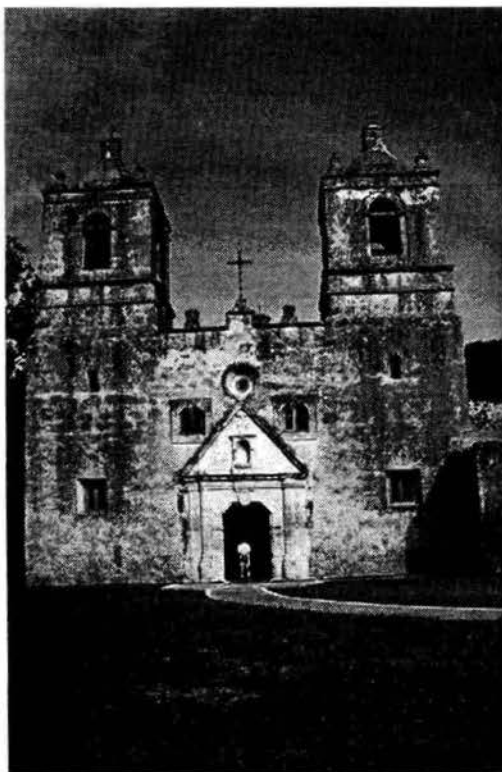
Figure 109b. In 1994 grass lawn has replaced the cacti gardens that were present at the base of the church in the 1930s, and a concrete walk has been added to provide access to the church.

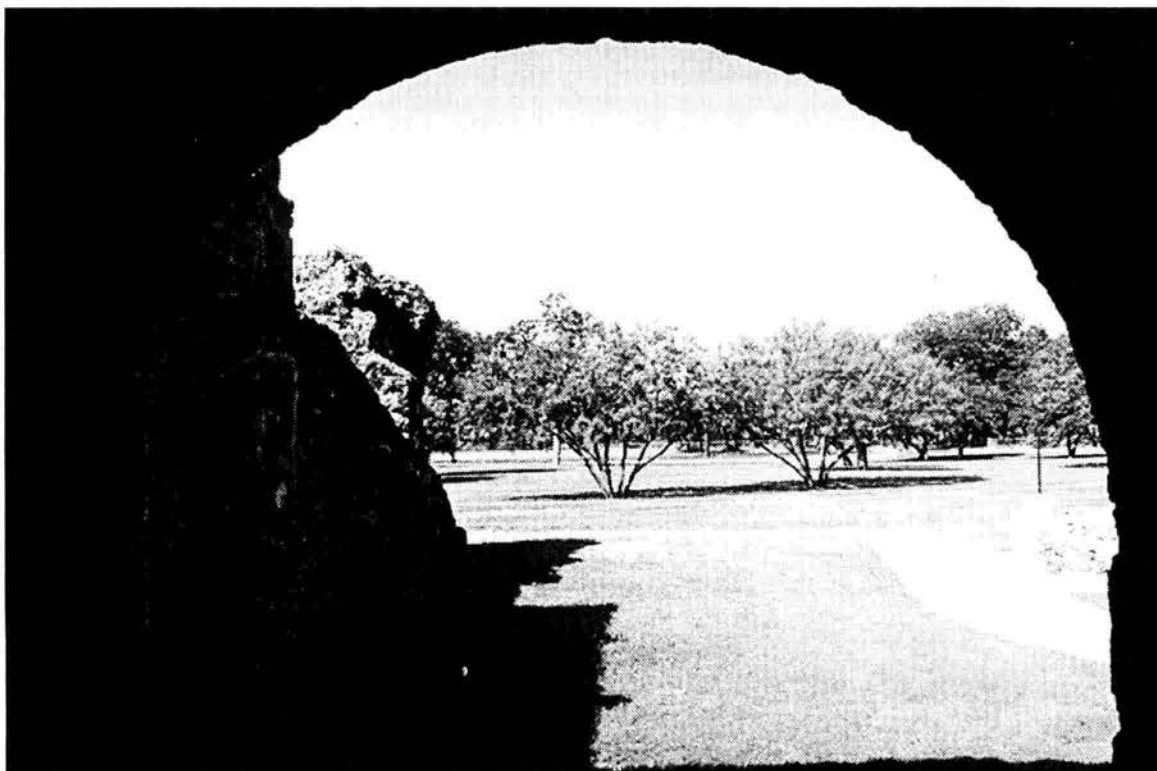
*Figure 110b. The gardens that once occupied the area around the convento and corredor have been replaced in 1994 with grass lawn and a concrete walk.*
