# Mission Espada North Gate

## Documentation, Condition Assessment, and Treatment Plan

The University of Texas at San Antonio  
Center for Archaeological Research | Center for Cultural Sustainability  
November 2019

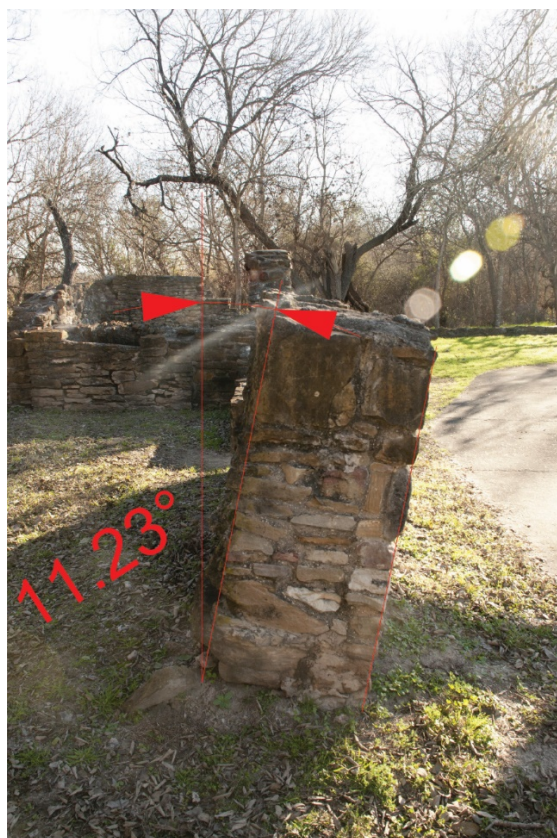
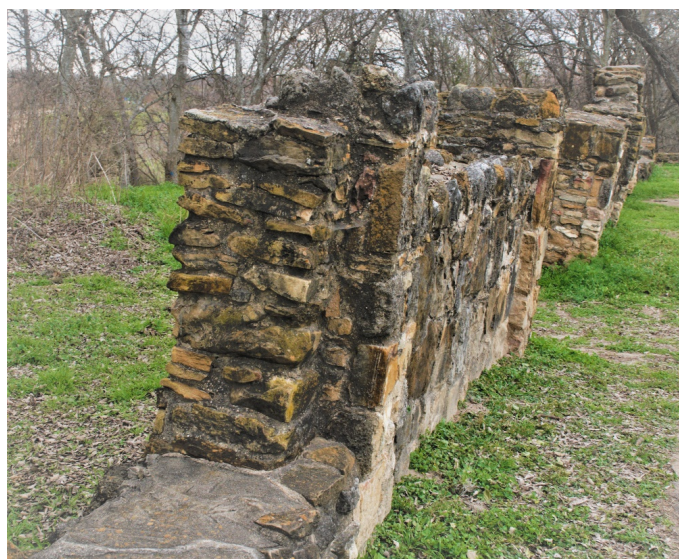
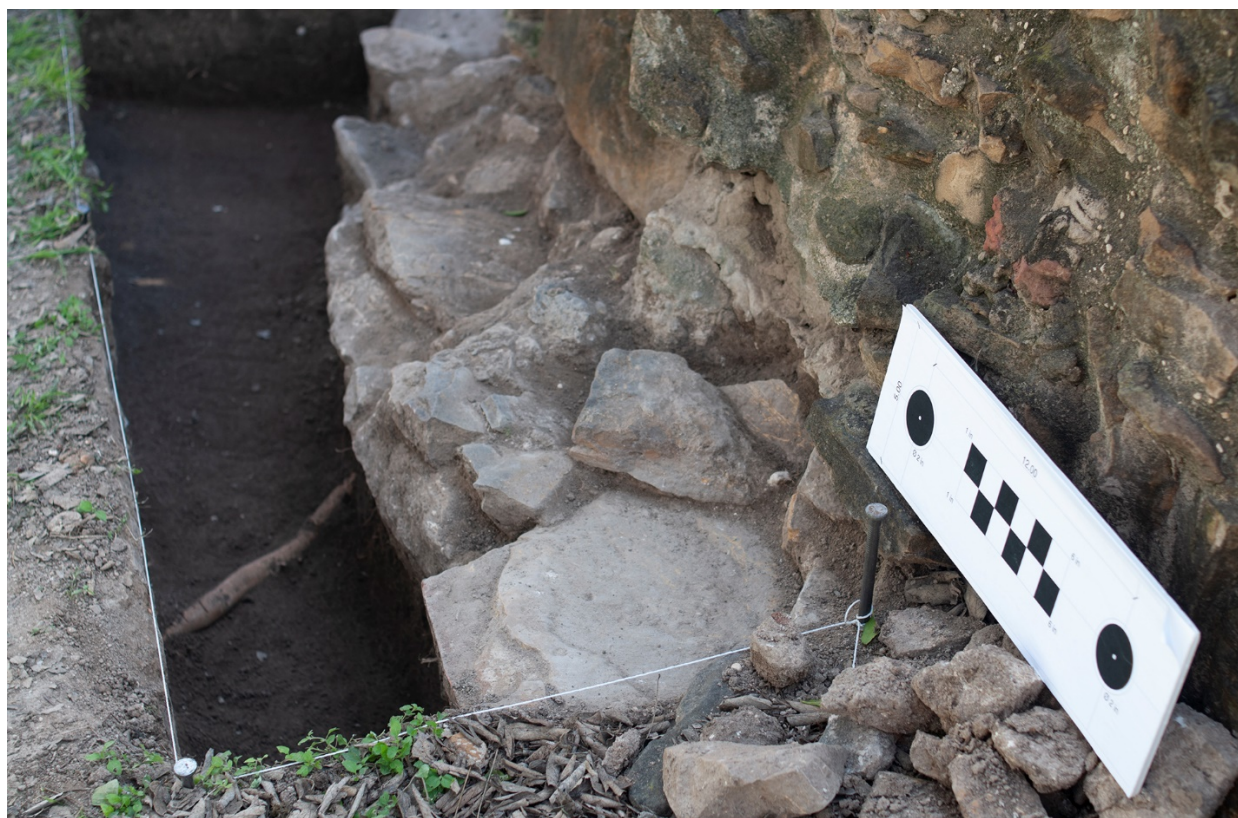
The north gate wall is structurally deficient, exhibiting a rotational movement along its length, easily visible as a severe lean to the south. The lean of the east section is worse than the west. The deficiency is most likely due to a combination of construction and environmental issues. Regarding quality of construction, the 1950s wall sections do not appear to be structurally connected to the Spanish Colonial foundation stones upon which they sit. Exacerbating the problem is the portland cement mortar utilized in the 1950s, which causes each large section of wall to behave monolithically as a free body unit of masonry, very heavy and not connected to the ground. Since the north gate wall sections bear upon colonial foundations without proper anchorage, any movement in bearing condition of the foundation stones translates to shifting of position for wall sections relative to the foundation stones below. Clay in soils, compressed by the weight of the stones when dry and expanded when wet, is a source of movement in bearing conditions. Another source is the vegetative growth (tree root, see Figure 3.3) found underneath the east section of wall when exposed by the archaeological excavation. Furthermore, the north gate feature is located at a drainage exit point for the compound (see Figure 2.2), resulting in water from rain dwelling in the soils as well as possibly causing some soil erosion over the years. The poor construction and unfavorable environmental issues in combination are the cause of the obvious deformation of the wall.

lean has been unchanged since he started working at this branch office in 1991 (personal communications, June 24, 2019). Again, illuminating a longer history of the lean exhibited by the north gate, Susan Snow described that she first wrote a request for money to fix the lean in the early 2000s (personal communications, June 24, 2019). This means that the north gate has illustrated a severe lean for about 28 years and is not a new development.

Figures 3.1 (left) and 3.2: Side views looking east of the north gate illustrating the severity of its lean. The west section of the wall does not lean as dramatically as the east section.

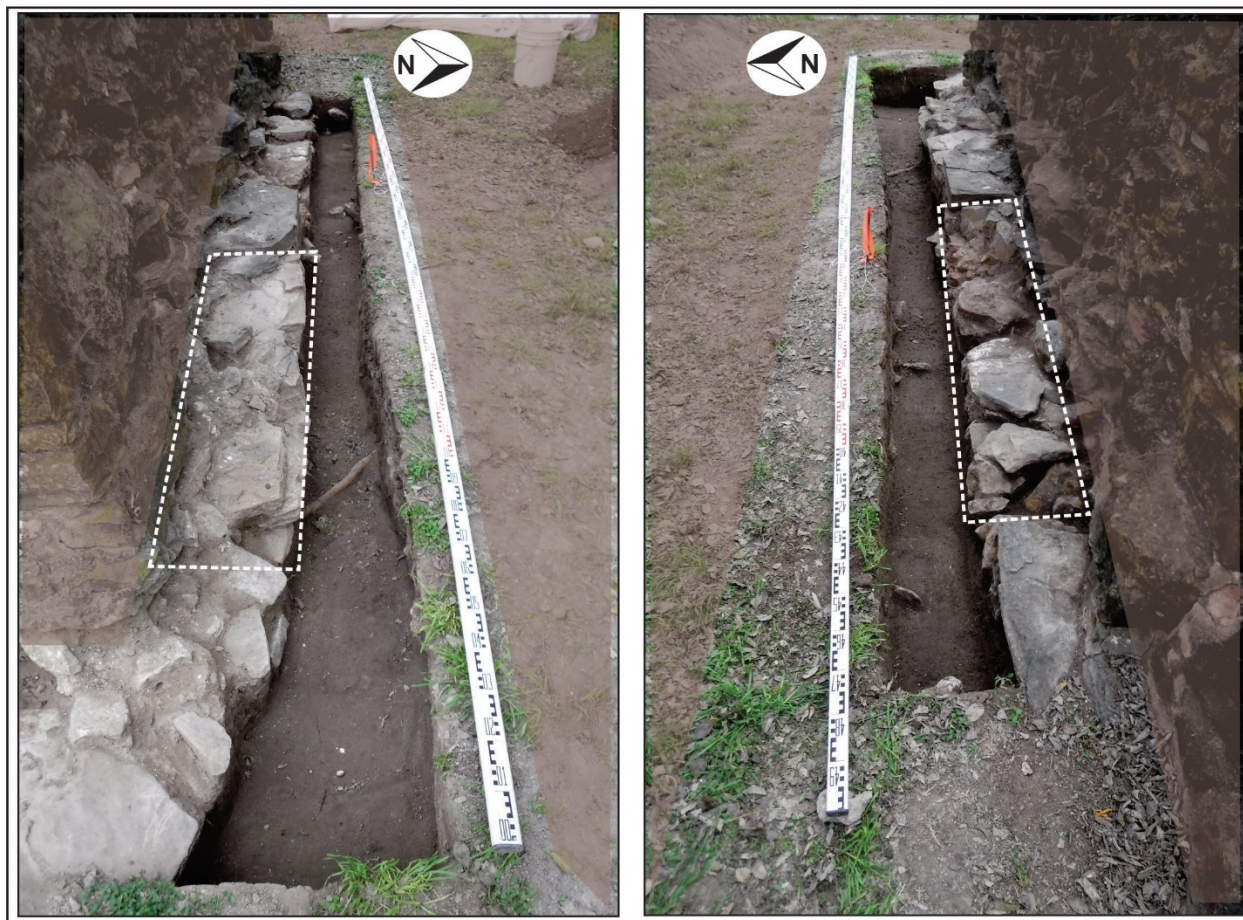
Testing of the north gate determined the reconstructed walls were not aligned on the original wall footings, and that the sections of reconstructed wall footings are atypical of Spanish Colonial-period wall footings (Figures 4.9 and 4.10). Exposure of the wall footings revealed that the reconstructed walls were not centered on the wall footings and that sections of these wall footings at both segments had been poorly reconstructed.

Figures 4.9 and 4.10: West wall segment—view west (left) and view east (right); note poorly reconstructed section (outlined).

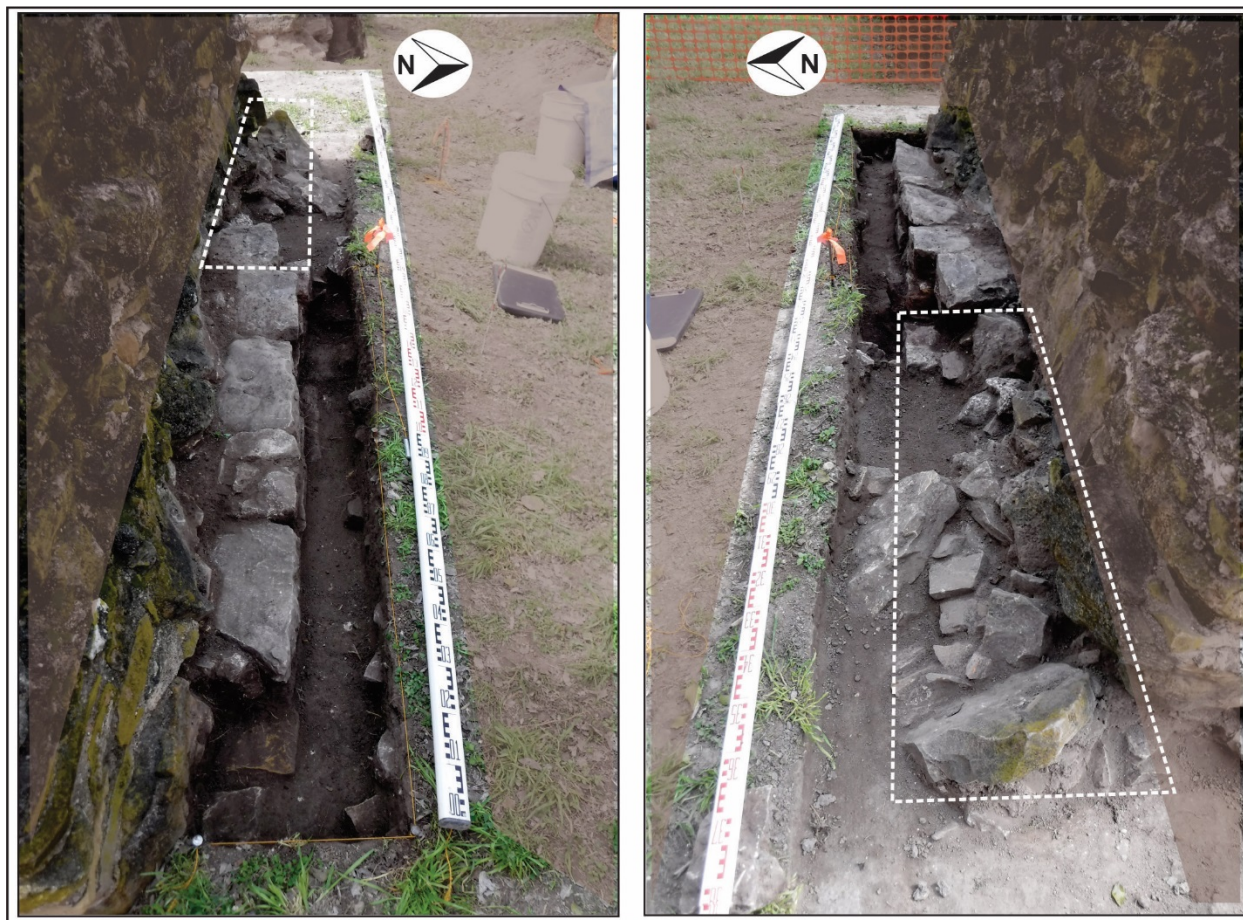
Figures 4.11 and 4.12: East wall segment—view west (left) and view east (right); note poorly reconstructed section (outlined).

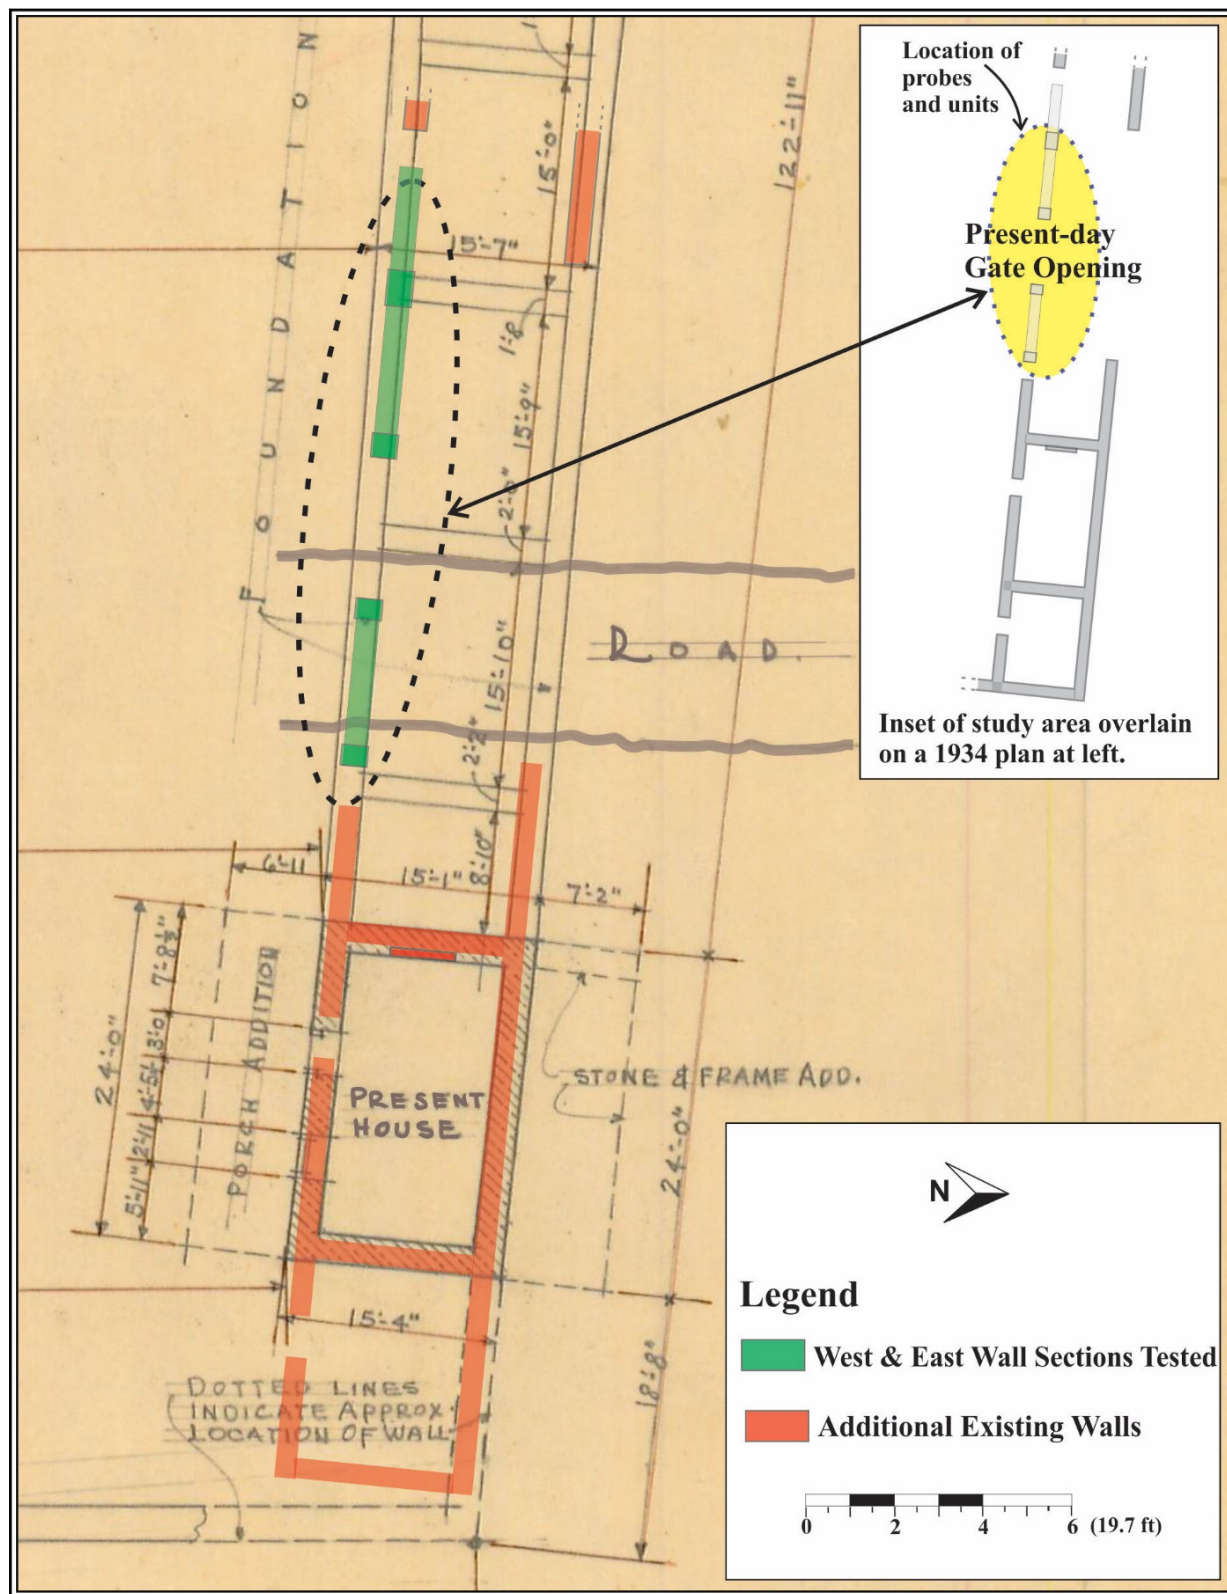
In addition to these missteps, CAR staff noted the present-day gate opening does not align with the opening shown on the 1934 measured drawing (Figure 4.13). The inset shown in Figure 4.13 is taken from the plan of the area produced by CAR staff. The plan view includes the existing stone walls to the west and east (shown in orange) of the north gate (shown in green), which was then overlain on the 1934 drawing. CAR staff aligned the present-day house ruins approximately over the area on the 1934 plan labeled “present house.” CAR staff also enhanced the trajectory of the road on the 1934 plan in order to emphasize its misalignment. However, we note the informal probes with the quarter-inch diameter rod failed to locate evidence of a wall footing between the reconstructed gate opening. This would suggest the opening was correctly aligned, or that the stones were removed for reuse elsewhere.

Figure 4.13: Cropped image of 1934 measured drawing by Harvey Smith, overlain by recent field drawing of study area; road indication on 1934 plan was enhanced for effect by CAR staff. Image courtesy of The Alexander Architectural Archives, The University of Texas Libraries, The University of Texas at Austin.
