Mission San Jose Y San Miguel De Aguayo, Convent  
6539 San Jose Road  
San Antonio  
Bexar County  
Texas

HABS No. TX-333-C

WRITTEN HISTORICAL AND DESCRIPTIVE DATA

MISSION SAN JOSE Y SAN MIGUEL  
DE AGUAYO, CONVENT

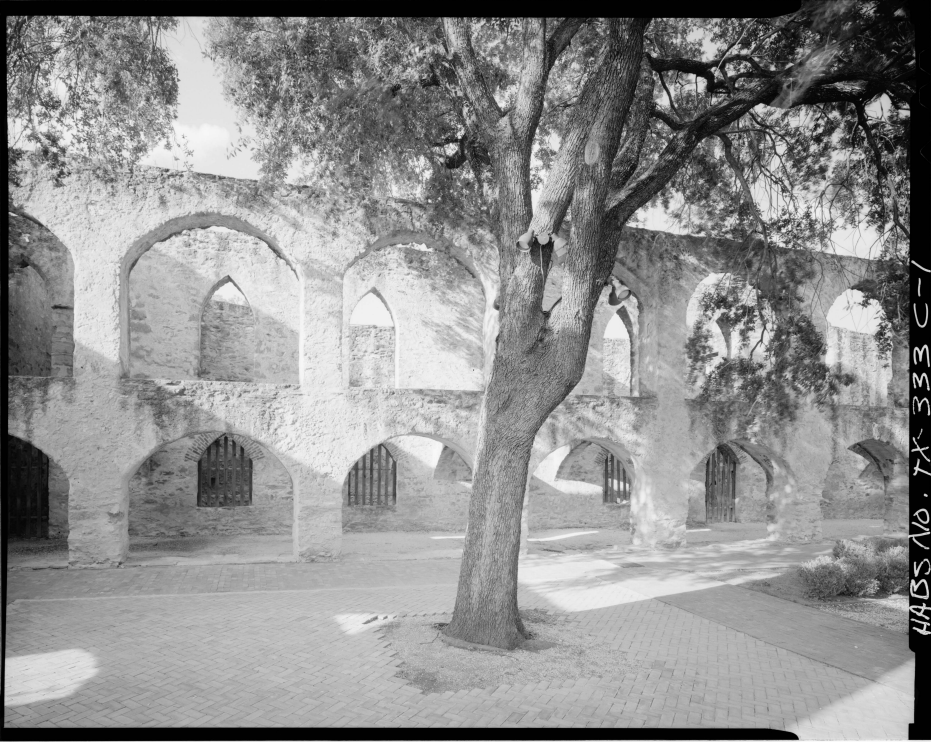
HAAS No. 7X-333 C-1

TX -333-C-1 GENERAL VIEW AND SOUTH SIDE OF CONVENT, FROM COURTYARD

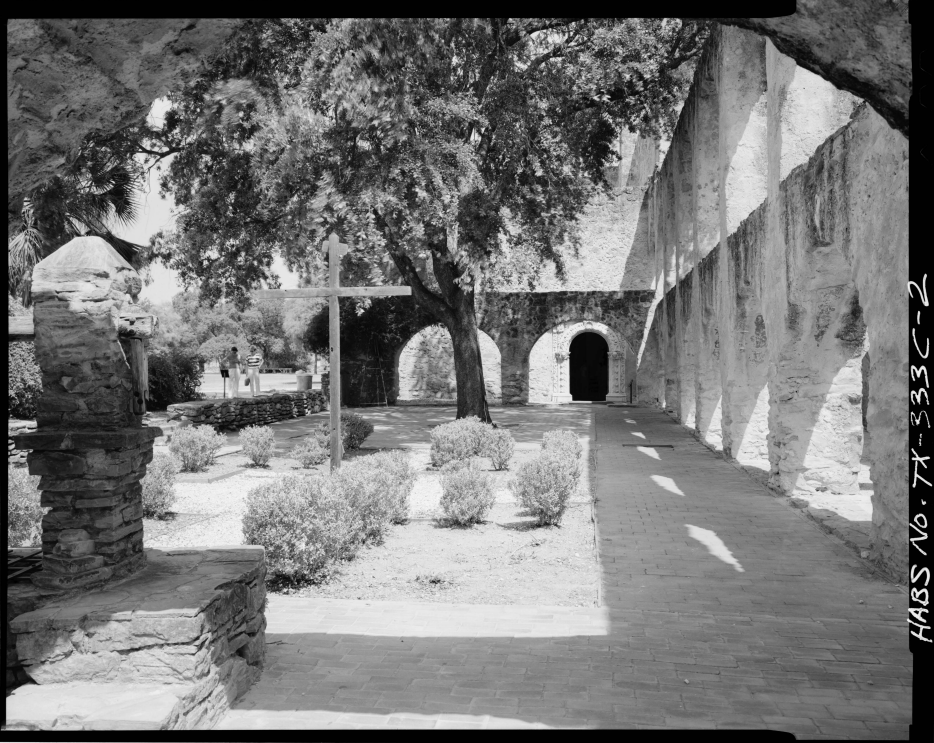
HABS No. 7X-333C-2

TX-333 C-2 ONE-STORY WALL, EAST SIDE

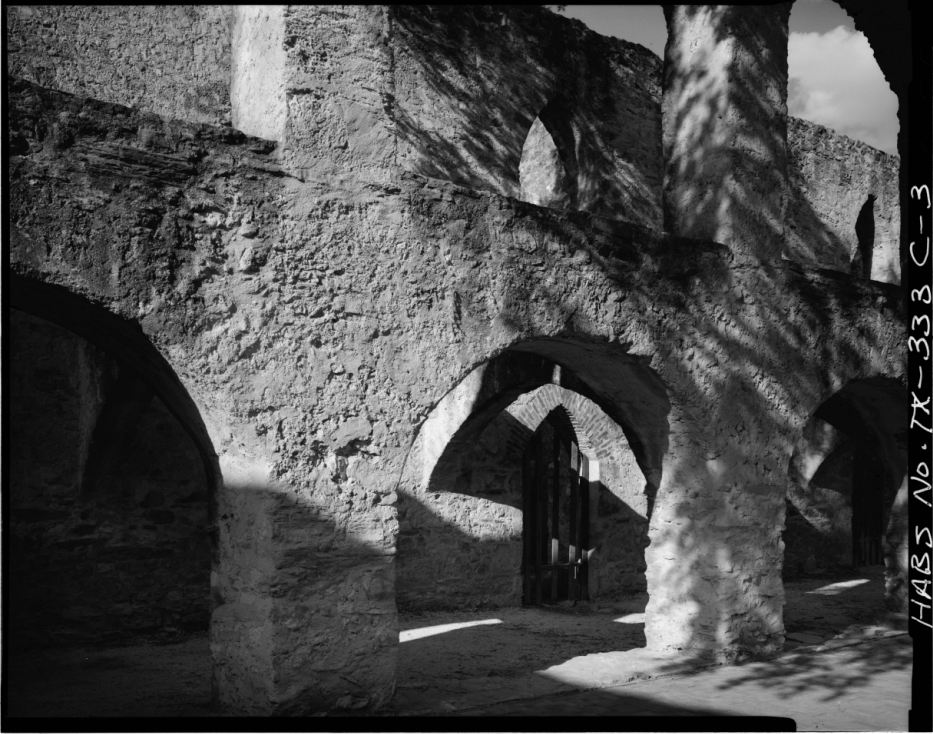
HABS No. 7X-333 C-3

TX-333 C-3 DETAIL OF ARCHES AND LANCET ARCHES
