National Park Service  
United States Department of the Interior  
San Antonio Missions National Historical Park  
Texas

# Historic Structure Report Mission Concepción Convento

100% Submission  
2019

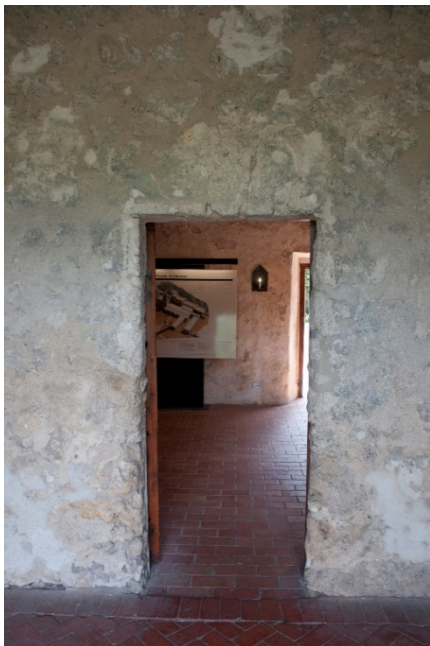
Figure 6.B.14: 104 A—East wall (A11, A12, B11, B12), door leading to the portería. Around the door several types of mortar patching can be found.

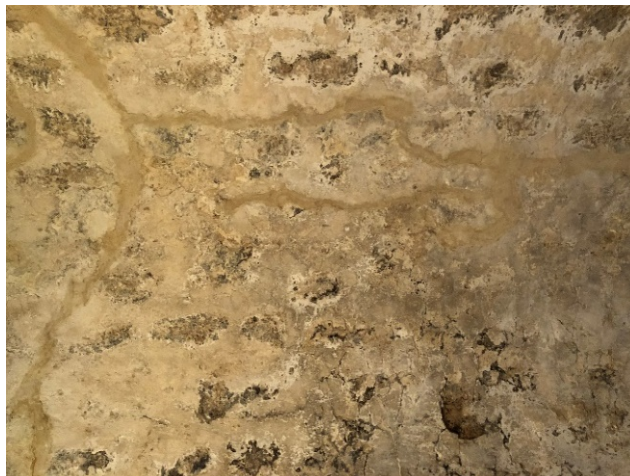
Figure 6.B.52: 104 C—North part of the ceiling (E5, E6, F5, F6). The barrel-vaulted ceiling is characterized by a scratch coat partially covering the rubble stones with numerous filled fractures. Its appearance looks non-historic.

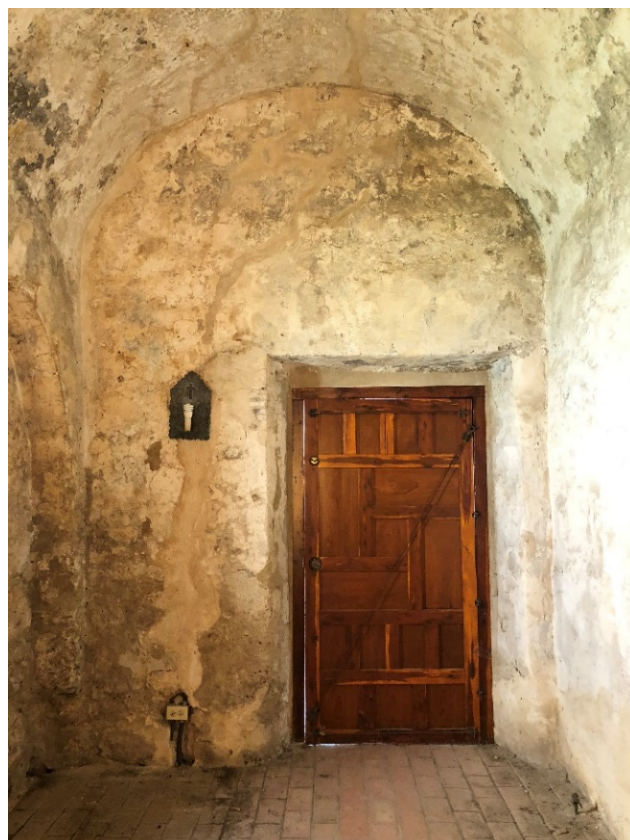
Figure 6.B.55: 104 C—South wall. Patching and filled fractures are observed on a historic plaster featuring a high level of erosion.

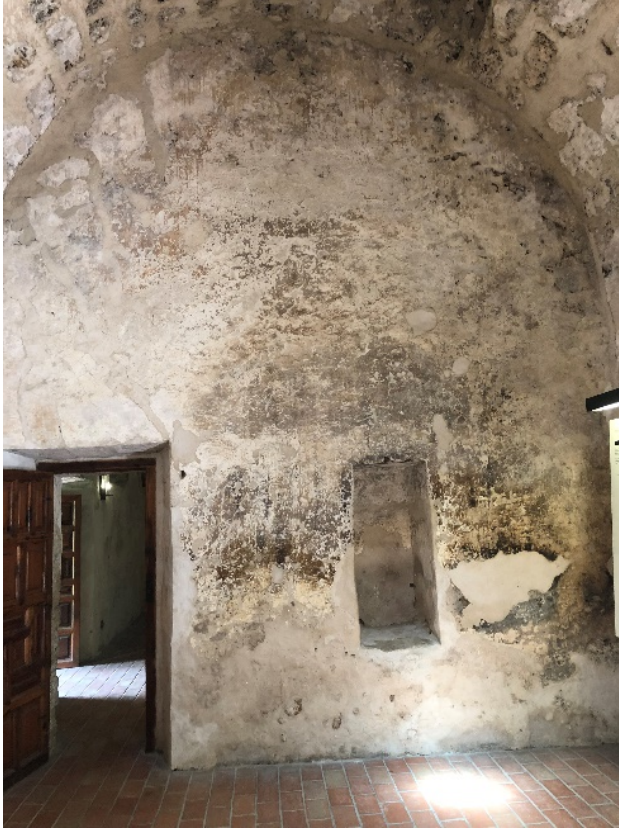
Figure 6.B.56: 104 D Portería—North wall. High level of surface decay with efflorescence. Fractures on the windowsill.

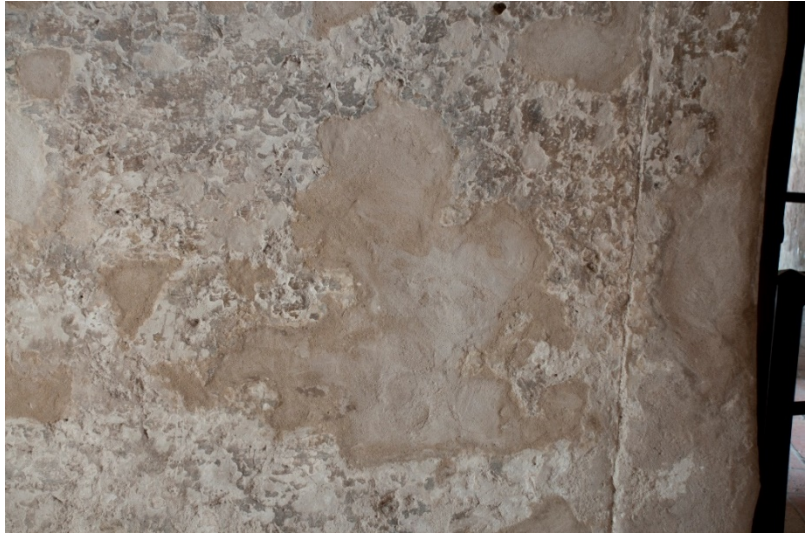
Figure 6.B.67: 104 D Portería—South wall left jamb of the door (A1, A2, B2). The remnants of historic plaster feature discoloration and differential erosion. Visually intrusive patchings were added to give continuity to the plaster.

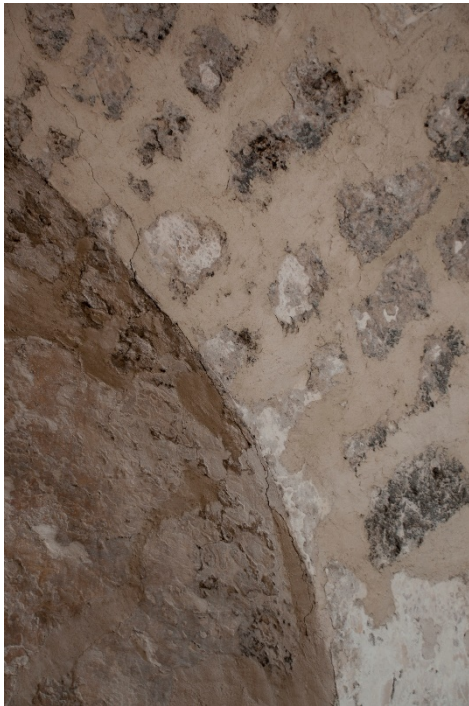
Figure 6.B.70: 104 D Portería—Southwest corner (C1, D1). Features a hair crack that starts at the corner and then extends to the vault, erosion of the painted finish of the historic plaster, and roughly executed brown mortar repointing in the masonry of the vault. Some stones have remnants of whitewash.

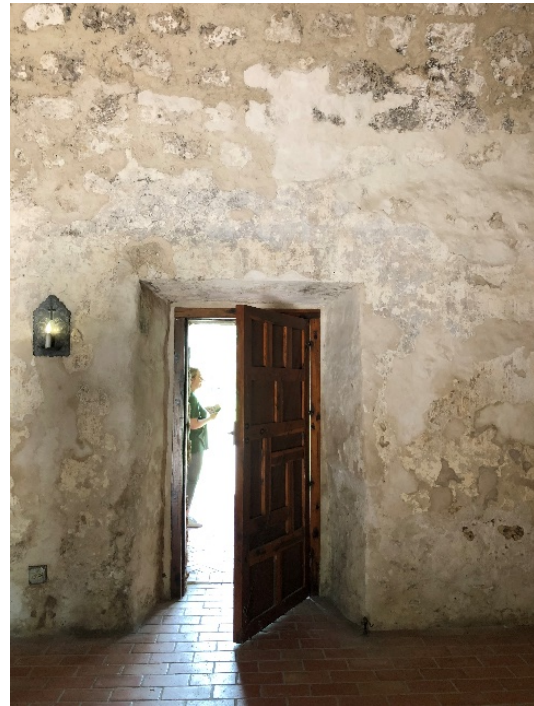
Figure 6.B.71: 104 D Portería—West wall, large patching interrupts the continuity of the historic plaster finish.

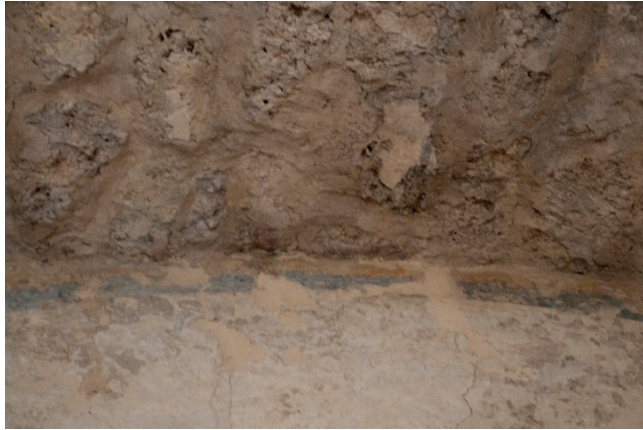
Figure 6.B.80: 104 E Library—North wall (E3). Upper part of the north wall, connection with the vault. Features hair cracks, patching, and erosion of the painted finish.

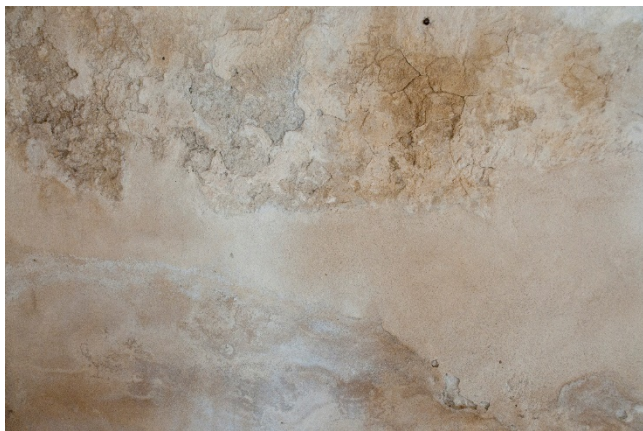
Figure 6.B.81: 104 E Library—East wall (A7, B7). Patching in the bottom part that features high level of efflorescence, and the upper part shows craquelé and delamination of the plaster layers.

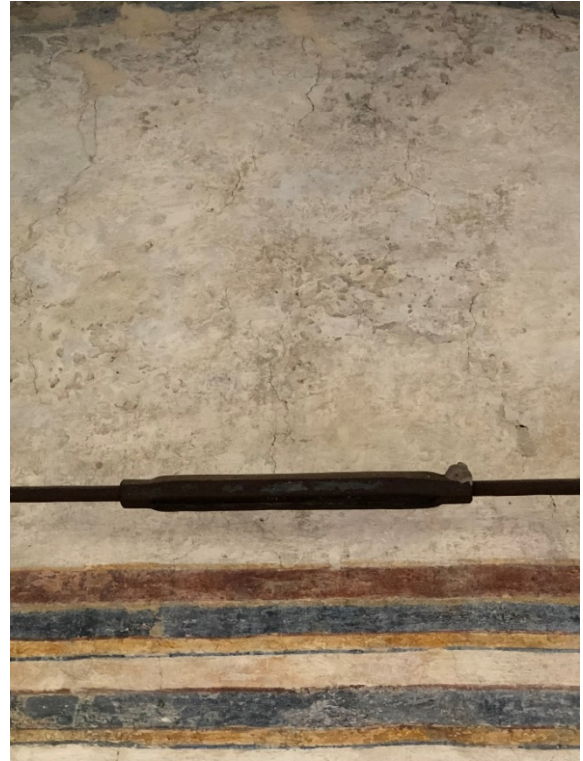
Figure 6.B.79: 104 E Library—North wall (C2, C3, D2, D3). Photo showing some hair cracks and the iron tie rod that connects the east and west wall. Discoloration of the historic painted plaster. Some erosion on the top part.

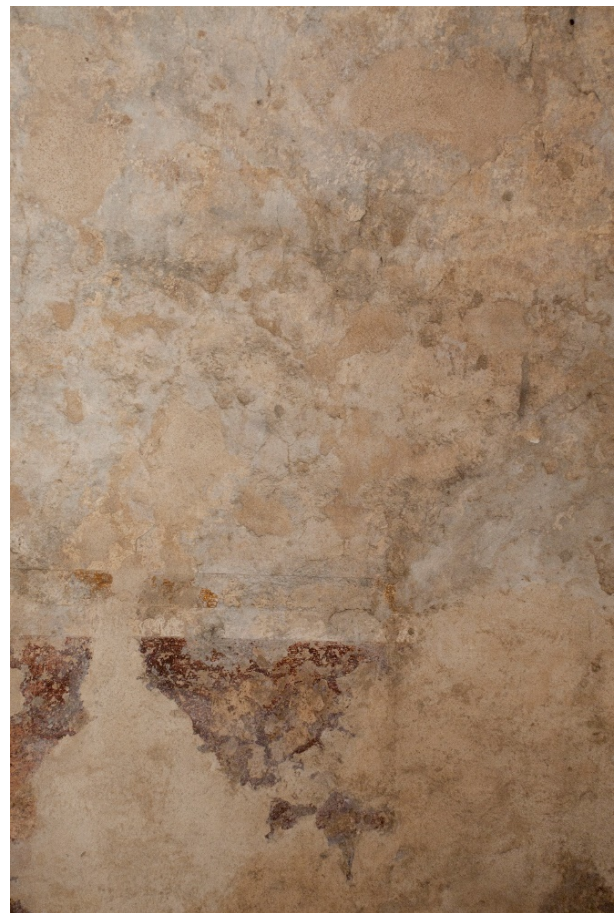
Figure 6.B.87: 104 E Library—Ceiling detail (A1, B1). Decorative geometric lines of painted plaster in yellow and red in the bottom part. Above the wainscot, erosion of the painted finish and well-executed patching, having material and visual continuity with the substrate.

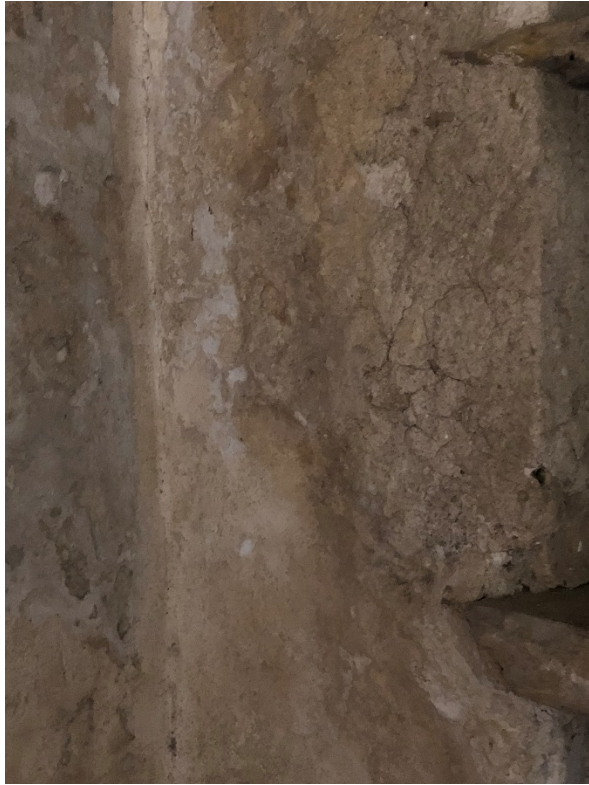
Figure 6.B.88: 104 E Library—South wall, featuring efflorescence and several hair cracks.

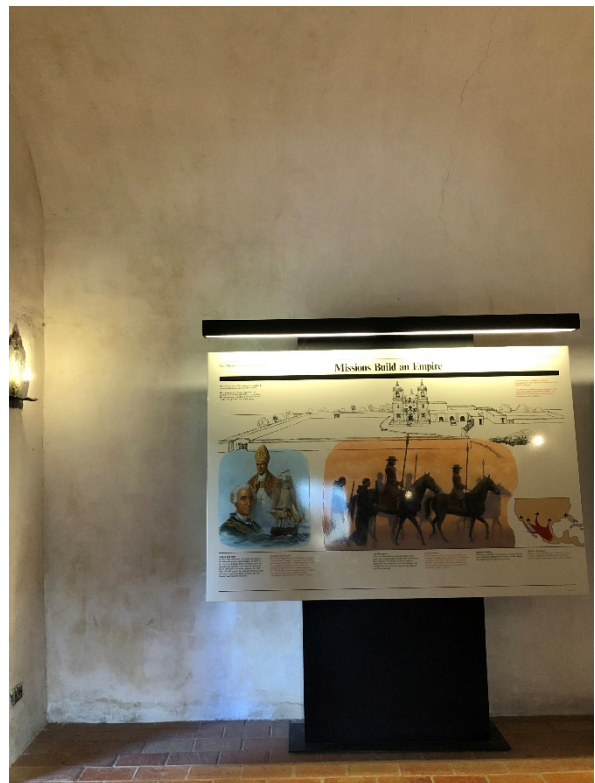
Figure 6.B.105: 104 F Refectory—East wall. On the northeast corner, stains due to moist areas are visible, due to the low porosity of the new plaster materials.

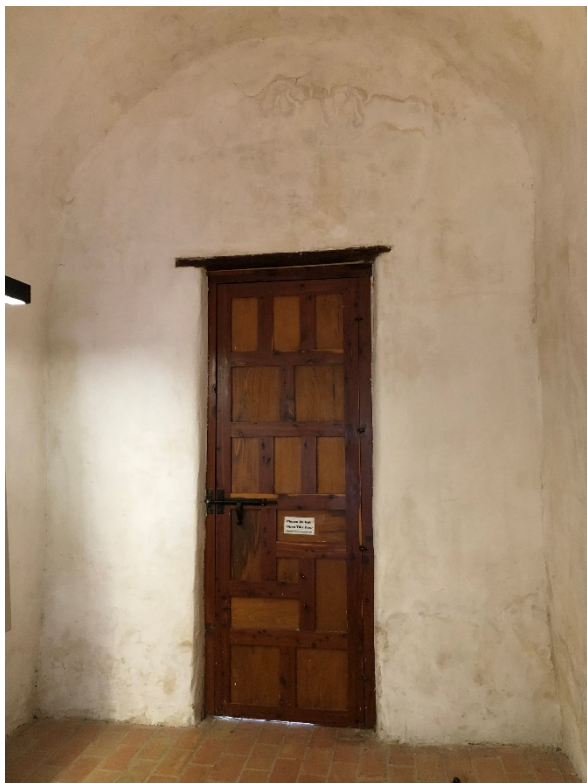
Figure 6.B.106: 104 F Refectory—South wall. Erosion of the painted surface and stains are located both on the lower portion of the wall and on the top, near the vault.

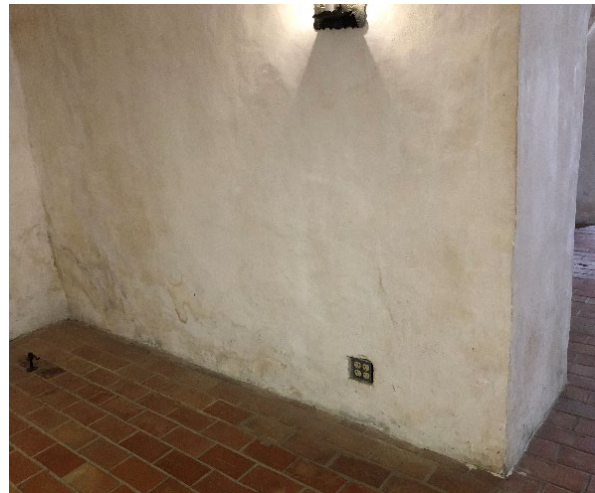
Figure 6.B.107: 104 F Refectory—West wall. Stains due to rising damp are visible on the south west corner.

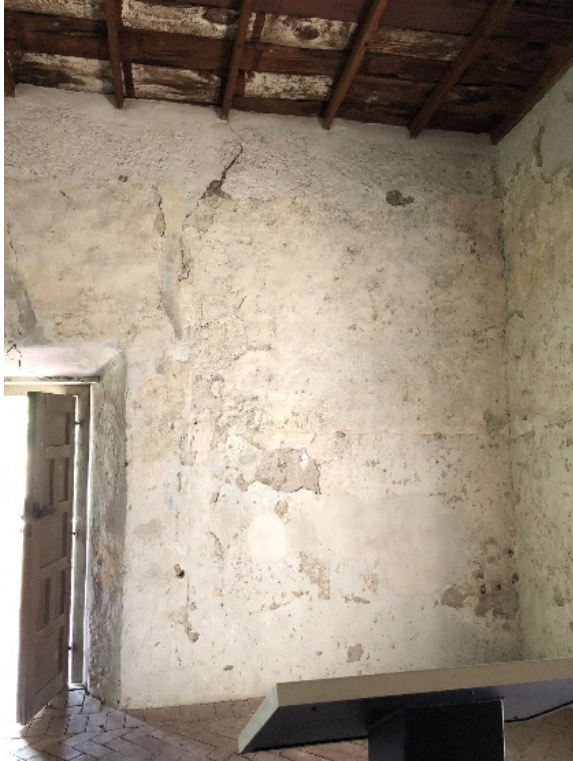
Figure 6.B.122: South wall, west corner. Diagonal cracks starting from the door architrave are visible.

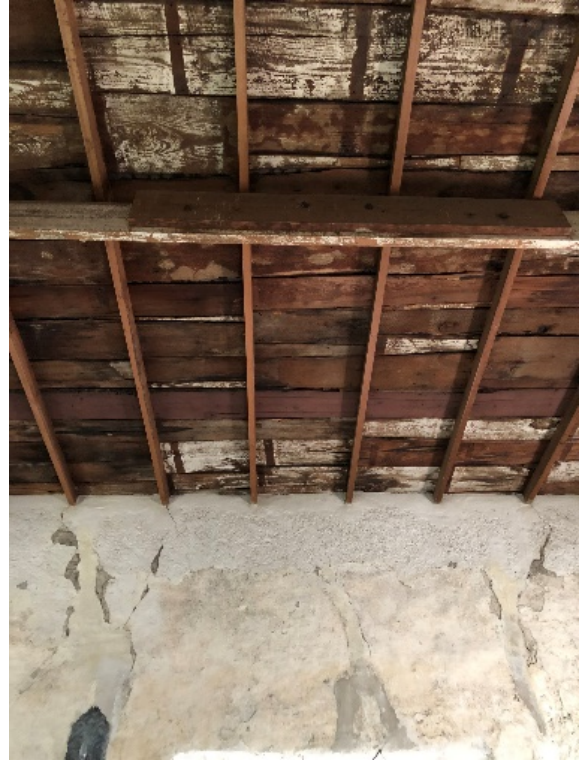
Figure 6.B.123: Ceiling and part of south wall. Cracks reach the ceiling.

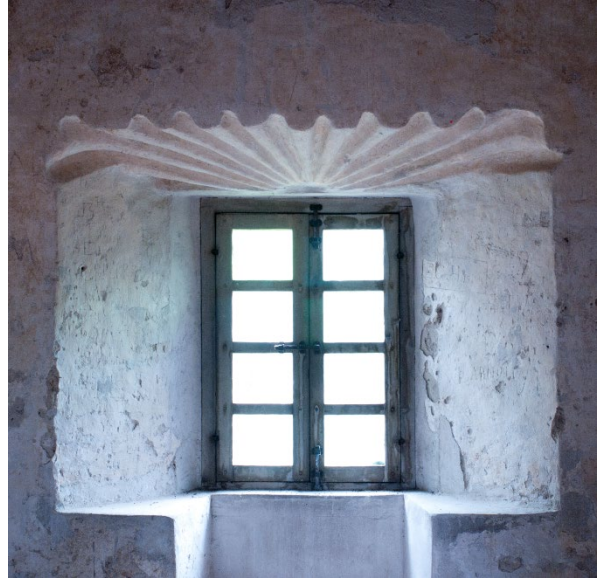
Figure 6.B.133: East wall, view of the decorative clamshell window openings. Its surface exhibits historic graffiti, a crack in its architrave, and detachment of the patching of the right jamb.

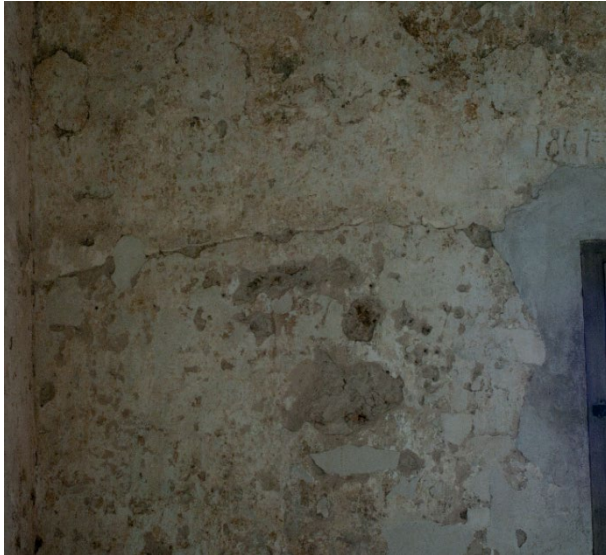
Figure 6.B.138: West wall (B4). Features numerous missing parts, a horizontal hair crack starting at the corner of the window, and visually intrusive patching at the jamb of the window.

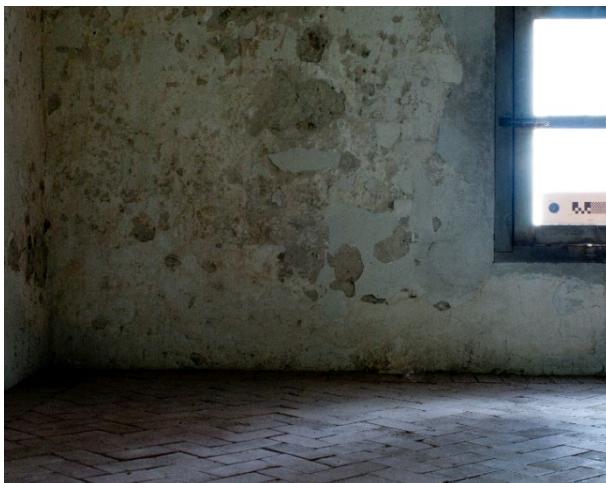
Figure 6.B.141: West wall (A4, B4). Features numerous missing parts, differential erosion of the plaster, and erosion of the painted finish.

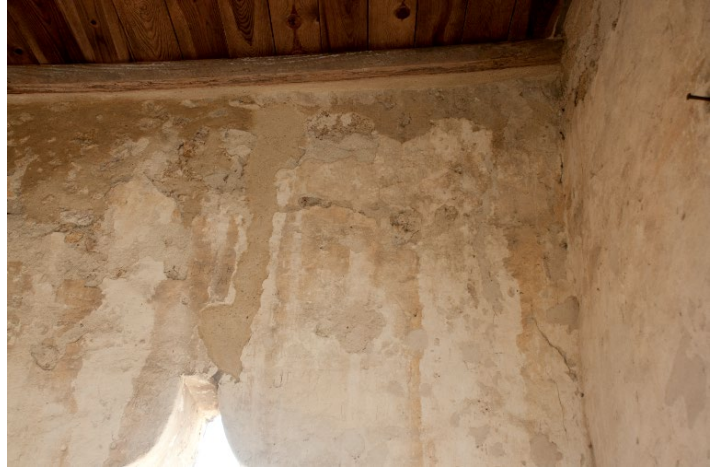
Figure 6.B.159: West wall. Upper part of the wall. Exhibits a crack starting from the upper point of the window that has been filled, concrete patching on the top of the wall, and detachment of edges of the plaster.

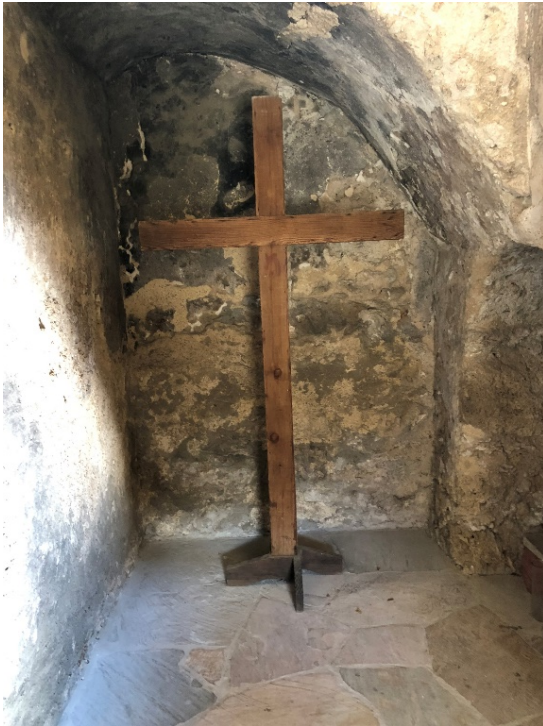
Figure 6.B.173: East wall under the staircase features mortar patching from different time periods.

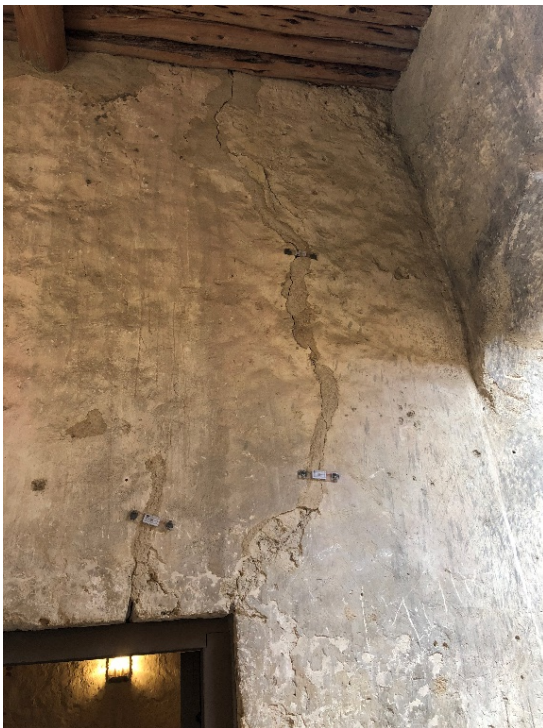
Figure 6.B.176: North wall has deep fractures filled with mortar. The wall may need stabilization.

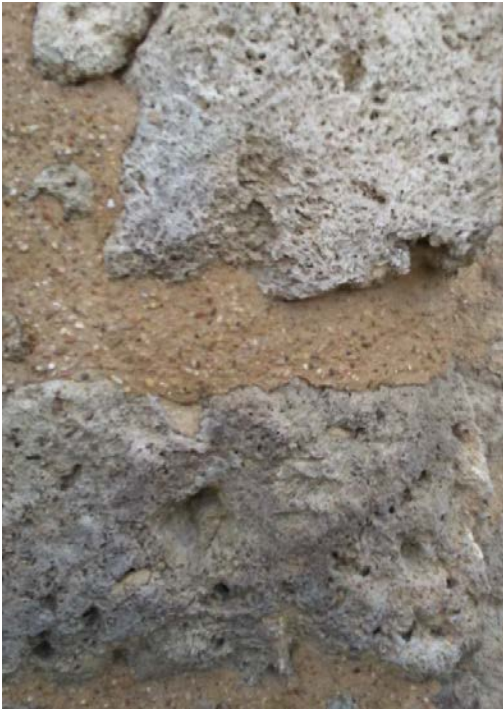
Figure 6.B.190: Detail of a buttress with no evident biological colonization.

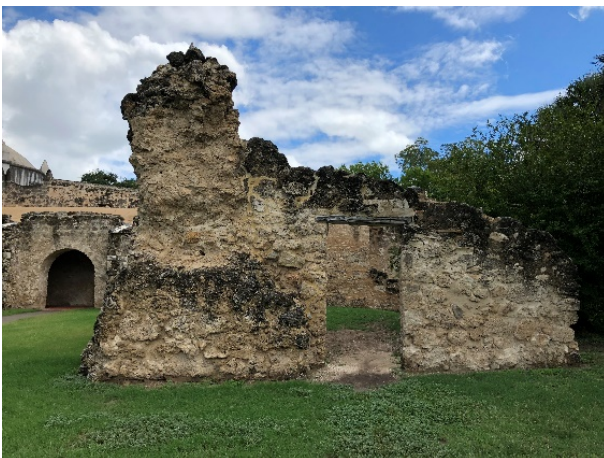
Figure 6.B.205: The west ruined wall has an irregular shape, due to the collapsed vaults. Masonry of the uppermost is in fragile condition.

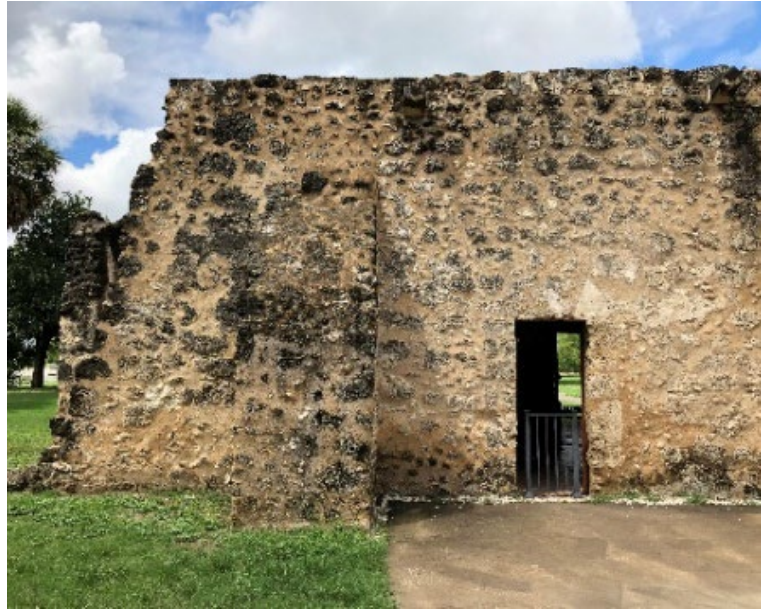
Figure 6.B.207: East wall (segment B), corresponding to the library. This façade is in fairly good condition.

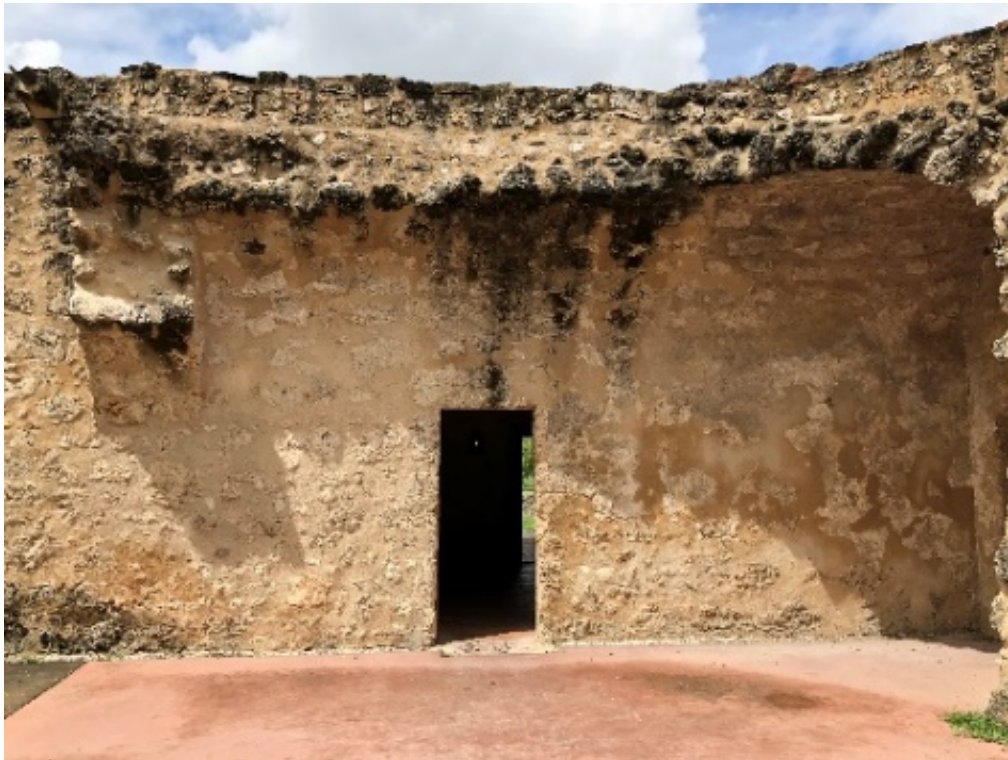
Figure 6.B.208: East wall (segment B), corresponding to the portería, in generally good condition.

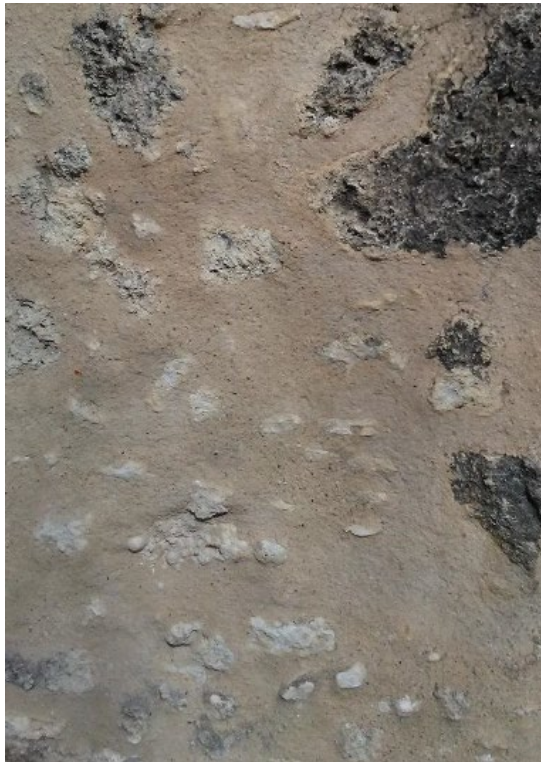
Figure 6.B.209: Brown mortar patching applied on the small tufa rubble.

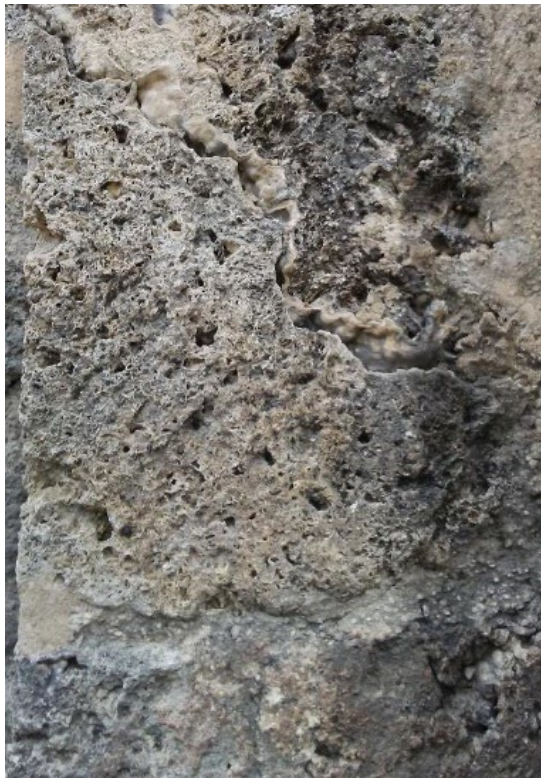
Figure 6.B.211: Detail of a tufa block with darkening of biological origin. The biological colonization of cyano-bacteria appears to infiltrate inside large pores.

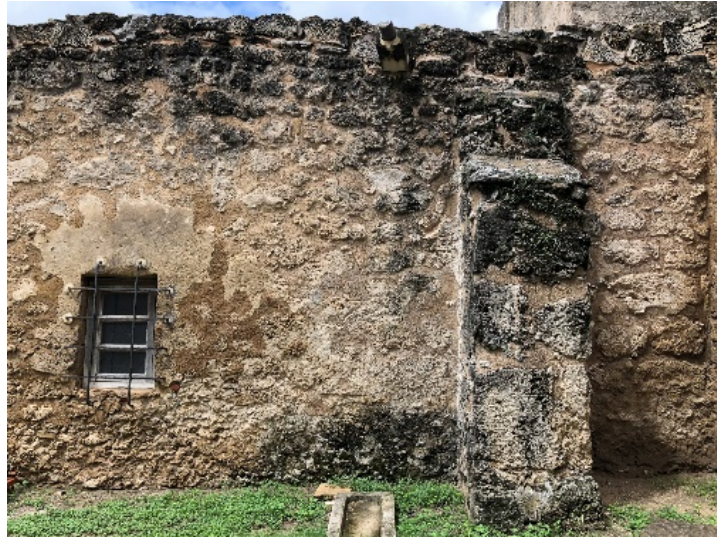
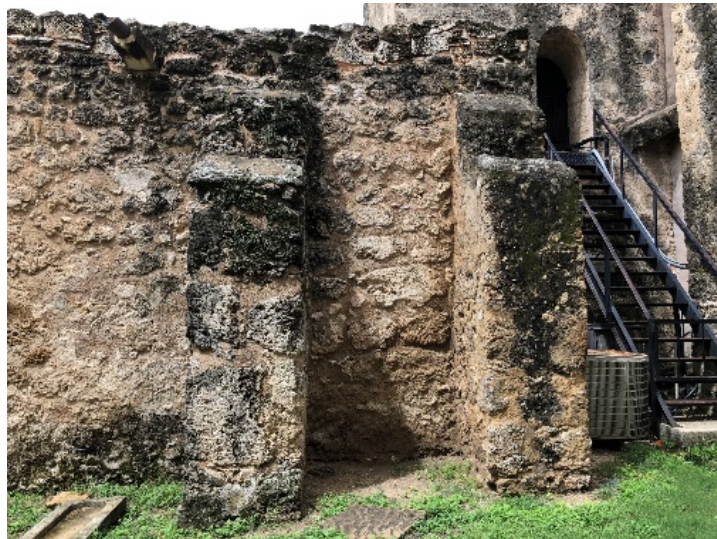
Figures 6.B.212–6.B.214: East wall (segment A), corresponding to the guest room. This wall affected by biological growth, moist areas, stone fragmentation, delamination, and erosion.

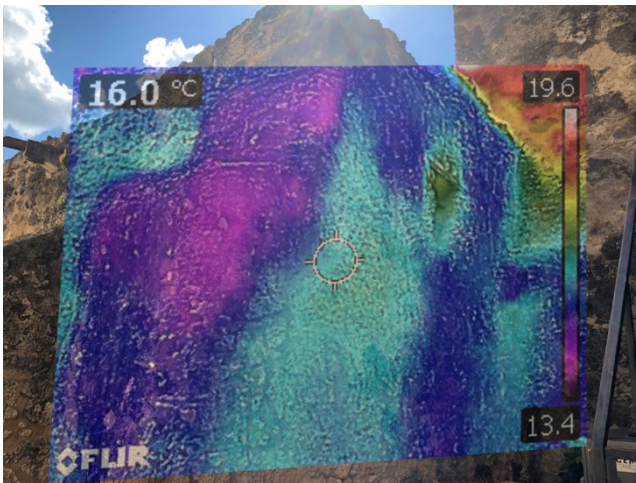
Figures 6.B.215–6.B.216: North wall of the guest room. The condition of this wall is critical, with thick layers of biological growth and wall erosion. High moisture contents are enhanced by incorrect water drainage both at the roof and ground levels.

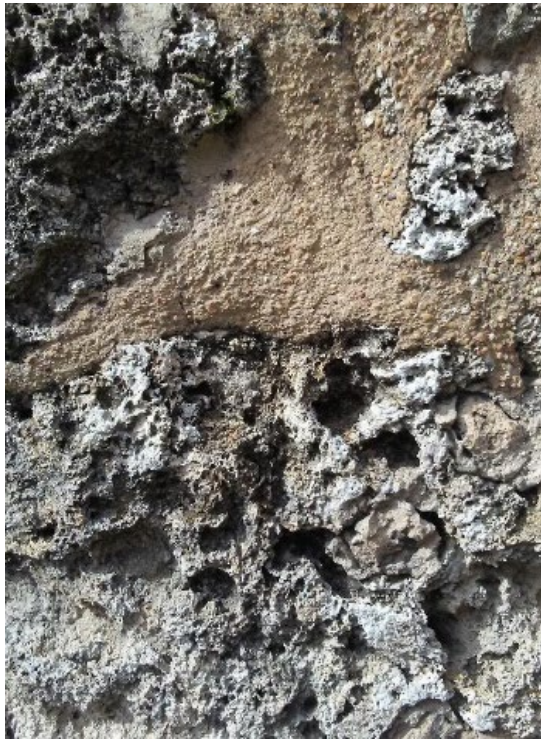
Figure 6.B.217: Brown mortar joints between heavily eroded stones.

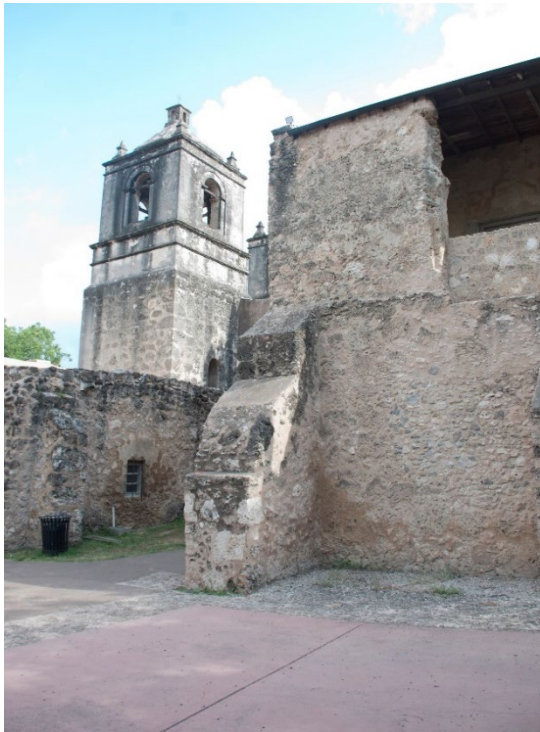
Figure 6.B.222: Exterior south wall. This façade is in good condition, recent repointing work can be seen between the two buttresses.
