National Park Service  
United States Department of the Interior  
San Antonio Missions National Historical Park  
Texas

# Historic Structure Report Mission San José Convento

Final Submission  
2019

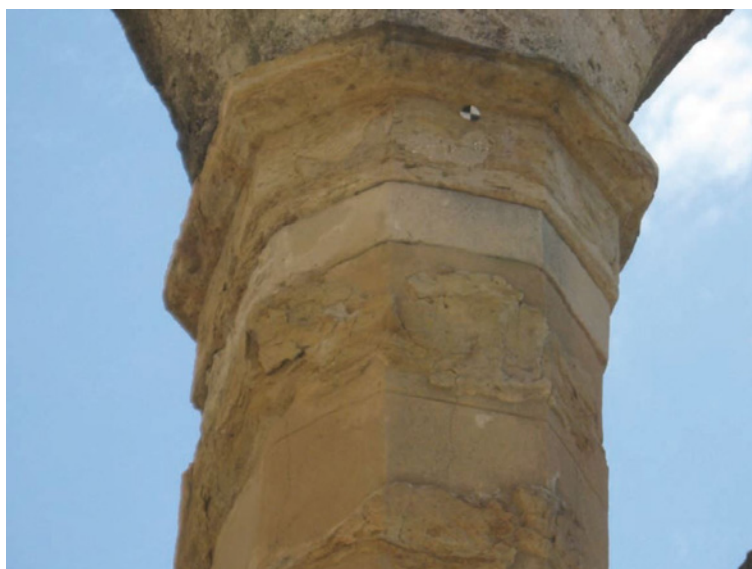
Figure 6.A.2: The column: microcracking observed during the 2011 assessment attributed to the swelling of clays inherent within the stone. The resulting 2012 thesis investigates also the effects of an elastified ethyl silicate consolidant with a swelling inhibitor.

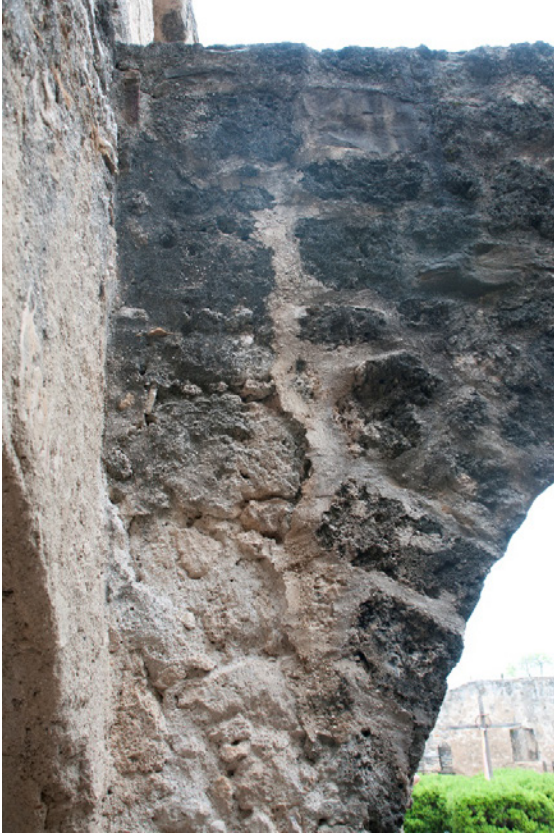
Figure 6.B.6: Room HS 203 S—East wall. Filled crack on the arcade north section.

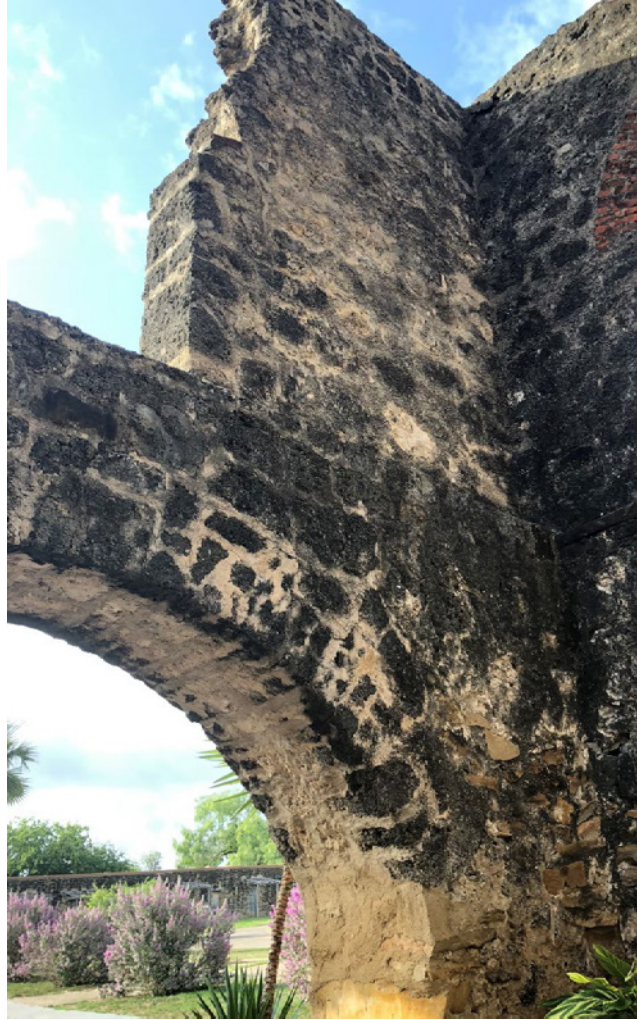
Figure 6.B.7: Room HS 203 S—East wall. The southeast corner has a thick layer of biological growth.

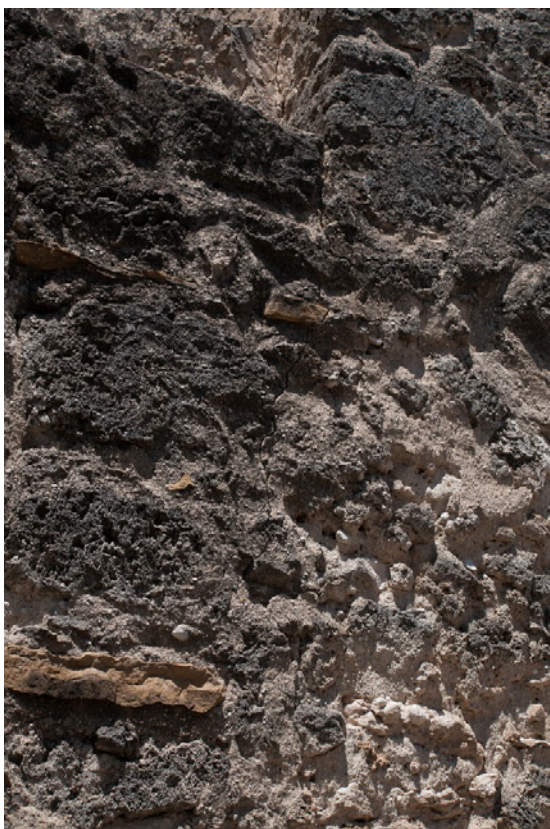
Figure 6.B.12: Room HS 203 S—West wall. Detail showing a crack in the corner where the wall's thickness changes.

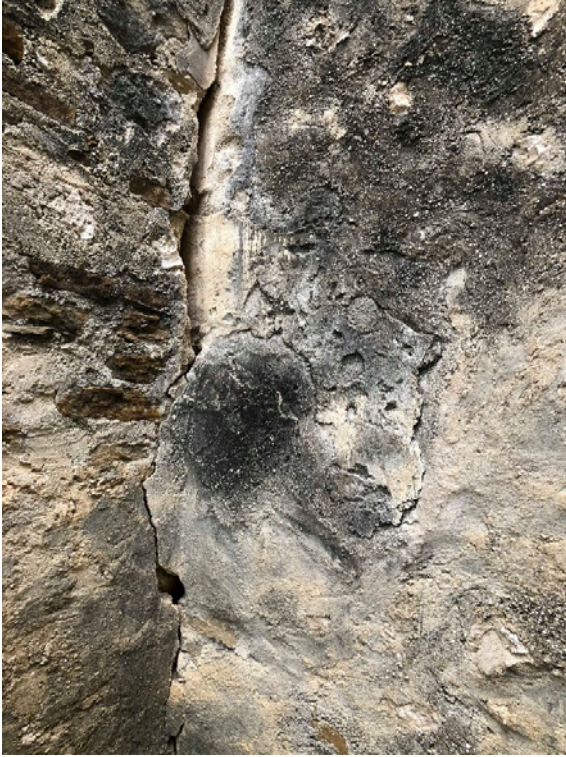
Figure 6.B.43: Room HS 203 A—North wall. The northwest corner is characterized by a vertical fracture/separation extending for the entire wall height. Remnants of historic plaster are visible on the north wall inside the fracture, indicating the west wall was added in a latter phase of construction.

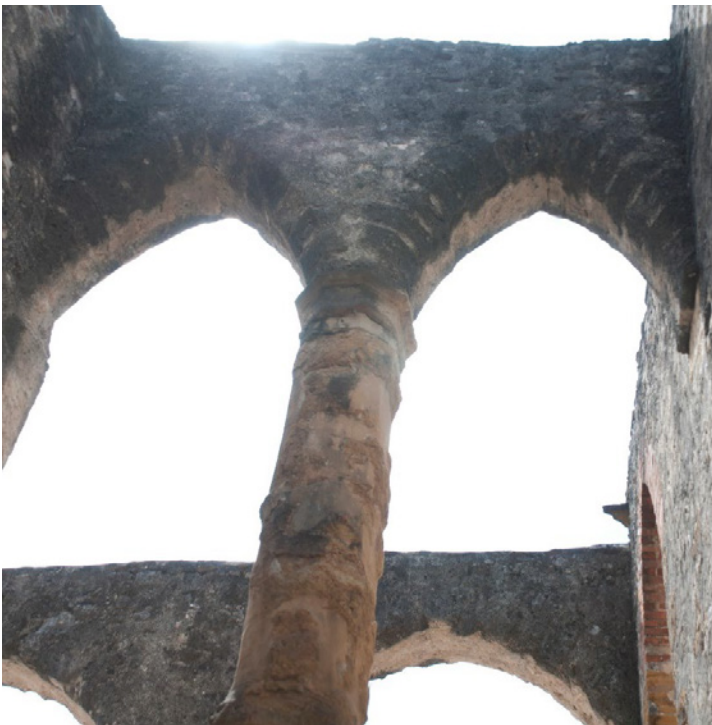
Figure 6.B.44: Room HS 203 A—South wall. Upper level. The thick layer of biological growth alters substantially the color of the tufa and sandstone. The octagonal column exhibits fragmentation and missing parts in its upper portion.

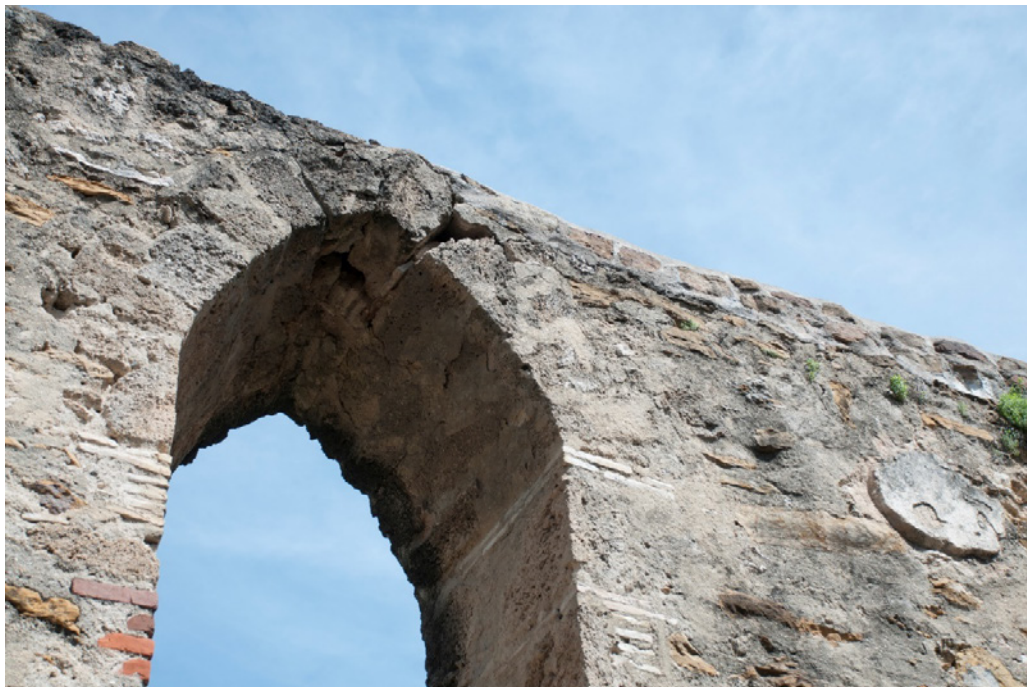
Figure 6.B.57: Room HS 203 D—North wall. Detail of the upper part of the window. A structural crack can be seen at the right of the keystone, and also additions of bricks in the construction or reparation of the window.

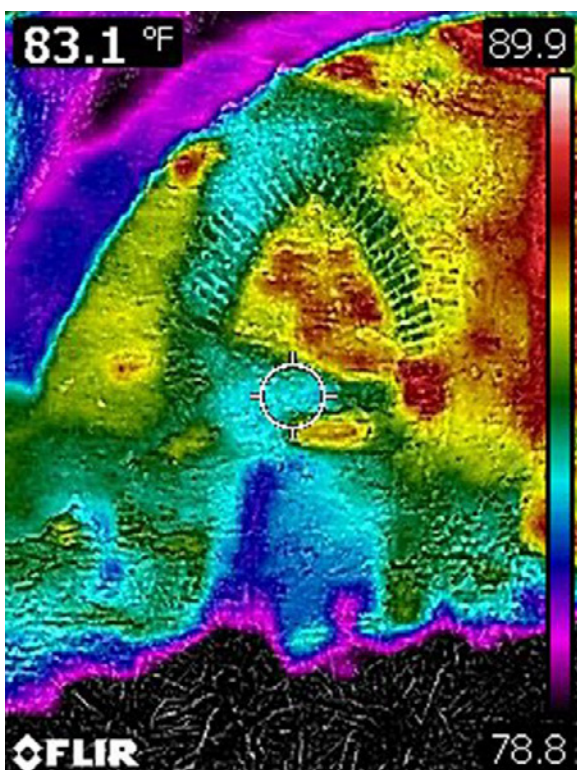
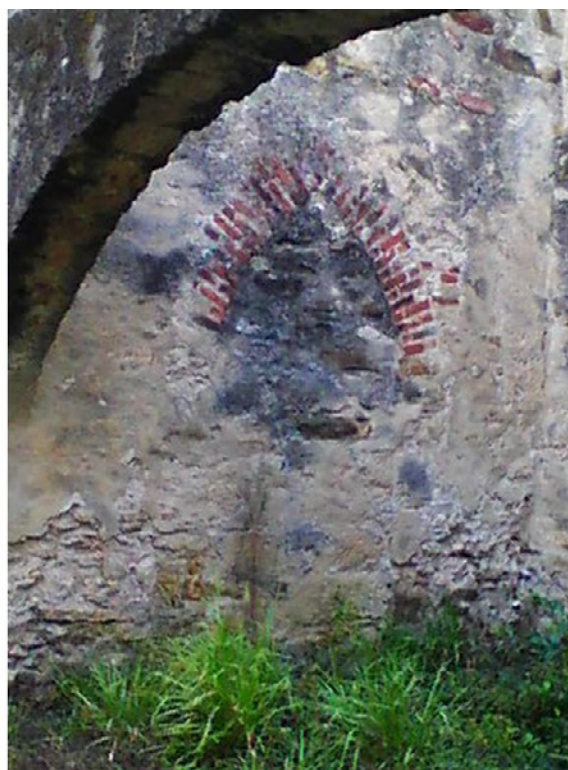
Figures 6.B.58 and 6.B.59: Room HS 203 D—North wall. Same portion of wall—a detail of the right area—is shown in both photos. Left photo shows temperature differences in the wall. The difference in the temperature seems to be caused both by the difference of materials used in construction (brick, limestone, sandstone, mortar) and the level of humidity—the bottom part, which shows erosion due to rising damp, is the colder area.

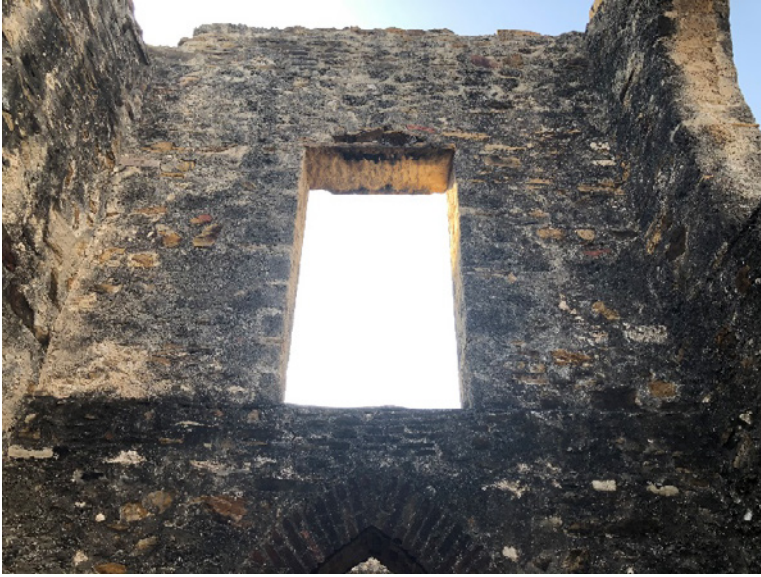
Figure 6.B.60: Room HS 203 D—East wall, upper part features a thick layer of biological growth that is less intense in the upper left area.

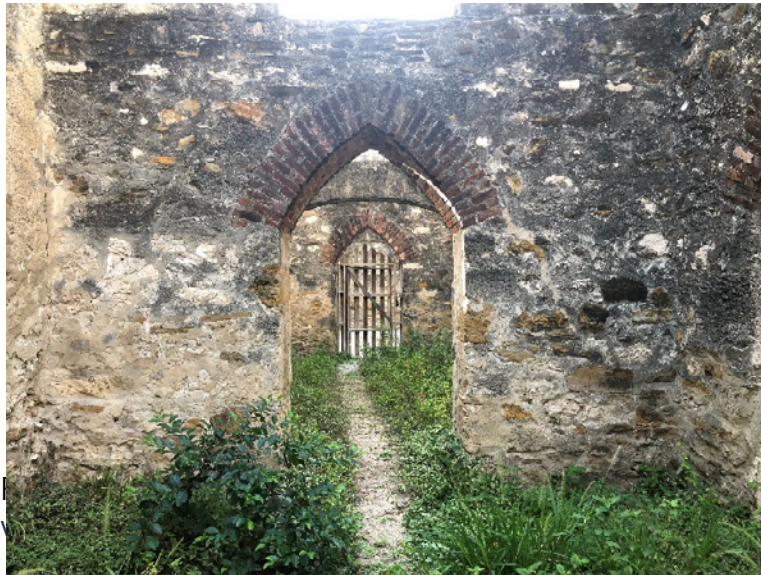
Figure 6.B.61: Room HS 203 D—East wall, bottom part features a crack to the left of the lancet brick arch, erosion in the bottom part of the wall and vegetation growth in the higher part.

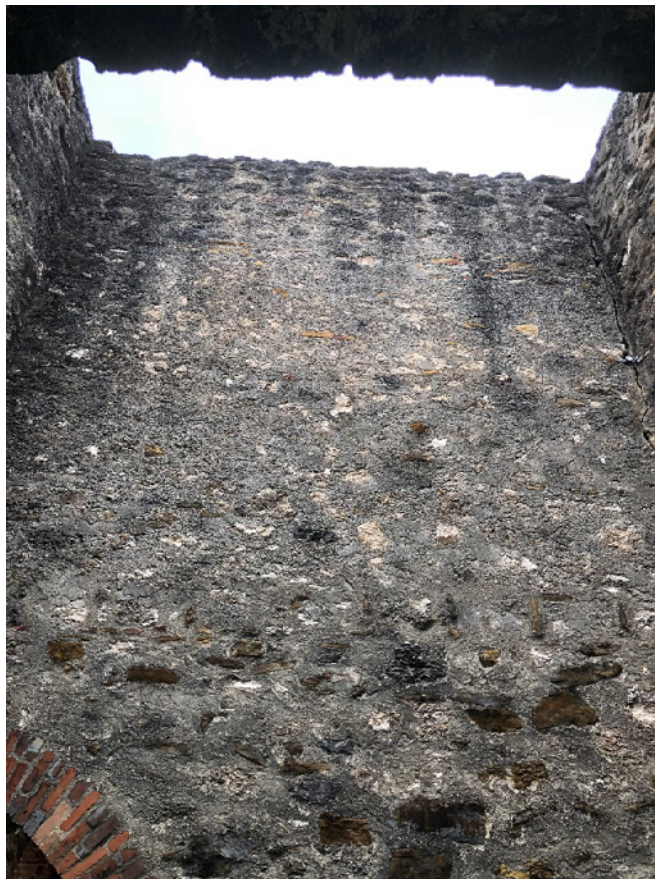
Figure 6.B.65: Room HS 203 D—West wall exhibits vegetation growth and a fracture in its right corner.

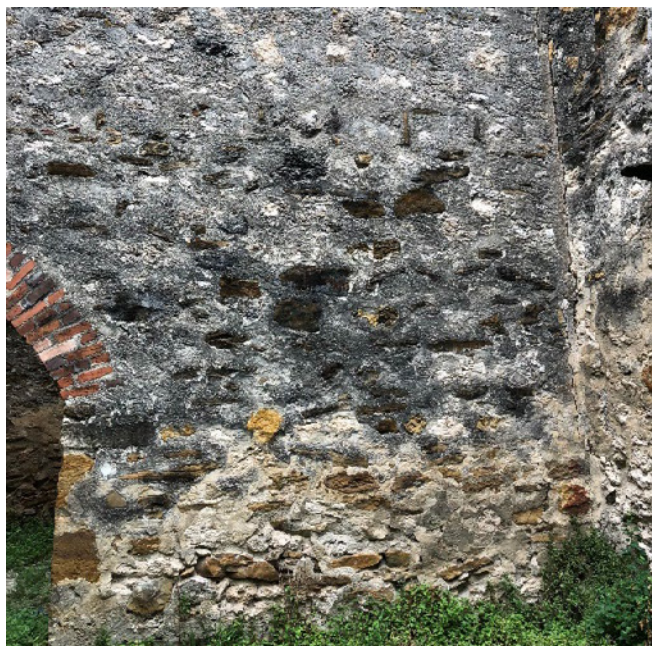
Figure 6.B.67: Room HS 203 D—West wall, bottom area exhibits erosion of the masonry due to rising damp and loss of mortar joints. In the northwest corner there is a fracture that goes all the way to the top of the wall and causes discontinuity in the structure.

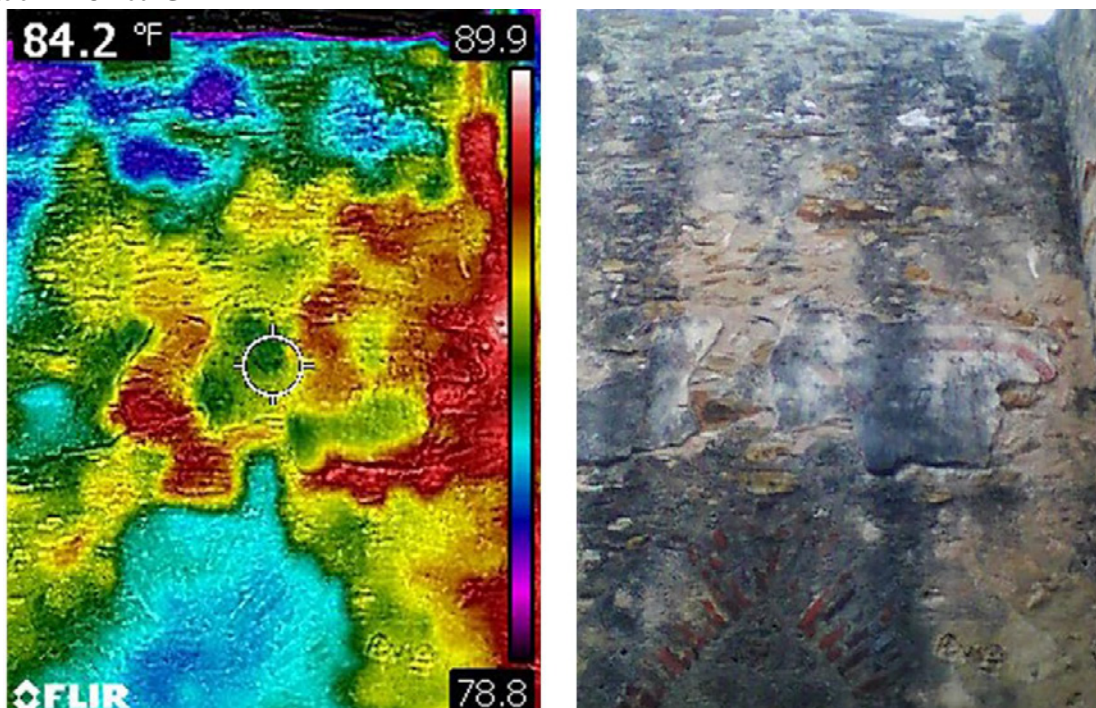
Figures 6.B.76 and 6.B.77: Room HS 203 C—North wall. Both images show the same area of the wall. The differences in temperature are caused by the different construction materials and the presence of humidity. In the historic plaster area, the difference of temperature could be caused by the detachment of certain parts of the plaster.

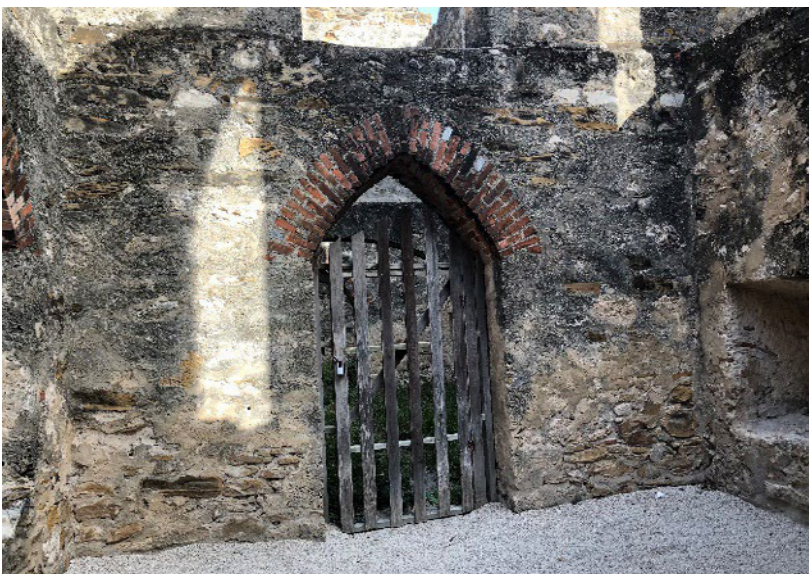
Figure 6.B.104: Room HS 203 B—West wall. Lower level general view, which exhibits biological growth in the upper part and erosion and missing parts in the lower part.

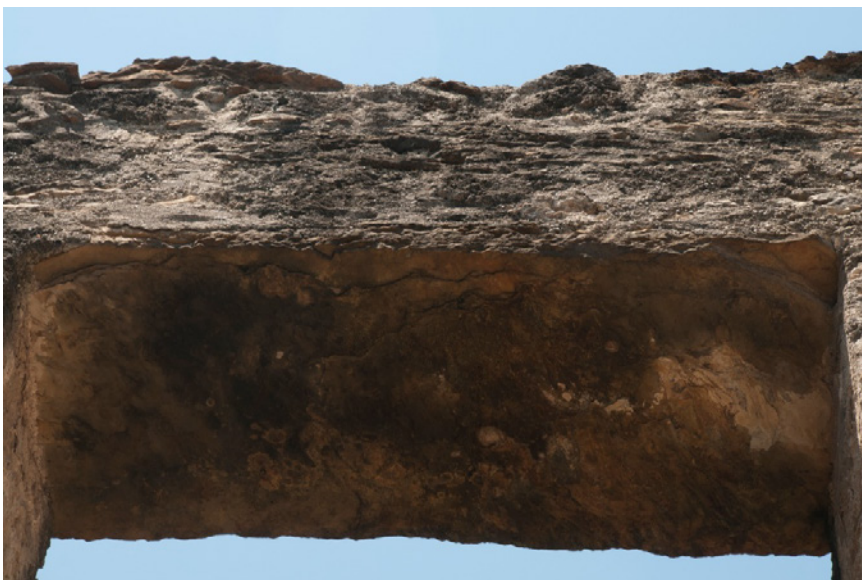
Figure 6.B.105: Room HS 203 B—West wall. Detail of the upper-level door D26 architrave, featuring delamination of the flagstone.

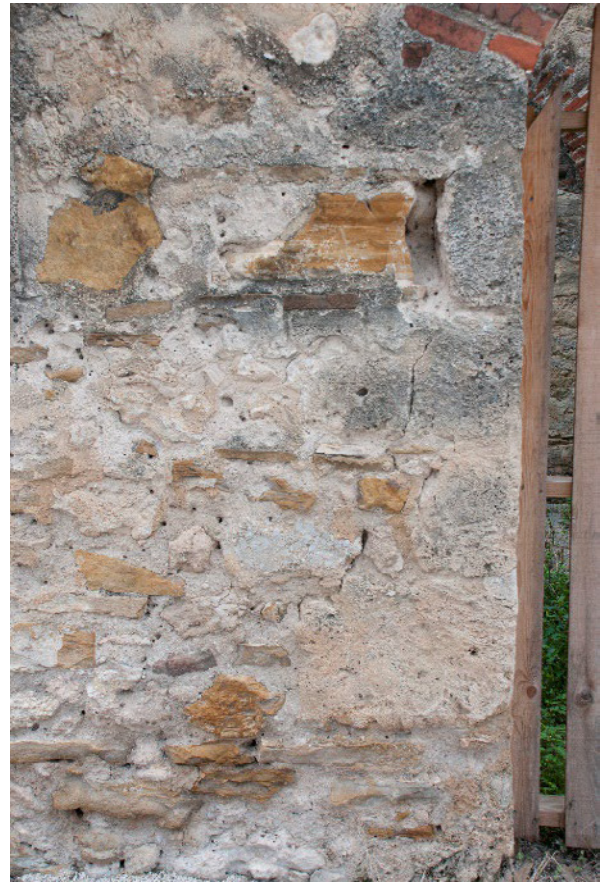
Figure 6.B.115: Room HS 203 E—North wall. Fracture at the ground floor, located left of the second door (D08) staring from the west. Erosion is also occurring at the bottom part of the wall.

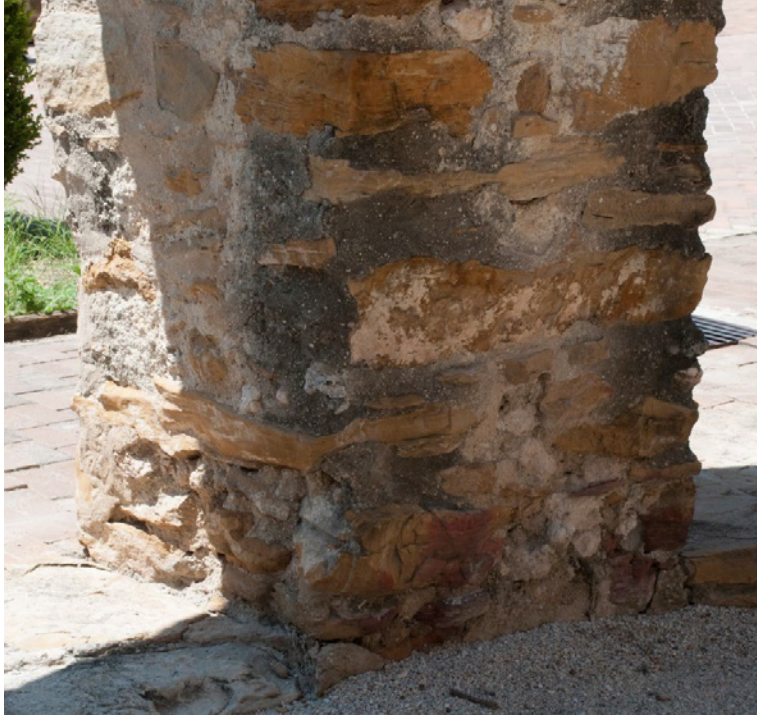
Figure 6.B.129: Room HS 203 E—South wall. Detail of one pillar, which features erosion of the masonry wall and encrustations in the stones.

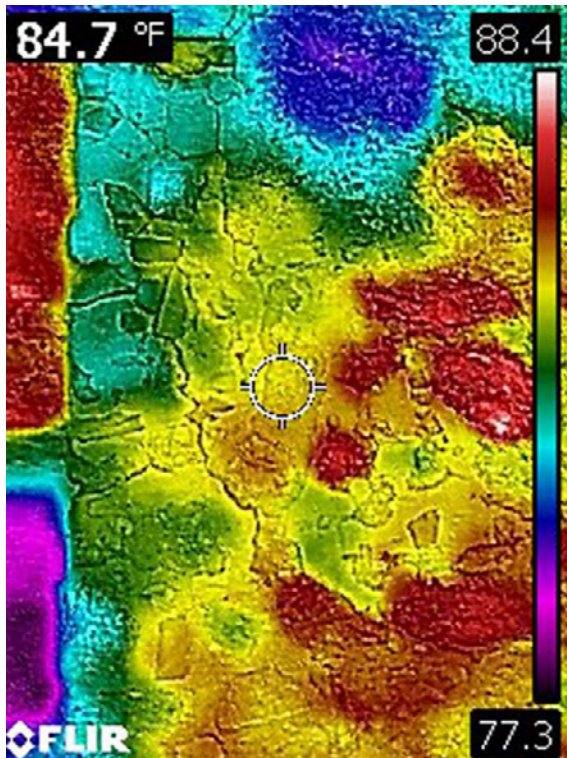
Figure 6.B.155: Room HS 203 H—East wall. Same view of the a detail of the right jamb of door D05 and nearby wall. The differences in temperature are caused by the different construction materials and the presence of humidity. Features a fracture that starts in the upper right corner of the door and develops diagonally downward.

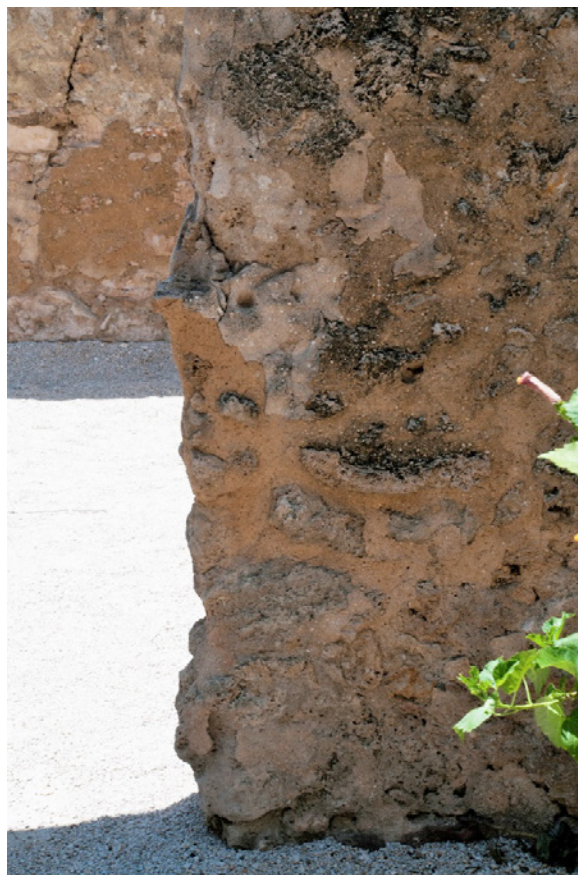
Figure 6.B.159: Room HS 203 H—South wall. Detail of the right jamb of the door D04. Features vegetation growth, different types of visually contrasting mortar patchings and erosion of the wall.

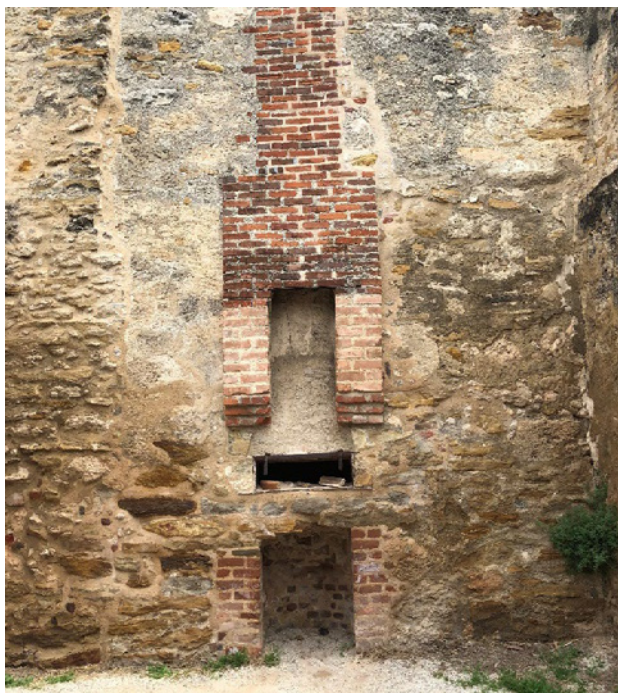
Figure 6.B.160: Room HS 203 K—North wall. General view. Features two filled cracks, one between the south arcade and the wall (left of the photo) and another in the right side of the chimney.

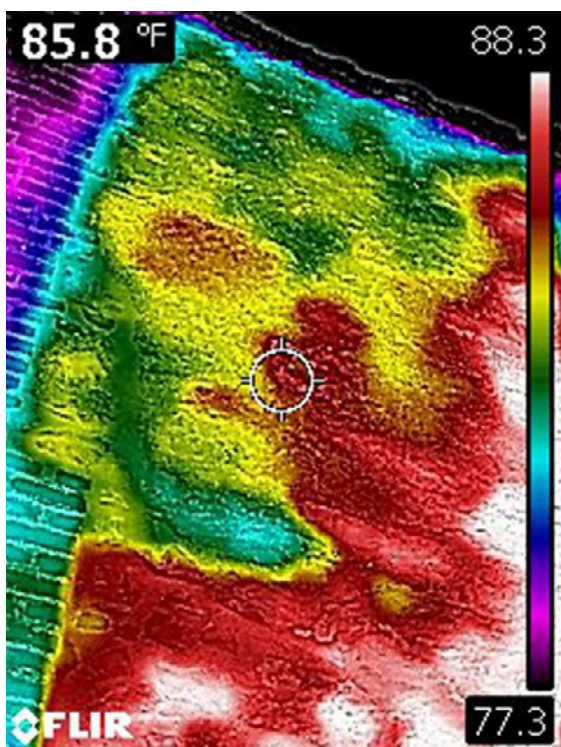
Figures 6.B.162 and 6.B.163: Room HS 203 H—North wall. Same view of the right part of the wall. The differences in temperature are caused by the different construction materials, the presence of humidity and the presence of the flue inside the chimney.

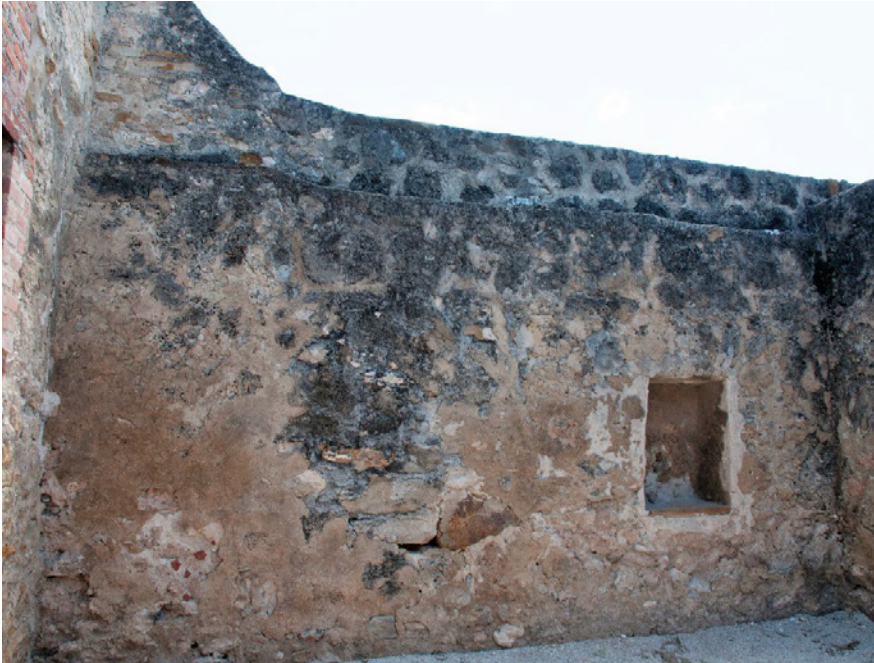
Figure 6.B.166: Room HS 203 K—East wall. General view. Exhibits erosion both in the higher and lower areas of the wall, numerous holes and visually disturbing mortar patchings.

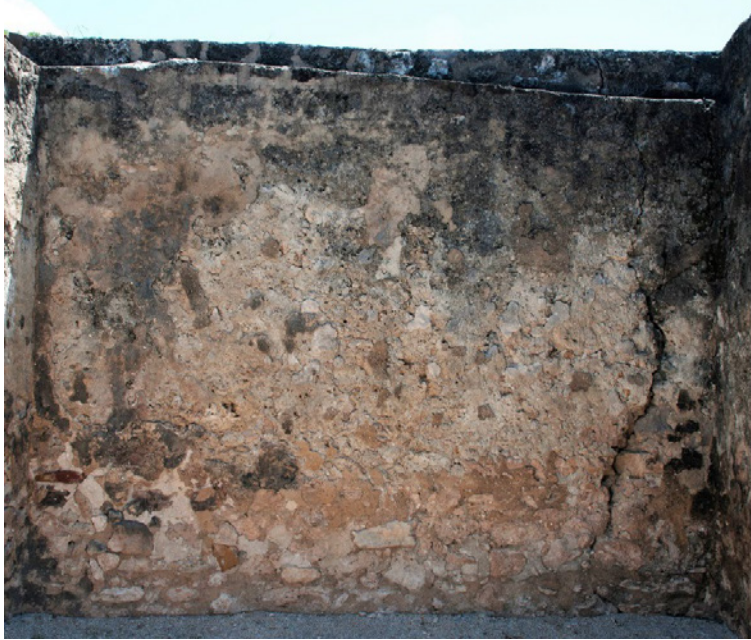
Figure 6.B.179: Room HS 203 R—East wall. General view. Exhibits a big fracture, biological growth in the upper part, erosion and roughly executed patching.

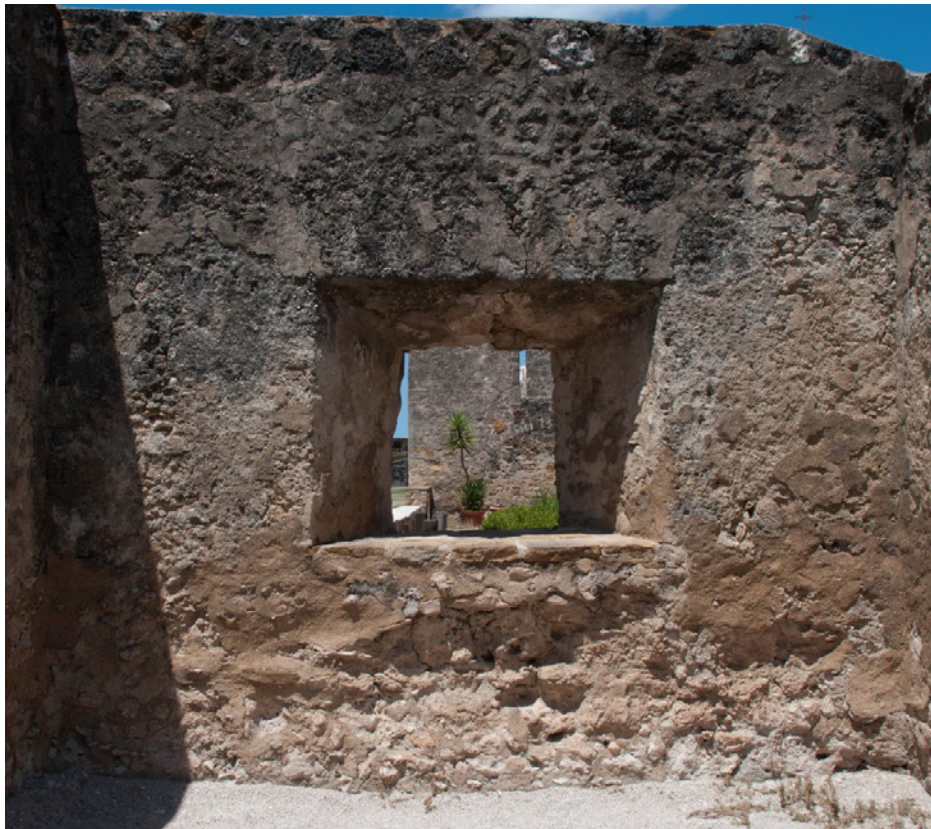
Figure 6.188: Room HS 203 R—West wall. General view. Features severe erosion below the window W03, biological growth in the upper part of the wall and cracks in the architrave of the window.

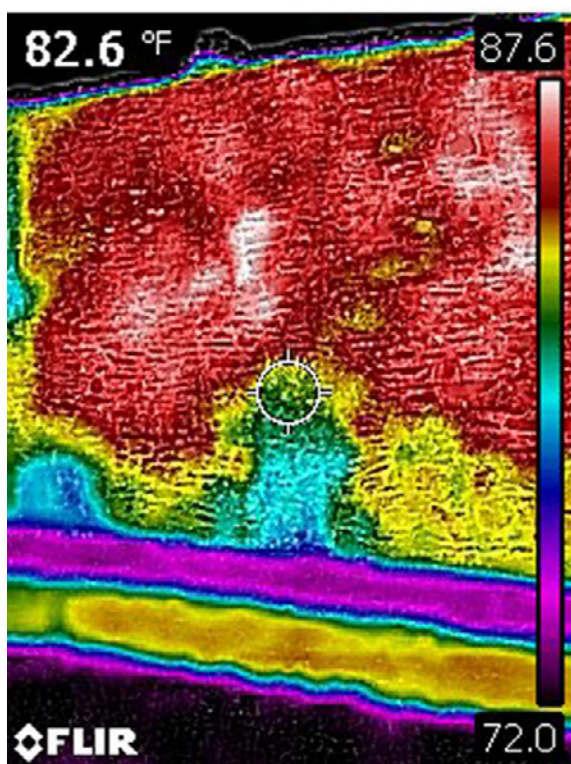
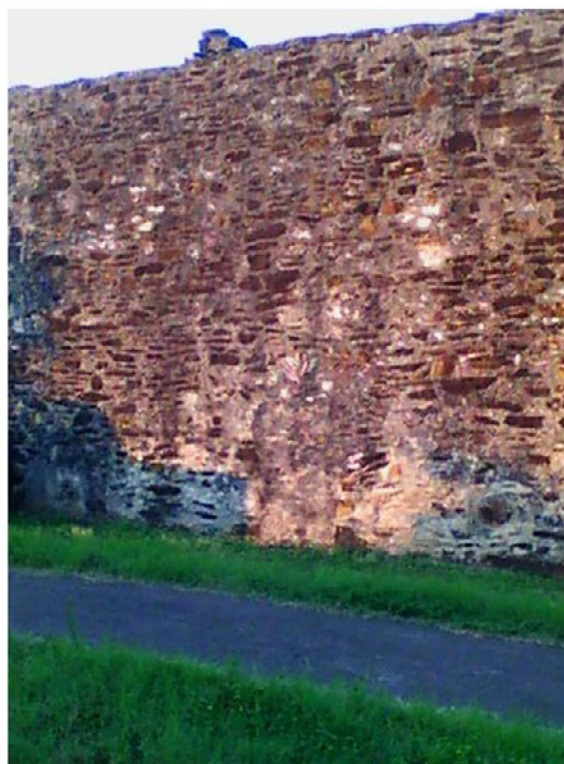
Figure 6.B.198 and 6.B.199: Exterior walls—North wall. Area corresponding to the 203 D room. The differences in temperature are caused by the different construction materials and moisture content of the wall. The right light blue area correspond with a filled door D01 and the left light blue area could be due to the presence of a niche N01 in the other side of the wall.

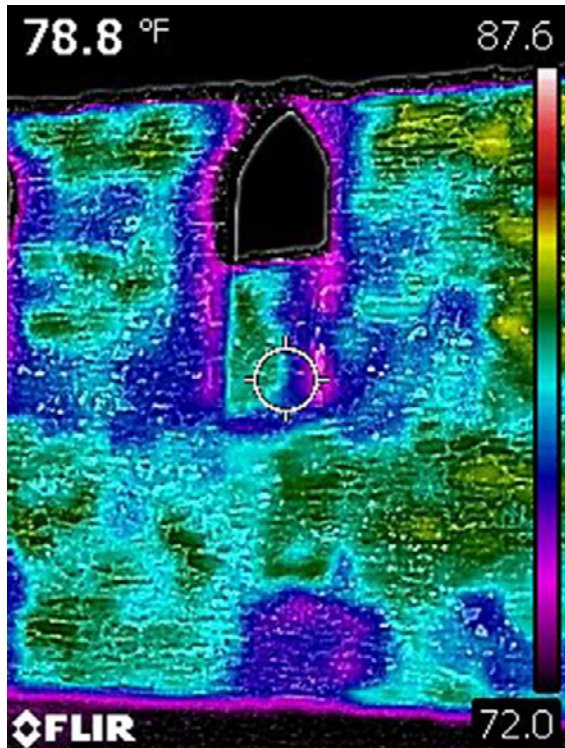
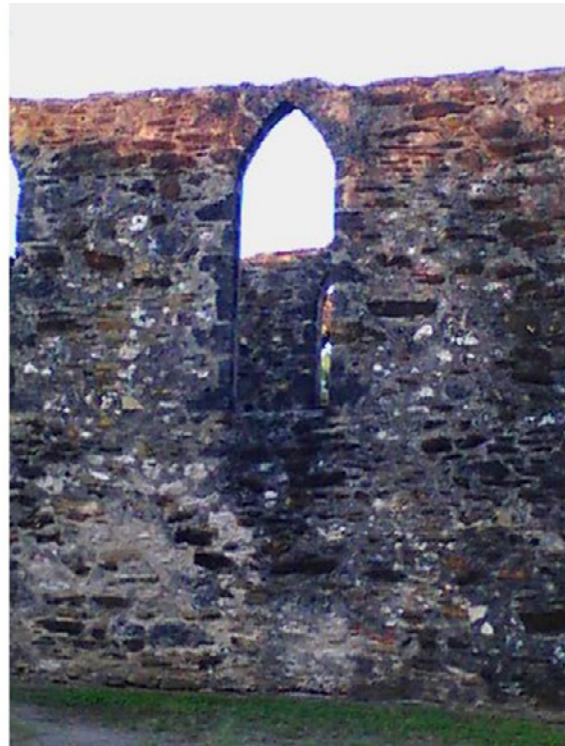
Figure 6.B.202 and 6.B.203: Exterior walls – North wall. Area corresponding to the 203 C room. The differences in temperature are caused by the different construction materials and moisture content. The left dark blue area could be caused by the presence of a niche N02 in the other side of the wall.

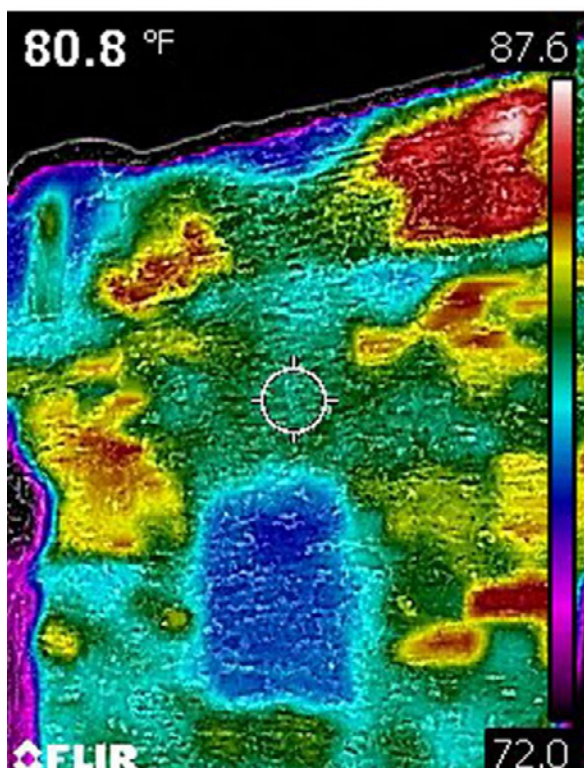
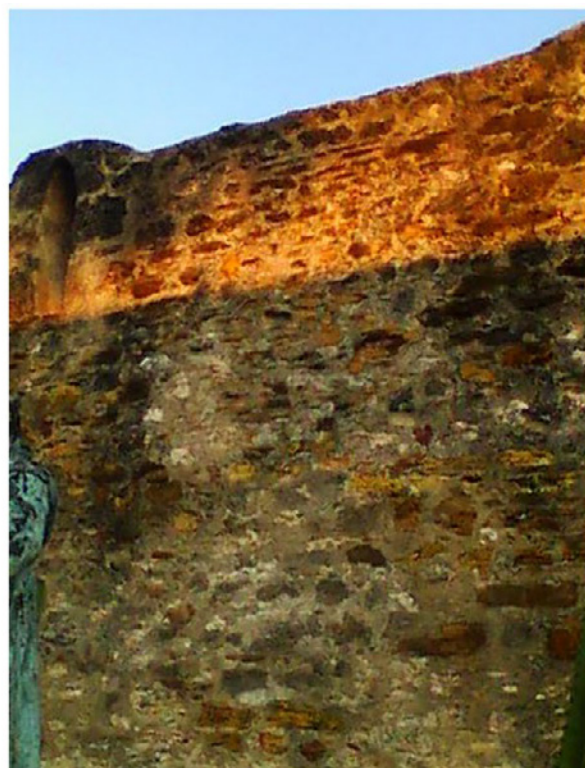
Figures 6.B.209 and 6.B.210: Exterior walls—East wall. Area corresponding to the 203 P room. The differences in temperature are caused by the different construction materials and moisture content. The dark blue area in the middle of the picture is due to the presence of the oven in the other side of the wall.

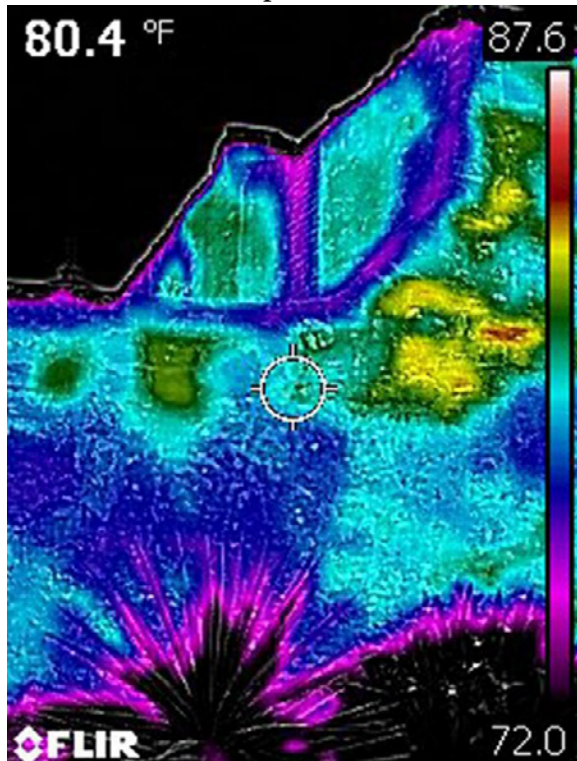
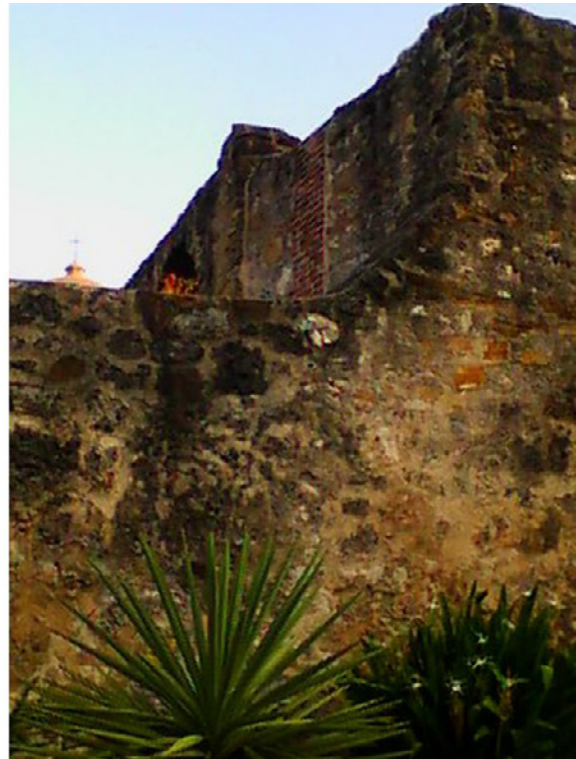
Figures 6.B.211 and 6.B.212: Exterior walls—East wall. Area corresponding to the 203 K room. The differences in temperature are caused by the different construction materials and moisture content.

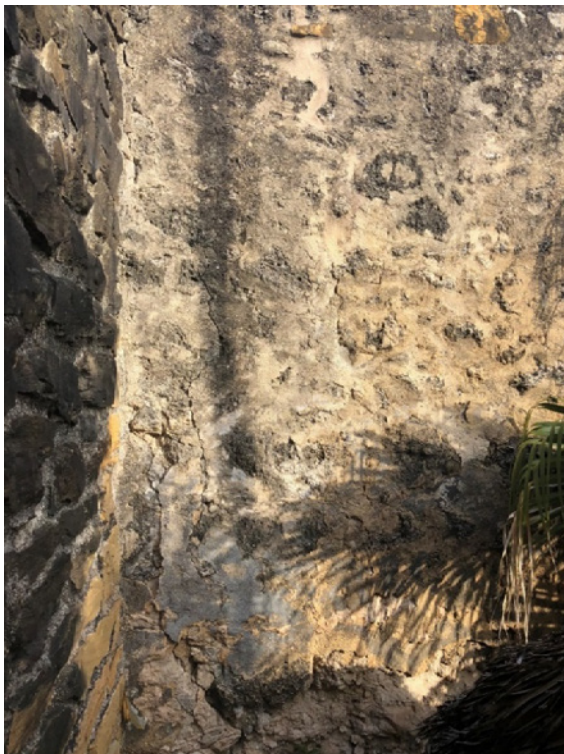
Figure 6.B.213: Exterior walls—East wall. South corner. Detail of the deep fracture, also visible from the inside.

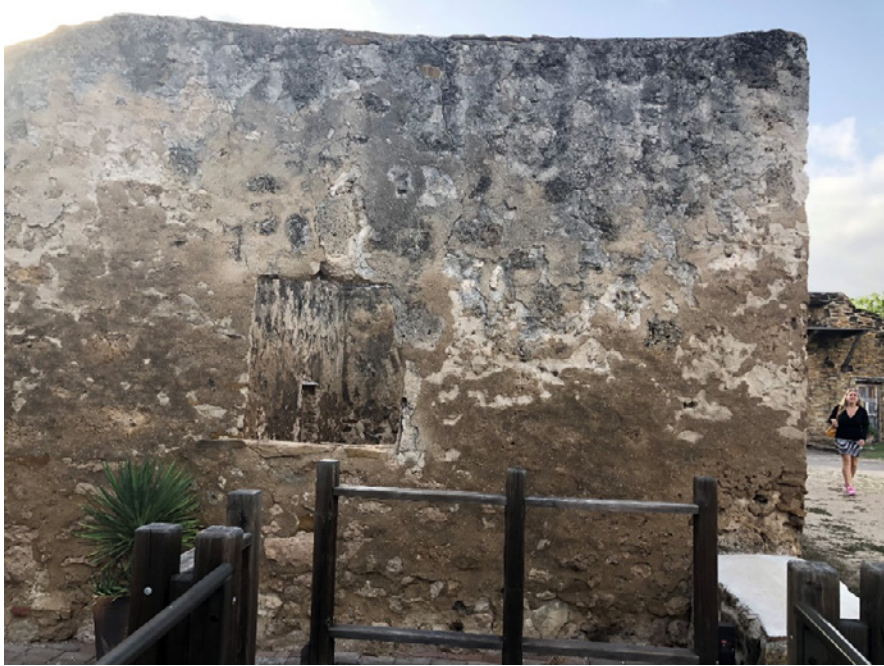
Figure 6..B.224: Exterior walls—West wall. Area corresponding to room 203 R. General view. Features vegetation growth in the upper part, multiple cracks near the window and detachment of edges of the visually contrasting patching.

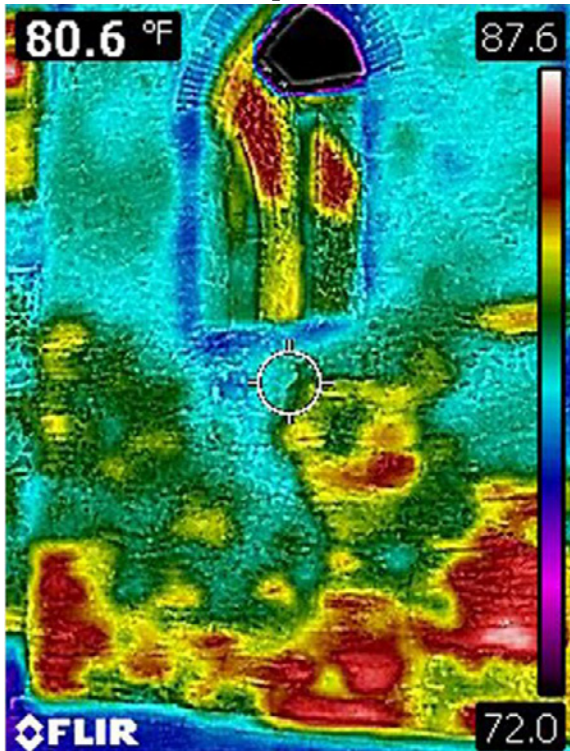
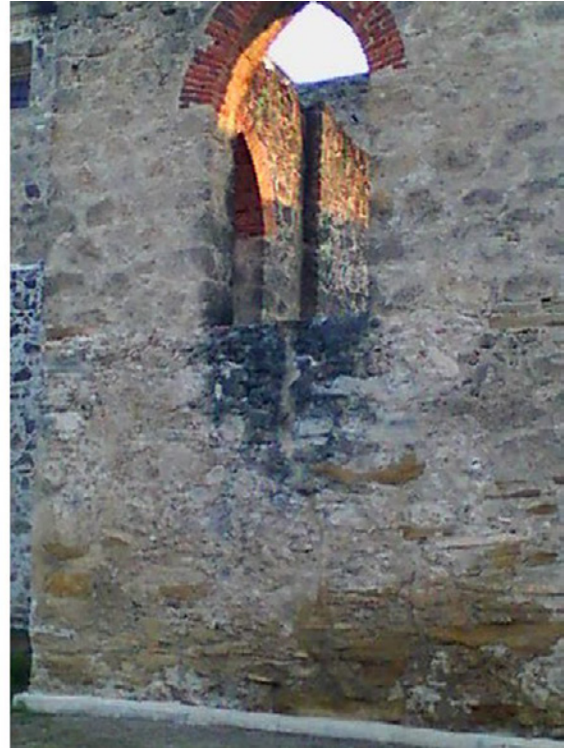
Figure 6.B.236 and 6.B.237: Exterior walls—South wall. Area corresponding to the 203 S room. The differences in temperature are caused by the different construction materials and moisture content.

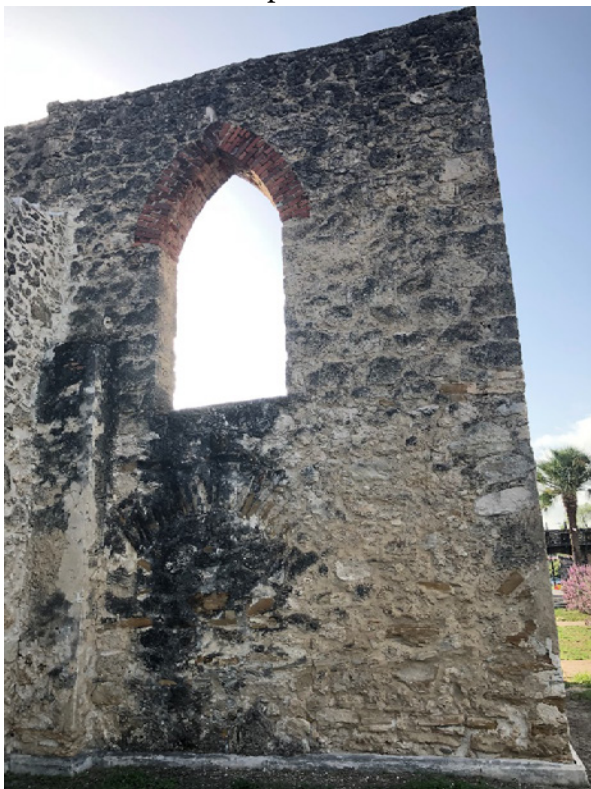
Figure 6.B.244: Exterior walls—West wall. General view. Features an accumulation of vegetation growth in the upper part and in the area below the window.

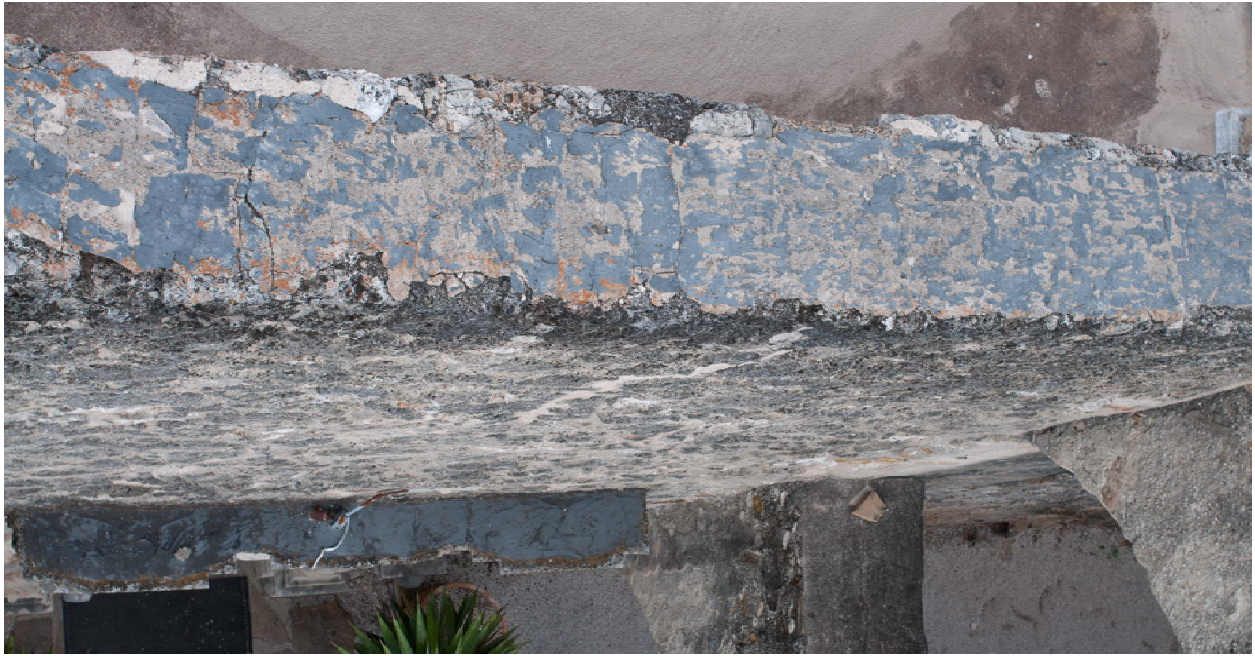
Figure 6.B.245: 203 S—West wall, disintegrating capping, with loss of material on the edges. Fragmented waterproof layer. This photo shows four cracks.

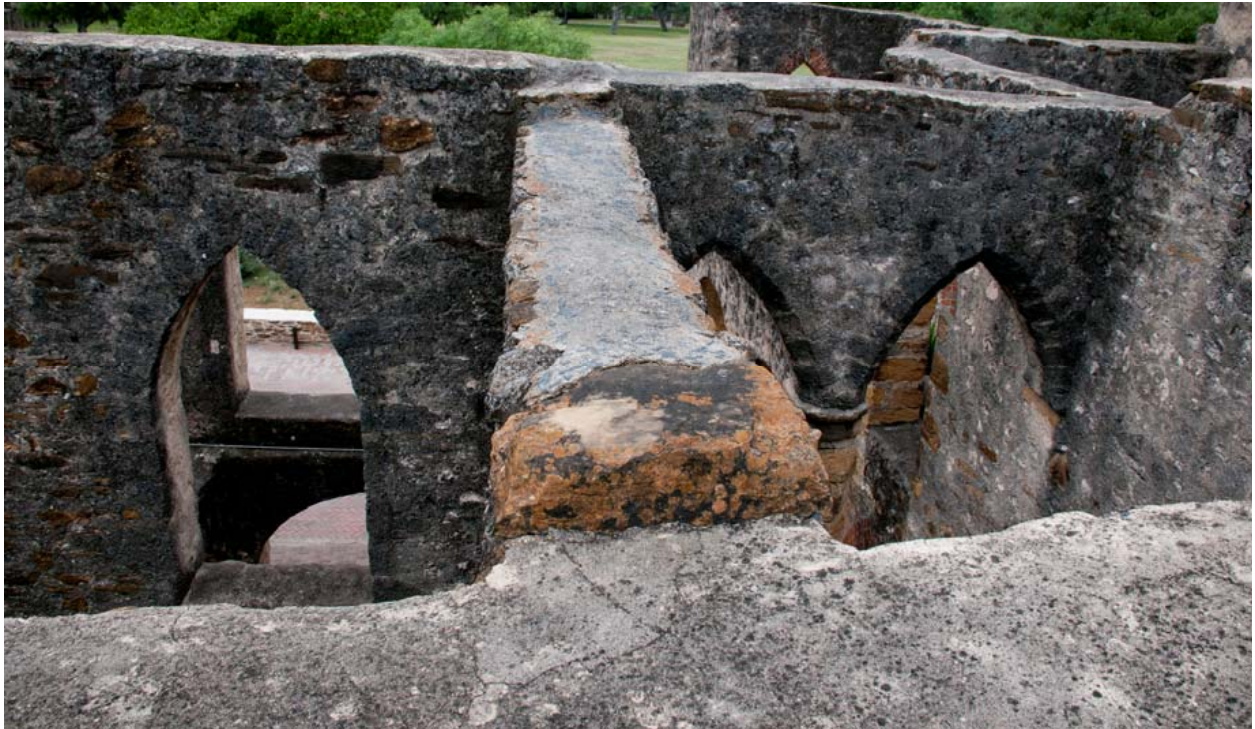
Figure 6.B.246: Wall between 203 A and 203 D—Disintegrating capping with detachment of the edges.

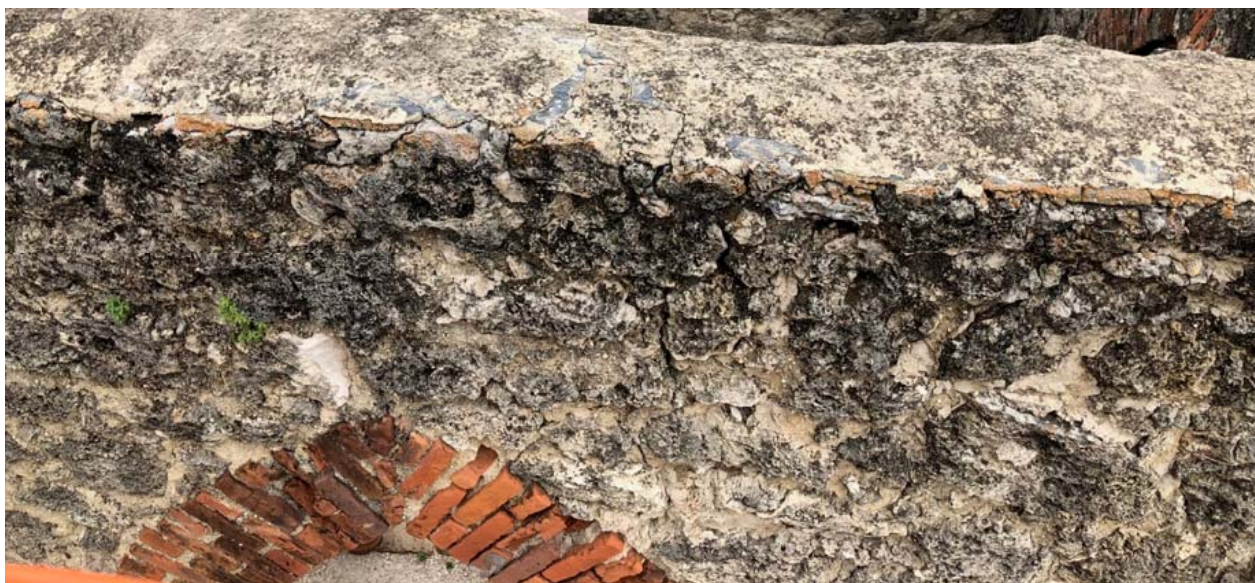
Figure 6.B.247: 203 S—West wall, exterior façade. Disintegrating edges, with associated detachment, and three cracks extended to the vertical wall.
