National Park Service  
United States Department of the Interior  
San Antonio Missions National Historical Park  
Texas

# Historic Structure Report Mission San José Convento

Final Submission  
2019

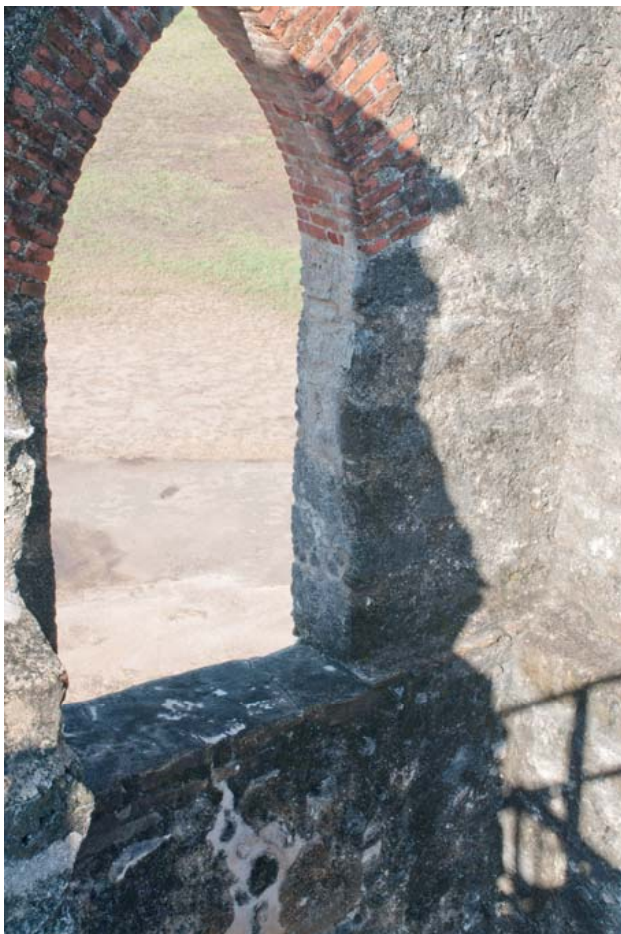
Figure 6.B.249: 203 S—South wall, featuring several cracks. There is evidence of a large filled area.

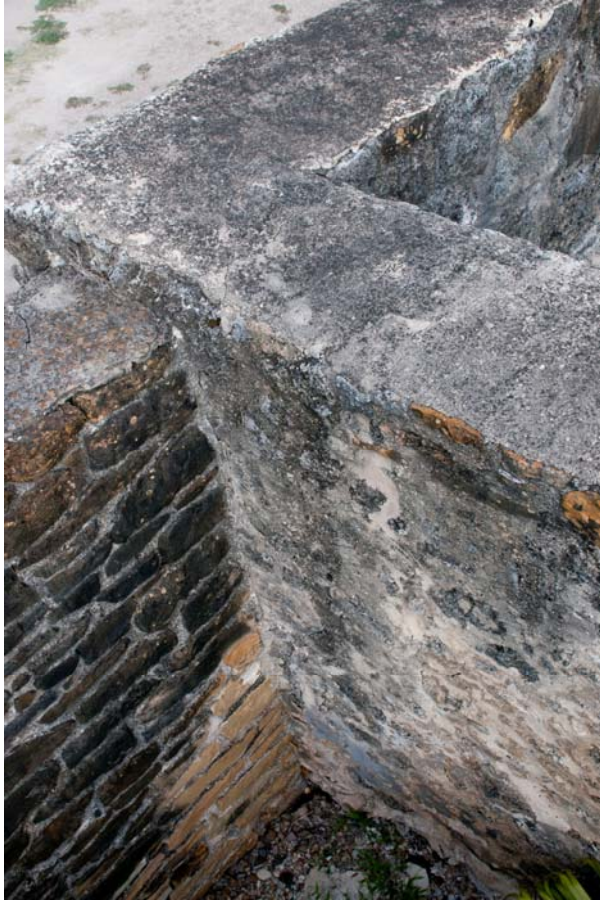
Figure 6.B.260: 203 R—East wall. View of the exterior side of the west wall. Close to the corner, the coping exhibits two cracks, continuing on the exterior wall as a sub-vertical crack.

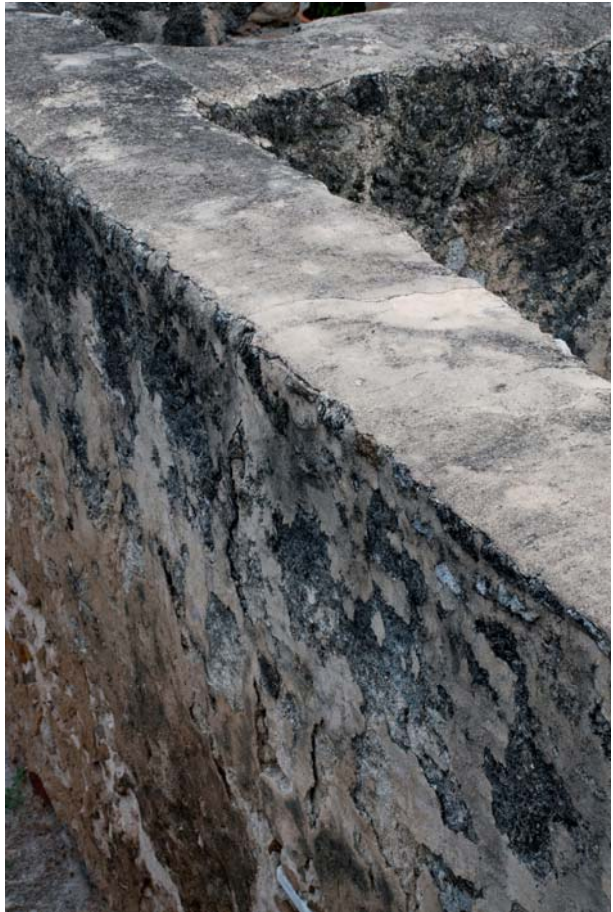
Figure 6.B.261: 203 R—South wall. Coping and wall fracture, located in the area where the interior niche is located.

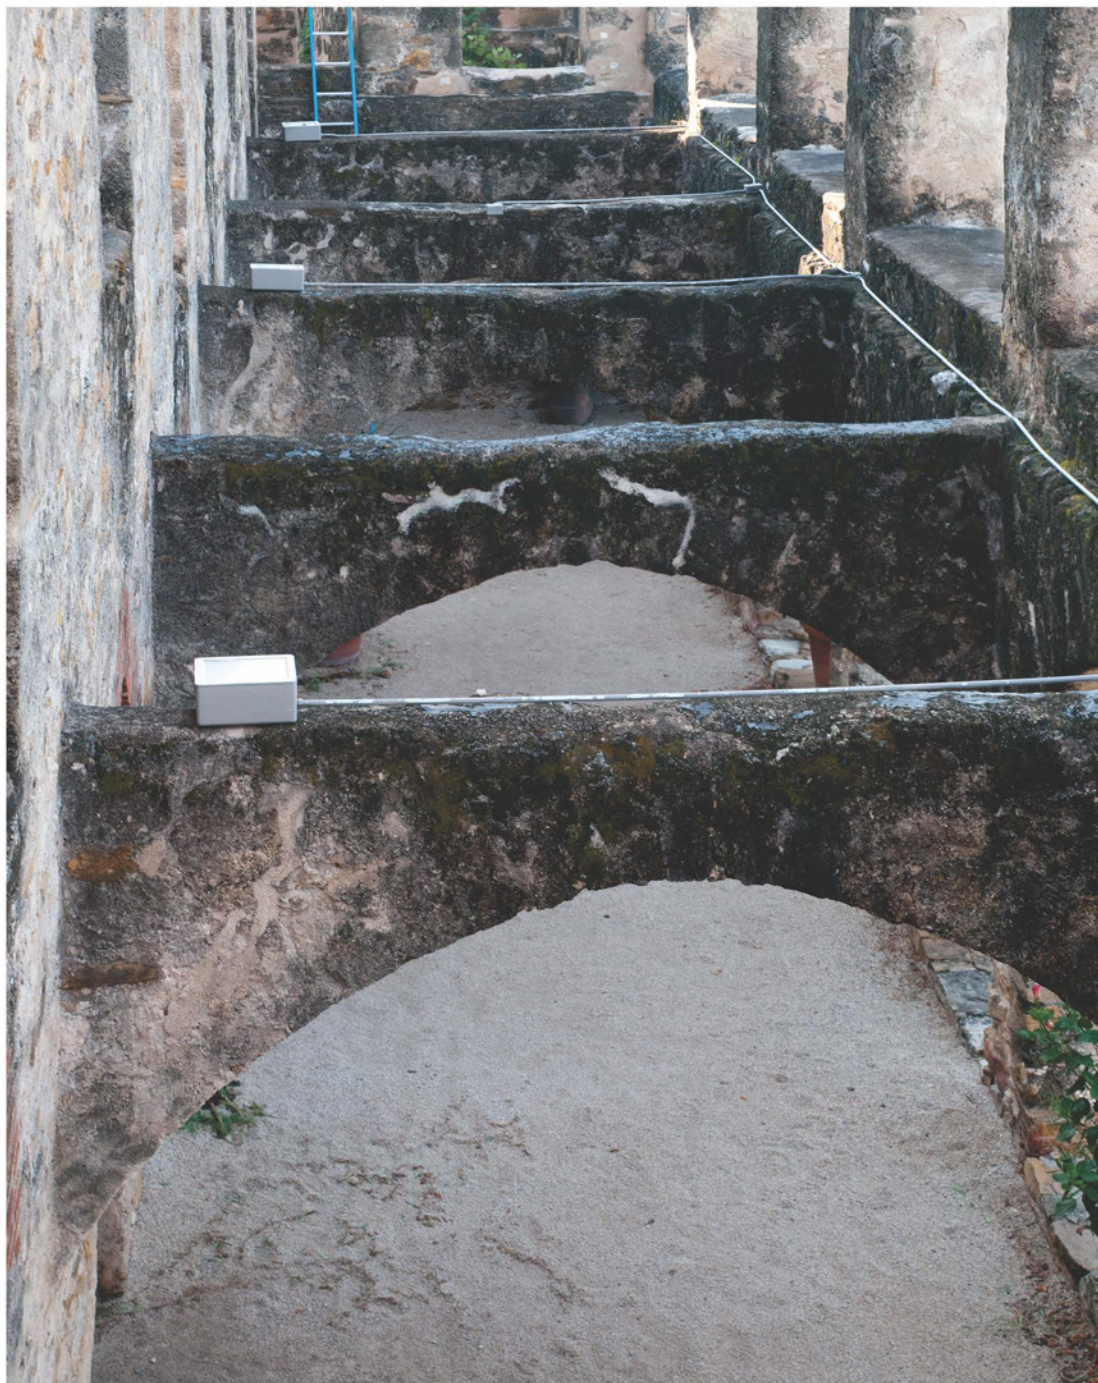
Figure 6.B.262: Room 203 E— Transverse arches. View from toward the east wing. The transverse arches feature an area with higher level of disintegration of the thin coping.
