# MISSION CONCEPTION

ARCHEOLOGICAL COMPLETION REPORT SERIES, NUMBER 5

Archeological Completion Report Series, Number 5  
Division of Grants  
Office of Archeology and Historic Preservation  
National Park Service  
Department of the Interior  
Washington, D. C.  
1975

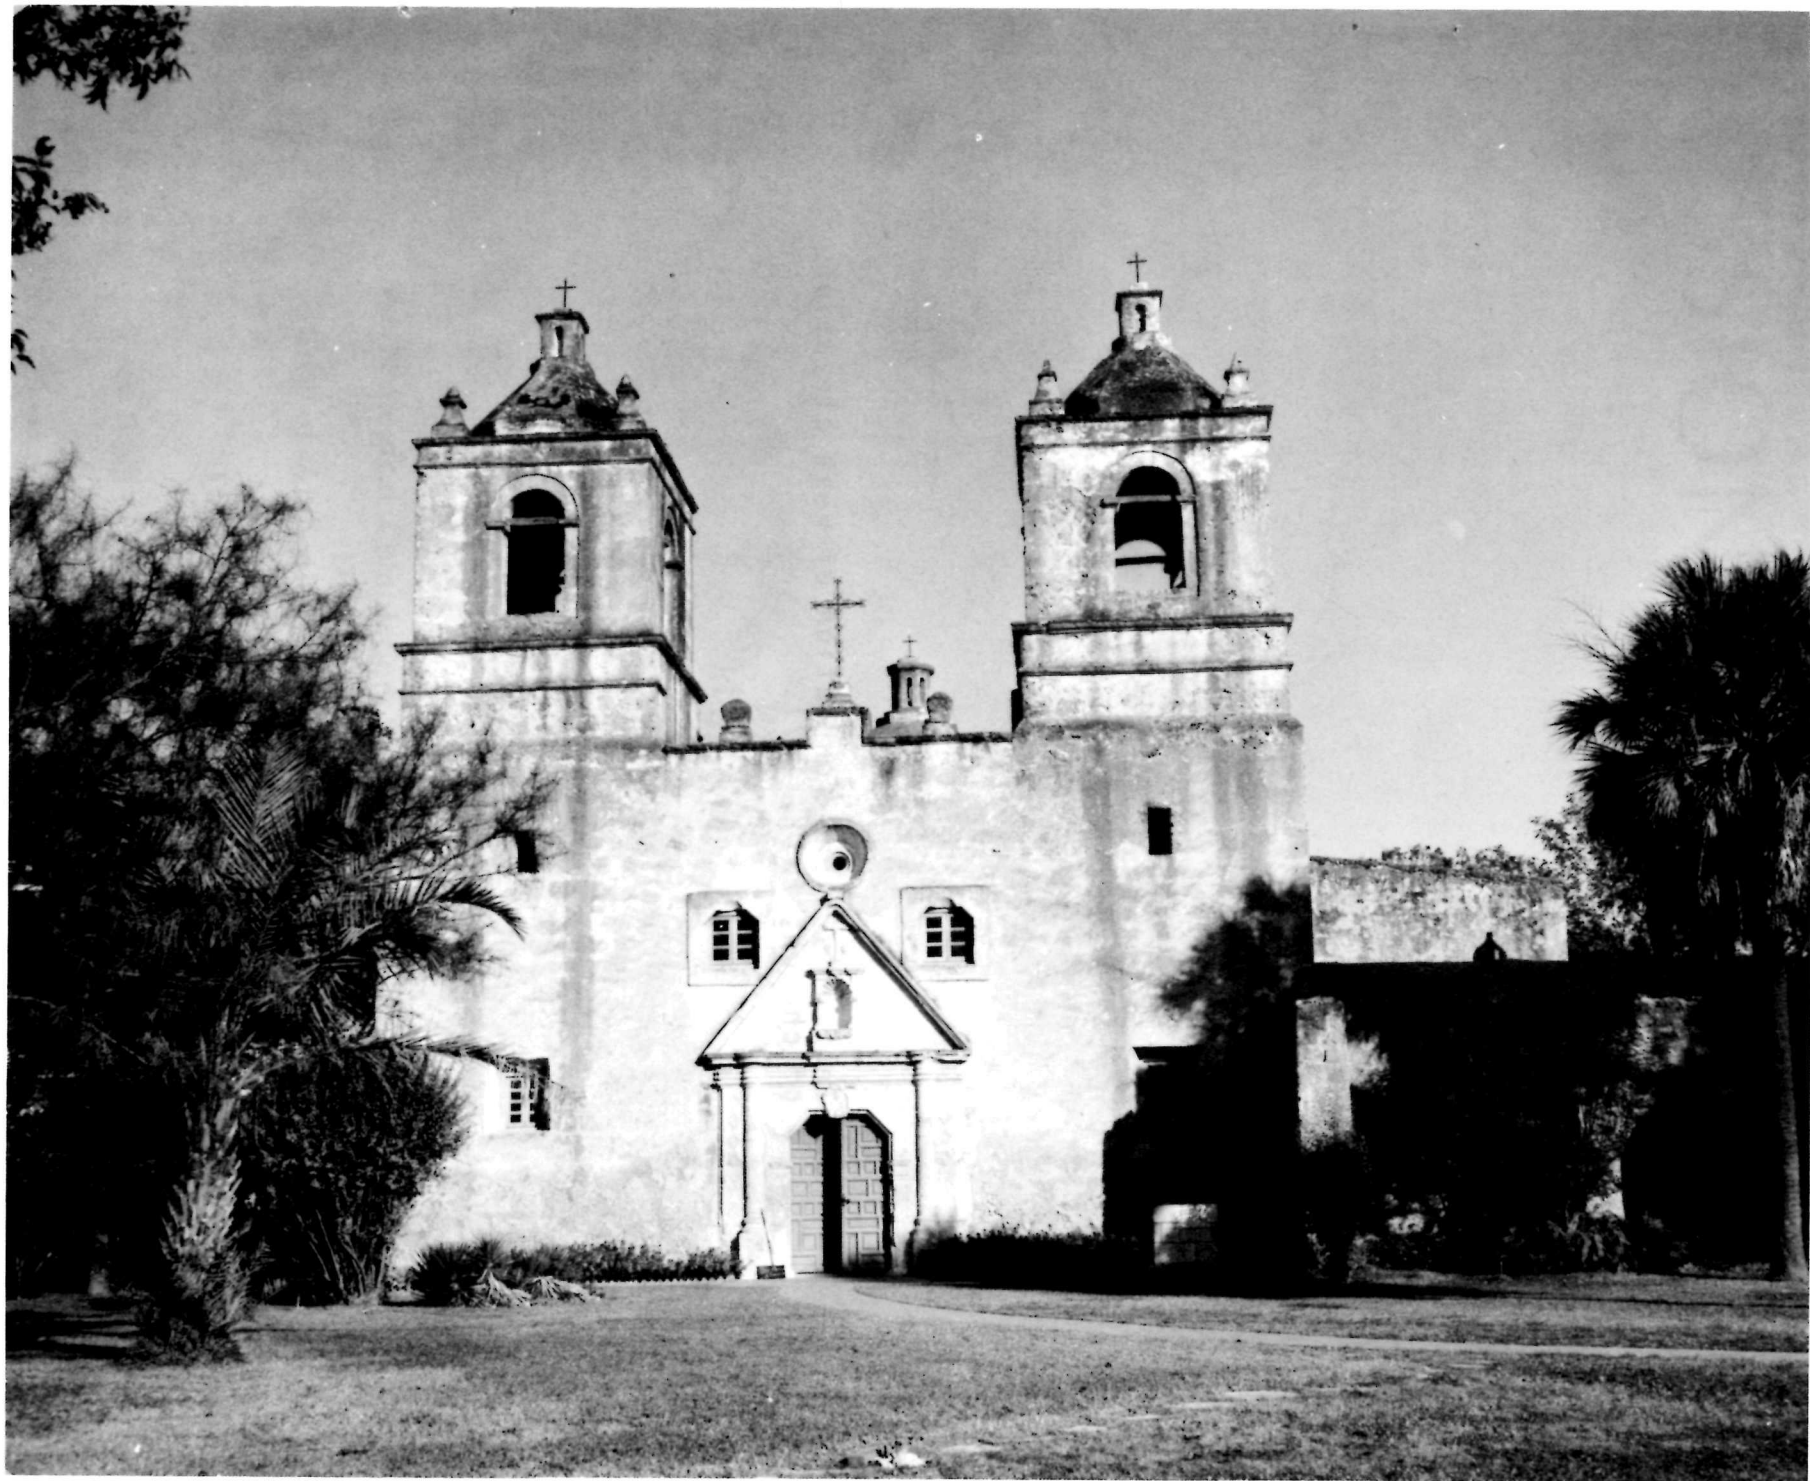
2. Deep tests along the foundation of the west elevation of the church; these tests indicated that the lower portion of the foundations are dry and the moisture which is damaging the facade is originating primarily from surface water applied to plants along the base of the wall.

1. West elevation of church prior to Fall, 1971, excavations. Note: Deterioration of lower portion of wall.

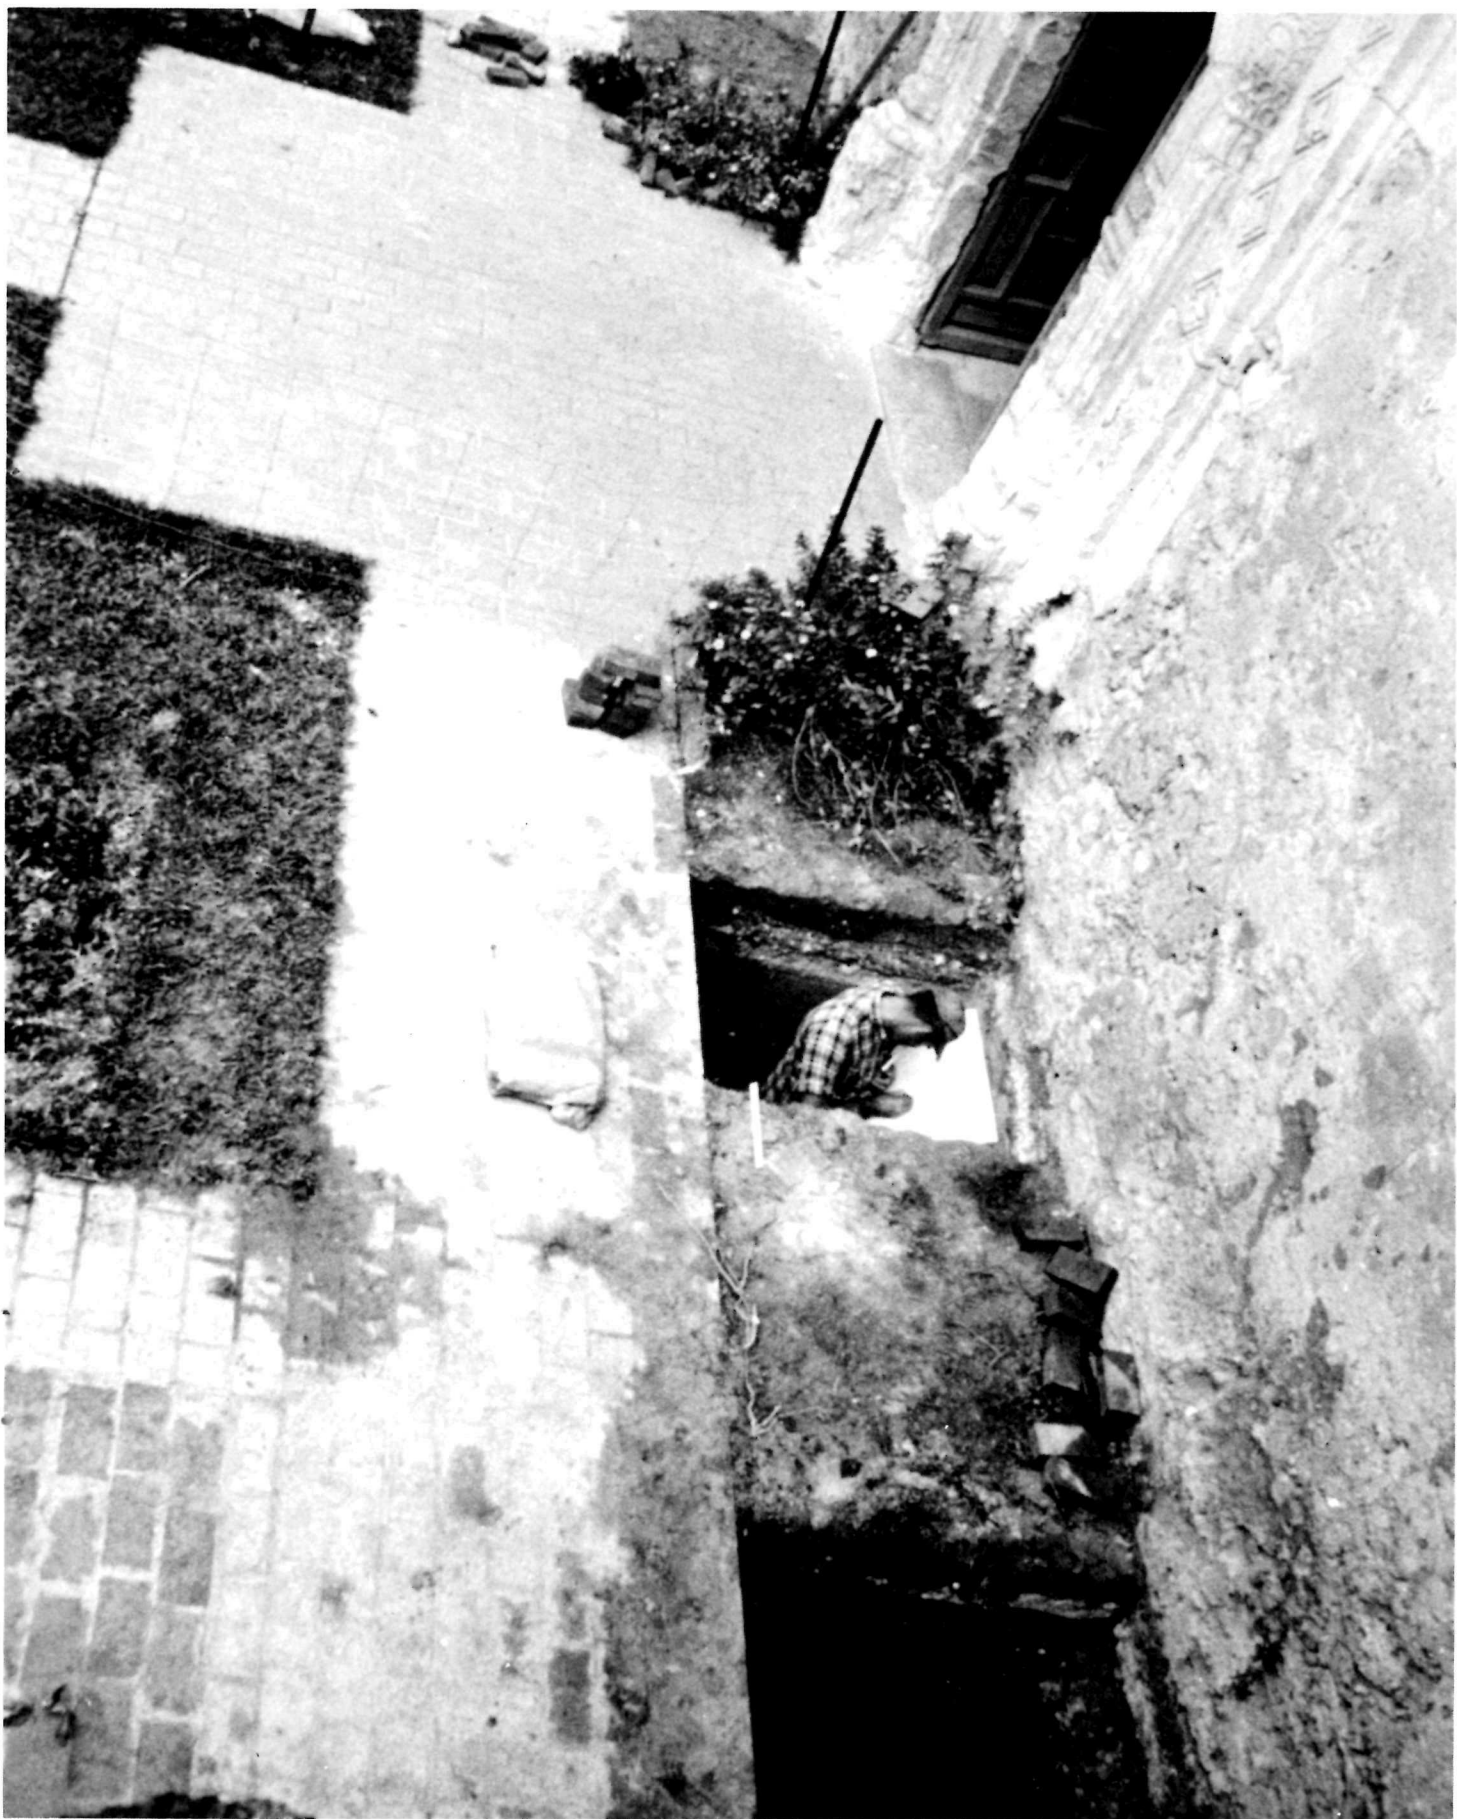
2. Test pits along foundation of west elevation of church, Fall, 1971.

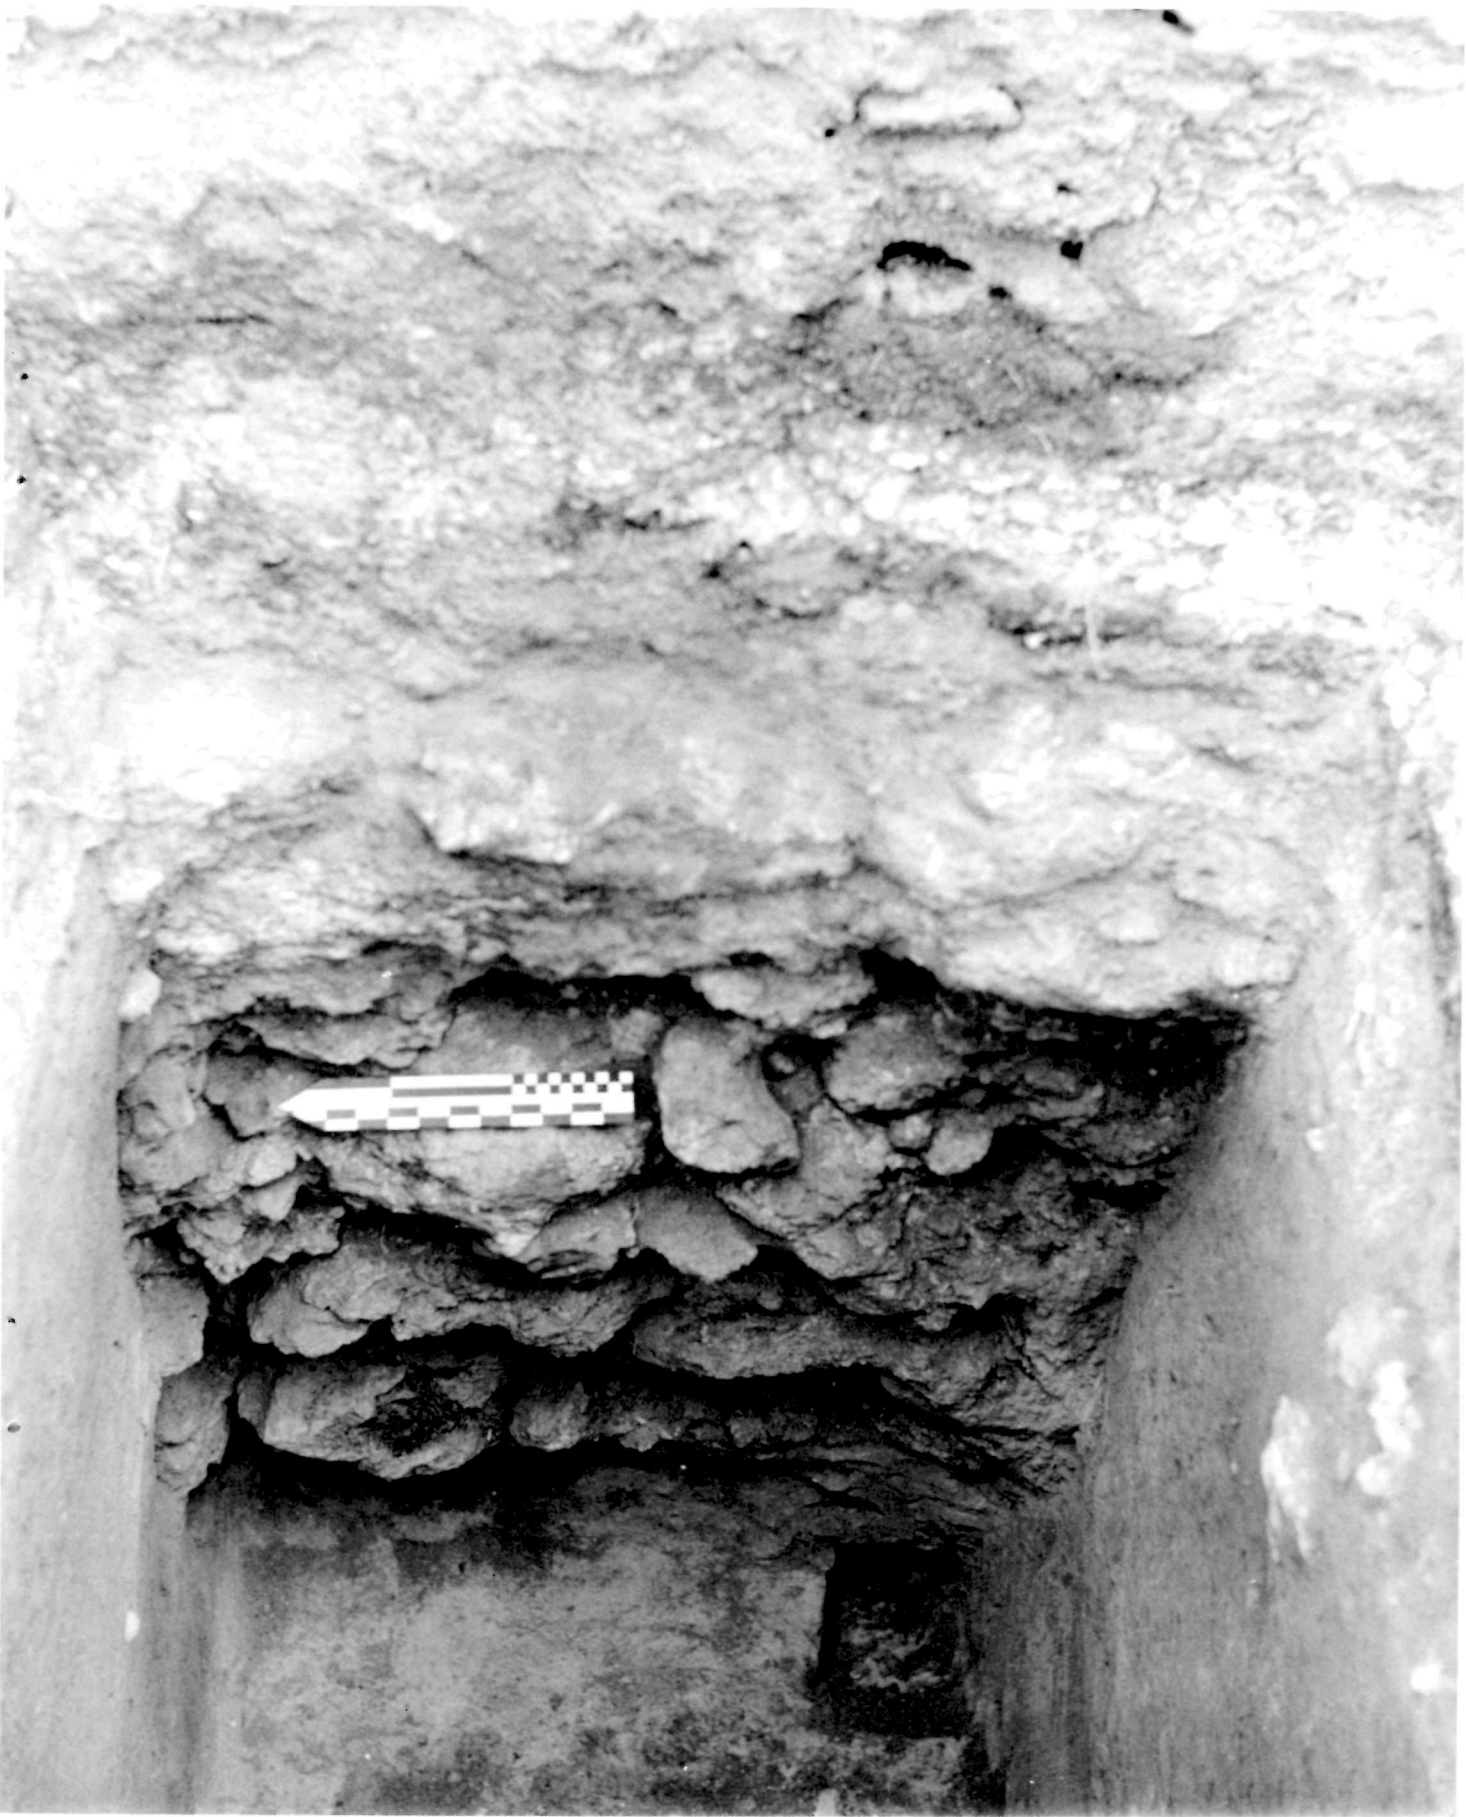
3. Tests along other portions of the church foundation indicated that it is consistently well-laid, sound and essentially dry.
4. Excavation of portions of the ruins near the current entrance to the site produced information on wall foundations, multiple adobe floors, and showed clearly the damage done to archeological remains by the many decorative and exotic plants which have been put into the site in recent years.

3. Exposed foundation on wall of west elevation of church, Fall, 1971.

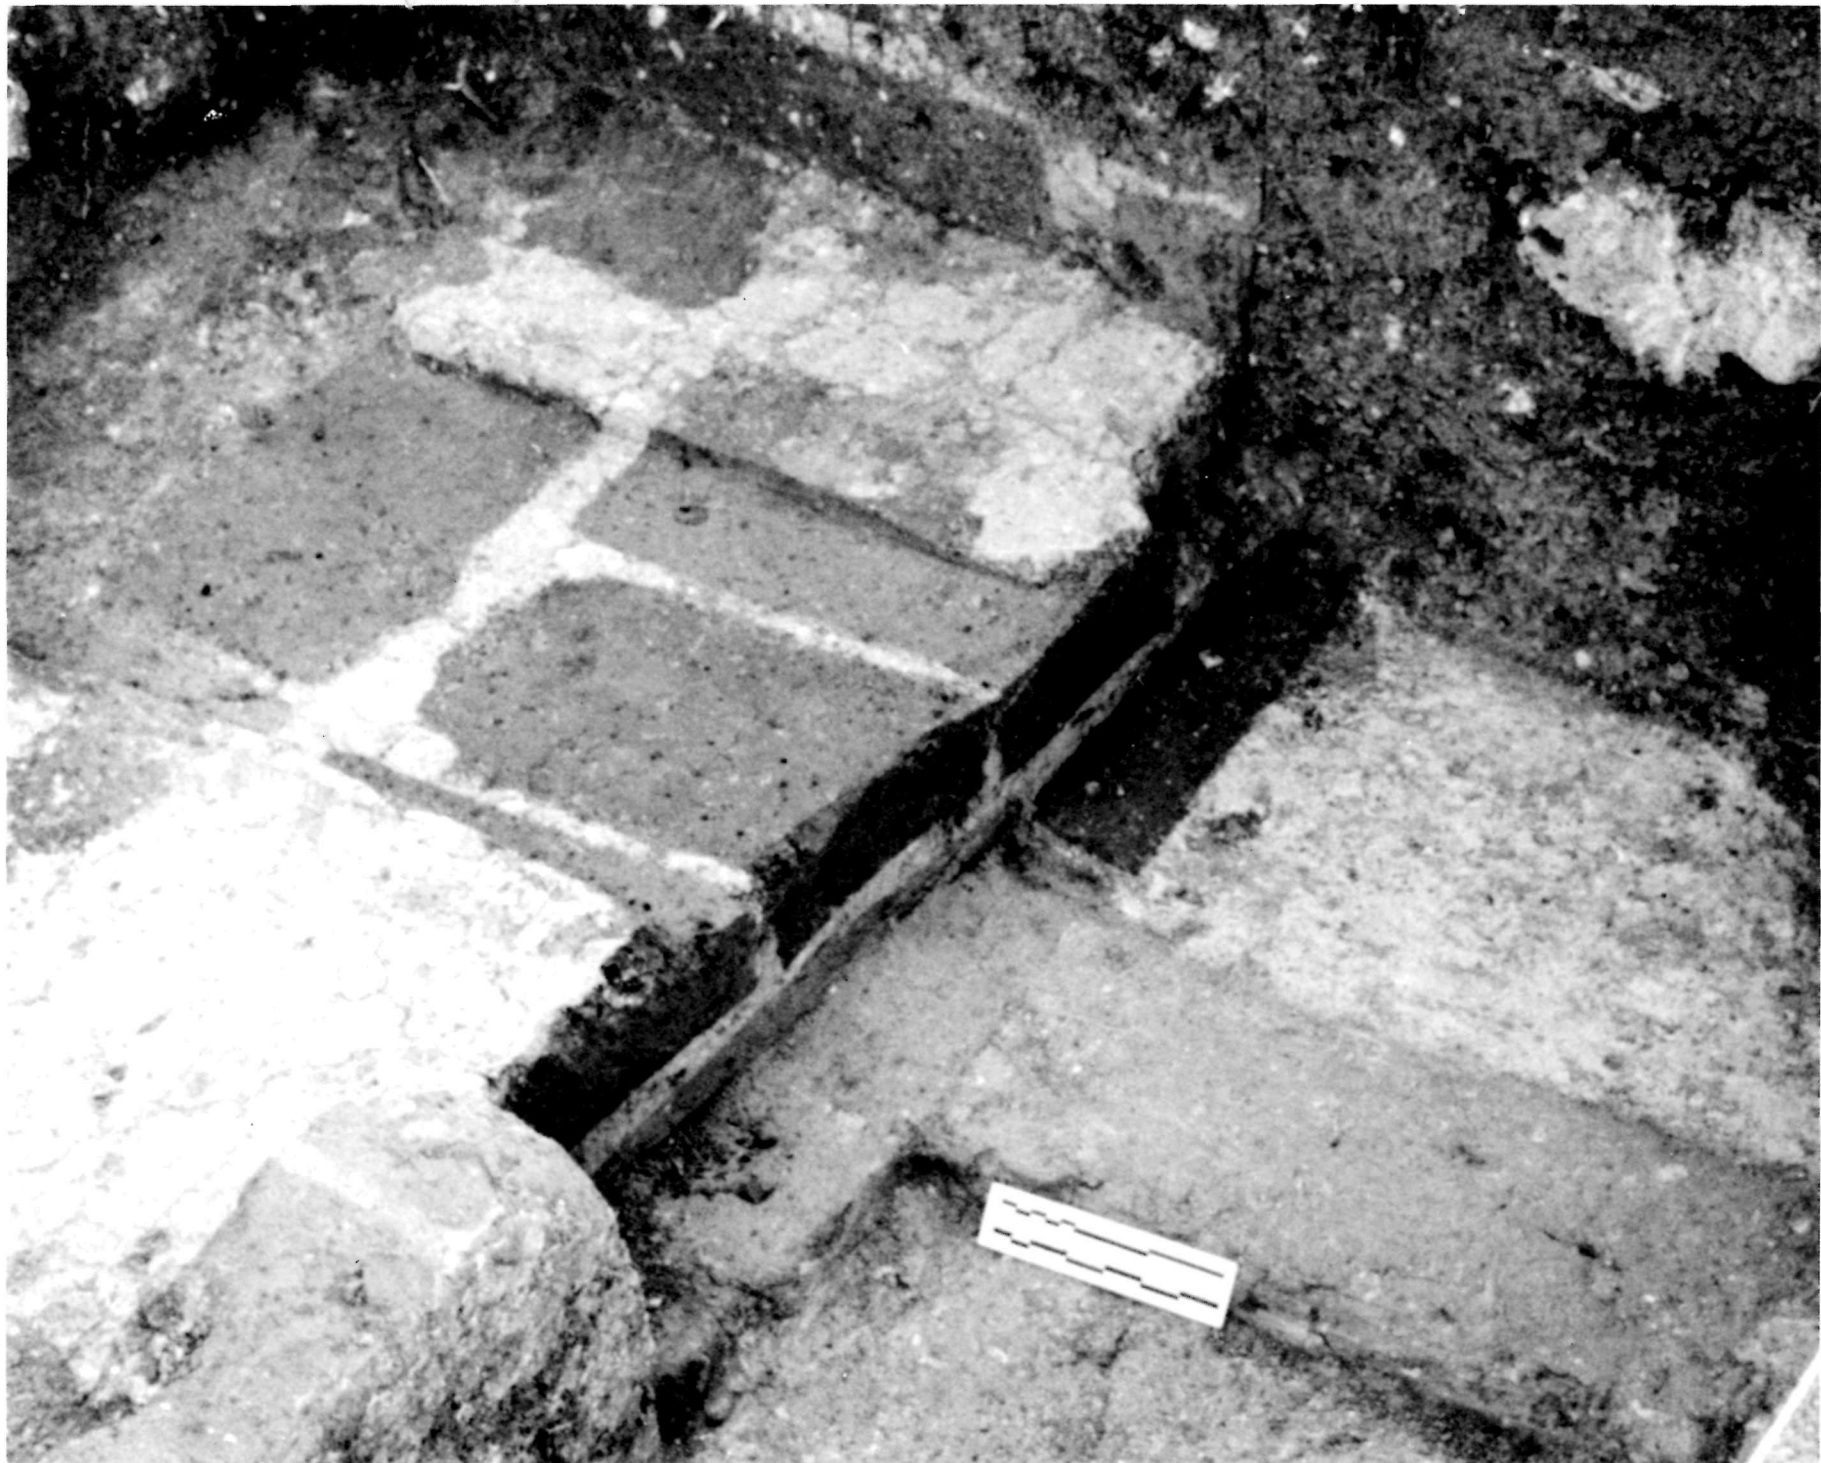
4. Plaster floors and adobe brick walls excavated in ruin adjacent to present day office, Fall, 1971.

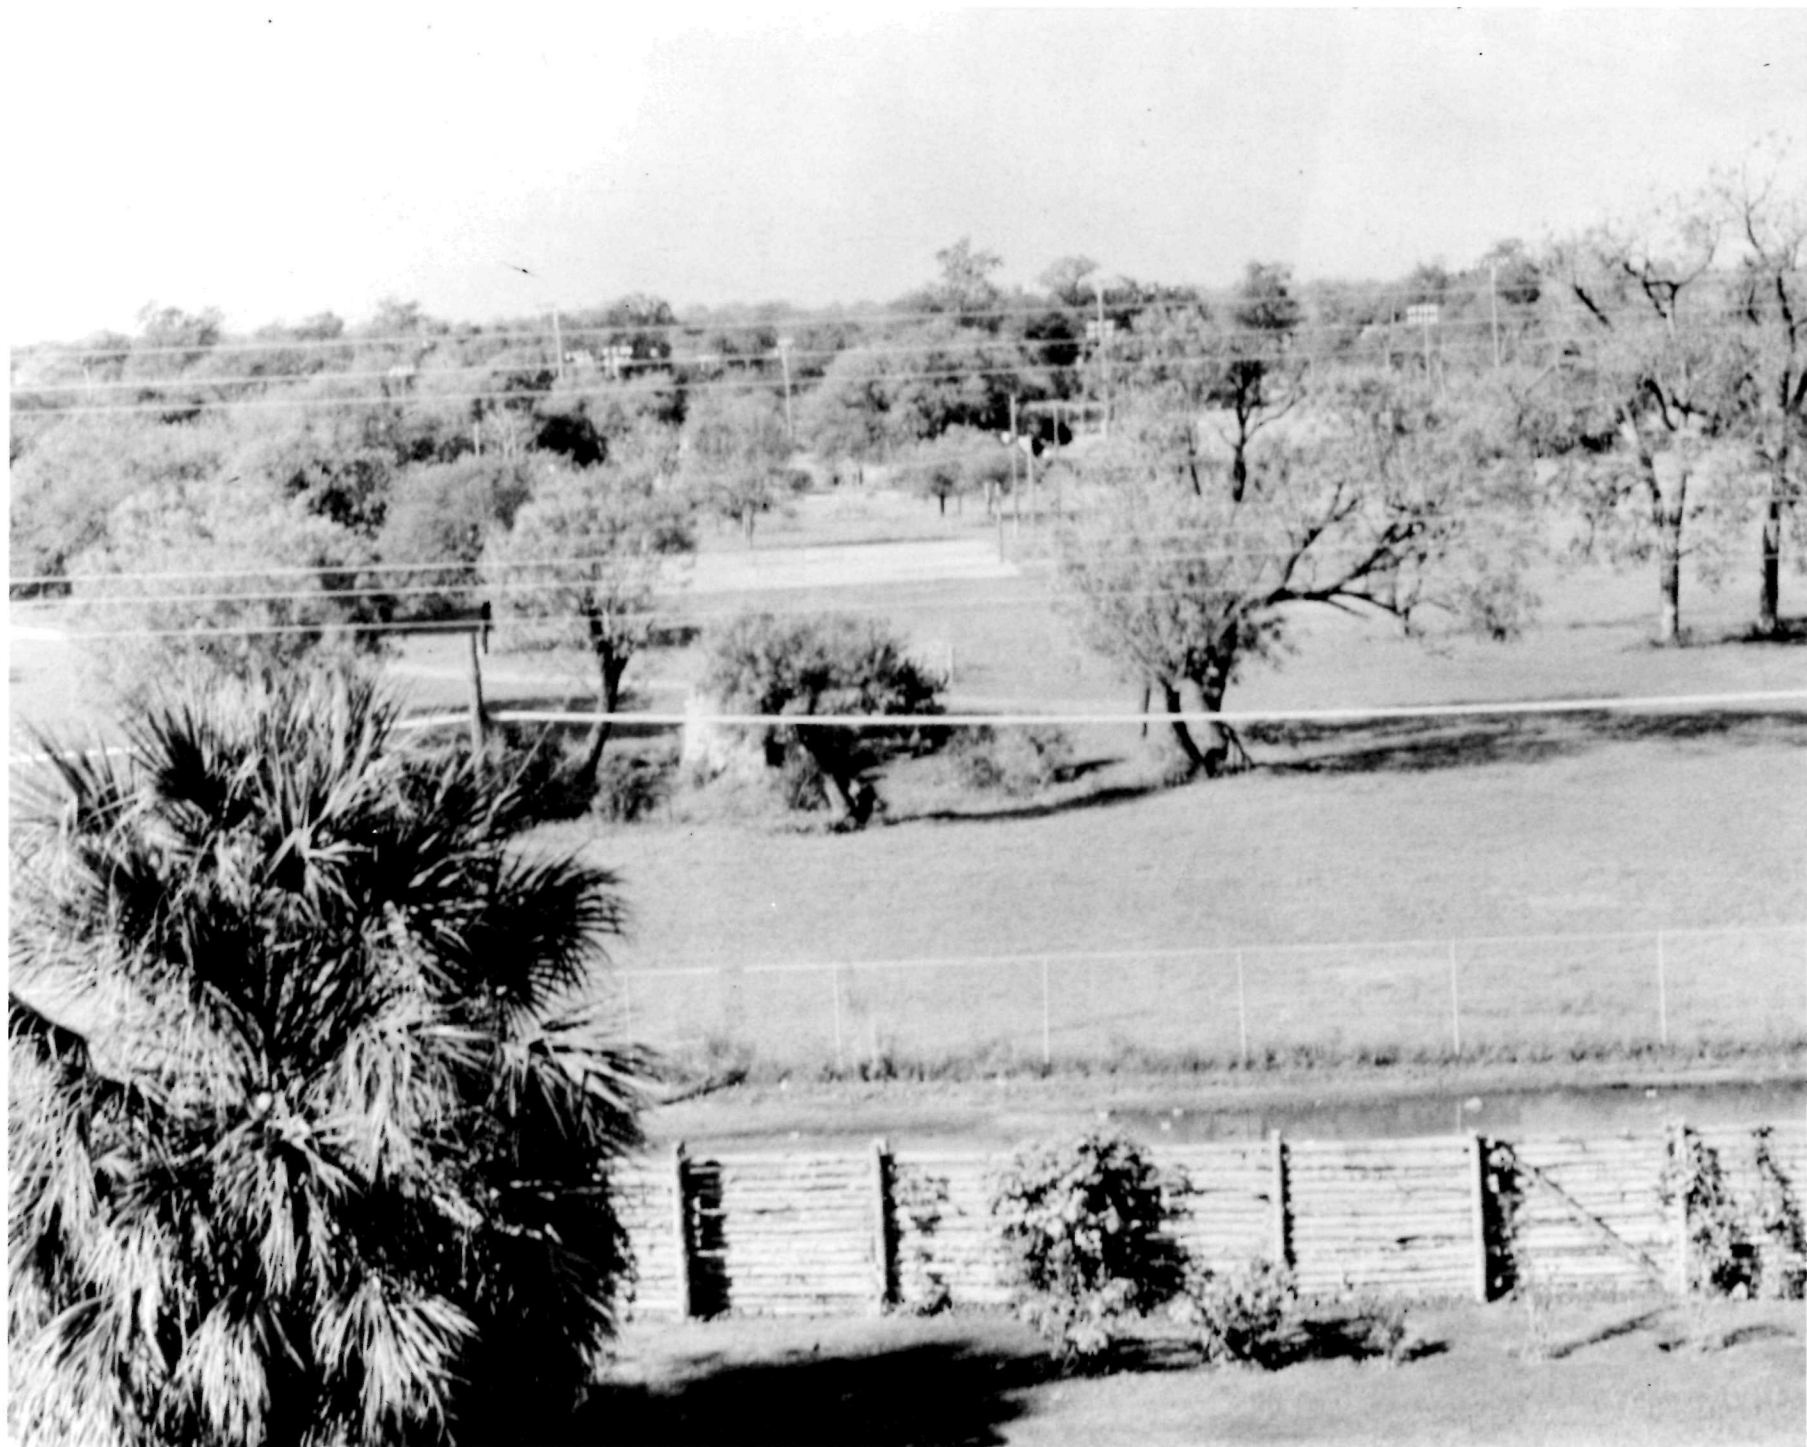
5. West compound-quarry area prior to Fall, 1971.

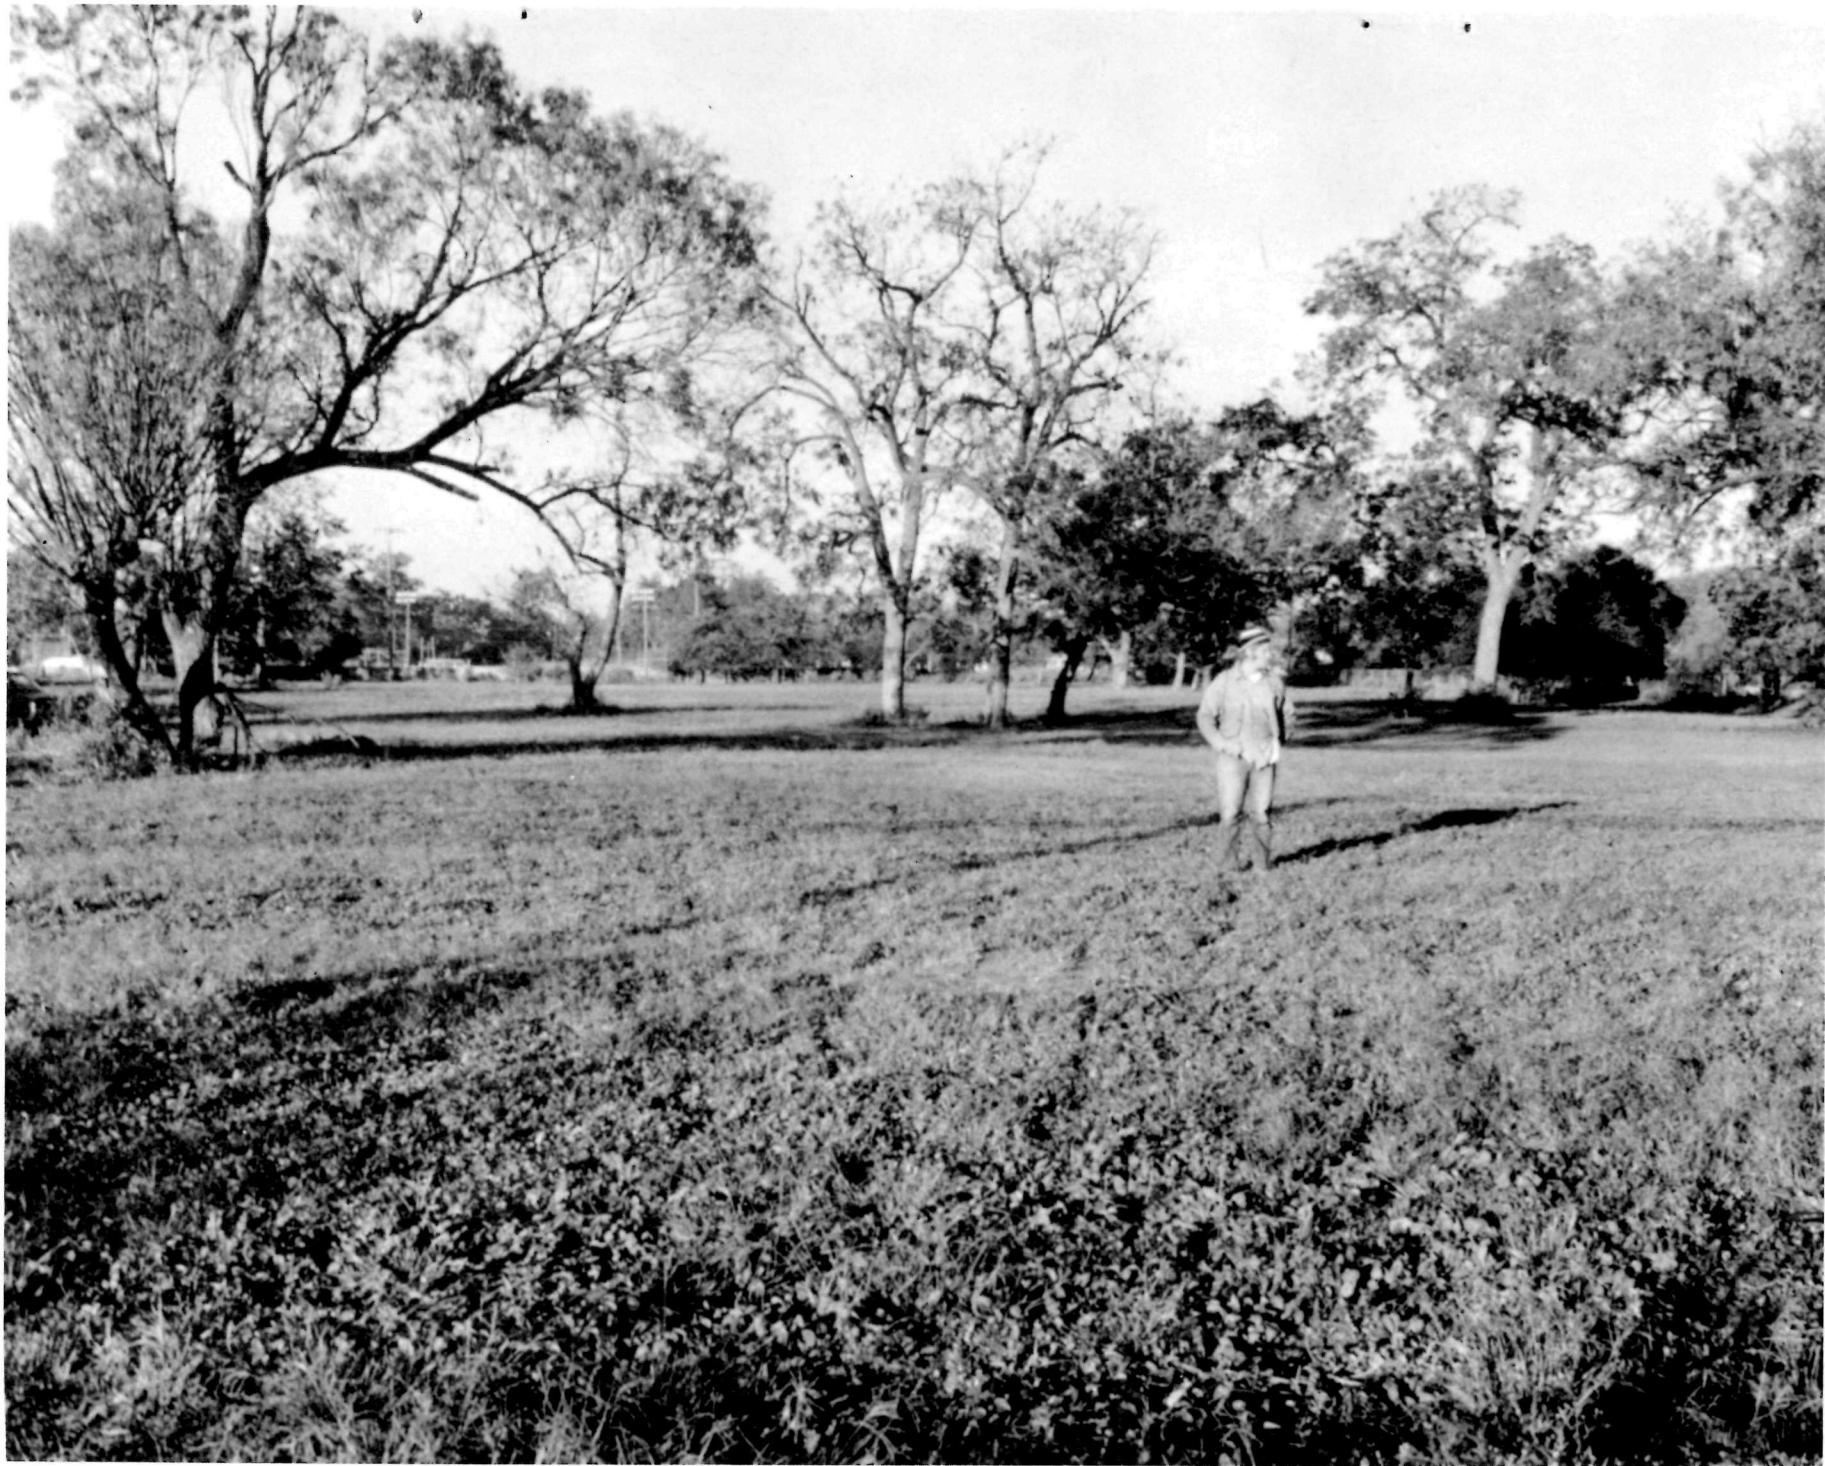
6. West compound area prior to Fall, 1971, excavations. Portions of west compound wall are located to right and just behind field laborer in photograph.

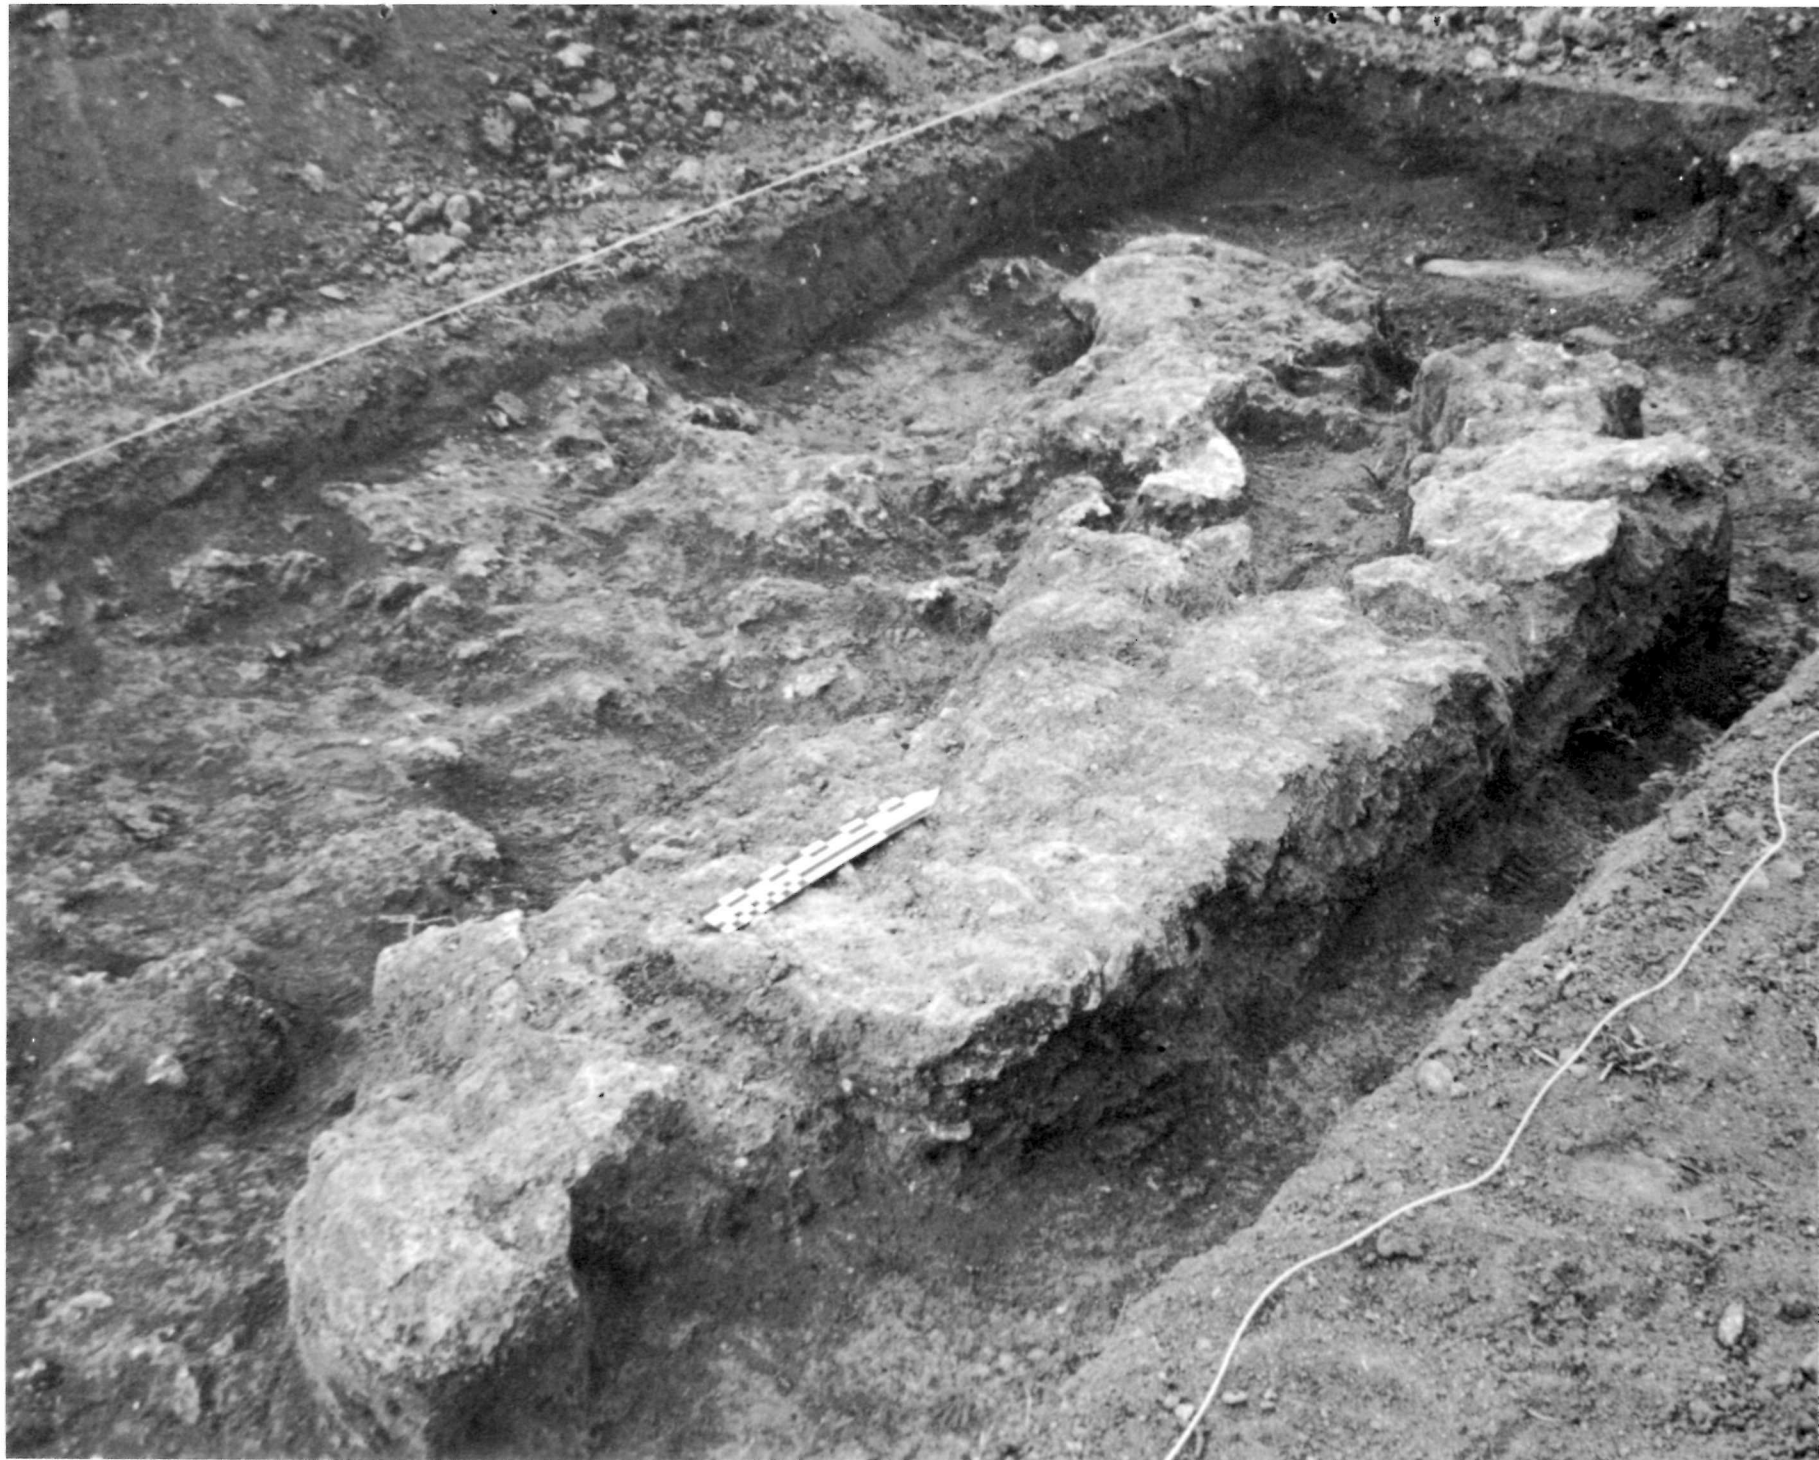
7. Section No. 1 of excavated west compound wall,  
Fall, 1971.

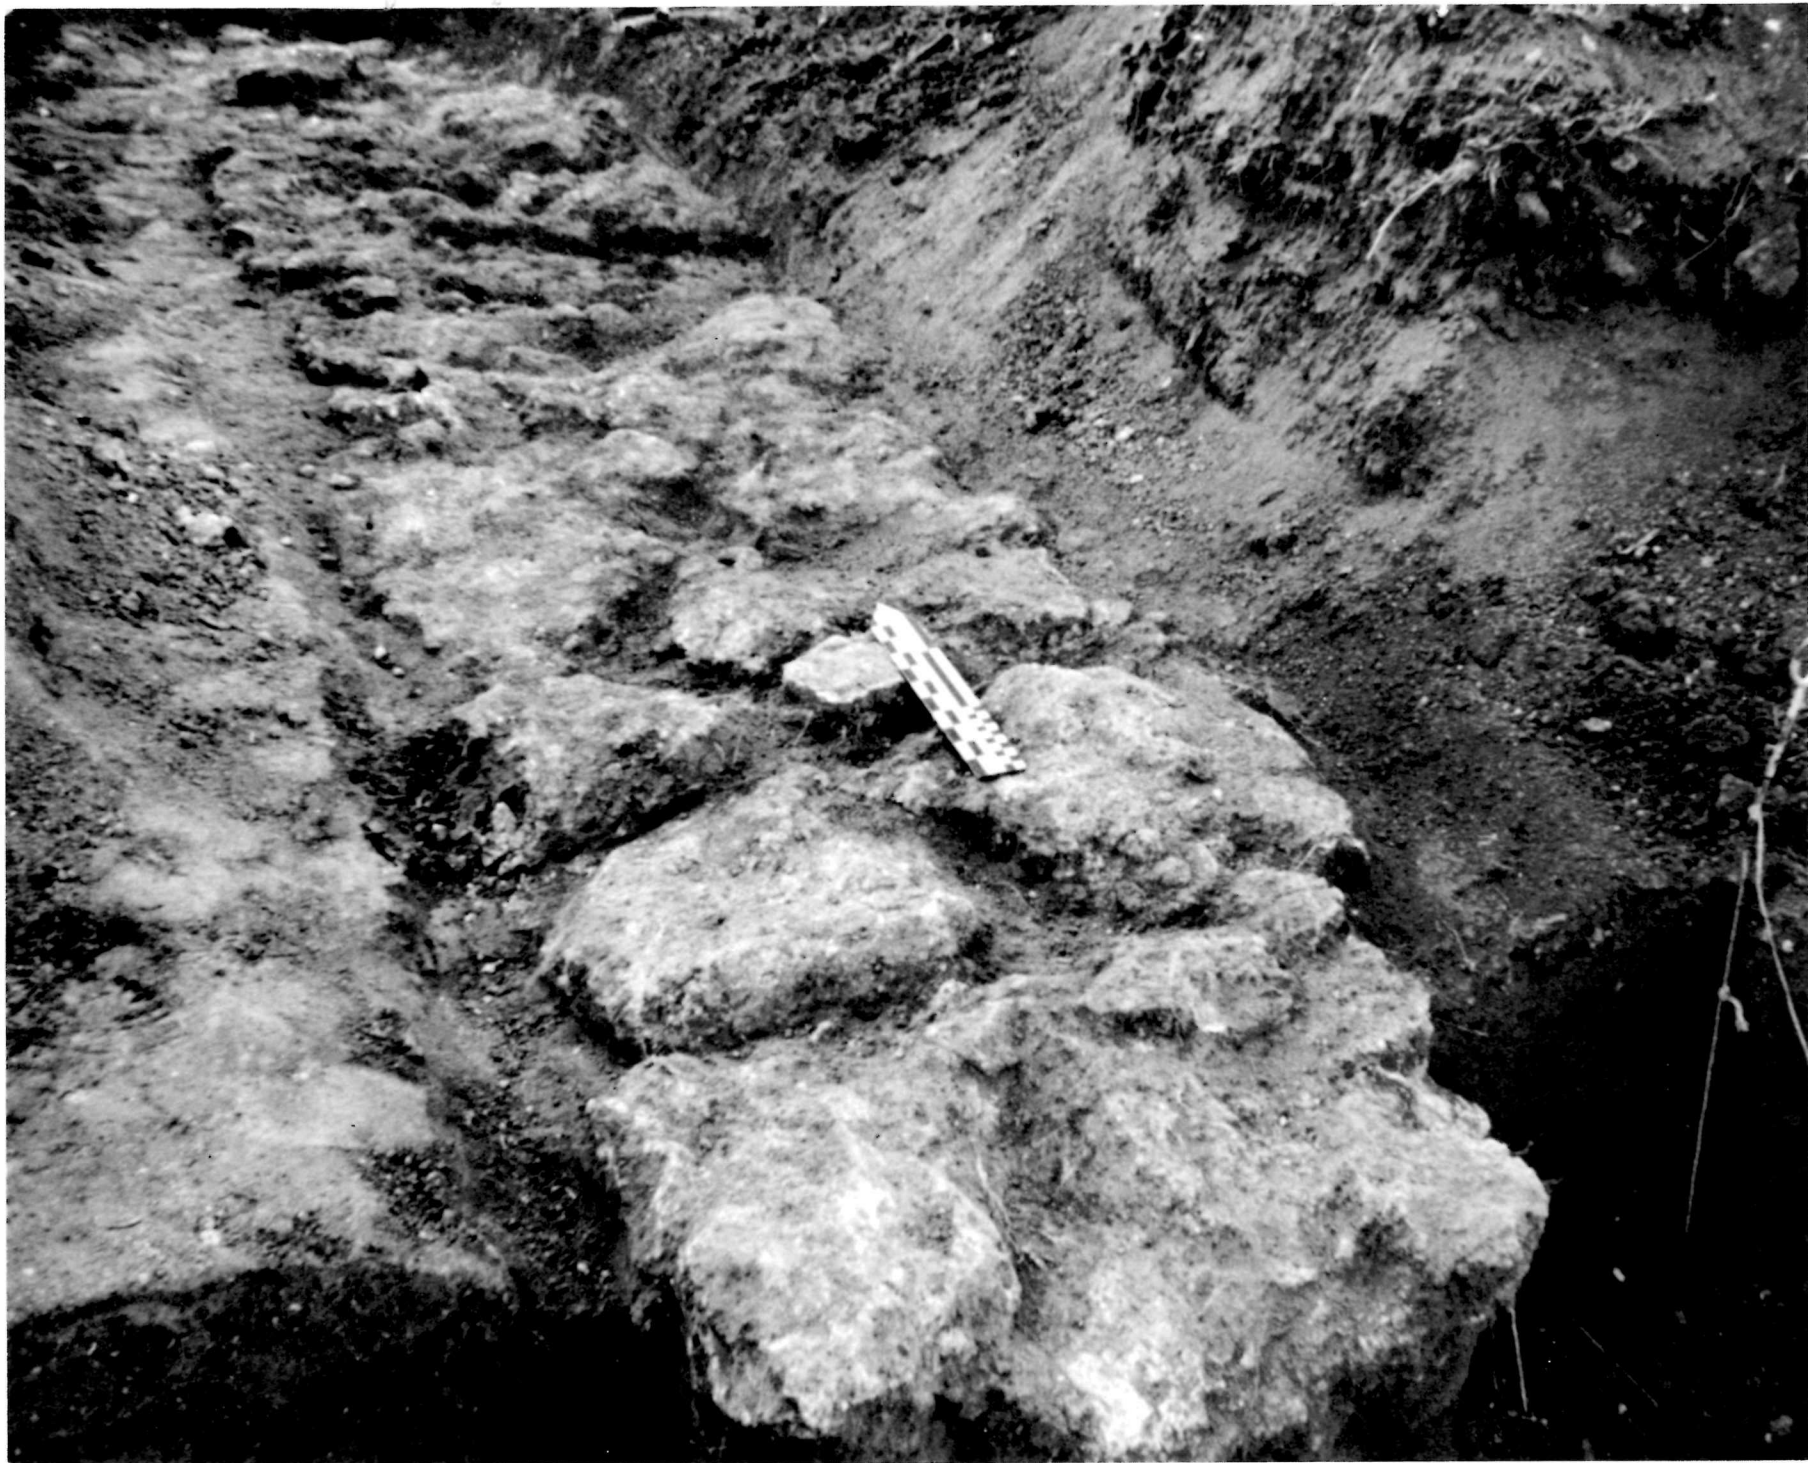
8. Section No. 2 of excavated west compound wall,  
Fall, 1971.
