# MISSION CONCEPTION

ARCHEOLOGICAL COMPLETION REPORT SERIES, NUMBER 5

Archeological Completion Report Series, Number 5  
Division of Grants  
Office of Archeology and Historic Preservation  
National Park Service  
Department of the Interior  
Washington, D. C.  
1975

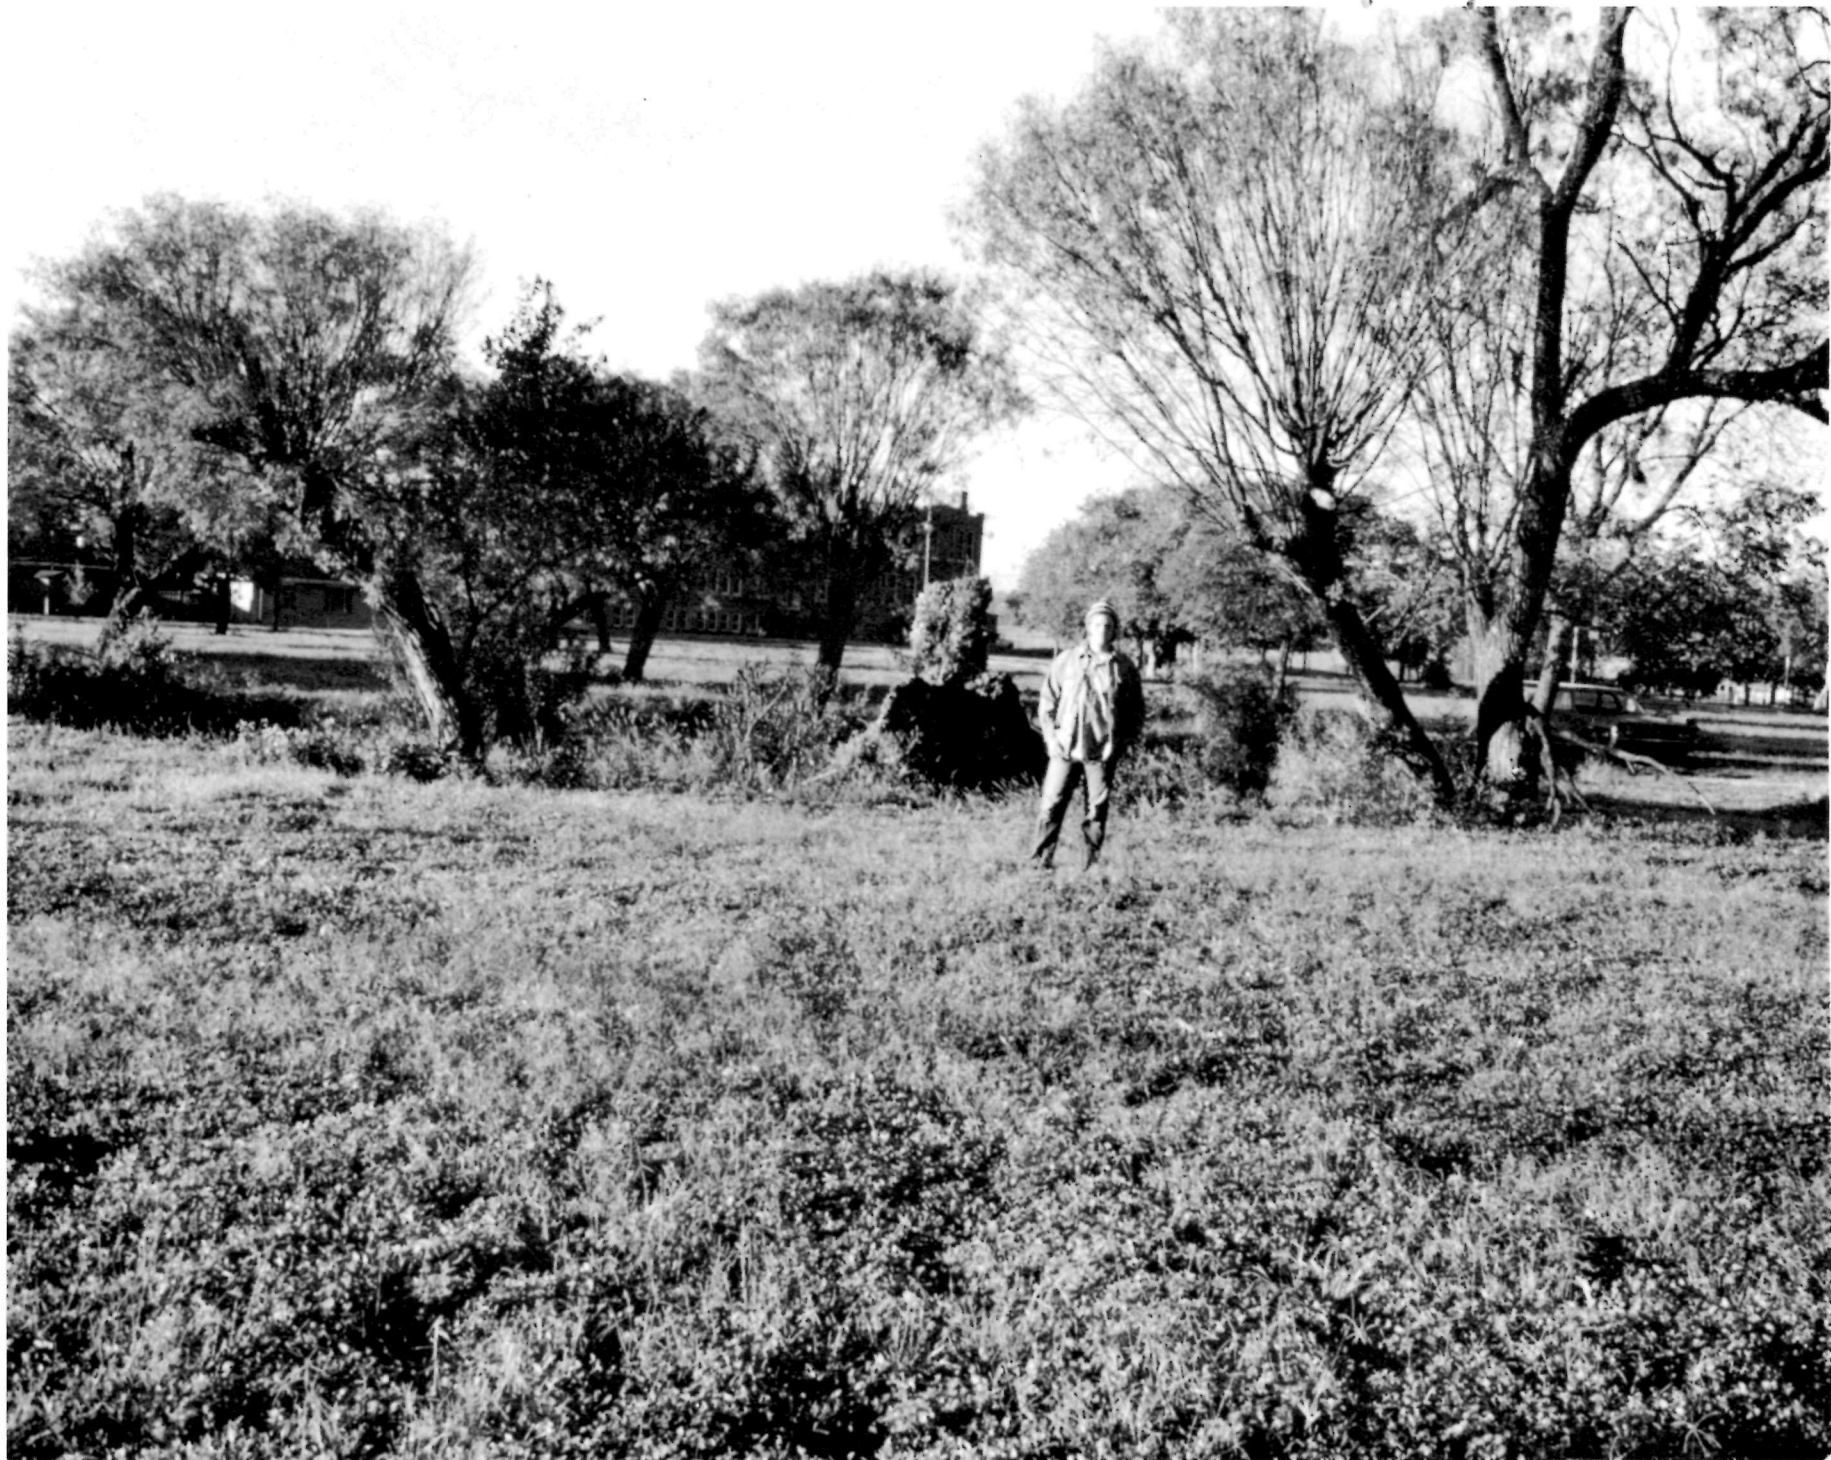
9. Quarry area (depression behind field laborer)  
prior to Spring, 1972 excavation.

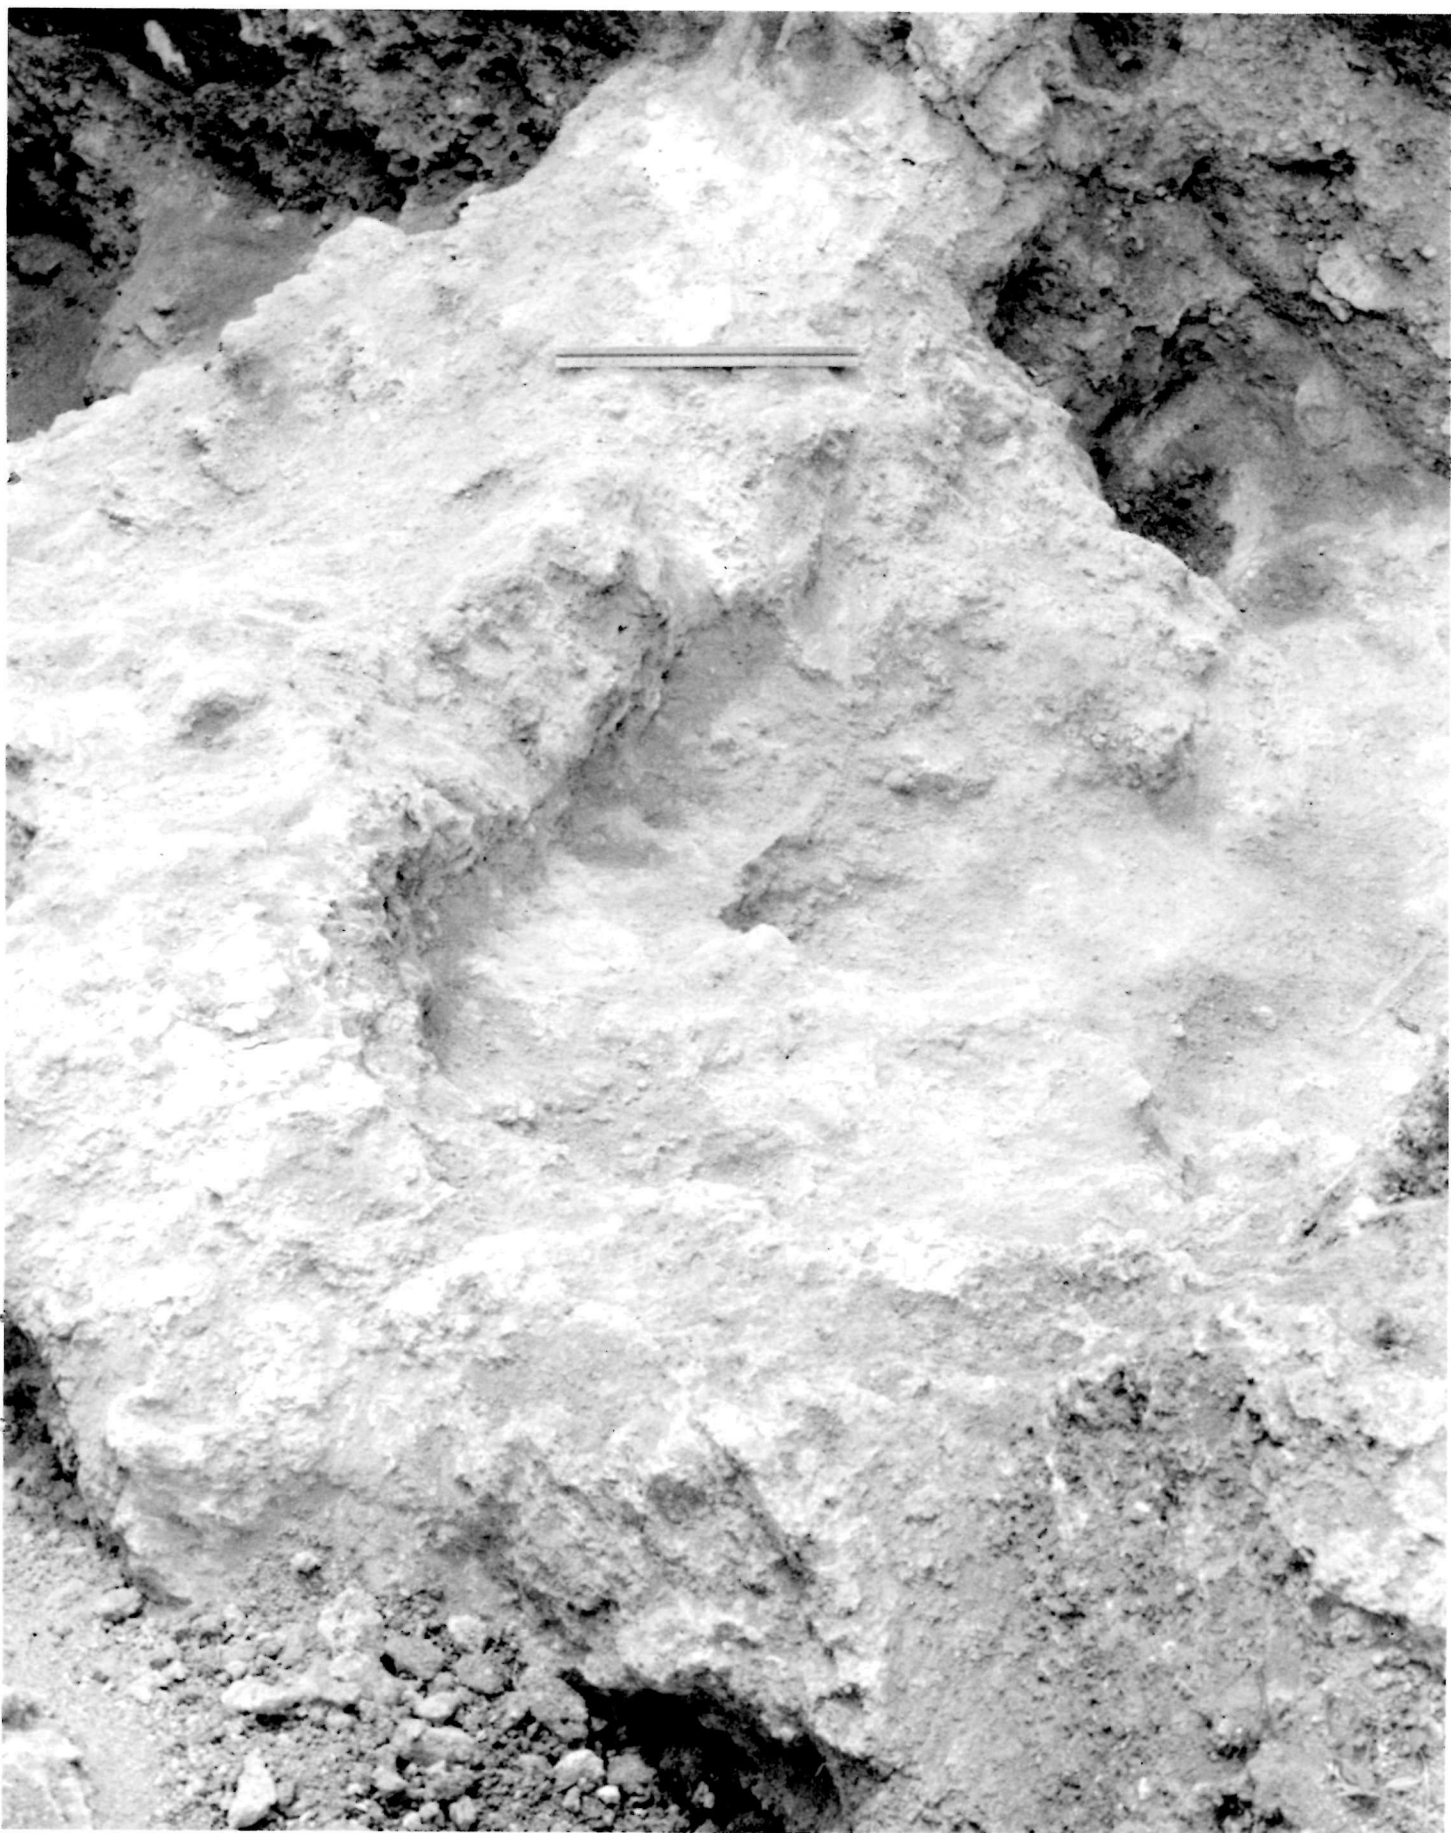
10. Quarried travertine limestone, Spring, 1972,  
excavation.

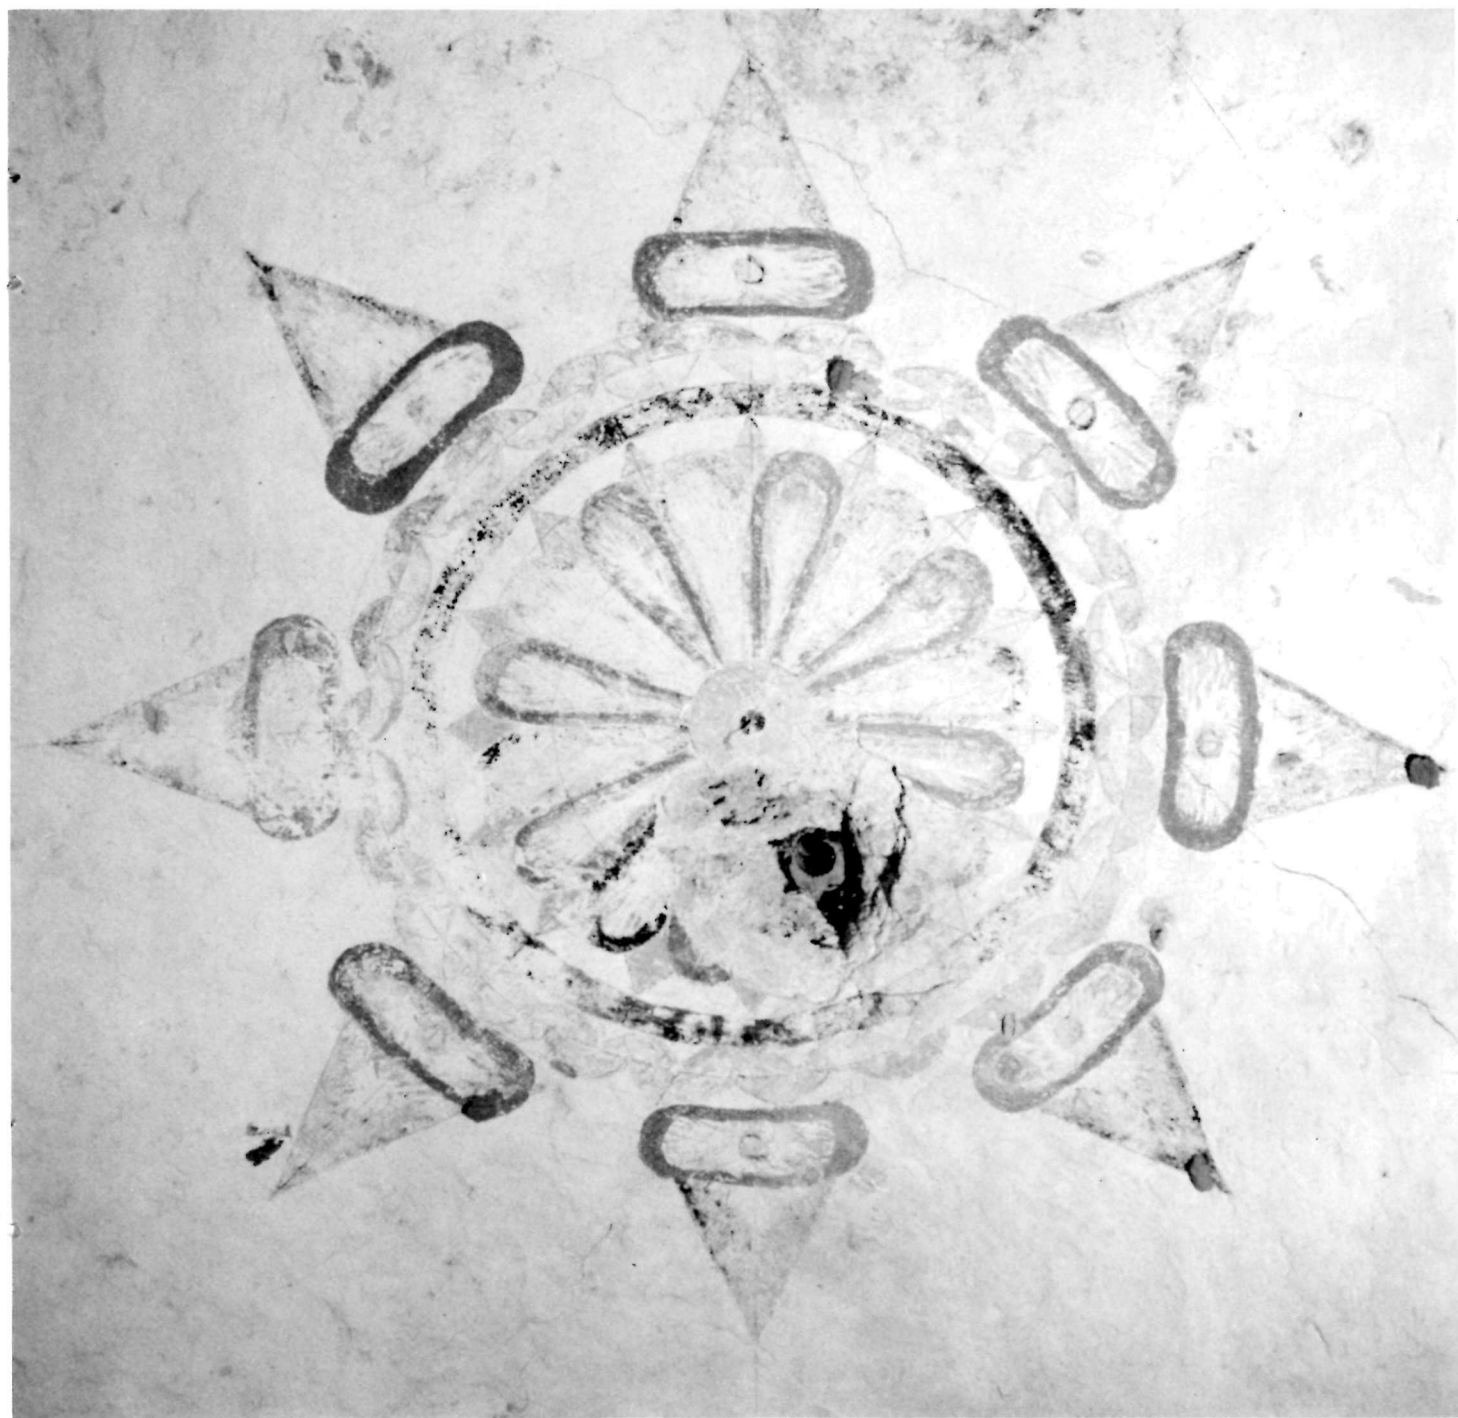
11. 18th Century painting on ceiling of room on ground floor, northwest corner of church.
