UNITED STATES  
DEPARTMENT OF THE INTERIOR  
NATIONAL PARK SERVICE  
Region One  
Richmond, Virginia

PHOTOGRAPHIC REPORT OF CONDITIONS,  
ST. CROIX ISLAND

Roy E. Appleman  
Historian

October 14, 1949

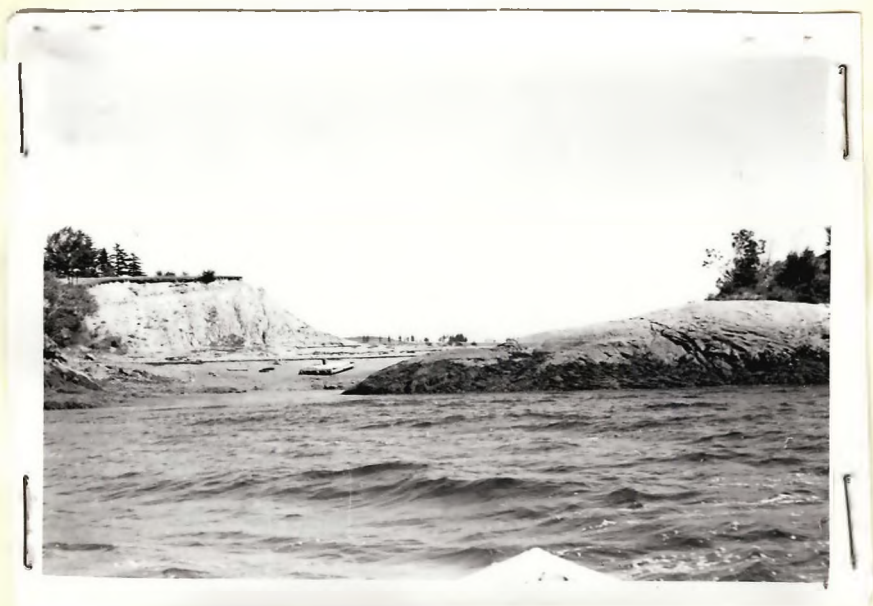
5. View showing erosional cut through island at southern tip of island. High tide almost completely covers cut.

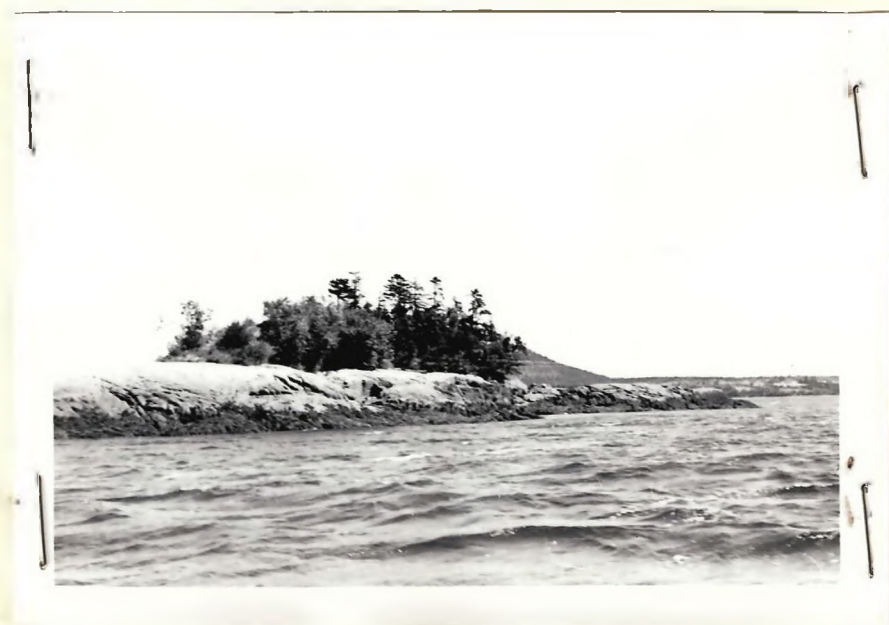
6. One of nubbles at southern tip of island almost completely separated from main island at high tide.

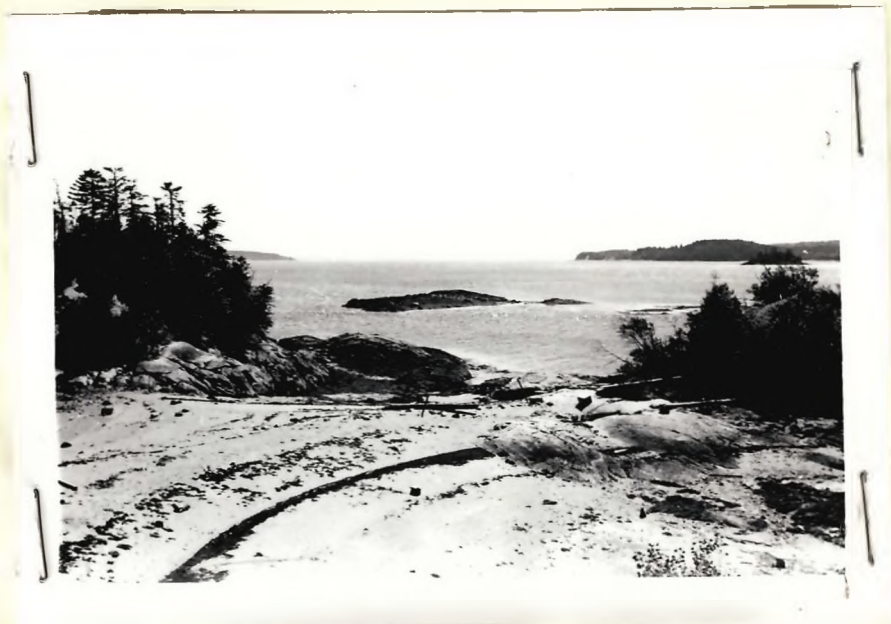
11. View showing erosional wear at southern tip of island.

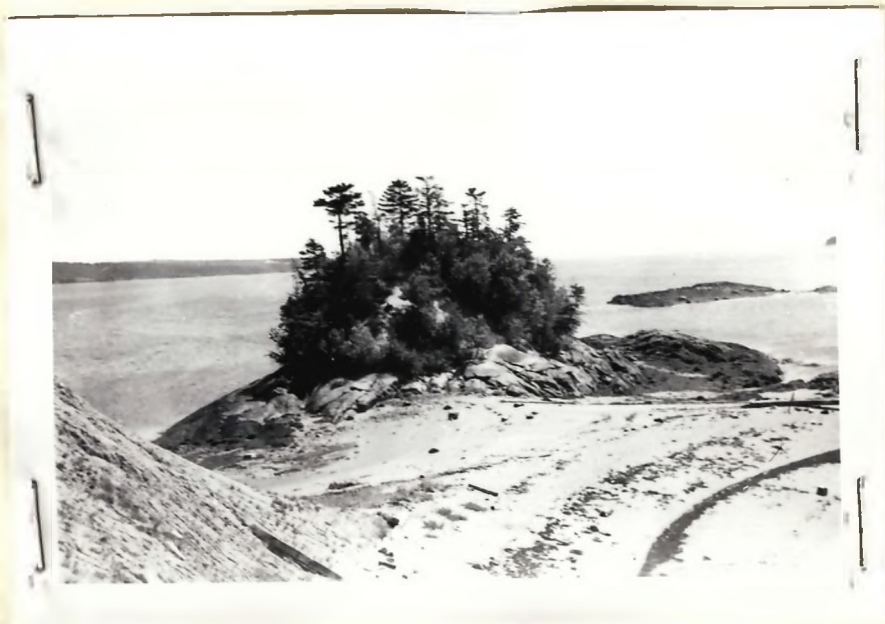
12. Wrights Nubble at southeastern tip of island; separated from main island at high tide.

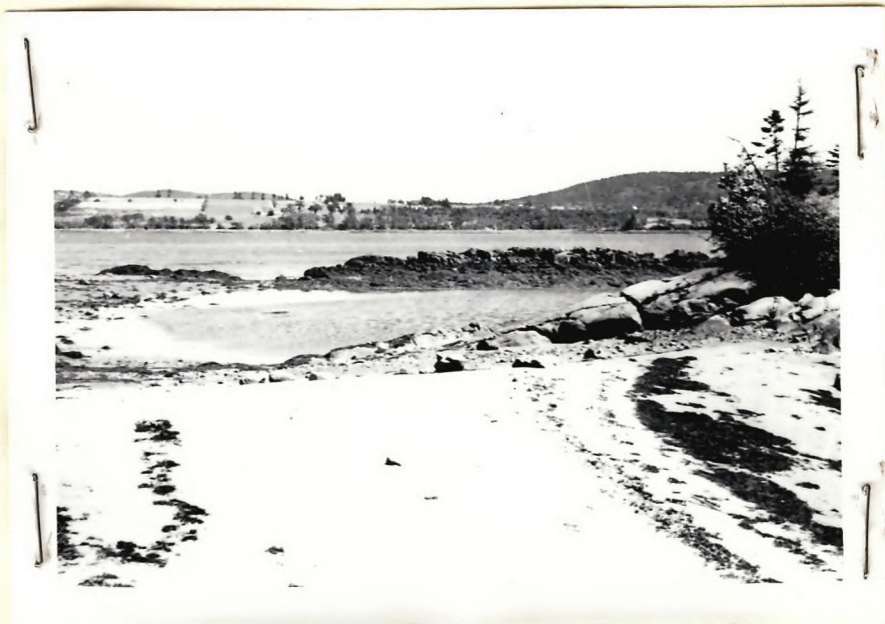
13. View showing erosional wear at southeastern end of island. Canadian shore in the background.

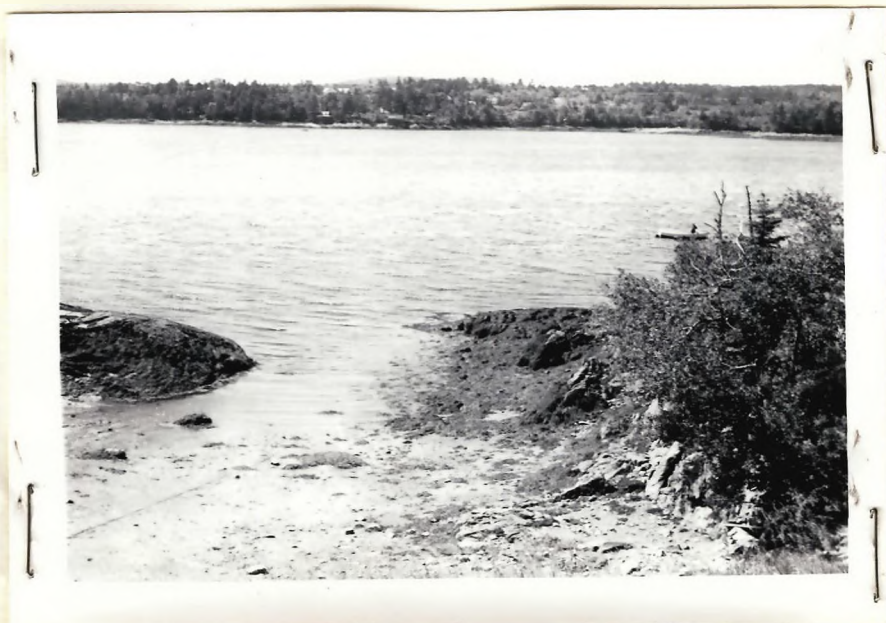
14. View from top of island, looking down into erosional cut across southern tip. American shore in background.

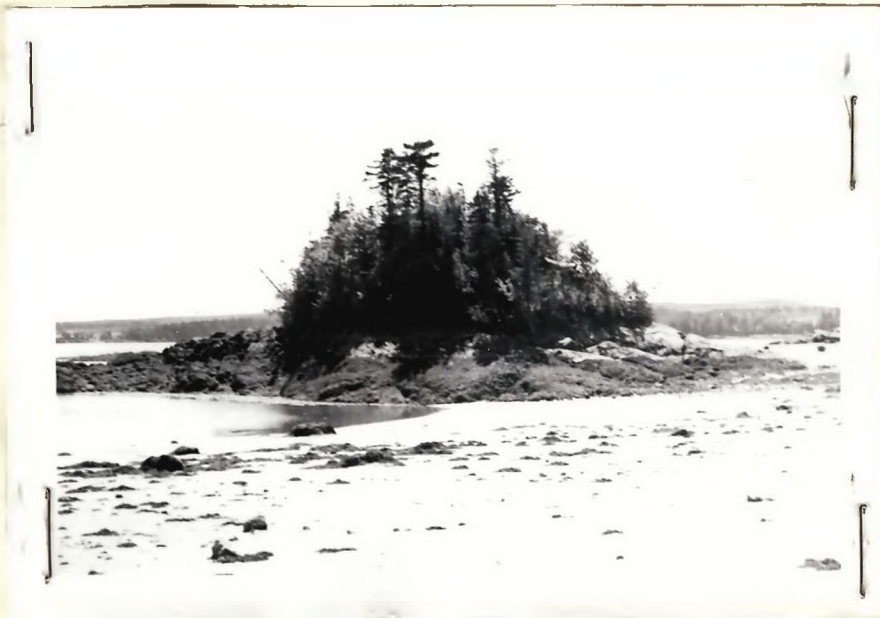
15. Chapel Nubble, southwestern tip of island; separated from main island at high tide.

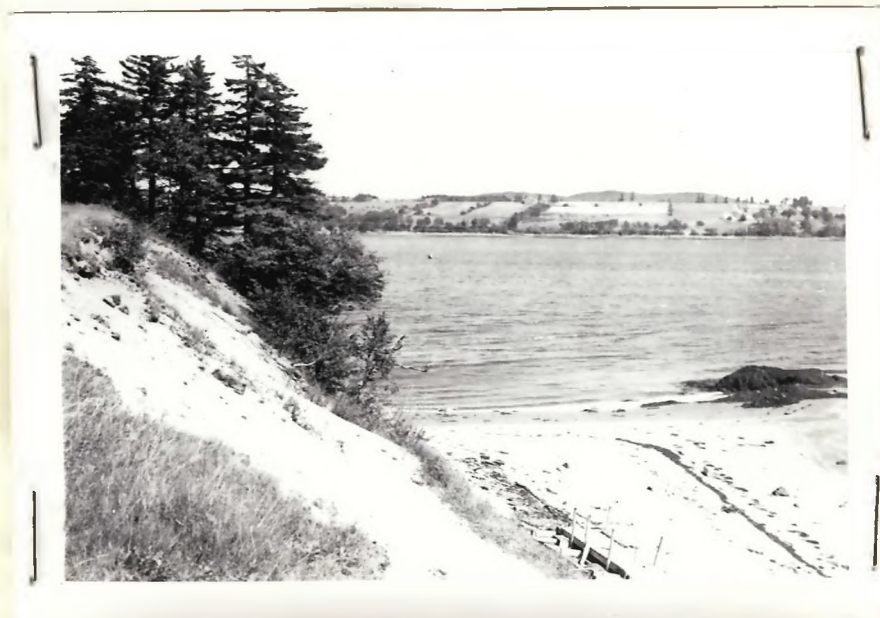
16. Looking from top of island across erosional cut at southern tip of island toward the Canadian shore.

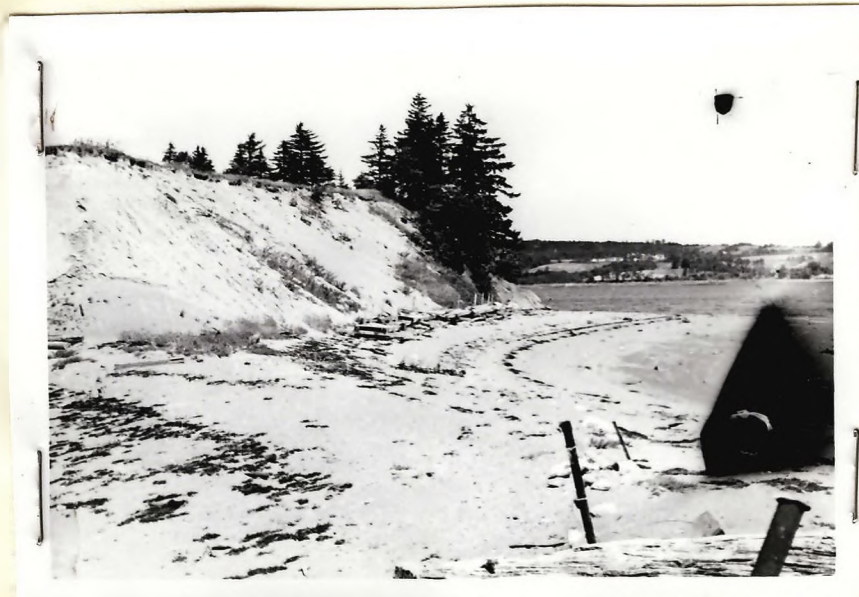
17. Looking across erosional cut at southern tip of island toward Canadian shore; almost low tide.

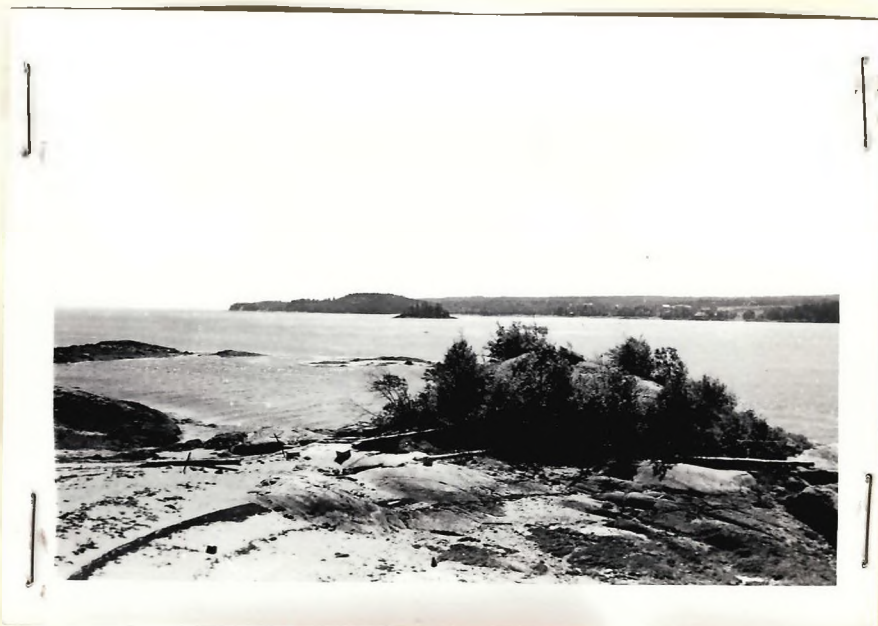
18. View down St. Croix River (direction, generally south), showing erosional character of southern tip of island. Little Docket Island and American shore in background.

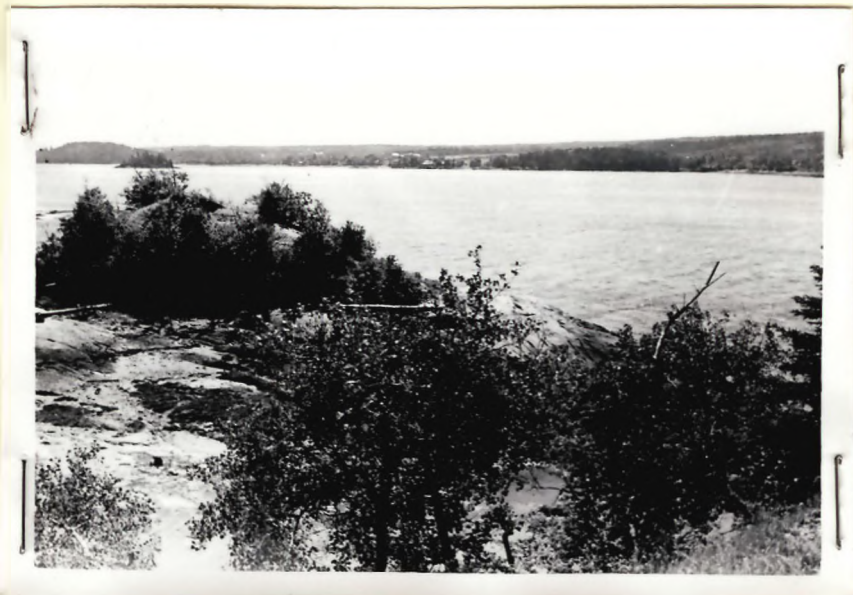
19. Another view of general conditions at southern tip of island.

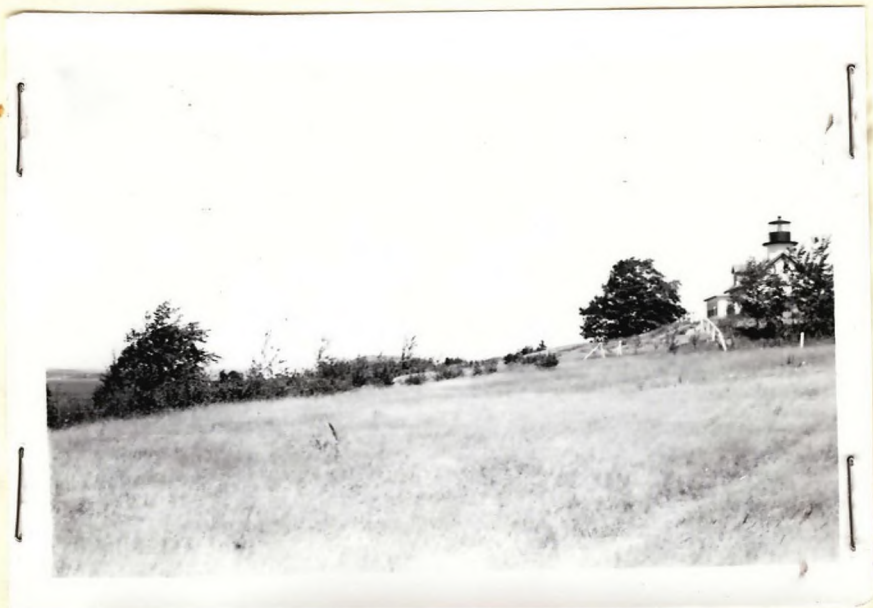
21. General view looking north, showing grassy nature of island.  
This was in garden at time of French settlement, 1604.

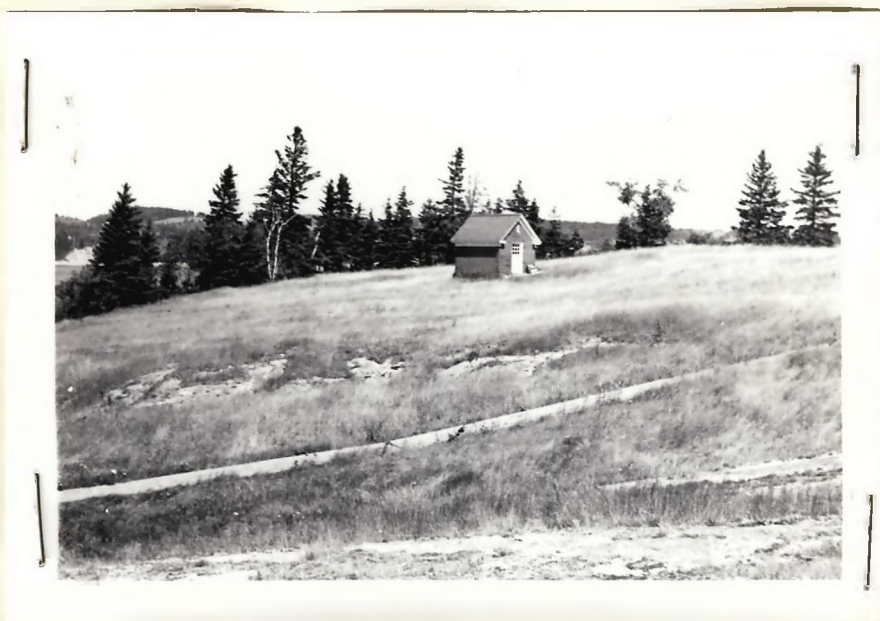
26. View showing northwest tip of island. Tree fringe marks precipitous drop to water.

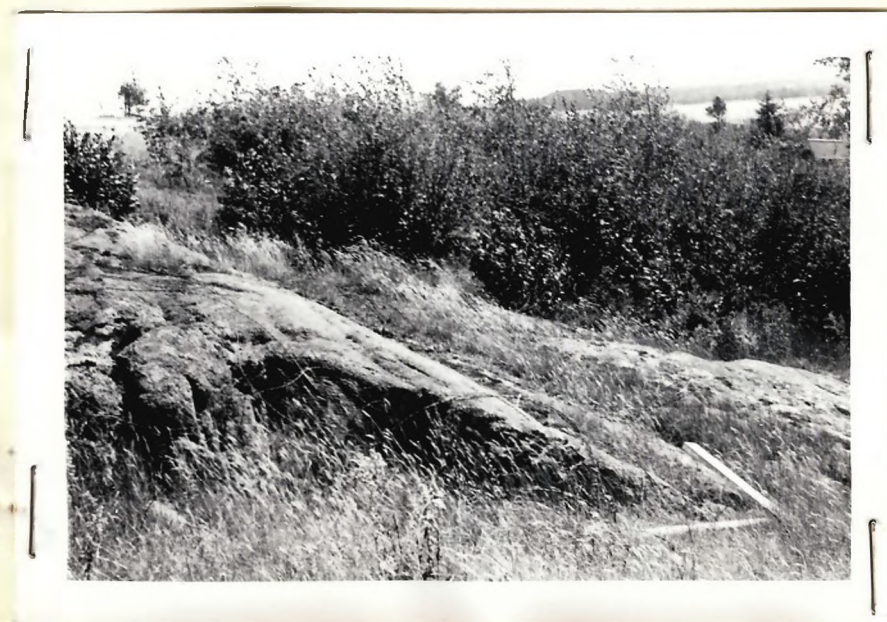
34. View of general conditions on top of island: Granite outcropping, heavy grass, and low shrubbery.

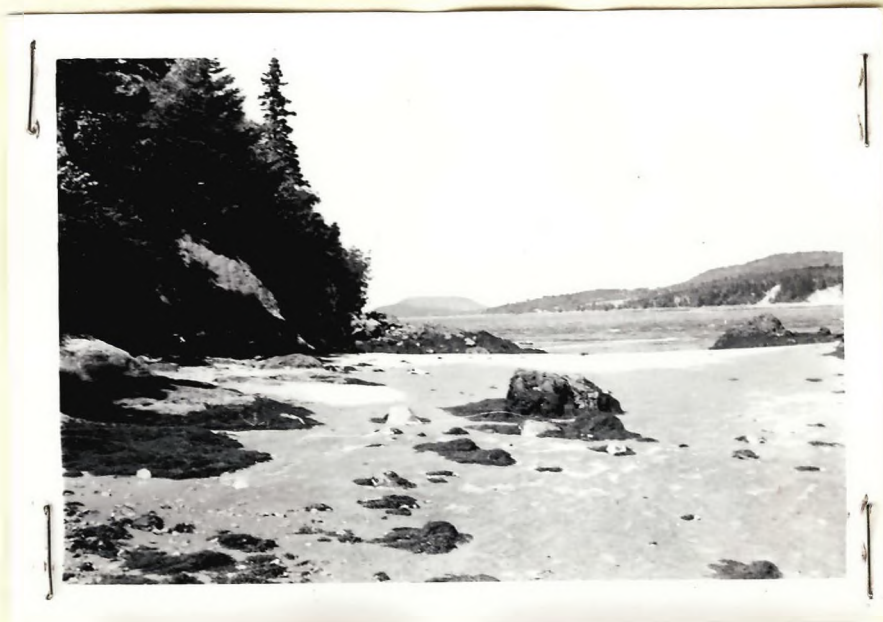
41. View north along eastern shore of island at low tide, showing sand and boulders.

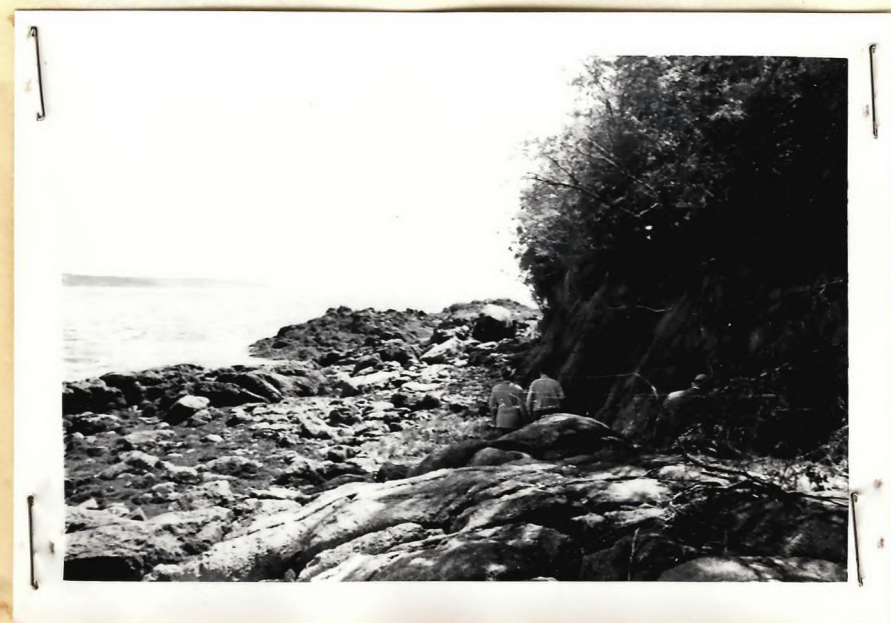
42. View south along eastern side of island, showing granite boulder and ledge condition. Lee and Cox are in the picture. *f Porter?*

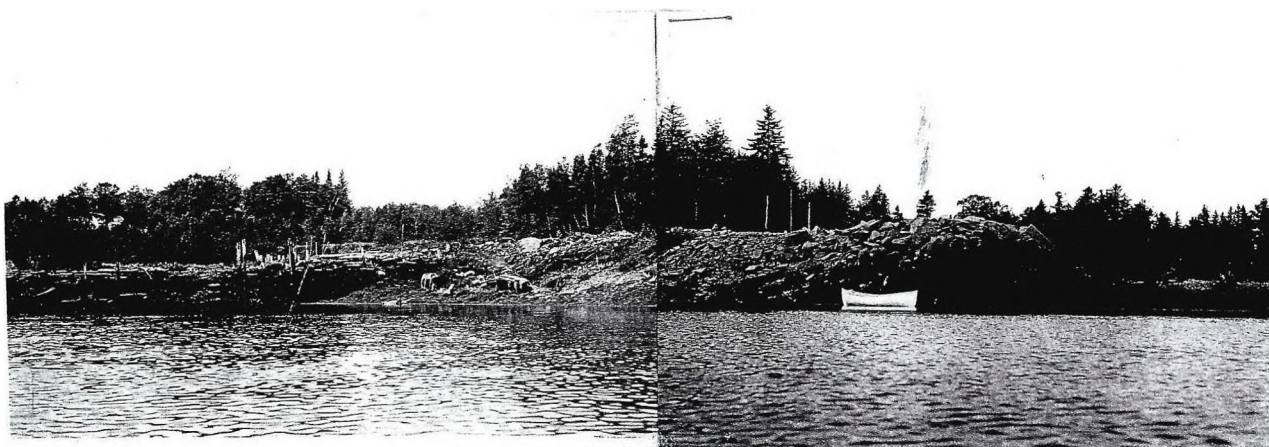
48. Plaster mill site at normal low tide (looking northwest from boat). White boat is alongside uncompleted stone pier. (Photo by Harrington, 9/16/49.)
