**HISTORIC  
STRUCTURES  
REPORT  
CROOK HOUSE  
SEPTEMBER 1984**

**SAN JUAN ISLAND  
NATIONAL  
HISTORICAL PARK**

CROOK HOUSE  
HISTORIC STRUCTURES REPORT

English Camp  
San Juan Island National Historical Park  
San Juan Island, Washington

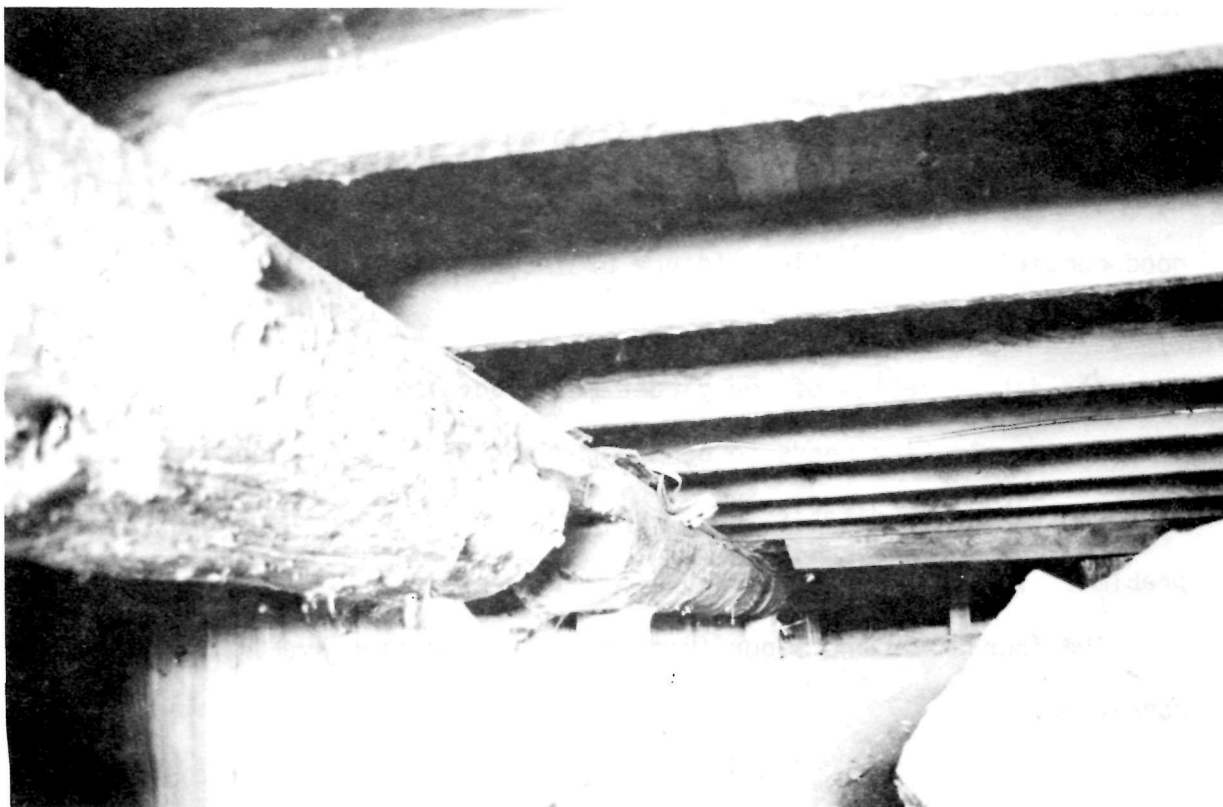
FIGURE 35 Crook House foundation: notch in log girder for original post, 1984. Photo by Barry Schnoll, National Park Service.

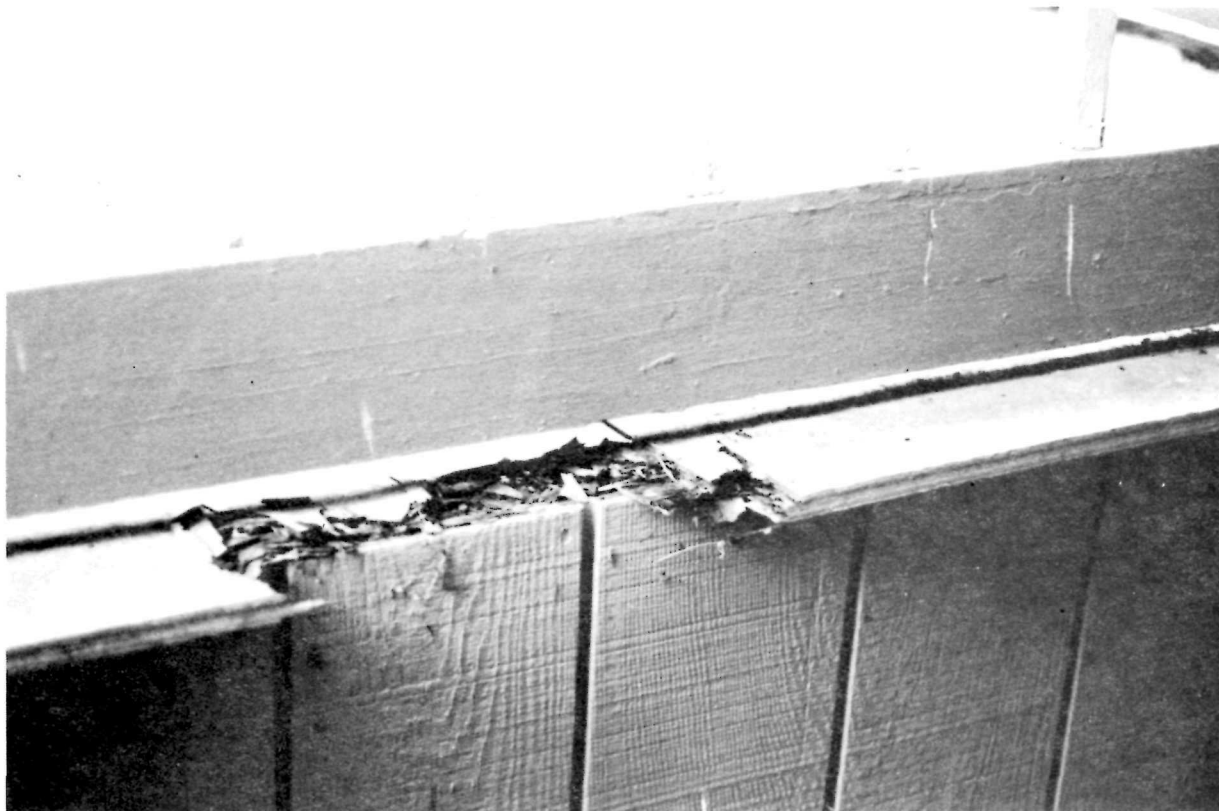
FIGURE 39 Deteriorated first floor porch deck, southwest corner of Crook House, 1984. Photo by Barry Schnoll, National Park Service.

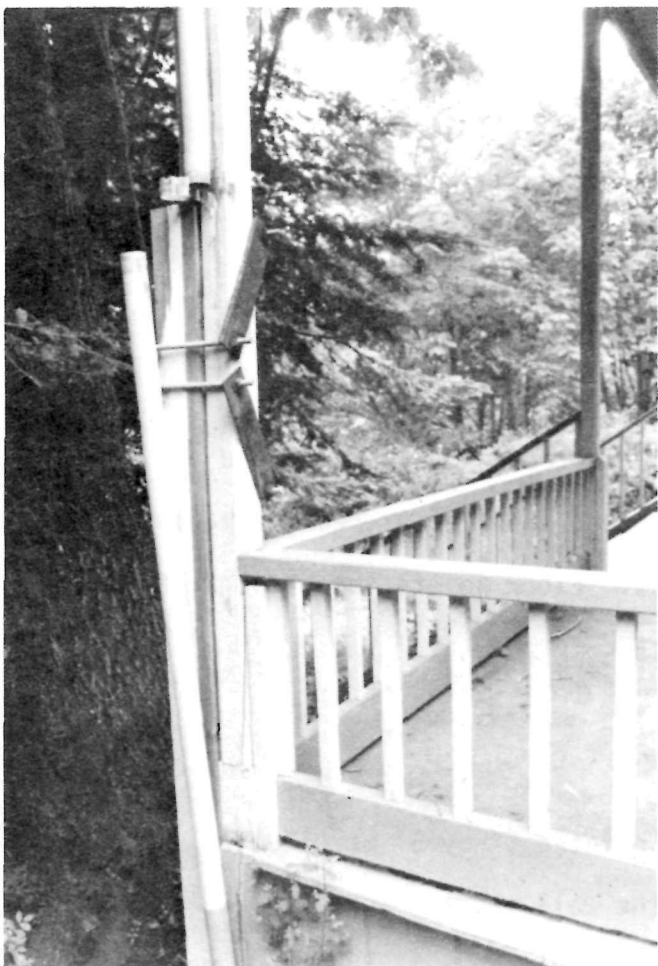
FIGURE 40 (Above left) Temporary bracing for southwest corner porch column, 1984. Photo by Barry Schnoll, National Park Service.

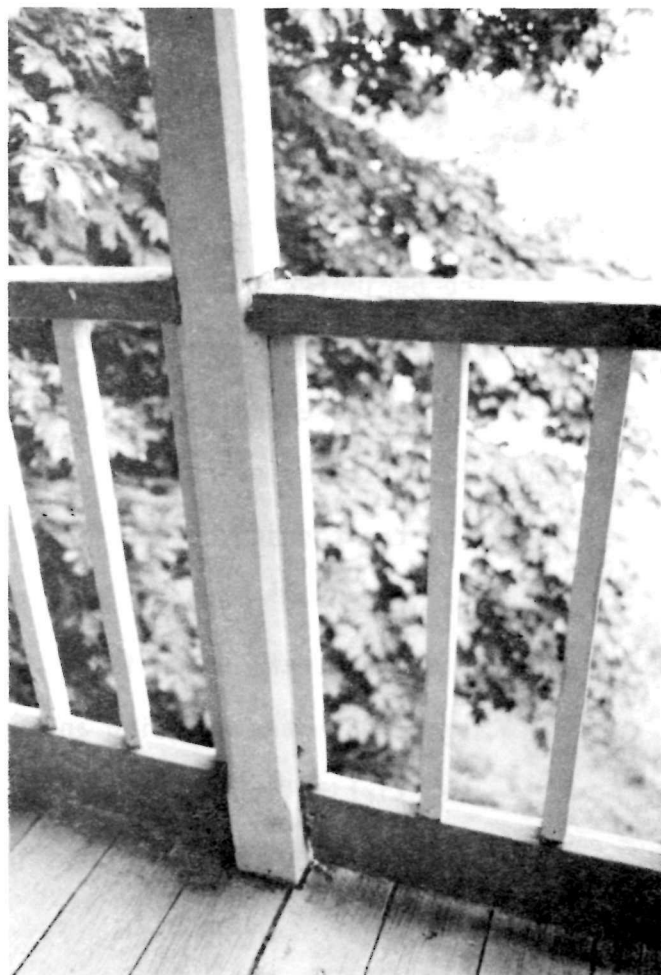
FIGURE 42 (Right) Second floor porch railing. The top rail is separating from the column and the balusters are loose, 1984. Photo by Barry Schnoll, National Park Service.

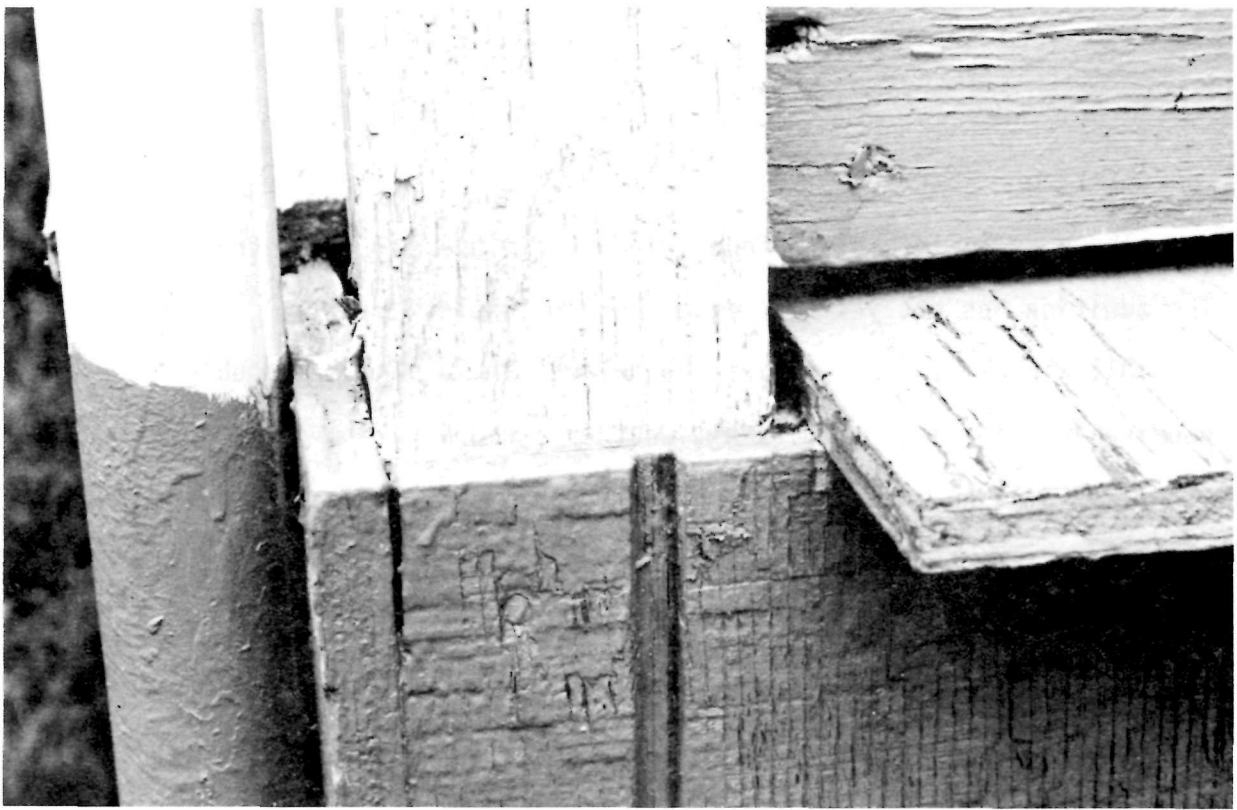
FIGURE 43 Northwest corner of Crook House porch, 1984. Lack of sealant allows moisture penetration. Photo by Barry Schnoll, National Park Service.

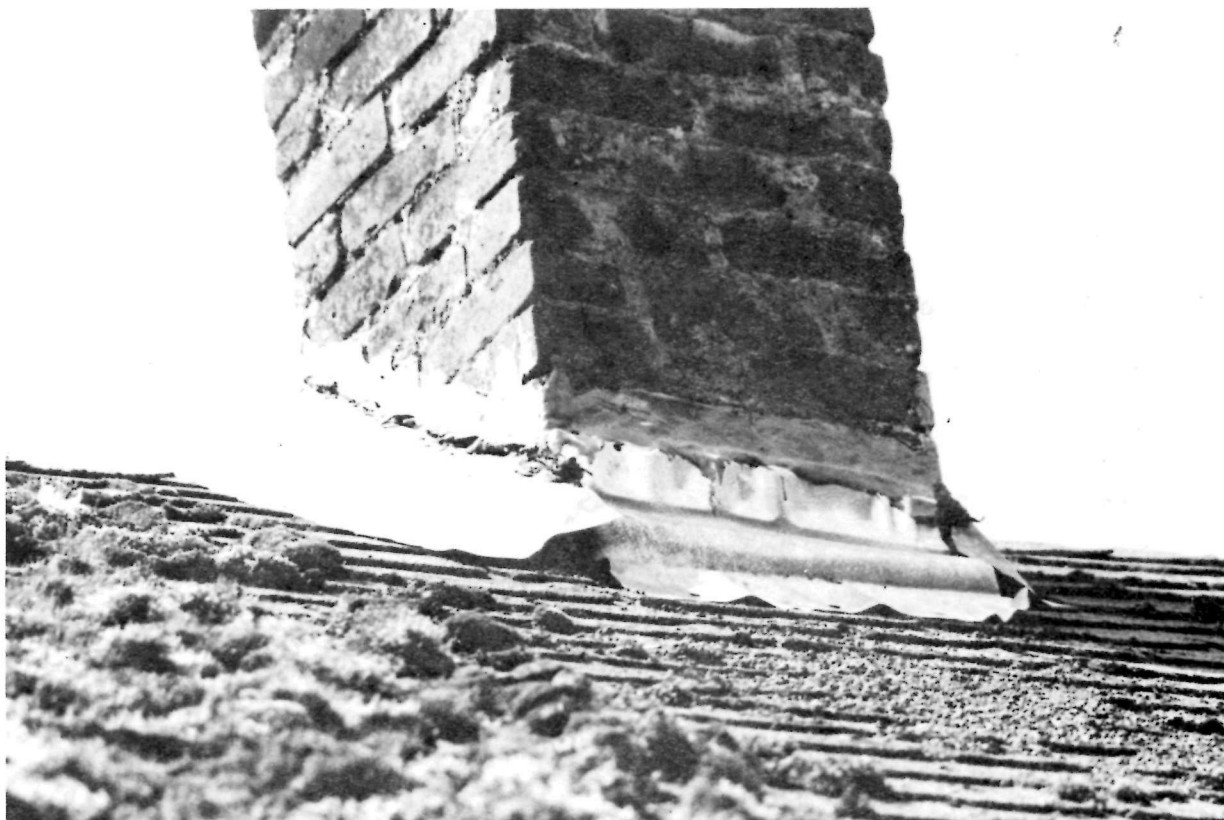
FIGURE 45 East gable roof of Crook House, 1984. Shingles, brick and flashing show advanced deterioration. Photo by Barry Schnoll, National Park Service.

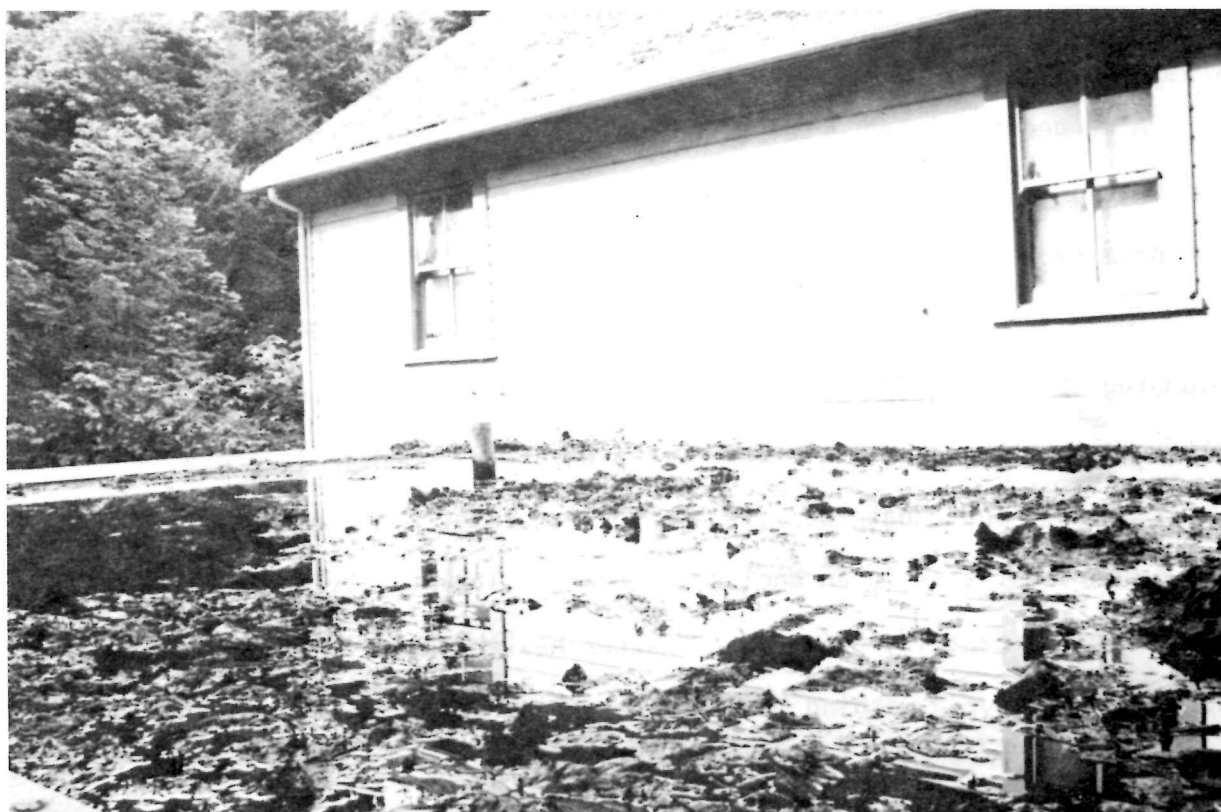
FIGURE 46 Crook House addition, 1984. Flat roof contributes to ponding. Photo by Barry Schnoll, National Park Service.

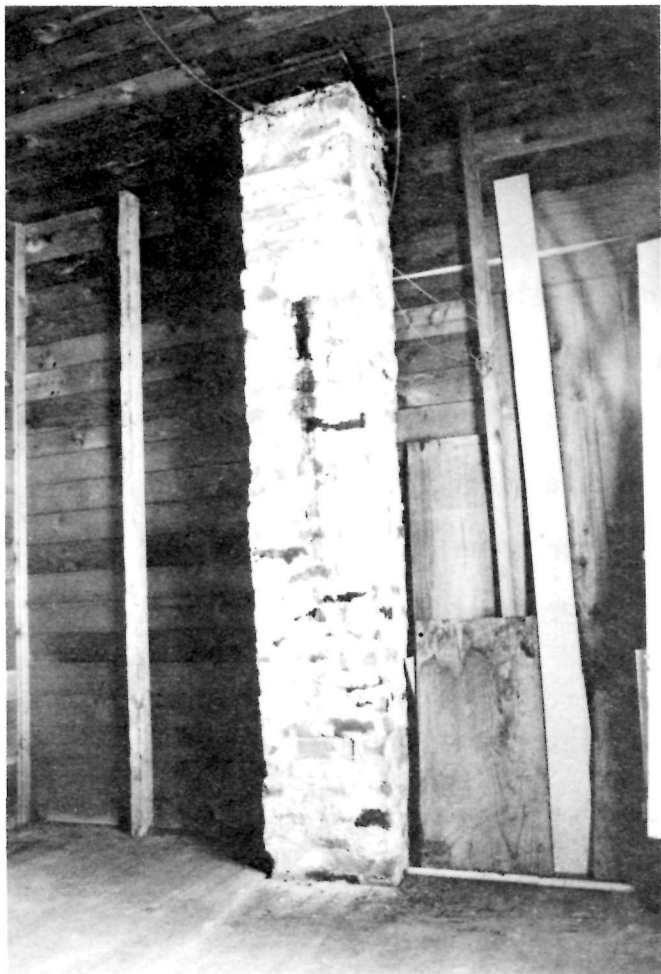
FIGURE 47 Chimney on unfinished west wall of Bedroom #3, Crook House, 1984. Stove flue hole filled with mortar. Photo by Barry Schnoll, National Park Service.

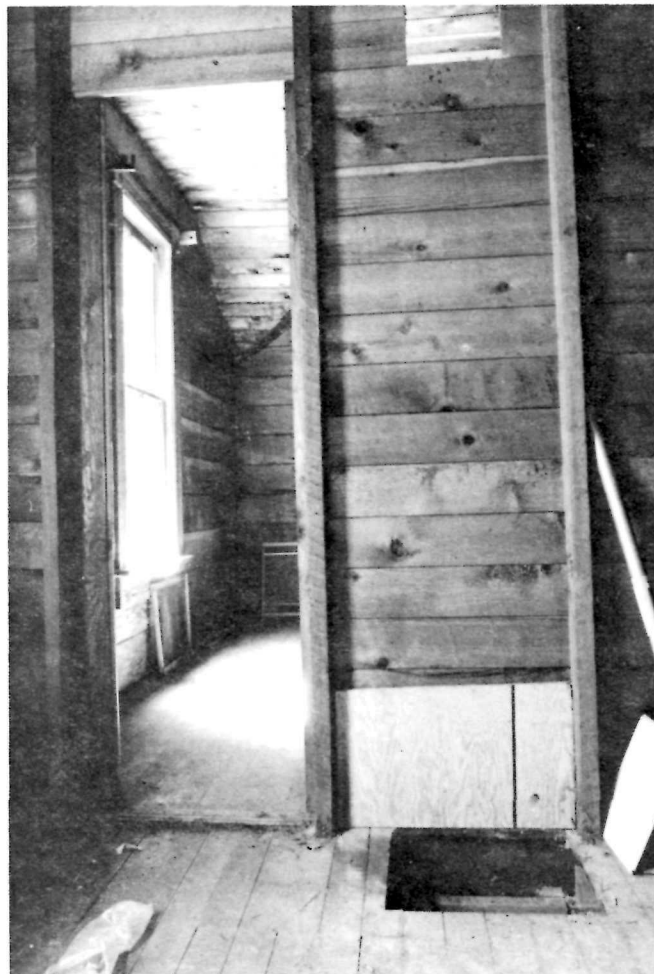
FIGURE 48 Bedroom #4 of Crook House, 1984. Upstairs rooms were never finished.. Opening in floor indicates location of dismantled chimney. Photo by Barry Schnoll, National Park Service.

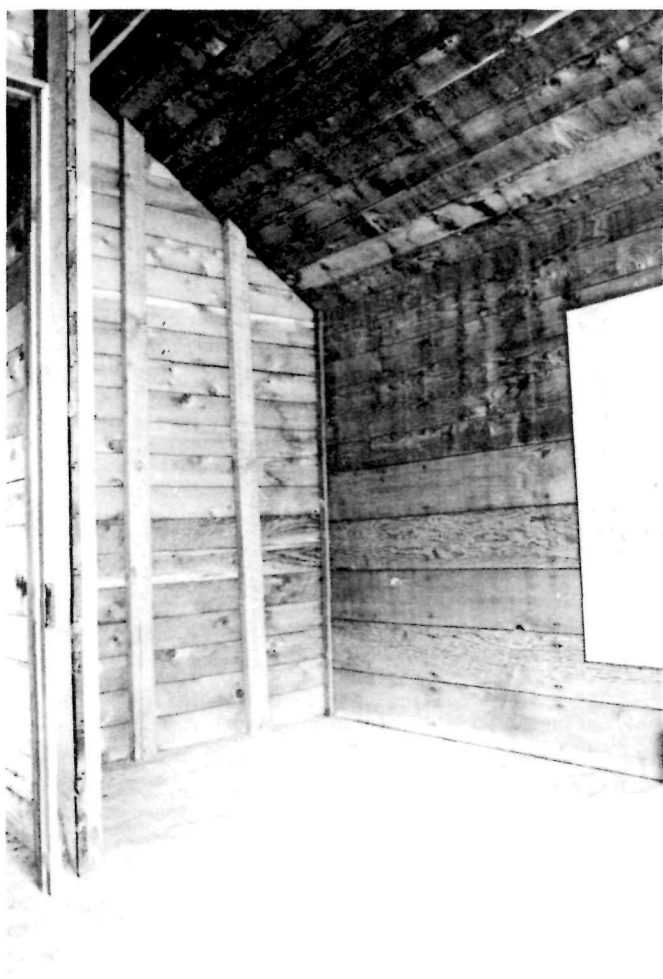
FIGURE 49 Unfinished interior of Bedroom #4, Crook House, 1984. Ceiling drop and studs laid flat on the north wall. Photo by Barry Schnoll, National Park Service.

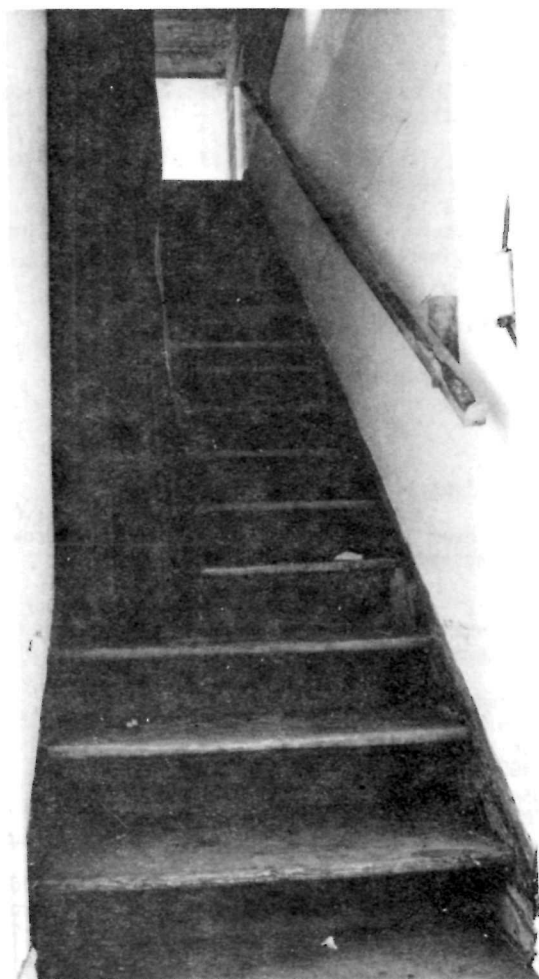
FIGURE 50 Crook House staircase, looking west, 1984. Tread depth and riser height are not consistent. Photo by Barry Schnoll, National Park Service.
