historic structure report

architectural data

OFFICERS' QUARTERS HS-11,
LAUNDRESS' QUARTERS HS-6, AND
ENGLISH CAMP HOSPITAL HS-18

DENVER SERVICE CENTER
HISTORIC PRESERVATION DIVISION
NATIONAL PARK SERVICE
UNITED STATES DEPARTMENT OF THE INTERIOR
DENVER, COLORADO

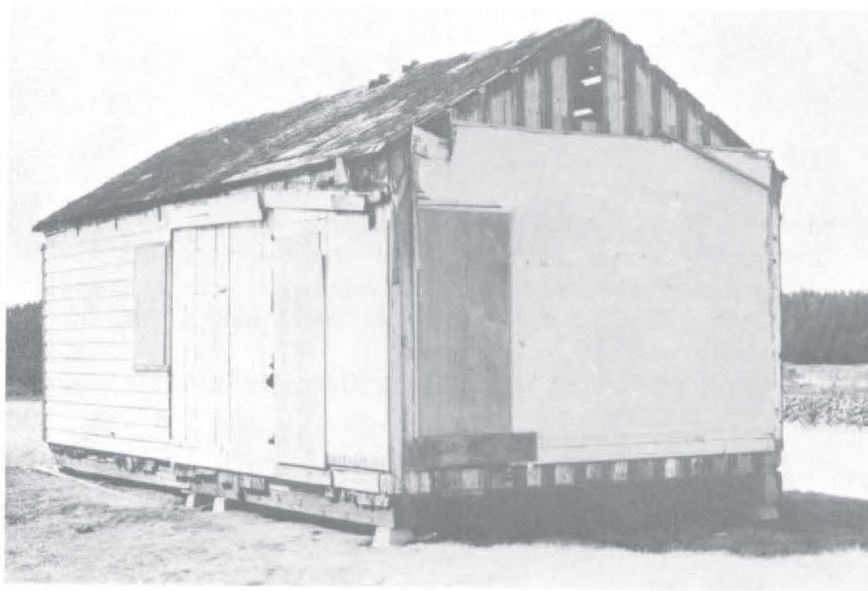
Warbass House/Laundress' Quarters, HS-6, on its present, temporary site at American Camp. This view is from the northwest and shows the end containing Room 1. Note the pockets in the ledger on the north for attaching Warbass's former porch. Note the poor condition of the roof.

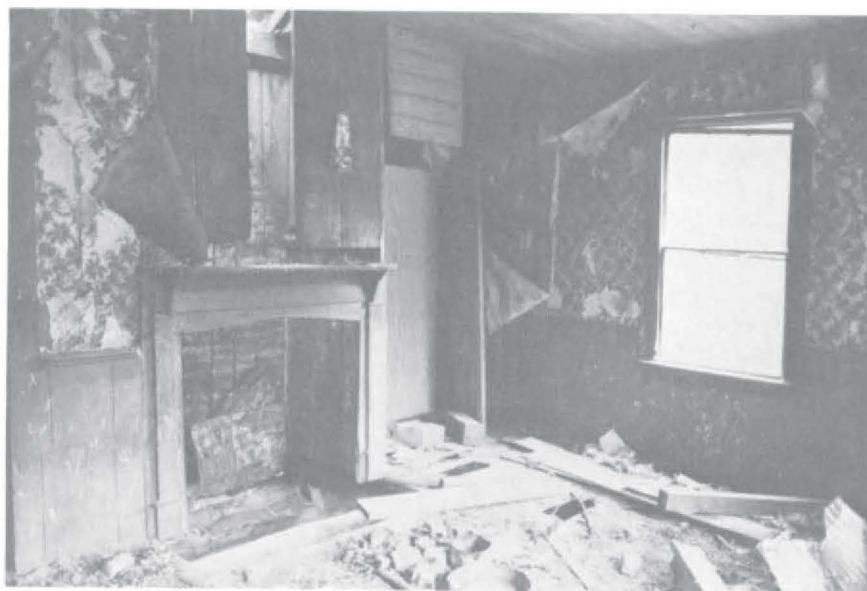
FIGURE 28.

English Camp Hospital, HS-18. Interior of Room 2. Note the extremely poor condition of the fabric except at the ceiling. The plywood behind the wall planks attempts to protect the structure from weather. Wallpaper is still extant on the side walls, but is in poor condition.
