# GENERAL PHILIP SCHUYLER HOUSE KITCHEN AND KITCHEN PASSAGEWAY

Historic Structure Report Addendum

**NOVEMBER 2022**

**JOHN G. WAITE ASSOCIATES, ARCHITECTS**

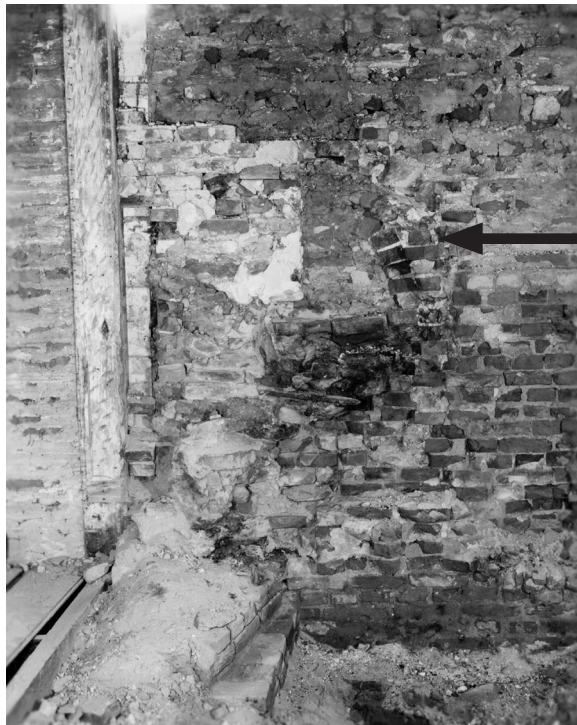
BAKE OVEN  
ARCH

Figure 35. The fireplace after removals. An arched opening to a bake oven was found at the back of the firebox. Photographs by Gordon Whittington, 1958. SARA.

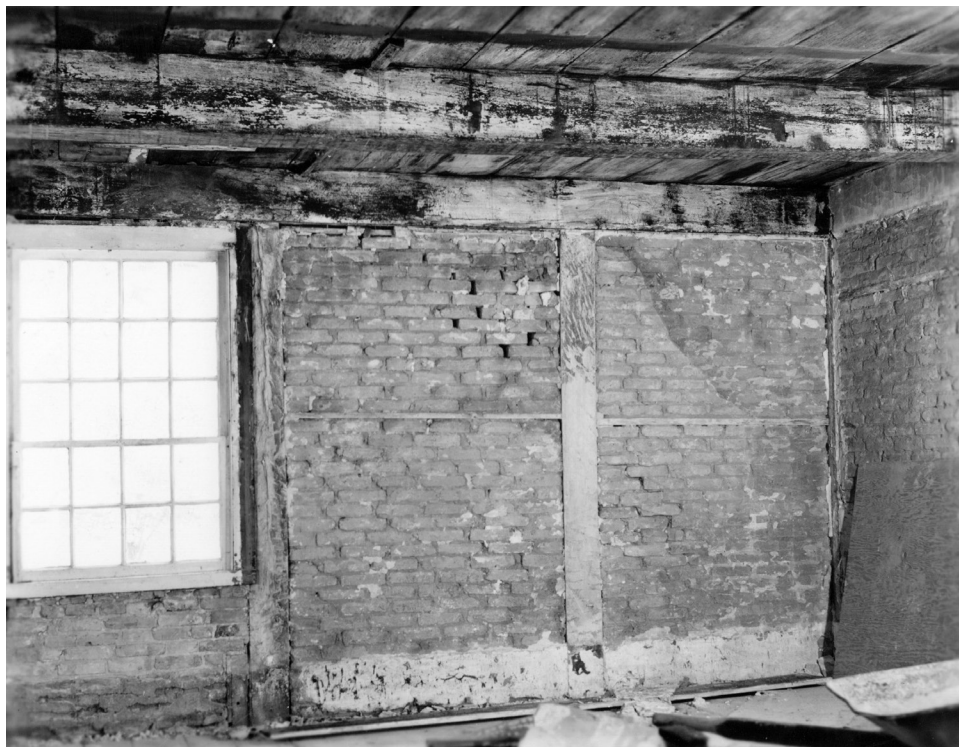
Figure 37. The west wall of the kitchen with original unfired brick nogging. The window opening replaced an original doorway. Photograph by Henry Judd, 1958. SARA.

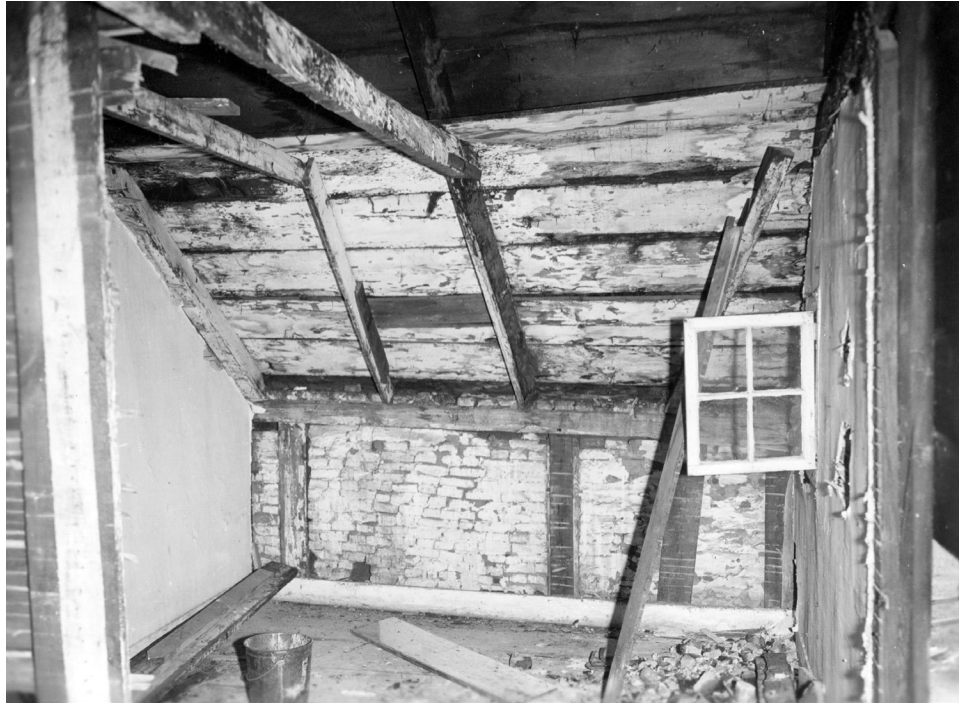
Figure 46. The south garret room in 1958. Note the later partition to the left that divided the east space into two rooms, and the brick nogging that was removed in the 1963 restoration. Photograph by Charles Hutchins. SARA.

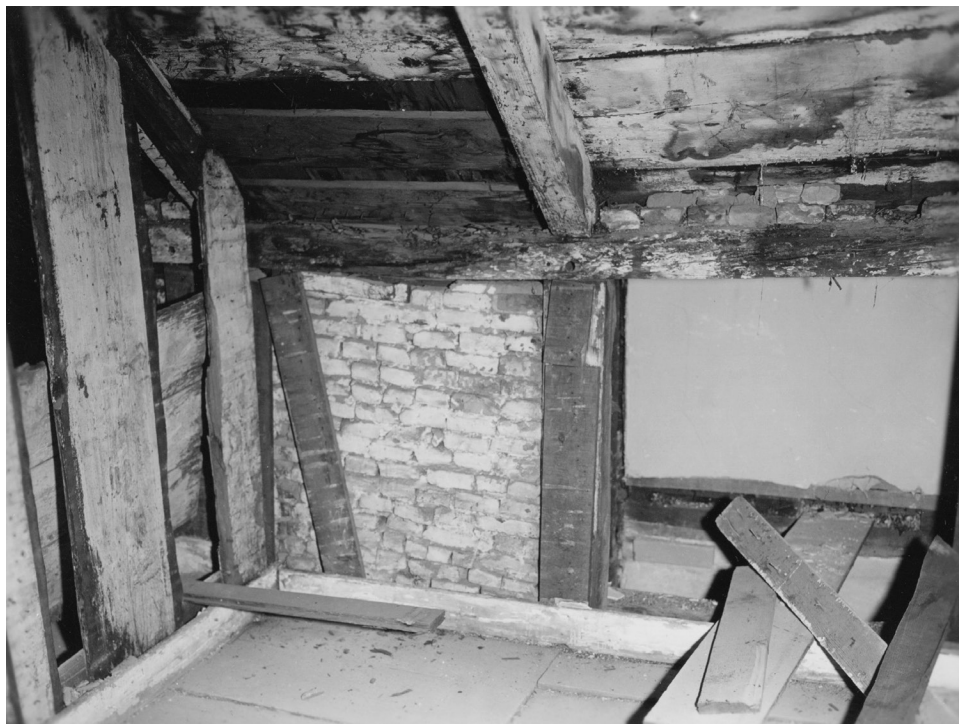
Figure 47. The kitchen plate and rafters below the south cricket in 1958. The deterioration was such that Judd recommended replacing these members. The brick nogging was removed in the 1963 restoration work. Photograph by Henry Judd. SARA.

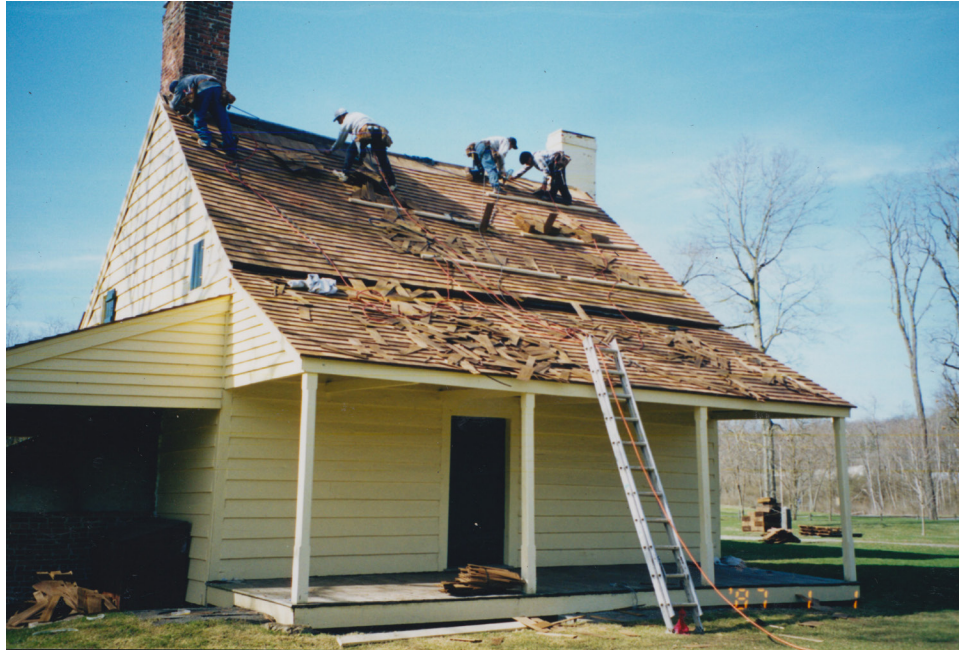
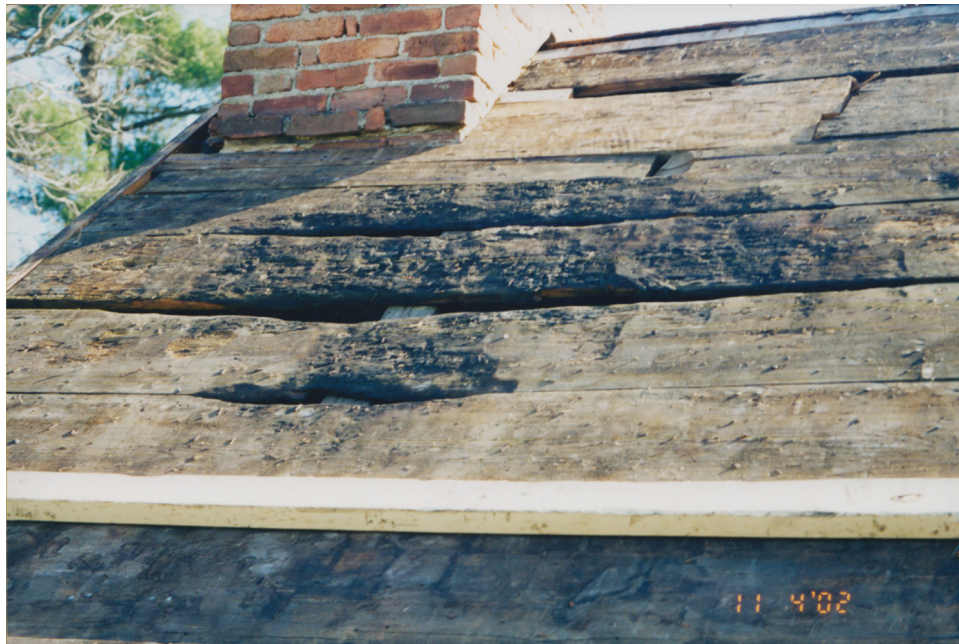
Figure 71. New cedar shingles were installed on the kitchen roof in 2002. Note the section of burned roof boards possibly relating to a chimney fire, revealed when the old shingles were removed. SARA, Box 41, Folder 7.
