HISTORICAL OVERVIEW AND ASSESSMENT OF CIVILIAN  
CONSERVATION CORPS ROCK WORK ALONG GENERALS HIGHWAY FROM  
ASH MOUNTAIN TO GIANT FOREST IN SEQUOIA NATIONAL PARK

HARLAN D. UNRAU  
HISTORIAN  
WESTERN TEAM  
DENVER SERVICE CENTER

AUGUST 1988

#### E. PHOTOGRAPHS OF EXISTING ROCK WORK CONDITIONS

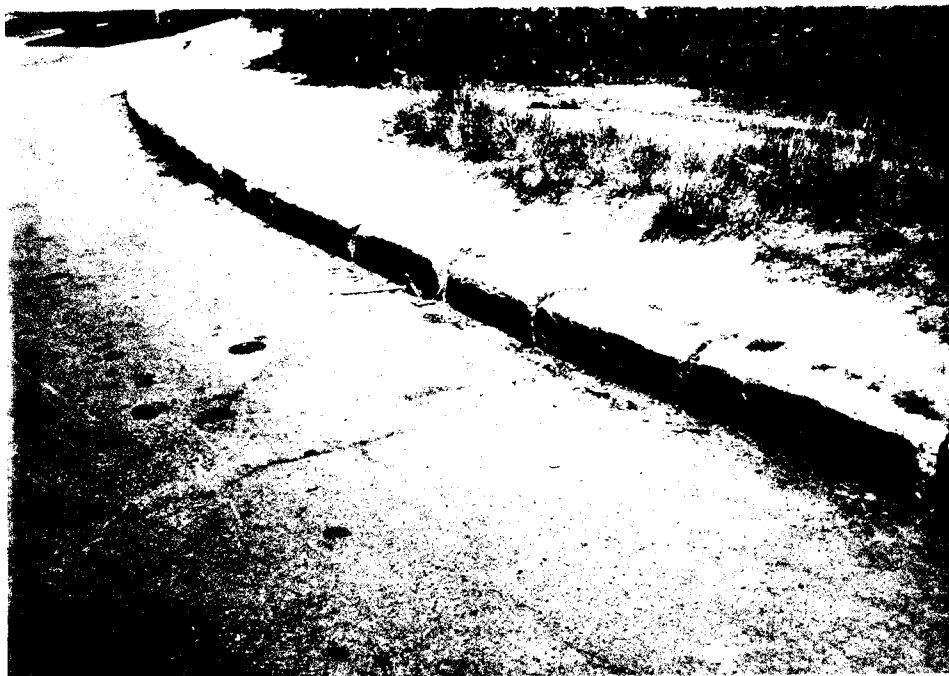
Photograph No. 1 -- Cut stone curbing around parking lot at Grant Forest Market Plaza

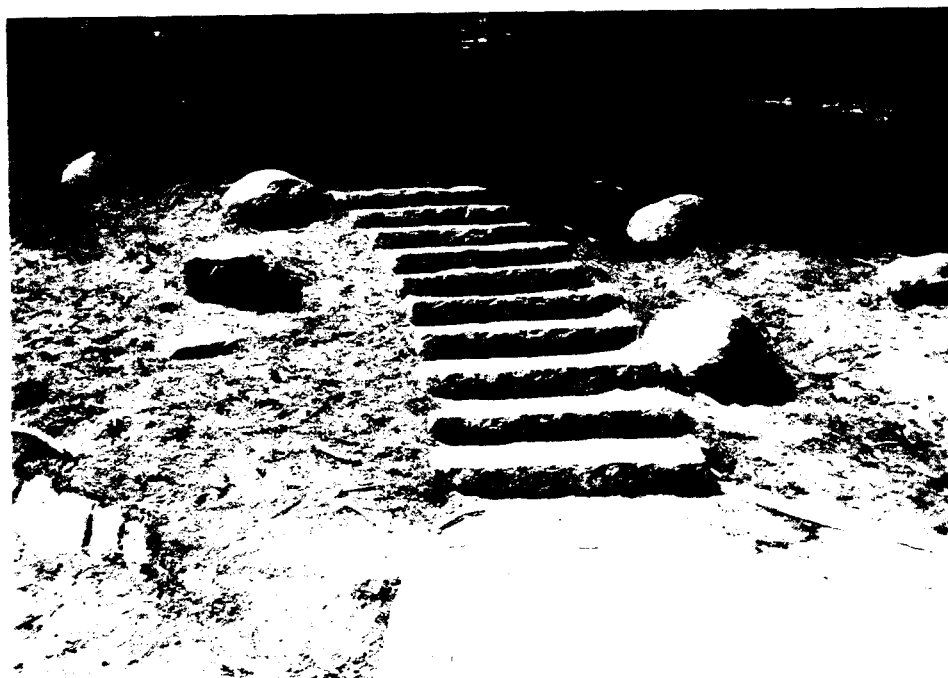
Photograph No. 4 -- Cut stone steps leading from  
highway toward Camp Kaweah Motel area

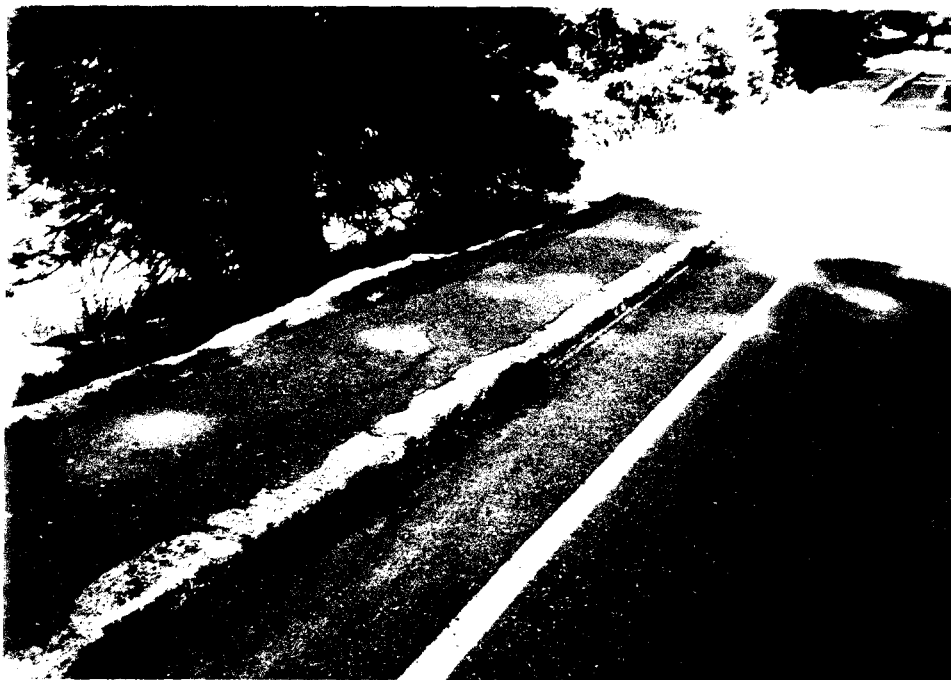
Photograph No. 5 -- Blacktop walk between cut stone curbing along highway just above Giant Forest Market Plaza

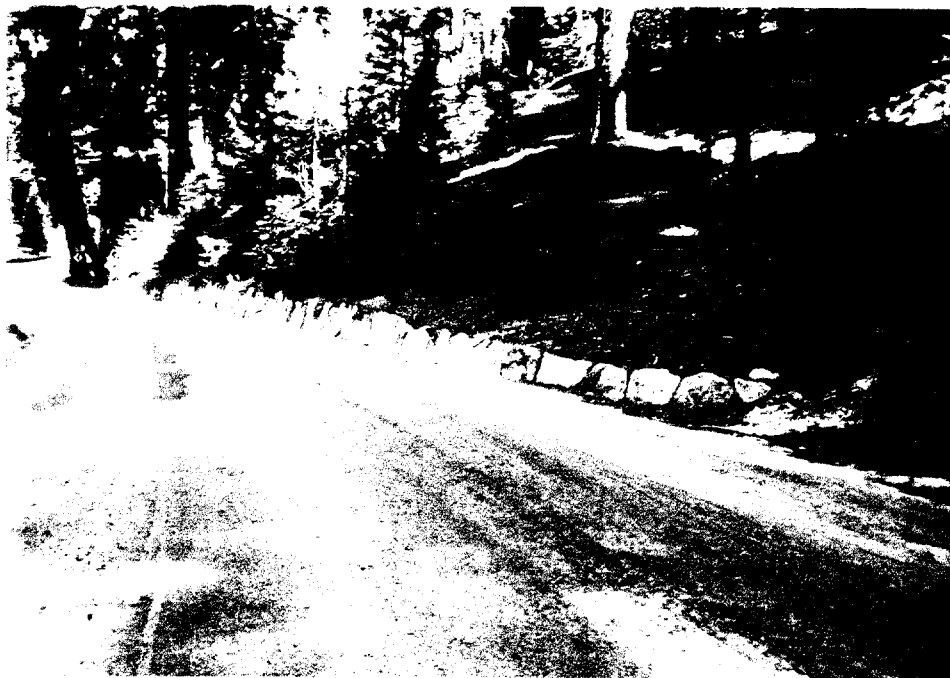
Photograph No. 7 -- Stone retaining wall along highway  
just above Giant Forest Market Plaza

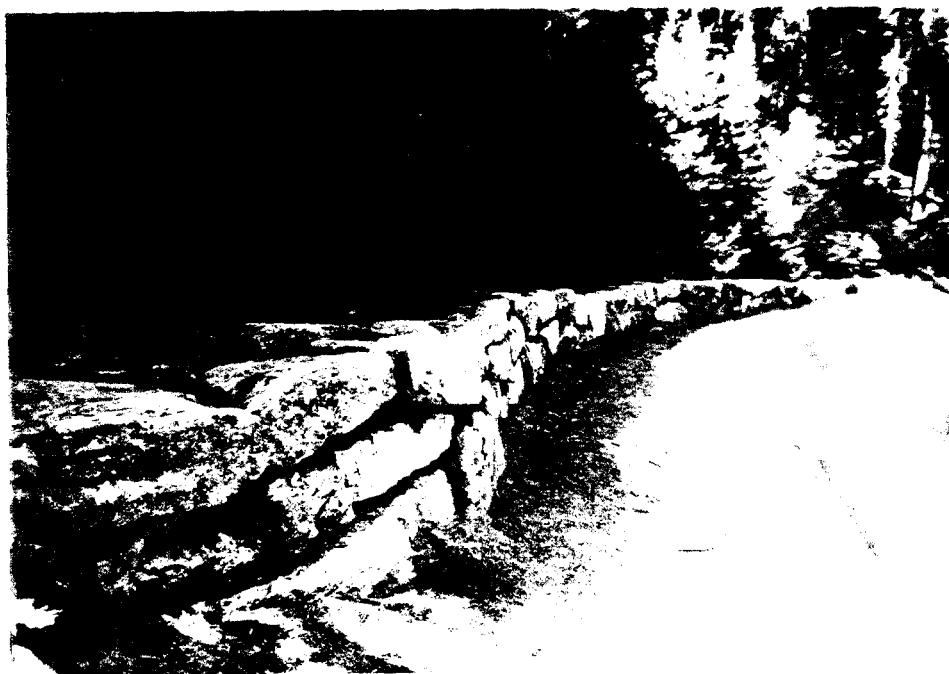
Photograph No. 10 -- Longest example of low granite retaining wall along highway; on upslope side just below Wall Spring (0.9 mile below Giant Forest Market)

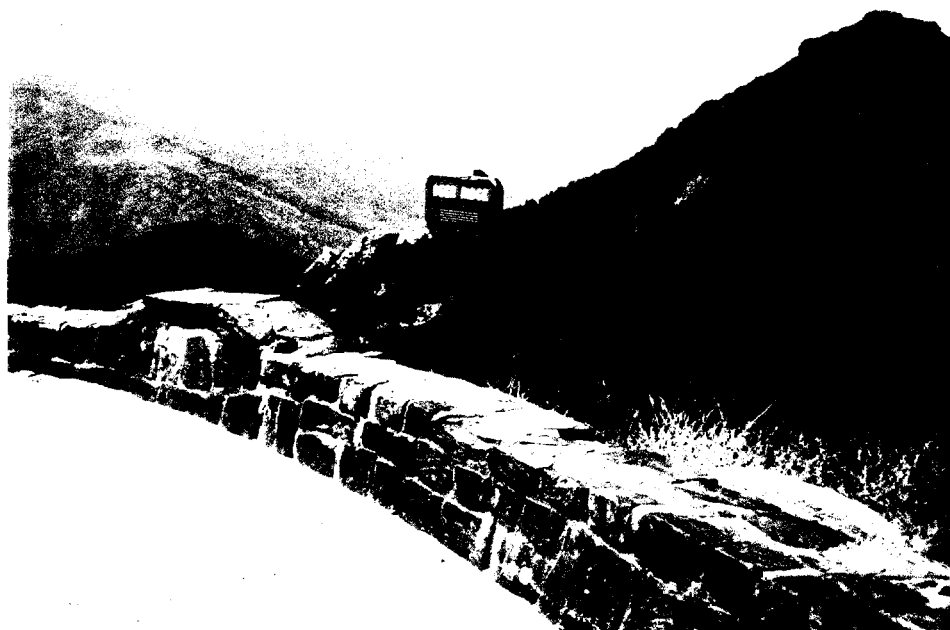
Photograph No. 14 -- Deer Ridge overlook parapet rock wall on downslope side of highway; uppermost turnout of rustic design (4.0 miles below Giant Forest Market)

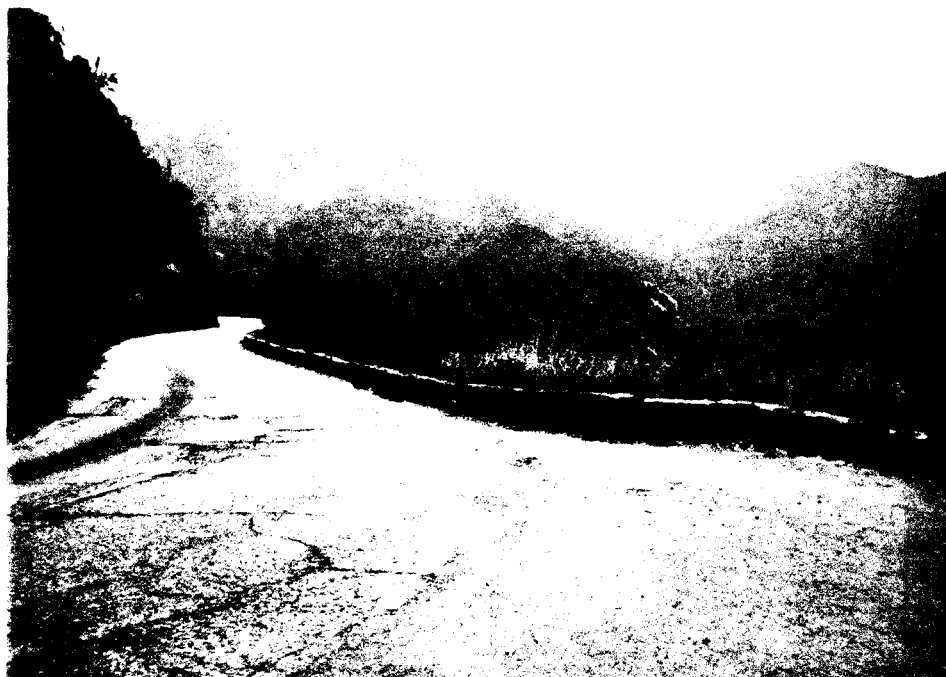
Photograph No. 15 -- Parapet rock wall at Deer Ridge overlook and  
along downslope side of highway below turnout  
(4.0 miles below Giant Forest Market)

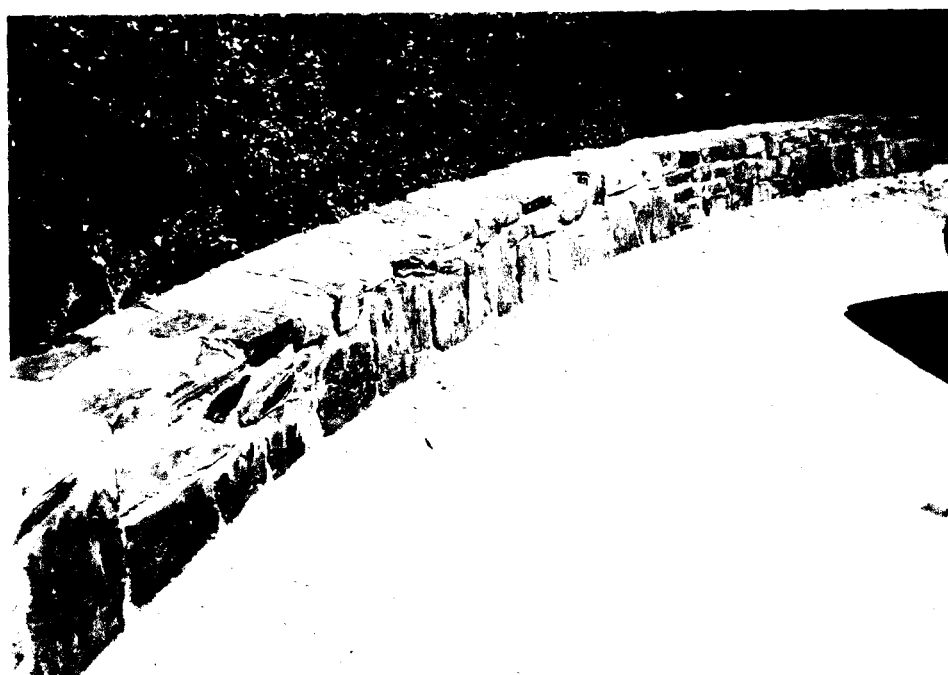
Photograph No. 16 -- Parapet rock wall at Deer Ridge  
overlook on downslope side of highway  
(4.0 miles below Giant Forest Market)

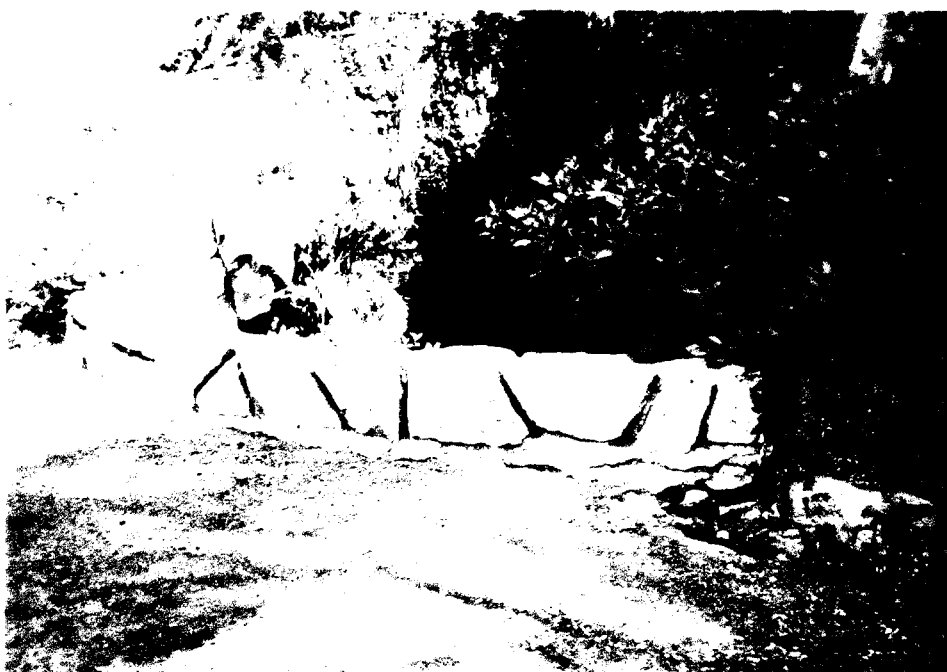
Photograph No. 17 -- Granite Spring rock work on  
upslope side of highway; water fall ring  
(4.7 miles below Giant Forest Market)

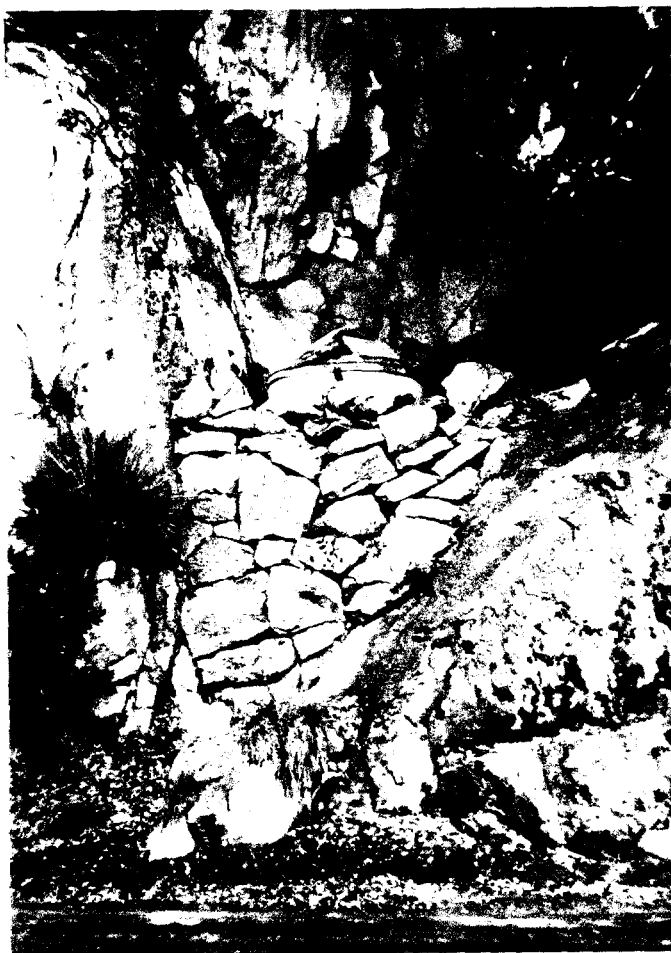
Photograph No. 18 -- Granite Spring water tower and stone  
retaining wall on upslope side of highway  
(4.7 miles below Giant Forest Market)

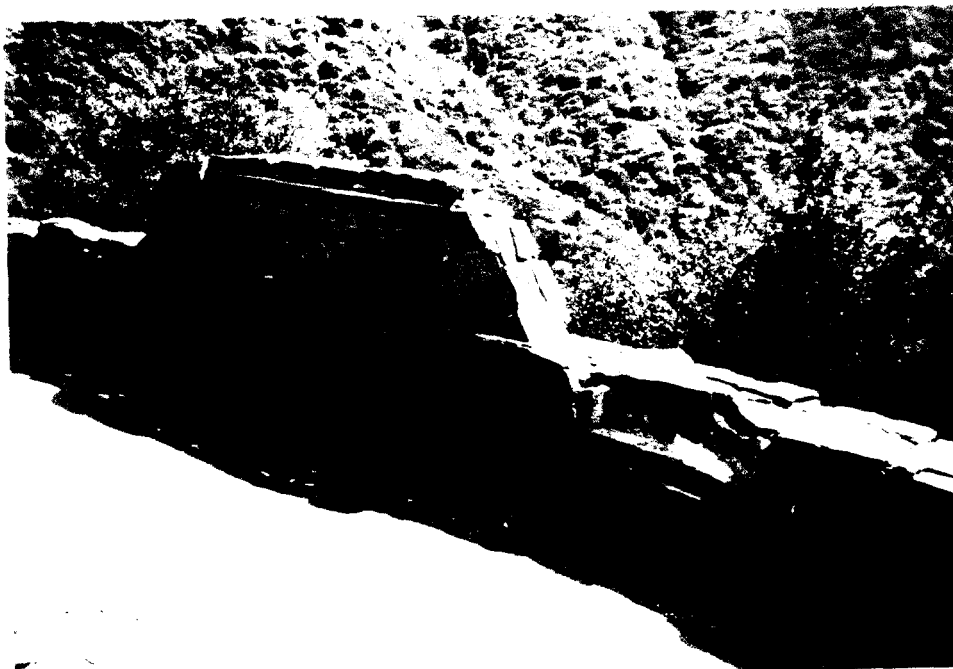
Photograph No. 22 -- Amphitheater Point overlook parapet wall along downslope side of highway; only place where signing, exhibit and visitor view platform is located along highway (5.55 miles below Giant Forest Market)

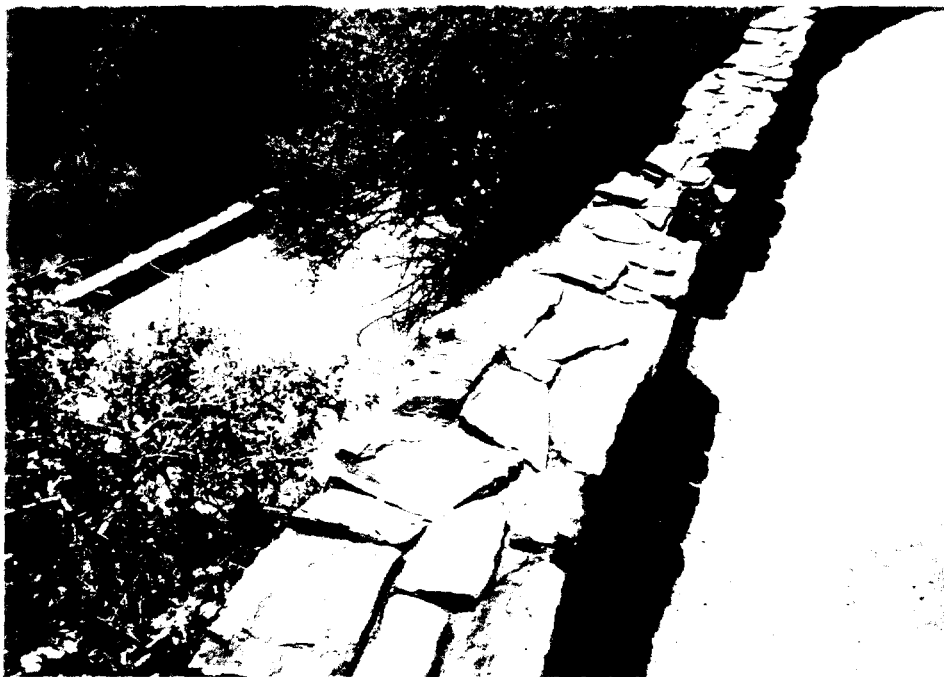
Photograph No. 25 -- Amphitheater Point overlook parapet wall in foreground with parapet wall along downslope side of highway below (5.55 miles below Giant Forest Market)

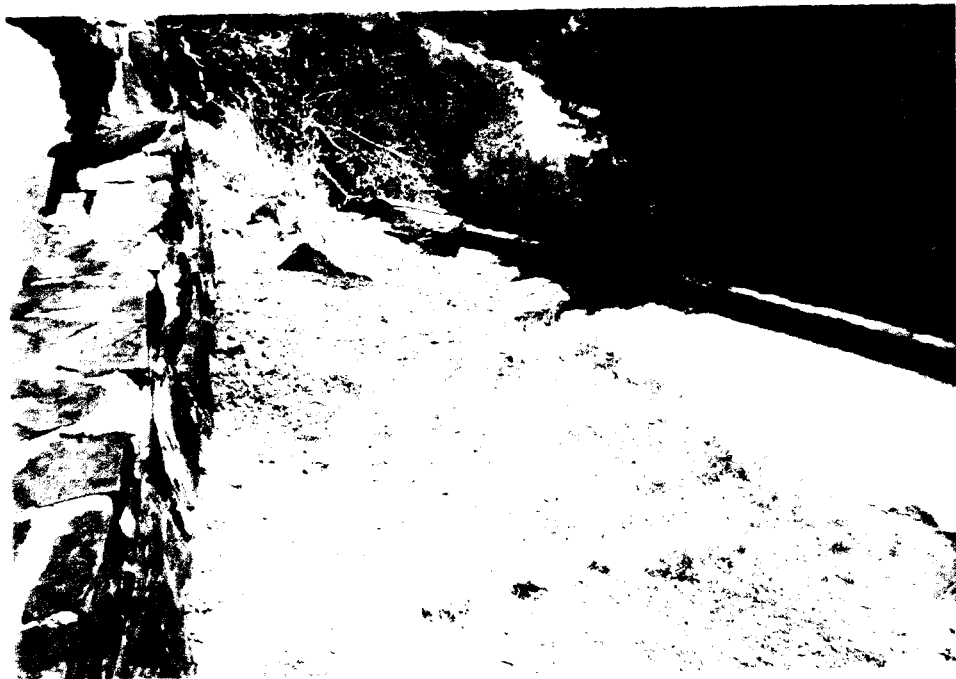
Photograph No. 26 -- Amphitheater Point overlook parapet wall at left; parapet forms top of stone retaining wall on upslope side of highway below; parapet wall along downslope side of highway below at right (5.55 miles below Giant Forest Market)

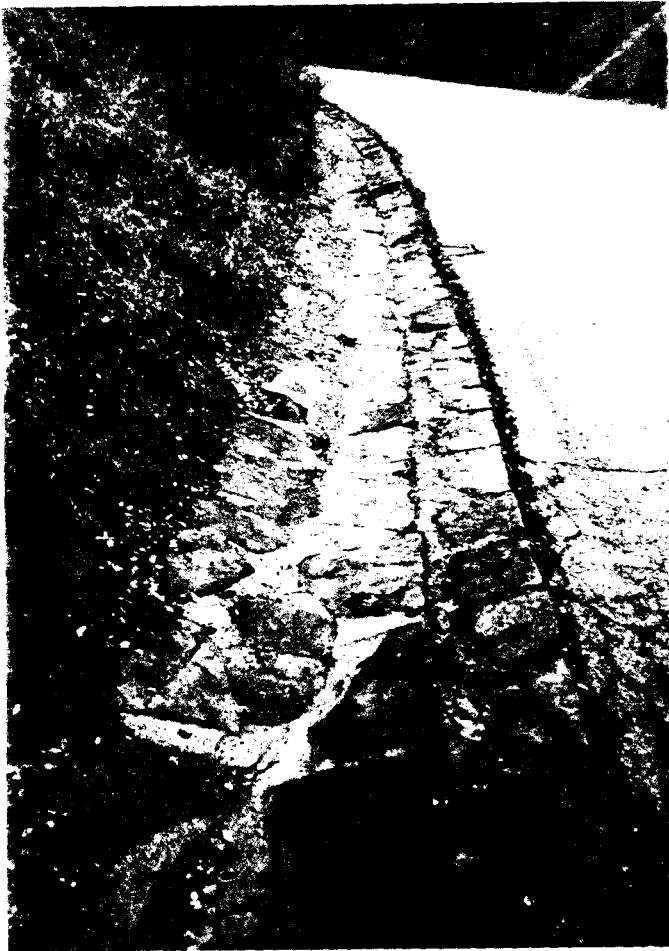
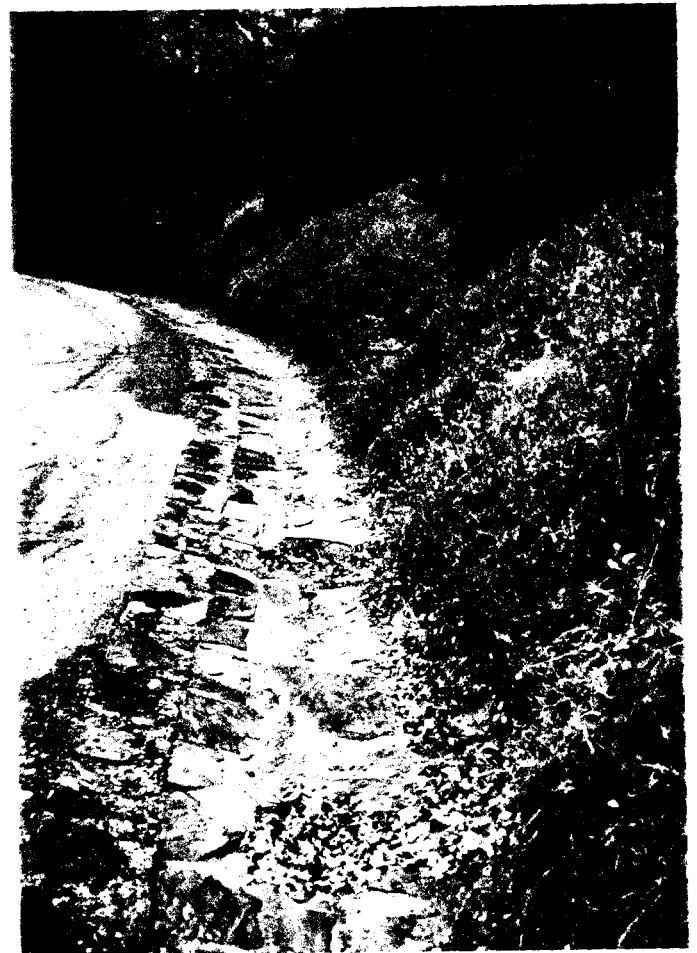
Photograph Nos. 53 and 54 -- Stone-lined gutter on upslope  
side of highway near Ash Mountain  
(15.1 miles below Giant Forest Market)

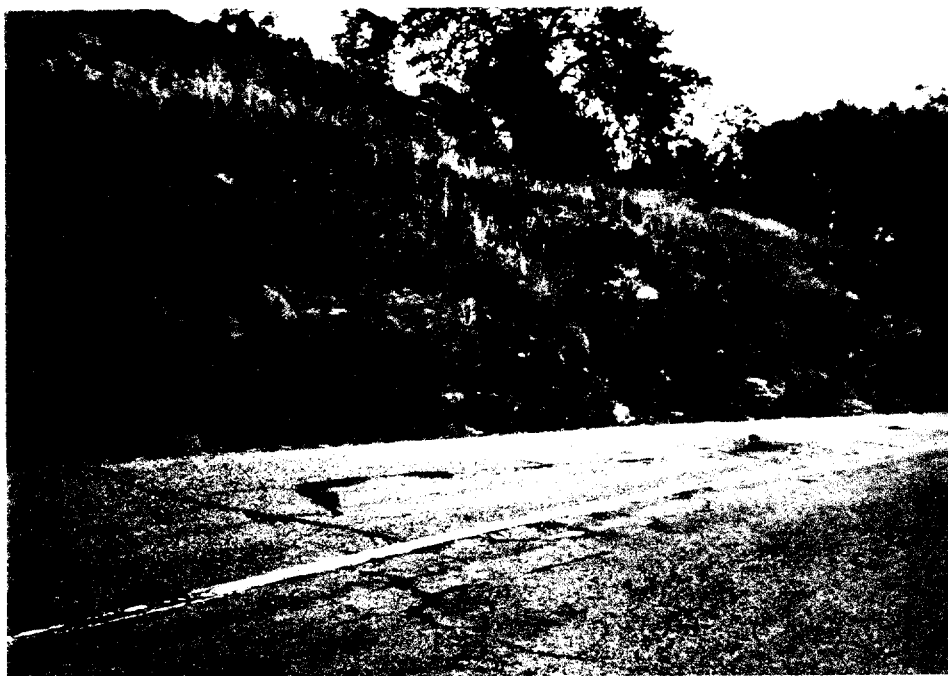
Photograph No. 64 -- Stone retaining wall along upslope side  
of highway between Ash Mountain and south park entrance  
(15.75 miles below Giant Forest Market)

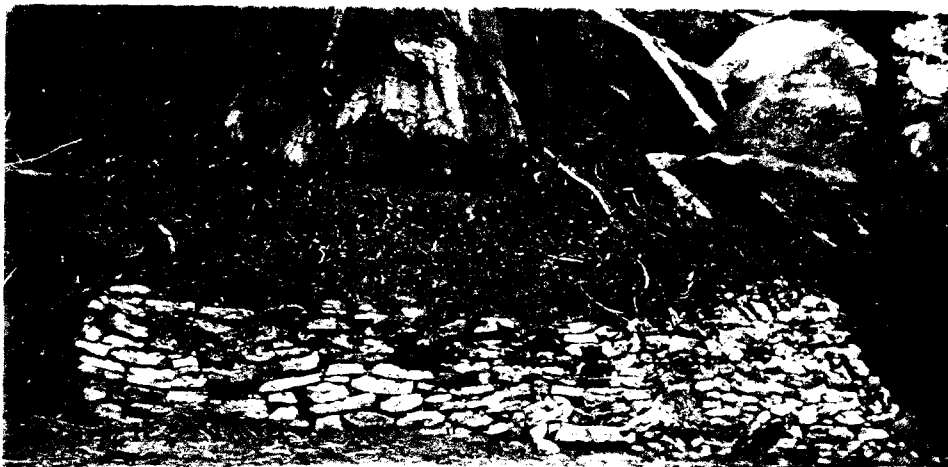
Photograph No. 69 -- Loose rock retaining wall along upslope side of highway to protect Sequoia tree  
(1.85 miles above Giant Forest Market)

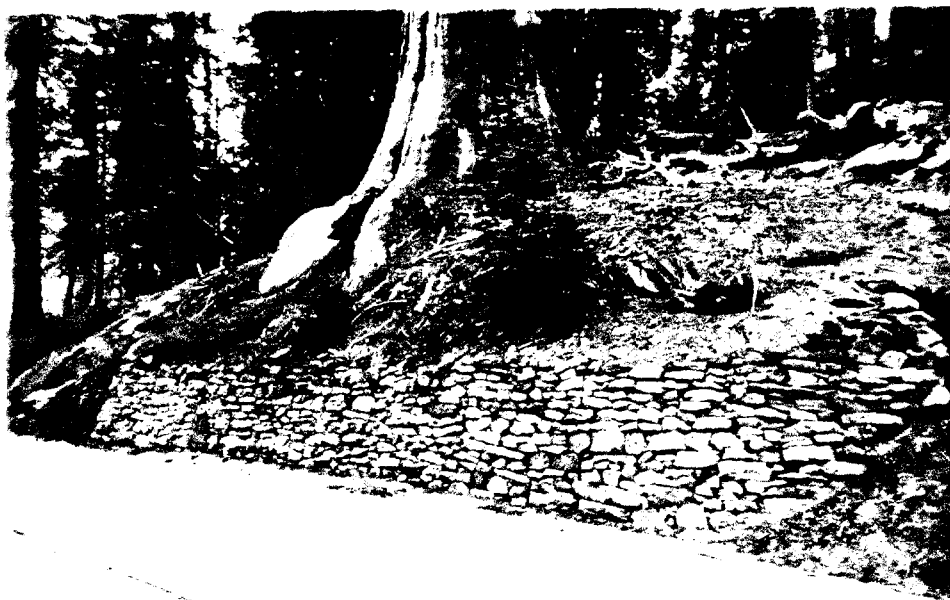
Photograph No. 70 -- Loose rock retaining wall along  
upslope side of highway to protect Sequoia tree  
(1.9 miles above Giant Forest Market)
