Civilian Conservation Corps  
Technical Building  
Historic Structure Report  
Piney River, Shenandoah National Park  
Luray, Virginia  
September 2020

# Civilian Conservation Corps (CCC) Technical Building

Shenandoah National Park

Lowell, Massachusetts  
September 2020

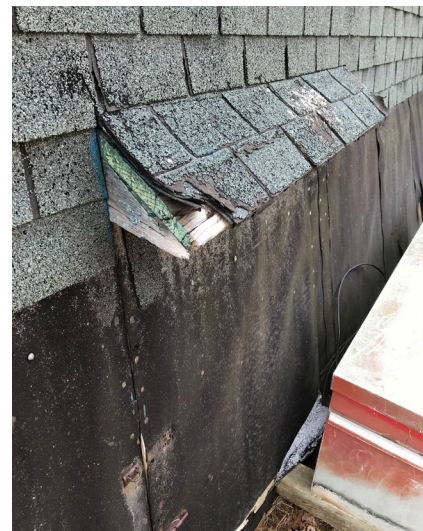
The CCC Technical Building is built upon a pier foundation. Crawlspace access is located on the southeast corner of the building. The opening is filled with a wood door covered in black asphalt siding and is sheltered with a small, pent roof. (Figure 4.1) A thorough inspection of the foundation by the Denver Service Center resulted in a detailed, measured description of the foundation framing:

**Figure 4.1.** Crawl space access door and pent roof, August 24, 2020. (Image by author)

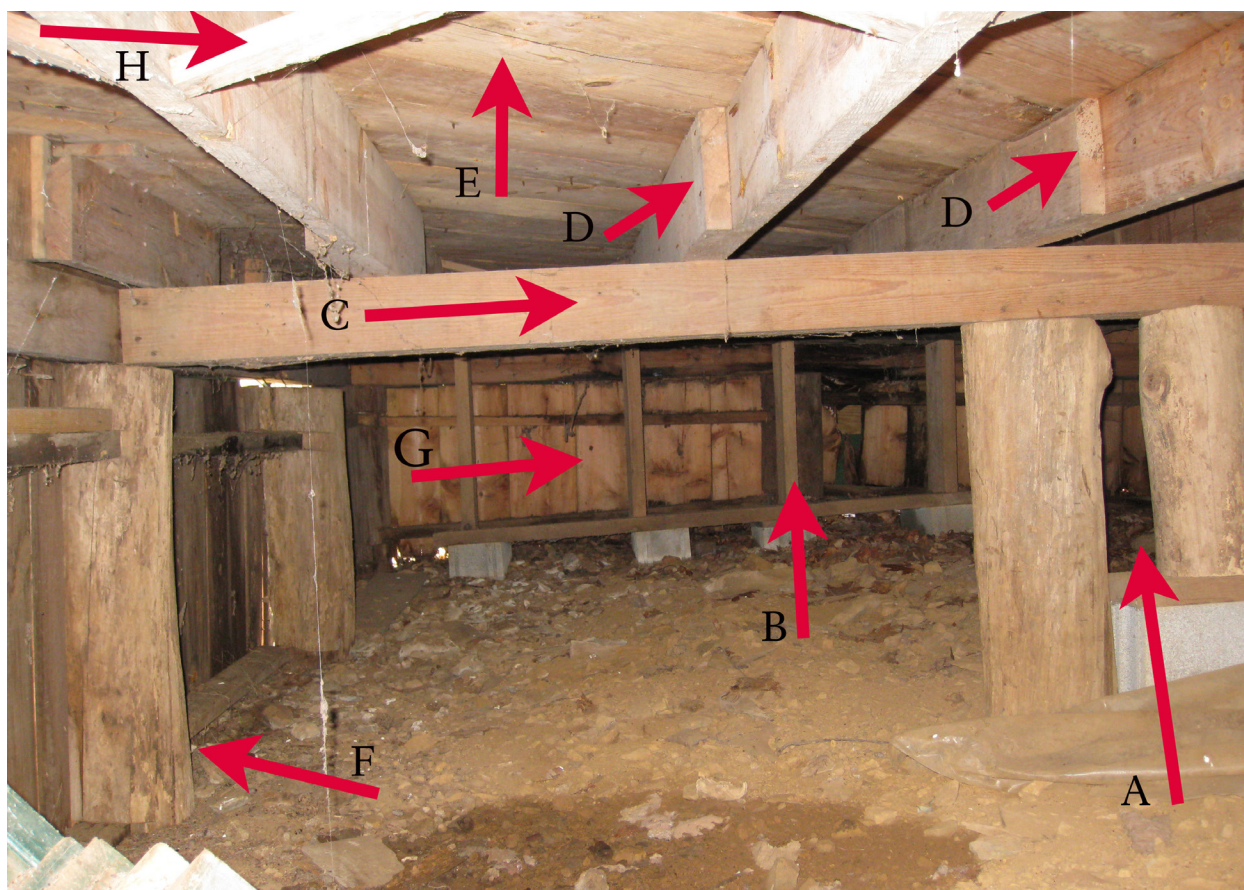
**Figure 4.2.** Crawlspace looking west, August 24, 2020. A: Center Row of pier logs. B: Replacement pier studs. C: North-south beam. D: Lap-spliced floor joists. E: Diagonal sub-floor. F: Original perimeter log pier. G: Vertical wood boards enclosing crawlspace. H: Wood bridging. *(Image by author)*

The wood logs that make up the perimeter of the pier foundation are set either on the ground or resting on concrete blocks. In some cases, the logs are missing, and square wood posts are resting on a wood board straddling a row of concrete blocks. A row of log piers runs down the center of the structure. Occasionally these logs are missing or have been supplemented with smaller logs resting on concrete blocks, elevating the center wood beam above the height of the larger log. (Figure 4.2) The floor joists are resting on a wood beam running north to south. The joists nearer to the south wall and on the west side of the center beam are lap-spliced. The space between floor joists is filled with wood bridging and fiberglass insulation, which in many places has deteriorated or fallen onto the ground. The structure's subfloor is made of wood planks running diagonally from southeast to northwest. The dirt crawlspace floor is lined with plastic sheeting,

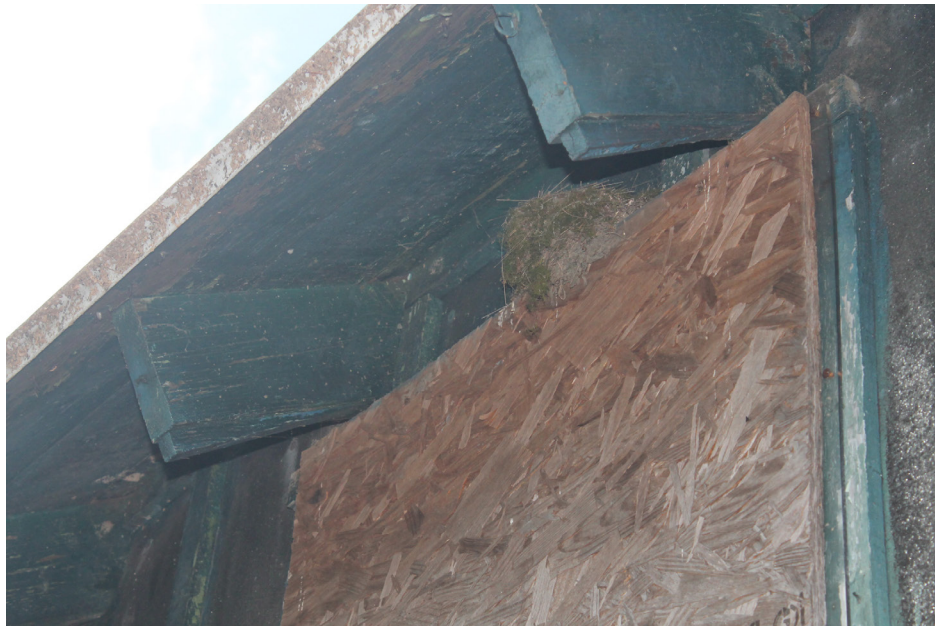
**Figure 4.5.** (top) West elevation shimmed rafter tails, August 25, 2020. *(Image by author)*

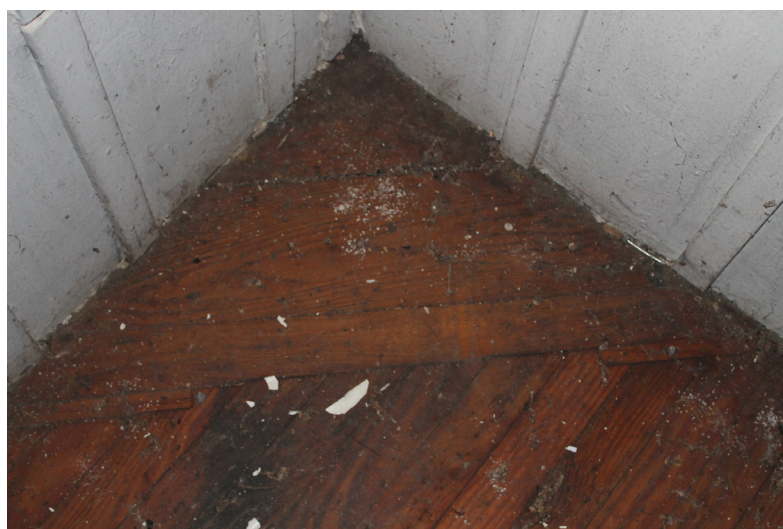
**Figure 4.20.** (right) R102, northeast corner flooring, August 24, 2020. *(Image by author)*

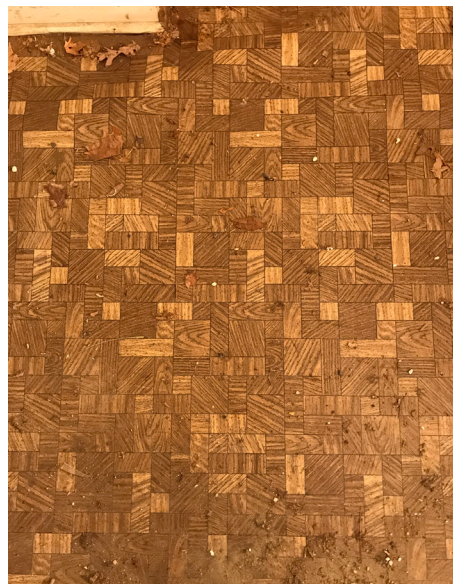
**Figure 4.29.** (right) R104 vinyl flooring, February 25, 2020. (Image by author)
