# HISTORIC STRUCTURE and CULTURAL LANDSCAPE REPORT

South Manitou Island Light Station  
(Historic Structures 51-120 A-I)

Sleeping Bear Dunes National Lakeshore  
Empire, Michigan

January 29, 1999  
Final Report  
Project # 94117.01

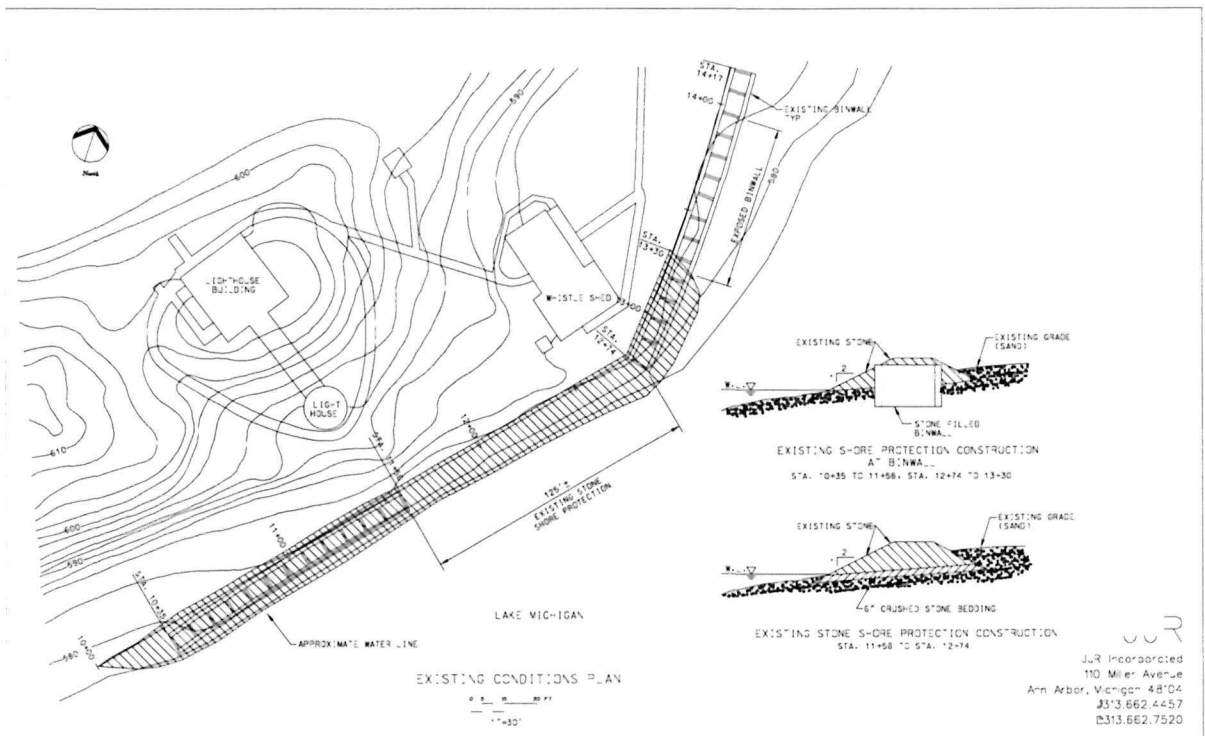
**Figure 15** Existing shoreline conditions.

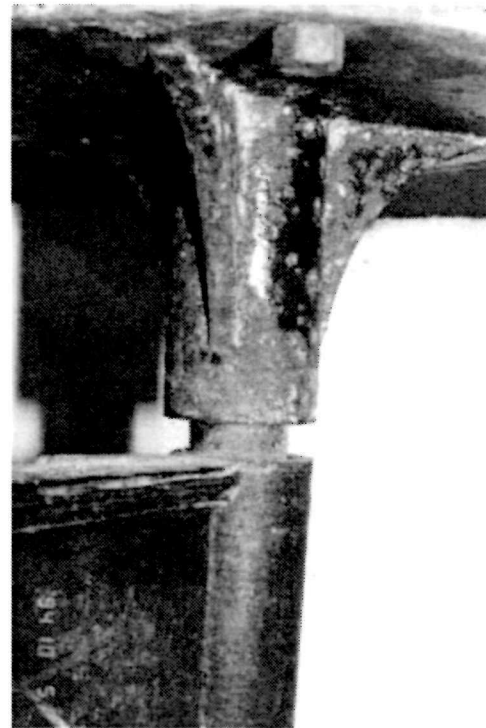
**Figure 7** View of the 1" gap at the top of the spiral stair, 1995.

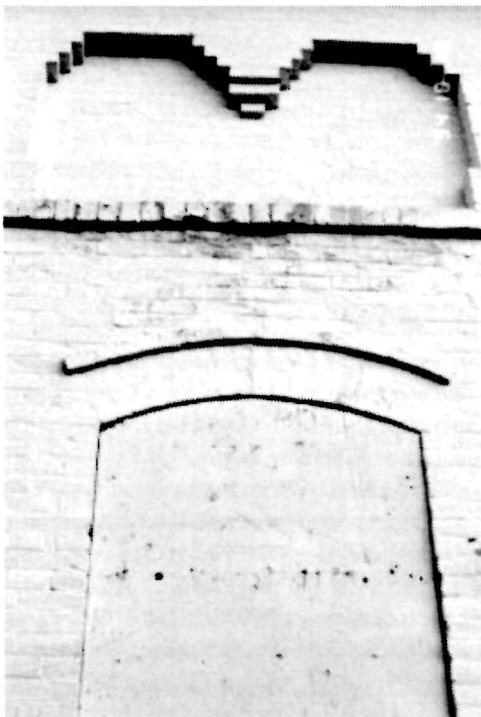
**Figure 15** View of the south wall of the Keeper's Dwelling, showing the cracked keystone, 1995.

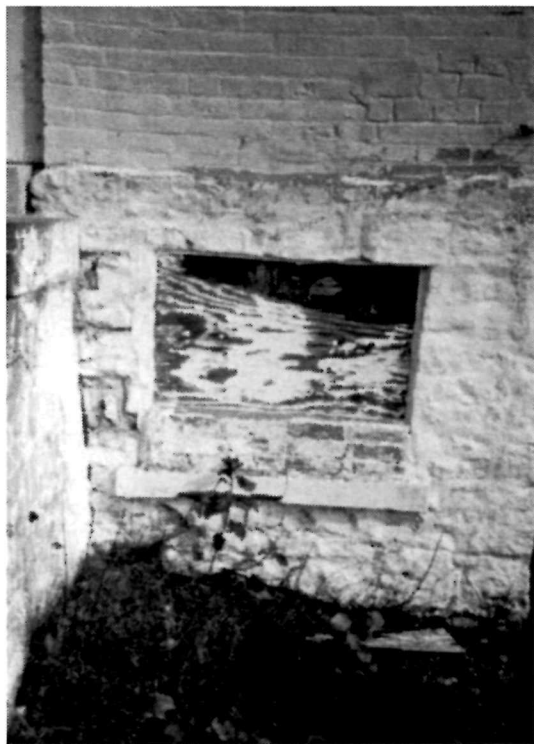
**Figure 29** View of the basement window (D-1) at the east end of the south elevation of the Keeper's Dwelling, 1994. Note the deteriorated foundation wall between the window and the concrete steps.

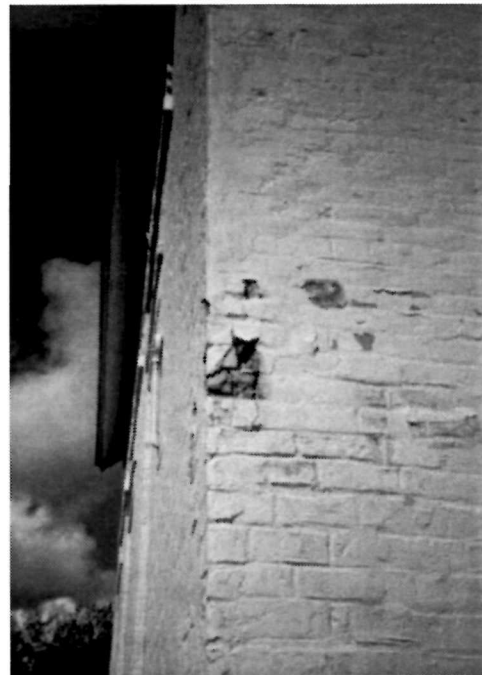
*Figure 34 View looking west at the southeast corner of the Keeper's Dwelling, 1994. Note the deteriorated condition of both the cementitious parging and the underlying brick.*

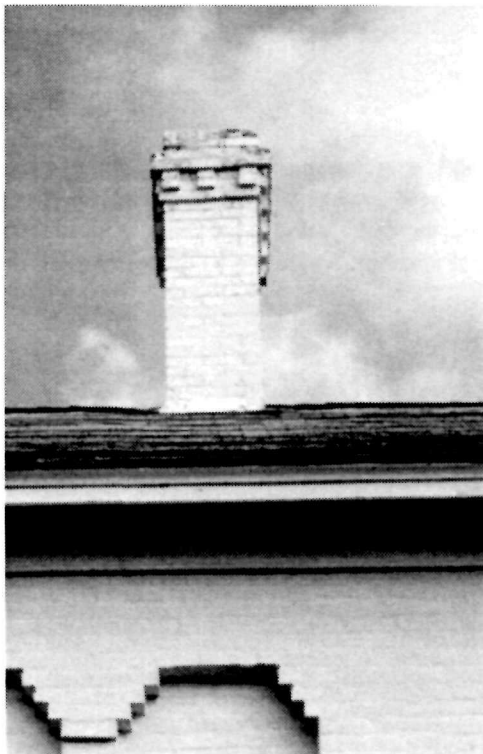
**Figure 37** View of the deteriorated top portion of the chimney, 1994.

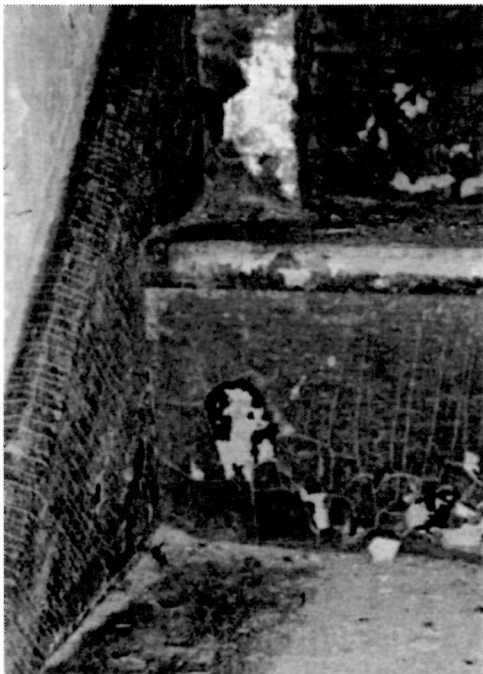
**Figure 55** Detail view of the basement stair (Room B-04) of the Keeper's Dwelling, 1994. Note the paint failure and buildup, and the change in color indicating the previous location of the stair runner.

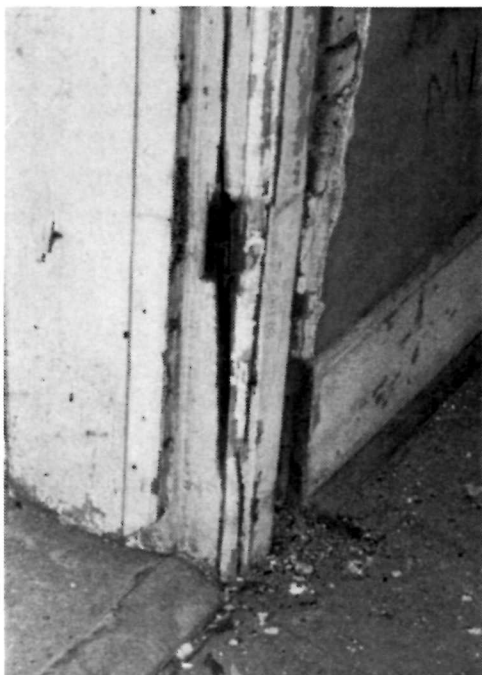
**Figure 59** Detail view of the deteriorated and damaged wood door jamb at Door E-4 in Room 101 of the Keeper's Dwelling, 1994.

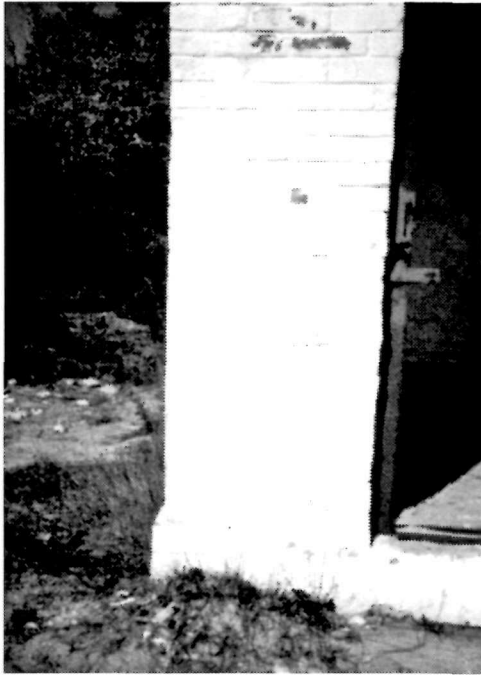
*Figure 76 Detail view of the south corner of the east elevation of the Brick Oil House, 1994. Note the parging, which was tooled to resemble brickwork and is falling off.*

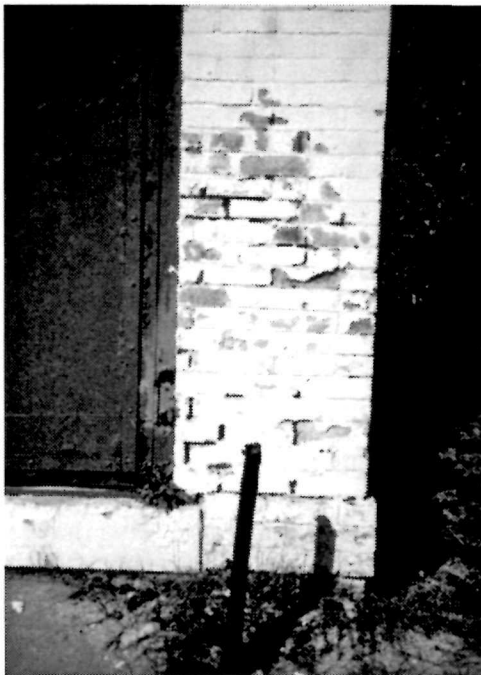
*Figure 77 Detail view of the north end of the east elevation of the Brick Oil House, 1994. Note the spalling brick and deteriorated mortar joints.*

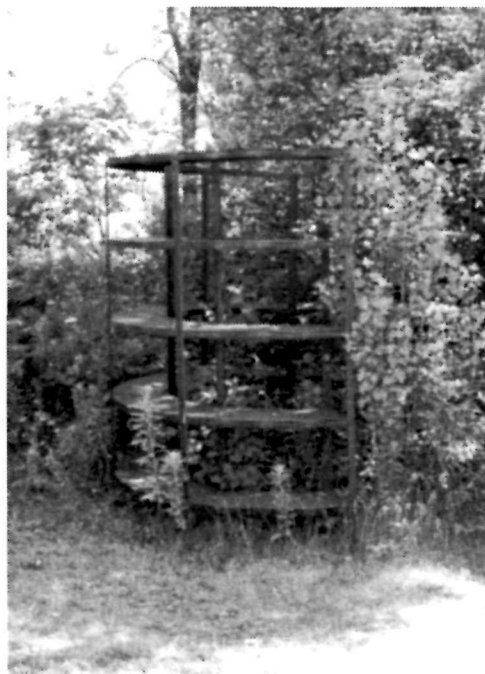
**Figure 80** View of the rusted metal shelving previously located inside the Metal Oil House, 1994.
