# Delassus-Kern House

STE. GENEVIEVE NATIONAL HISTORICAL PARK  
STE. GENEVIEVE, MO

## Historic Structure Report

PMIS 311634  
OCTOBER 2024

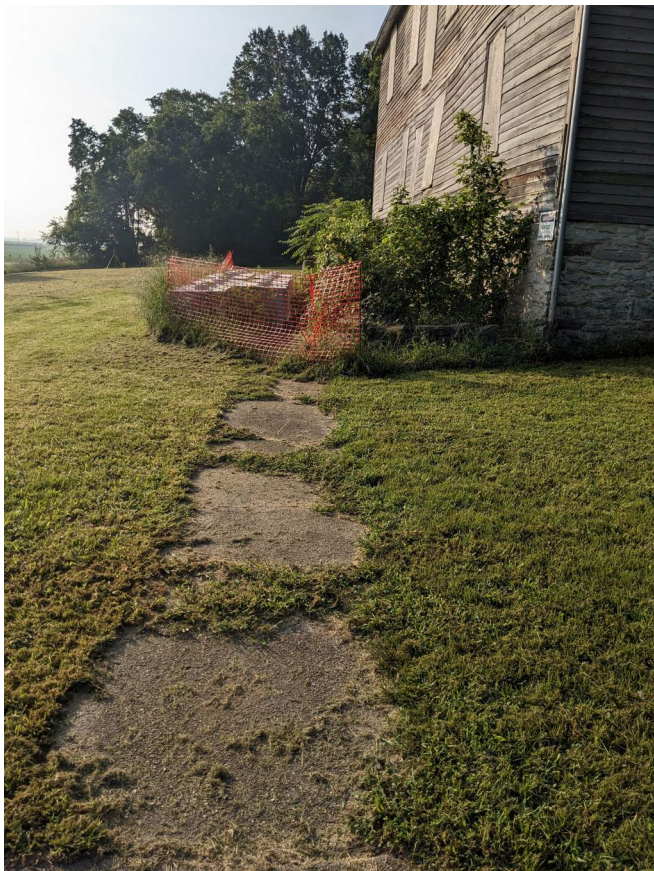
The walk measures 3 feet 6 inches in width and continues 28 feet toward the site of the front door. The concrete is broken, and grass is growing through the cracks and over top of the surface of the walk.

Figure 86. View southeast along the concrete walk connecting the driveway with the principal façade of the house. (Source: LSHLA 2023)

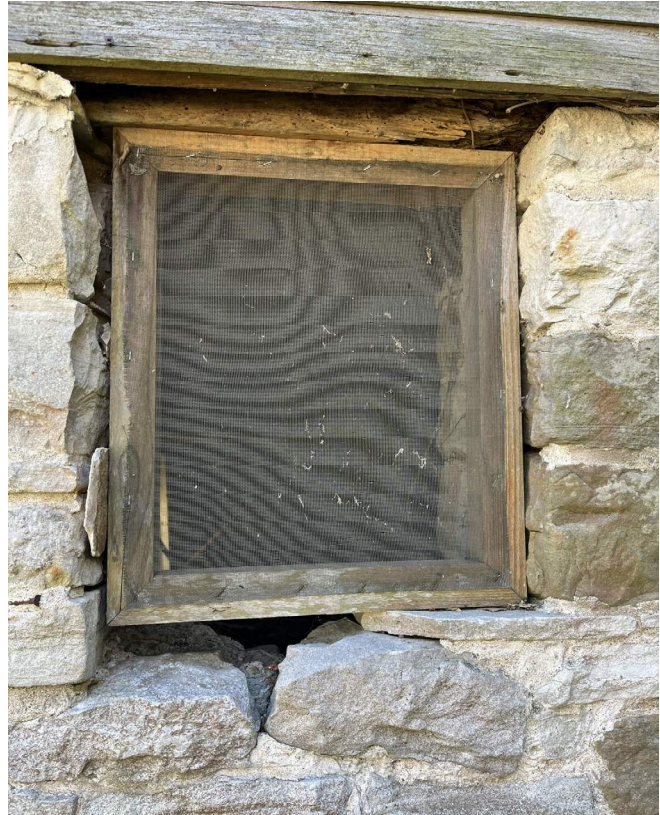
Figure 107. W001B, a basement level window on the north exterior wall, showing deterioration of the frame and masonry. (Source: RRJ 2023)

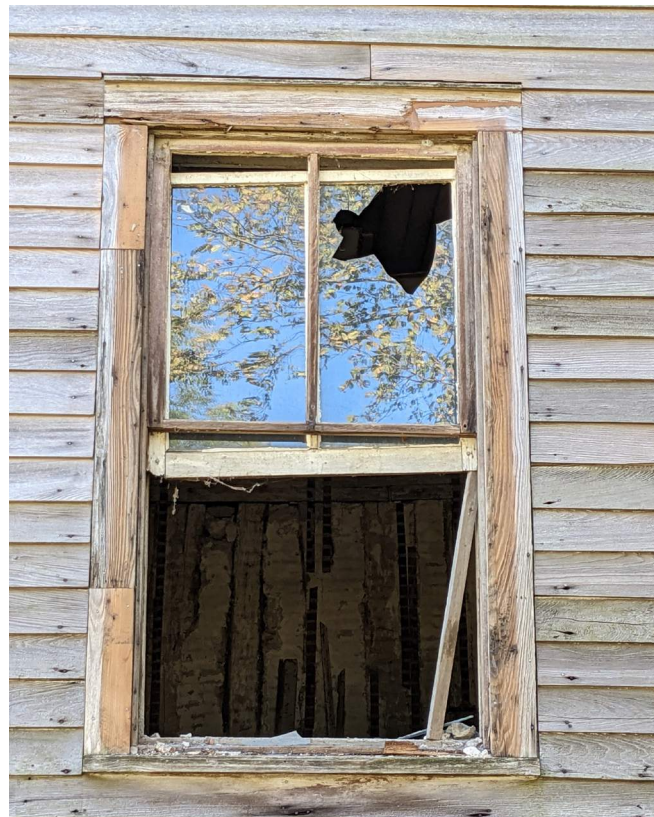
Figure 110. W104A, a first floor window on the east wall in failed condition, dating to the 1903 alterations to the house. (Source: RRJ 2023)

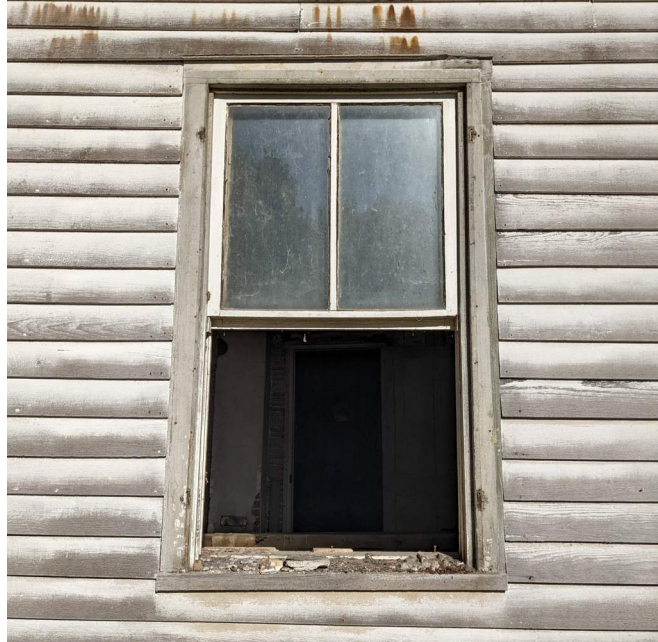
Figure 113. W106B, a first floor window on the south wall with a missing lower sash but intact upper sash, dating to the 1903 alterations to the house. (Source: RRJ 2023)

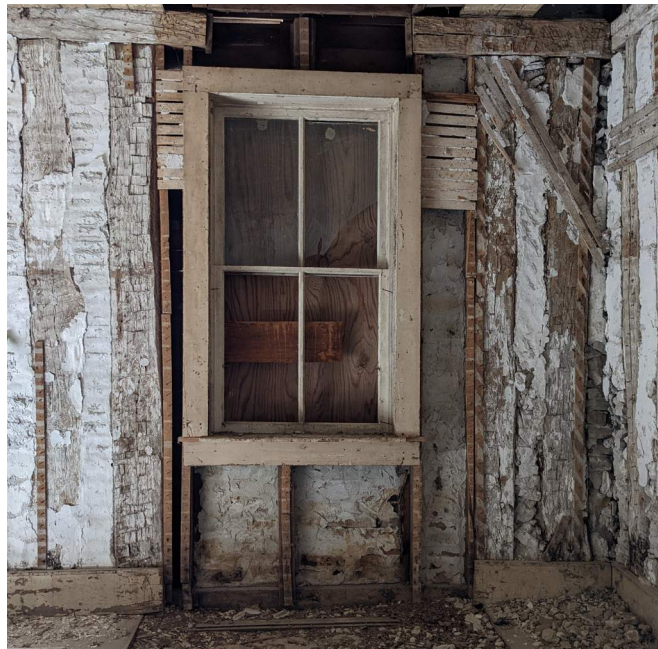
Figure 114. W106B, a first floor window on the south wall, showing the stud frame infill where the stone masonry chimney was removed. (Source: RRJ 2023)

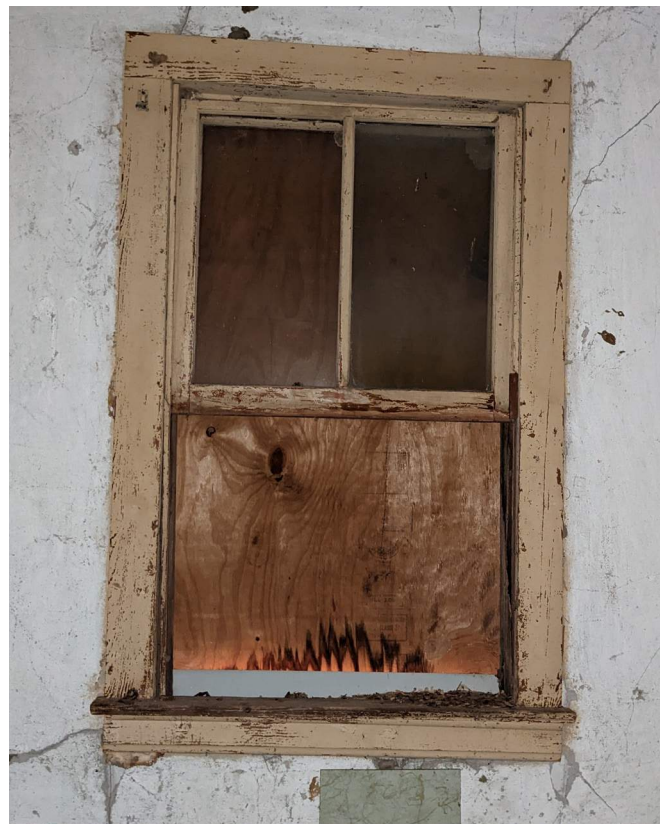
Figure 116. W201B, with missing lower sash. (Source: RRJ 2023)

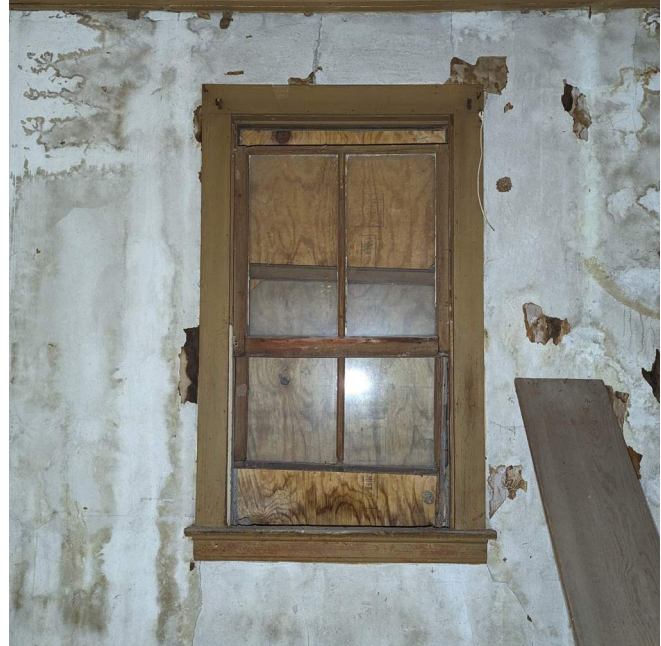
Figure 117. W203B, a second floor window on the east wall with damaged but intact upper and lower sashes with glazing. (Source: RRJ 2023)

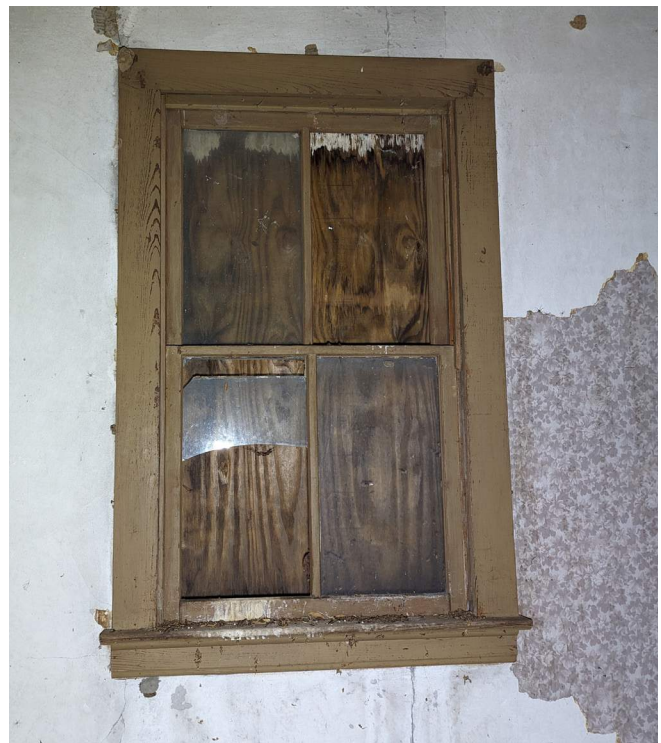
Figure 118. W204A, a second floor window on the west wall with relativelyt intact upper and lower sashes with damaged glazing. (Source: RRJ 2023)

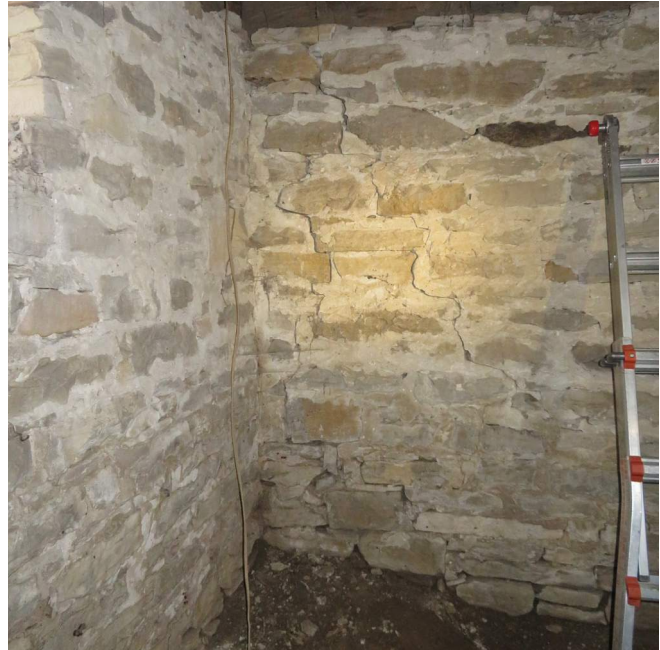
Figure 129. Step cracking and mortar deterioration at the northwest corner of the basement limestone foundation wall. (Source: RRJ 2023)

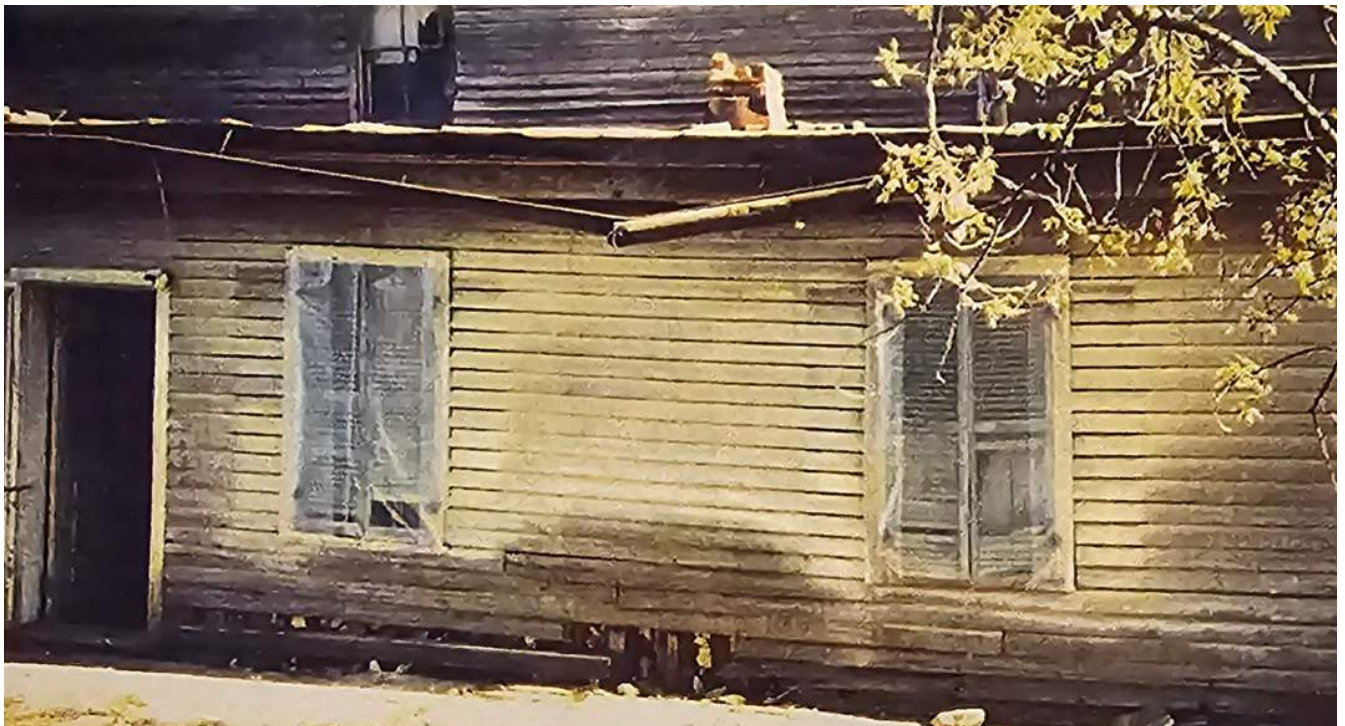
Figure 29. 2000 photograph of the west exterior, showing the deterioration and deformation of the sill plate in Rooms 101 and 102 prior to the stud wall repairs. (Source: Volz and Associates, "Pierre Delassus de Luziere House (Kern House) Condition Assessment Report").

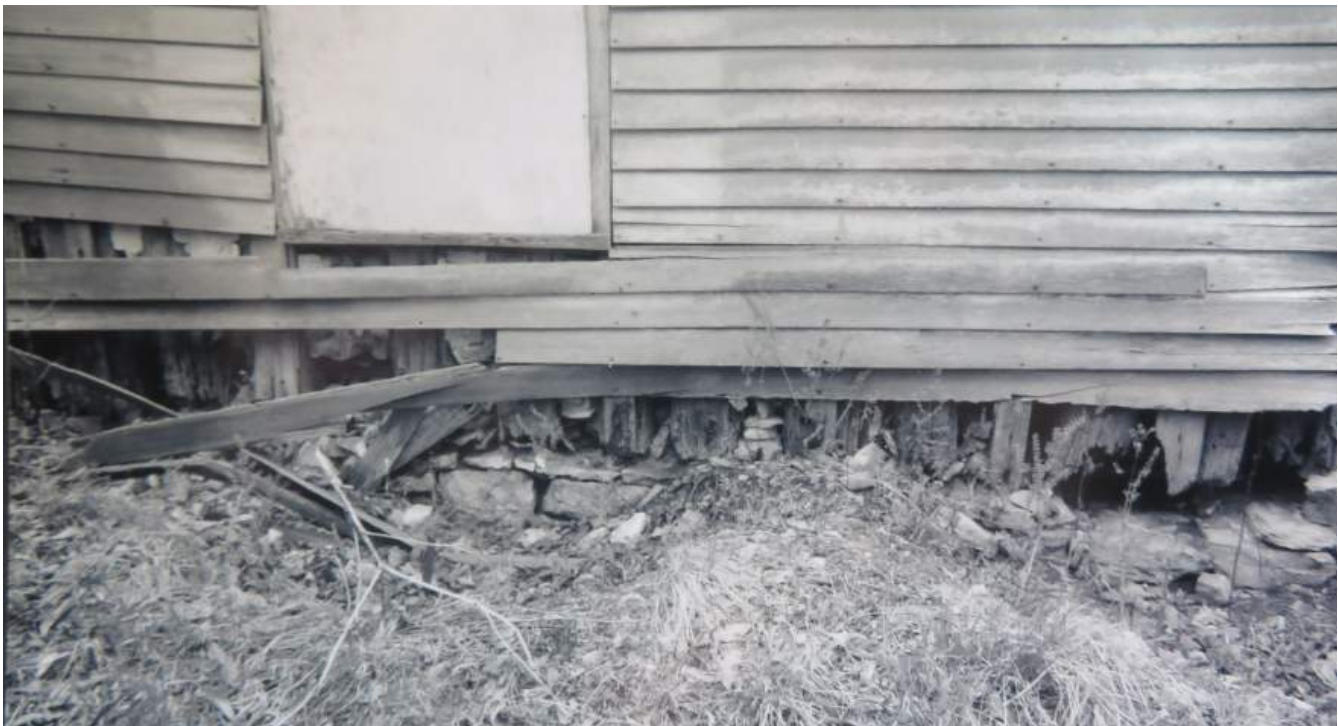
Figure 35. April 2007 photograph, showing the deterioration of the west wall sill plate and bottom of the vertical logs at Room 102. (Source: MoDNR Felix Vallé House archives)

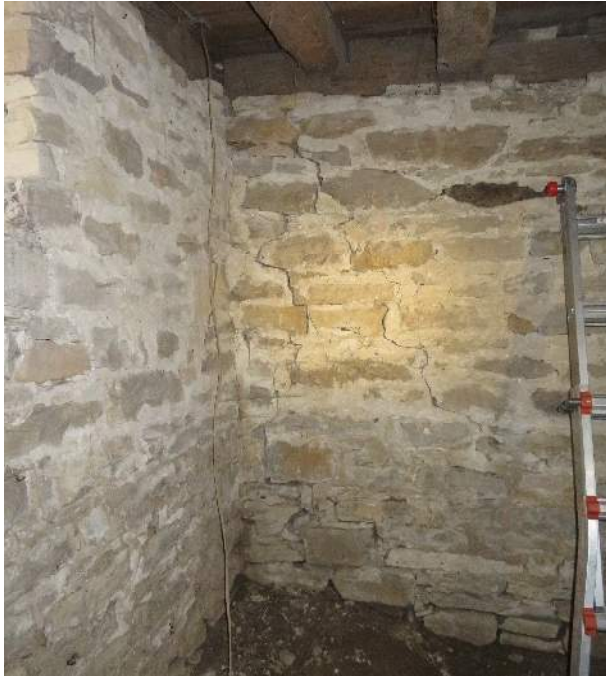
Photo 37. Step cracking at northeast corner, east wall viewed from basement.

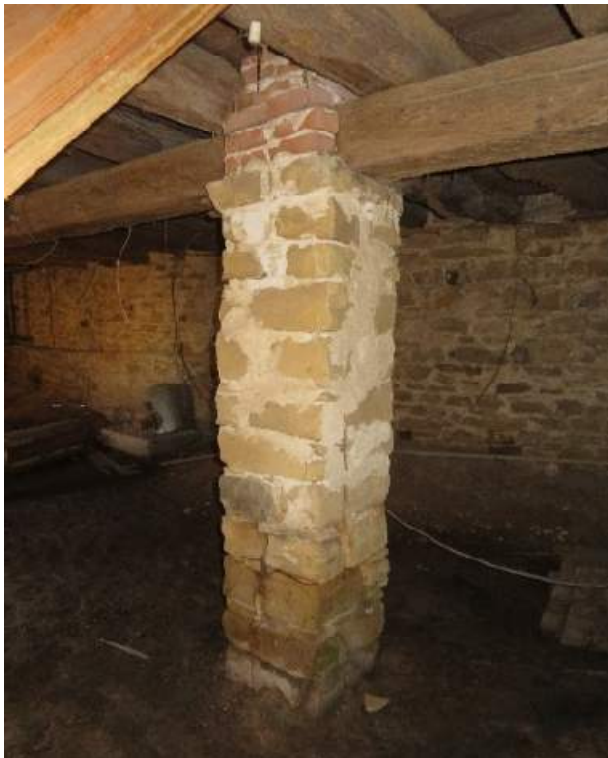
Photo 38. Masonry pier in the basement. Note mortar loss at base and transition from stone to brick masonry at the bottom face of the wood girder.

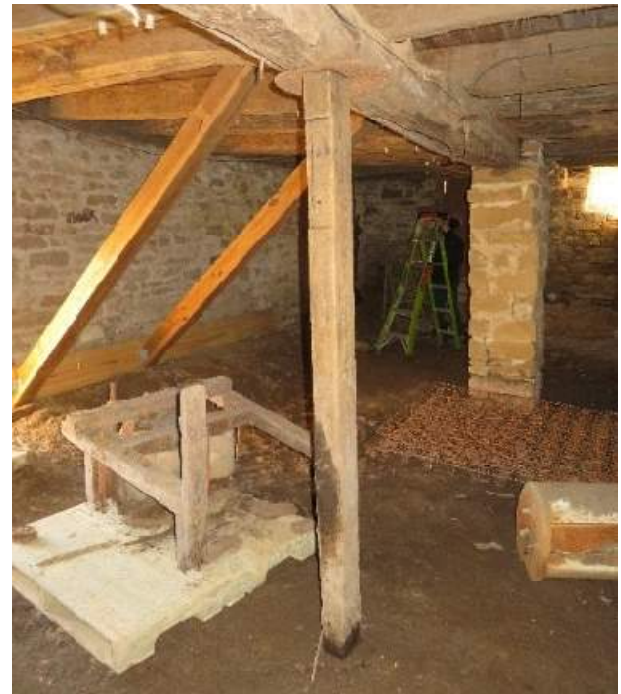
Photo 47. Timber post at girder center exhibits some wood decay at the post/soil intersection.

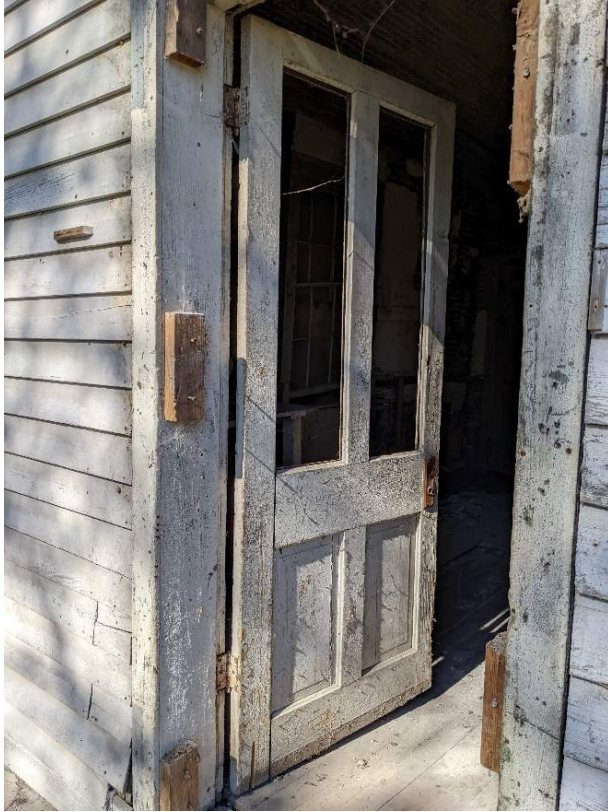
Photo 85. Door 101A, missing hardware and glass.

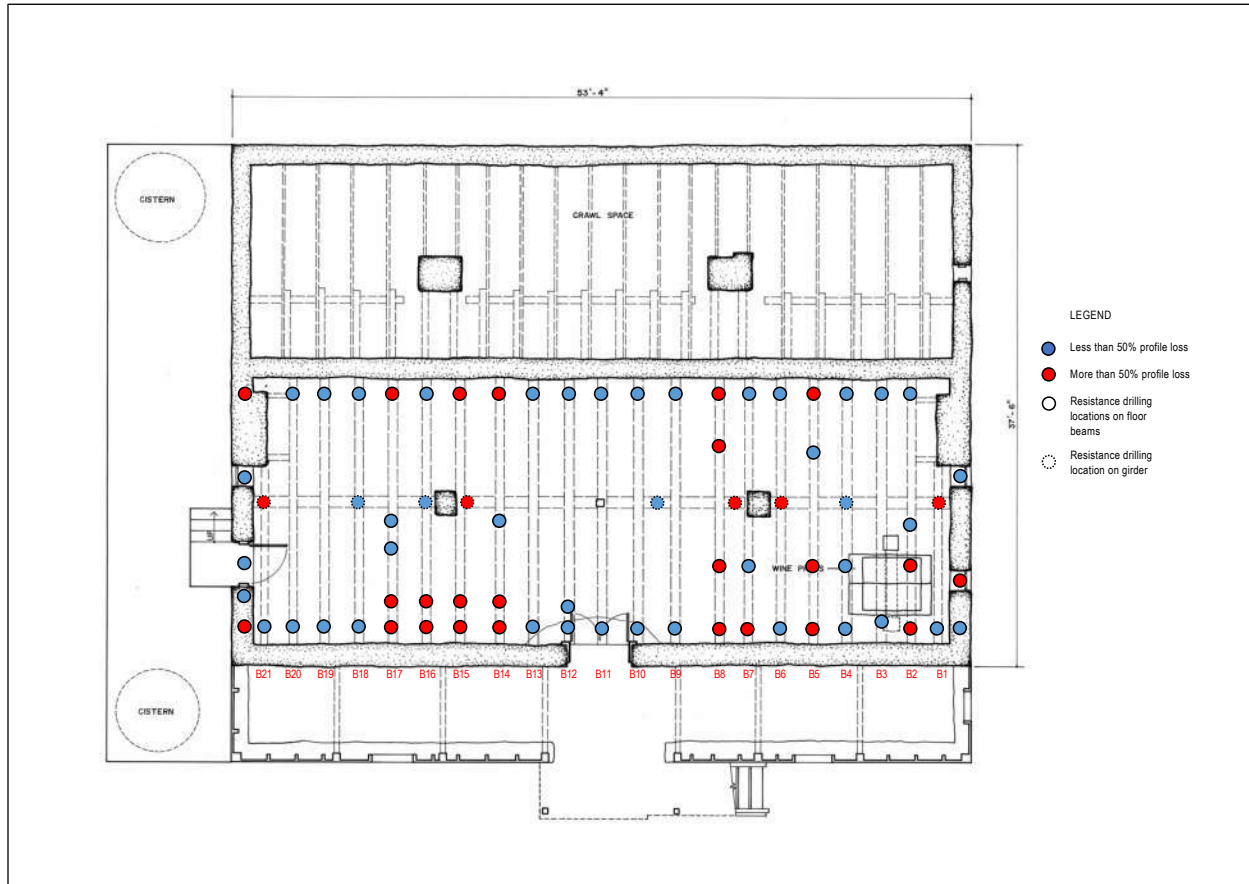
**Figure 13. Resistance drilling locations and findings for the floor framing members. Resistance drilling locations are marked as having more (red dots) or less (blue dots) than 50% profile loss at that location.**

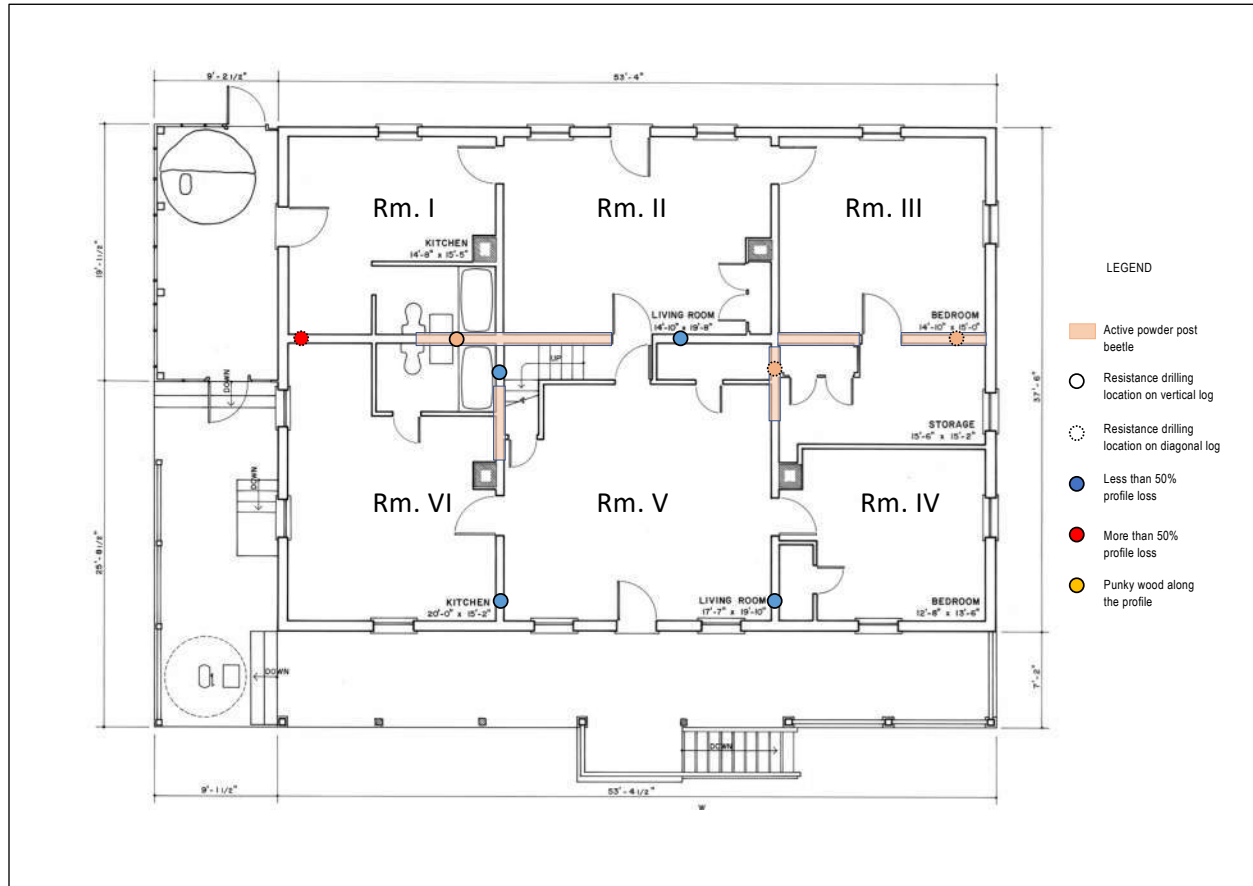
**Figure 31. Summary of findings for the first-floor interior partition walls showing wall sections with active powderpost beetle infestation and the condition of interior vertical and diagonal logs.**
