# Jean Baptiste Vallé House

STE. GENEVIEVE NATIONAL HISTORICAL PARK  
STE. GENEVIEVE, MISSOURI

## Historic Structure Report

PMIS 311236  
OCTOBER 2024

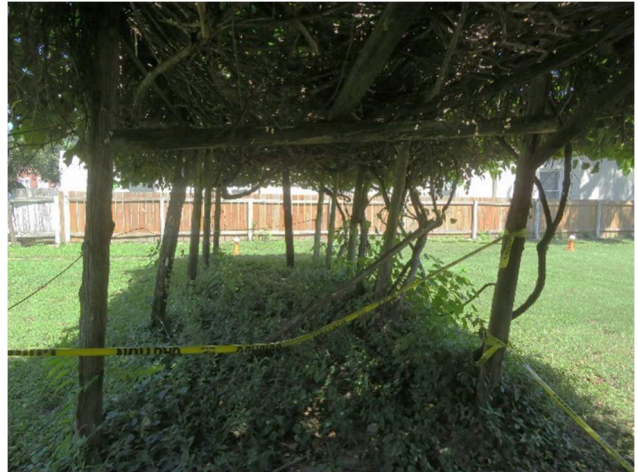
Since the initial assessment for the HSR, the grape arbor has been stabilized in place by NPS pending future repairs.

Figure 52. North end of grape arbor exhibiting failed members (Source: RRJ, 2022).

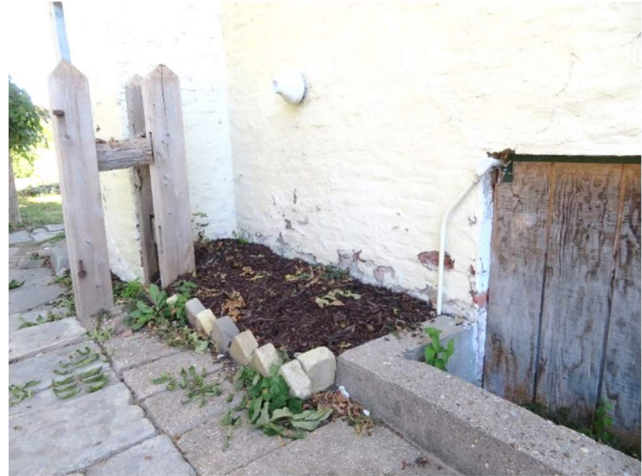
Painted brick masonry columns support the west gallery. Mortar failure was noted at several locations.

Figure 83. Masonry Foundation wall with peeling finishes and missing mortar (Source: RRJ, 2022)

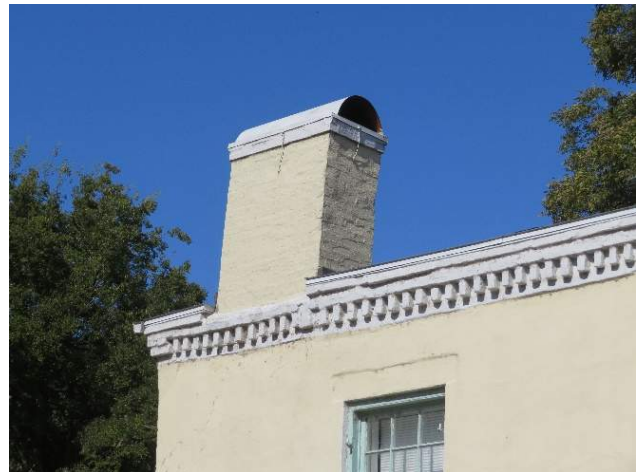
The five chimneys were capped with sheet metal. Brick decay was noted on the southeast chimney, which was also leaning towards the northeast. The Office Chimney was leaning deeply toward the north. Both the southeast and office chimneys will need to be partially rebuilt.

Figure 84. Office Chimney leaning toward the north . (Source: Source: RRJ, 2022)

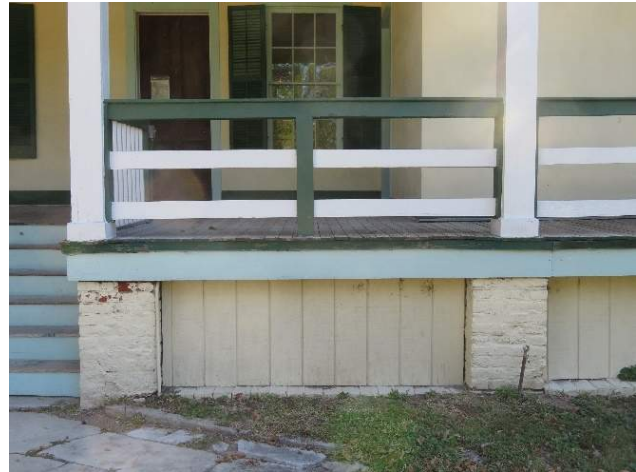
Figure 86. Exterior Panelboard Covering Basement Windows (Source: RRJ, 2022)

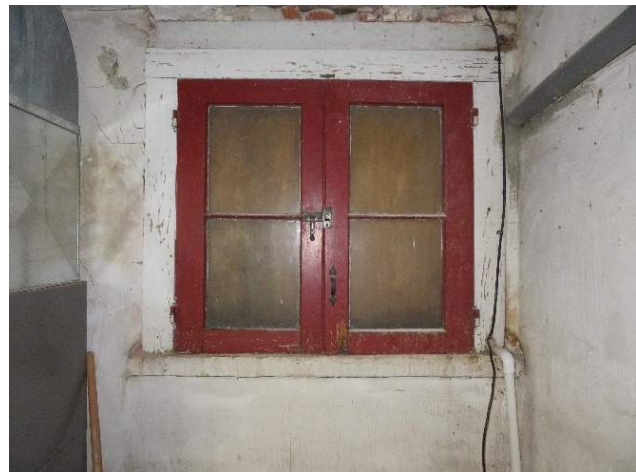
**W002A and W002B** – W002A and W002B are one-over-one wood-framed shutter casement windows (Figure 87). The exterior of these windows was closed off with panel board that was unpainted. Both windows have an interior swing and a pull handle. W002A was not operable, however, W002B was operable. Water stains were present on W002A which may indicate previous leak locations. The glazing and putty at W002A were in good and fair condition, respectively. The interior casing of this window was painted white and was in fair condition. Overall, W002A was in fair condition. Wood decay was present at the lower rail and jambs of W002B. The glazing in W002B was good, however, the putty was in poor condition. Interior casing at W002B was in fair condition with the presence of some wood decay and deterioration of paint. The exterior sill of W002B was failed. Overall, W002B was in poor condition.

Figure 87. A basement casement window with exterior panel board behind (Source: RRJ, 2022).

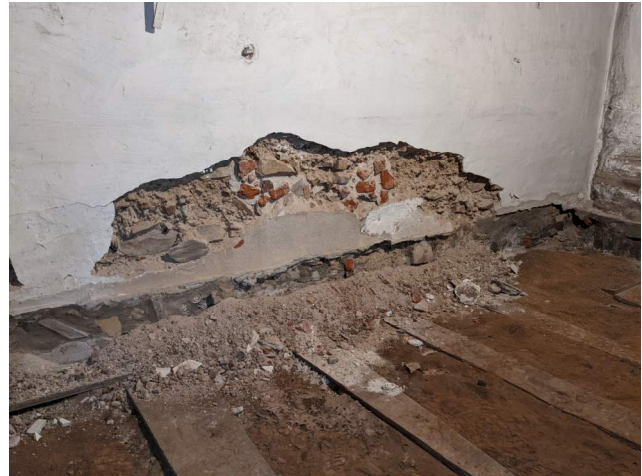
Figure 127. Stone masonry distress including spalling and mortar loss in room 009. (Source: RRJ, 2022)

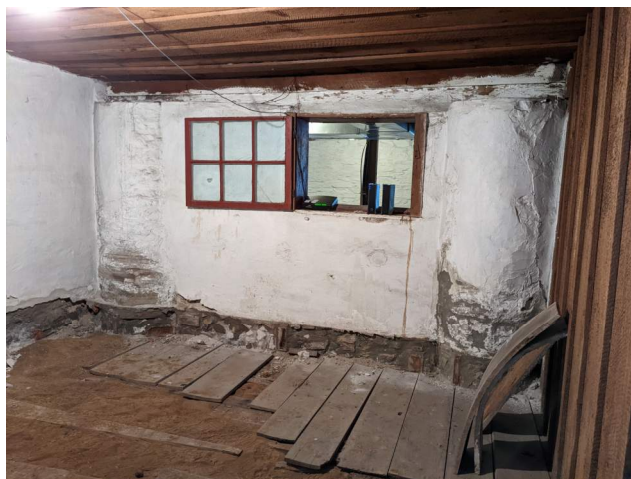
Figure 131. Overview of missing floor planking and remaining sleepers within Room 009 (Source: RRJ, 2022)

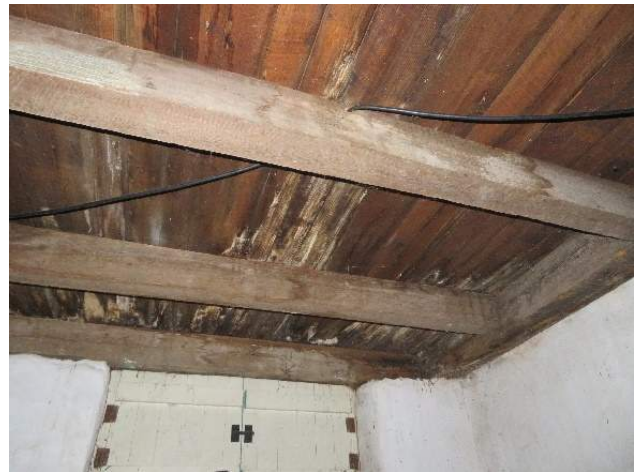
Figure 134. Evidence of past water infiltration near window. (Source: RRJ, 2022).

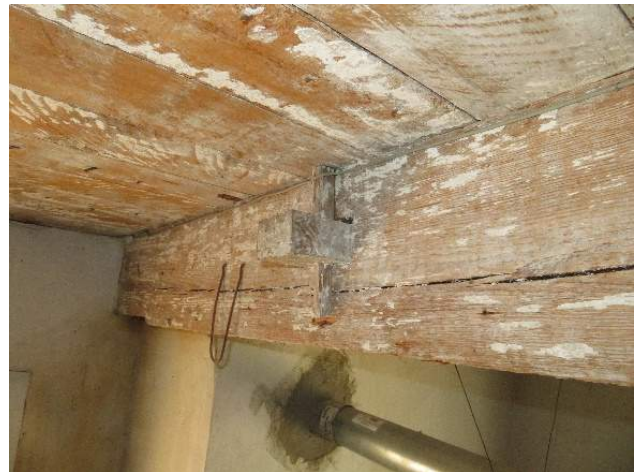
Figure 143. Pinned tenon joint and joist checking. (Source: RRJ, 2022).

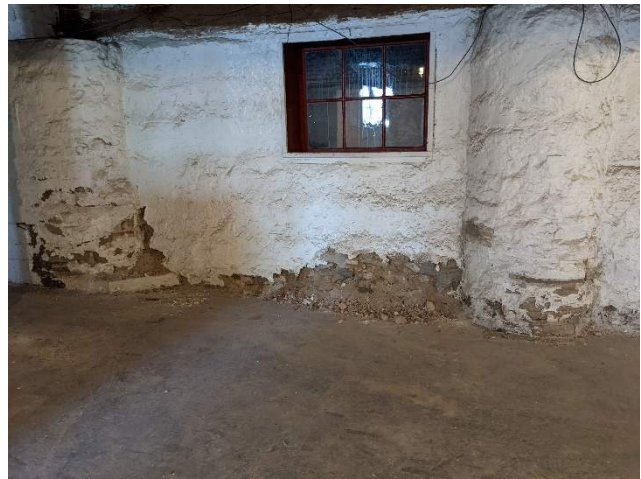
Figure 191. Moisture related masonry decay at basement foundation between Rooms 005 and 009. (Source: RRJ, 2022).

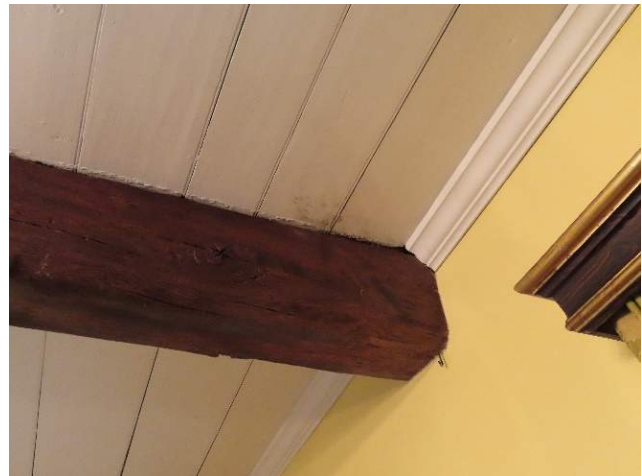
Figure 210. Mild mildew and moisture damage at west wall at ceiling beam. (Source: RRJ, 2022).

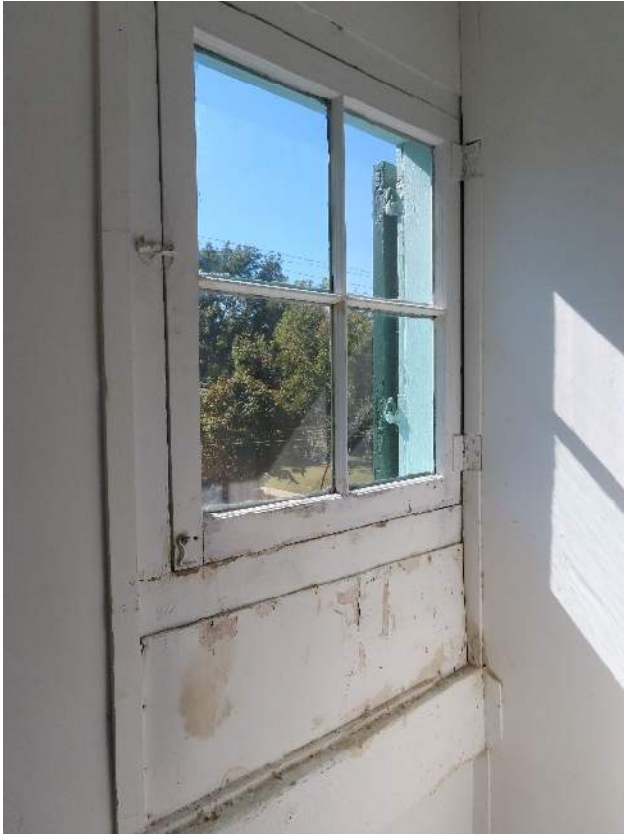
Figure 233. Staining and water damage below window in Room 203. (Source: RRJ, 2022)

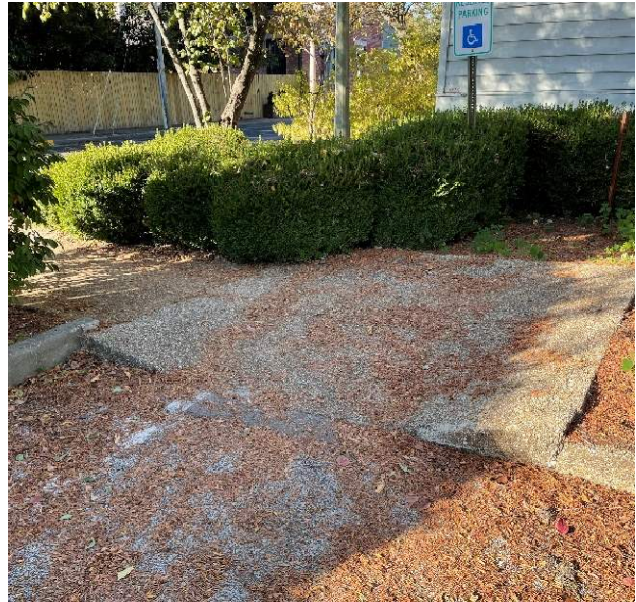
Figure 375. View of the existing ramp adjacent to the accessible parking space in the welcome center parking lot, which does not meet accessibility standards. The parking space striping was also not clear at the time this photograph was taken. (Source: LSHLA, 2022)

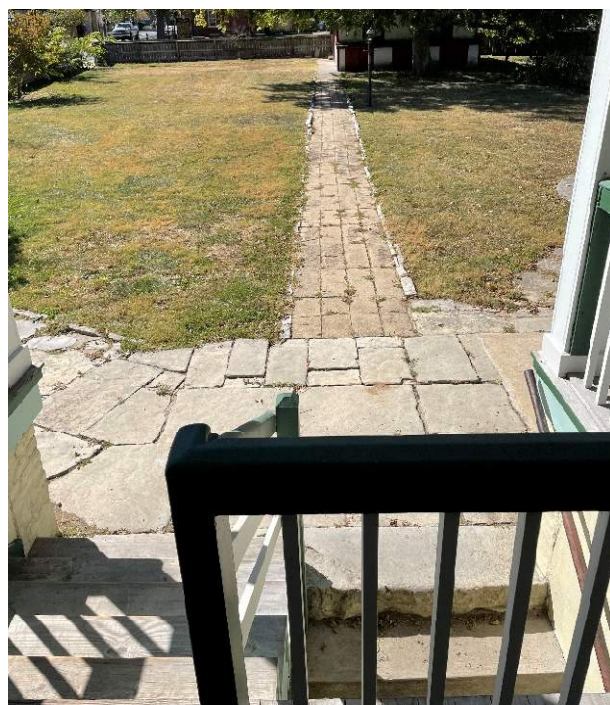
Figure 384. View of the intersection of the cut-stone walkways, their deteriorated condition, and the staircase leading to the west porch. The existing conditions interfere with an accessible route to the west entrance of the house. (Source: LSHLA, 2022)

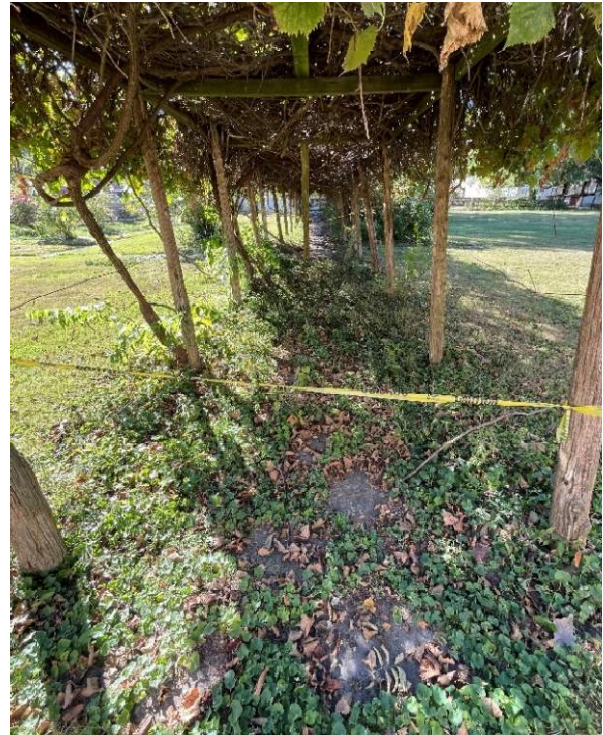
Figure 386. The pathway under the arbor (looking south) is paved with cut stones. It is overgrown with grass and groundcovers. The NPS has closed this path to visitors due to the condition of the arbor. (Source: LSHLA, 2022)
