ELLIS ISLAND  
L STATUE OF LIBERTY NATIONAL MONUMENT  
NEW YORK

EVALUATION OF IMPACT OF COLUMN  
REHABILITATION ON CULTURAL RESOURCES

NATIONAL PARK SERVICE  
DENVER SERVICE CENTER  
755 Parfet Street  
P.O. Box 25287  
Denver, Colorado 80225

May, 1981

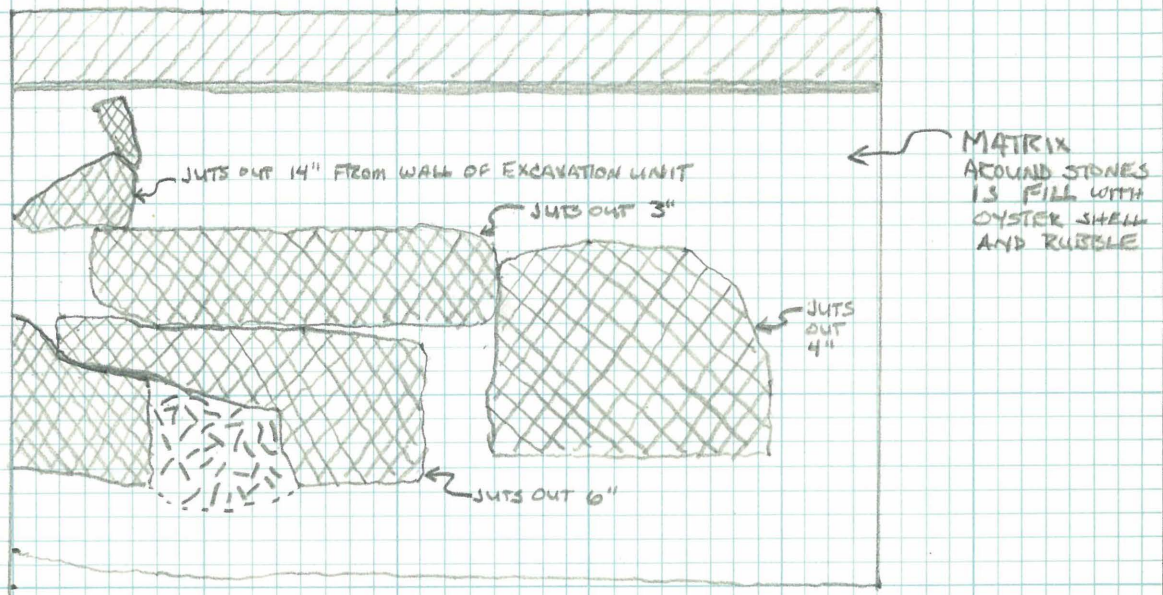
PROFILE OF NORTH WALL / EXCAVATION UNIT AROUND COLUMN # 118  
 WALL IS 3' NORTH OF STRUCTURAL COLUMN  
 SCALE: 1 SQUARE = 2"

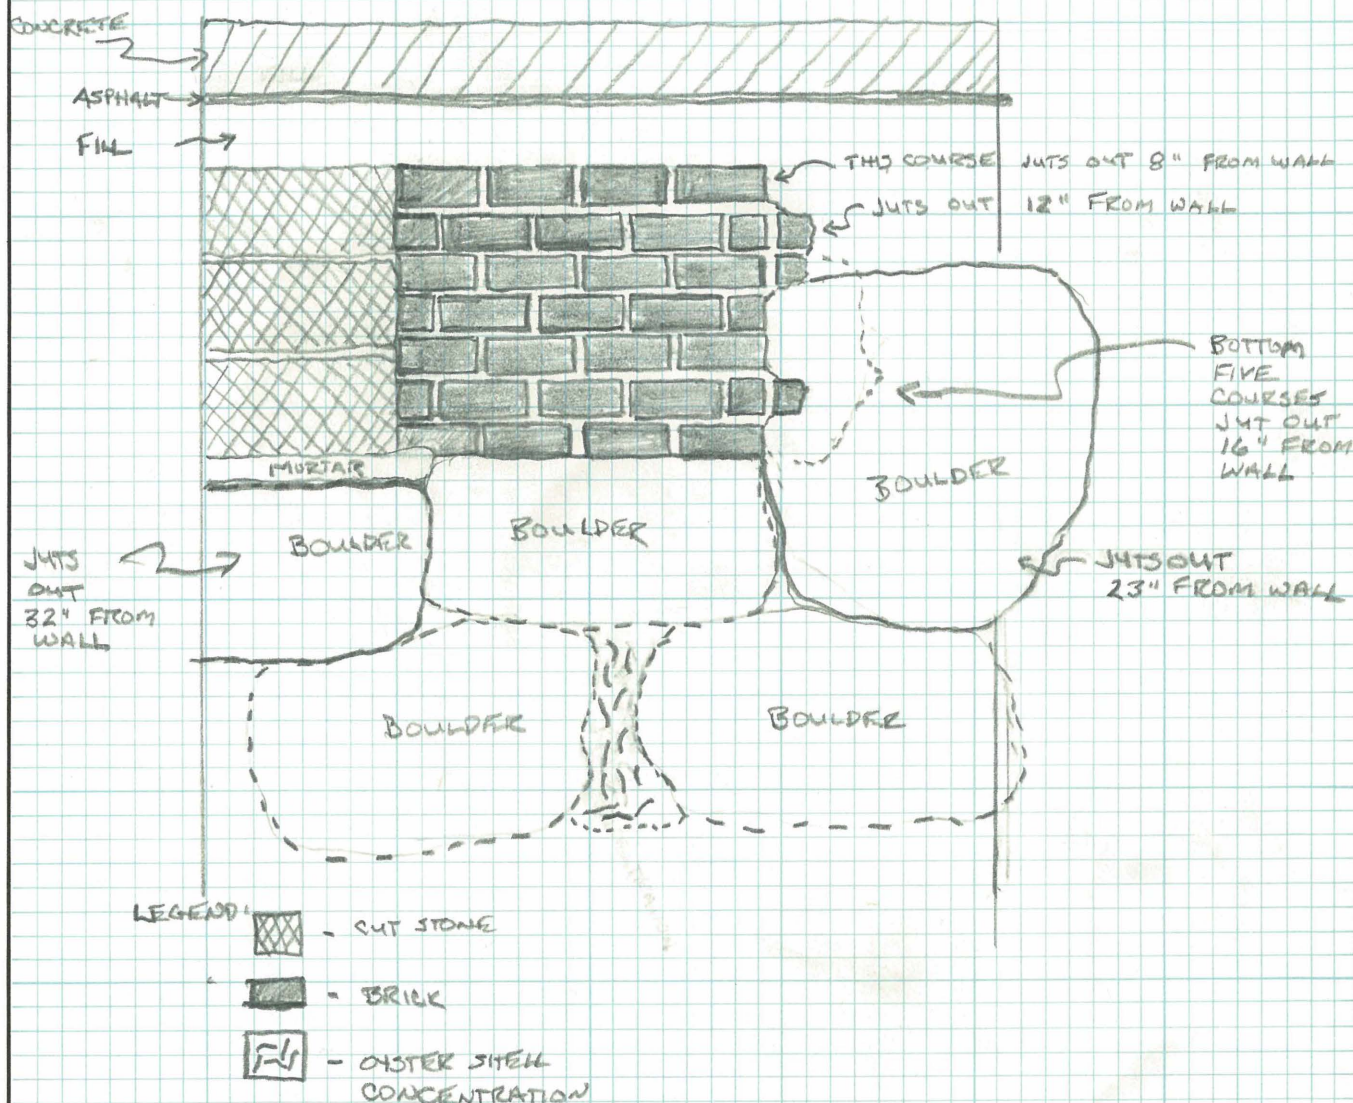
PROFILE OF EAST WALL OF EXCAVATION UNIT AROUND COLUMN #8  
 WALL IS 3' EAST OF STRUCTURAL COLUMN  
 SCALE: 1 SQUARE = 2'

OUTLINE OF LOWER BOULDERS IS ONLY AN APPROXIMATION.  
 BOULDERS ARE IN MATRIX OF ORANGISH-RED CLAYEY SILT,

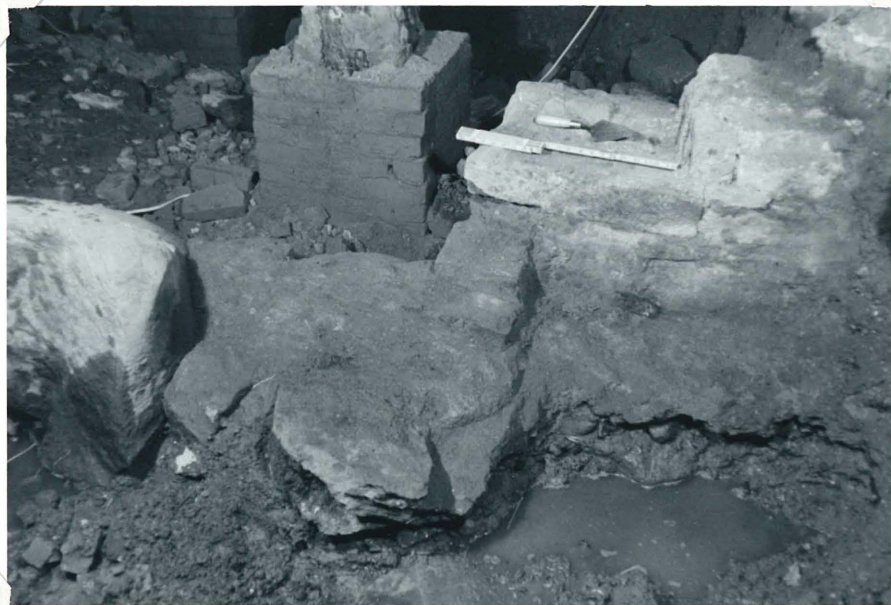
Excavations around column # 8 and column # 13 uncovered structures of potential archeological interest. The fill between columns # 13 and 29 had been removed before February 18, resulting in the effective joining of the two excavation units. To the east of column # 13 and to the west of column # 29, the excavators uncovered a cut stone wall running north to south about 8 inches below the surface of the concrete floor (Fig. 7 and 9). The stone wall, which is two courses wide and three courses deep, incorporates a brick extension that runs east to west for two lengthwise courses, and then continues south for several courses (Fig. 10). This extension is connected by mortar to a large boulder, concave on its western aspect. This boulder appears to be the first in a line of large stones that continue to the west (Fig. 11).

Figure 9. Stone and brick and boulder wall between columns # 13 and 29 (trowel points in direction of project north; folding ruler is extended to 18 inches.)

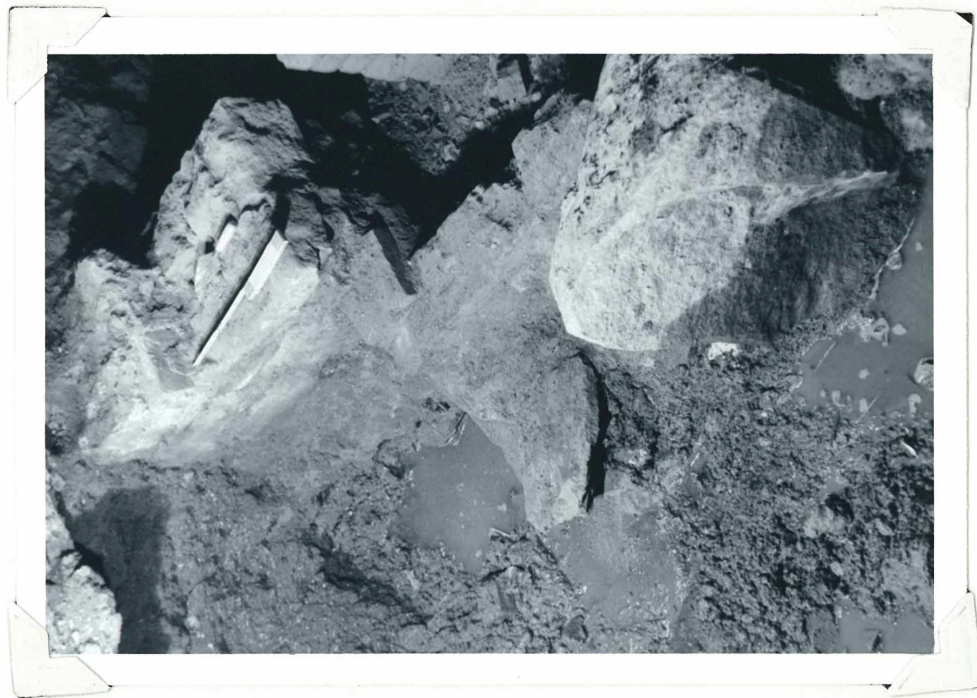
Figure 10. Stone and brick and boulder wall  
between columns # 13 and 29.

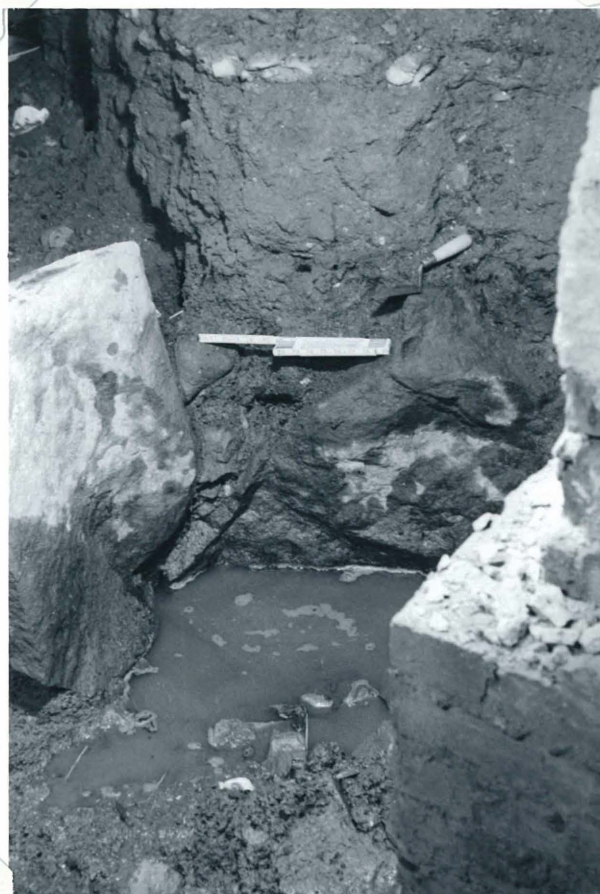
Figure 11. Detail of boulder portion of wall between columns # 13 and 29.

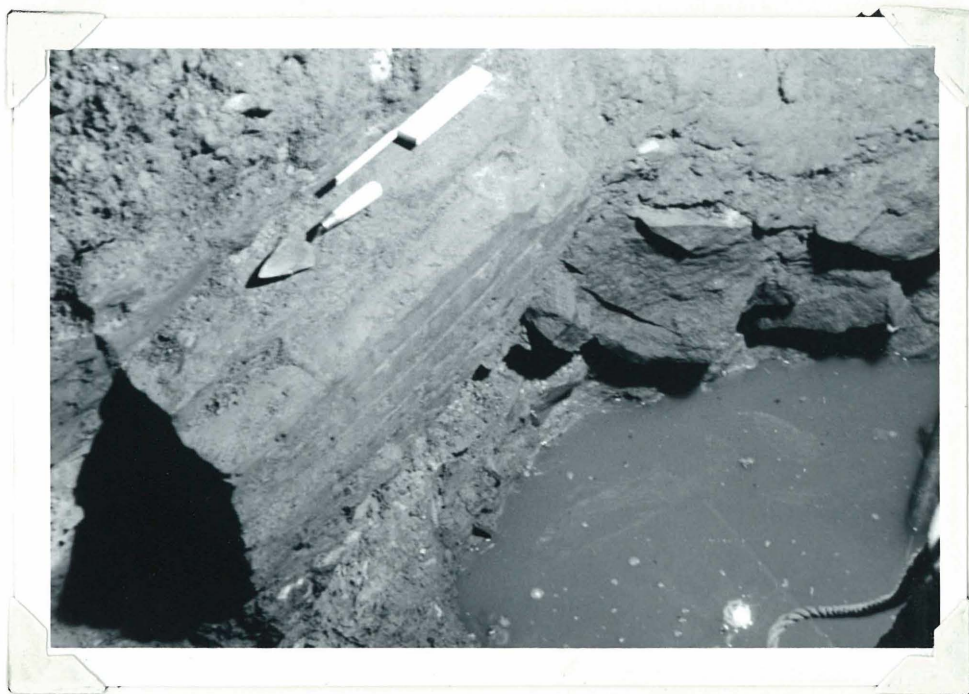
Excavation around column # 8 uncovered a similar structure, running parallel to and about 16 feet to the west of the structure just described. In the east wall of the excavation unit, a cut stone structure abuts a brick extension which is attached by mortar to a large boulder (Fig. 8, 12 and 13). The structure is about 6 feet long and is underlain by large stones on a matrix of orangish-red clayish silt.

Figure 12. Stone and brick and boulder wall  
in east wall of excavation unit around  
column #8.

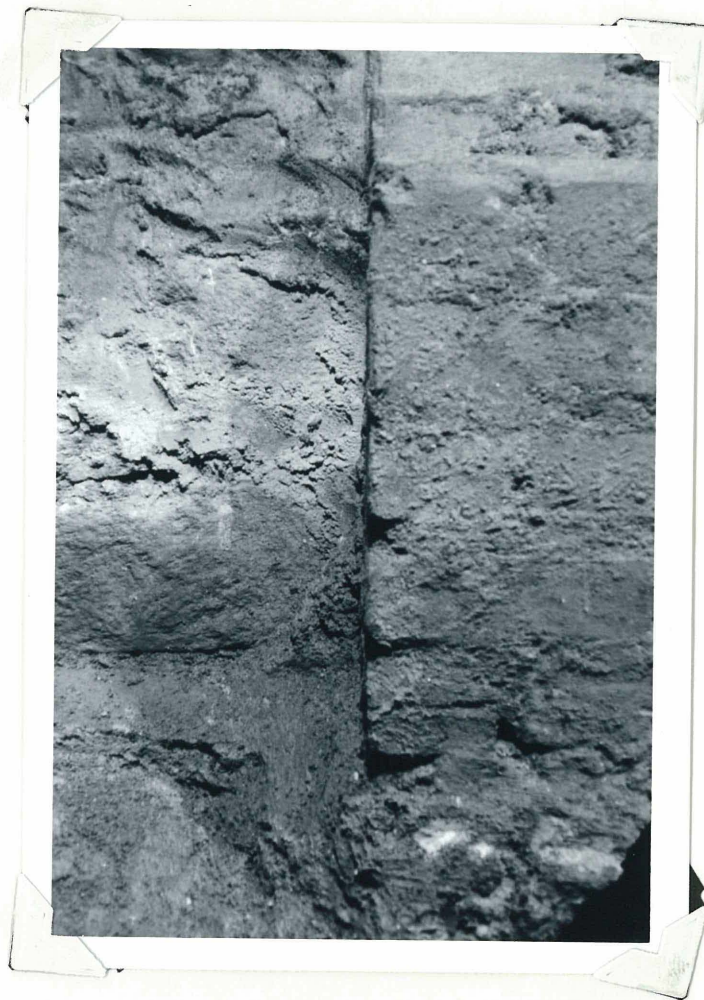
Figure 13. Detail of junction between stone and brick portions of wall in excavation unit around column #8 (eastern profile of wall; stone portion is 24 inches in height).

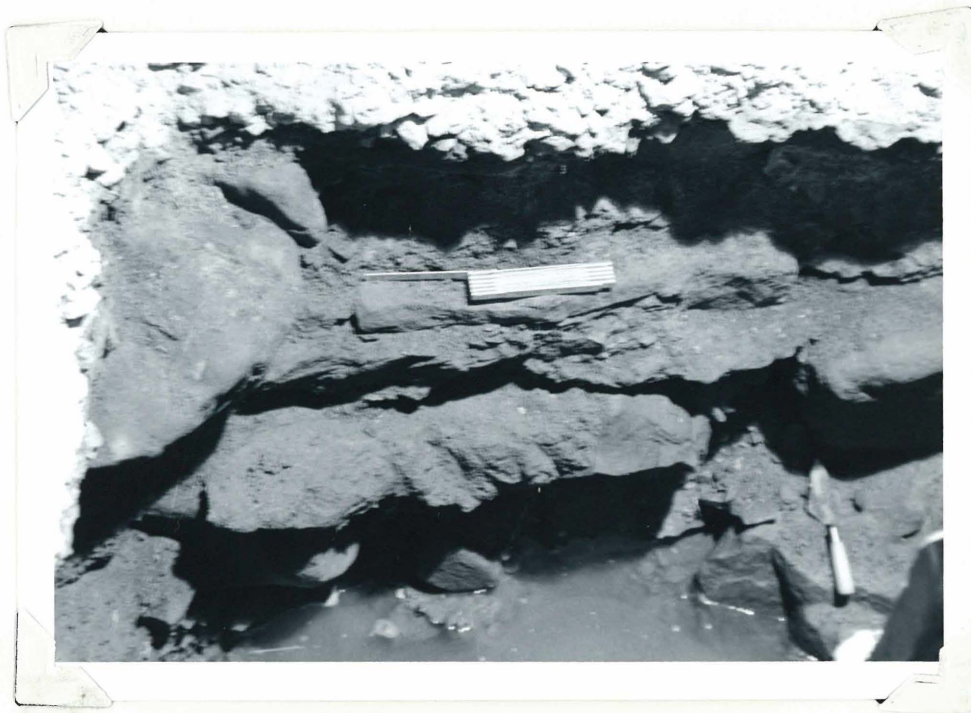
Figure 14. Stone structure in north wall  
of excavation unit around column #118.

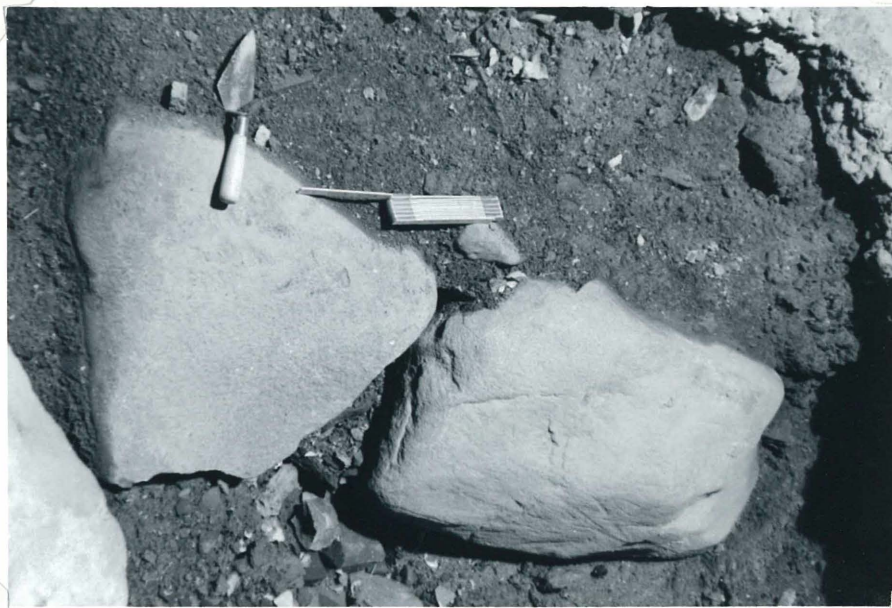
Figure 15. Plan view of boulders near north wall of excavation unit around column #123.

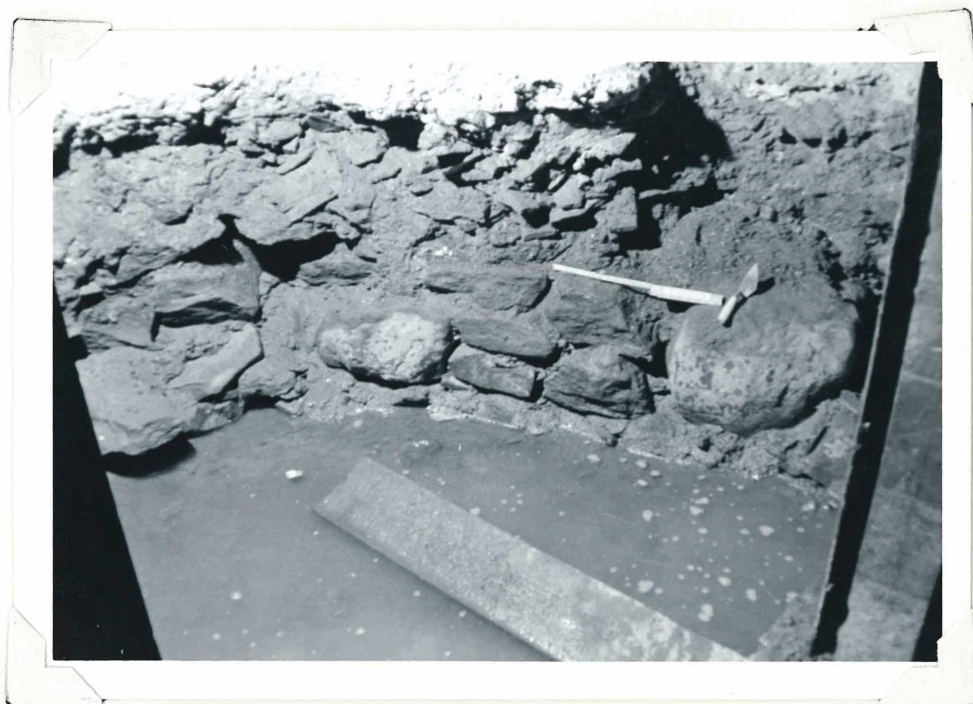
Figure 16. Stone structure in north wall  
of excavation unit around column #144.
