# historic structure report

FORT WOOD

Architectural Data Section

Statue of Liberty National Monument

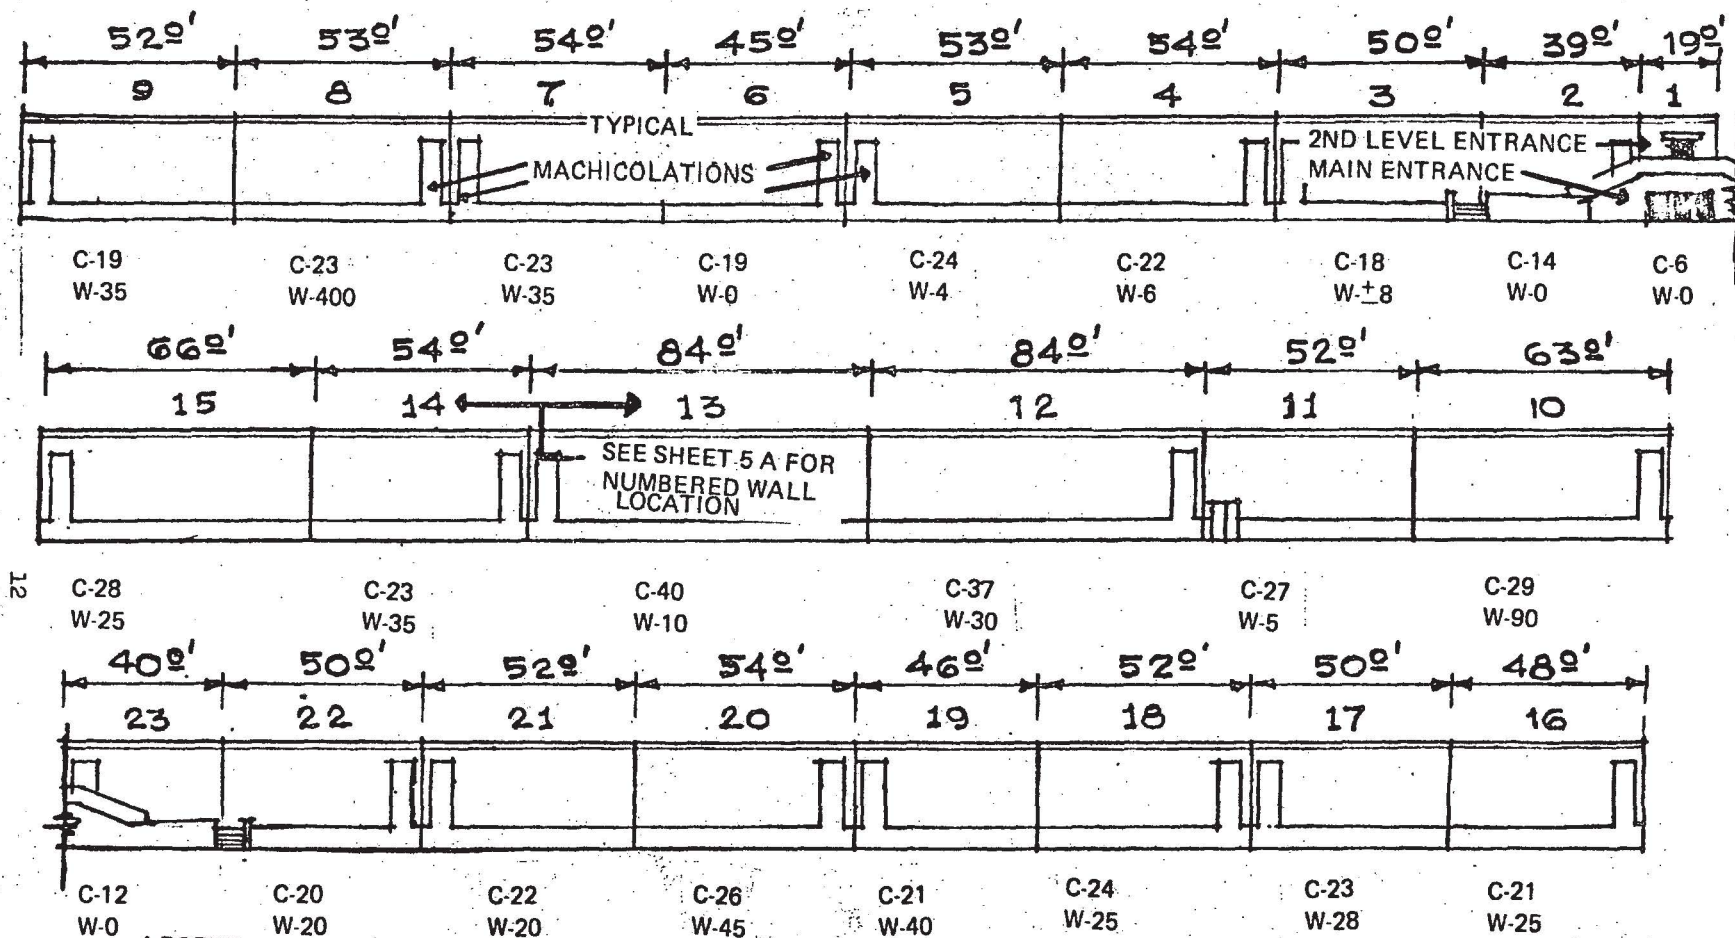
FOLDOUT OF WALL ELEVATIONS

C-19 = PARAPET COPING - 19 JOINTS TO REPLACE (±8' Lin. Ft. each joint)

W - ±25 = WALL - ± 25 Lin. Ft. Joints to replace

1. Repointing as necessary the mortar joints between the granite blocks on the exterior sloping wall of the rampart of the fort. See sheet 5b for 1973 evaluation of extent of work.
2. Repointing all of the mortar joints in the parapet coping (front edge, top, and back edge).
3. The Granite Association has no current recommendations for preservative to be applied to deteriorating granite. Plastic coatings would yellow with age and any other application would be highly experimental. It is recommended that we do nothing to the portions of coping that are giving way. When these blocks begin to slough away to the point where they are dangerous, replacements will have to be made. We will have little chance to match the old blocks, and replacements will be just as obvious as those added in c. 1930, a further injury to the historic integrity of the building.

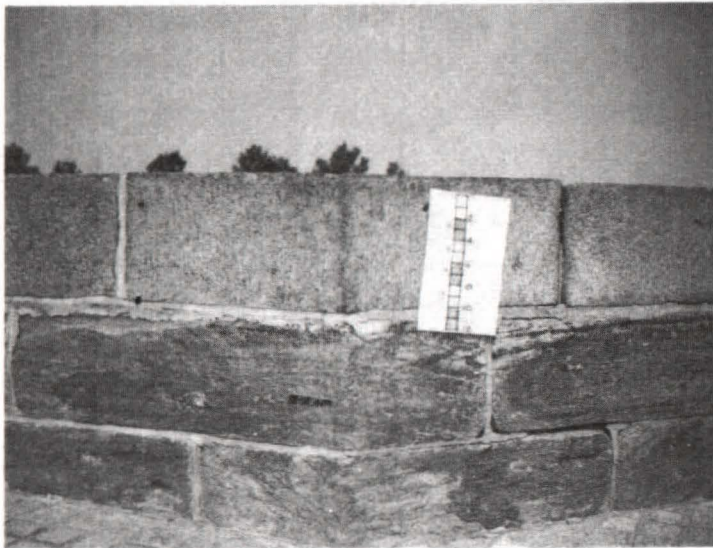
Illustration No. 1

is possible that when repairs were made in the early 1930's some wall repointing was done, but if so, the mortar color was a good match of the existing one, and forty years time has weathered the building to the point that differentiation is impossible. The major area for necessary repair is the coping block of the parapet. This relatively flat plane, close to six feet wide, is exposed to all moisture of the area. It receives the brunt of winter freezing and thawing, and so joints have opened up in quantity. An added factor is that approximately 10% of the coping is an inferior granite. Probably all of the granite walls and parapet were from the same quarry but there must have been a difference in the strata of the formation. In this 10% we have a granular and stratified block rather than the solid mass of stone that we normally call granite, and this block is decomposing. Winter moisture has worked into the veining and cracks and freezing has opened the cracks up further so that it is easy to chip off hunks of these particular blocks.

Fort Wood: decomposing granite under 1930 parapet coping, interior face of parapet at corner.

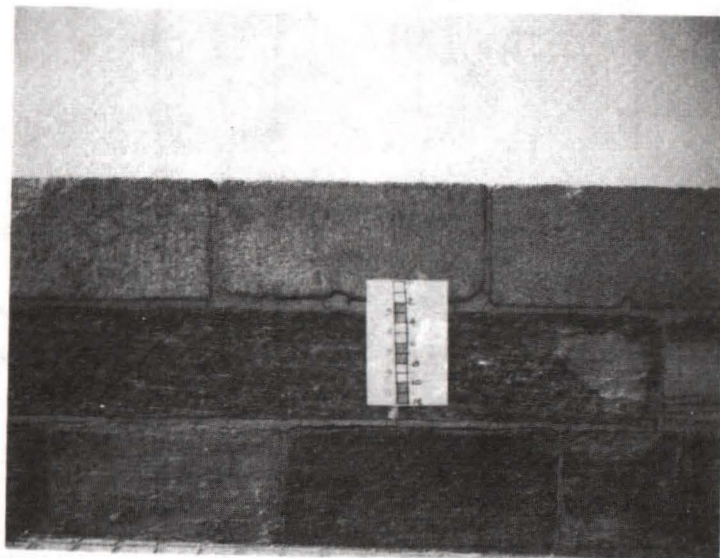
Illustration No. 2

Fort Wood: similar to above on straight run.

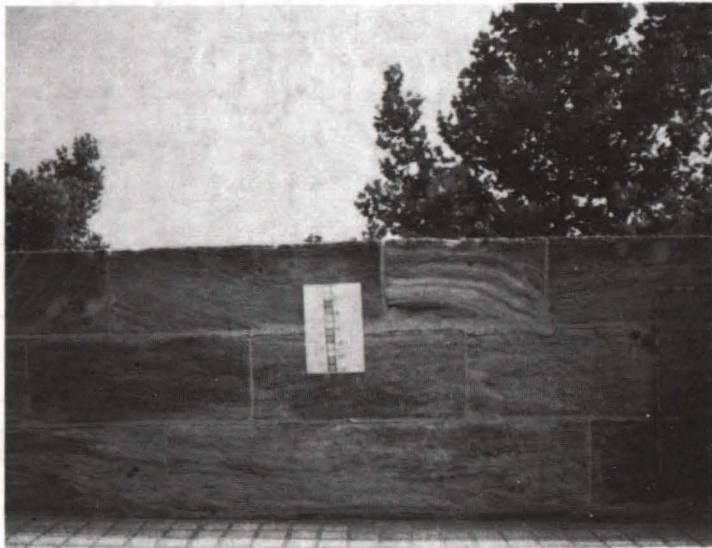
Illustration No. 3

Fort Wood: decomposing granite, inter face of  
parapet.

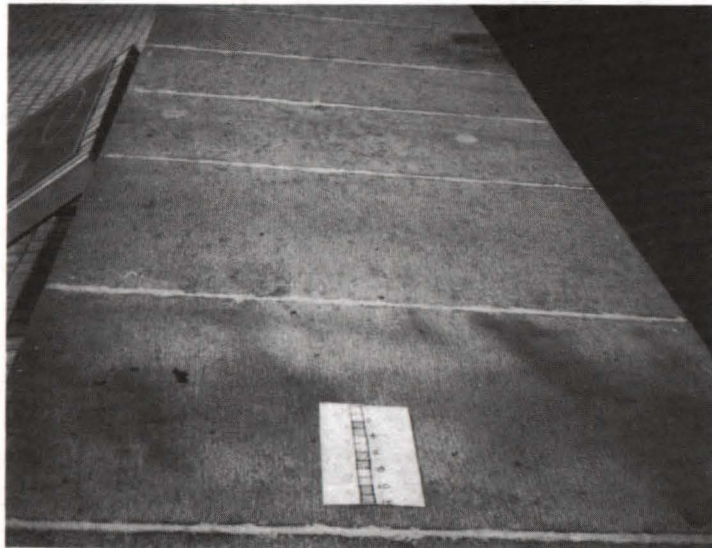
Illustration No. 4

adjoining blocks. No doubt an attempt was made in these replacement blocks to match the existing color, but there is a noticeable difference. The newer is a lighter, grayed down version of the original. The parapet coping blocks then represent three distinctly observable types of block: solid 1844 granite, decomposing 1844 inferior granite, and c. 1930 replacements. Ninety percent of the coping joints need repointing and it would seem reasonable to do all of them, since this would make for a uniform appearance and give a fresh solidarity to all joints.

Fort Wood: 1930 replacements of parapet coping.

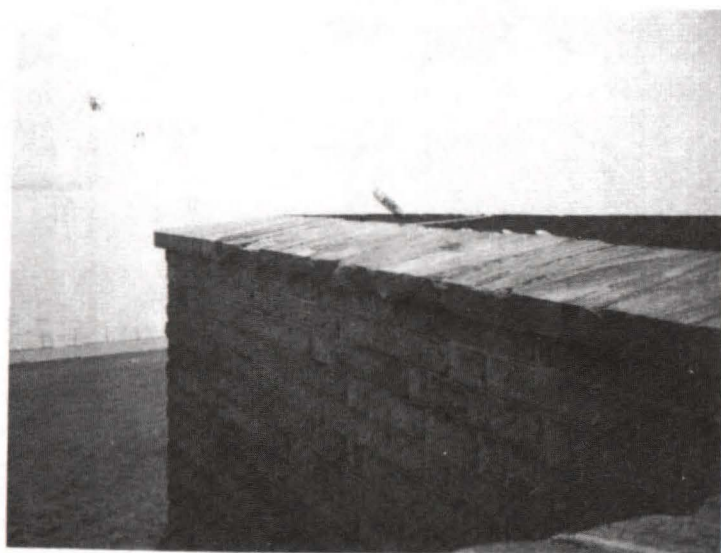
Illustration No. 6

Fort Wood: parapet coping, weather side.

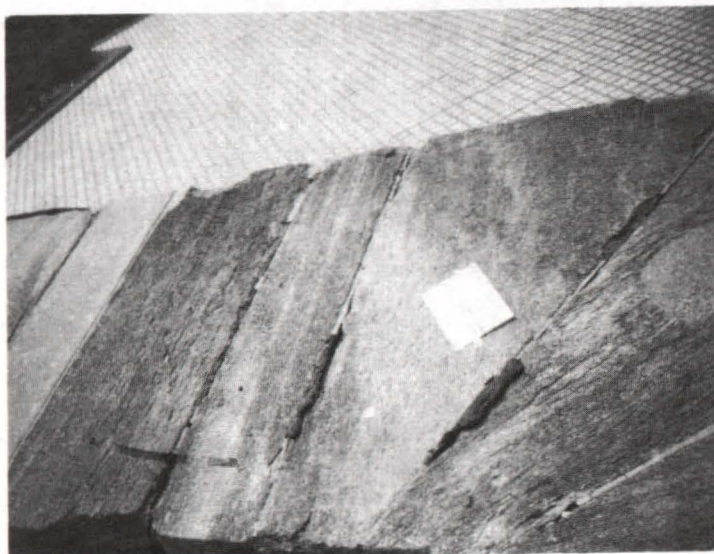
Illustration No. 7

Fort Wood: decomposed granite with tar squeezing  
from joints.

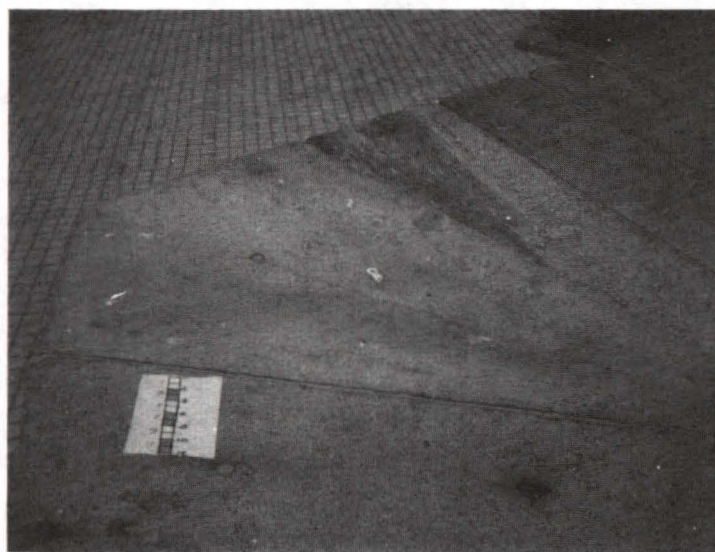
Illustration No. 8

Fort Wood: 1930 granite parapet coping at corner.

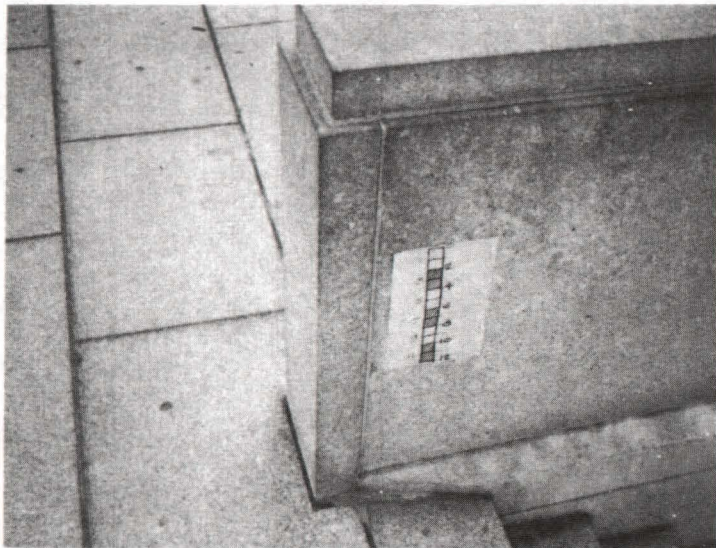
Illustration No. 9

American Museum of Immigration: faulty joints in  
parapet.

2. Remove all joint mortar (probably up to 80% is loose on the entire surface of the exterior of the museum and parapets; therefore, it would seem reasonable to remove all) to a clean depth of three-fourths of an inch, probing the setting bed for soundness, removing any unsound portions; and replacing all necessary parts with new materials. Any setting bed removed should be replaced with compacted mortar in several layers to the minimum cutting depth. The cut depth should be repointed to a flush joint in the proper mortar as determined by the research.

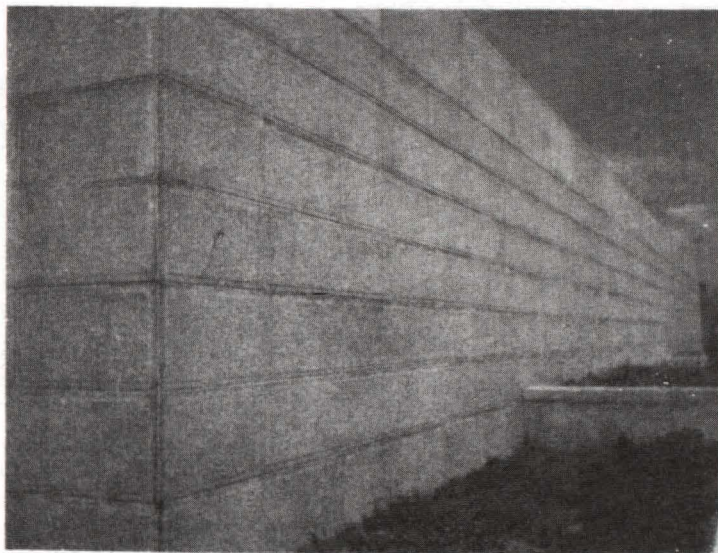
Illustration No. 10

American Museum of Immigration: open corner, first  
level.

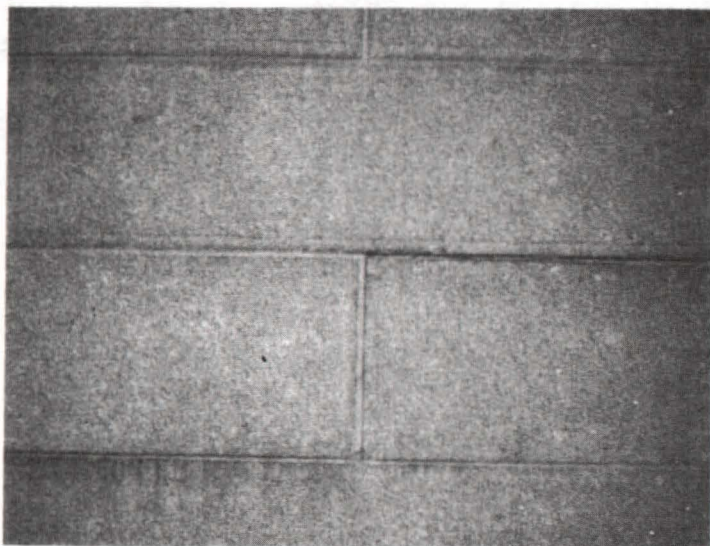
Illustration No. 11

American Museum Immigration: typical faulty  
grouted joints.

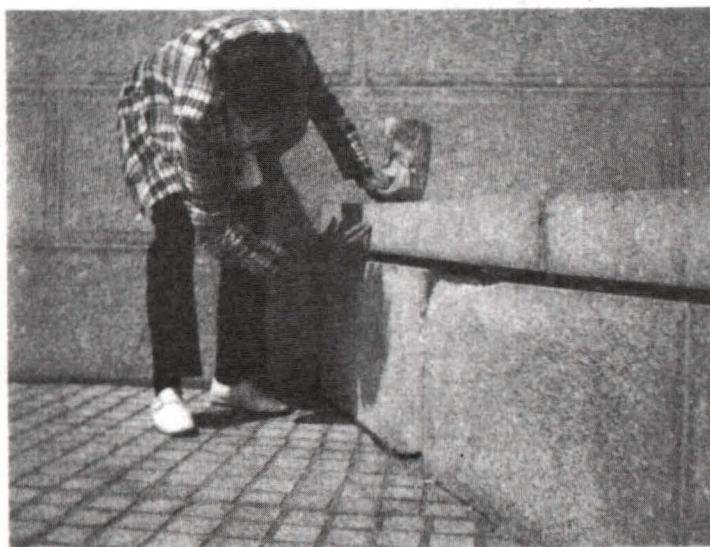
Illustration No. 12

American Museum of Immigration: settling of planters  
and lack of grouts.

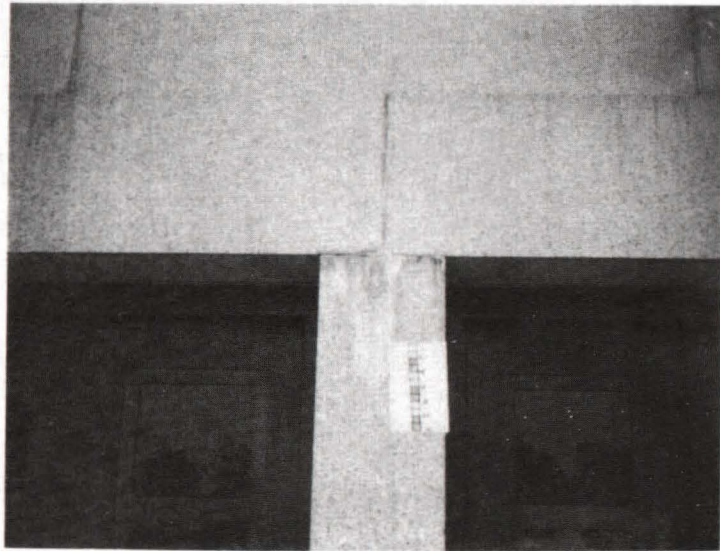
Illustration No. 13

Further injury is occurring to the building through efflorescence at many of the granite joints. It starts as a bead at both top and bottom of the joints and in many cases has built up and run down the granite veneer. Visually this is quite disturbing. Its cause is interior water seepage from above. The most likely place for the entrance of the water is the juncture of the inner face of the parapet and the promenade deck. The joint between the two is a mastic joint and unless there is complete adhesion of the mastic to the decking and parapet material there is a chance for water seepage. The water seeping down will come out of any possible opening and bring with it the calcium-like deposit that forms on the granite.

American Museum of Immigration: efflorescence  
at main entrance doors.

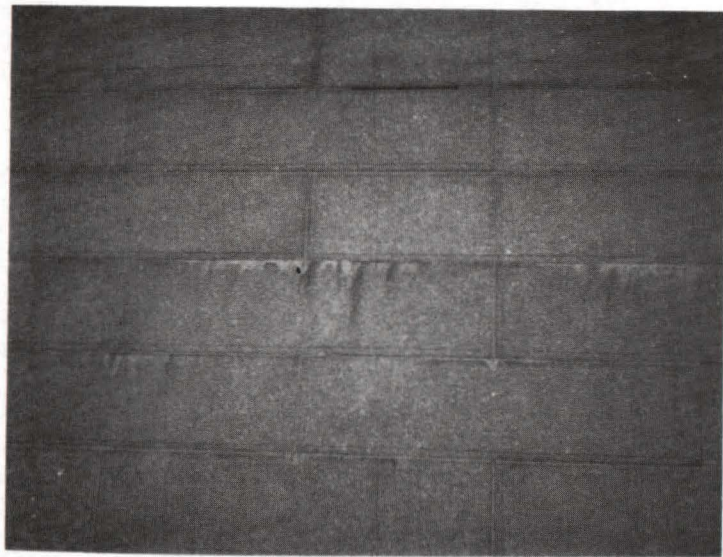
Illustration No. 14

American Museum of Immigration: typical efflorescence on exterior walls.
