**PART II HISTORIC STRUCTURES REPORT**

# **Ansley Wilcox House N.H.S.**

**NOV. 1969**

**Office Of Archeology And Historic Preservation**

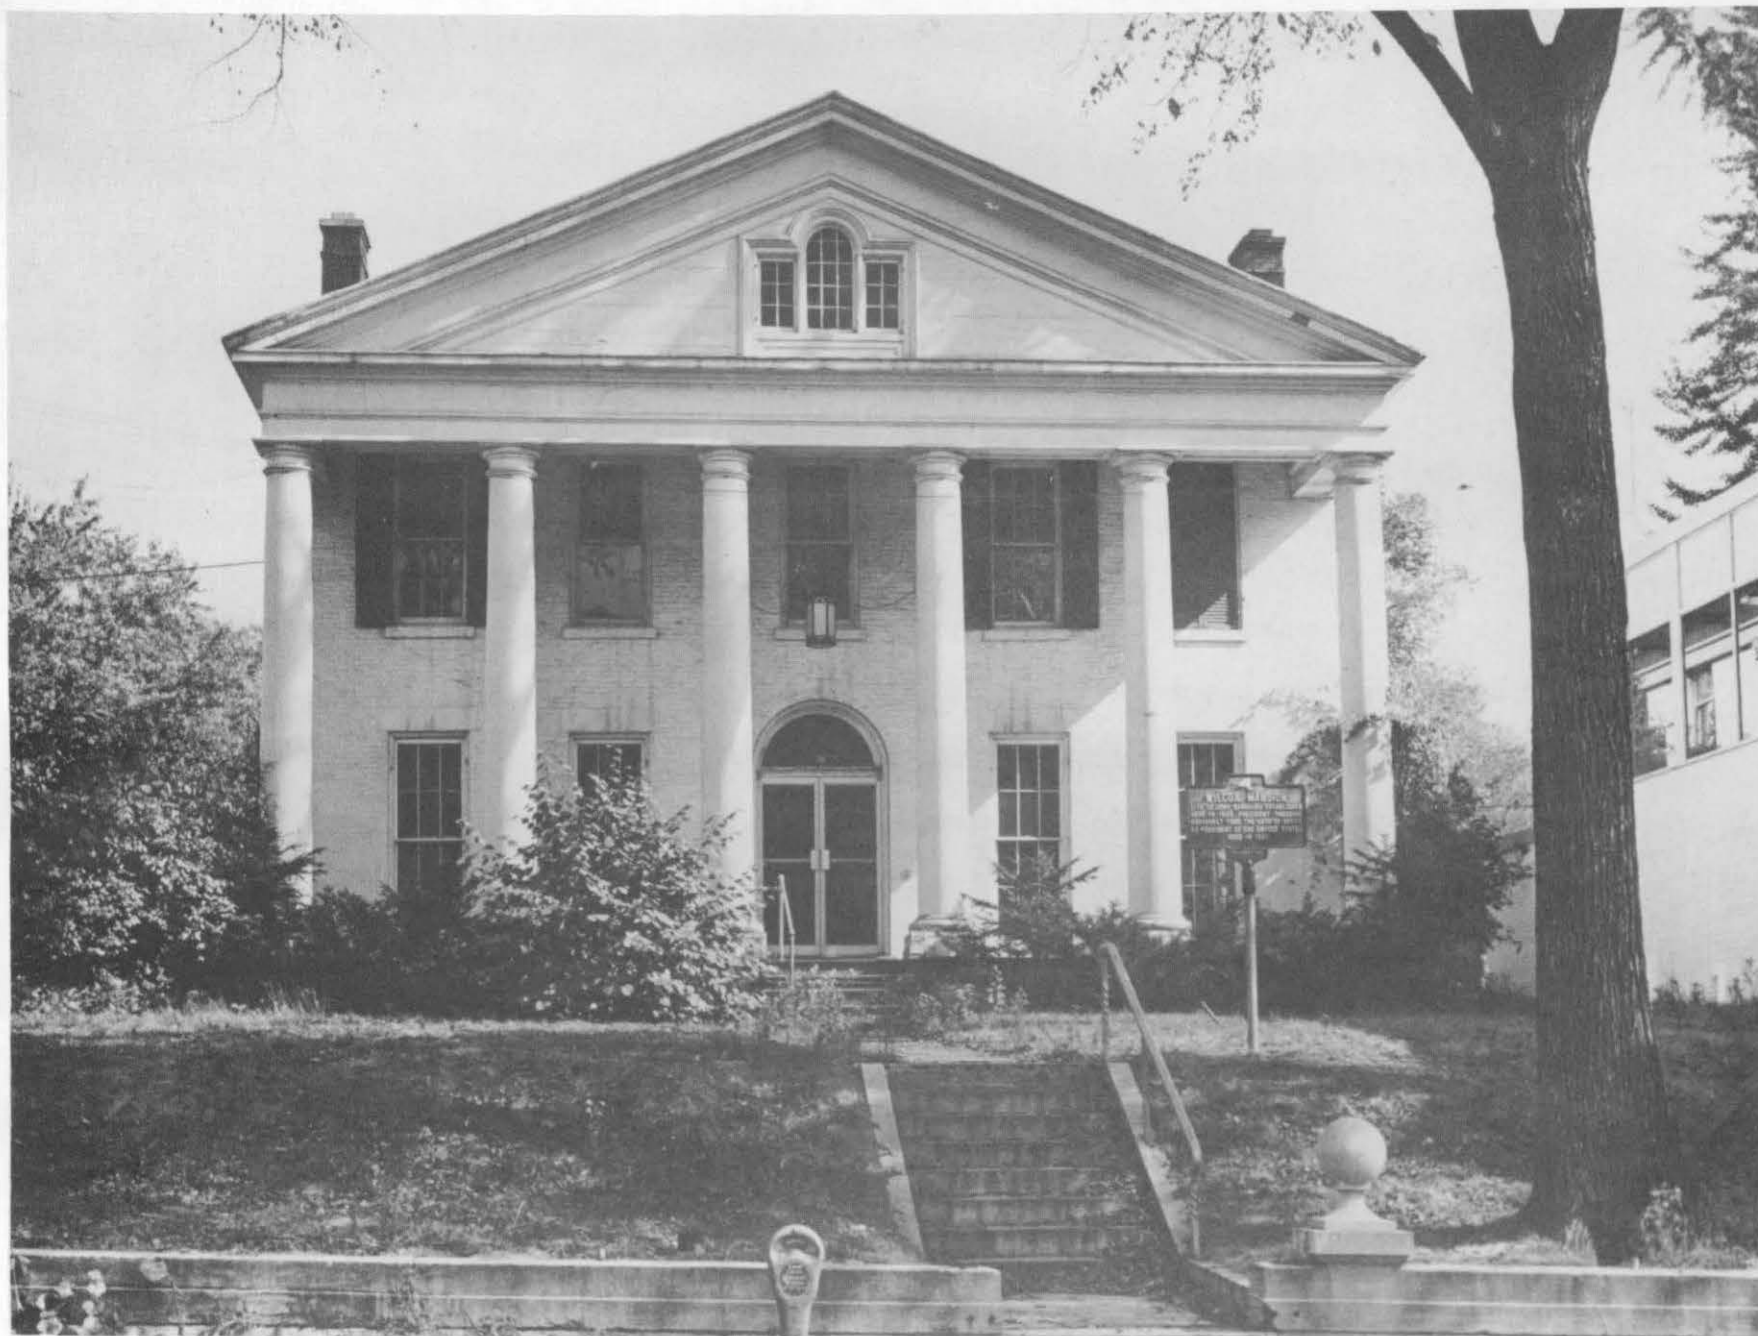
The front elevation of the Ansley Wilcox house in its present condition. The original flush siding on the tympanum can be noted in this photograph. The Palladian type window is also original. Three of the five pairs of blinds on the second floor windows remain. Only these five windows were fitted with blinds during the historic period. The glass doors and transom on the front entrance date from the building's use as a restaurant. The period doors remain in storage in the basement. On the 1838 portion of the house as shown in this photograph, the window sash are six over six light.

The flush siding in the tympanum will require repairs to seal the open joints.

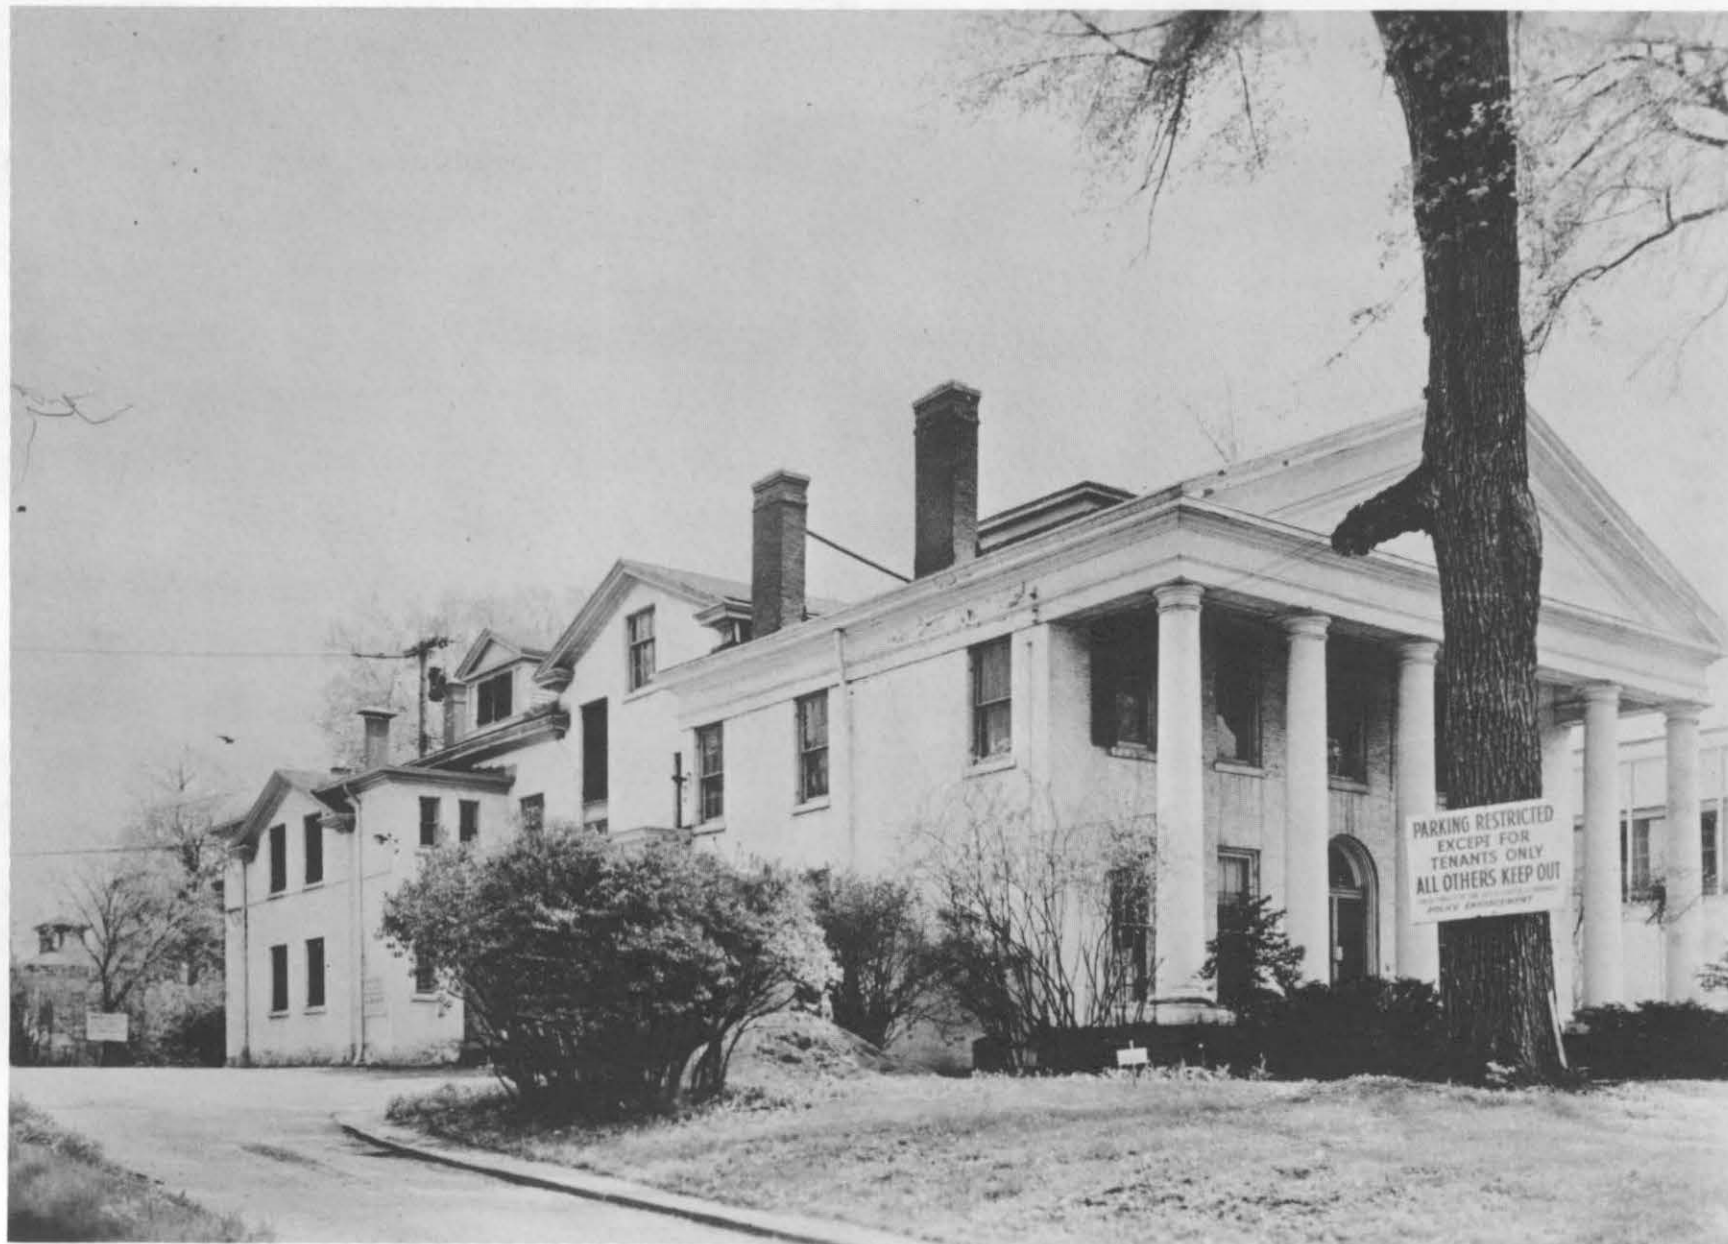
ILLUSTRATION NO. 2

View of the house from the northwest showing the drive from the street. The old cobblestone drive has been covered with blacktop. Several of the old bushes on this side are remains of the Wilcox tenancy. The foundation planting along the front of the porch is more recent and was not a part of the Wilcox landscaping.

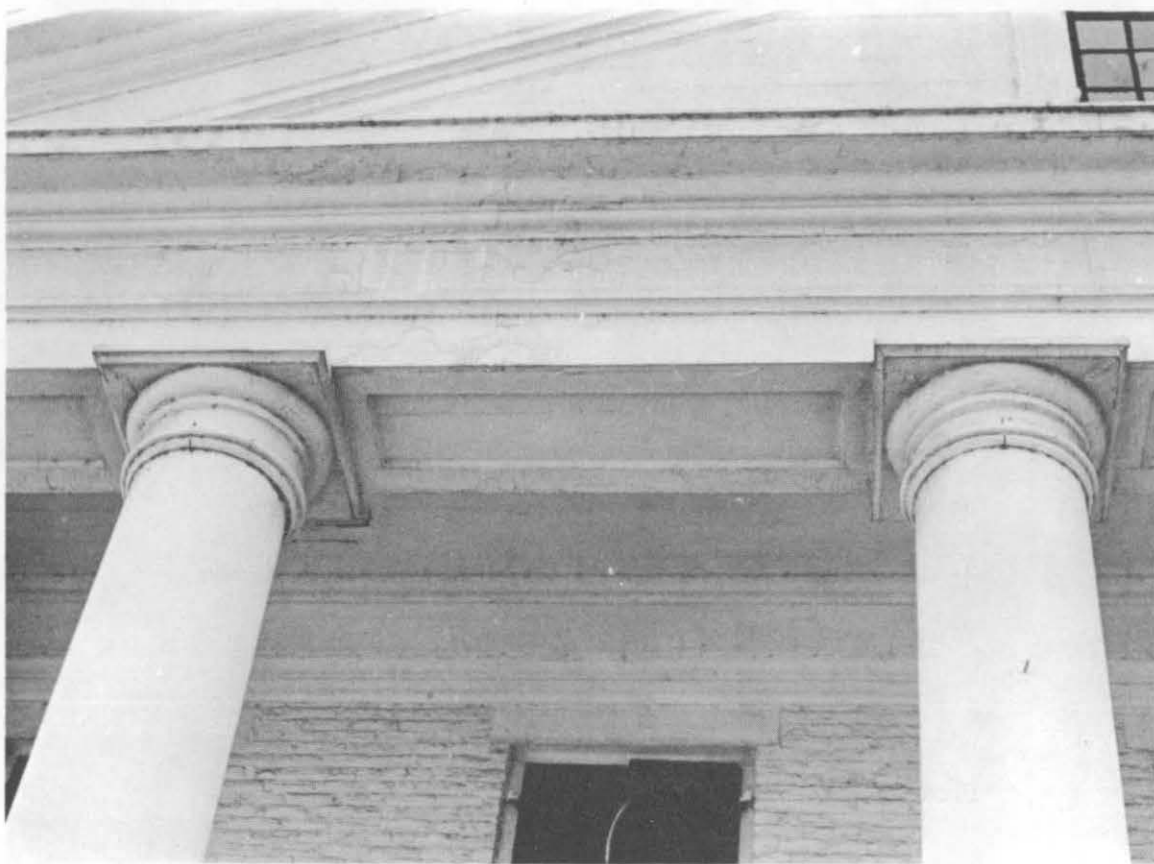
ILLUSTRATION NO. 3

Detail of the 1838 Greek Revival portico facing the street. The columns are in good condition as is the entablature and cornice on this facade.

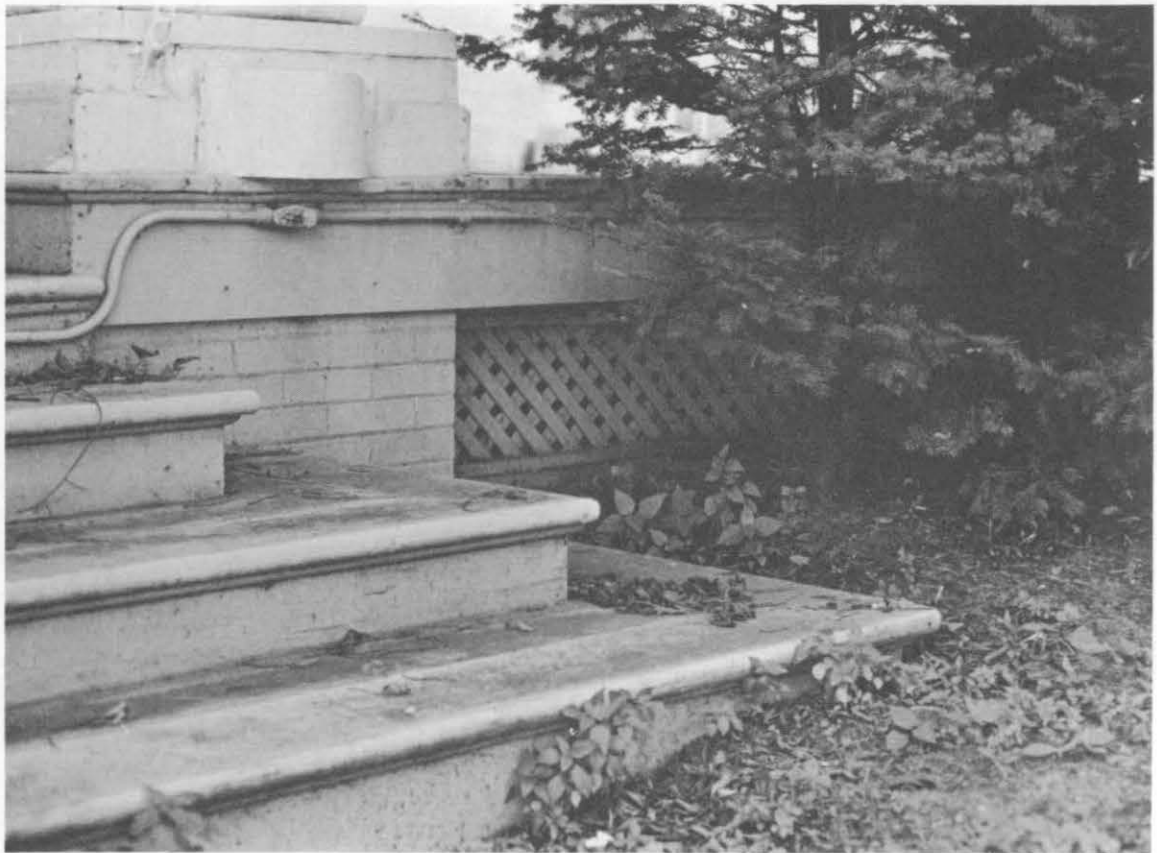
ILLUSTRATION NO. 4

The brick column base and the existing steps to the entrance of the portico. The steps are not original. The photographs of the historic period show wood steps with Victorian hand rails and spindles. The railings were curved outward at the base of the steps. The present pyramidal form steps are a replacement. It is proposed that the Victorian version be restored.

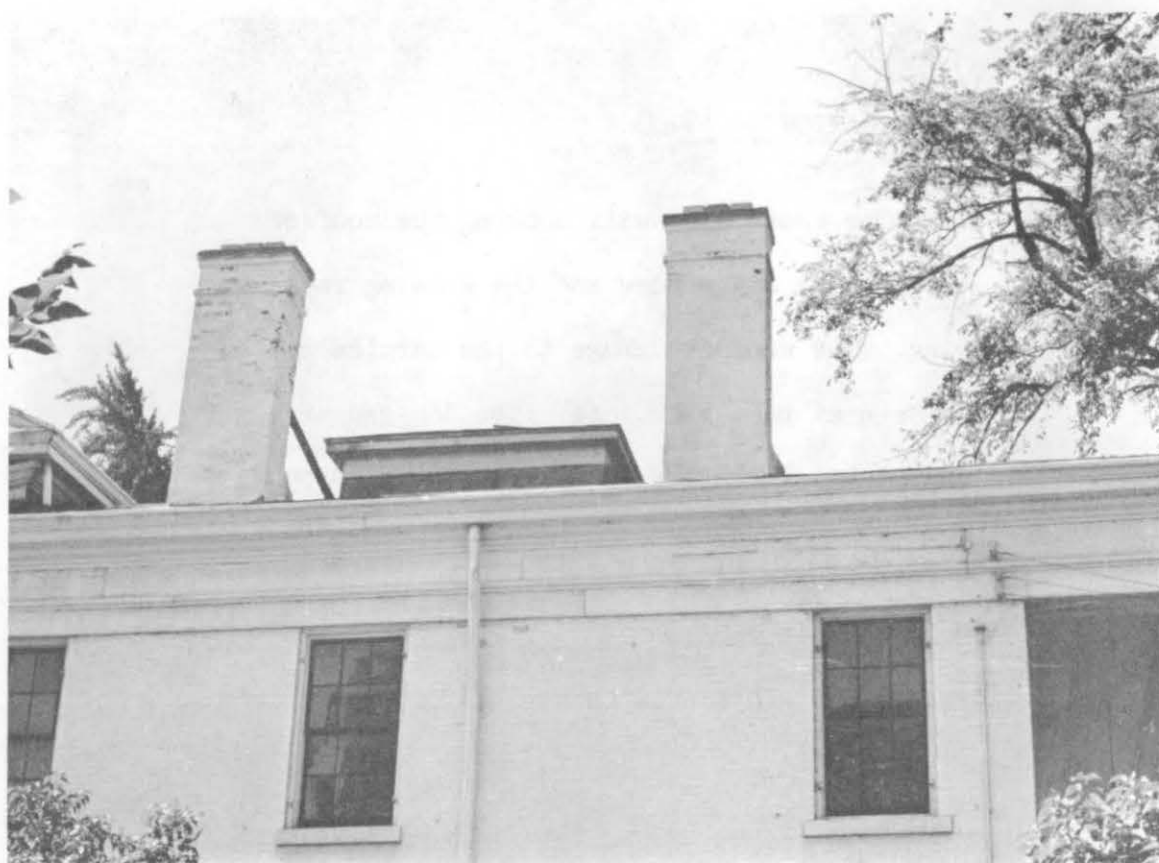
ILLUSTRATION NO. 5

The cornice and roof line of the oldest part of the house. The chimneys shown here are typical of the nine chimneys on the house.

The remains of the roof observation platform can be seen between the chimneys. Early photos show an ornamental railing in place. The stubs of the newels remain. A plan for the design of the balustrade has been found in the archives of the Historical Society.

It is proposed that the observation platform, or "Captain's Walk," be restored to original condition.

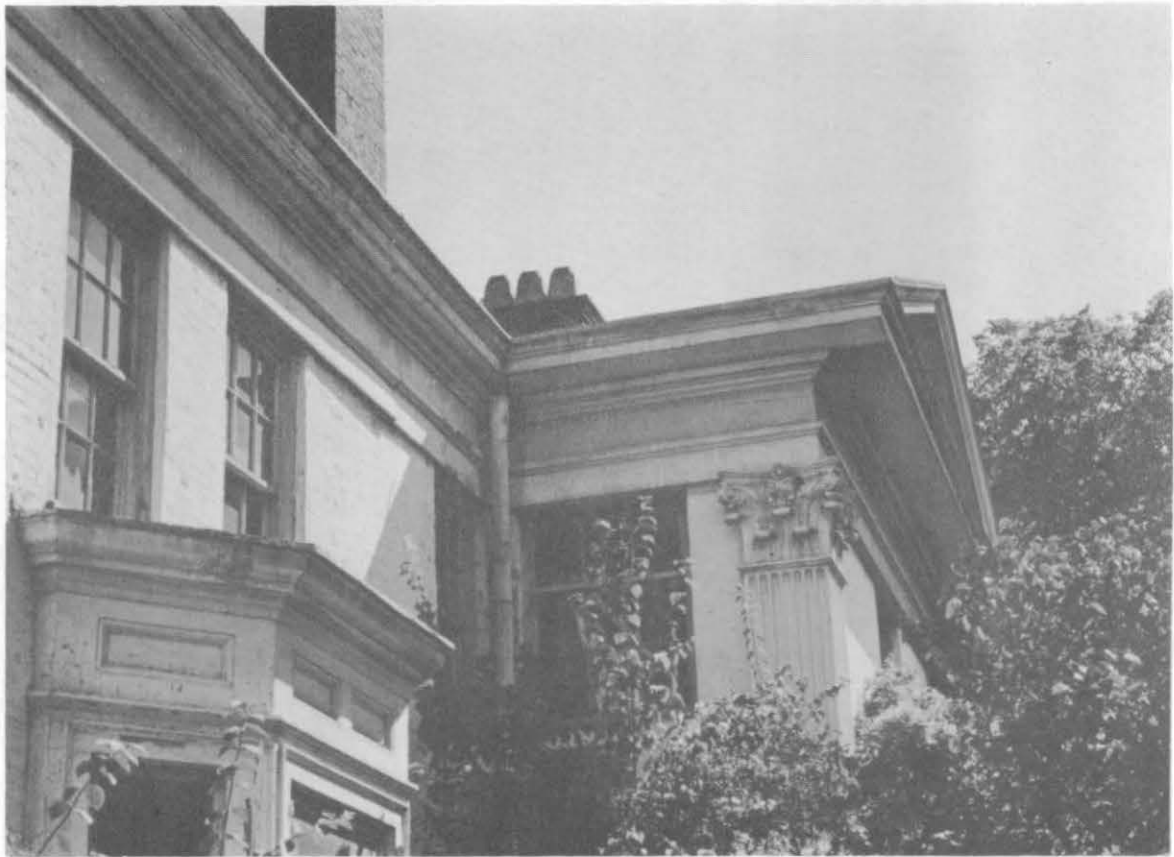
ILLUSTRATION NO. 6

The south side wall showing the roof of the library bay window and the morning room wing. The weather damage to the cornice can be seen at the upper left. The damaged area of the brick wall is located at the downspout. See Illustration No. 10.

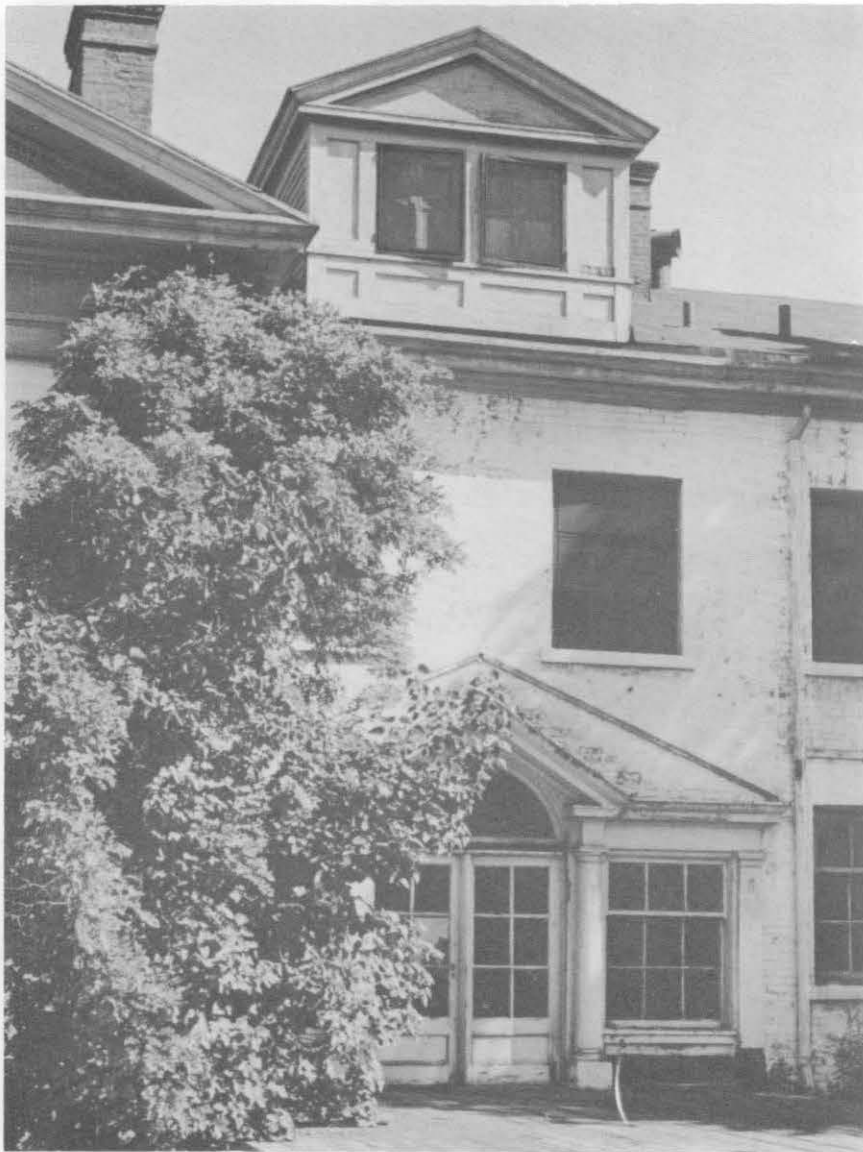
ILLUSTRATION NO. 8

The south wall of the Ansley Wilcox addition at the dining room. The wood terrace together with the scars over the doors and windows are the remains of a long terrace pavillion for outdoor restaurant dining.

The existing wood terrace on the south side shall be removed. The existing foundations of the original c.1894 terrace shall be repaired and wooden duck boards replaced. The wood sill at the dining room window trim shall be repaired.

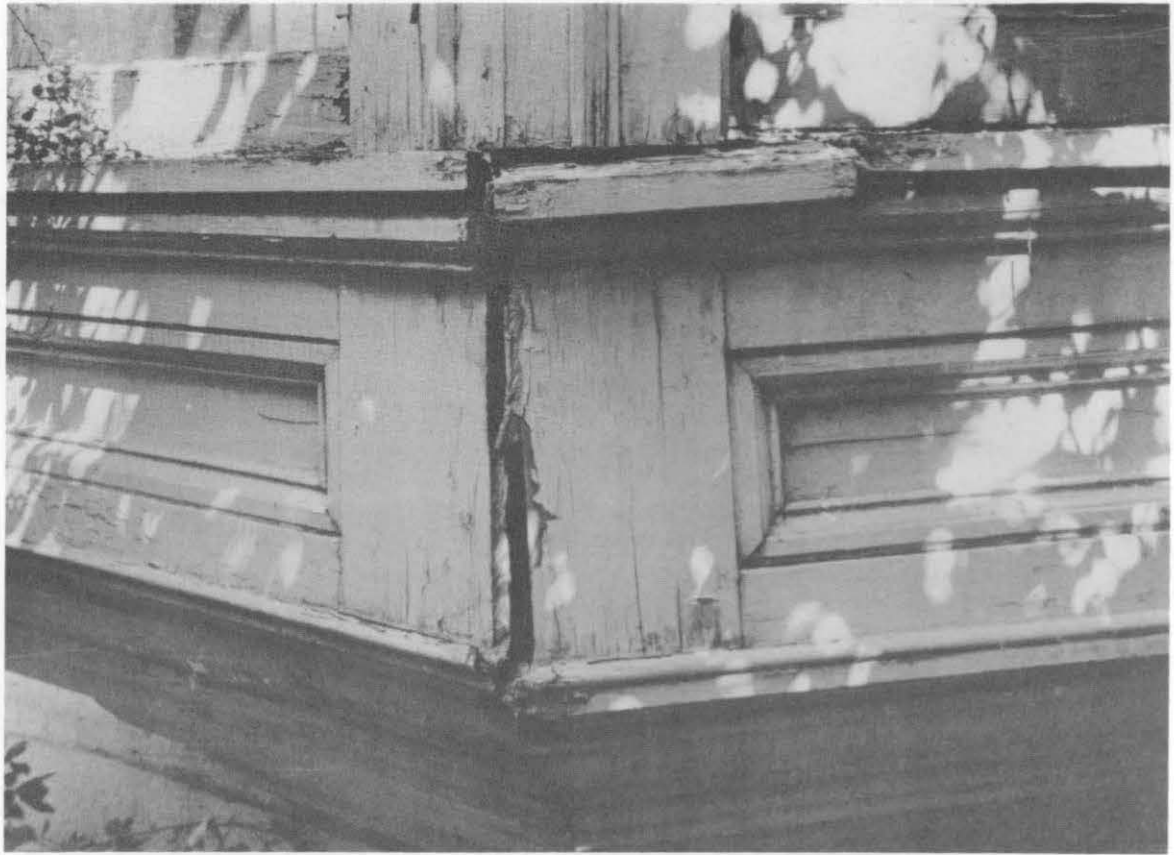
ILLUSTRATION NO. 9

The condition of the woodwork on the exterior of the library bay window is evident in this photo. The window structure is cantilevered from the main wall. The bay window will require considerable replacement of rotted woodwork throughout.

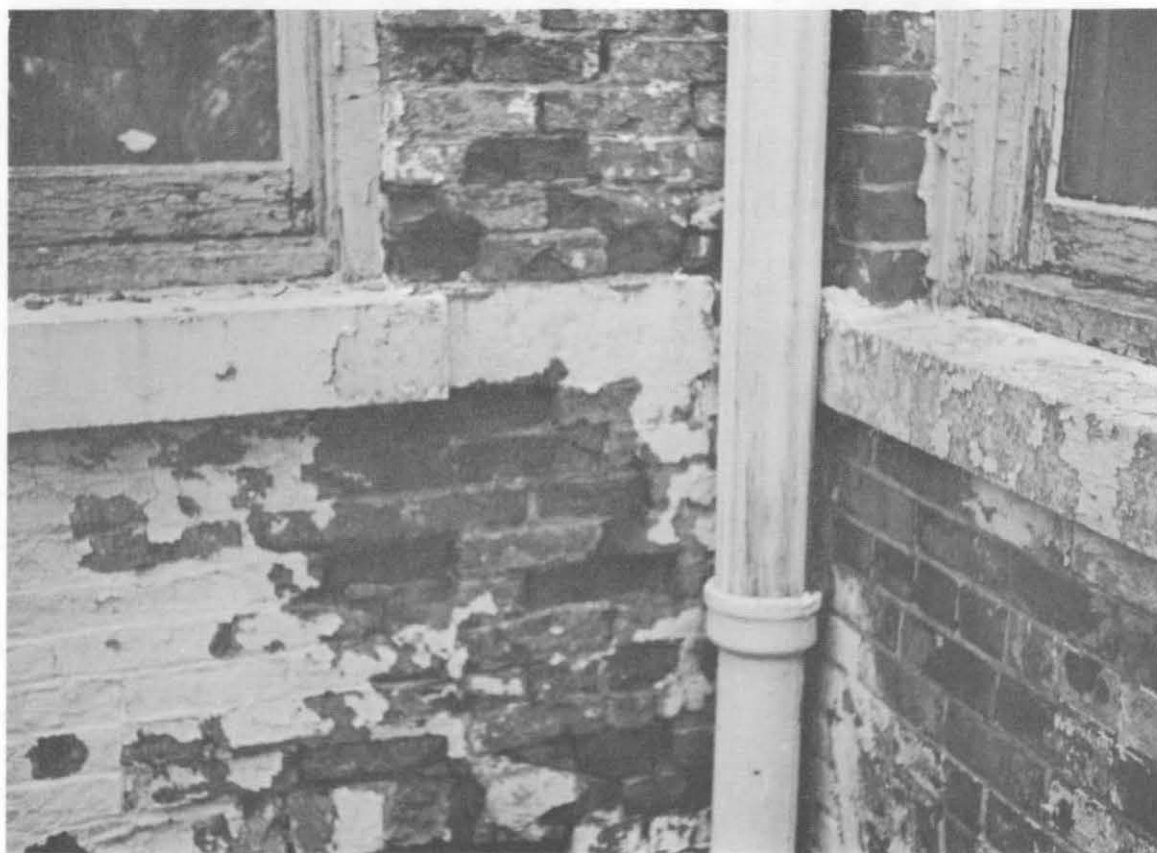
ILLUSTRATION NO. 10

This photo shows the deterioration of the brick wall due to an unrepaired roof gutter and downspout failure of long standing. The location is on the south side at the juncture of the 1838 barracks building on the right and the Ansley Wilcox addition on the left. The stone window sill at the left is original, cut back when Wilcox remodelled the library which included reducing the window width and the installation of the stained glass window.

The deteriorated brick on the south side shall be cut out and replaced with matching brick. The vine on the east wall shall be removed.

This portion of the brick wall from foundation to roof will require patching and replacement.

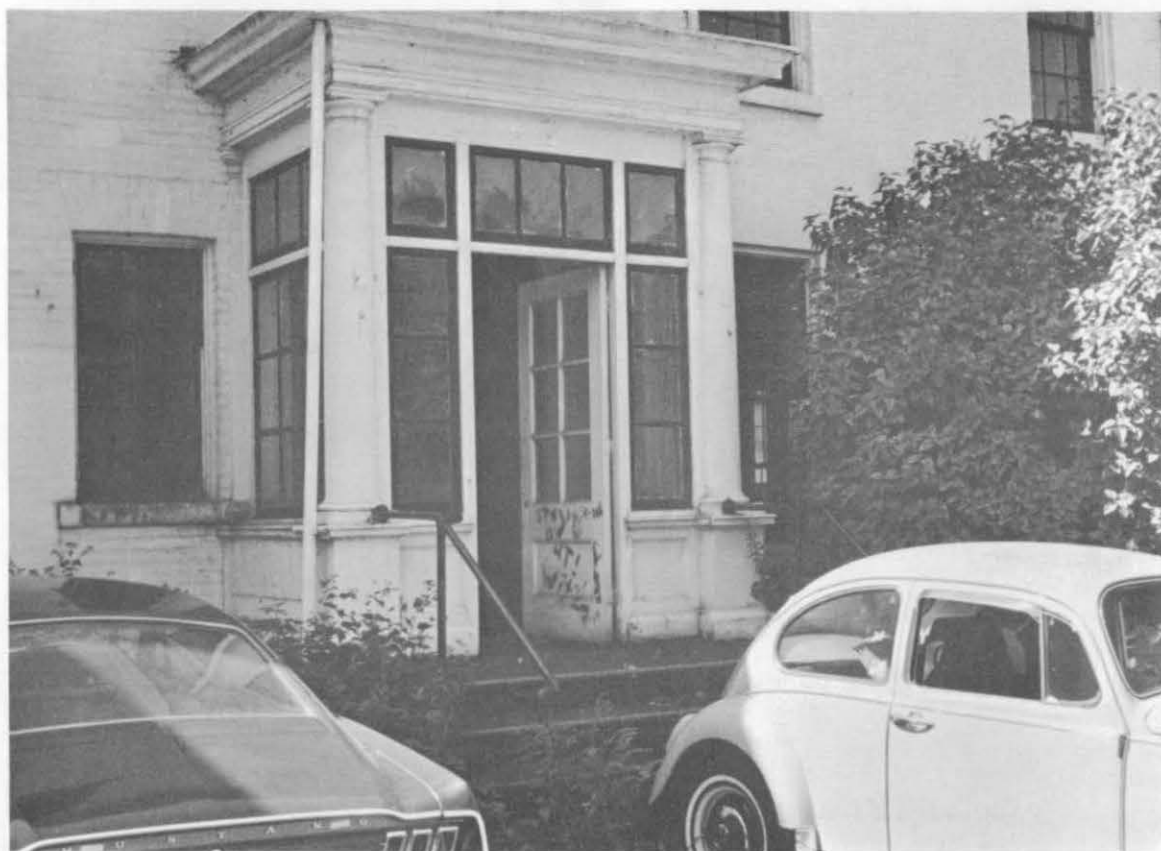
ILLUSTRATION NO. 11

The West Carriage entrance in its present condition. The existing porch floor is wood and the steps are precast concrete. When the building is restored the steps and flooring will be replaced with wood. The roof of this entrance will also require renewal.

The steps and floor of this porch shall be repaired or replaced with new wood. The columns, roof structure and railing at top platform shall remain. Roofing shall be replaced with new tin. The damaged leaded glass in the sidelights shall be replaced with new, matching the design of the original remaining. The glass panel in the door shall be replaced with leaded glass following the design of the original which exists in the attic in damaged condition.

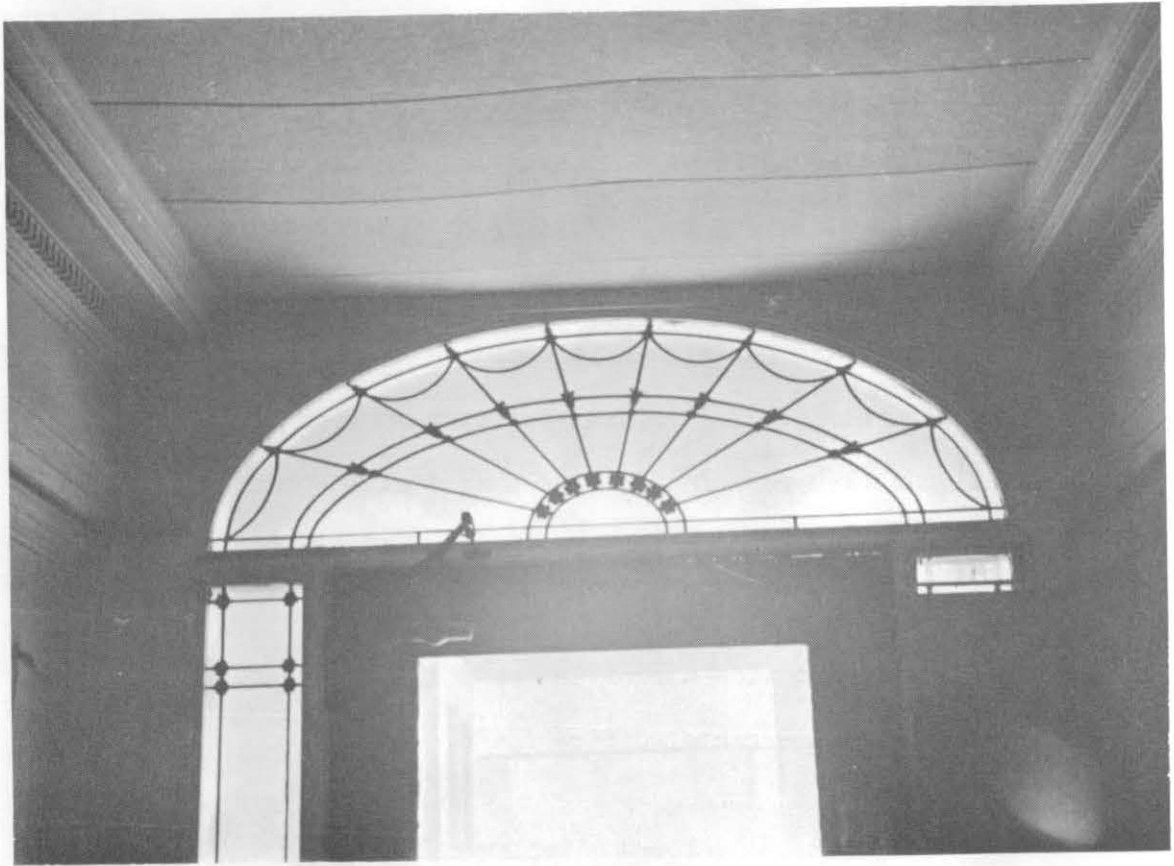
ILLUSTRATION NO. 12

The interior of the fanlight at the west, or carriage entrance. The leaded glass on the sidelights has been damaged and the leaded glass light in the door replaced with a sheet of plain glass. The leaded glass removed from this door has been located, in a damaged condition, but it is sufficiently intact to provide a pattern for an accurate copy.

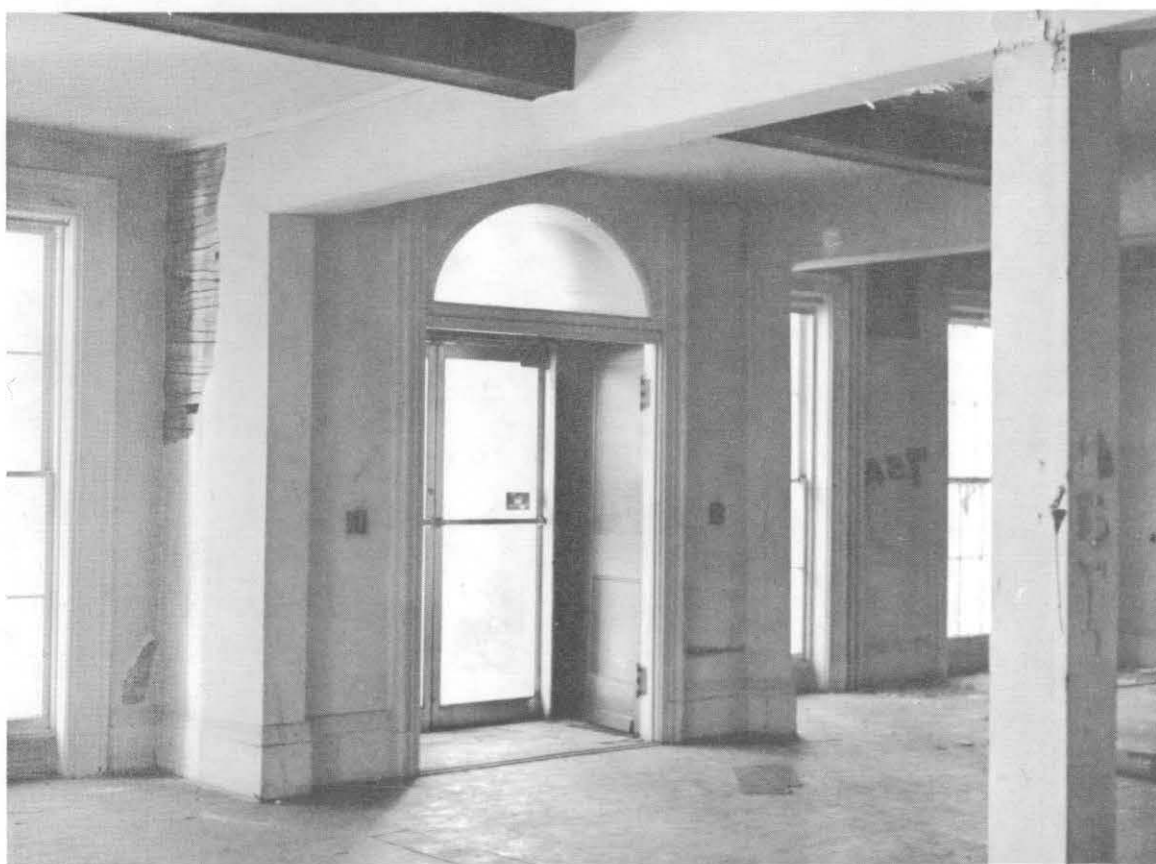
ILLUSTRATION NO. 14

The present interior showing the front entrance and vestibule from the former library and looking toward the northwest reception room. When the interior partitions were removed the posts, one of which can be seen at the right, were installed. The marks of the old partitions remain on the floor and a portion can be noted in the left foreground. The interior etched glass transom was repeated at the exterior pair of doors but has been replaced by clear glass.

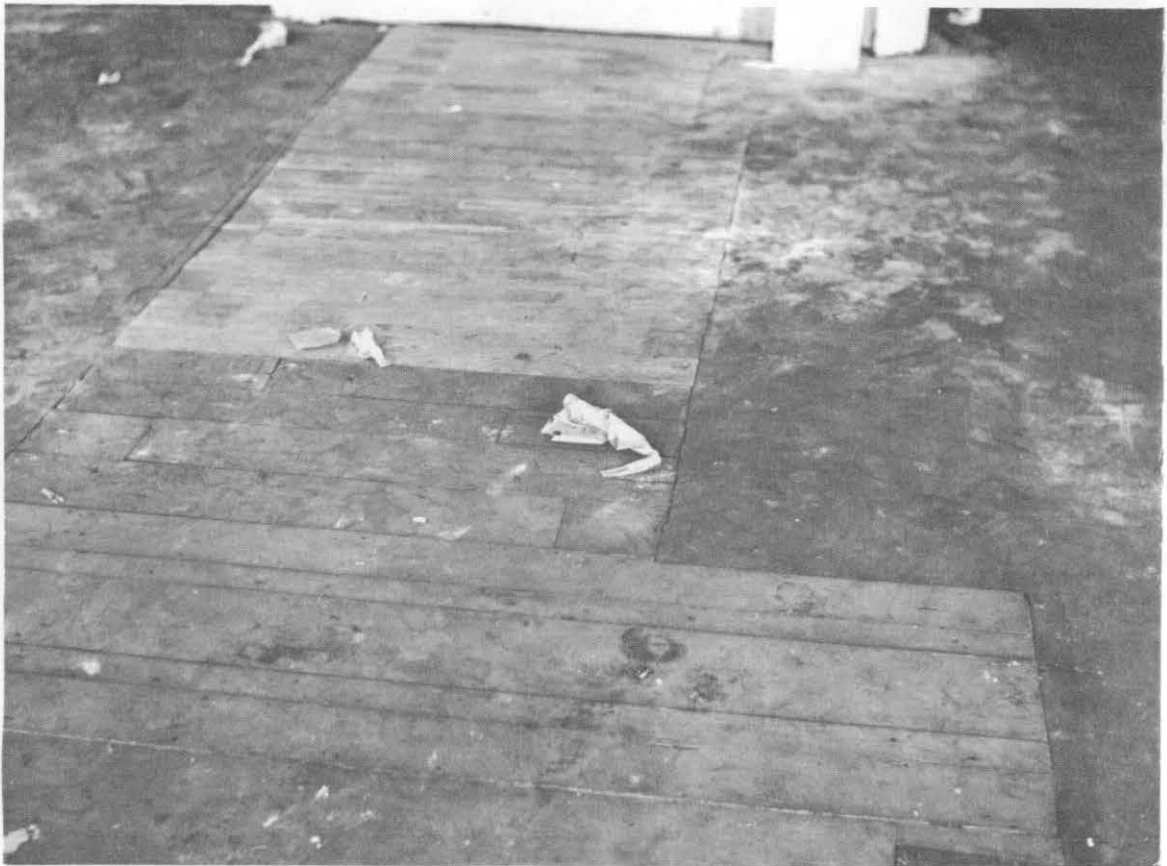
ILLUSTRATION NO. 15

Flooring patches showing the area of the original front staircase. The staircase can be reconstructed from the scars showing the location on both the first and second floors. A spindle is said to have been located leaving the newels, mouldings and handrails for further study.

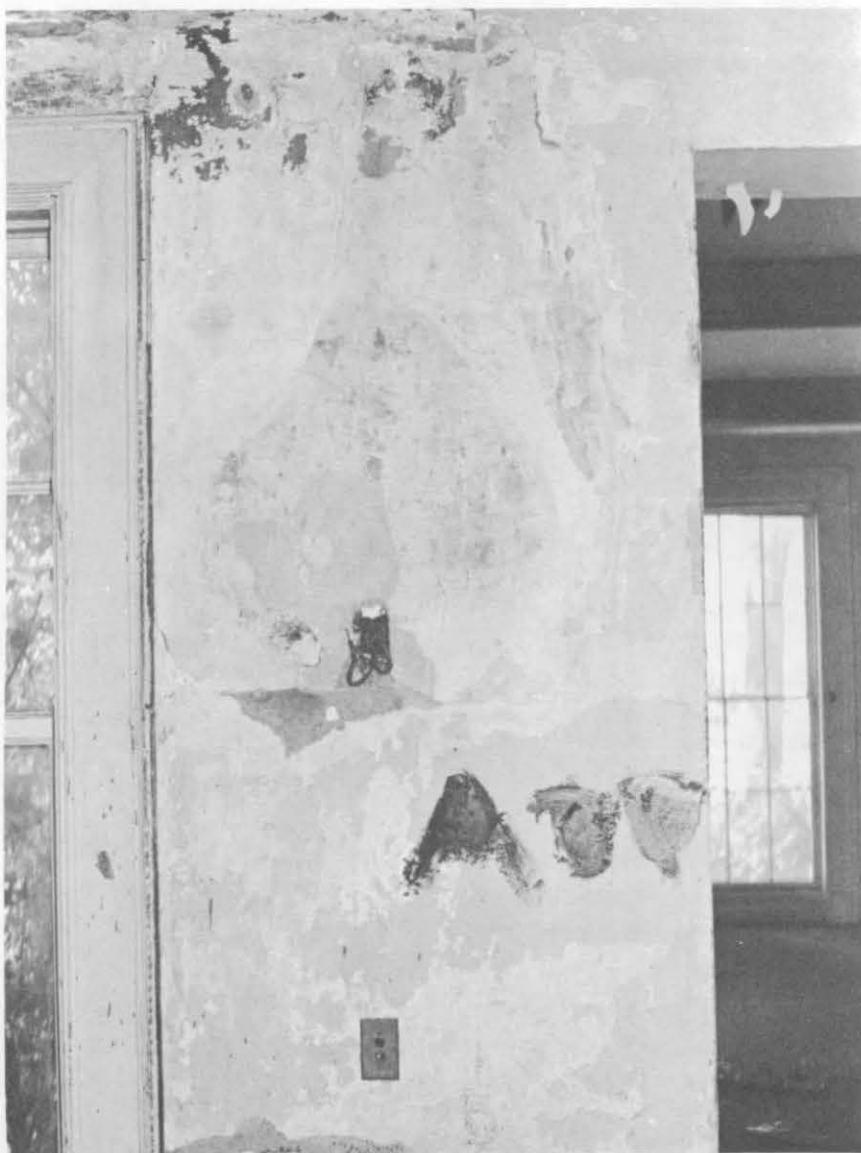
ILLUSTRATION NO. 16.

The long standing leak at the juncture of the early building and the Wilcox addition which caused deterioration to the exterior brickwork also damaged the plaster in the morning room. Note the line in the plaster wall at the level of the meeting rail of the window sash. This line marks the top of the oak wainscot which was removed when the room partitions were removed to adapt the house to restaurant use.

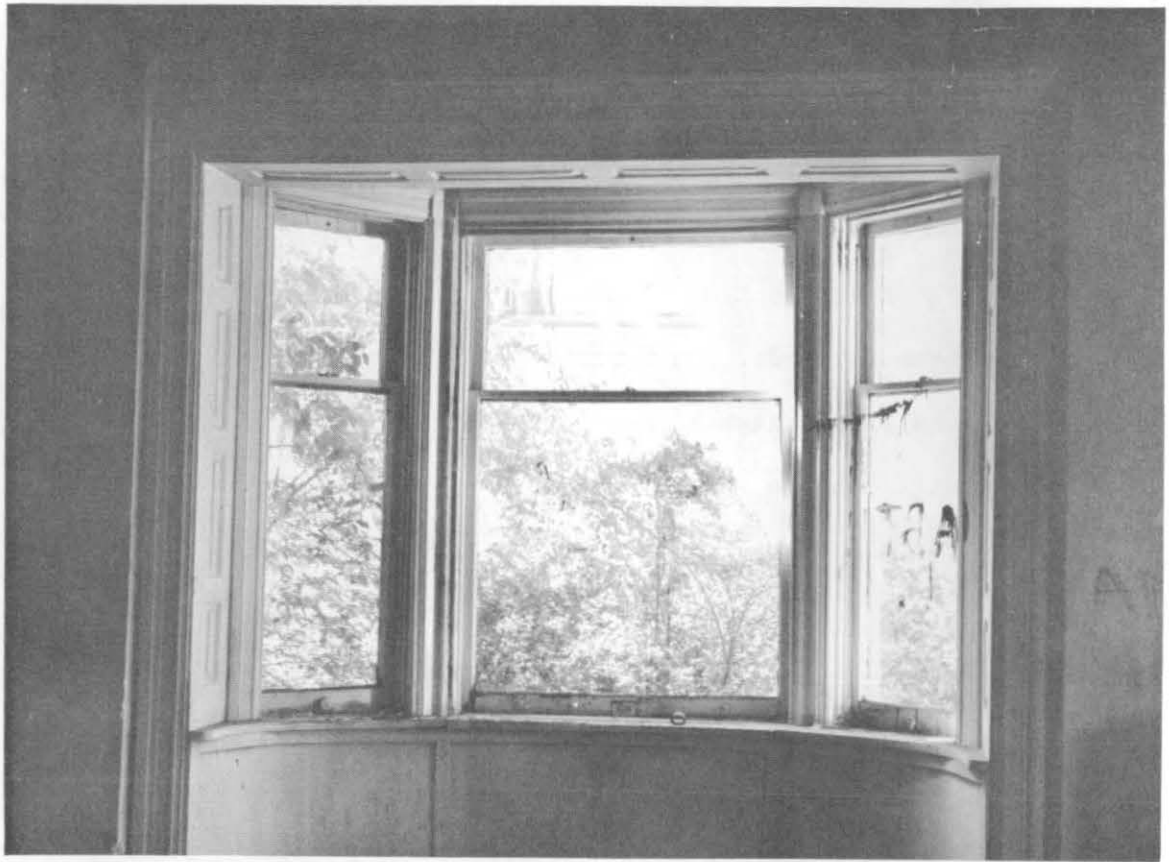
ILLUSTRATION NO. 17

The interior of the Library bay window. The ceiling shows signs of leaks. The window seat which was in place at the Inaugural has been removed. The seat can be restored by utilizing the early photographs together with the marks of the apron on the flooring. The woodwork in the Library was natural wood, varnished, during the historic period.

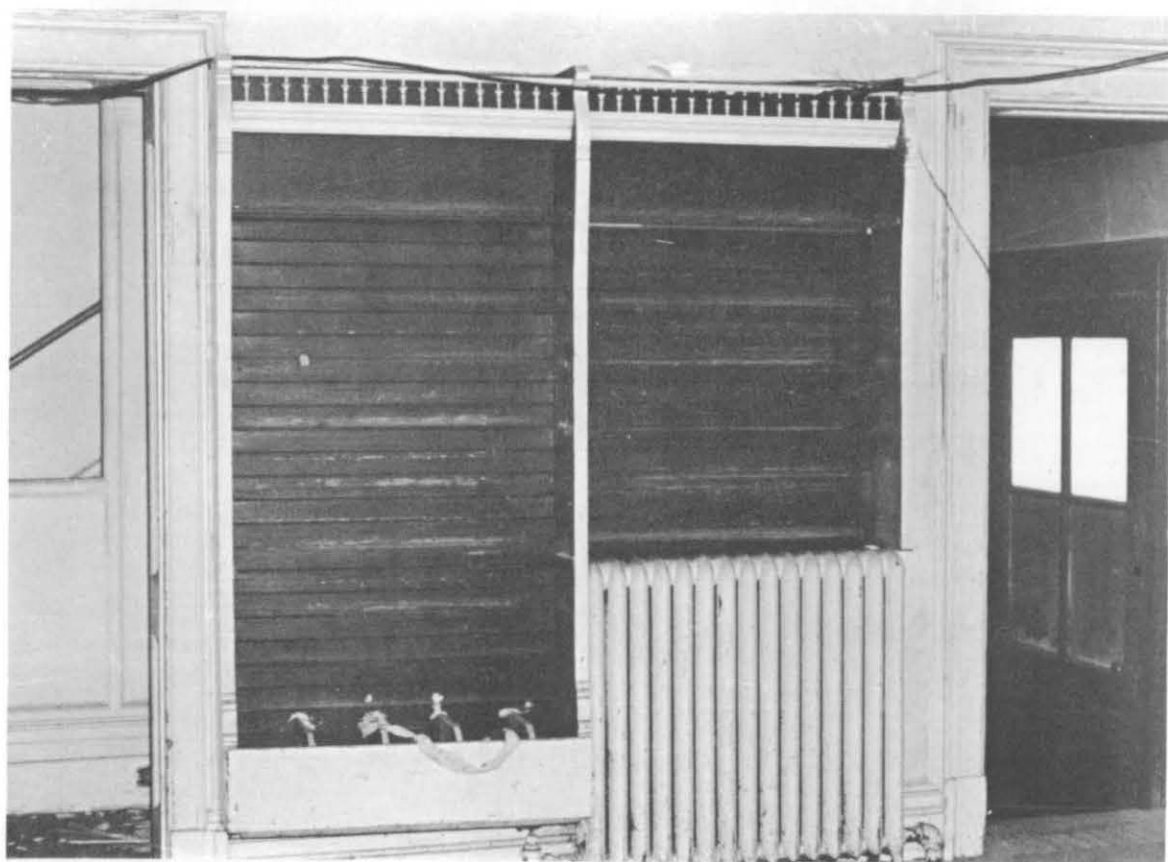
ILLUSTRATION NO. 18

The only remaining section of the Library bookcases relocated in a Kitchen storage room. The lower section is missing. The oak case has been painted. The movable pegs for adjusting the shelf heights remain in place. This section will provide the pattern for the restoration of the bookcases in the Library.

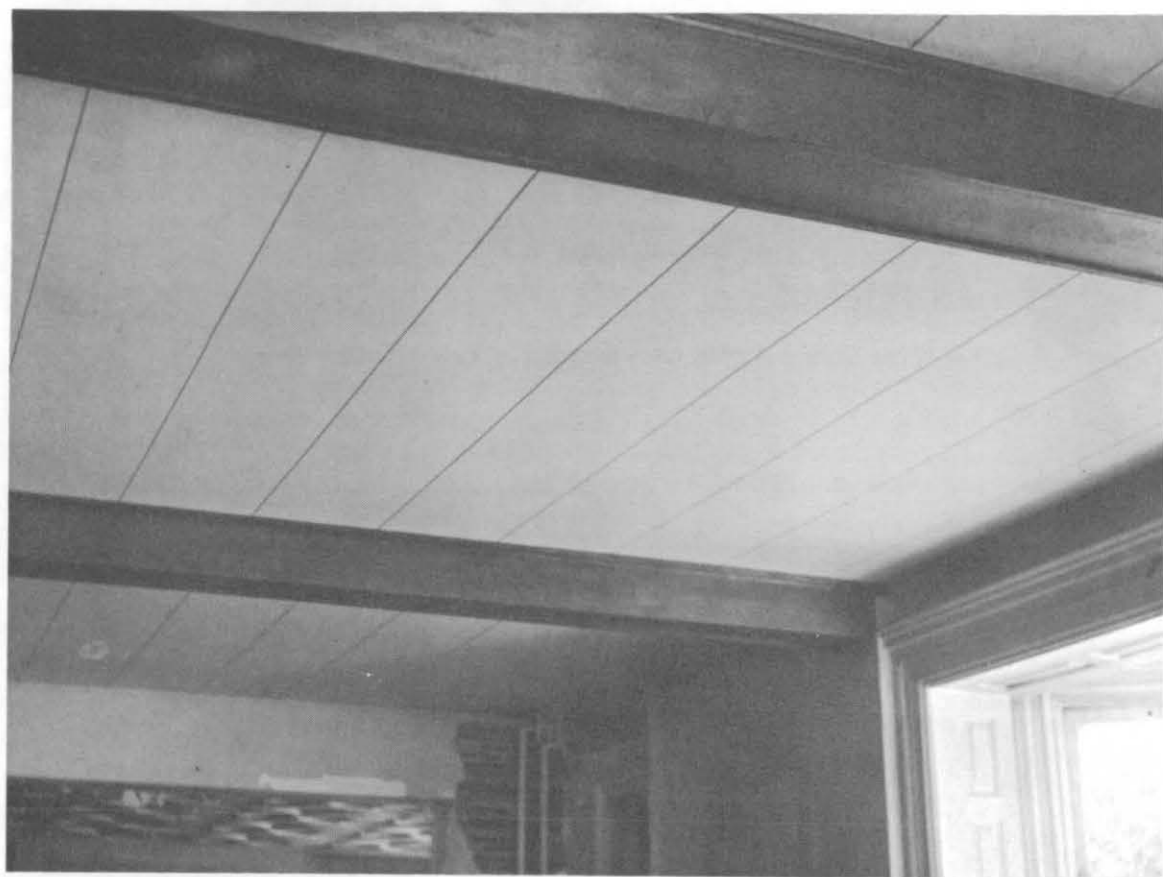
ILLUSTRATION NO. 19

When the bearing partitions were removed from the first floor steel beams and posts were added, the beams were covered with the falsework shown here and the old plaster ceiling covered by the fibreboard planking. The library bay window can be seen at the lower right. The restoration will require the removal of the posts, beams and fibreboard and the restoration of the partitions, including the molded plaster ceiling medallions.

The demolished south partition shall be replaced, base and trim on this wall to match that existing on other walls. Ceiling shall be replastered (existing fiberboard, beams and old plaster to be removed). Existing plaster walls to be patched as required. Existing wood floor shall be carpeted. New wood and glass exhibit cases with integral lighting shall be installed.

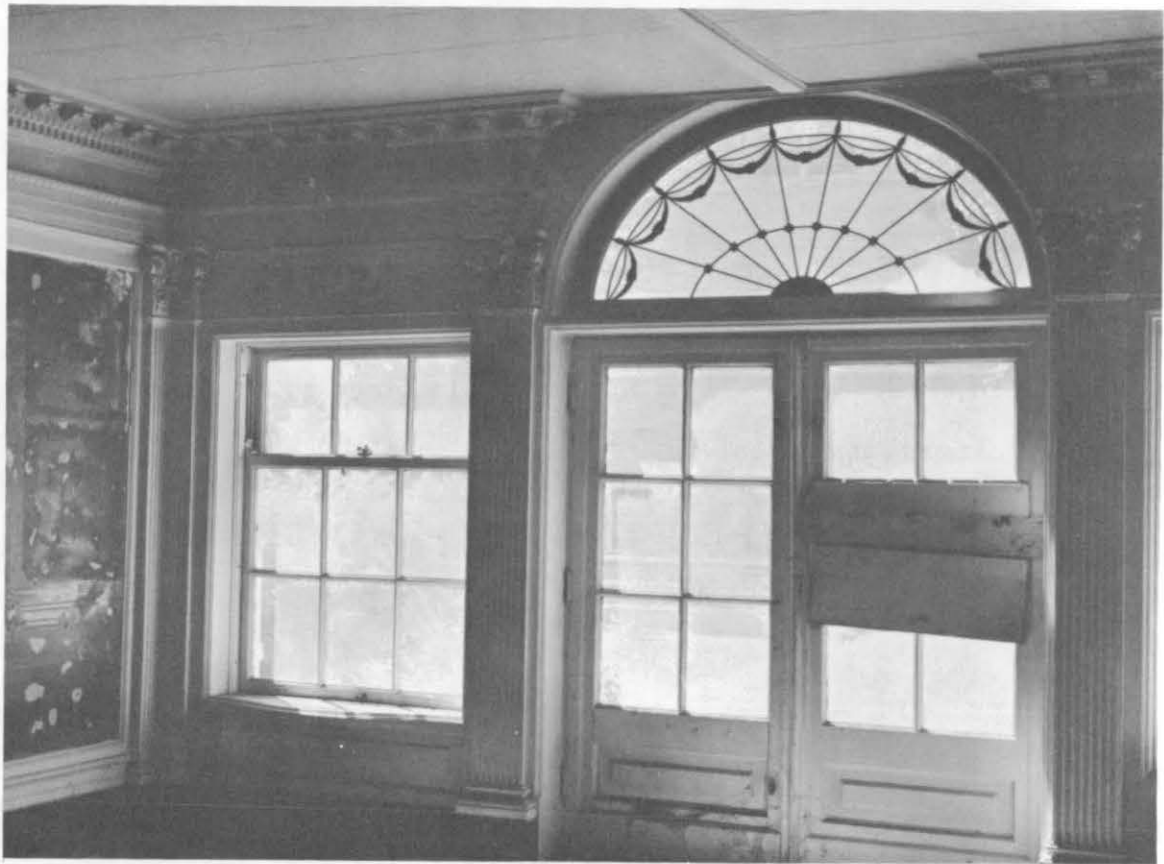
ILLUSTRATION NO. 20

The doors from the dining room to the terrace,  
showing the leaded glass fan light and one of the  
glass areas broken by vandalism.
