**PART II HISTORIC STRUCTURES REPORT**

# **Ansley Wilcox House N.H.S.**

**NOV. 1969**

**Office Of Archeology And Historic Preservation**

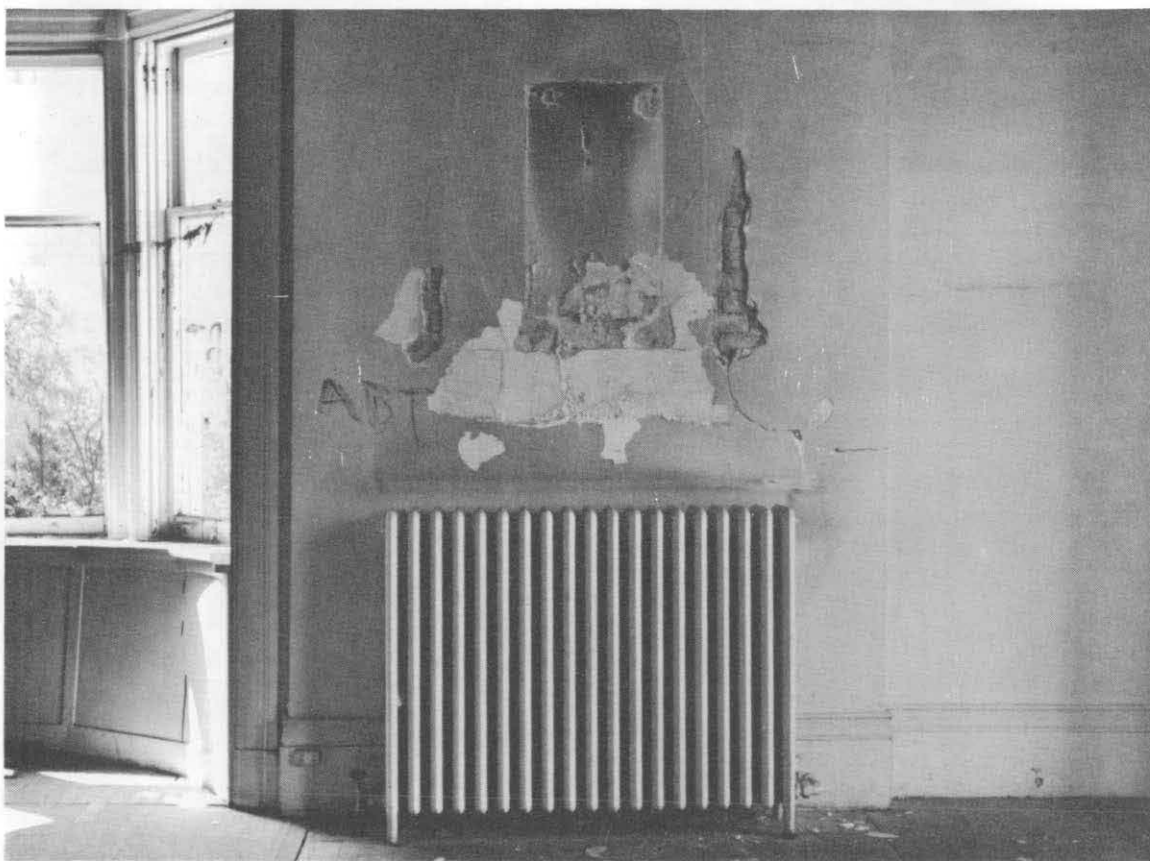
ILLUSTRATION NO. 22

The location of the fireplace with the ornate mantel before which Roosevelt took the oath of office. When the restaurant was installed in the house, the mantel was removed and the fireplace closed. Only the tile hearth remains. It will be possible to restore the room from the photographs of the room taken at the time of the Inaugural ceremony and the marks of the missing elements indicating the points of fastening. The marks of the former bookcases remain on the hardwood flooring together with the scars of the two entrances to the room.

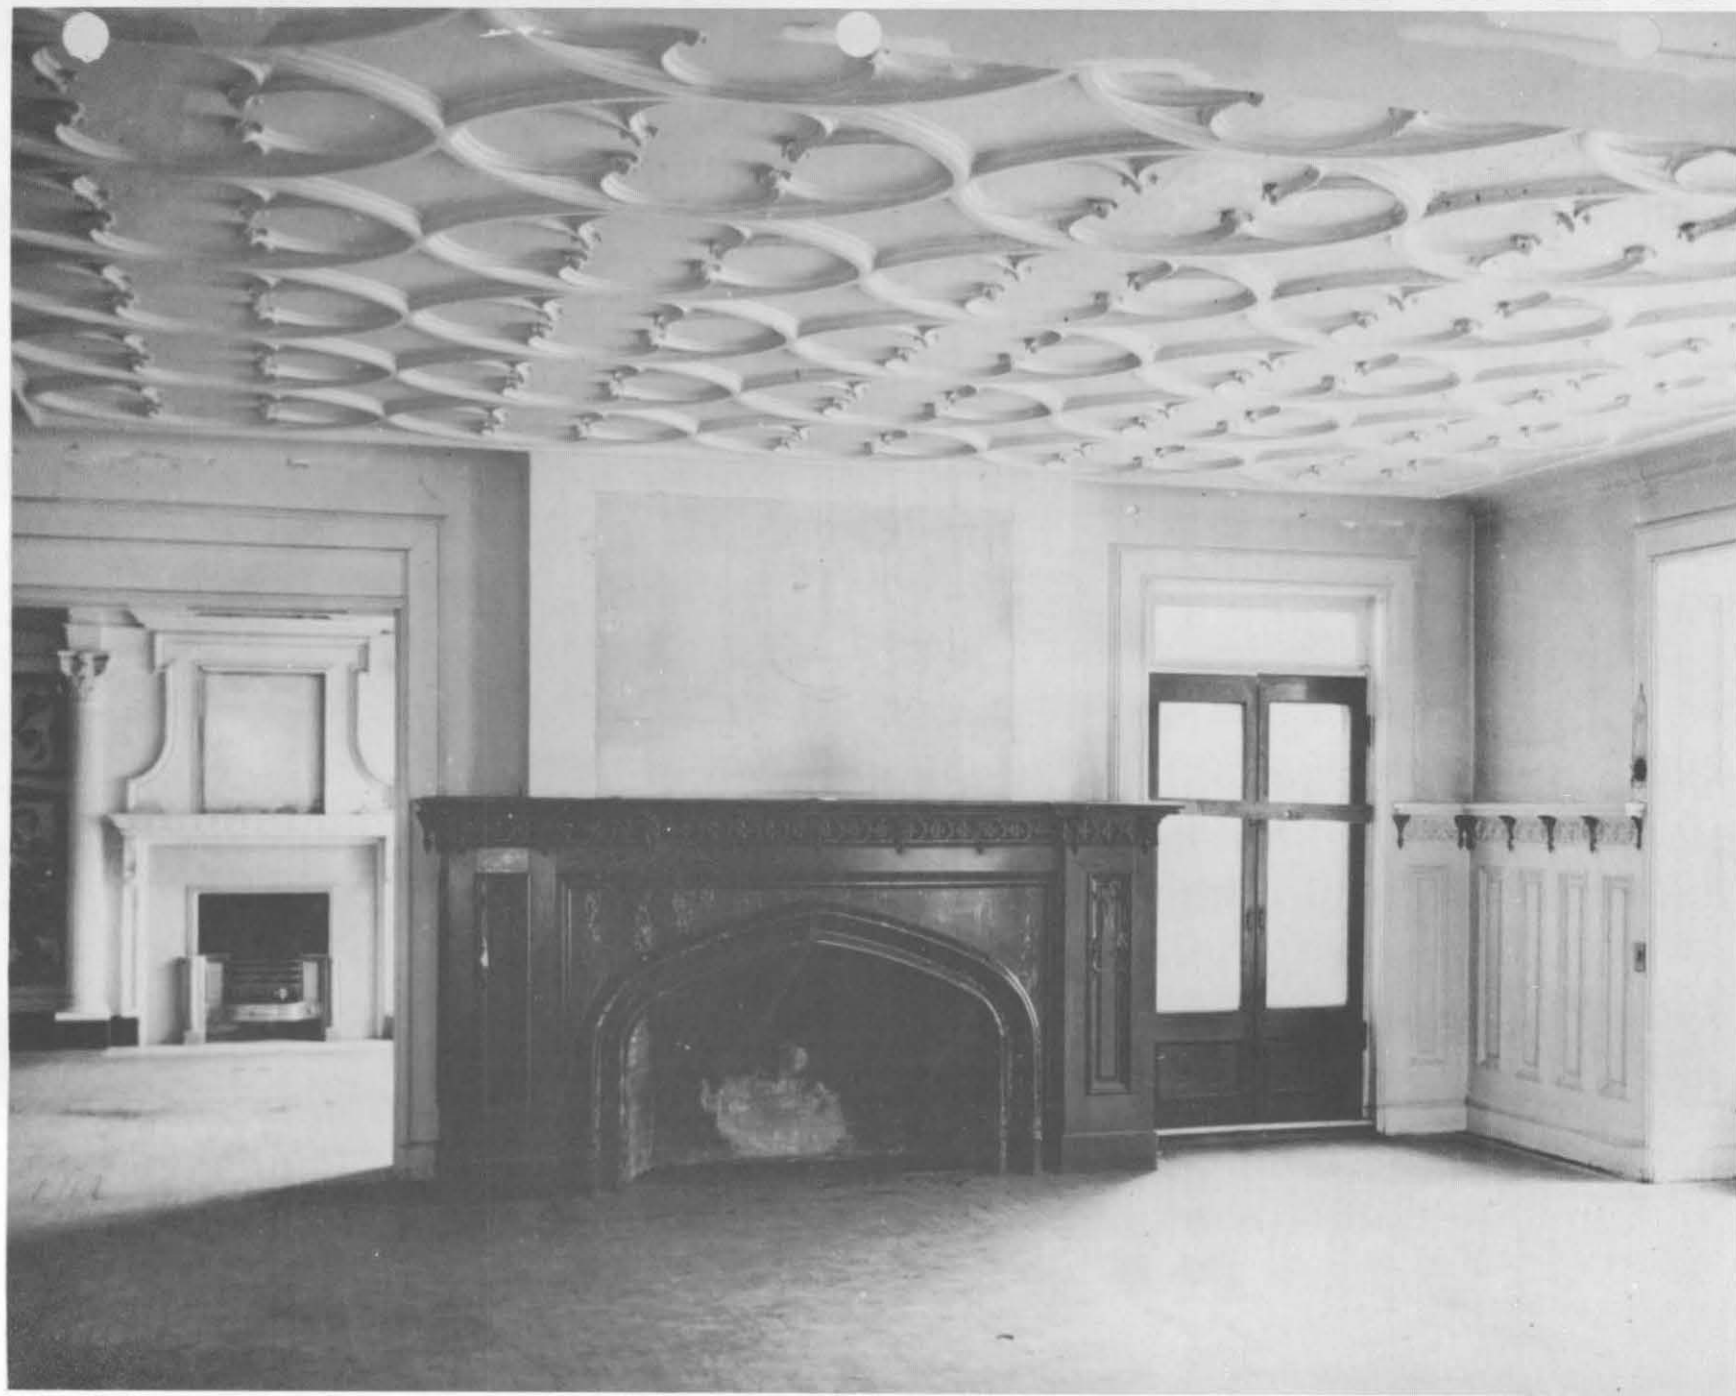
ILLUSTRATION NO. 23

The existing condition of the "Morning Room" or living room. The Tudor Gothic detailing remains on the east walls and up to and including the fireplace mantel. This room is proposed as a Visitor Orientation Room and as such will have only the existing remaining features restored to suggest what the room once looked like. The hardwood flooring is in good condition. The west wall between the former hall and the morning room will not be restored to provide more space for audio-visual programs.

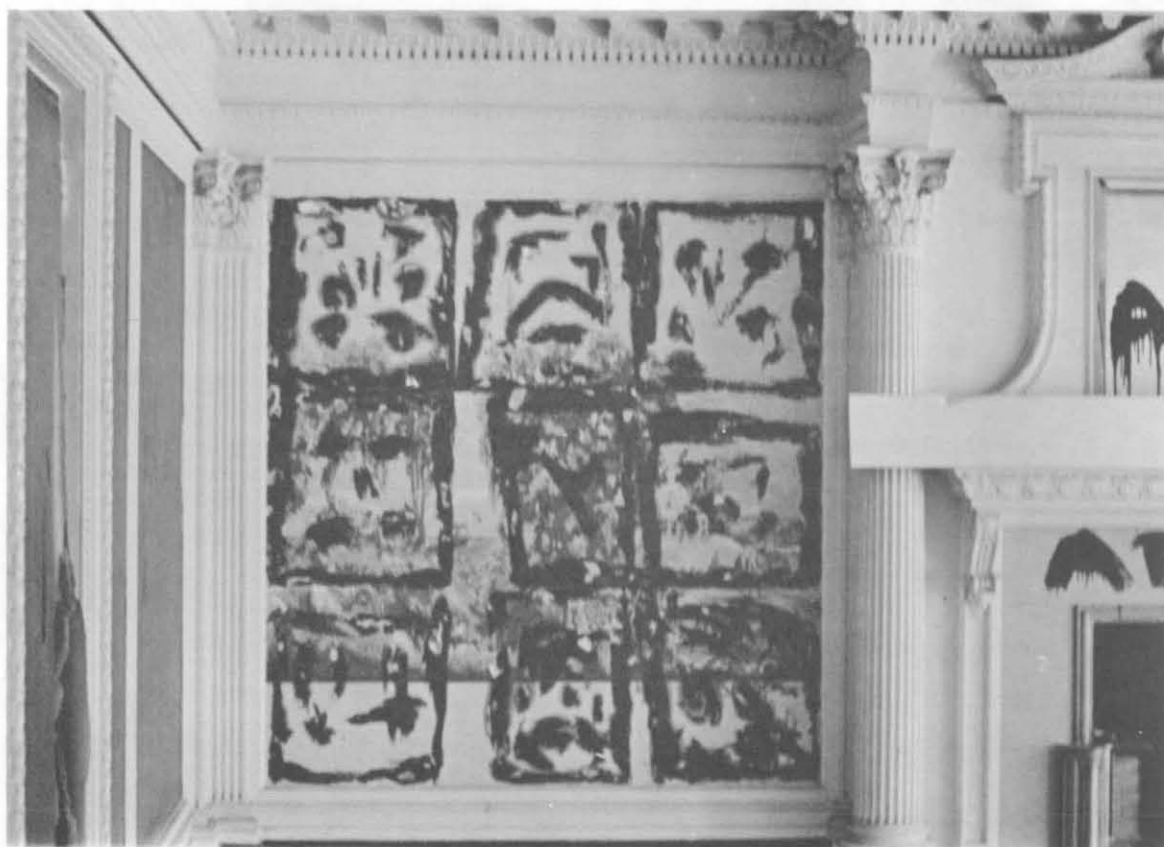
ILLUSTRATION NO. 24

The walls flanking the fireplace in the dining room were covered with mirrors for the restaurant decor. The mirrors were removed leaving the adhesive attached to the plaster walls. Evidences of the vandalism can be noted on the mantel at the right.

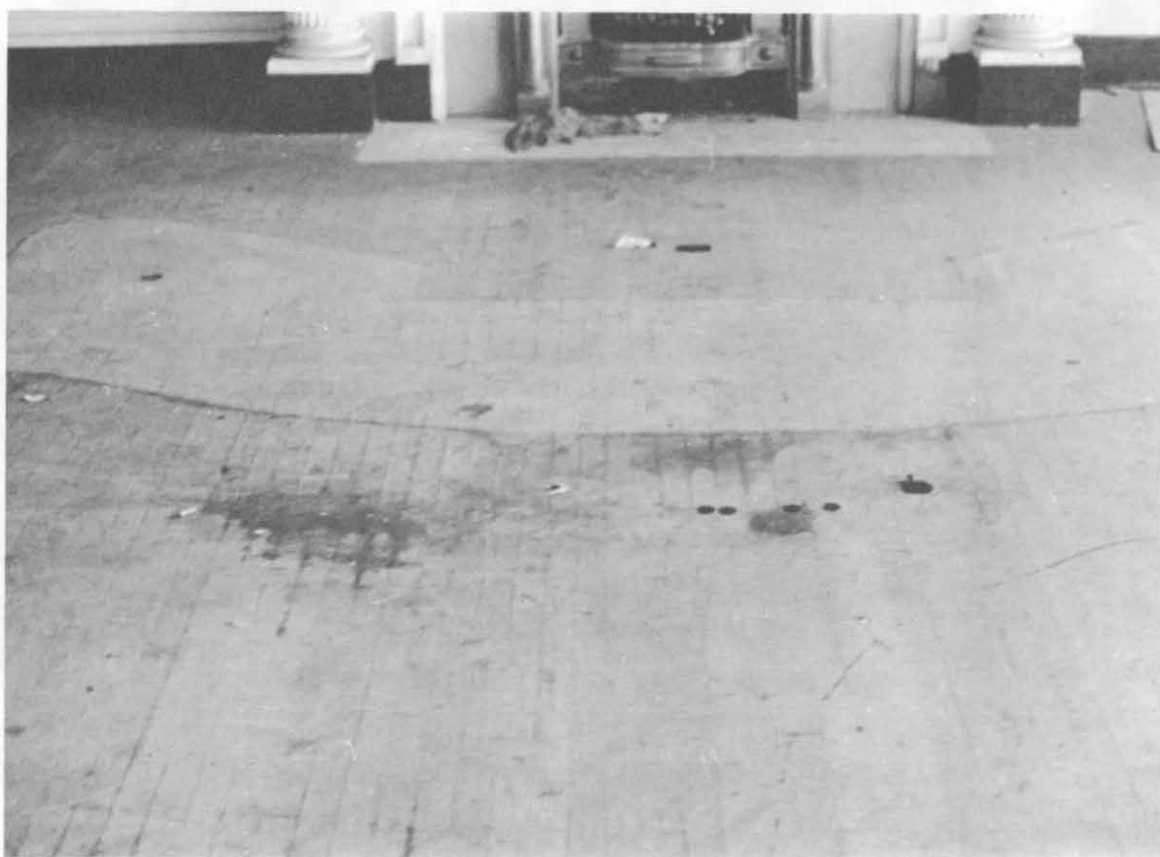
ILLUSTRATION NO. 27

The dining room flooring showing the marks of the restaurant bar remaining on the hardwood flooring. The flooring can be resurfaced and repaired during the restoration process.

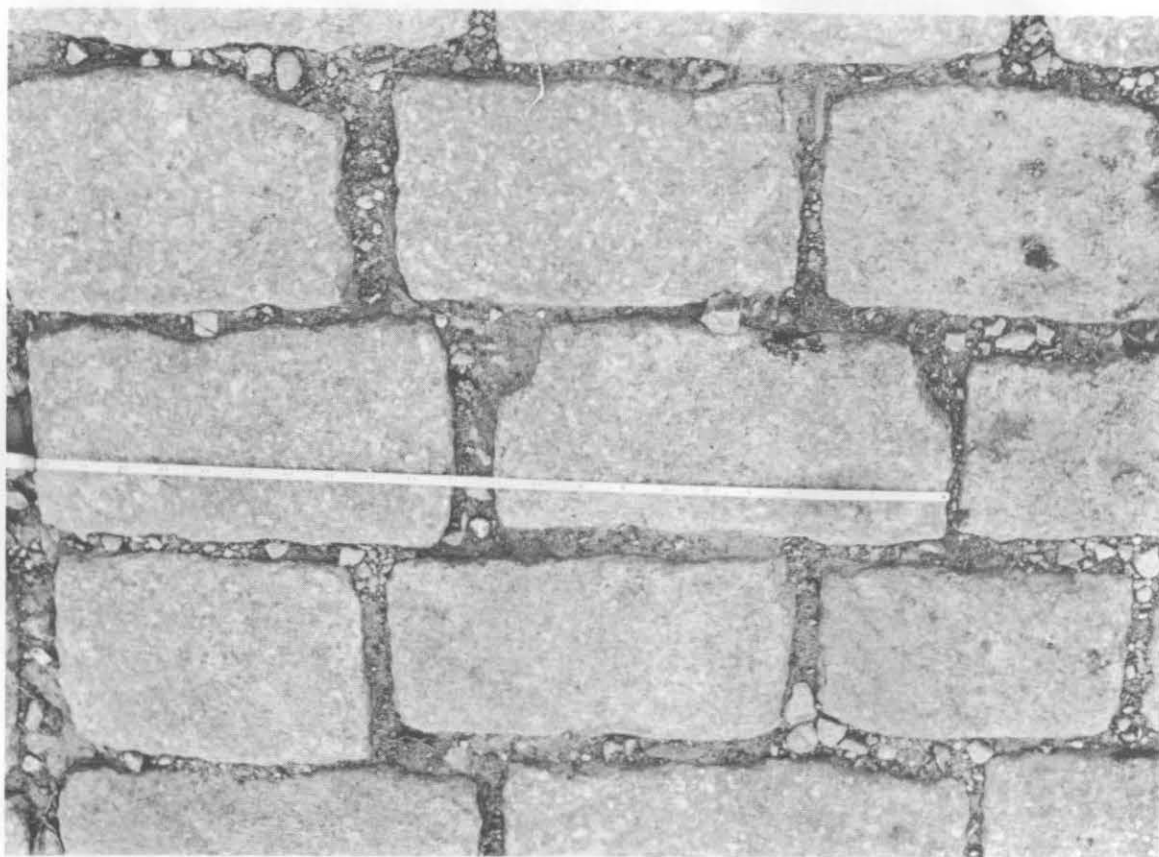
ILLUSTRATION NO. 35

Detail of the cobblestone drive which was found to remain under the present blacktop surface. It is proposed that the cobblestone drive be restored as a part of the restoration and rehabilitation of the house and grounds.

Driveway: The stone bumpers shall be replaced at the retaining wall line on each side of the driveway. The cobblestone portion shall be cleaned out and spaces between stones filled with mortar. From the retaining wall to the west wall of the former carriage house location, a new cobblestone driveway shall be installed.
