# Preservation/Restoration of Moton Field

## Phase II

Tuskegee Airmen  
National Historic Site  
Tuskegee, Alabama

*Historic Structure Report*  
Bath & Locker House

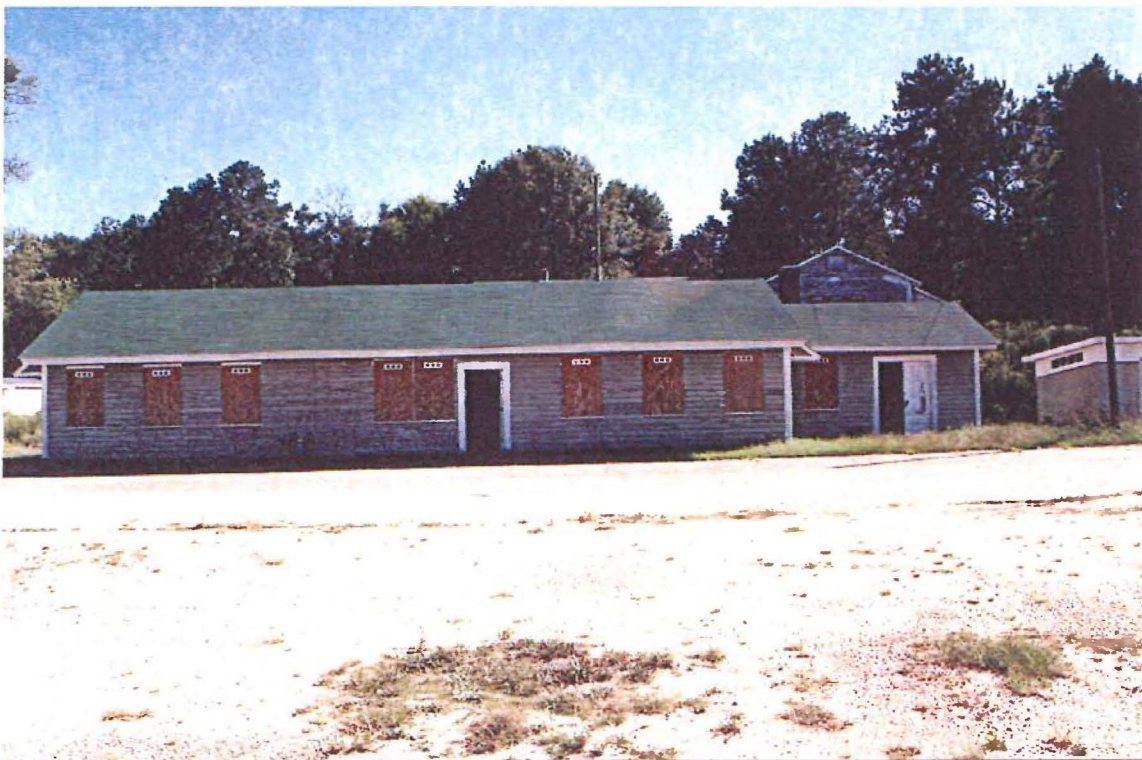
**Figure 7:** South facade in 1997 prior to stabilization. National Park Service, SERO, Atlanta, Georgia.

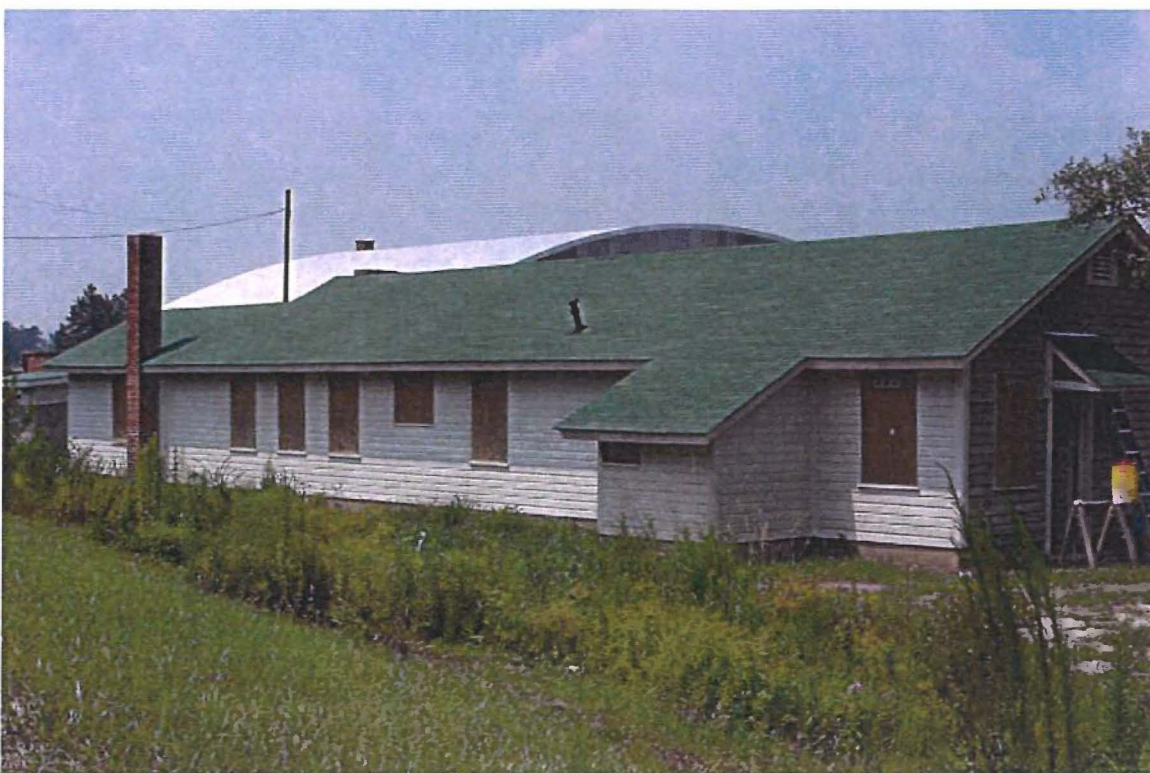
**Figure 8:** Existing north front facade.

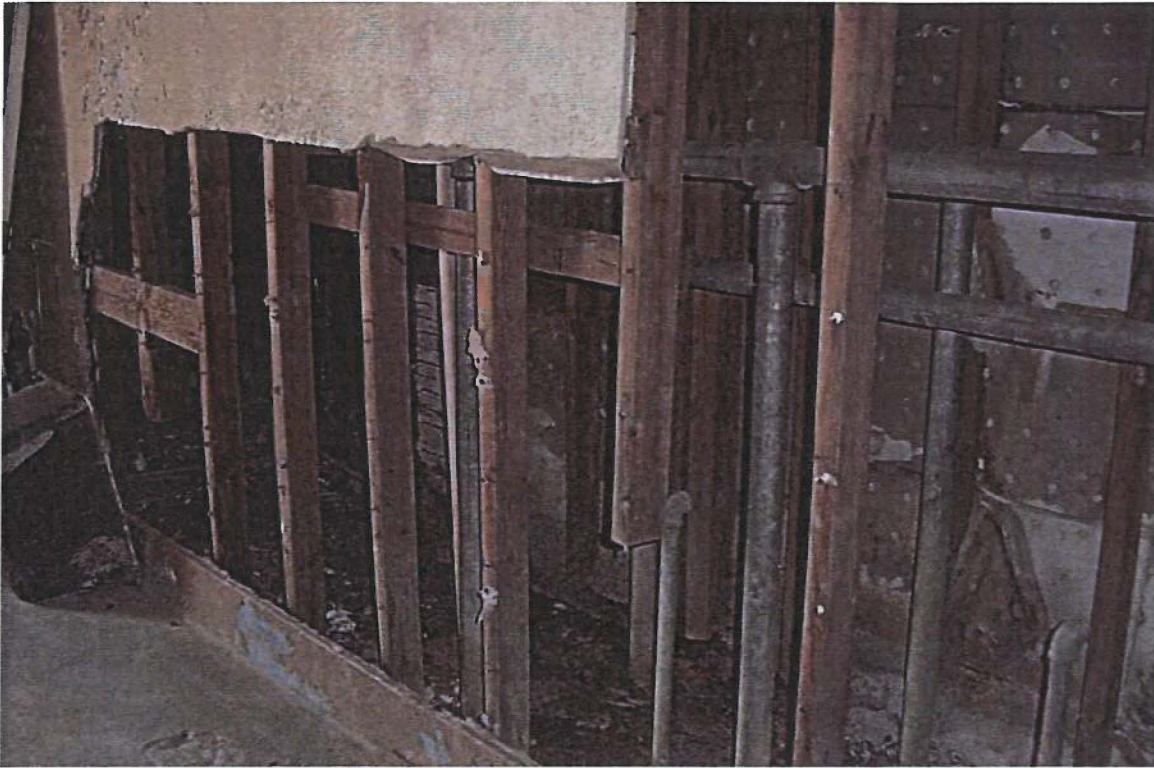
**Figure 10:** Former location of toilets in men's toilet room.

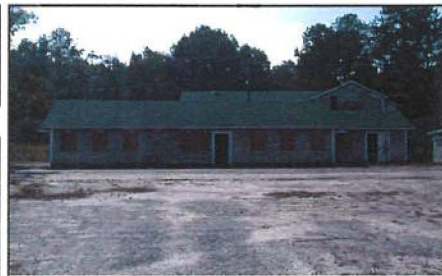
| <b>Deficiency:</b> | Loose and warping siding has been replaced. Loose and peeling paint has been corrected |

| <b>Recommendation:</b> | Repaint to match original color scheme. |

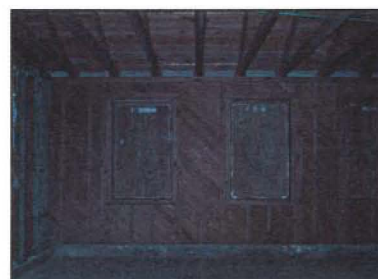
| <b>Deficiency:</b> | Collapsed portions have been replaced. |

| <b>Recommendation:</b> | Utilize as restored. |

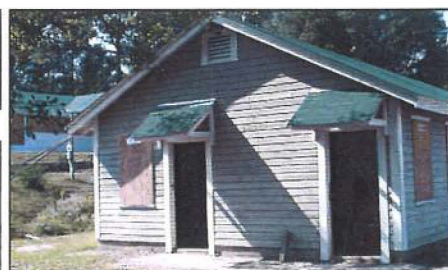
| <b>Deficiency:</b> | Missing boards and deteriorated trim have been replaced during stabilization. Loose and peeling paint has been corrected. |

| <b>Recommendation:</b> | Repaint to match original color scheme. |

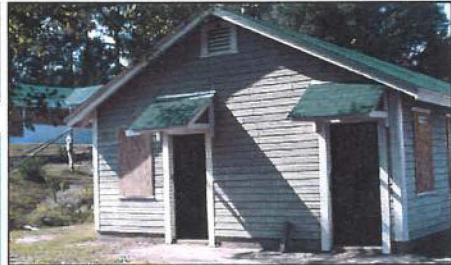
**Deficiency:** Missing and deteriorated elements have been replaced during stabilization.

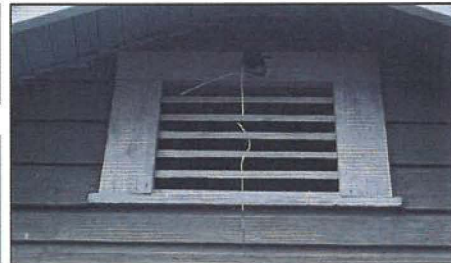
**Deficiency:** None

**Recommendation:** Repaint to match original color scheme.

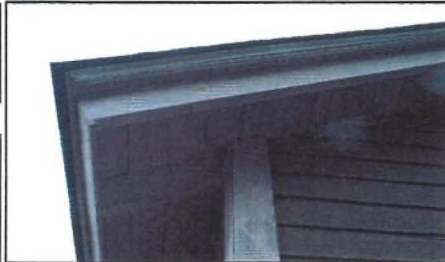
**Deficiency:** Missing boards and deteriorated trim have been replaced during stabilization. Loose and peeling paint has been corrected.

**Recommendation:** Repaint to match original color scheme.

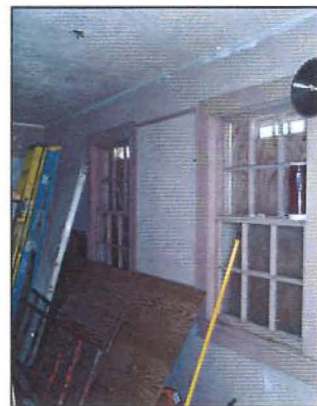
**Deficiency:** Missing some windows and frames.

**Recommendation:** Remove vented plywood. Replicate missing windows and install.

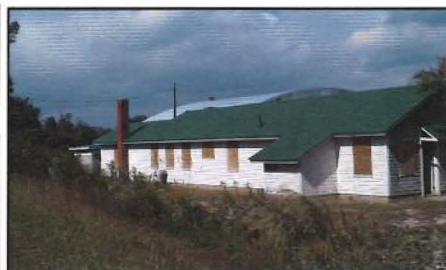
The current roof covering is green three tab asphalt shingles. The shingles were replaced during recent stabilization work and do not accurately reflect the historic roof covering.

**Recommendation:** Remove modern roofing material and replace with replicated roofing material to match original construction.

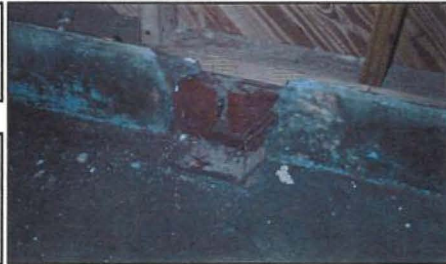
The original concrete slab on grade floors remain intact throughout the building. Concrete curbs around the perimeter of each room were constructed of brick with concrete applied over the surface. The floors and curbs are generally in sound condition but are cracked and broken in some areas.

| <b>Recommendation:</b> Repair broken curb with in-kind concrete material. |

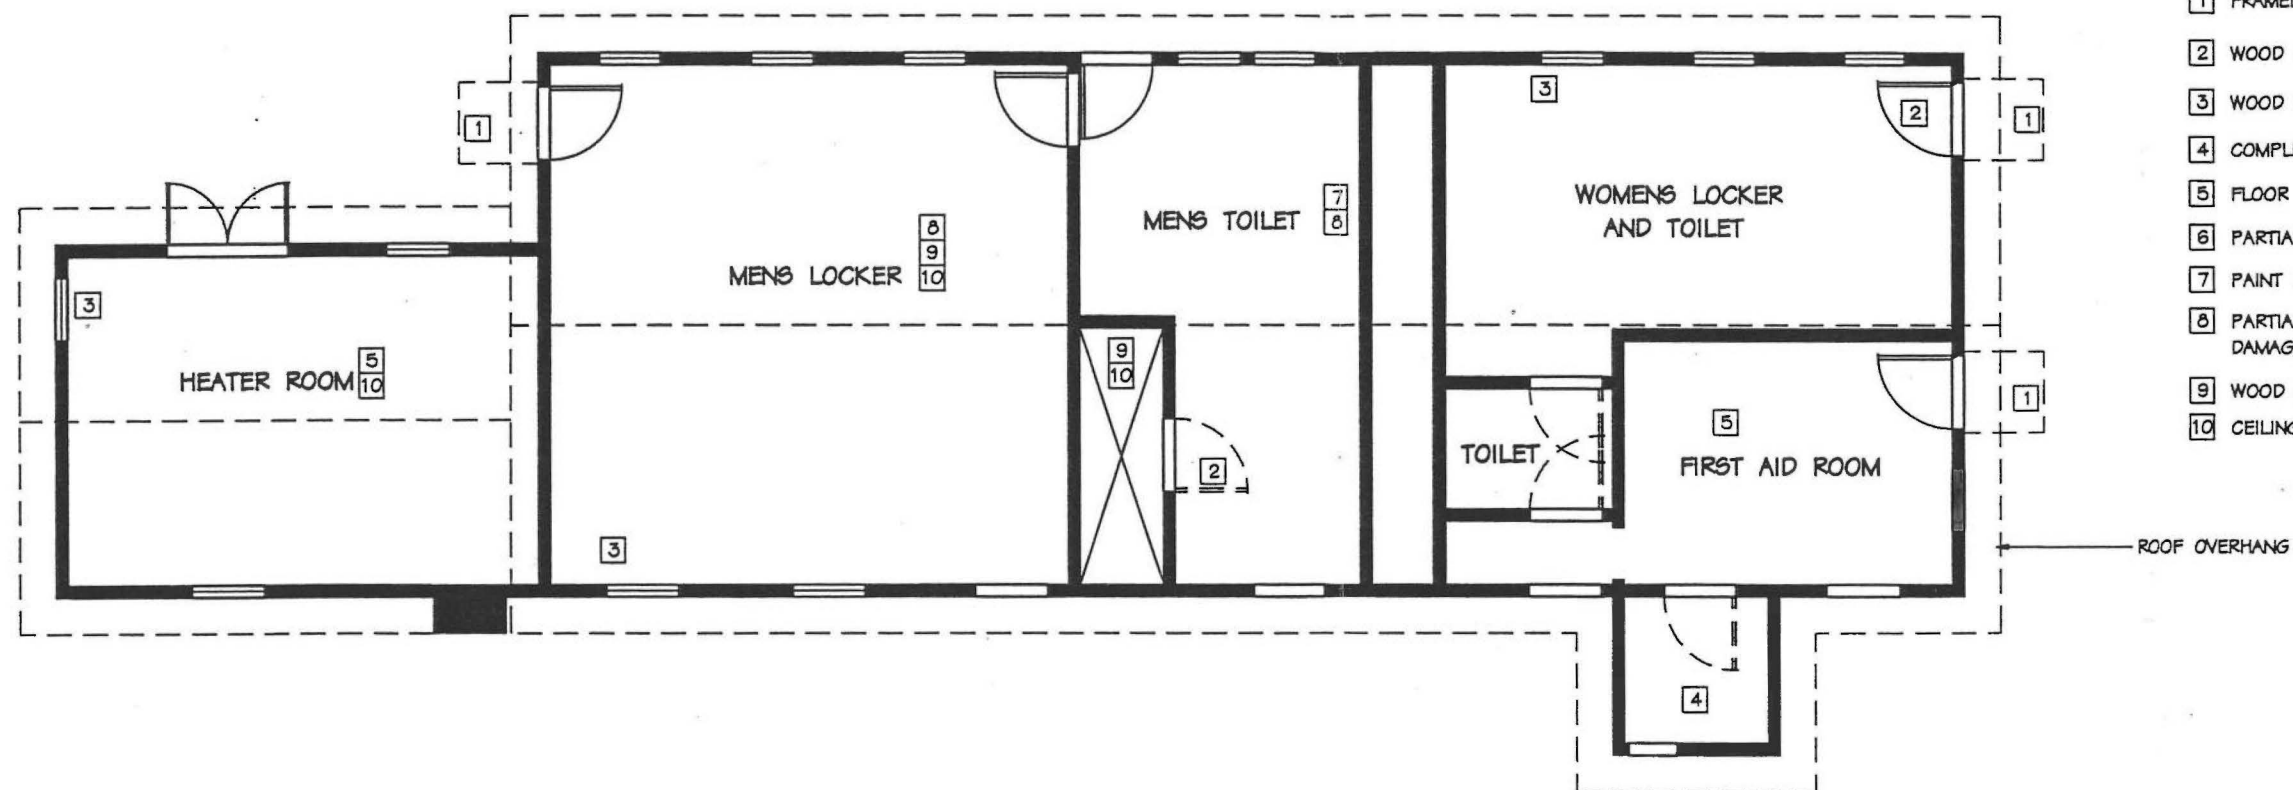
FLOOR PLAN  
SCALE: 1/4" = 1'-0"

- 1 FRAMED AWNING
- 2 WOOD DOOR (TYP)
- 3 WOOD FRAMED WINDOW W/ SCREENS (TYP)
- 4 COMPLETELY REDONE
- 5 FLOOR EXPOSED CONCRETE W/ CONCRETE 6" BASE
- 6 PARTIAL 6" CONCRETE BASE
- 7 PAINT PEELING OFF MOST/ALL WALLS
- 8 PARTIAL STRUCTURE OF WALL IS MISSING/DAMAGED/ROTTED
- 9 WOOD SUPPORT GONE/ROTTED
- 10 CEILING DAMAGED/MISSING

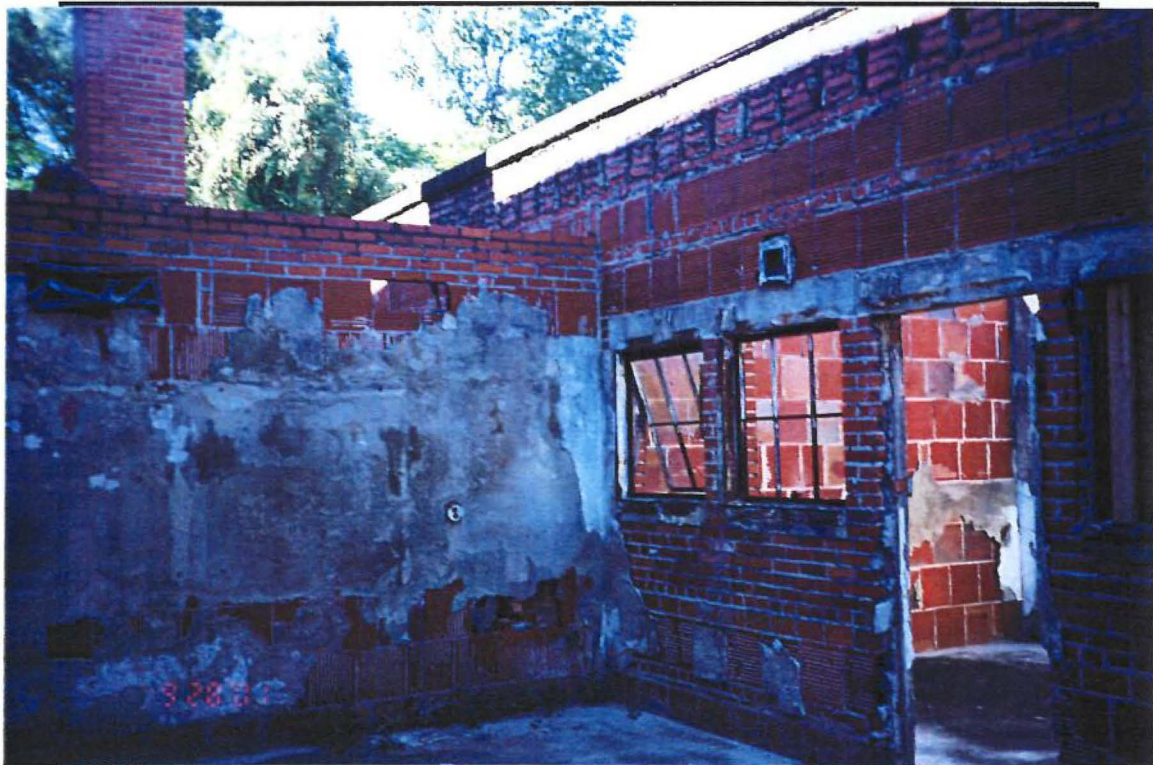
**Photo 10. Hangar No. 1, Interior – Parge coat mortar observed on structural clay tile and masonry surfaces.**

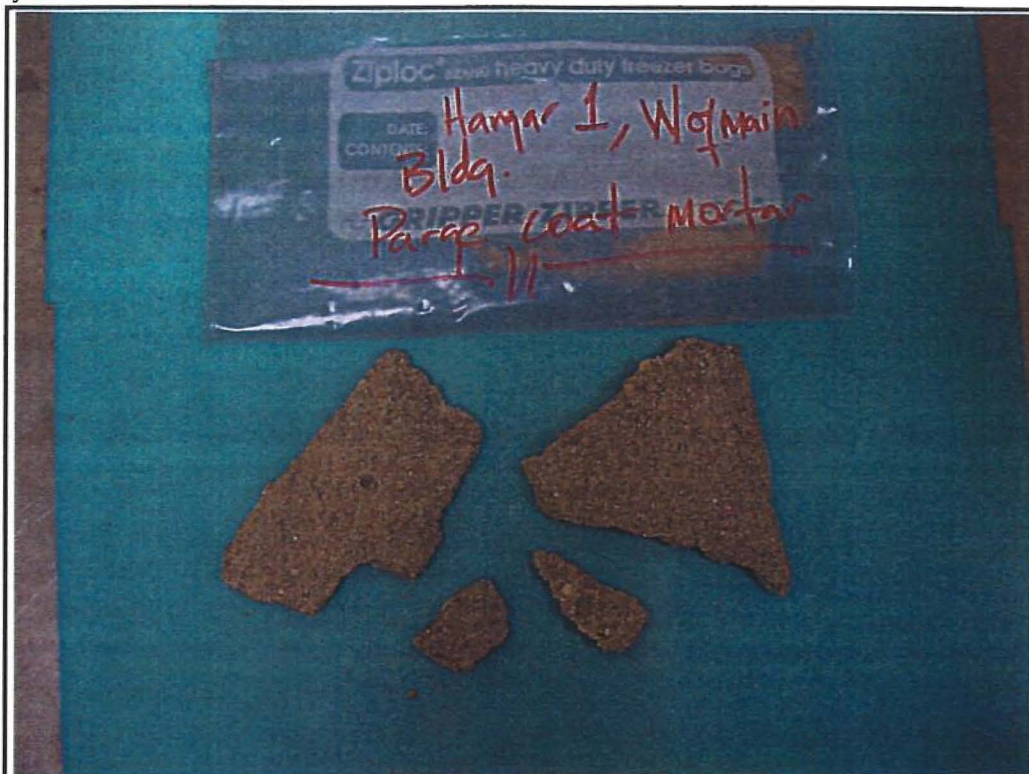
Photo 11. Hangar No. 1, Interior – Parge coat mortar observed. Note sand particles on surface poorly bonded to mortar.

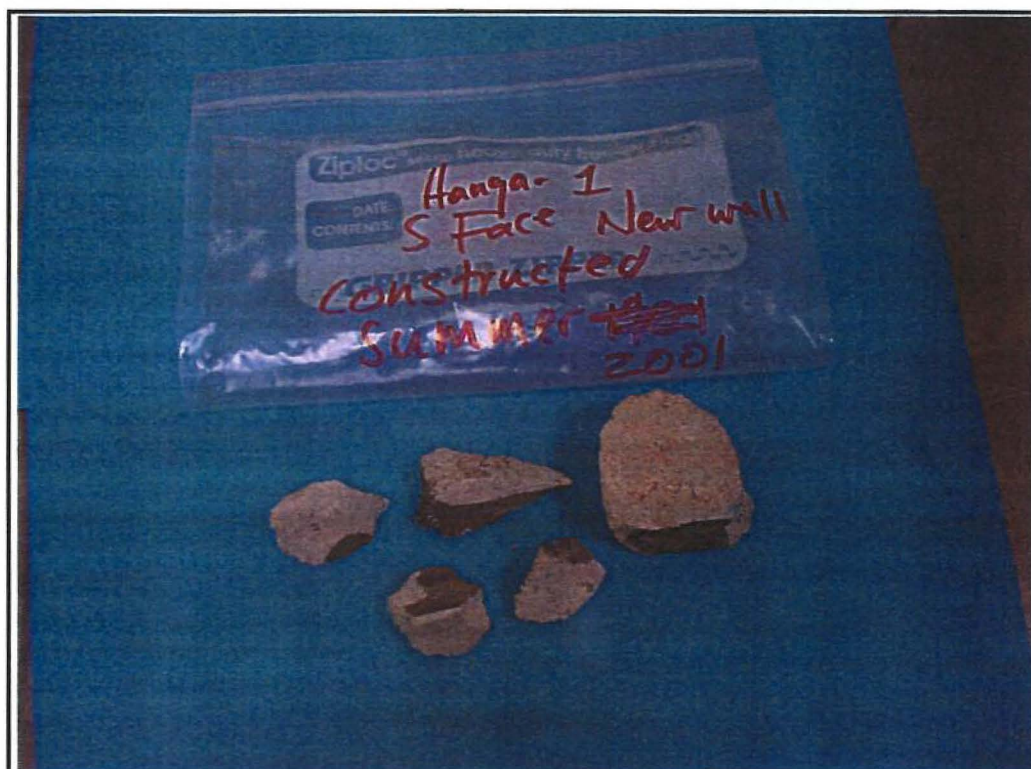
Photo 12. Hangar No. 1, Exterior South Face – Mortar samples taken from new construction. Note white mortar color (A) and brown smear coat (B) on tooled joint surface.

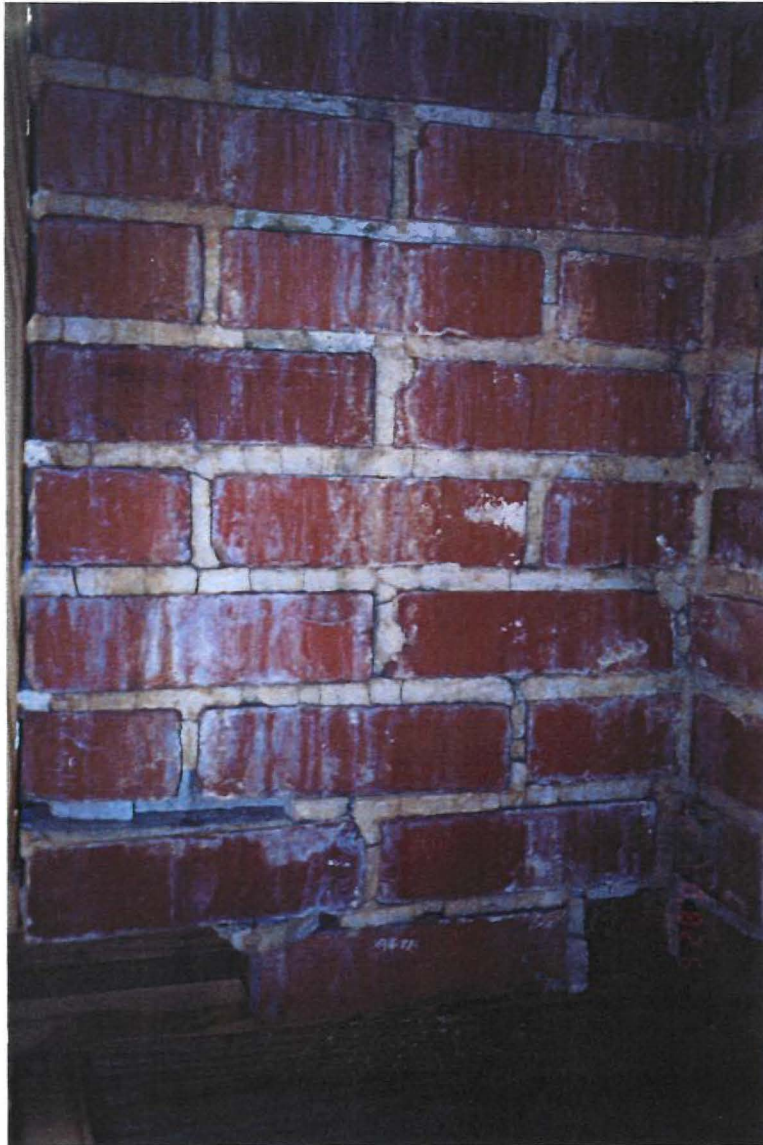
**Photo 15. Fire Protection Shed – Interior face beside door. Note cracked mortar.**

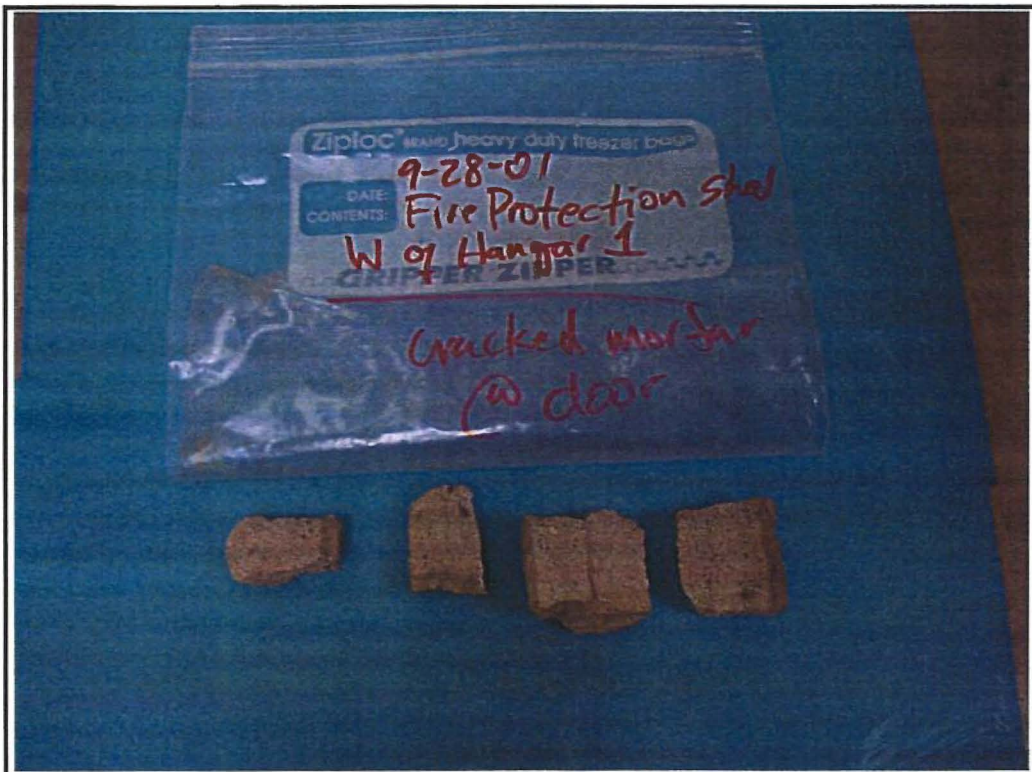
Photo 17. Fire Protection Shed – Interior cracked mortar at door. Note mortar discoloration at surface (extending approximately ¼ inch from surface).
