# Preservation/Restoration of Moton Field

## Phase II

Tuskegee Airmen  
National Historic Site  
Tuskegee, Alabama

*Historic Structure Report*  
Entrance Gate

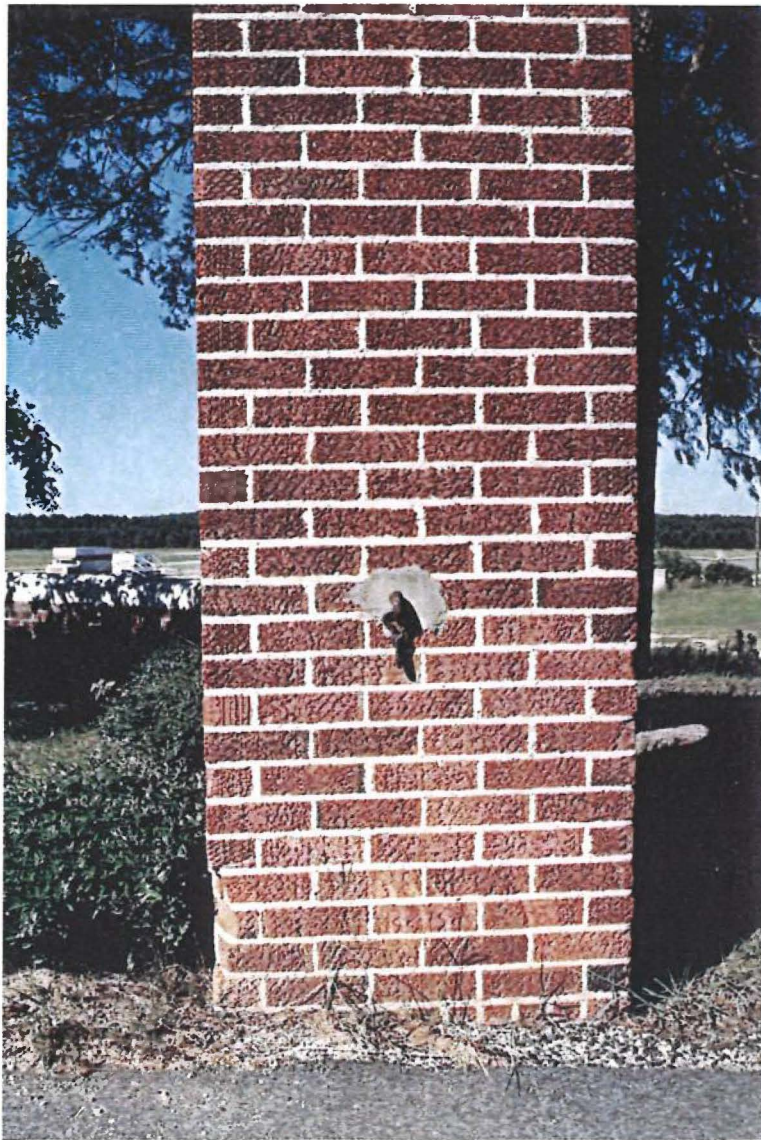
Figure 6: Evidence of the security chain on the south side of the North Wall.

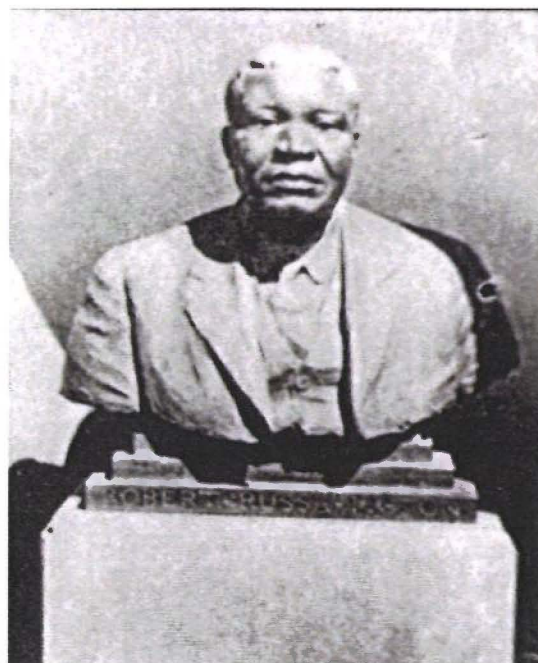
**Figure 8:** Bust of Robert Moton that was formerly located in the niche in the South Wall. AFHRA, Maxwell AFB.

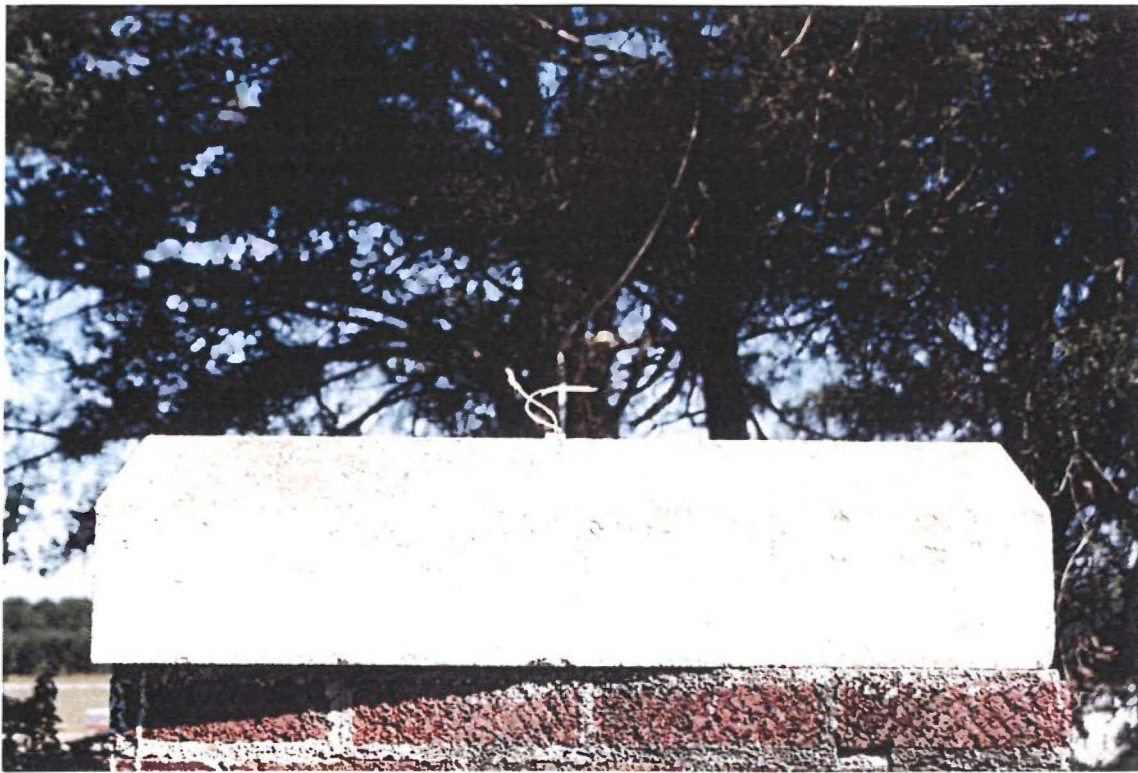
**Figure 9:** Existing lighting wiring on top of gate pier for lanterns.

- Repair structural deficiencies (stress fracture and separation of seat wall from wing wall) in North Wall.
- Clean gate hardware.
- Replicate missing light fixtures on gate piers based on physical evidence and historic photographs.

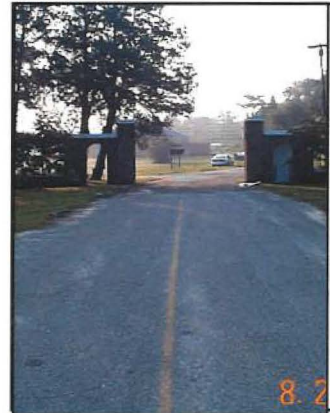
**Deficiency:** Minor discoloration on bricks  
Some deterioration of mortar.

**Recommendation:** Clean masonry to remove  
discoloration without harming existing brickwork.  
Repair and repoint mortar as necessary.

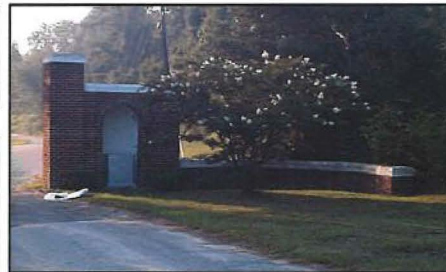
| <b>Deficiency:</b> | Missing sculpture for niche. |

| <b>Recommendation:</b> | Repair and re-paint interior of niche. Replicate missing bust and install in niche. The replicated bust is not included in the estimate. |

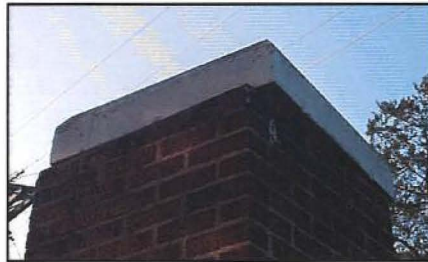
**Feature Condition:** Fair**Total Inventory:** 1**Historic Rating:** H**Priority:** Minor**Deficiency:** Pre-cast cap set askew

**Recommendation:** Re-align and secure as necessary.

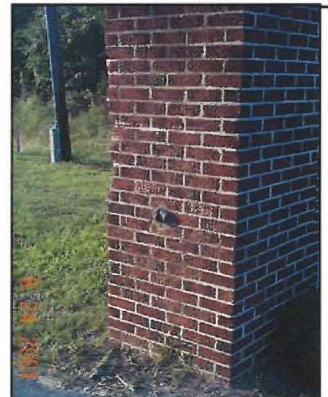
**Feature Condition:** Fair**Total Inventory:** 15 brick**Historic Rating:** H**Priority:** Minor**Deficiency:** Deterioration of brick on col.

**Recommendation:** Replace damaged bricks and re-point deteriorated masonry mortar joints as needed.

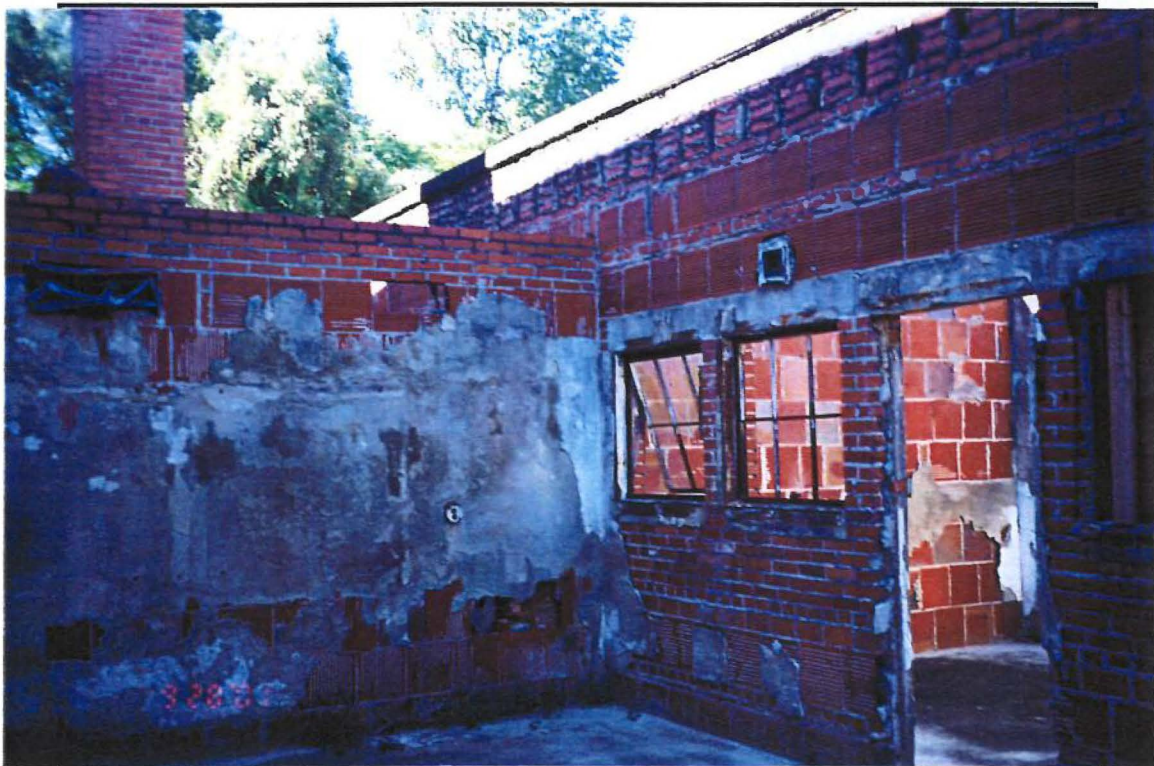
**Photo 10. Hangar No. 1, Interior – Parge coat mortar observed on structural clay tile and masonry surfaces.**

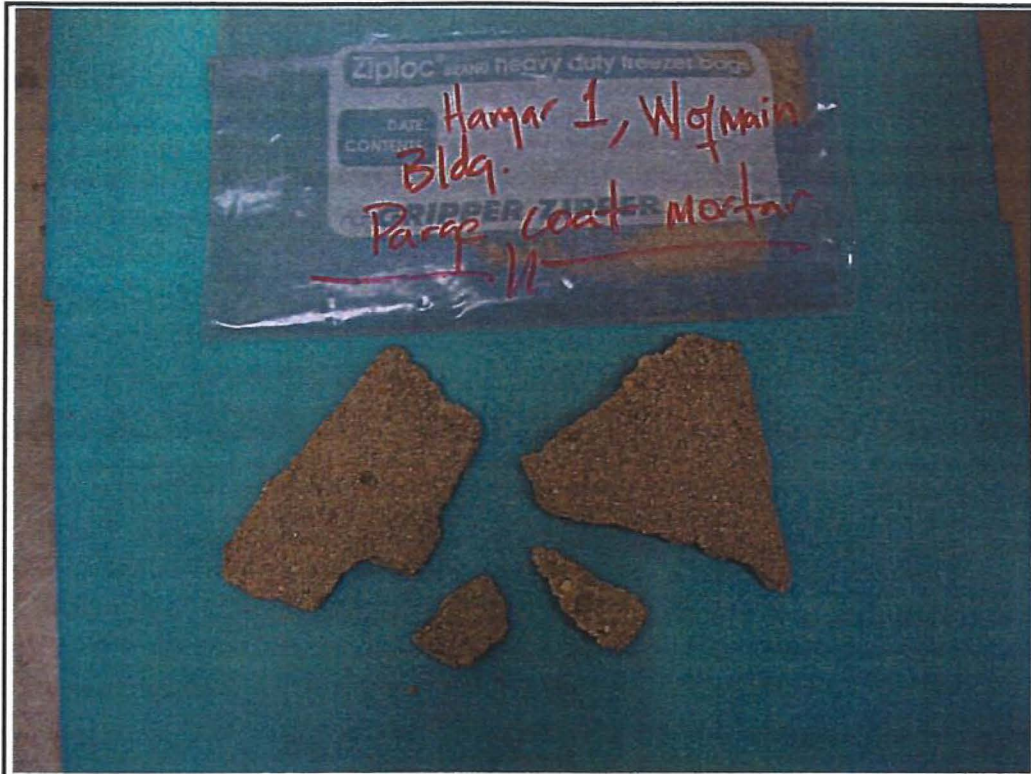
A visual survey of the Skyway Club was performed, but samples were not taken. The mortar observed at this structure was similar to the others and competent. Ms. Toole informed LAW that the block used for the Skyway Club was made with local materials and called "Tuskegee Block". The parge coat mortar taken from Hangar No. 1 was intact, but could be broken easily. The sand particles on the surface of the parge coat were exposed and poorly bonded (Photo 11).

Photo 11. Hangar No. 1, Interior – Parge coat mortar observed. Note sand particles on surface poorly bonded to mortar.

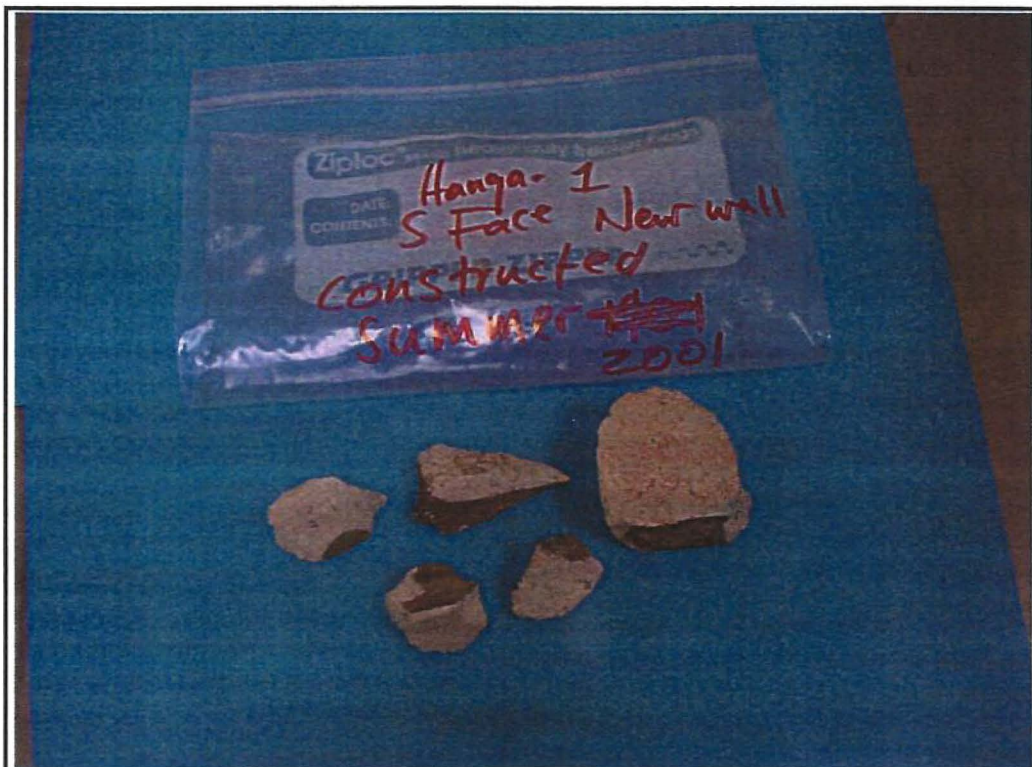
Photo 12. Hangar No. 1, Exterior South Face – Mortar samples taken from new construction. Note white mortar color (A) and brown smear coat (B) on tooled joint surface.

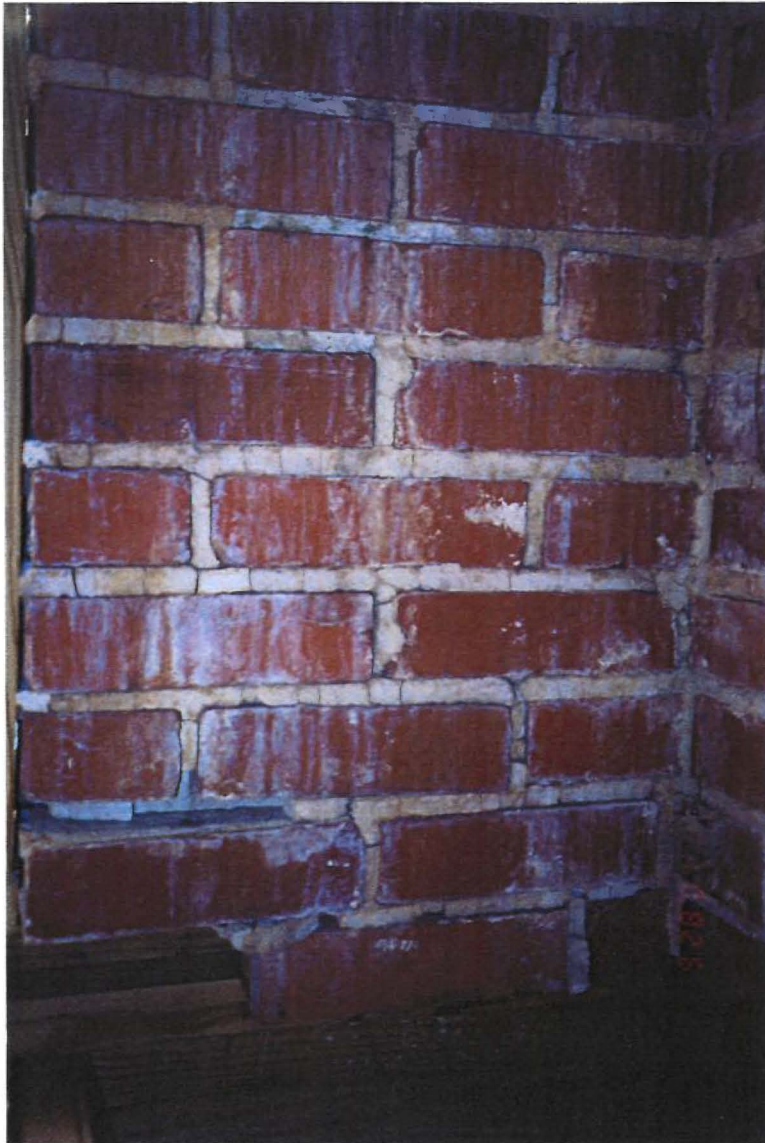
**Photo 15. Fire Protection Shed – Interior face beside door. Note cracked mortar.**

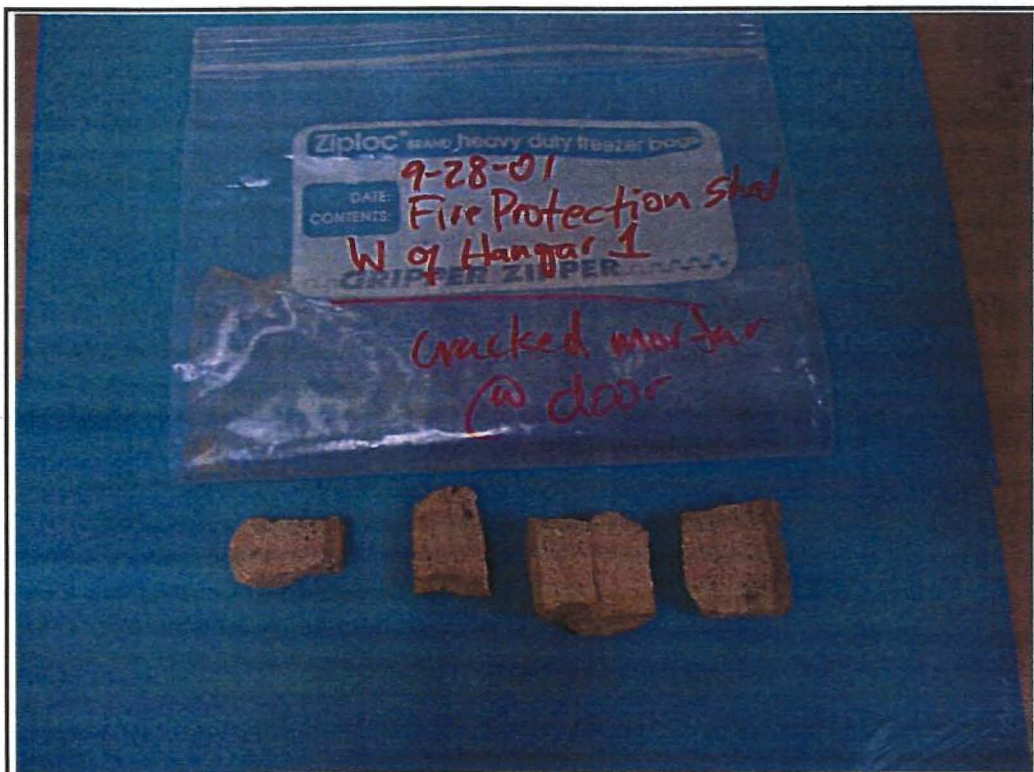
Photo 17. Fire Protection Shed – Interior cracked mortar at door. Note mortar discoloration at surface (extending approximately  $\frac{1}{4}$  inch from surface).
