# Preservation/Restoration of Moton Field

## Phase II

Tuskegee Airmen  
National Historic Site  
Tuskegee, Alabama

*Historic Structure Report*  
Hangar Number One

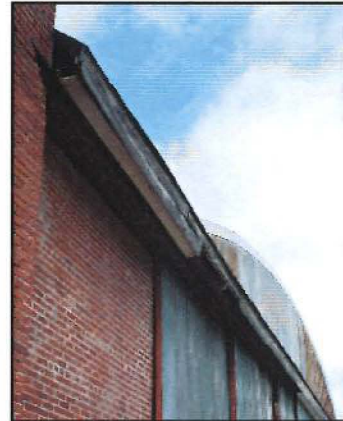
**EXTERIOR****4117****Eave/ Soffit****Wood****Feature Description:** Soffit/ fascia at east elevation at hangar door track.**Feature Notes:** Constructed of (2) 1 x 8 wood members on fascia and (1) 1x8 wood member on soffit.**Feature Condition:** Poor**Total Inventory:** 118 L.F.**Historic Rating:** H**Priority:** Critical**Deficiency:** Wood fascia/ soffit deteriorated**Recommendation:** Repair and replace all deteriorated wood at fascia and soffit to match original construction.

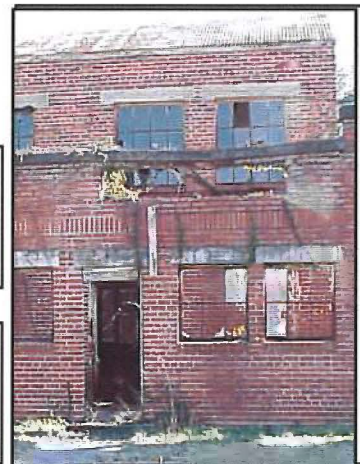
**EXTERIOR****4140****Exterior Window Unit****Metal****Feature Description:** 6-pane windows, with openings measuring approximately 3'-2" x 3'-2", Pane size 12 1/4" x 17 1/4".**Feature Notes:** The openings have been stabilized with vented plywood.**Feature Condition:** Poor**Total Inventory:** 11**Historic Rating:** H**Priority:** Serious**Deficiency:** There are (11) openings that are missing entire frames and glass, (2) on the west, (4) on the north, and (5) on the south.**Recommendation:** Remove vented plywood. Replicate and install missing metal window frames and glass. Install with plaster sills to match original construction.

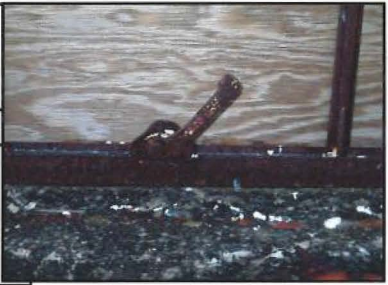
**Feature Condition:** Poor **Total Inventory:** 58  
**Historic Rating:** H **Priority:** Serious

| <b>Deficiency:</b> Rusted and most inoperable | |

| <b>Recommendation:</b> Repair window hardware for operation. Replicate as necessary. Paint to match original color. | |

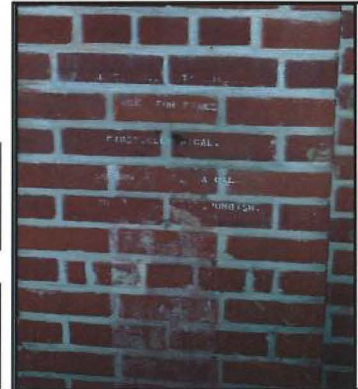
**INTERIOR****4756****FS Extinguisher****Feature Description:** Fire extinguisher locations**Feature Notes:****Feature Condition:** Fair**Total Inventory:** 5**Historic Rating:** H**Priority:** Minor**Deficiency:** Extinguishers removed, stenciling difficult to read.**Recommendation:** Leave existing stenciling in place. Replicate extinguishers and holders.

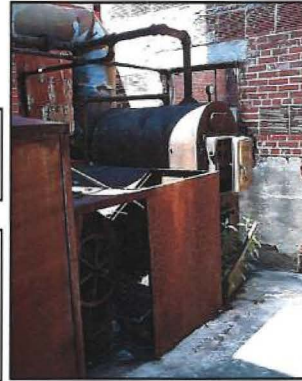
**FEATURE INVENTORY: EXTERIOR - MECHANICAL SYSTEMS****Hanger 1****All Estimable Items****Materials:** \$500.00 **Labor:** \$2,000.00 **Total =** **\$2,500.00****MECHANICAL 5851 Boiler****Feature Description:** Steam heating boiler.**Feature Notes:** Boiler is not functional.**Feature Condition:** Poor**Total Inventory:** 1**Historic Rating:** H**Priority:****Deficiency:** Boiler is rusted badley, doors are not operational.**Recommendation:** Clean, repair and repaint in existing location.  
Leave in place for interpretive purposes only.

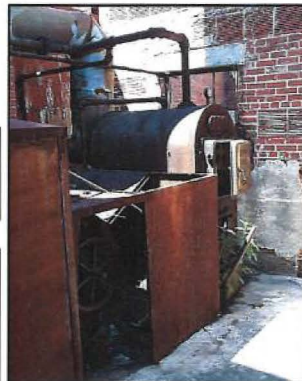
**Materials:** \$250.00 **Labor:** \$1,000.00 **Quantity:** **Total =** **\$1,250.00**  
(Refer to HVAC Allowance in estimate)**MECHANICAL 5871 Air Handling Unit****Feature Description:** Hot air furnace with steam to air heat exchanger.**Feature Notes:** Furnace is no longer functional.**Feature Condition:** Poor**Total Inventory:** 1**Historic Rating:** U**Priority:****Deficiency:** Unit is badley rusted and panels are missing.**Recommendation:** Clean, repair and repaint in existing location.

Leave in place for interpretive purposes only.

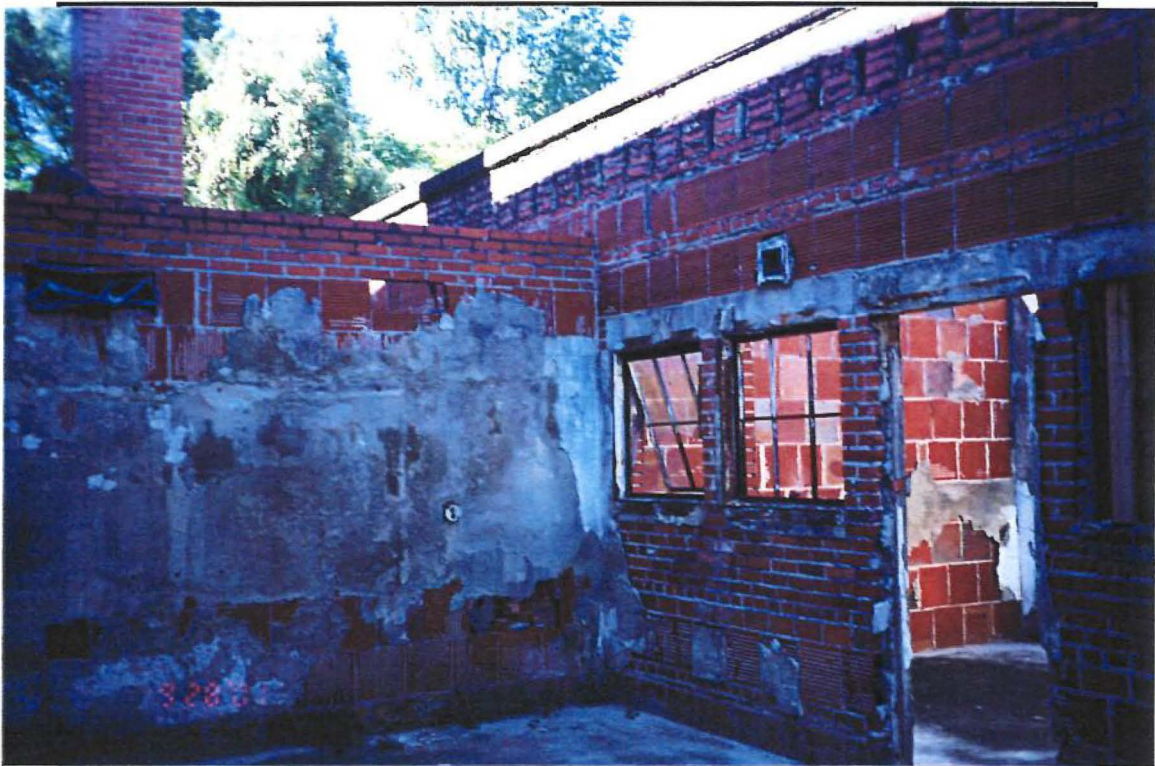
Photo 10. Hangar No. 1, Interior – Parge coat mortar observed on structural clay tile and masonry surfaces.

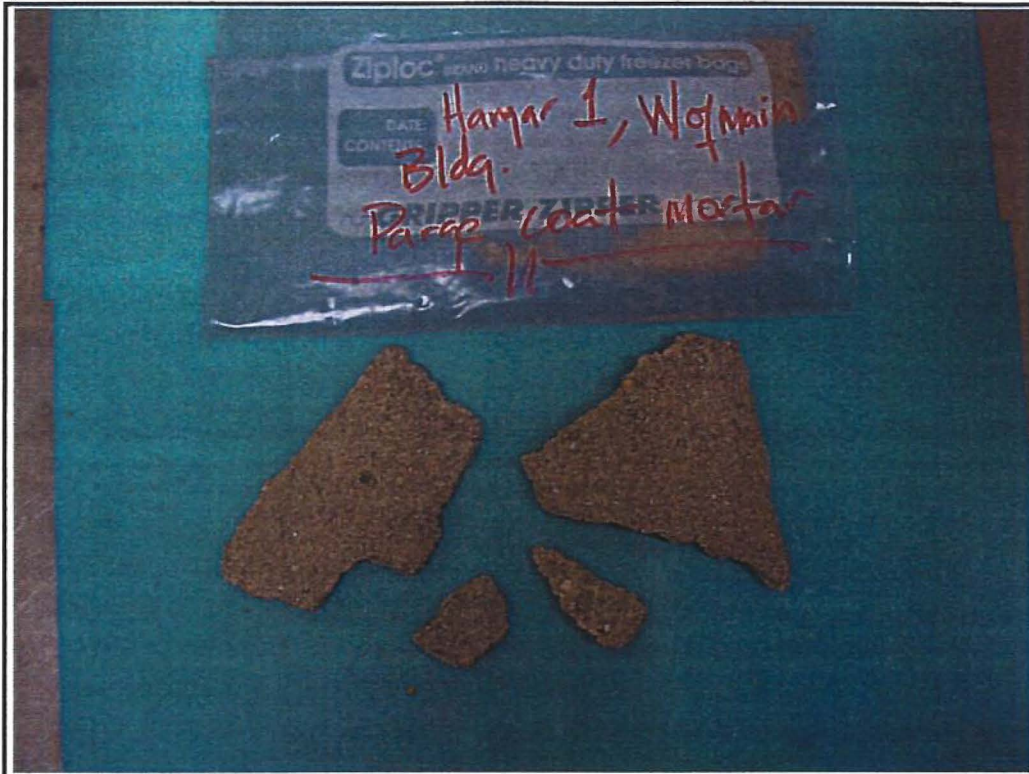
Photo 11. Hangar No. 1, Interior – Parge coat mortar observed. Note sand particles on surface poorly bonded to mortar.

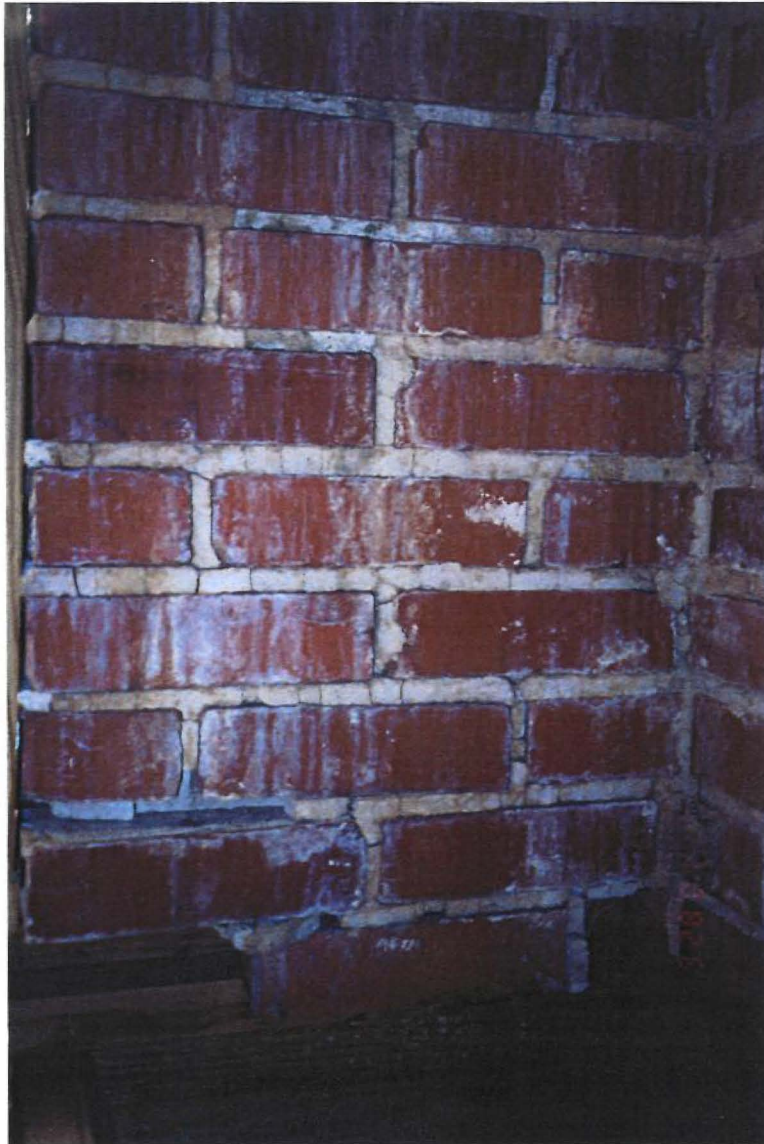
**Photo 15. Fire Protection Shed – Interior face beside door. Note cracked mortar.**

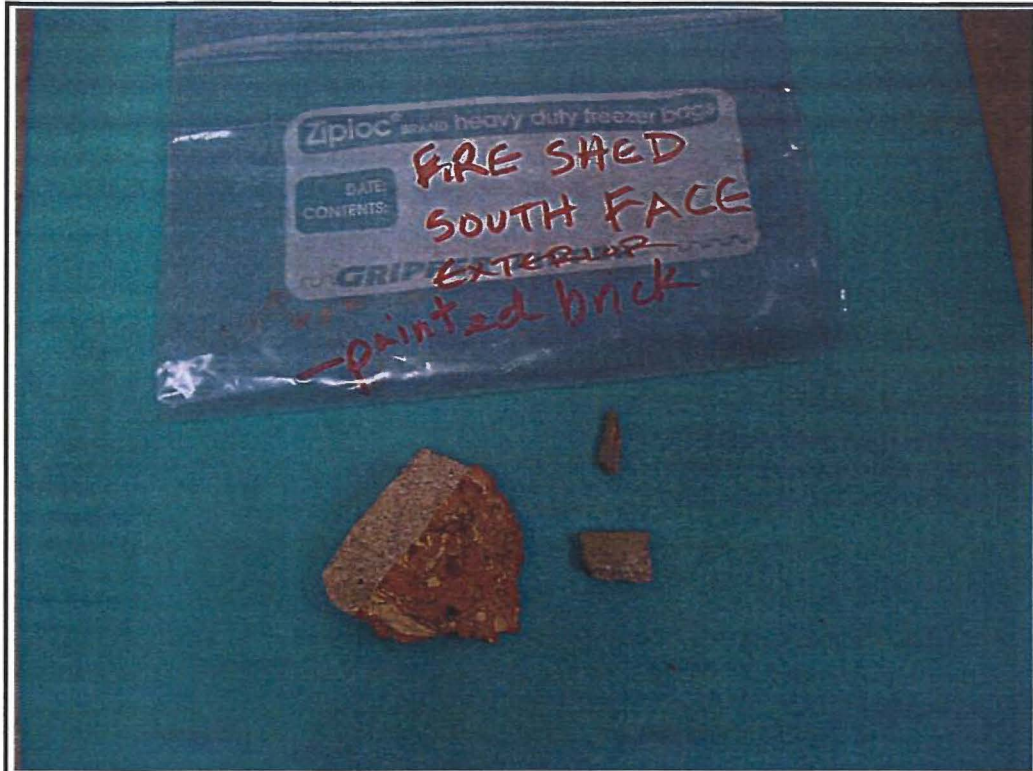
Photo 16. Fire Protection Shed – Mortar/brick samples from south face. Brick painted on side not shown.

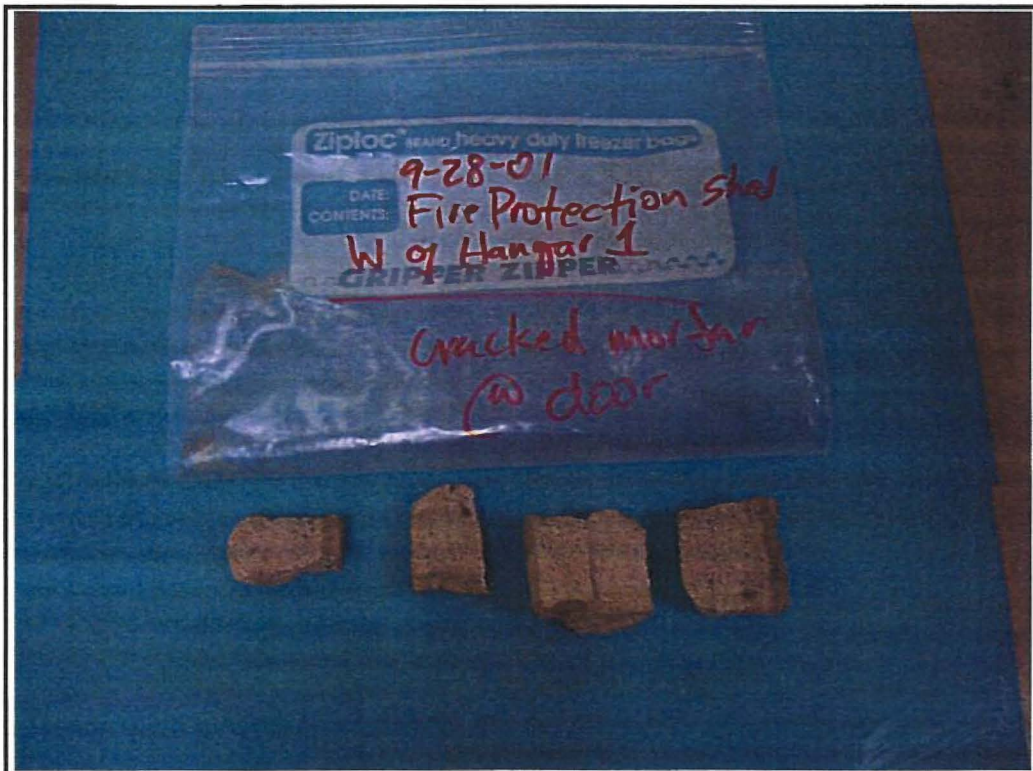
Photo 17. Fire Protection Shed – Interior cracked mortar at door. Note mortar discoloration at surface (extending approximately ¼ inch from surface).
