# Preservation/Restoration of Moton Field

Tuskegee Airmen  
National Historic Site  
Tuskegee, Alabama

*Historic Structure Report*  
Warehouse/Vehicle Storage Building

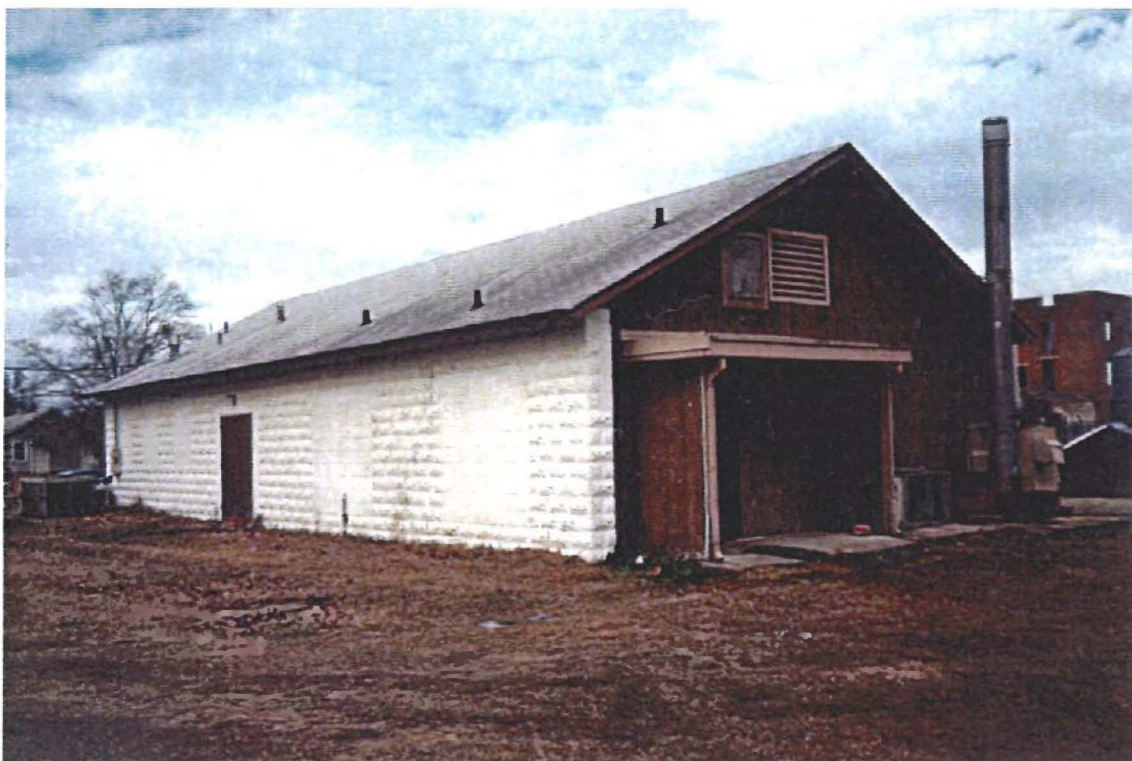
The exterior of the building is in generally good condition, but the historic character of this building has been compromised by the complete replacement of the walls on the east and west facades and the infill of original window and door openings. (See *Figure 6*.)

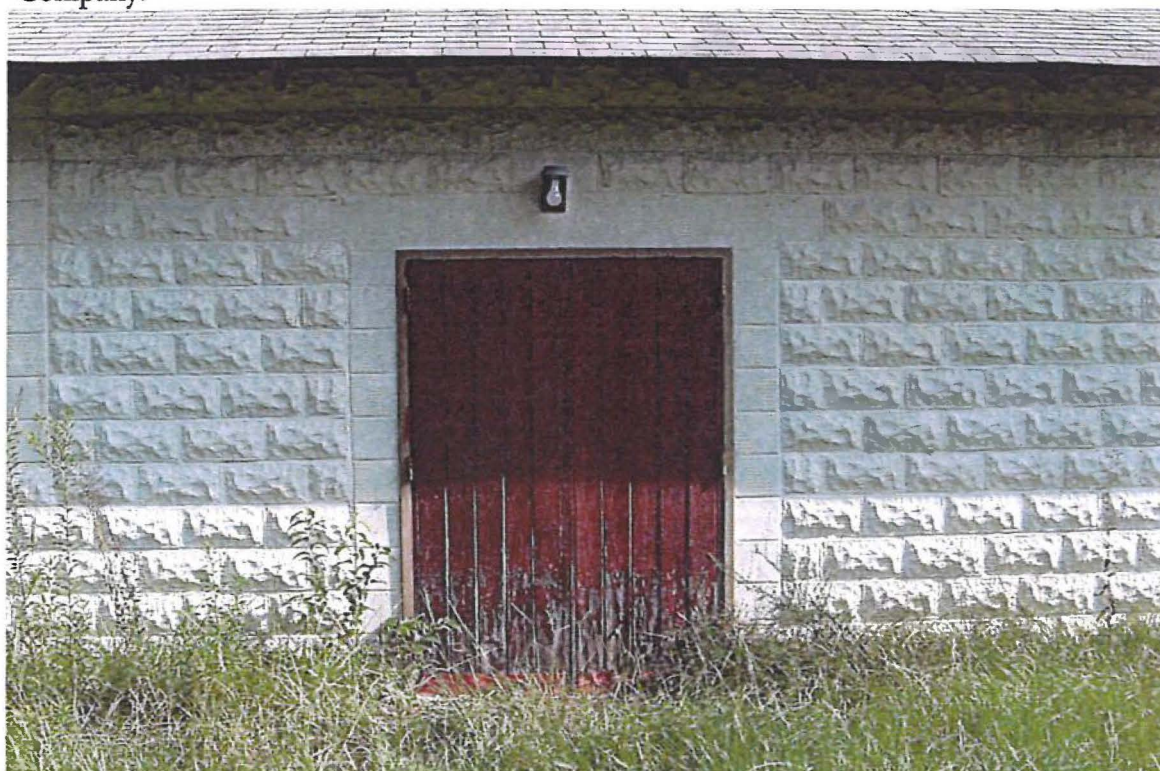
**Figure 7:** A door opening on the south façade created during the 1974 renovation. Smooth-faced replacement block matches original courses. The original window lintel remains.

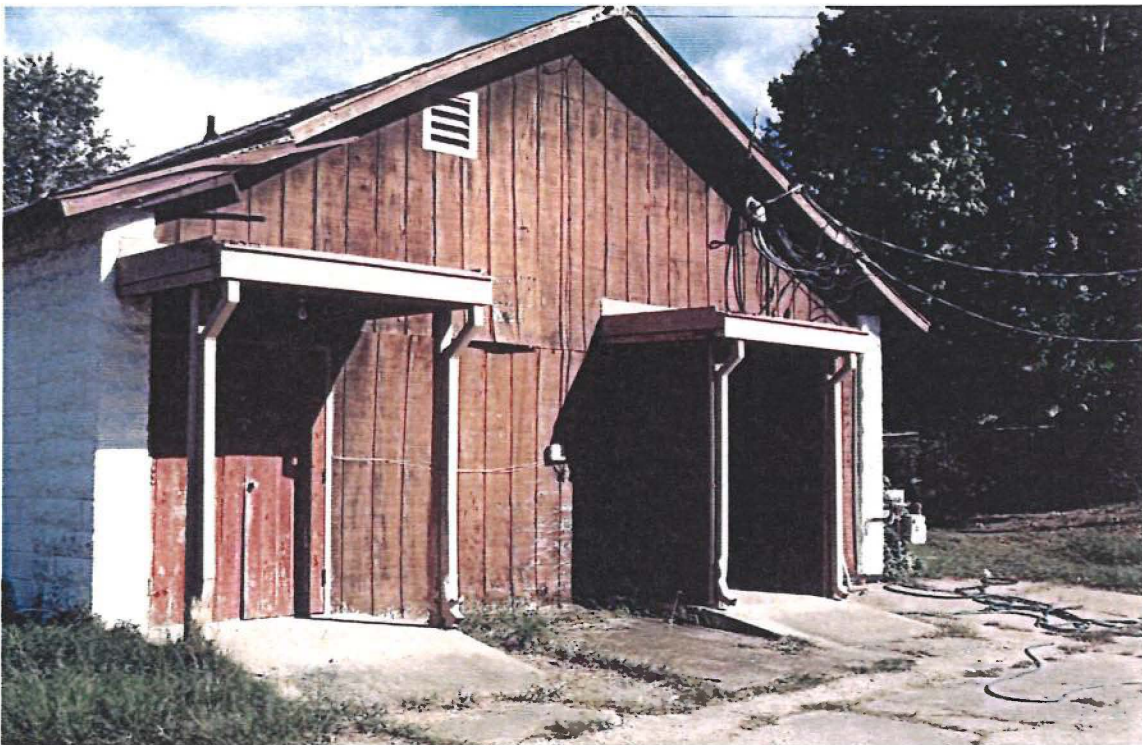
**Figure 8:** West facade as it looks today. Both the east and west facades were completely replaced as part of the 1974 renovation.

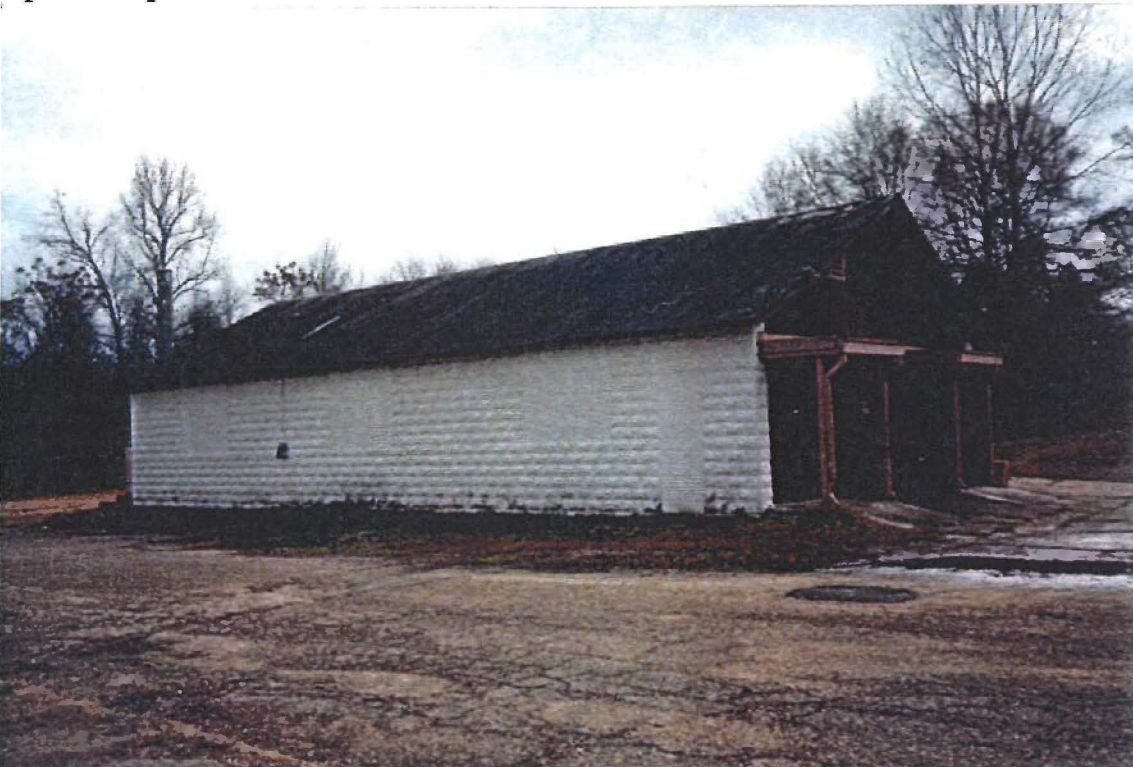
**Figure 9:** North facade of the Warehouse/Vehicle Storage Building as it looks today. Former window and door openings were infilled with smooth-faced block. Pond & Company.

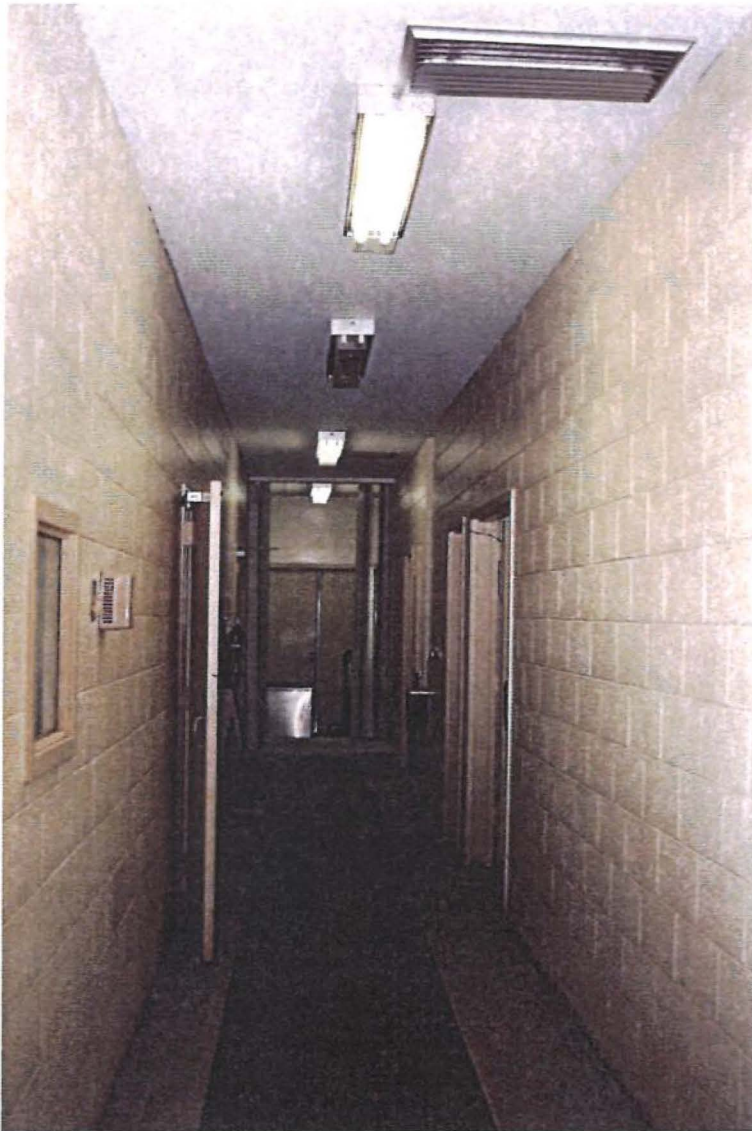
**Figure 10:** South interior hallway of the Warehouse/Vehicle Storage Building looking east. The walls, ceiling, and concrete floor were added during the 1974 renovation.

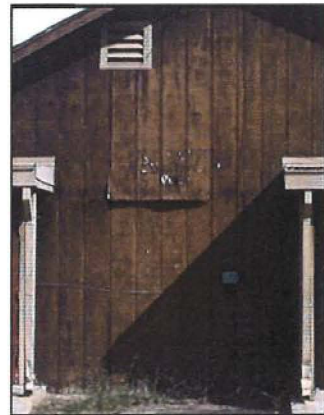
**EXTERIOR****4110****Exterior Wall Surface/ Cover****Wood****Feature Description:** Wood Siding**Feature Notes:** Generally good condition**Feature Condition:** Fair**Total Inventory:** 574 S.F.**Historic Rating:** N**Priority:** Historic**Deficiency:** Some splitting and separating of siding. Added in reuse of building.**Recommendation:** Remove later infill end panels and reconstruct as vehicle entrances.

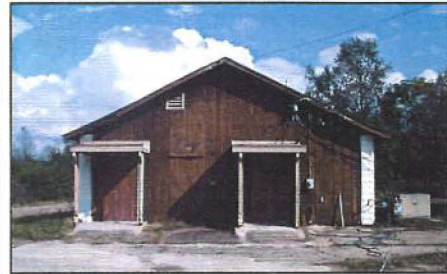
| <b>Deficiency:</b> | Added in reuse of building. |

| <b>Recommendation:</b> | Remove later infill end panels and reconstruct as vehicle entrances. |

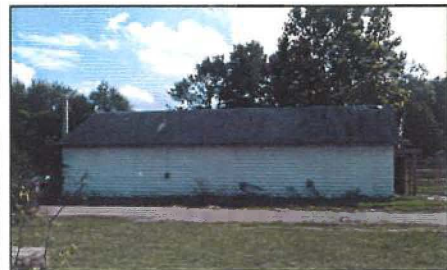
| <b>Deficiency:</b> | Infill of original openings with block units. |

| <b>Recommendation:</b> | Remove infill concrete blocks from original window and door openings. Replicate original windows and doors and install. |

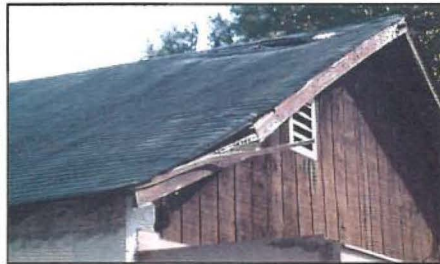
**Deficiency:** Damage to fascia on east elev.

**Recommendation:** Replace fascia to match original construction.

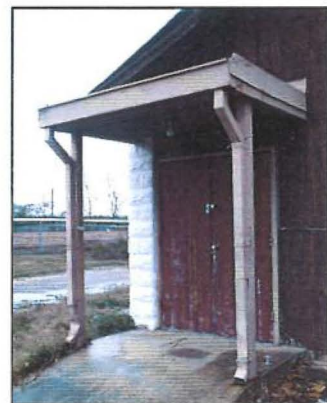
**Deficiency:** Added in reuse of building for veterinary school building.

**Recommendation:** Remove canopies.

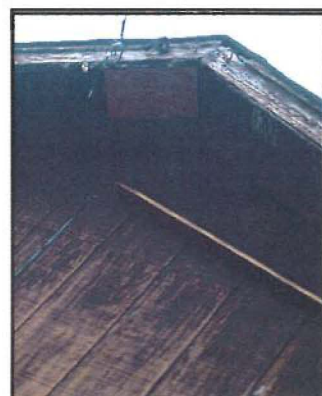
**Deficiency:** Some repair and paint chipping.

**Recommendation:** Repair eave per original construction.

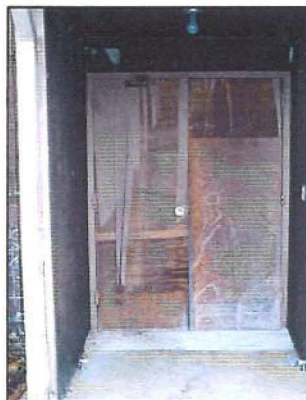
**Deficiency:** In generally poor condition.  
Added in reuse of building.

**Recommendation:** Remove entrances and restore to original vehicle entrance configuration.

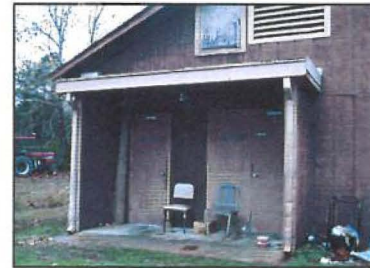
| <b>Deficiency:</b> | In generally poor condition. Added in reuse of building. |

| <b>Recommendation:</b> | Remove entrances and restore to original vehicle entrance configuration. |

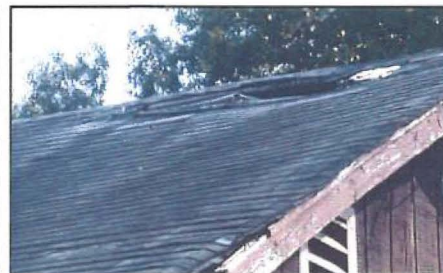
| <b>Deficiency:</b> | Some damage near eastern edge near roof peak. |

| <b>Recommendation:</b> | Remove roof, repair damaged area, and replace with 3 tab asphalt shingles to match original construction. |

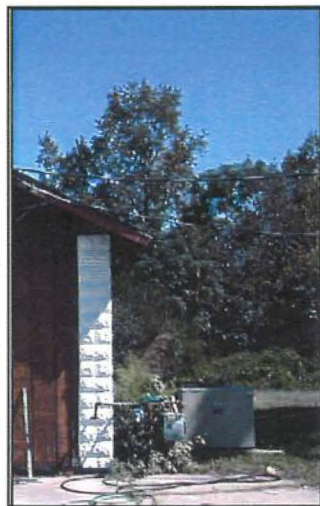
**FEATURE INVENTORY: MECHANICAL SYSTEMS****MECHANICAL****5864****Water Chiller****Feature Description:** Air cooled water chiller**Feature Notes:** Chiller is in fair condition, but nearing the end of its useful life.**Feature Condition:** Fair**Total Inventory:** 1**Historic Rating:** N**Priority:** Minor**Deficiency:** None**Recommendation:** Remove unit and associated connections.

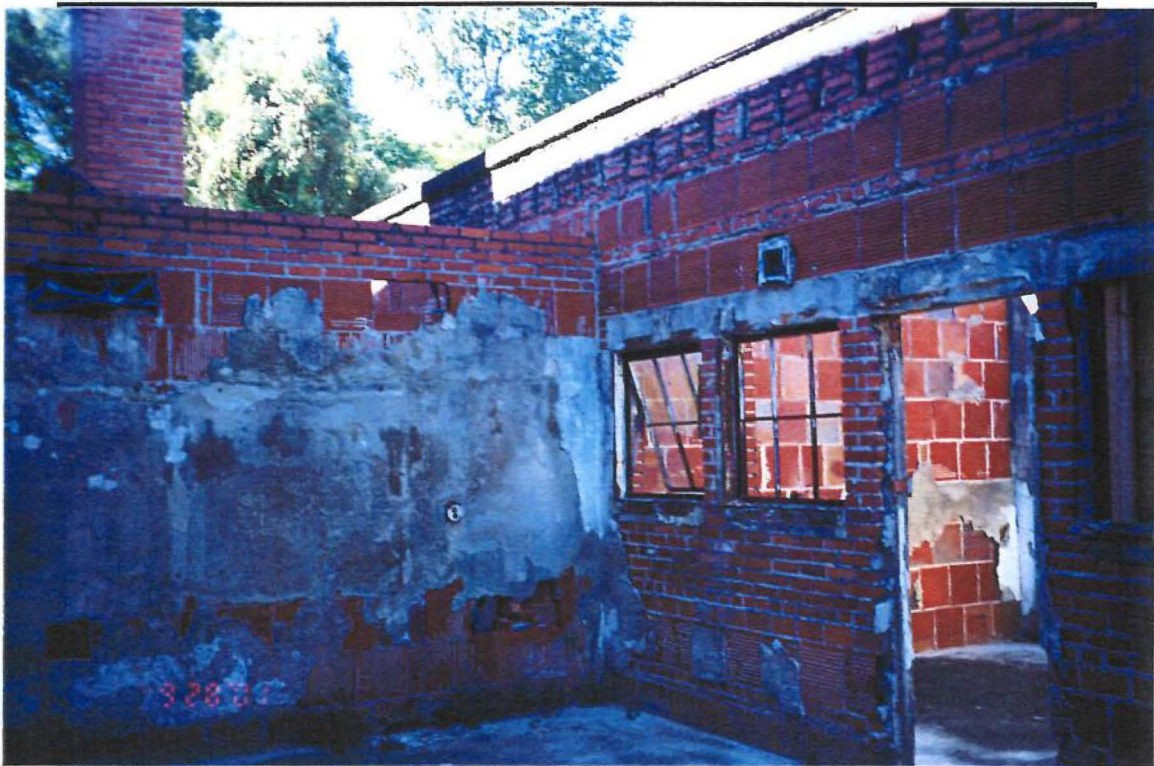
**Photo 10. Hangar No. 1, Interior – Parge coat mortar observed on structural clay tile and masonry surfaces.**

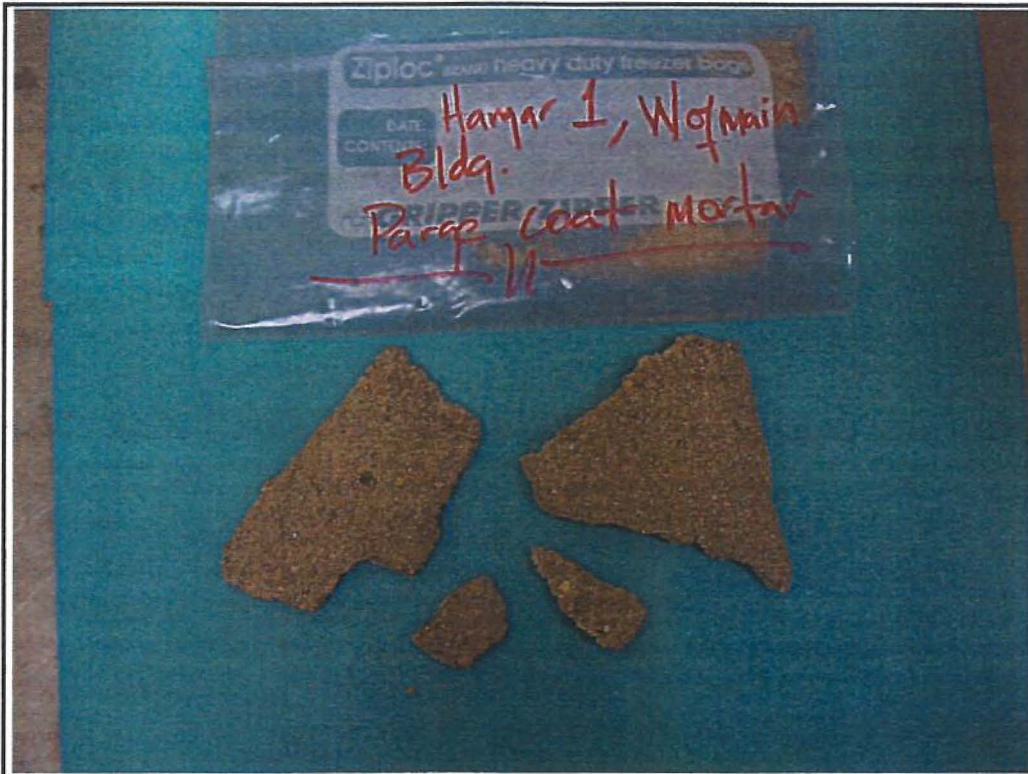
Photo 11. Hangar No. 1, Interior – Parge coat mortar observed. Note sand particles on surface poorly bonded to mortar.

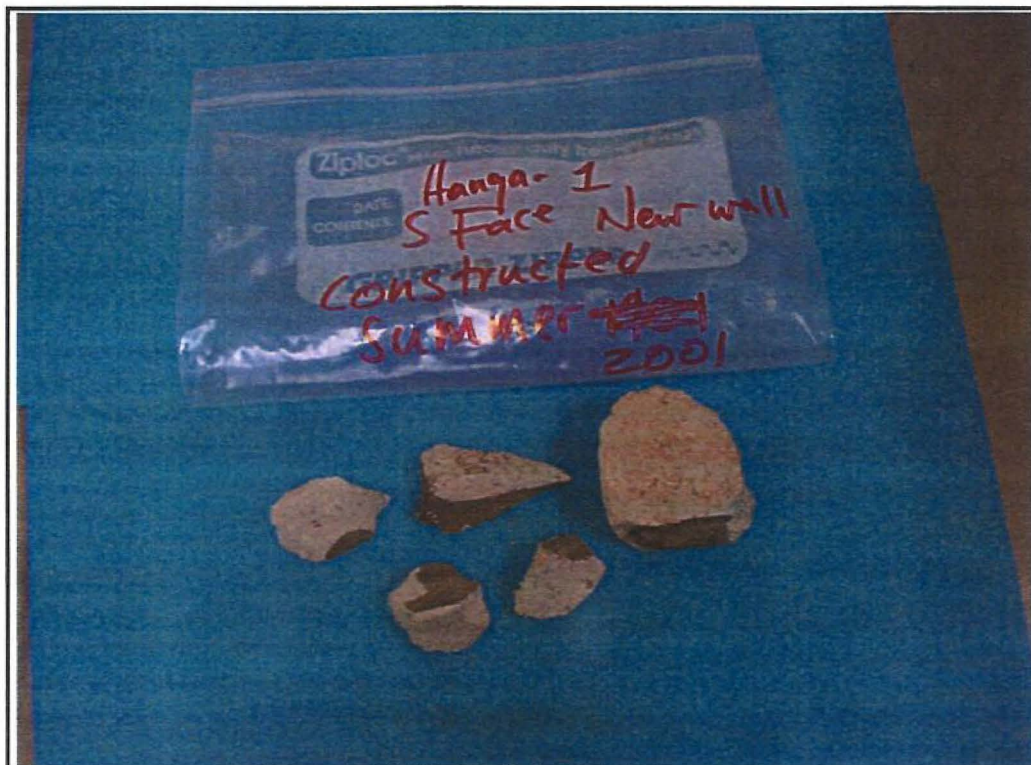
Photo 12. Hangar No. 1, Exterior South Face – Mortar samples taken from new construction. Note white mortar color (A) and brown smear coat (B) on tooled joint surface.

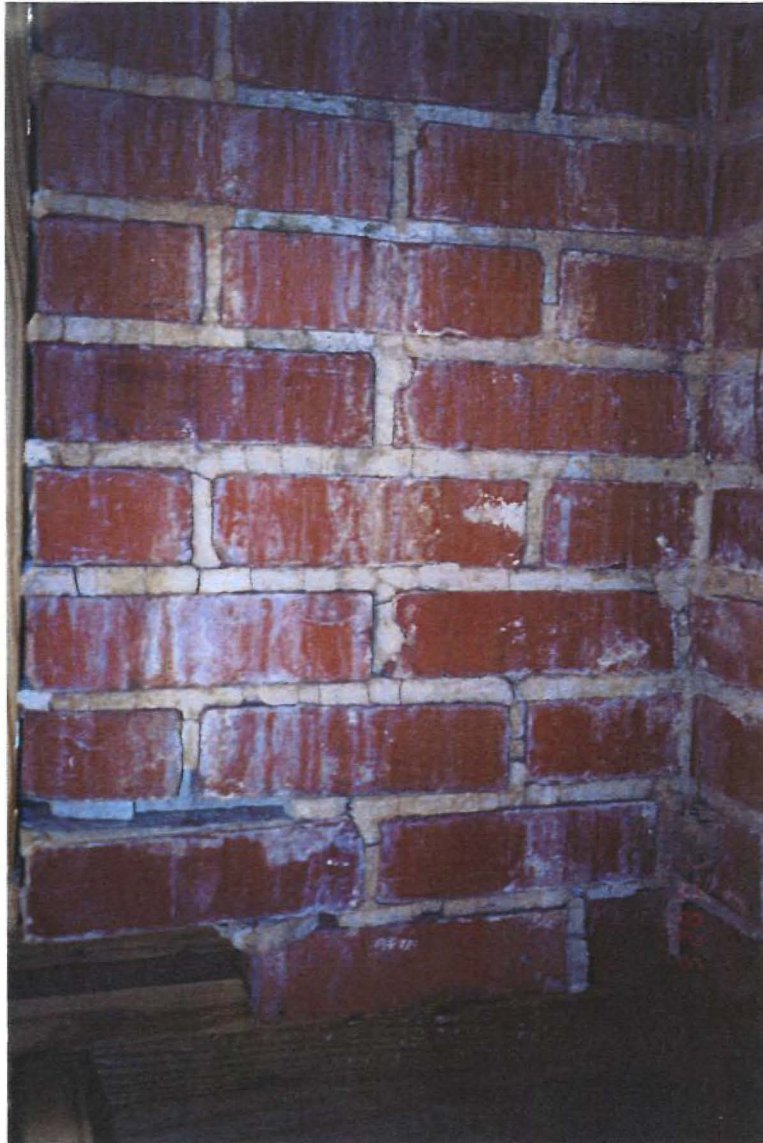
**Photo 15. Fire Protection Shed – Interior face beside door. Note cracked mortar.**

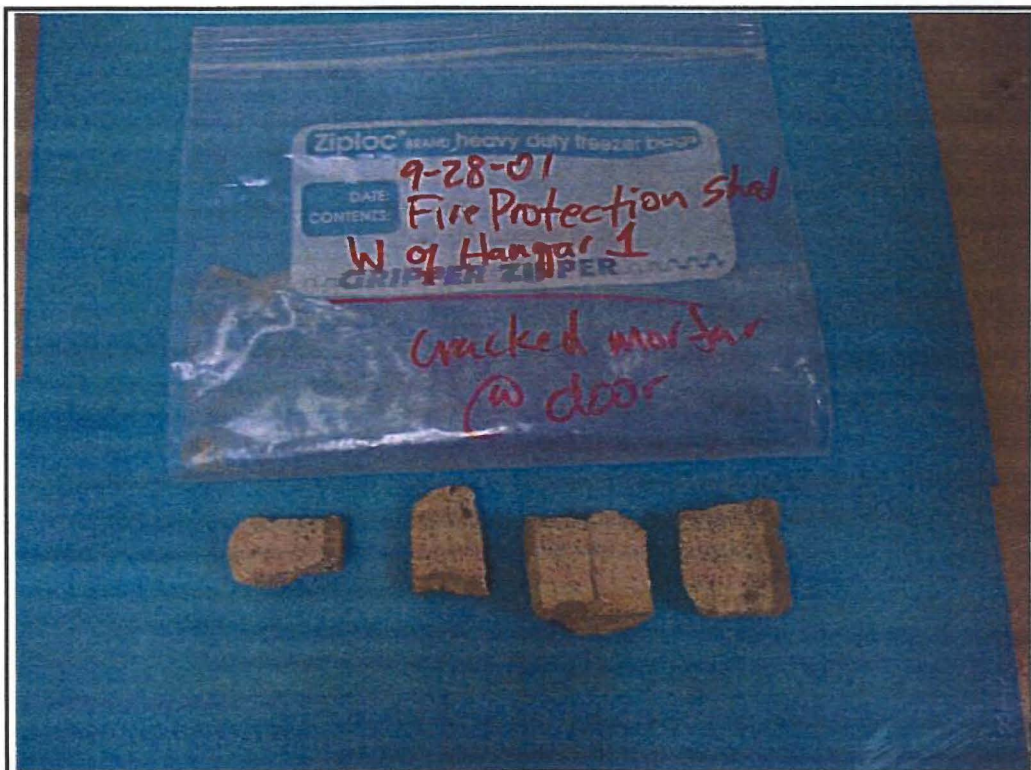
Photo 17. Fire Protection Shed – Interior cracked mortar at door. Note mortar discoloration at surface (extending approximately  $\frac{1}{4}$  inch from surface).
