# Historic Structure Report

# The Oaks

## Tuskegee Institute National Historic Site

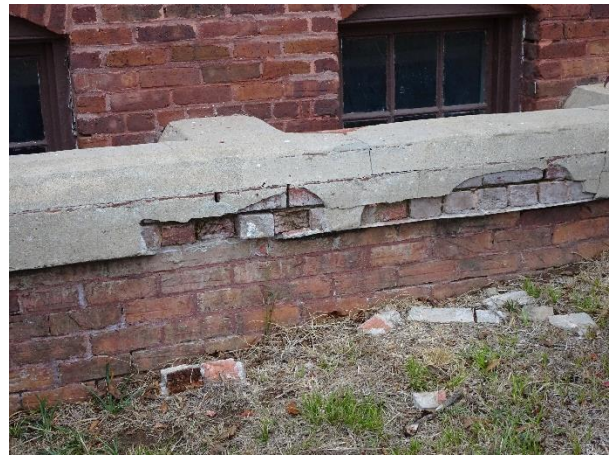
**FIGURE 81.** Spalling of the brick and cementitious parge coating at the light well walls.

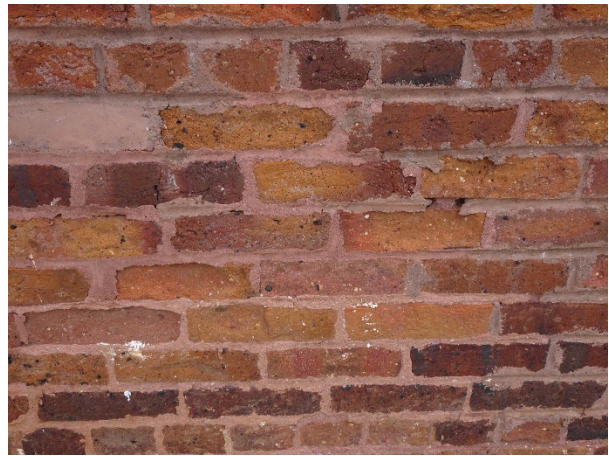
**FIGURE 84.** Evidence of previous mortar repointing in the field of the wall.

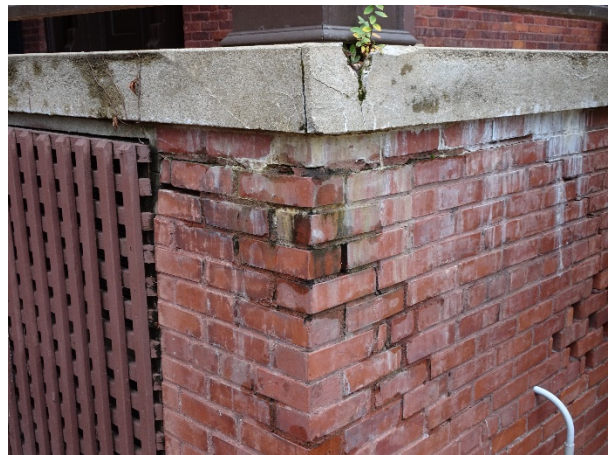
**FIGURE 85.** Step cracking, open joints, and evidence of water infiltration at the porch walls.

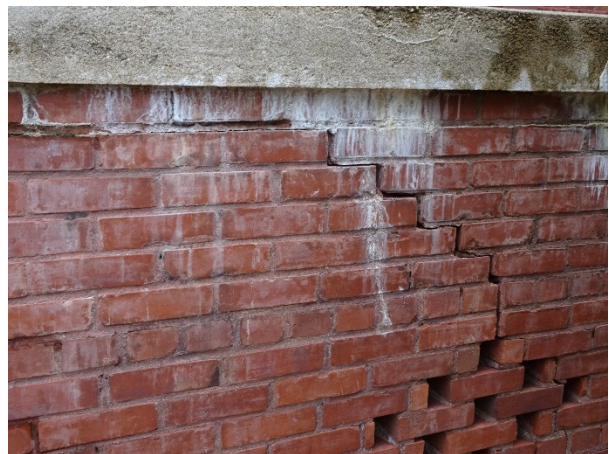
**FIGURE 86.** Step cracking and efflorescence at the porch walls.

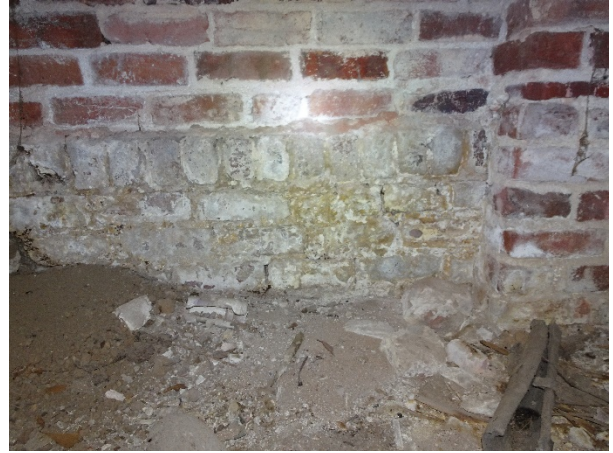
- Extensive accumulation of efflorescence was observed along the lower four courses of brick at the base of the north wall of the porch foundation (Figure 89). The efflorescence was visible from the crawl space and covered the face of the brick.

**FIGURE 89.** Accumulation of efflorescence at base courses of porch walls.

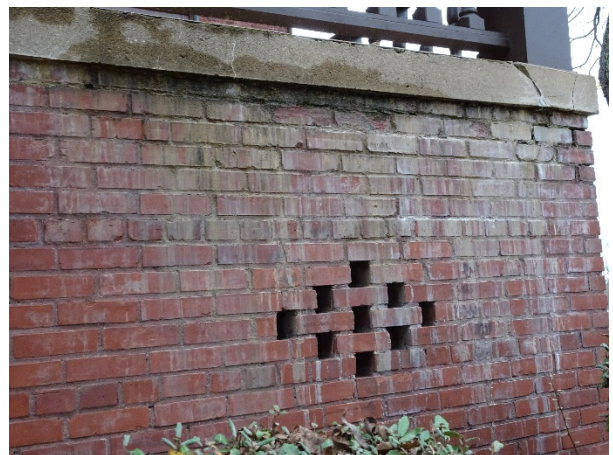
- Efflorescence and moisture staining was observed at the northwest corner of the brick masonry porch wall (Figure 90 and Figure 91). The efflorescence consisted of white staining at the top of the brick wall, below the concrete porch slab, and was most pronounced at the side of the wall facing the crawl space.

**FIGURE 90.** Moisture staining at porch walls.

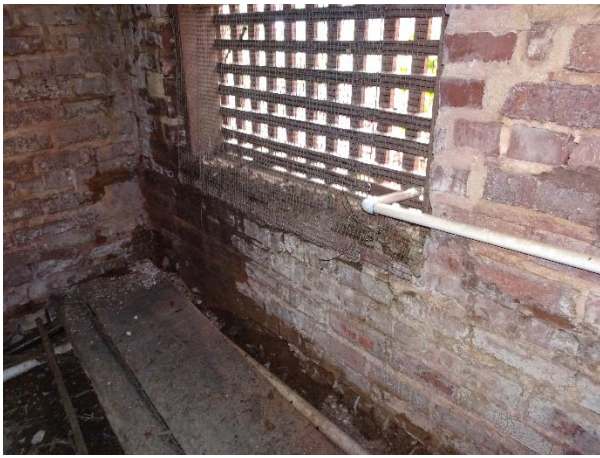
**FIGURE 91.** Evidence of moisture infiltration at northwest corner of porch.

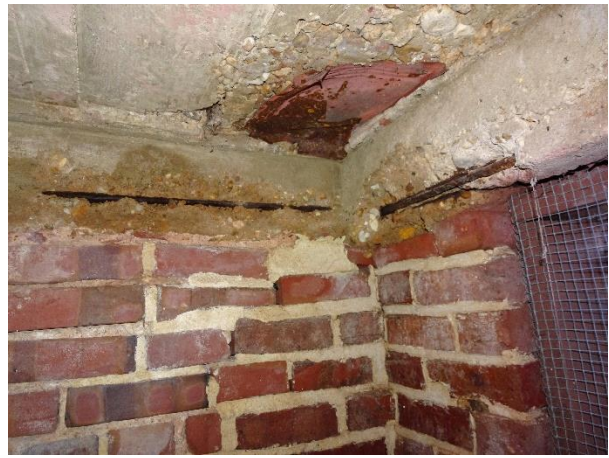
**FIGURE 93.** Spalled concrete bond beam at porch wall.

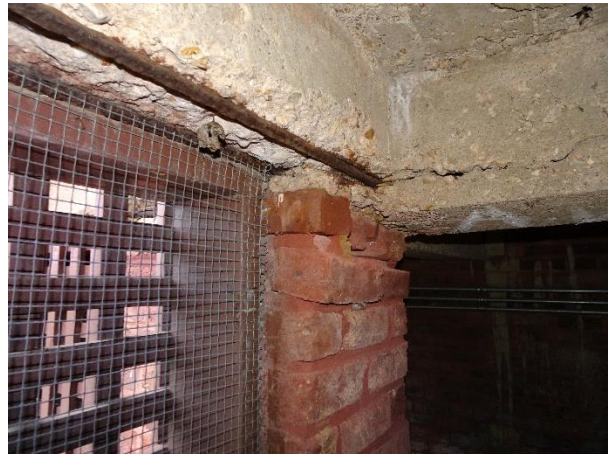
**FIGURE 94.** Spalled concrete bond beam at porch wall.

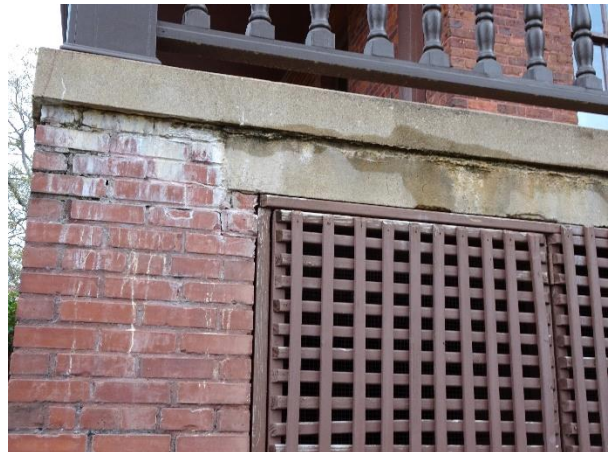
**FIGURE 95.** Moisture staining and evidence of moisture infiltration at concrete bond beam.

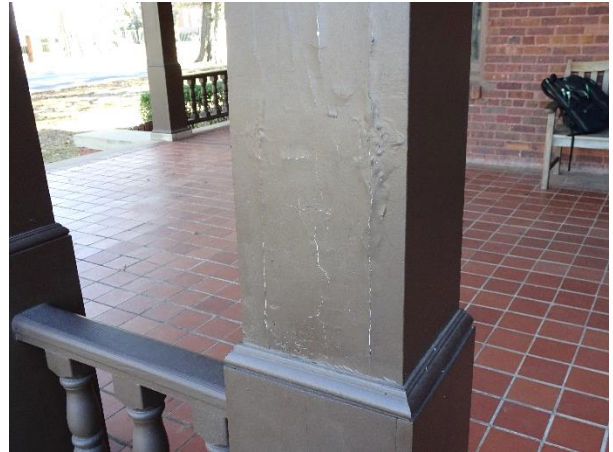
- Debonded and deteriorated coatings were observed at most of the wood porch framing members (Figure 98). Many of the porch columns had been previously repaired and resurfaced with a thin plaster coating. It appears the intent of the coating was to smooth the surface of the columns prior to repainting. Most of the plaster coating has cracked and debonded, and the underlying wood has been exposed (Figure 99 and Figure 100).

**FIGURE 98.** Debonded paint and plaster coating at columns.

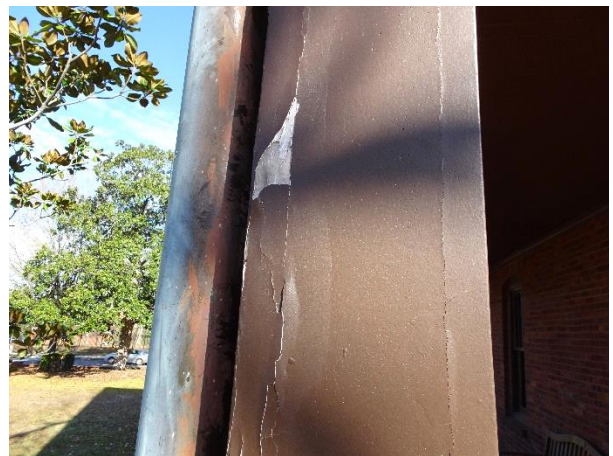
**FIGURE 99.** Cracking and flaking paint at columns.

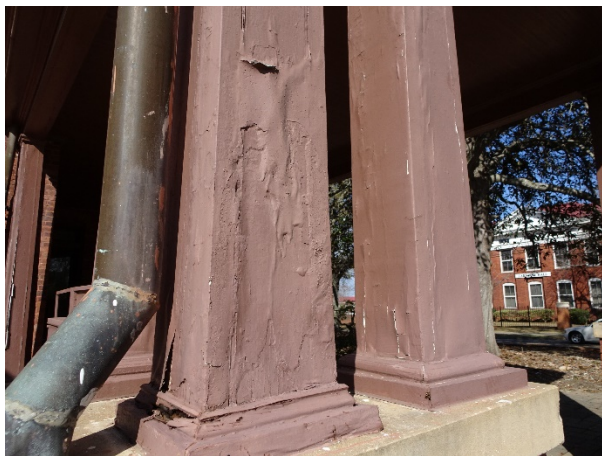
**FIGURE 100.** Deteriorated paint and underlying plaster coating at columns.

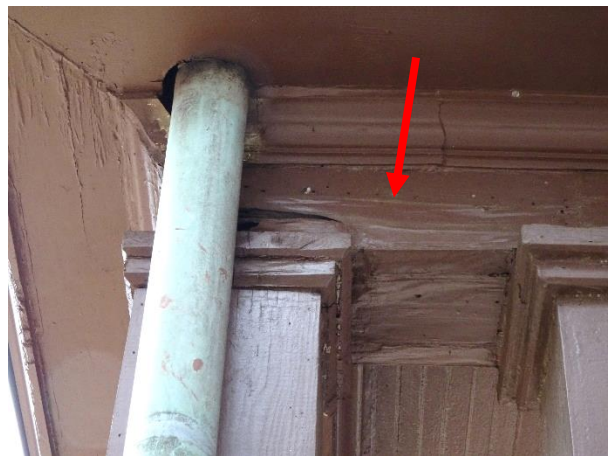
- Blistered and peeling paint was observed at wood porch columns. At many locations, the paint is blistered and debonded from the wood substrate (Figure 101). The underlying wood appeared to be deteriorated when probed. Throughout the porch, there is evidence of previous paint coatings that were not completely removed and remain in place (Figure 102).
- Biological growth was observed at the underside of the bead board porch ceiling (Figure 103). The growth consisted of dark-colored spots on the wood. Biological growth was also observed at the floor boards on the second floor balcony deck (Figure 104).
- One of the wood porch columns at the east end of the porch is displaced (Figure 105). The base of the column has been shifted approximately 1 inch to the northwest and is no longer centered on its concrete base.

**FIGURE 101.** Blistering paint at wood porch members.

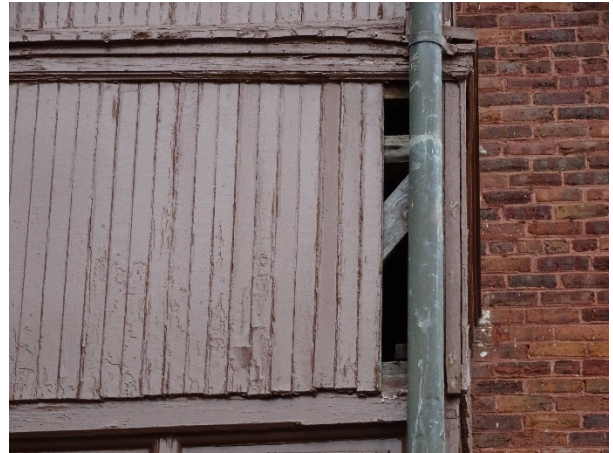
**FIGURE 106.** Missing wood cladding at south two-story porch.

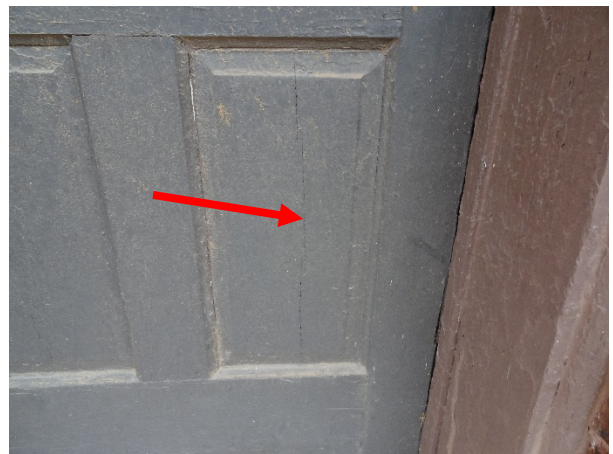
**FIGURE 107.** Vertical crack in recessed panel.

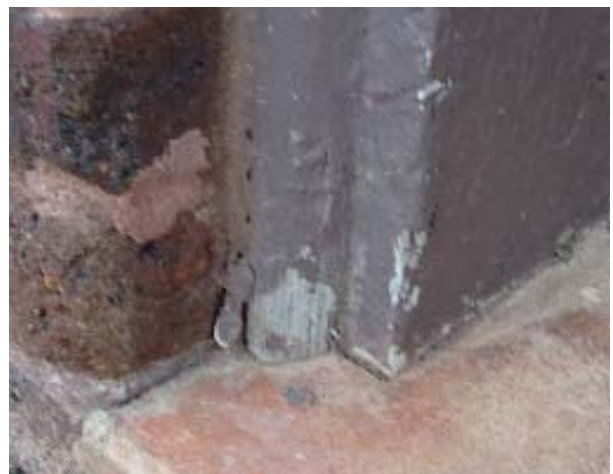
**FIGURE 108.** Peeling paint at door and window framing members.

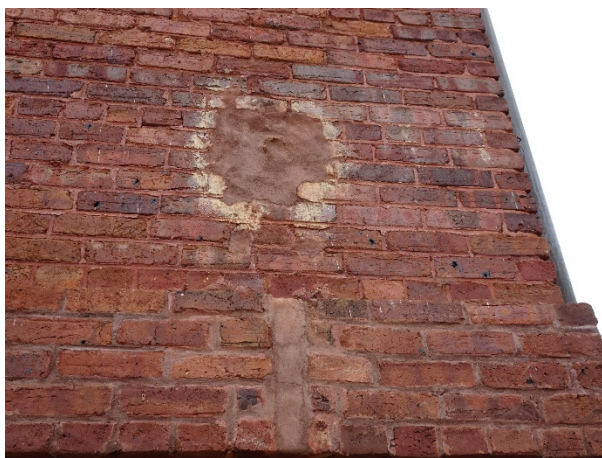
**FIGURE 110.** Previous cementitious patch repair at abandoned utility openings.

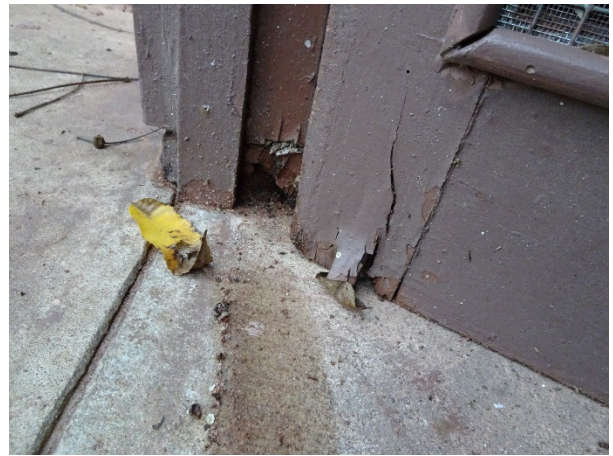
**FIGURE 115.** Deteriorated wood door sash.

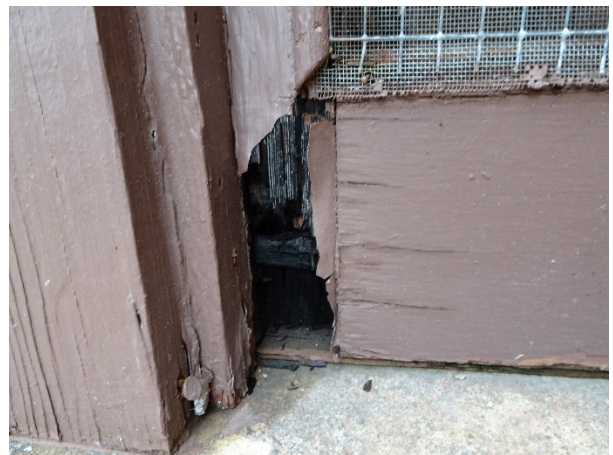
**FIGURE 116.** Severely deteriorated wood door sash.

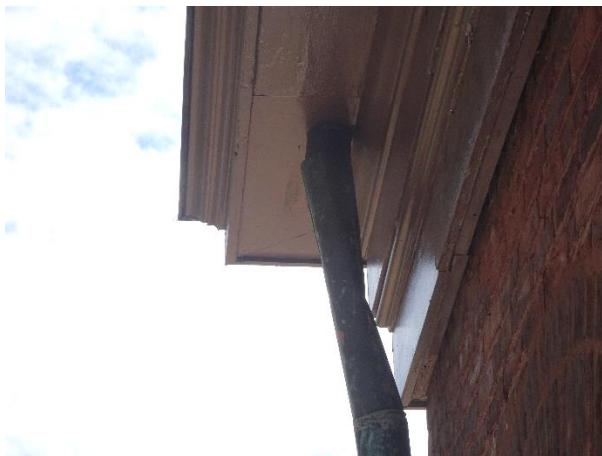
- Clogged, damaged, and backed-up downspouts were observed at many roof locations (Figure 117). Many of the downspouts are damaged or have evidence of being clogged. Some of the gutters also exhibited large amounts of debris (Figure 118). At one location, the gutter near the downspout was overfilled with water and flowing onto the adjacent cornice ledge (Figure 119). There were small branches in the gutter. The sheet-metal roof cladding adjacent to the gutter has deformed and separated from the gutter liner and flashing (Figure 120).

**FIGURE 117.** Damaged downspout.

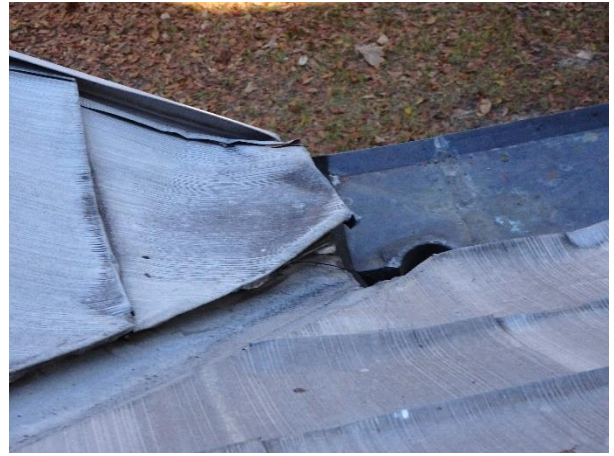
**FIGURE 124.** Damaged sheet-metal roof cladding near the gutter.

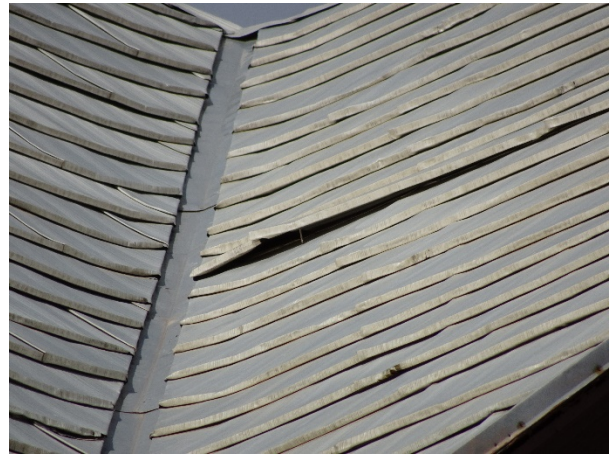
**FIGURE 125.** Bowed and displaced sheet metal at field of roof.

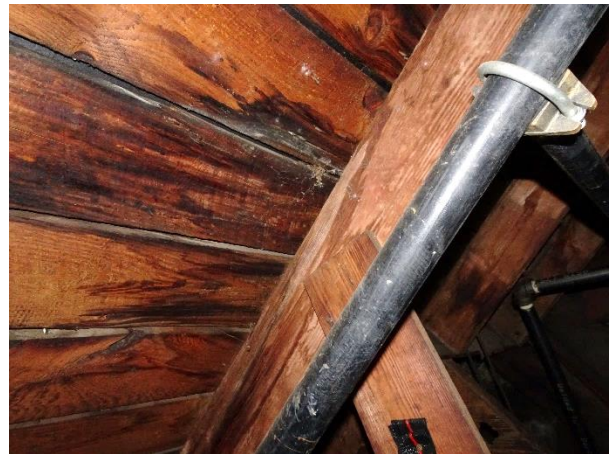
**FIGURE 126.** Moisture staining at wood sheathing.

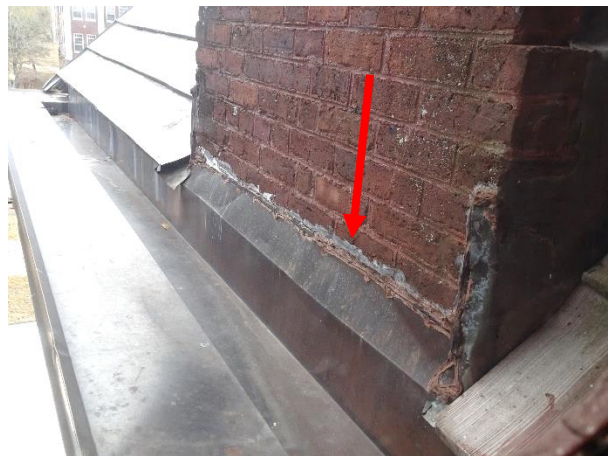
**FIGURE 129.** Deteriorated sealant at regletted flashing joint.

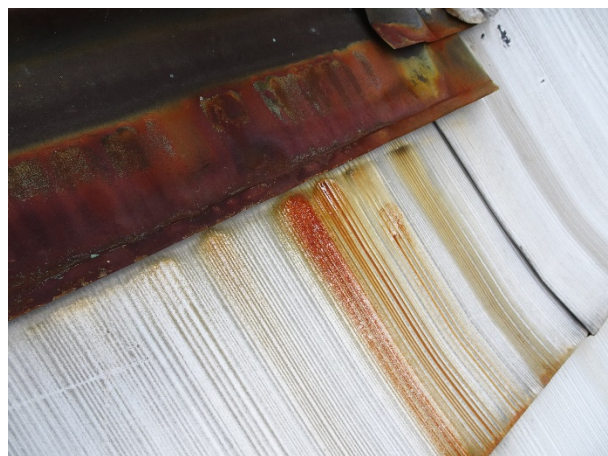
**FIGURE 130.** Corrosion staining at interface of flashing with roof cladding.

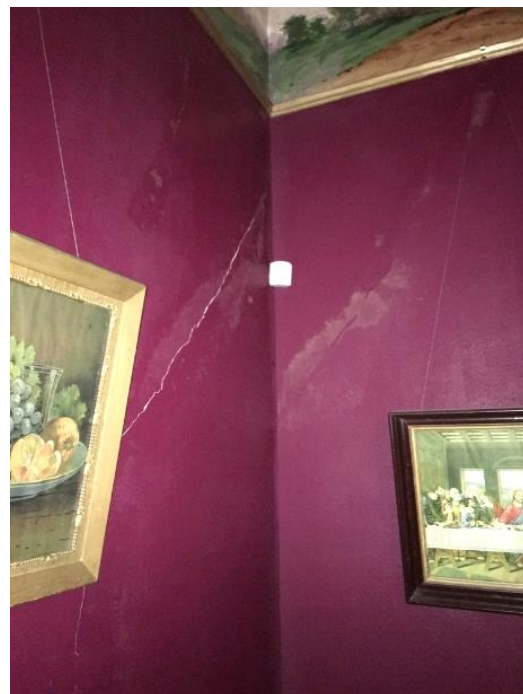
**FIGURE 134.** Detail of plaster cracking.

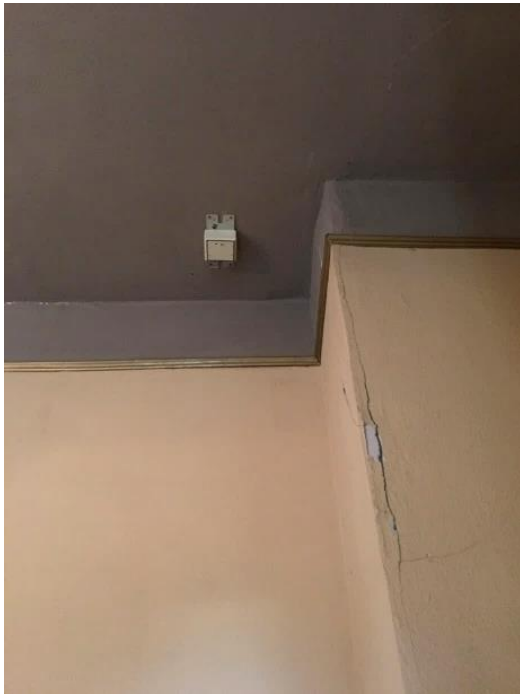
**Walls and Ceilings.** Exterior walls from the basement to the top of the second story are load-bearing brick masonry and finished with plaster on the interior. The exterior walls of the third floor and interior partitions on all three floors are wood-framed and finished with plaster over wood lath. Settlement and the structural deficiencies already noted led to cracks in the plaster. Although major and minor plaster repairs were included in the 1980, 1999, and 2007 rehabilitation and repair projects, there is plaster damage throughout the house. It is not pervasive and much of it is minor. However, the amount of minor damage is considerable (Figure 134). There are locations where the damage is serious because it compromises the integrity of the plaster and its appearance, in some places, the damage has adversely affected other historic materials (Figure 135).

**FIGURE 135.** Detail of plaster cracking.

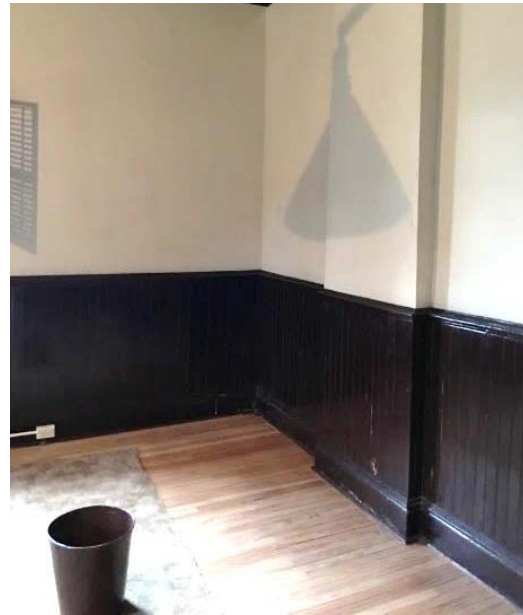
**FIGURE 140.** Stained wood wainscot.

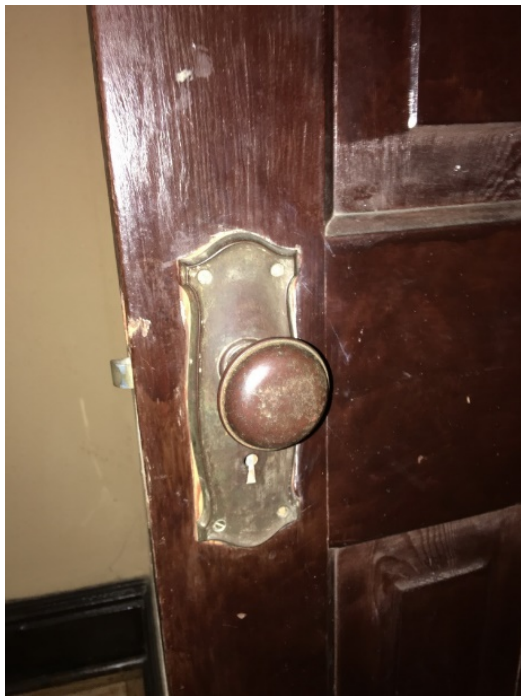
Much of the hardware throughout the house appears to be original or at least from the period of significance (Figure 154, Figure 155, and Figure 156). However, there are a number of lockset and latches of different designs representing different periods of The Oaks' history. A majority of original and older locks do not have keys. Some of the historic hardware was repaired with contemporary components or was abandoned in place and supplanted with modern hardware components (Figure 157). The original hardware appears to be brass or bronze; although, the finishes are worn, dull, and tarnished (Figure 158).

**FIGURE 158.** Worn finish on latch set.

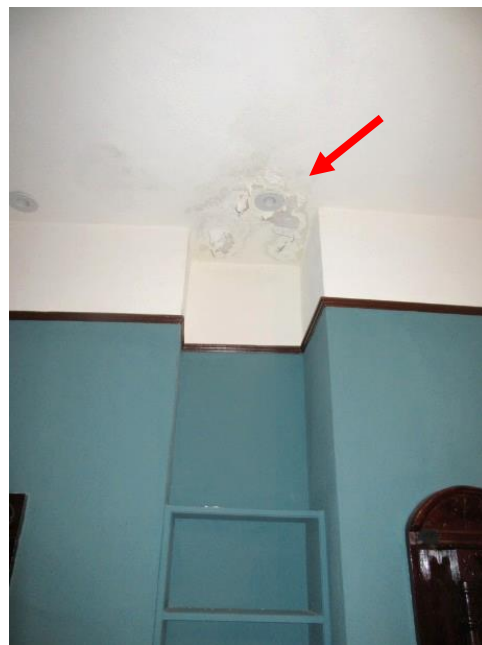
**FIGURE 177.** Plaster degradation and water damage at ceiling, Margaret Washington's bedroom.

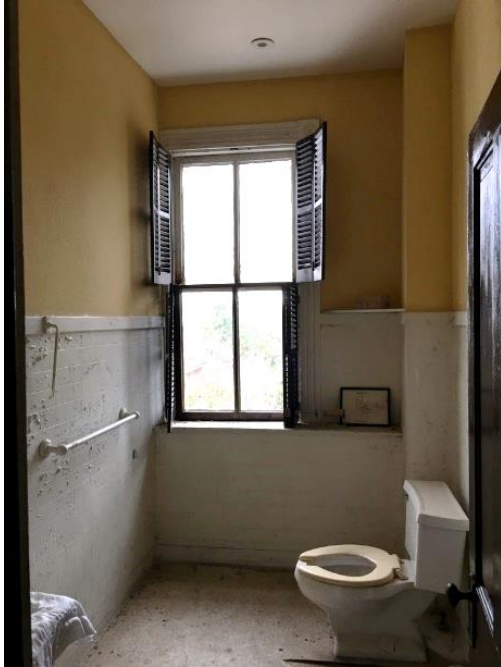
the attic door in the west wall is a large, dark water stain which is indicative of plaster damage. The bathroom door needs repairs and refinishing, and the hardware is tarnished, corroded, and not functional (Figure 214). The window and shutters are also in poor condition and are inoperable.

**FIGURE 212.** Third-floor south bathroom.

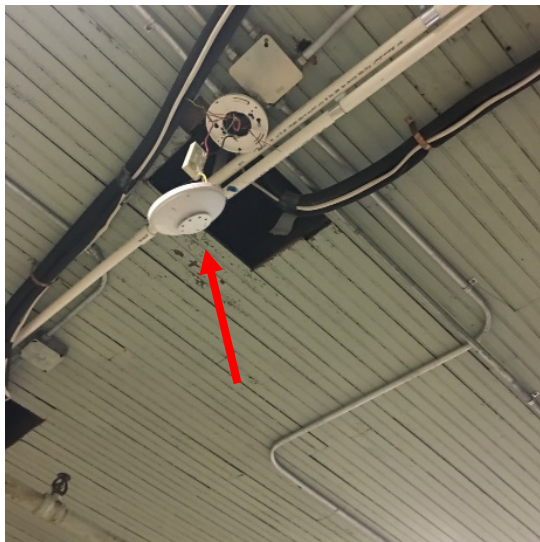
- The fire alarm and fire-suppression (sprinkler) systems were upgraded in 2007 and should be inspected and tested periodically for proper operation and compliance with current life safety codes.
- A few inoperable smoke and fire sensors were observed in the crawl space.

**FIGURE 225.** Disconnected smoke and fire detectors in basement.

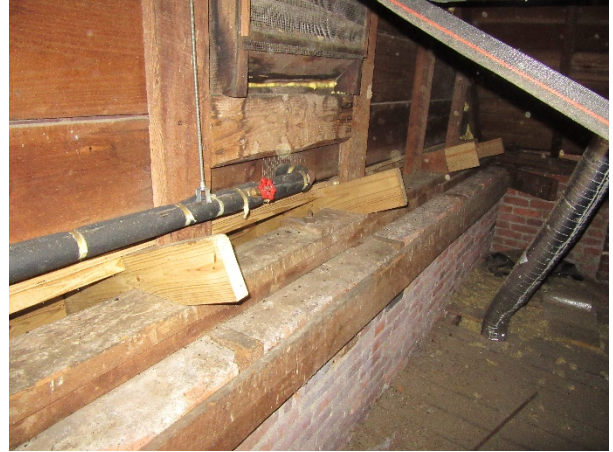
**FIGURE 235.** Replaced structural kickers at south wing roof.
