## Of Adobe, Lime, and Cement: The Preservation History of the San José de Tumacácori Mission Church (Part II - Structures)

### Introduction

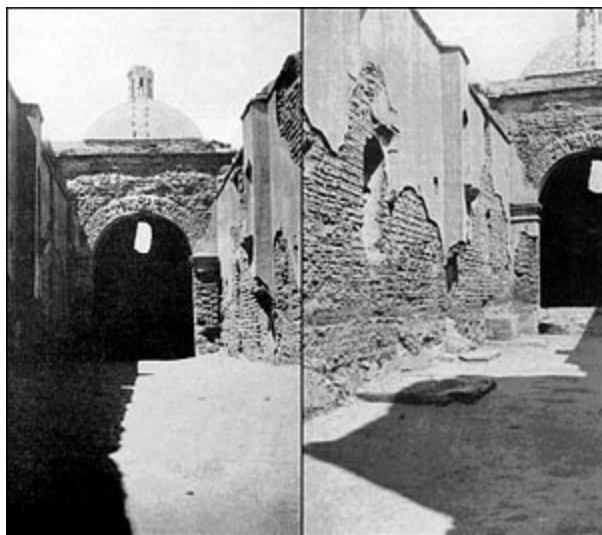
Nave floor before and after excavation by Noon in 1919. Four vertical feet of debris covered the floor.

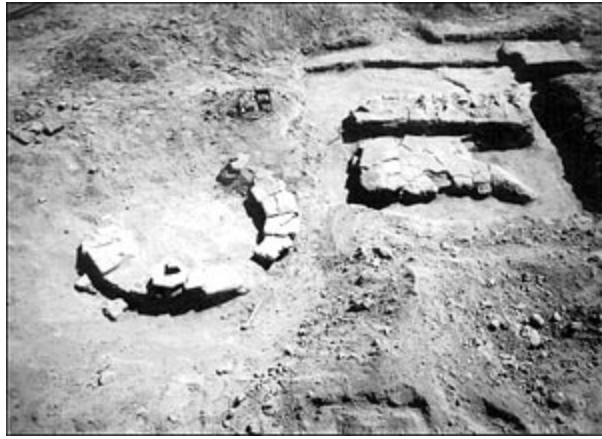
Heating features discovered by Beaubien in 1934 in Area 37A. Beaubien called the horseshoe shaped feature the retort and the square feature the furnace. Photo taken before the features were removed in 1970.

removed.<sup>1</sup> The features, located near the east wall of the nave between the sacristy and the bell tower, are within a *convento* work area designated Area 37a.

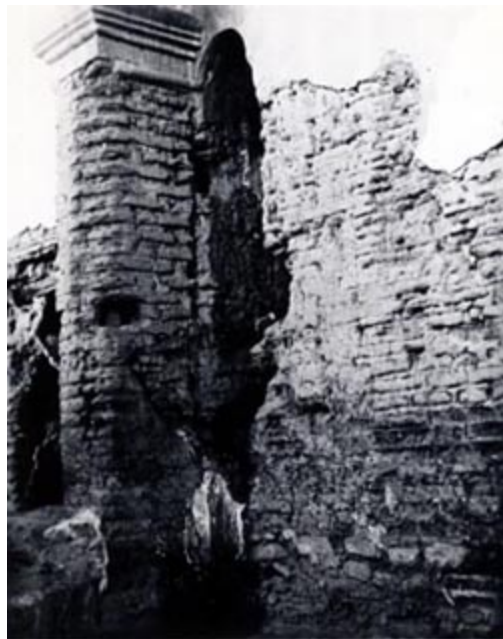
**The pulpit before restoration in 1922-1923. The photo shows the wall markings from the original pulpit floor. Pinkley used the marks to build an accurate pulpit floor.**

Noon uncovered remnants of the wooden frame of the pulpit when he excavated the church floor in 1919.<sup>11</sup> Pinkley partially restored the pulpit between 1923 and 1924, based on the existing architectural evidence and on pulpits of churches in Sonora. All that was left of the pulpit at the time of restoration was a few marks in the wall plaster. The pulpit is only partially restored. In 1978, a plugged doorway was found during the removal of cement on the eastern wall. Chambers suggests that this doorway may have been the pulpit doorway before the church was modified from its original cruciform design.<sup>12</sup>

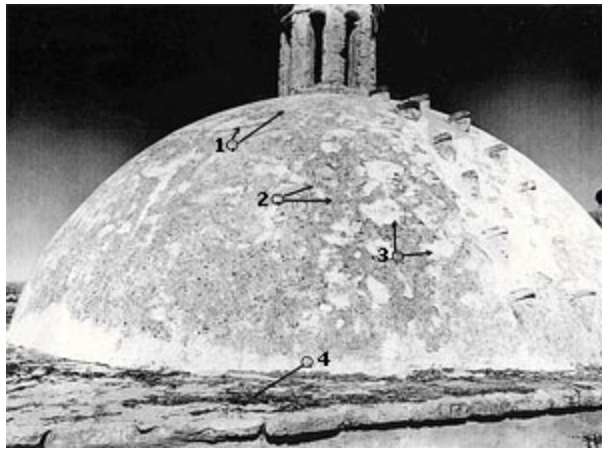
After Pinkley's work in 1921, only minor repairs were made to the dome and lantern. In 1961, Roland Richert of the Ruins Stabilization Unit began work on the eroded dome exterior. The dome had several different types of eroded plasters and the lantern was crumbling. Richert scraped all loose plaster off and removed the modern cement patches to reveal the underlying lime mortar base.<sup>20</sup> The dome was then painted with a mixture of Daraweld and water and deeper holes filled with bonding cement. Daraweld is an acrylic polymer bonding agent still in use at other parks. The bonding cement was a mixture of Trinity white water-proof cement, sand, Daraweld (acrylic-polymer bonding agent), and water. The entire dome and apron was covered with an eighth-inch coating of bonding cement. After 1961, numerous coats of cement bonding paints and latex paints were used to seal hairline cracks in the dome exterior plaster. These coats added weight to the dome and trapped moisture, increasing the erosion of interior plasters.

**Sanctuary Dome in 1961, before stabilization by Richert (RSU). Problems included: 1) Cracked patches of modern cement, 2) small furrows and cracks in original lime mortar, 3) white patches of modern lime-cement plaster (Pinkley 1921) and 4) eroded tar roofing.**

The next major project on the dome took place in 1979.<sup>22</sup> The deterioration and removal of the pendentive plaster in 1977 was the first indication of moisture problems inside the dome. All previous stabilization materials were stripped from the dome exterior down to fired adobe bricks. Once the underlying fired adobe bricks were exposed, voids were filled and the surface was covered with 2 to 2.5 inches of lime plaster. After plastering, two coats of lime white wash were applied. The white wash consisted of 8 gallons of lime paste mixed with 10 gallons of water, mixed with 12 pounds of table salt and 6 ounces of powdered alum in 4 ounces of hot water. After 30 minutes, 1 quart of molasses and 12 ounces of formaldehyde were mixed into the salt and alum mixture. The mix was then added to the lime and water mix. This was a unique mix for white wash, and five years later the white wash turned yellow.<sup>23</sup>

During the 1979 dome work, cement on the dome apron was removed, exposing deep cracks in the fired adobe bricks near the base of the dome. Weathered bricks were removed to a depth of 1 foot on the north, south, and west sides of the dome apron. Cracks were filled with lime mortar and burnt adobe brick pieces and the areas between the base of the dome and apron edge filled with fired adobe bricks laid in lime mortar. The dome apron was given two coats of lime plaster and the western sanctuary *canale* repaired.

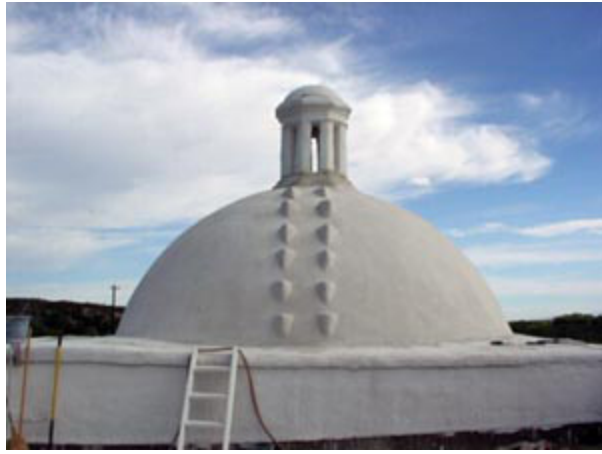
Work on the dome exterior was sporadic until 2004, when David Yubeta completed the most recent major repairs. Cracks had formed in the exterior plaster, and the bright white color of the dome was historically inaccurate. The first step was to remove the thick layer of paint and old plaster down to the brick substrate. Historic hand and toe-holds were discovered after the removal of over 2.6 tons of latex paint and eroded plaster. The hand and toe-holds begin at

**Sanctuary Dome after plaster replacement in 2004.**

Once the old stabilization plasters/paints were removed, the dome was sprayed with lime water, which made the dome better able to accept lime plaster. Next, St. Astiers Natural Hydraulic Lime (NHL 5), imported from France, was applied. Hydraulic lime sets in water, but it also sets by absorbing CO<sub>2</sub> from the air, therefore, it hardens or sets twice. Three plaster layers were applied over the fired adobe brick substrate. The final product is a more subdued grayish-white dome that is historically accurate and consists of natural materials. The dome exterior is on a 3-5 year maintenance cycle.

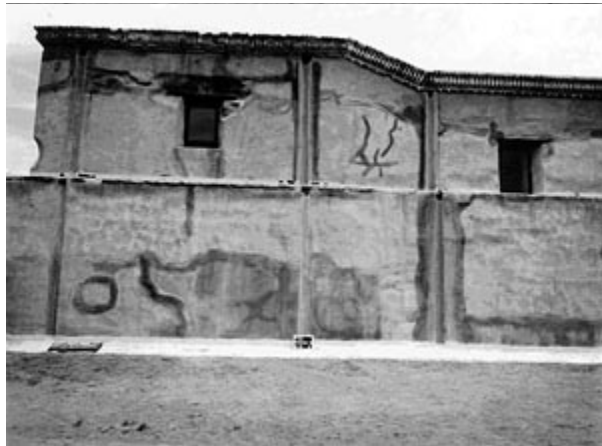
The exterior plaster of the west wall eroded at a quicker rate than other exterior walls and no original plaster exists on the west wall exterior. The biggest problem effecting plaster on the east wall exterior has been moisture entering through cracks and erosion at the base of the wall.

**West wall of nave/sanctuary exterior in 1972. Note the jigsaw like appearance.**
