Vanderbilt Mansion National Historic Site  
Hyde Park, New York

## **Vanderbilt Mansion National Historic Site Historic Structure Report**

Volume I: Executive Summary, History, and Record of Treatment  
October 2018

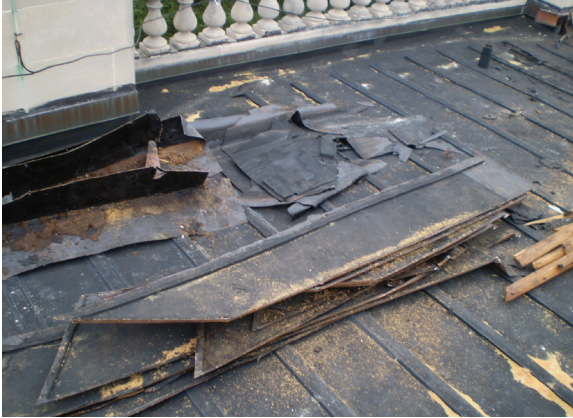
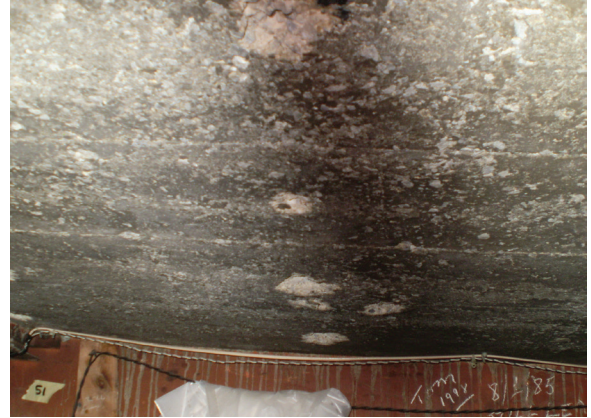
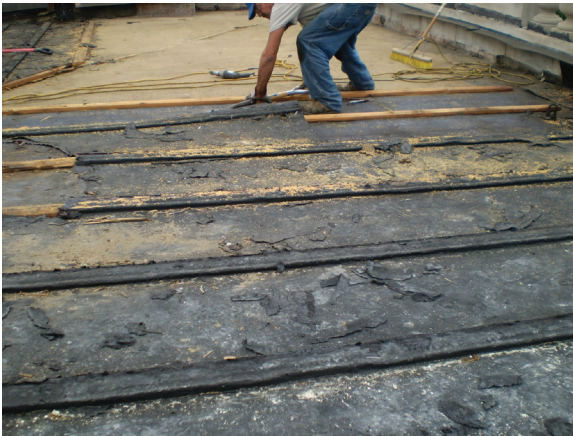
Figure 12. Roof demolition, September 8, 2009: original copper sheeting (upper left); removal of copper sheeting in progress (center); sweeping loose and excess materials on surface of exposed concrete roof deck (lower left). PBS&J.

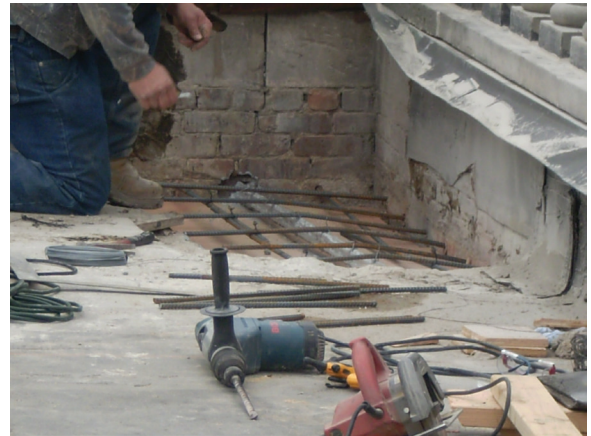
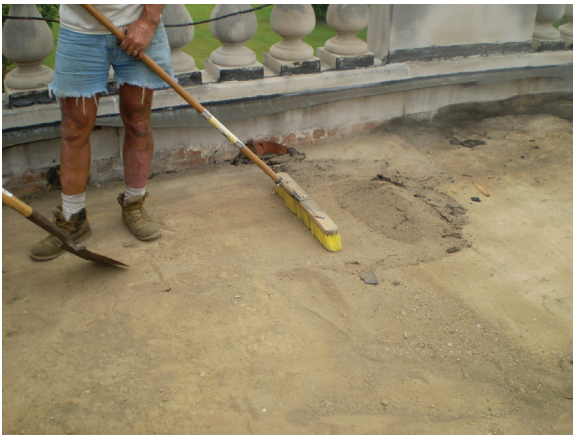
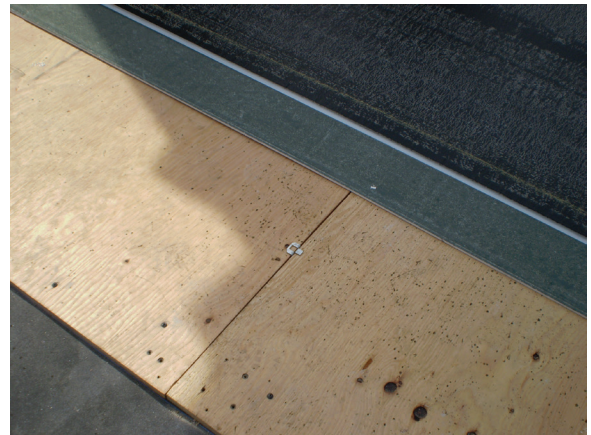
Figure 13. The drill down holes caused spalled areas on underside of roof deck in the attic (upper image); tying rebar into position at the southwest corner deck repair area (center image); and the plywood, dense deck and base sheet layers (bottom image). PBS&J, 2009-2010.

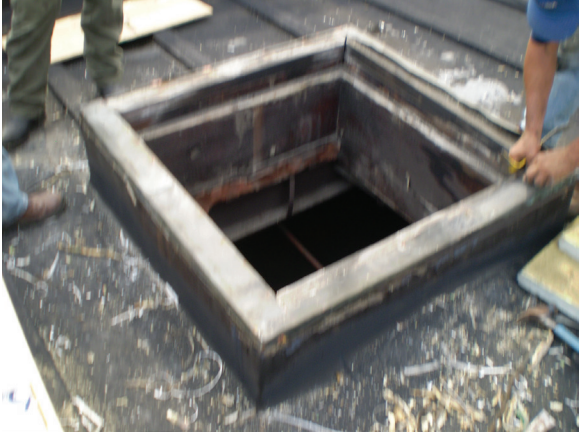
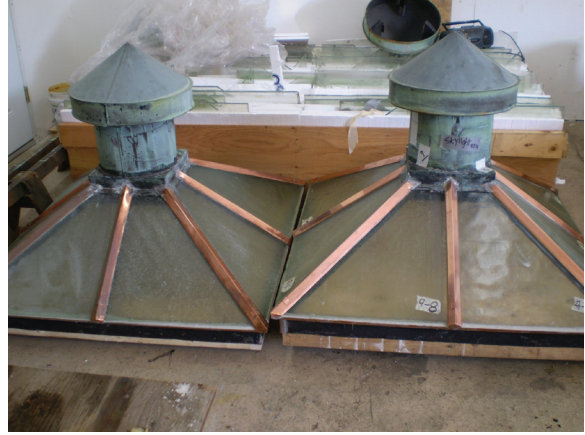
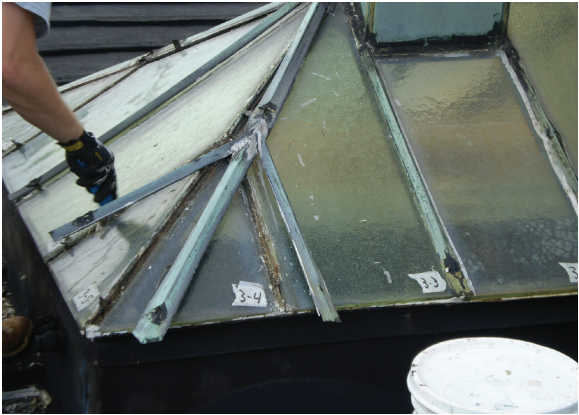
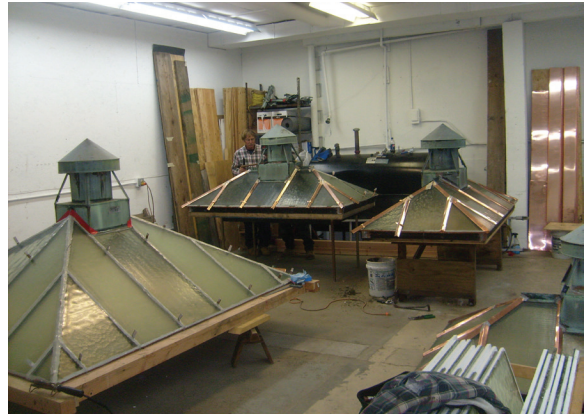
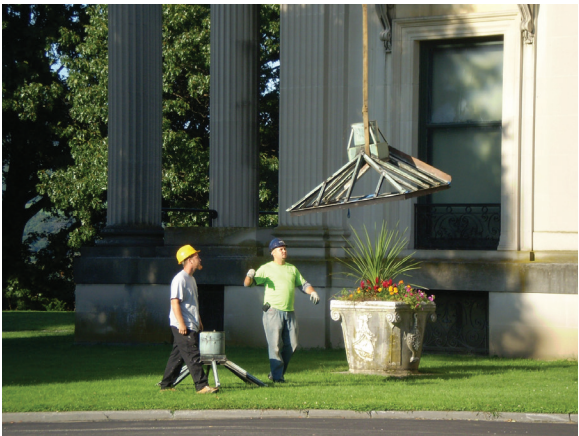
Initial inspection of the skylights revealed a "considerable quantity of existing cracks in individual glass panels" of the main skylight. Some panels in the smaller skylights were also cracked, causing concern that some of the panes might not survive dismantling. NPS chose to replace four of the cast-glass panels in the main skylight; six other cracked, fissured, and chipped panels were considered intact enough to be reinstalled. Following the inspection, the glass and muntin covers in the skylights were identified, mapped, and recorded before removing the glass and storing it for later reinstallation in the original locations (see Figure 15). All existing sealant was removed. The skylight frames were removed and repaired off-site at Diamond Construction's shop (see Figure 16). By January of 2010, all of the skylights were ready for reinstallation.

Figure 16. Skylight work: square skylight frames repaired and historic vent caps repaired and installed (upper image); skylights under repair (lower image). PBS&J, 2009.

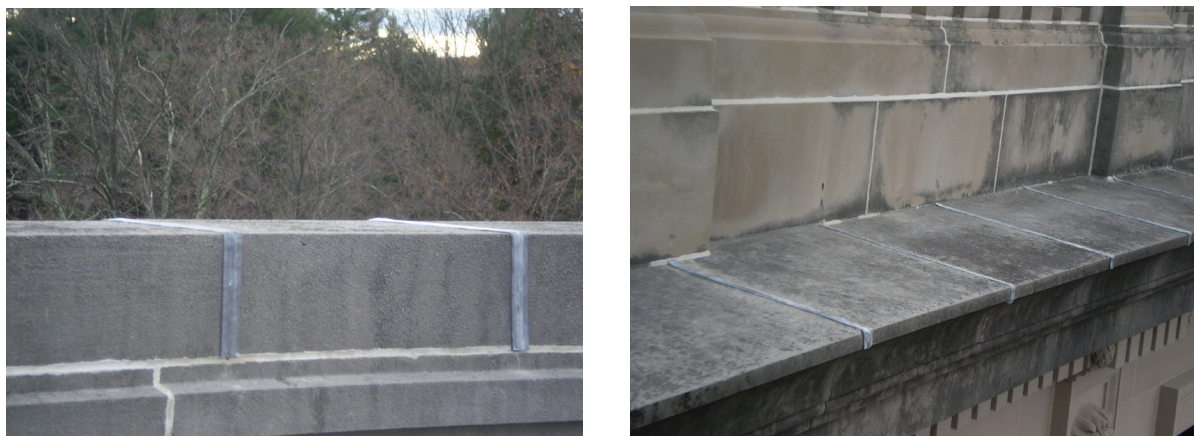
Figure 17. Lead-covered caulking joints on cap stones along east side of mansion parapet (left); and masonry joints and caulking/lead tee joints along exterior parapet at west side of roof perimeter (right). PBS&J, 2009.

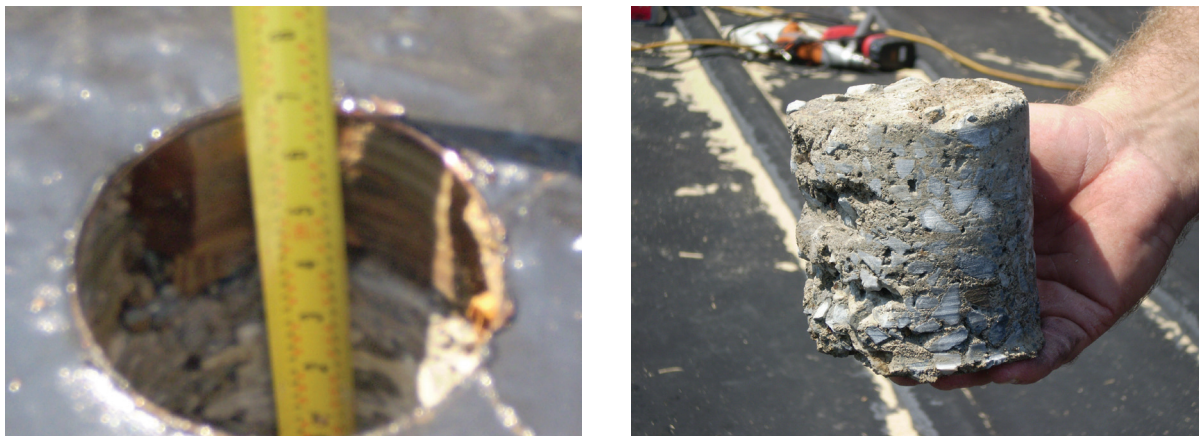
**Figure 18. Core drilling to check the composition and stability of the original concrete roof deck, August 18, 2009: measuring the depth of the first core drill hole (upper image); and close up of concrete core from the first core drill hole (lower image). PBS&J.**

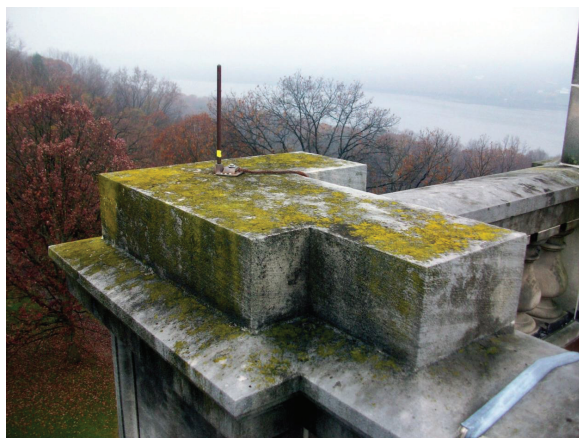
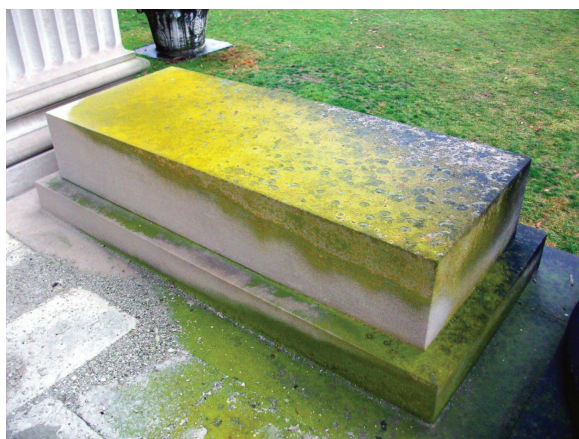
**Figure 20.** One of the primary issues with the stone was staining from several types of biological growth. JGWA, 2010.

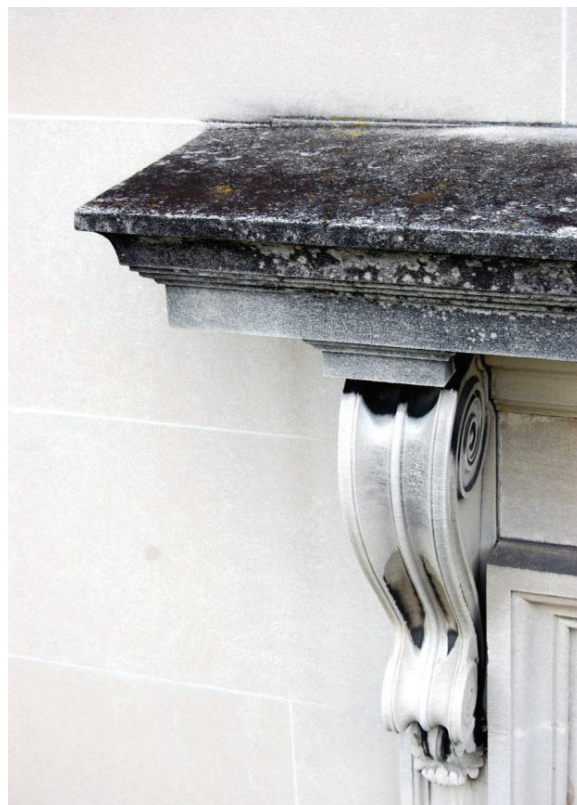
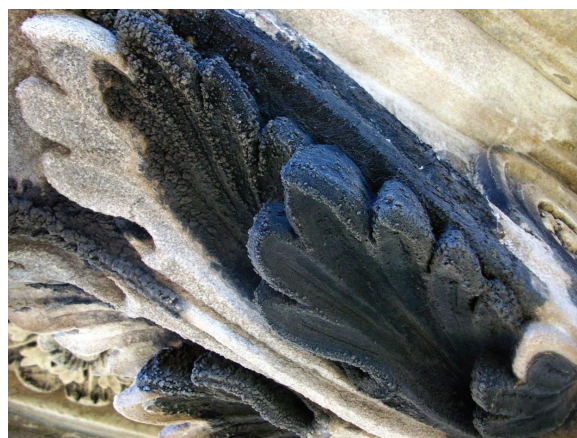
**Figure 21.** Stone deterioration was also attributed to gypsum crust. On the left, the window lintel is stained with biological growth and damaged by gypsum crust; below, gypsum crust has developed on one of the modillions. JGWA, 2010.

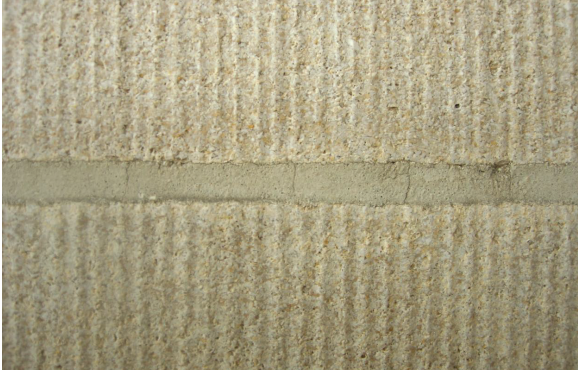
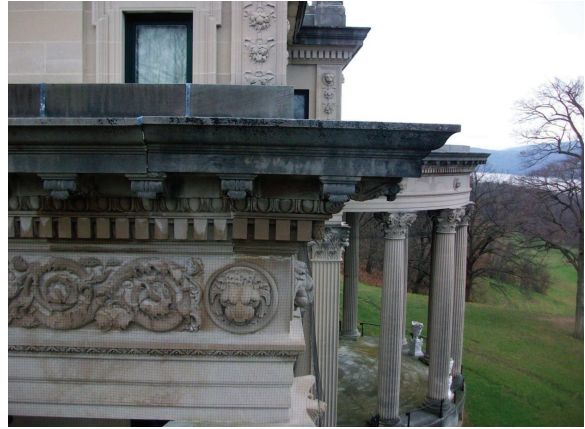
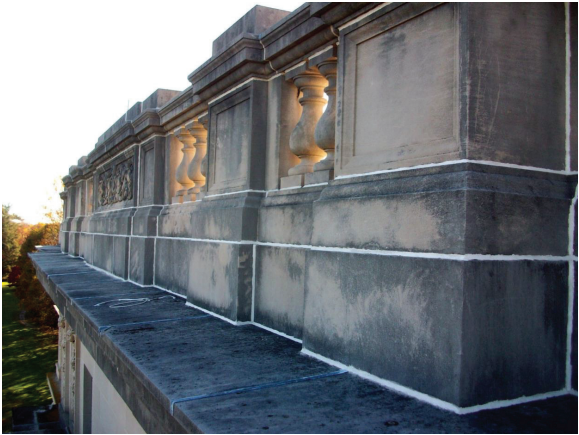
**Figure 22.** (Upper image) The original mortar joints are very thin; the original workmanship was meticulous and difficult to replicate. (Lower image) Repointed mortar joints on the balustrade did not match the original. JGWA, 2010.

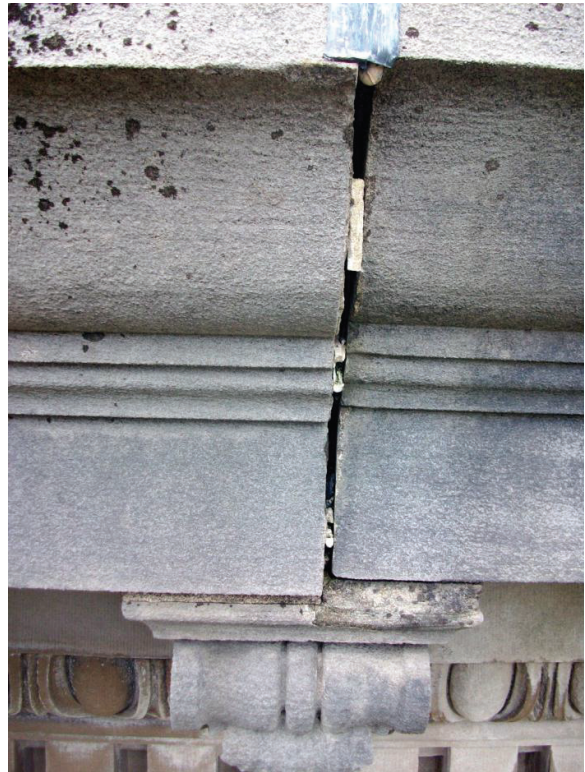
**Figure 23.** The corner stones in the north and south portico cornices were displaced and rotating out. JGWA, 2010.

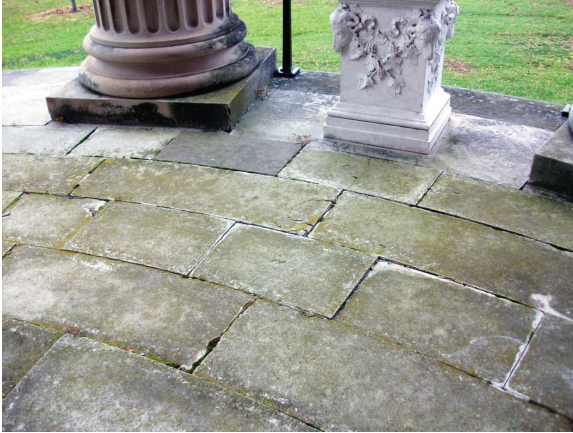
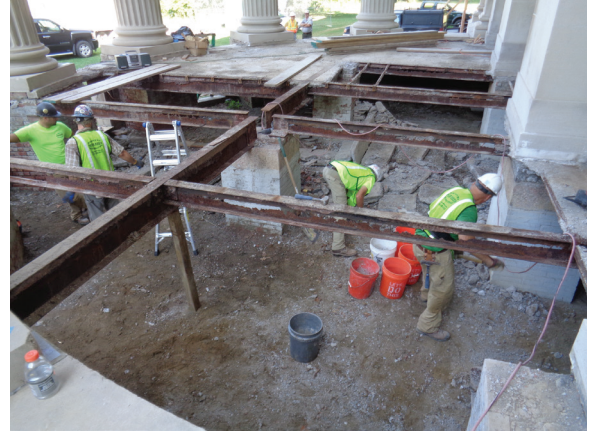
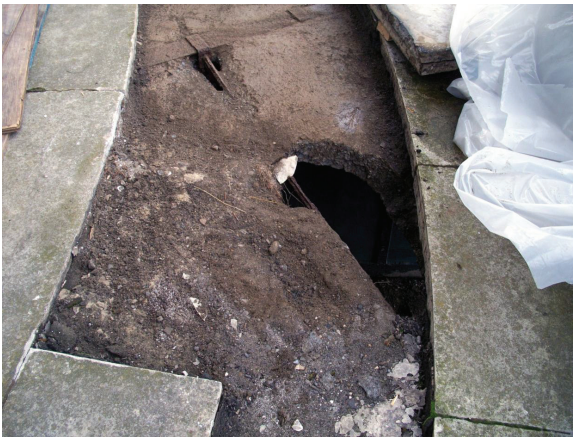
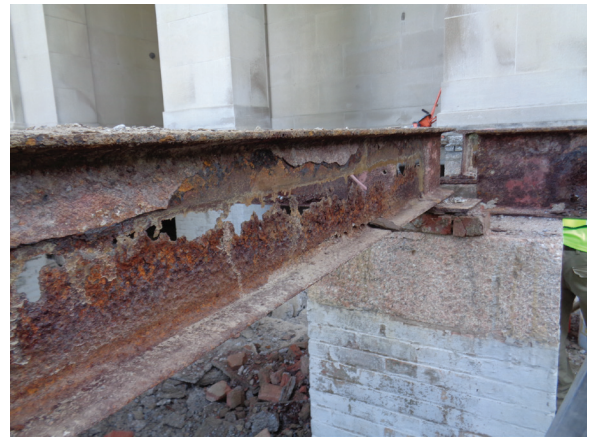
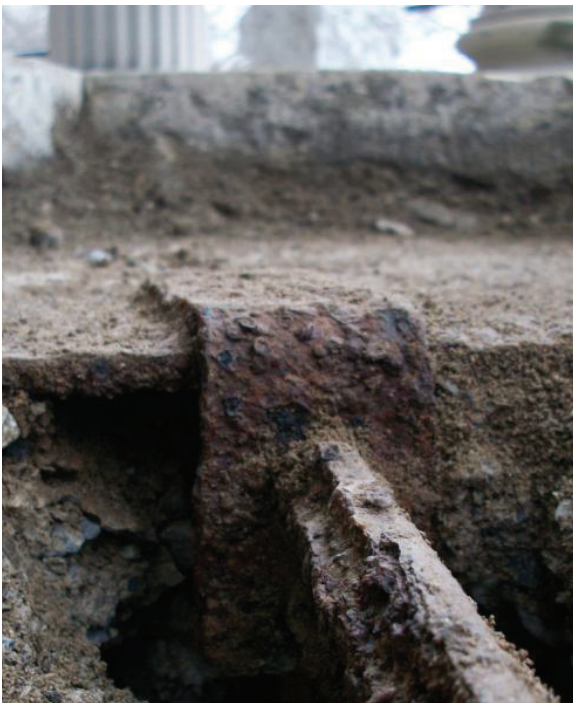
**Figure 24. Porticos:** The Joliet stone paving on the west portico was chipped and spalled, and the surface was uneven (upper left). Concrete patches did not match the stone. Removal of the stone revealed that the structural steel and concrete support slab were severely damaged (center image). Removal of the paving revealed the original 1899 structural system (lower left); saddles hung on the primary beams supported double-tee shaped bars. The two photos to the right show the severely rusted steel framing of the west portico slab. JGWA, 2010-2015.

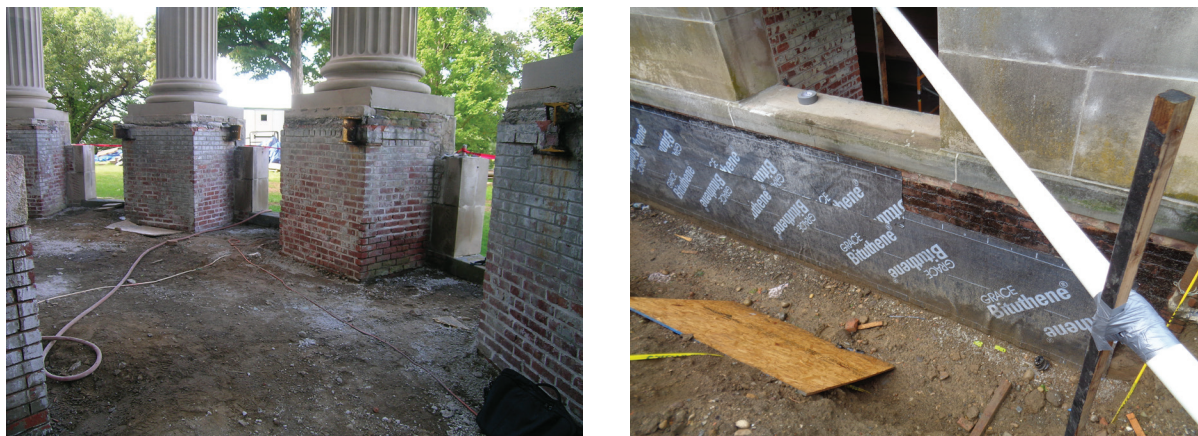
**Figure 25. (Left) View of the brick piers supporting the west portico columns, after the floor structure was completely removed. (Right) Waterproofing was applied to the foundation, four feet below grade. JGWA, 2015.**

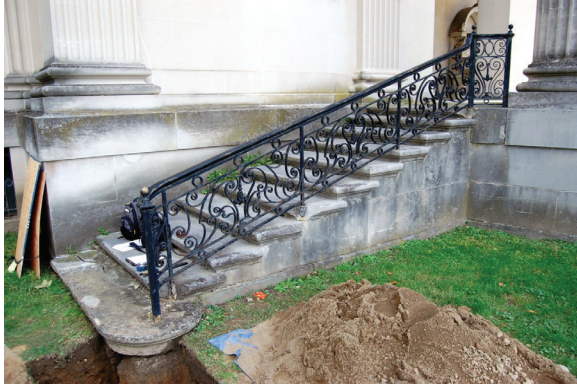
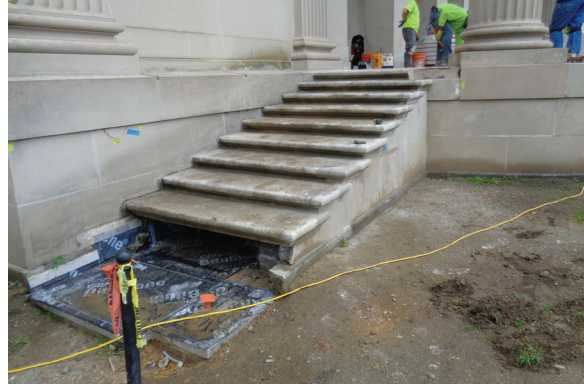
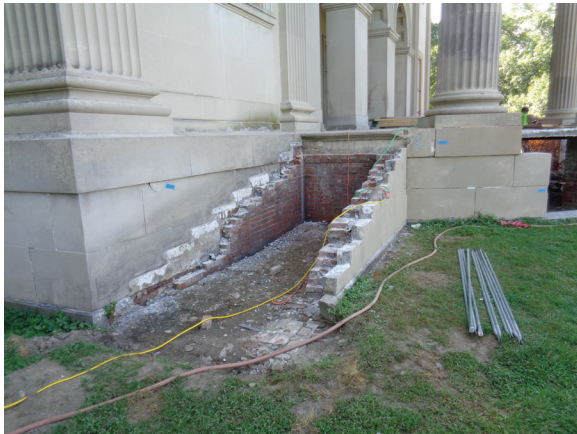
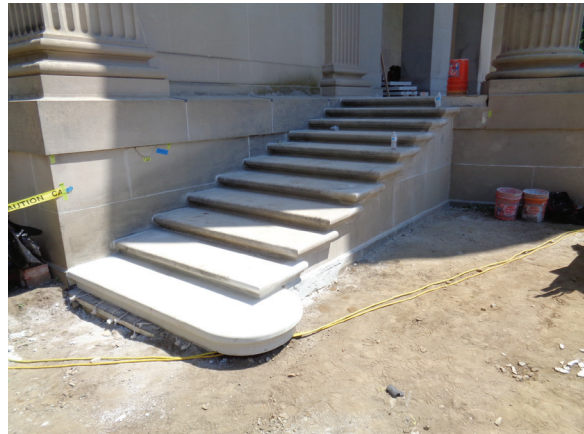
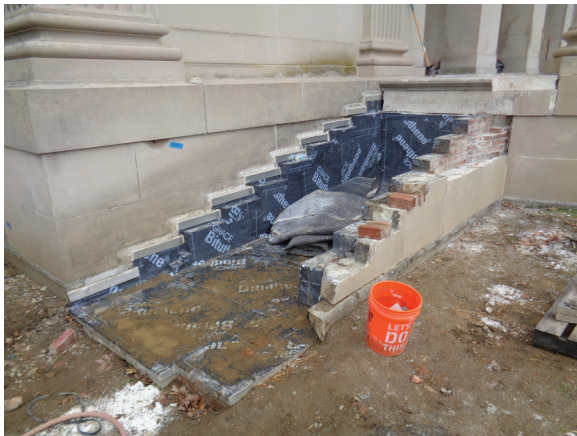
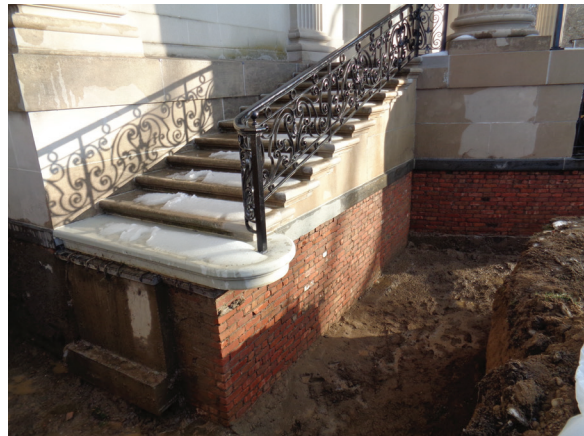
Figure 29. The restoration of the north steps to the west portico.  
 (Upper left) The condition of the steps in 2010.  
 (Center left) The pavers removed from the brick and stone support walls.  
 (Lower left) Waterproofing installed on the support walls.  
 (Upper right) The treads partially reinstalled.  
 (Center right) The treads installed and cleaned. The lowest tread is a new Joliet stone tread, as the original was cracked and deteriorated beyond repair.  
 (Lower right). The steps with their restored railing. During the second phase, this area was excavated and waterproofing installed on the brick walls. JGWA, 2015-2017.

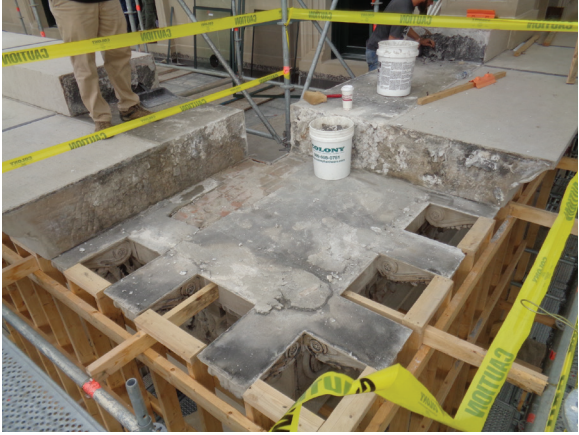
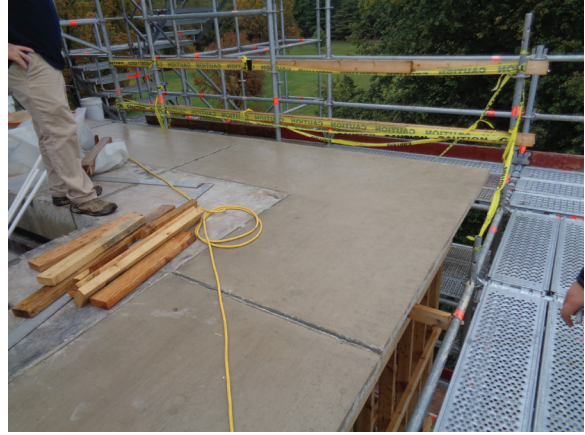
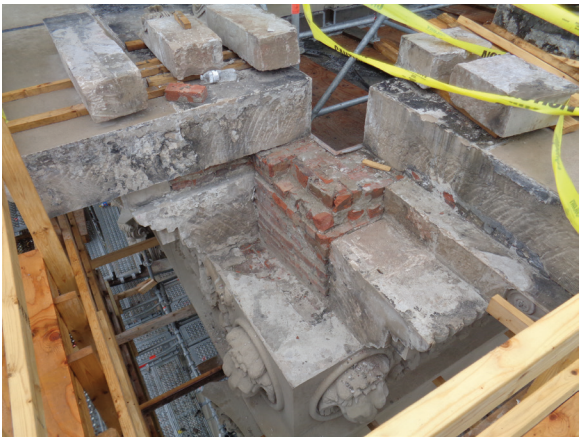
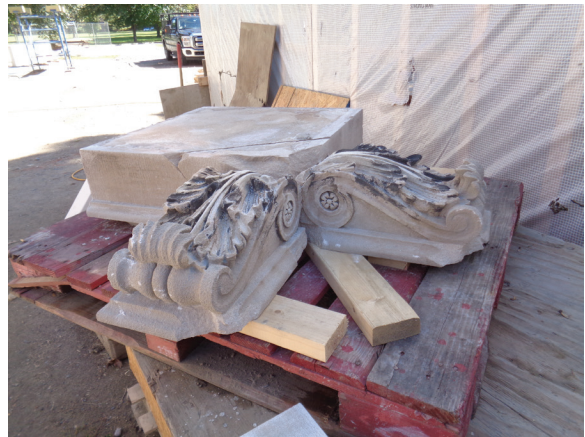
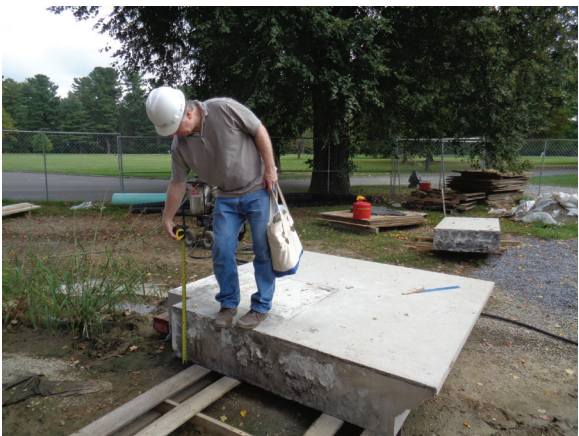
Figure 32. (Upper left and center) Views of the structure of the corner of the portico roof, with the top corner stone removed (upper image) and with the lower sections removed (lower image). (Bottom left) One of the corner stones after removal. (Above right) One of the corner stones after pinning and setting it back in place. (Lower right) After installation, one of the Lewis pins failed. The corner block dropped six inches, damaging the modillion brackets below. The damaged pieces have since been re-carved using Indiana limestone to match the original. JGWA, 2017.

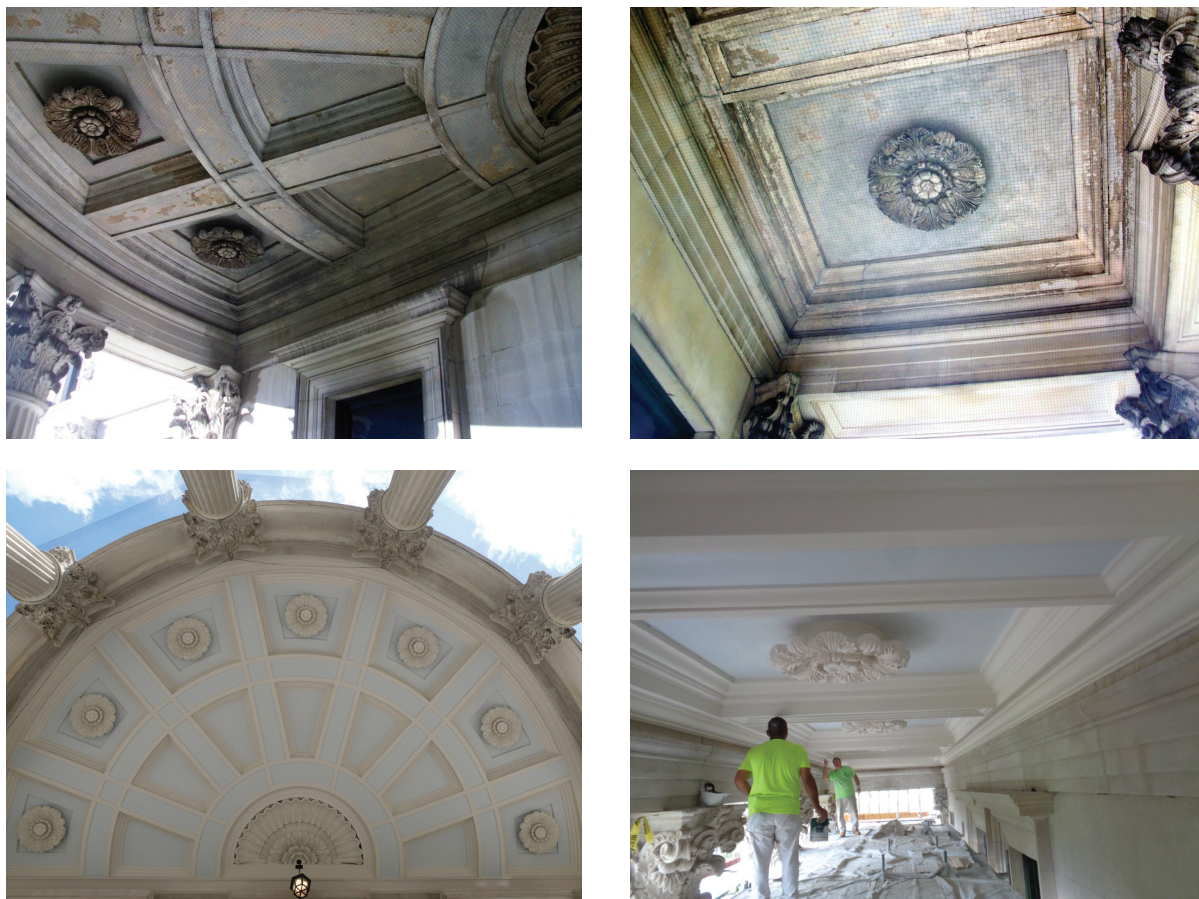
Figure 33. The west portico ceiling before and after restoration (left); the north portico ceiling before and during restoration. JGWA, 2017-18.

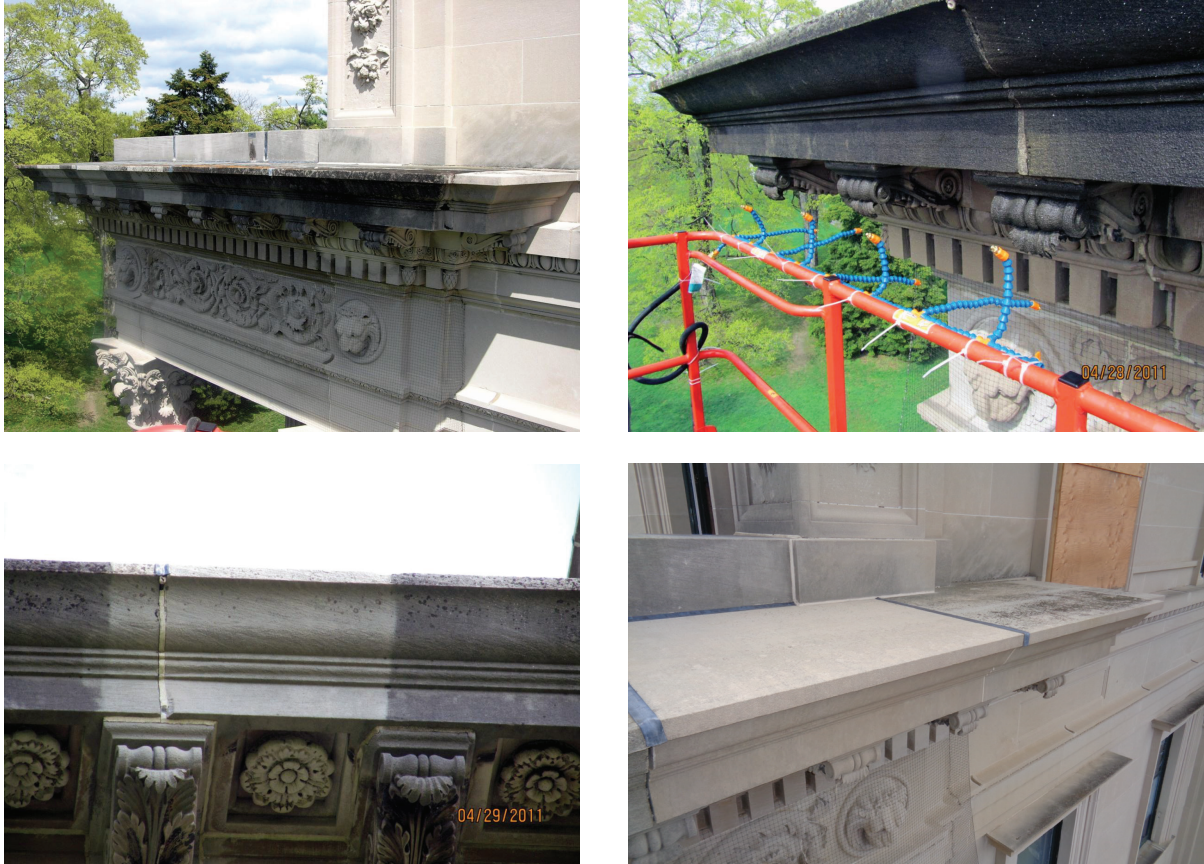
**Figure 34. Cleaning tests on the cornice (left and upper right); and mock-up by contractor for cleaning and repairing cornice. Lead ties were installed on the skyward joints. JGWA, 2011, 2017.**

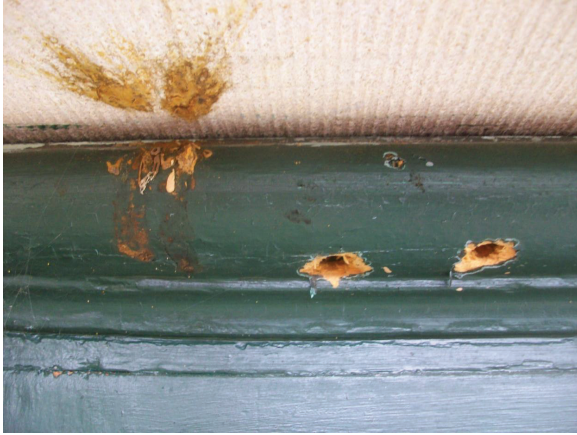
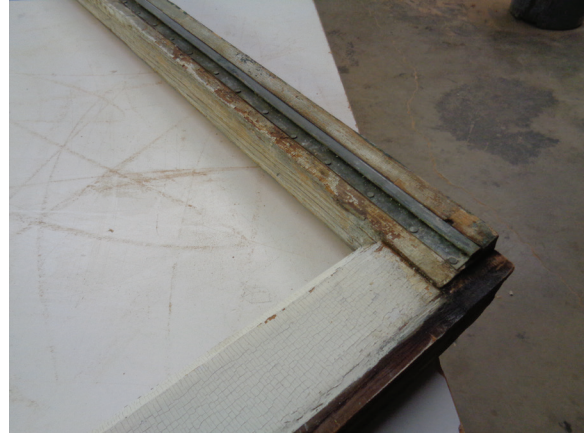
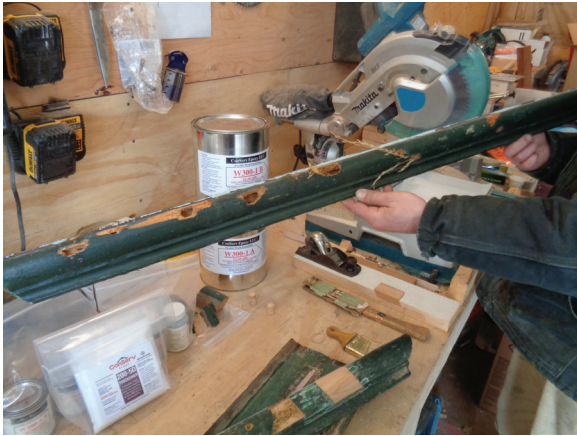
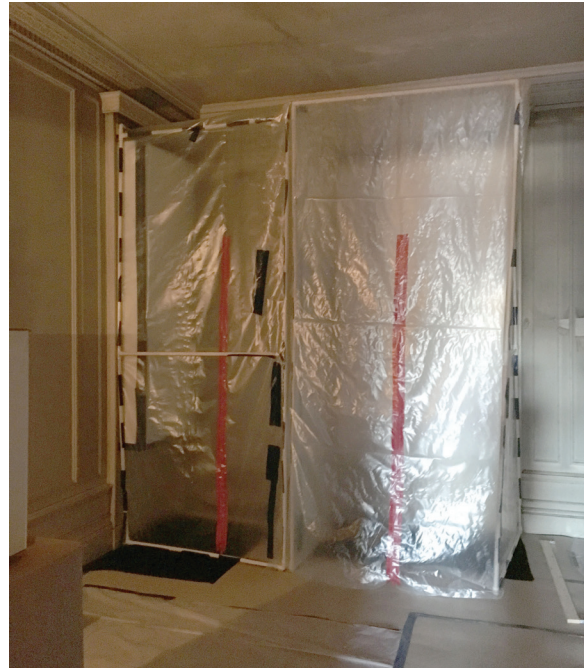
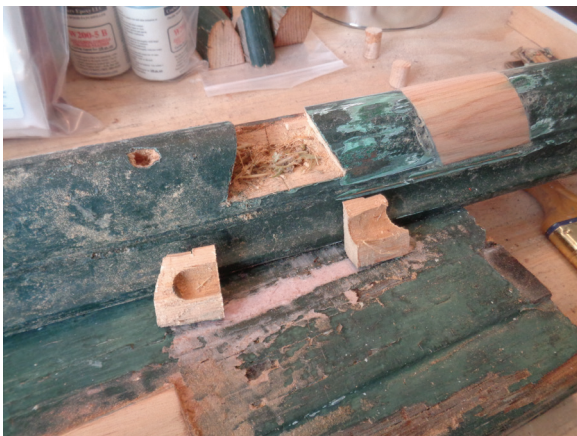
Figure 35. (Upper image) The woodwork was damaged from insects and woodpeckers. (Center and bottom image) Mock-up to develop techniques for dutchman repair on the windows' wood brick molds. Brick mold this damaged was typically replaced. JGWA, 2017.

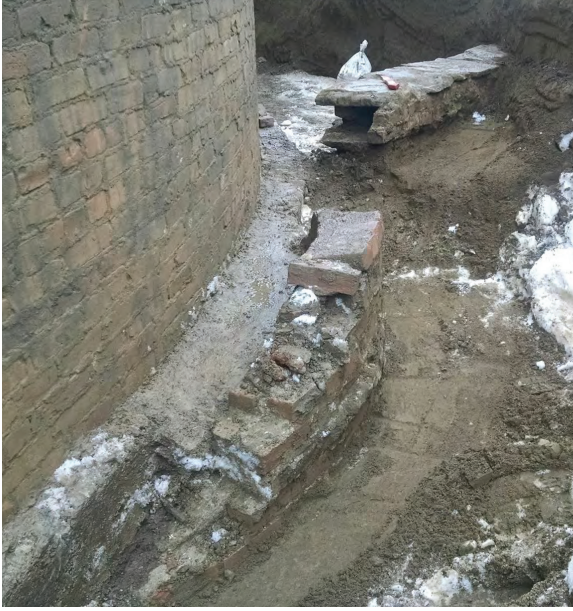
**Figure 40. A brick-and-flagstone drain and associated cistern, discovered immediately west of the west portico, is thought to be one of the only surviving elements from the Langston mansion. NPS, 2017.**

are most likely from the Langdon family (1840-1894). If so, they are the only known surviving remnants of the Langdon occupation. The features were avoided during the exterior restoration and reburied to prevent additional deterioration.<sup>482</sup>
