## **Vanderbilt Mansion National Historic Site Historic Structure Report**

Volume VIII: Appendix G - Record of Treatment Documents  
Complete the Exterior Restoration of the Vanderbilt Mansion: PMIS 152373  
October 2018

COMPLETE THE EXTERIOR RESTORATION  
OF THE VANDERBILT MANSION  
PMIS 152373

**JOHN G. WAITE ASSOCIATES, ARCHITECTS**

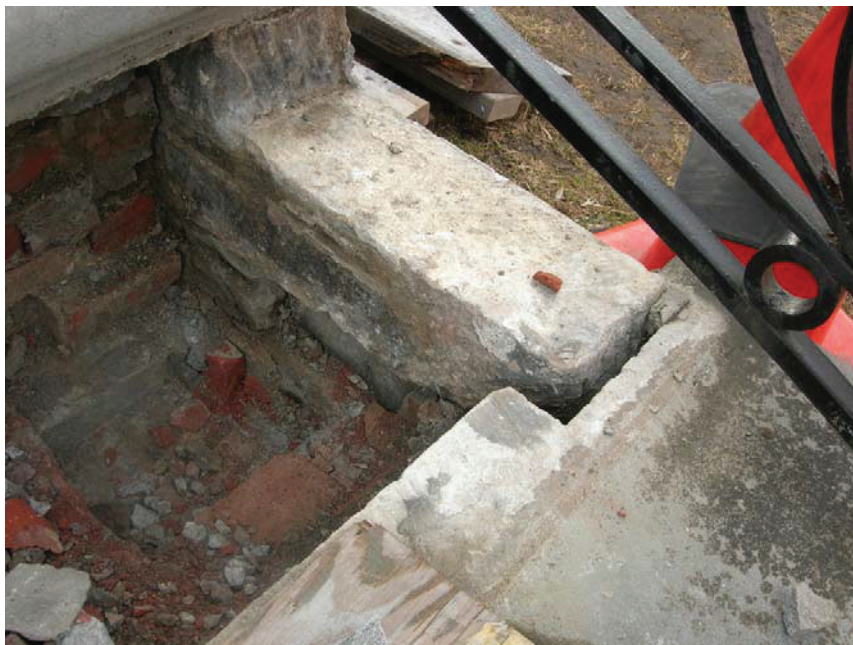
A probe was performed at a window architrave where substantial stone cracking has occurred. A steel floor framing beam was exposed and found to be in excellent condition. An interior probe at a basement window revealed lightly corroded steel angle lintels.

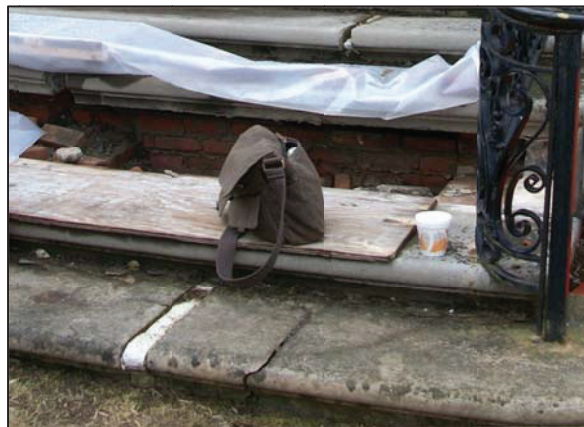
Photo 10 – Probe at North Portico Stairs

Looking at the stone treads many do not appear to be uniformly supported by the brick below and several show signs of significant displacement. The joints between treads show this movement and provide further evidence of no anchorage. Many of the joints are in excess of one inch wide, with layers of repairs attesting to a worsening condition (Photo 10). The movement has likely been the result of a freeze-thaw cycle for the water infiltrating the poorly maintained joints. Overall, the stone treads at all the porticos are in poor condition.

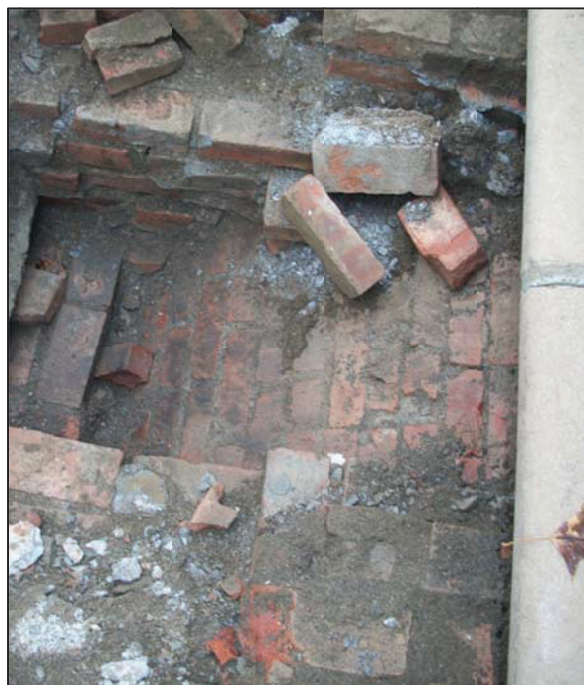
Photo 12 – Probe at Base of East Portico Stairs

A probe was opened up at the base of the east portico stairs leading up to the main entrance of Vanderbilt Mansion. The stairs are supported by an extensive brick vault system, which at the probe had a height of 17 inches over a 30 inch run (Photo 12). The condition and profile of the stone treads/brick infill were similar to what was observed below the north portico stairs. The treads are loose, displaced and non-

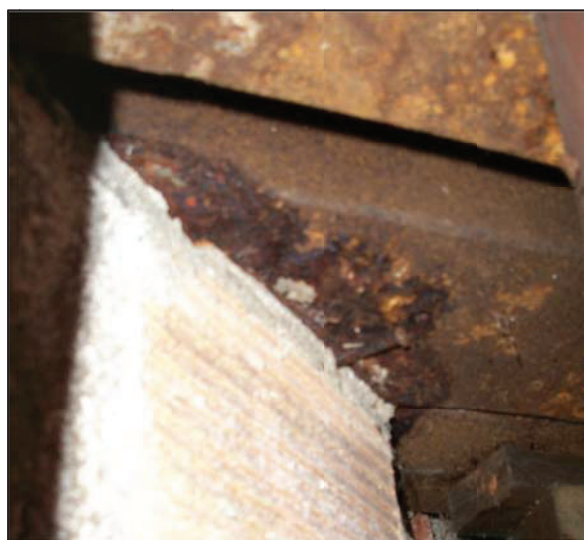
Photo 14 – Corrosion at Bearing of Steel Lintels

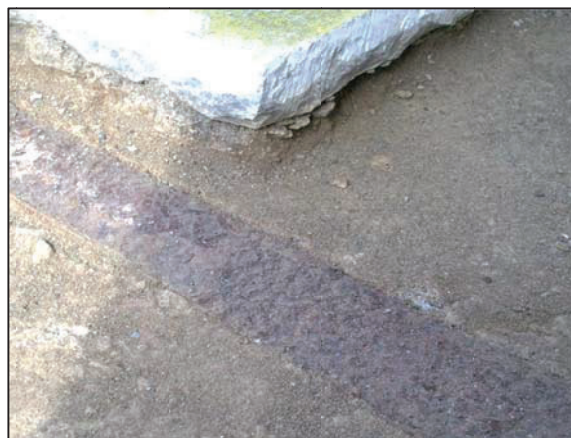
**Figure 3:** Exposed Top Flange at North Portico Probe

In general, the portico floor framing consists of steel beams supporting a concrete slab. At the west portico a 4 inch structural slab is supported from the top flange of the beams (Figure 2). At the north, south and east porticos the slab is approximately 9 inches thick with a 5 inch topping slab above a 4 inch structural slab (Figure 3). The structural slabs are reinforced with a proprietary system from the Columbian Reinforcing Company (Figure 4). Above the slabs there is a one inch setting bed and 3 inch thick stone pavers (Figure 7).

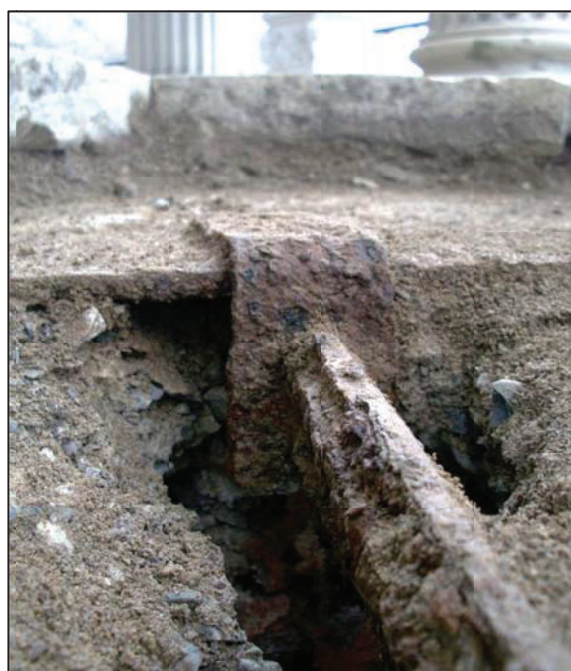
**Figure 4:** Proprietary System Used for Slab Reinforcement, West Portico

Probes, cracking patterns and observations in crawlspaces showed that at the north, south and east porticos the beam is fully embedded in the slab with only the top and bottom flanges exposed. At the west portico only the top half of the steel beam is embedded in the slab, leaving the bottom half and the top flange exposed.

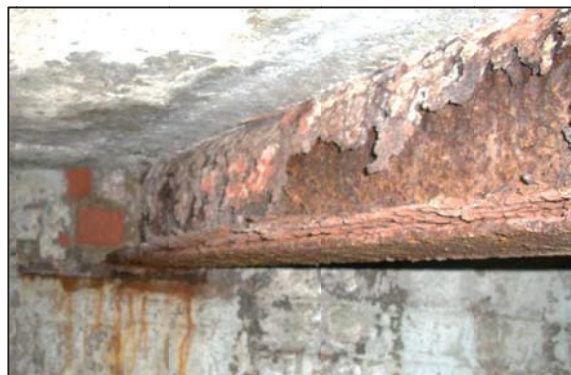
Without any waterproofing or shelter from the elements, the exposed steel has consistently been in the presence of moisture. The moisture has caused rust to build up along large portions of these members and has displaced surrounding finishes, fireproofing and stones. The most significant deterioration of steel beams was observed at the west portico, where in some places holes were observed in the beam web (Figure 5). Cracking of surrounding materials due to rust jacking was observed at the west portico, where fireproofing has fallen in many locations, and is pronounced at the underside of the north and south porticos (Figure 6).

**Figure 5:** Deterioration at West Portico Steel Wide Flanges

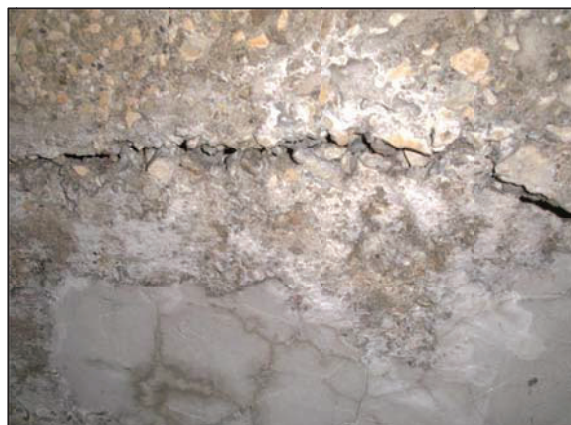
Figure 6: Spalling at the Underside of South Portico

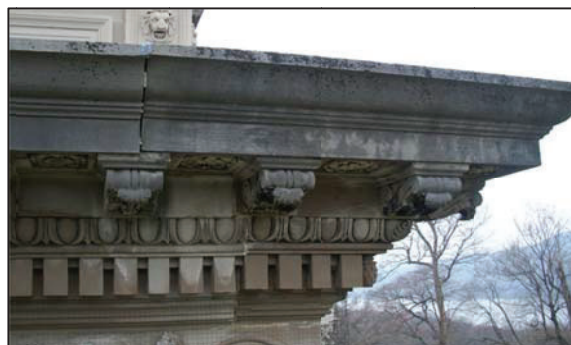
Figure 10: Cornice Stone at West End of North Portico

With that being said, the center of mass of the cornice assembly was only a few inches from the edge of its bearing support (Figure 12). The continued lateral displacement and rotation of the stone would lead to a shift in that center of mass and potentially an unstable condition. Until there is conclusive evidence otherwise, it must be assumed that there are no anchors and therefore it becomes even more imperative that the freeze-thaw

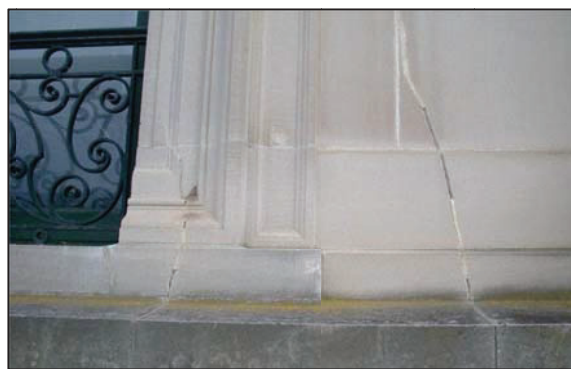
Figure 13: Stone Cracking Near Window on West Façade

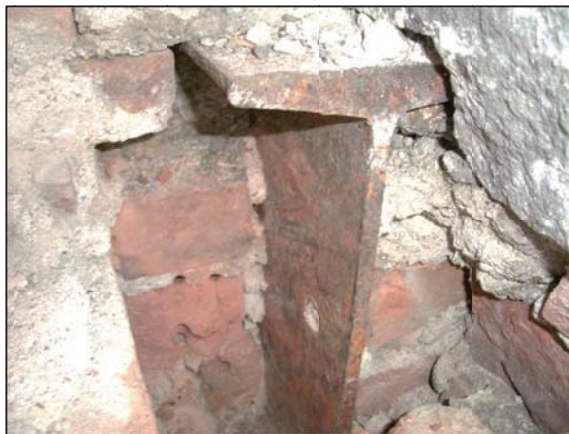
Figure 14: Steel Framing Exposed at Window Sill Probe

In the case of the cracks in the window jambs, it is thought that the cause may be a combination of building movements and tight mortar joints. When the building is subjected to lateral wind loading, the massive masonry walls act as shear walls resisting these loads. This causes some lateral movement of the walls. Where tolerances in the masonry joints are tight and masonry elements attempt to

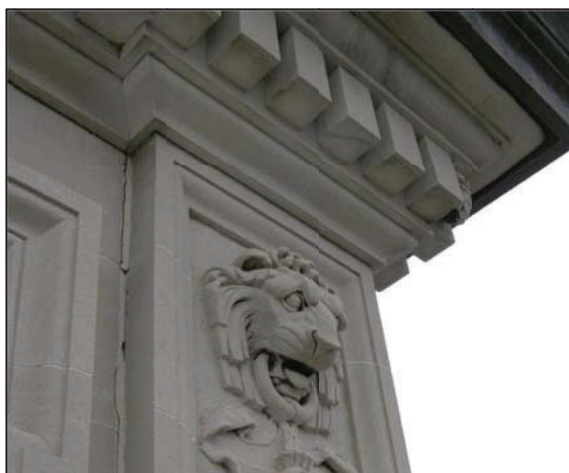
Figure 15: Cracking at Northwest Corner Stone

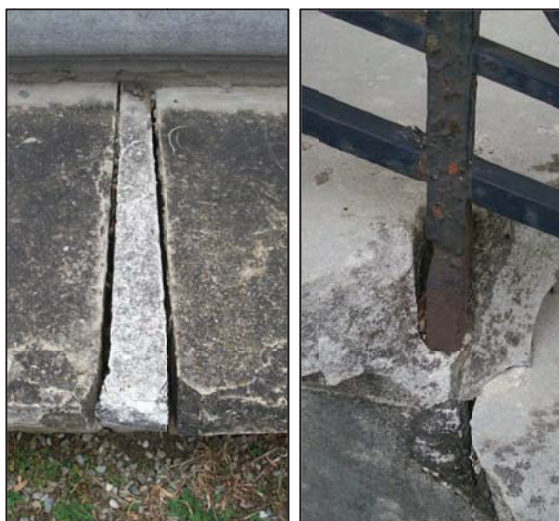
Figure 16: Joint Separation & Spalling at Portico Stairs

1. Chemically clean exterior masonry to remove soil and crusts, staining, and biological growth.
2. Disassemble and reset steps of north, west, south and east porticos, reconstruct masonry backup and foundations as required.

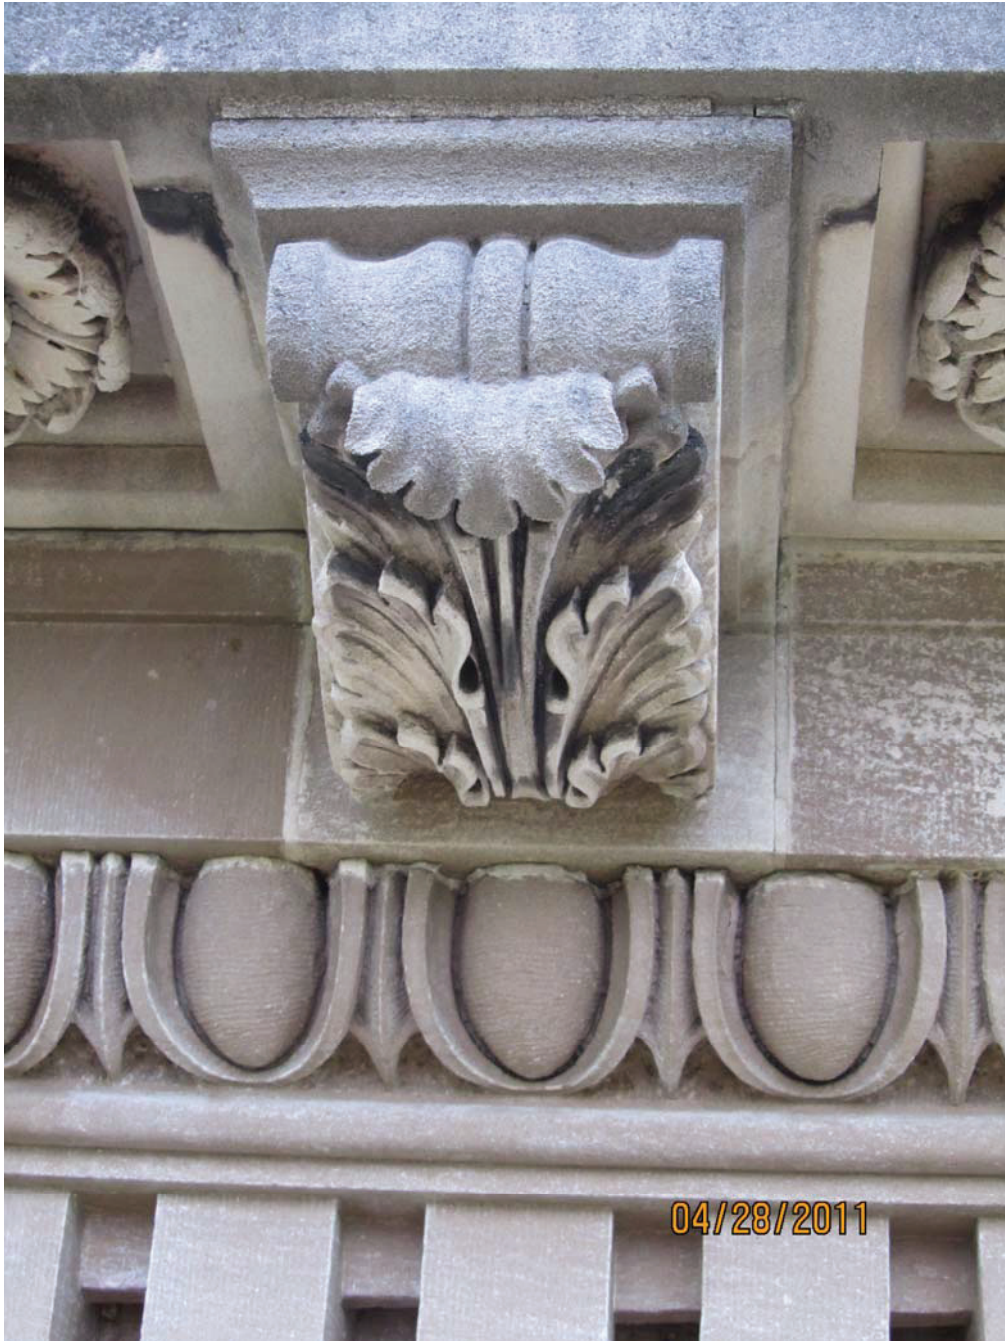
Test area #4, cornice modillion conditions with black crust in protected area

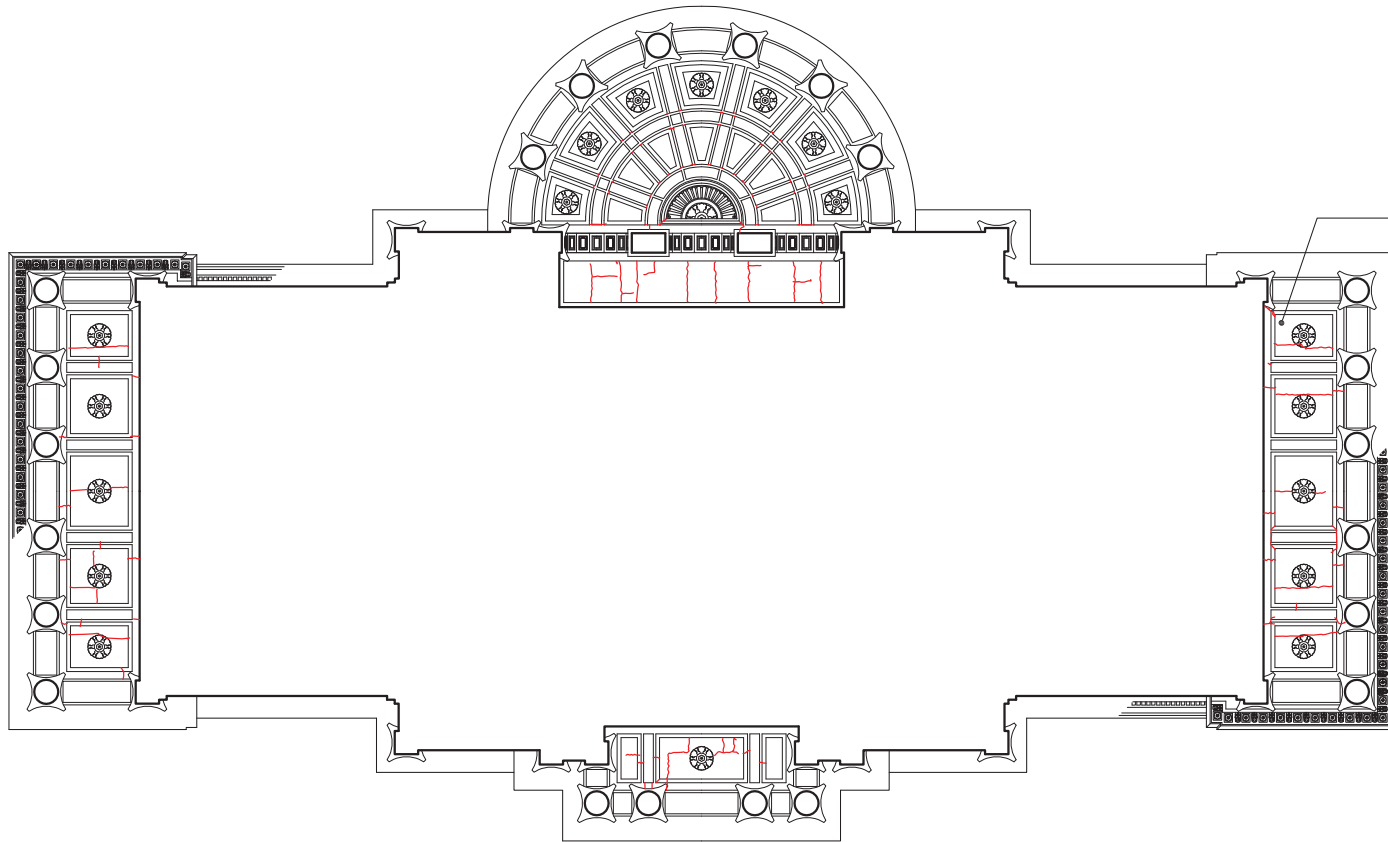
PAINT FAILED ON ALL PLASTER CEILINGS, CORNICES AND ORNAMENTS. TYPICAL ALL FOUR PORTICOS.
