**Vanderbilt Mansion National Historic Site  
Conservation of Interior Stonework  
May-June 2005**

## Conservation of Interior Stonework 2005

### Conservation Assessment and Treatment Reports

# **Vanderbilt Mansion National Historic Site Interior Architectural Stone Conservation Needs Assessment**

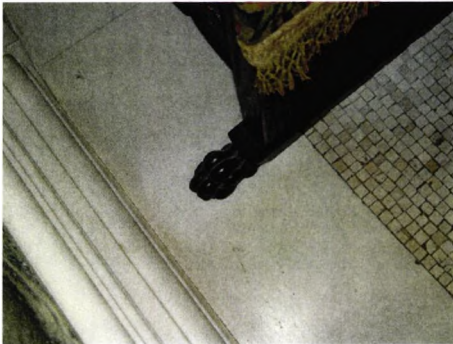
The floor is considerably stained with a disfiguring yellow tone, possibly from previous cleaning and/or waxing. Several areas of loose grout have resulted in detachment and loss of mosaic tiles. The Park inquired about applying a coating onto the floor to prevent loss of tiles.

The floor appears lighter under furniture, suggesting a yellowed floor coating.

A coating application to the floor should be avoided due to loose grout and tiles. Floor coatings will not be effective if there are any loose elements below the coating. A specialist in floor tile installation should be employed to correct areas of the floor where loose and failed grout has resulted in tile losses. The floor should be re-grouted and tiles replaced in problem areas. This should be addressed before any coating is considered. Buildings Conservation Branch architects should be consulted for coating options.

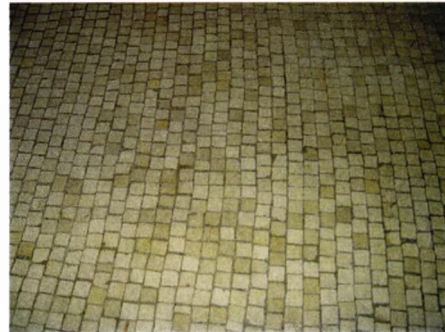
Grout is becoming loose, dislodging tiles in some areas.

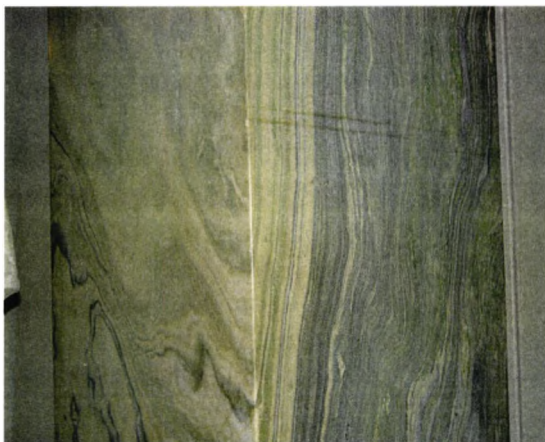
Twenty-four marble pilasters line the walls for the Reception Hall. The pilasters appear to have a yellowish-green tone, and have a curious matte and shiny surface. A yellow/green pigment can be seen in the recessed veining of the marble. This pigment is soluble in water and does not fluoresce, indicating little or no binder to the pigment.

**Yellow/green surface appearance.**

The yellow/green tone to the pilasters and matte and shiny surface appearance may be due to an historic finishing technique. Because no solvents tested thus far (water, acetone, ethanol, benzene, xylene, methyl ethyl ketone) appeared to alter the matte/shiny appearance, and no overall fluorescence was detected, it is possible that this appearance is a result of surface finishing and not an applied coating. While there are losses to some of the fills, the overall aesthetic appearance of the pilasters is not greatly altered, nor is stability affected. The pilasters should be cleaned of soot only with great care due to the water solubility of the overall toning. NMSC conservators should conduct further tests to determine the cleaning method for the pilasters.

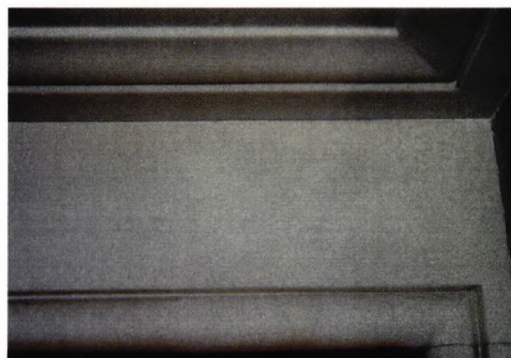
Cleaning tests were conducted on the caryatids and various areas of the entablature. A vinyl eraser did little to remove soot deposits, as did pure spring water, acetone, and ethanol. Saliva removed some soot, but a 3% ammonium citrate/water solution was most successful, exposing white marble below, especially as dwell time was increased. Ultra Violet light examination exposed areas of infills, toning, and joins on the caryatids.

**Cleaning test on white marble surround using 3% ammonium citrate and water solution.**

Soot on the mantel can be cleaned using the lowest effective percentage of ammonium citrate (<3%), wiped onto the surface using cotton pads and cleared with spring water. Due to the composite nature of the caryatids which resulted in considerable filling and toning, cleaning the surface would result in an overall irregular appearance. Toning and perhaps infilling would have to be redone, and additional toning may be necessary to achieve visual integration of composite elements. The curator should examine the possibility that the frieze element was meant to be darker grey in color than the rest of the entablature. Original design drawings or notes may provide clues to the original visual intent.

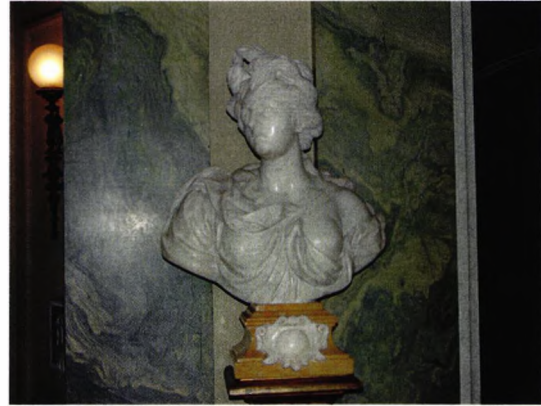
Two marble busts placed on yellow and red marble bases adorn the west side of the Reception Hall. They are now disfigured with dirt and soot.

**Marble bust of female figure.**

The busts can be cleaned of soot using a vinyl eraser or the lowest effective percentage of ammonium citrate (<3%), wiped onto the surface using cotton pads and cleared with spring water.

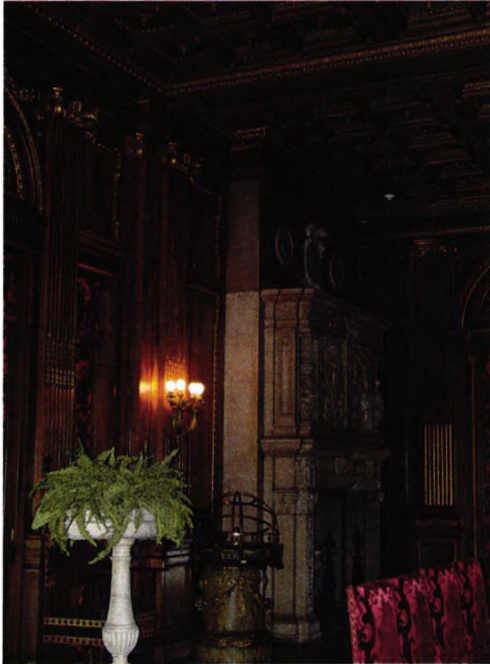
There are heavy overall soot deposits on all surfaces, especially the horizontal planes and areas near the vent. There are dark, paint-like streaks on the far proper left wall panel directly beside the vent. This streak-like stain does not fluoresce under ultraviolet light

**Proper right side of mantel showing previous cleaning of side panels.**

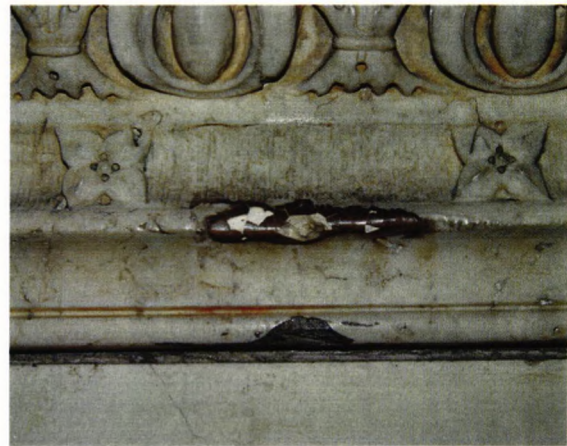
**Gold painted plaster fill.**

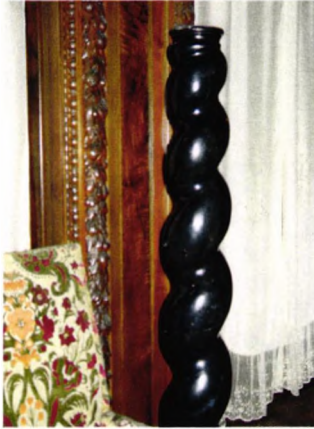
One of the two serpentine column capitals was dislodged during transport and is kept in Park storage. The capital had previously fallen off and was repaired by a conservator using a pin and grout. The Park would like the capital to be replaced onto the top of the serpentine column.

**Column missing capital.**

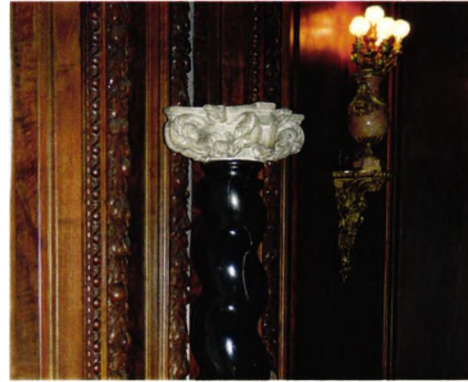
**Capital on one of the serpentine columns.**

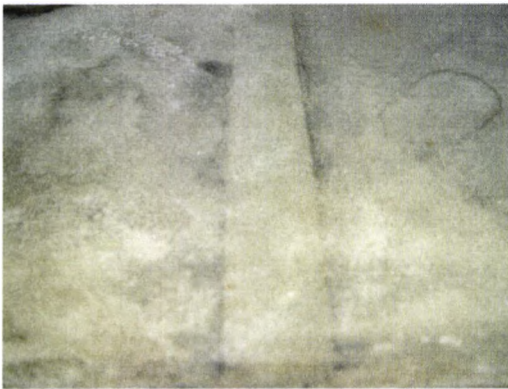
The balustrade consists of white marble posts and wide, flat white marble railing. People leaning on the railing during tours and the placement of potted plants have resulted in considerable surface grime and staining.

Staining on balustrade.

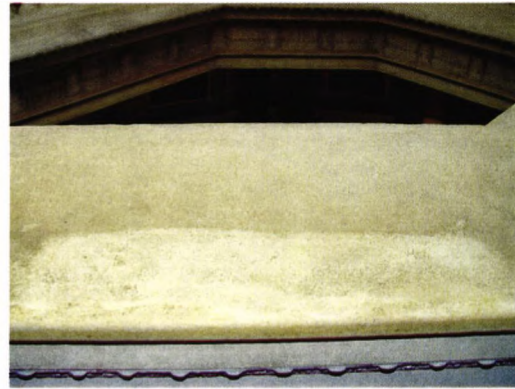
Cleaning test of balustrade showing removal of surface soiling with ammonium citrate and water.

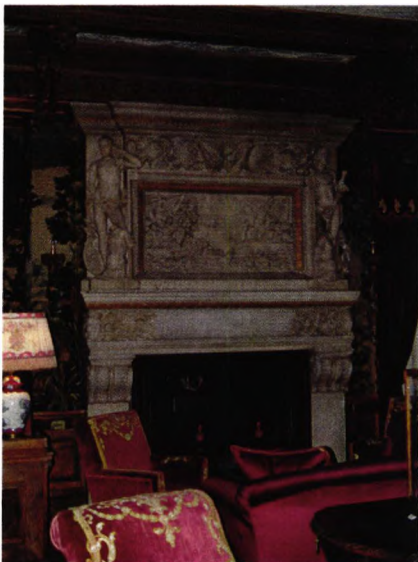
Areas of previous cleaning tests are visible on the proper left side of the mantel in Mr. Vanderbilt's bedroom. The mantel is disfigured with soot overall and past breaks and old fill repairs are visible on the proper left side where a section of metal armature is exposed. Orange/brown toning is visible in the recesses of the egg and dart molding although the toning does not fluoresce under ultraviolet light examination, suggesting little or no binders are present.

**Mr. Vanderbilt's Bedroom fireplace mantel.**

The mantel is very dirty and should be cleaned by an NMSC Conservator using the lowest effective percentage of an ammonium citrate (<3%) / water solution, wiped onto the surface using cotton pads and cleared with spring water. Exposed and corroded armature iron should be stabilized and previous failed and disfigured repairs removed and redone with improved toning for visual integration with surrounding marble.

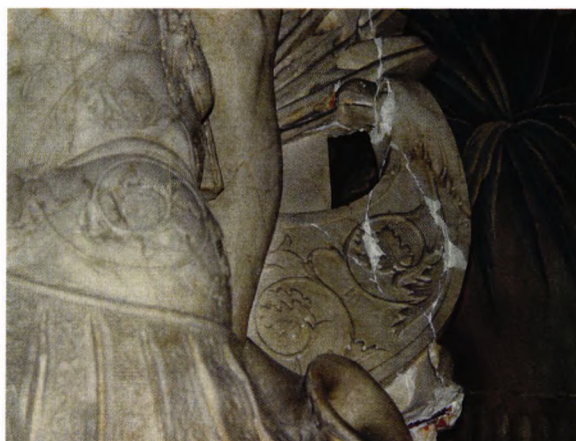
**Previous break and repair on proper left side.**

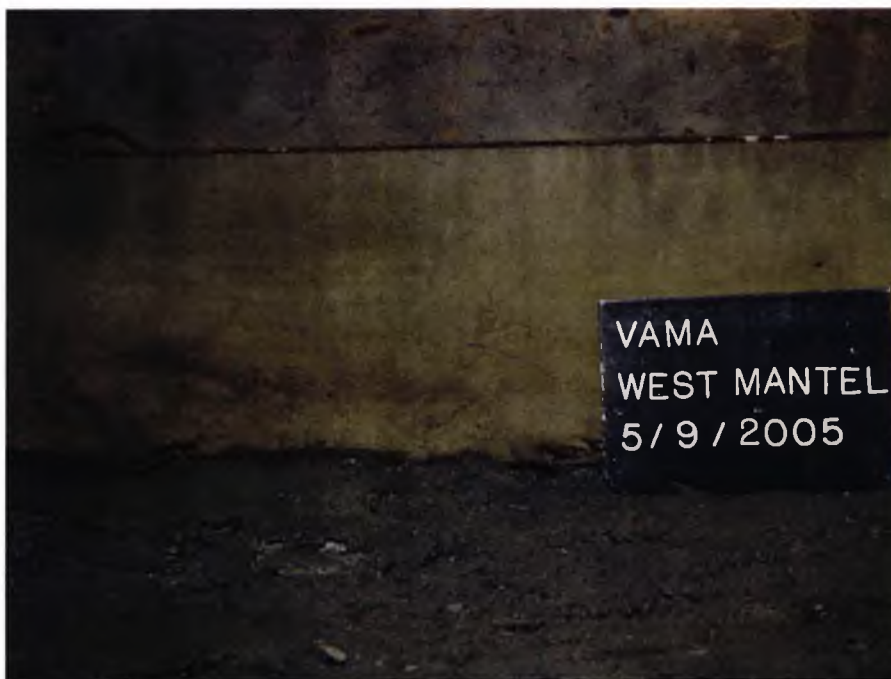
**Top Panel:** This area has the heaviest soot accumulation of the entire mantel piece (Figure 4). Two detached chips that spalled off due to the oxidation/expansion of iron pins in the white marble surround were found resting on the top the grey marble shield. The plaster medallions have a light brown coating that fluoresces a light green/blue color under ultraviolet light, possibly indicating a hide glue. These have suffered surface losses to the toned coating from soot deposition, resulting in a spotty white/grey appearance in many areas. The central shield has an overall irregular tone, and has been previously repaired at the bottom and the proper left top protruding areas. There is a large dark brown stain at the bottom of the shield (Figure 5).

**Figure 4. Detail of dirt on top panel near bottom.**

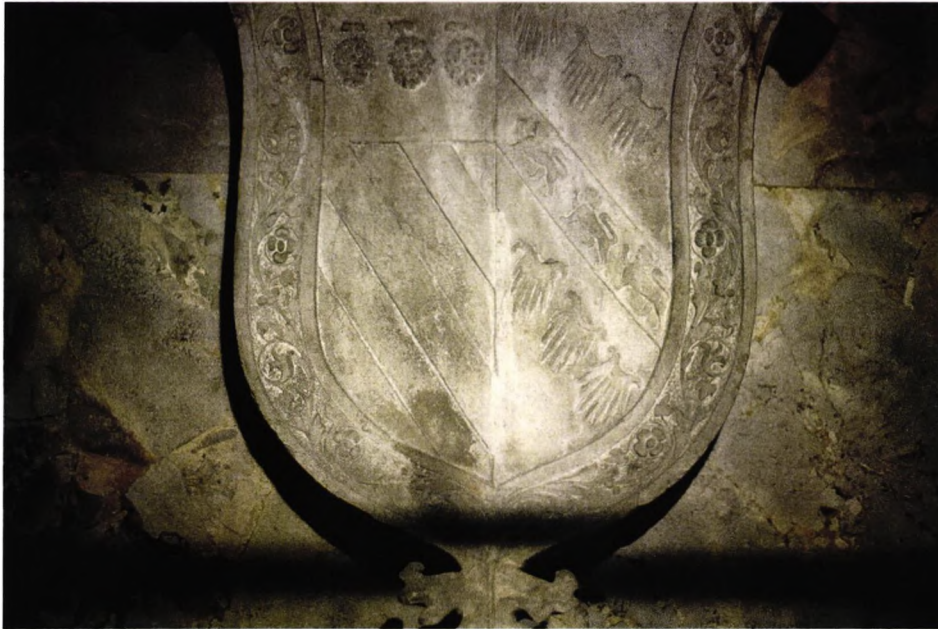
**Figures 5 a & b. Detail of shield before treatment with dark brown stain in lower p. right corner and after cleaning and toning with acrylic paints.**

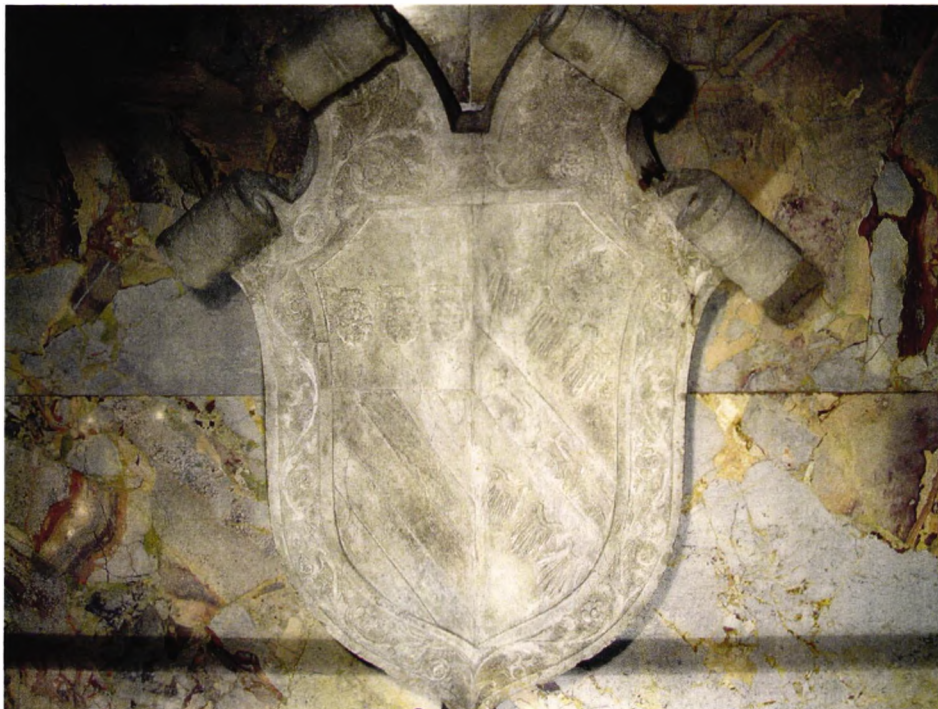
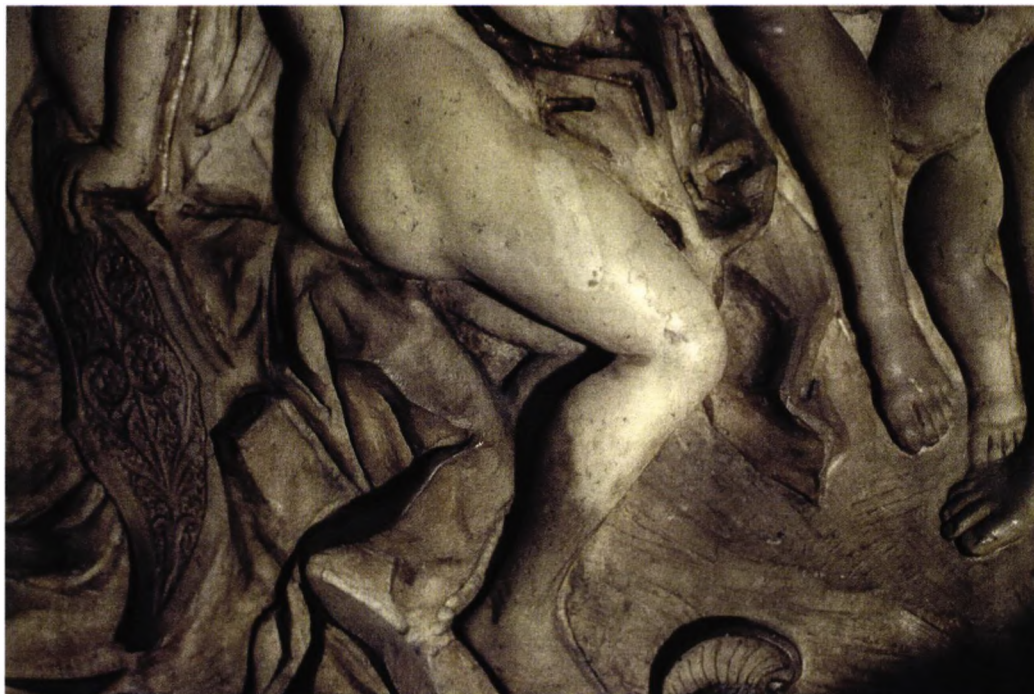
**Figure 6. Details of the figures on frieze panels during cleaning.**

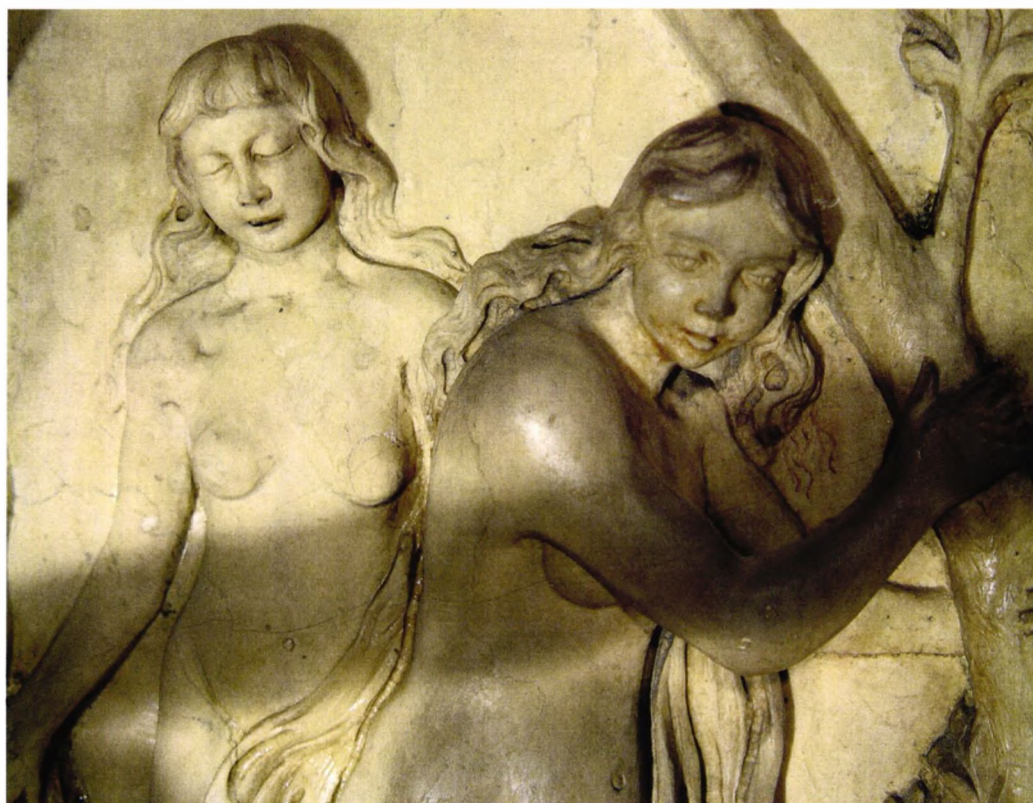
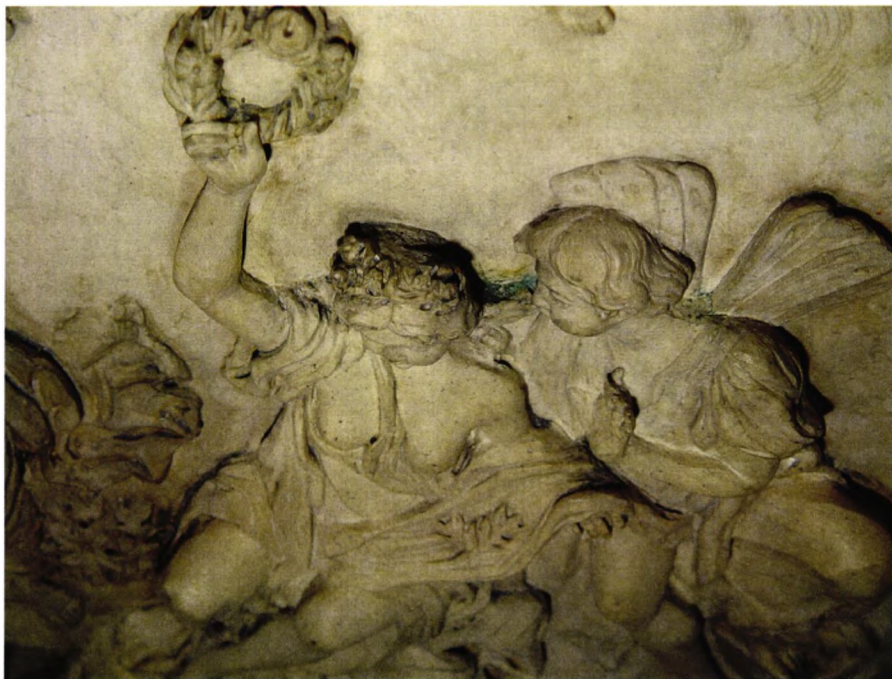
**Figure 7 a & b. Evidence of green paint is visible in the recesses of the carved figures of the frieze panel.**

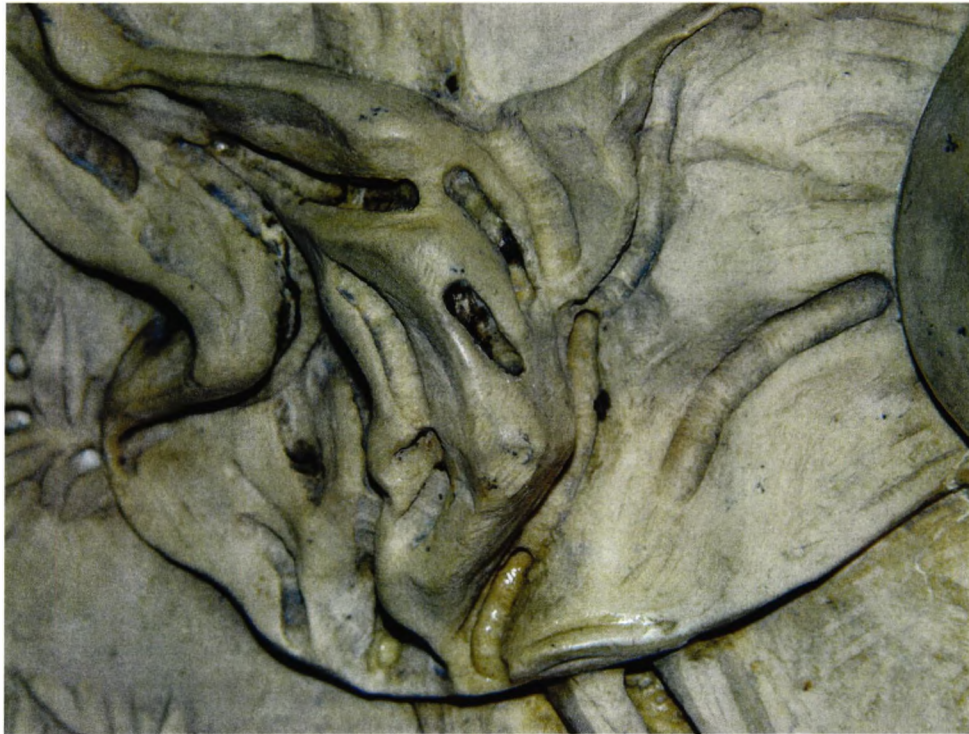
**Figure 8. Brown colored oil residue is also apparent in the drapery and tree recesses of the frieze panel.**

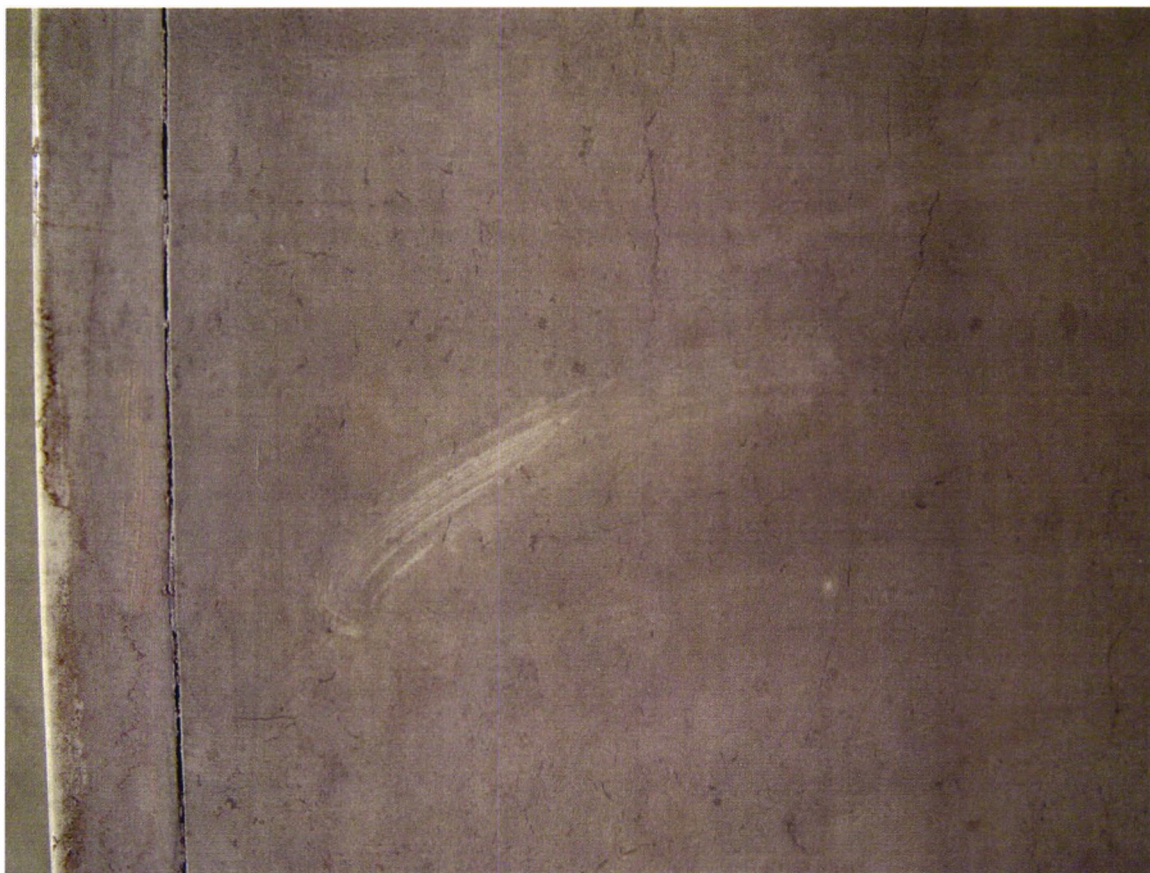
**Figure 12. Side flat panel showing streaks in toning application and light marble below.**

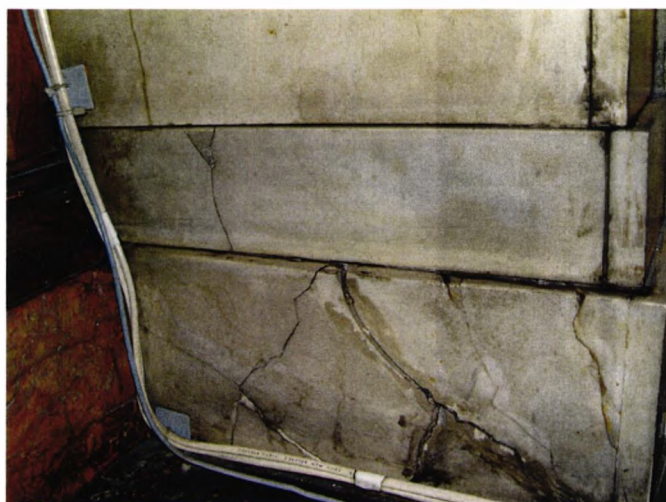
**Figure 14. Various cracks are apparent, and chips were repaired at the bottom proper right of the side panels.**

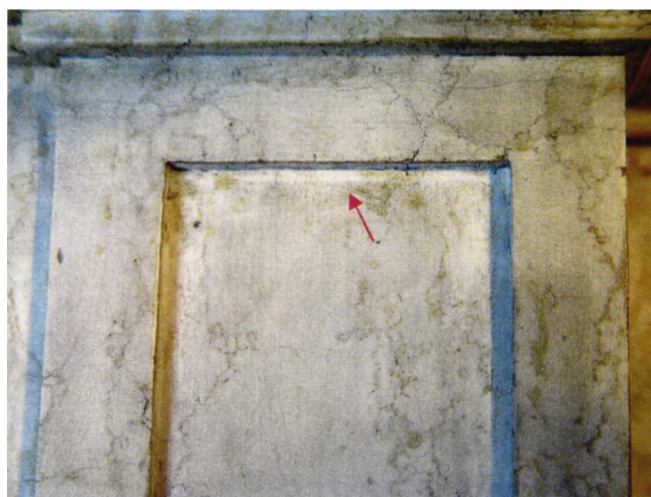
**Figure 15. Toning was also apparent on the fireplace surround. The natural, white color of the marble can be seen between the molding and inset piece.**

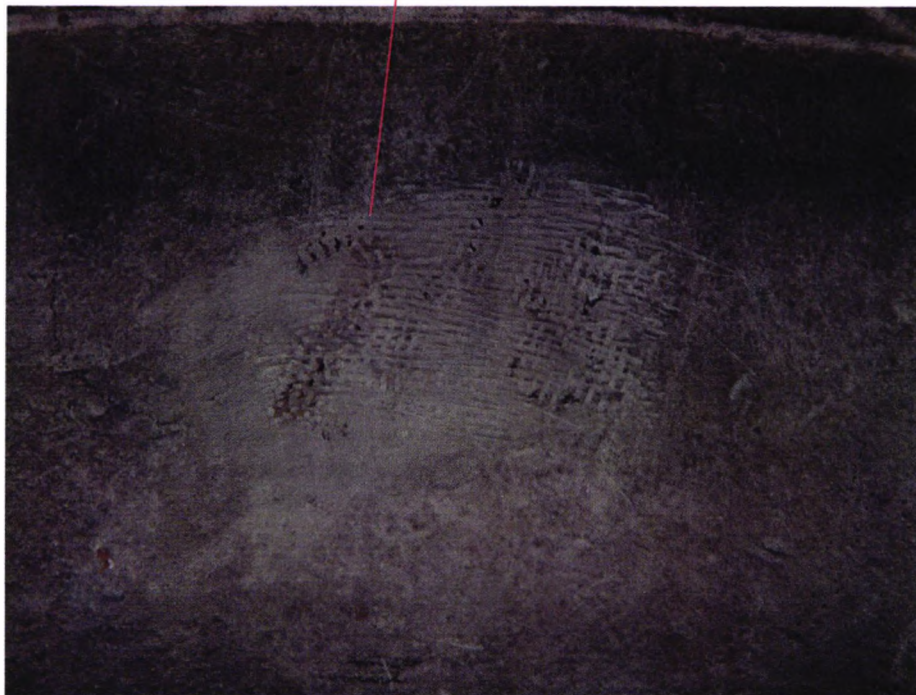
**Figure 7. Detail of ground down letters near center of shield.**

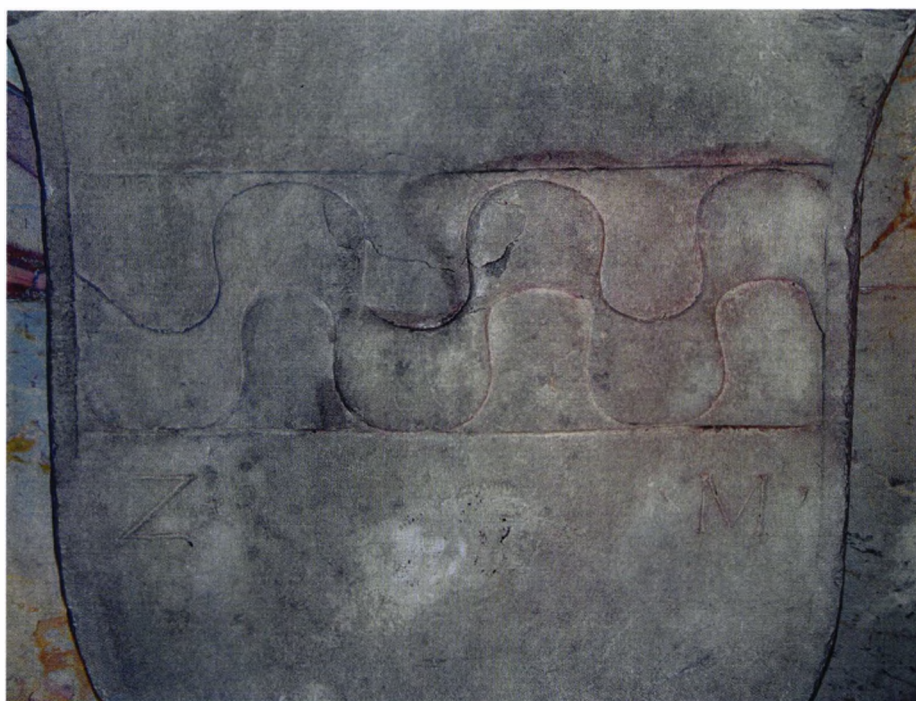
**Figure 8. Detail of partially cleaned shield showing red paint in recesses.**

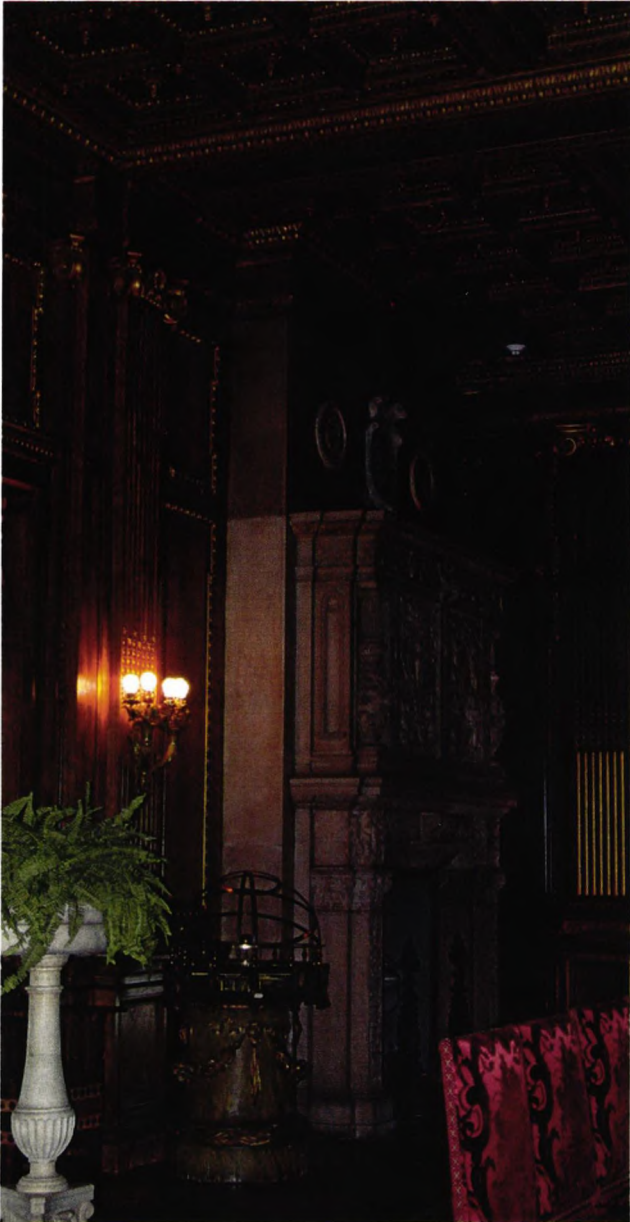
**Flat Surrounding Panels and Sides:** The two lower, proper right side panels have been previously cleaned (Figure 12). The proper left, bottom front panel has a brown/grey streaky/drip pattern (Figure 13), with various previous cleaning attempts to the adjacent side panel. The proper left side panels have heavy soot accumulation and various small cracks throughout.

**Figure 12. The two lower, proper right side panels had been previously cleaned.**

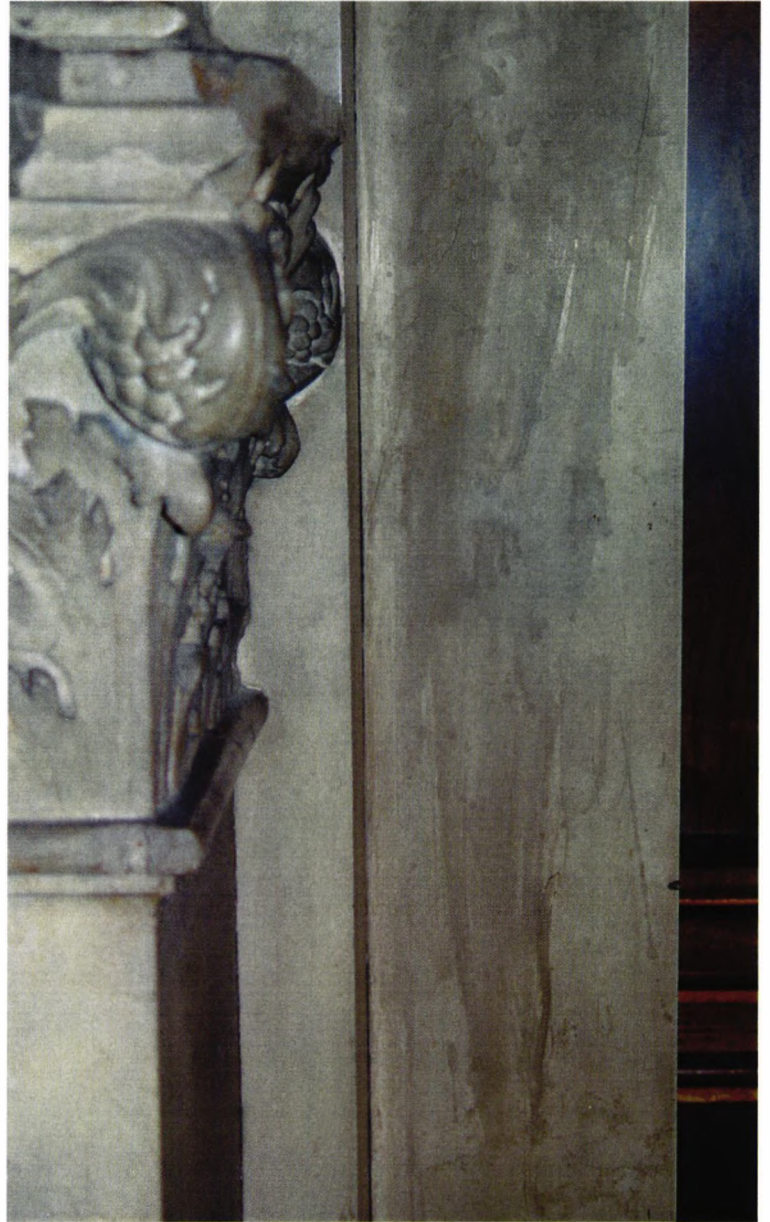
**Figure 13. Streaky/drip pattern of brown taping on lower proper left front panel.**

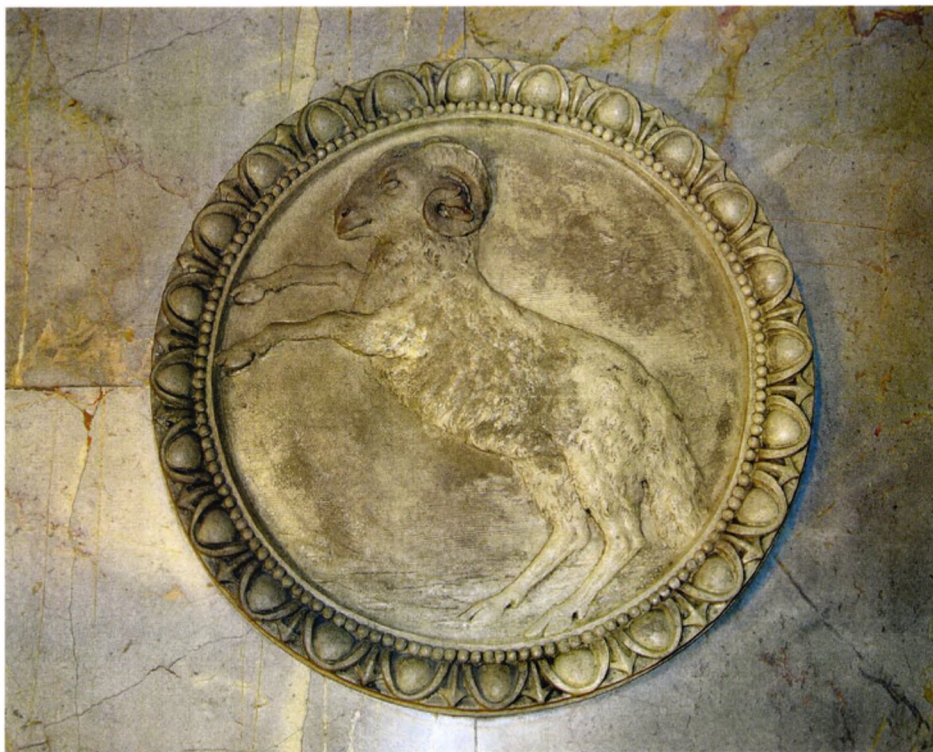
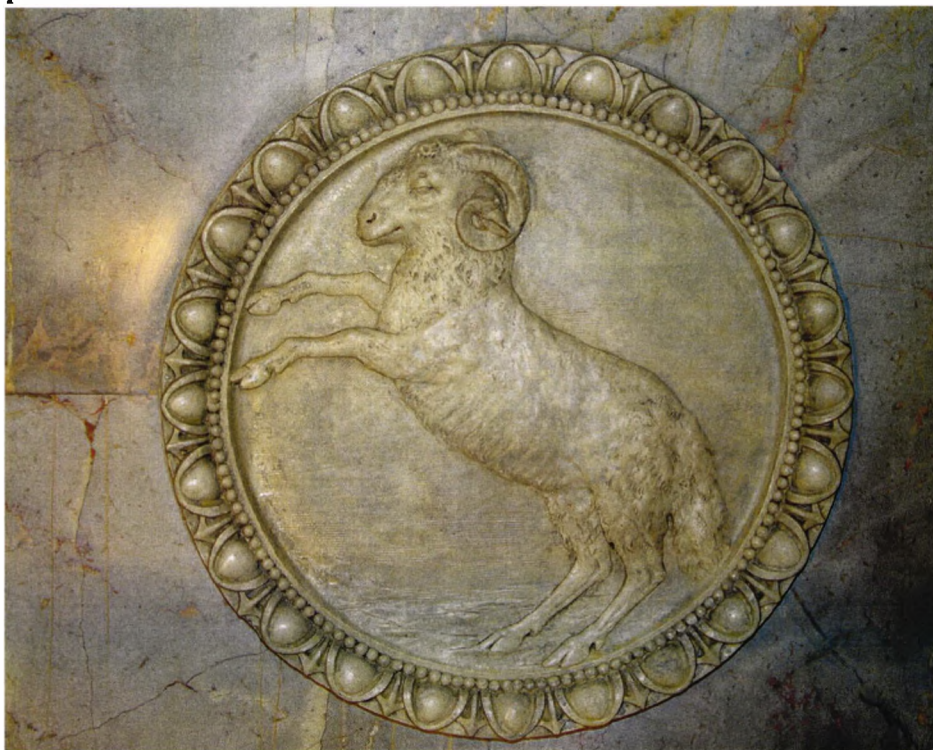
**Figures 14 a & b. Spotty appearance of Aries medallion due to surface coating loss during treatment, and after cleaning and toning with acrylic paints.**

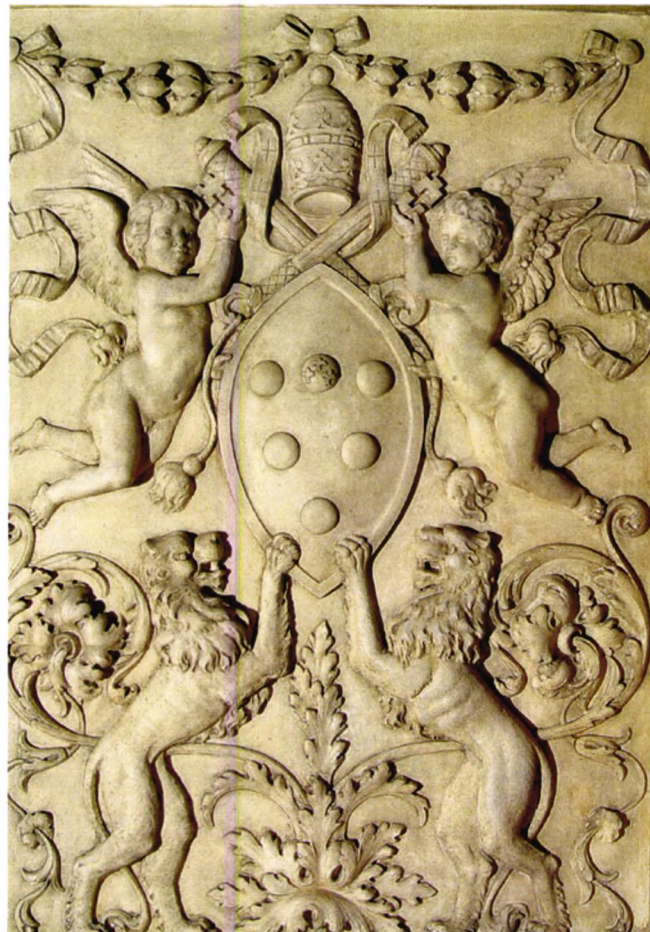
**Figure 16. Detail of proper left plaster frieze panel after cleaning and toning of putto and griffin.**

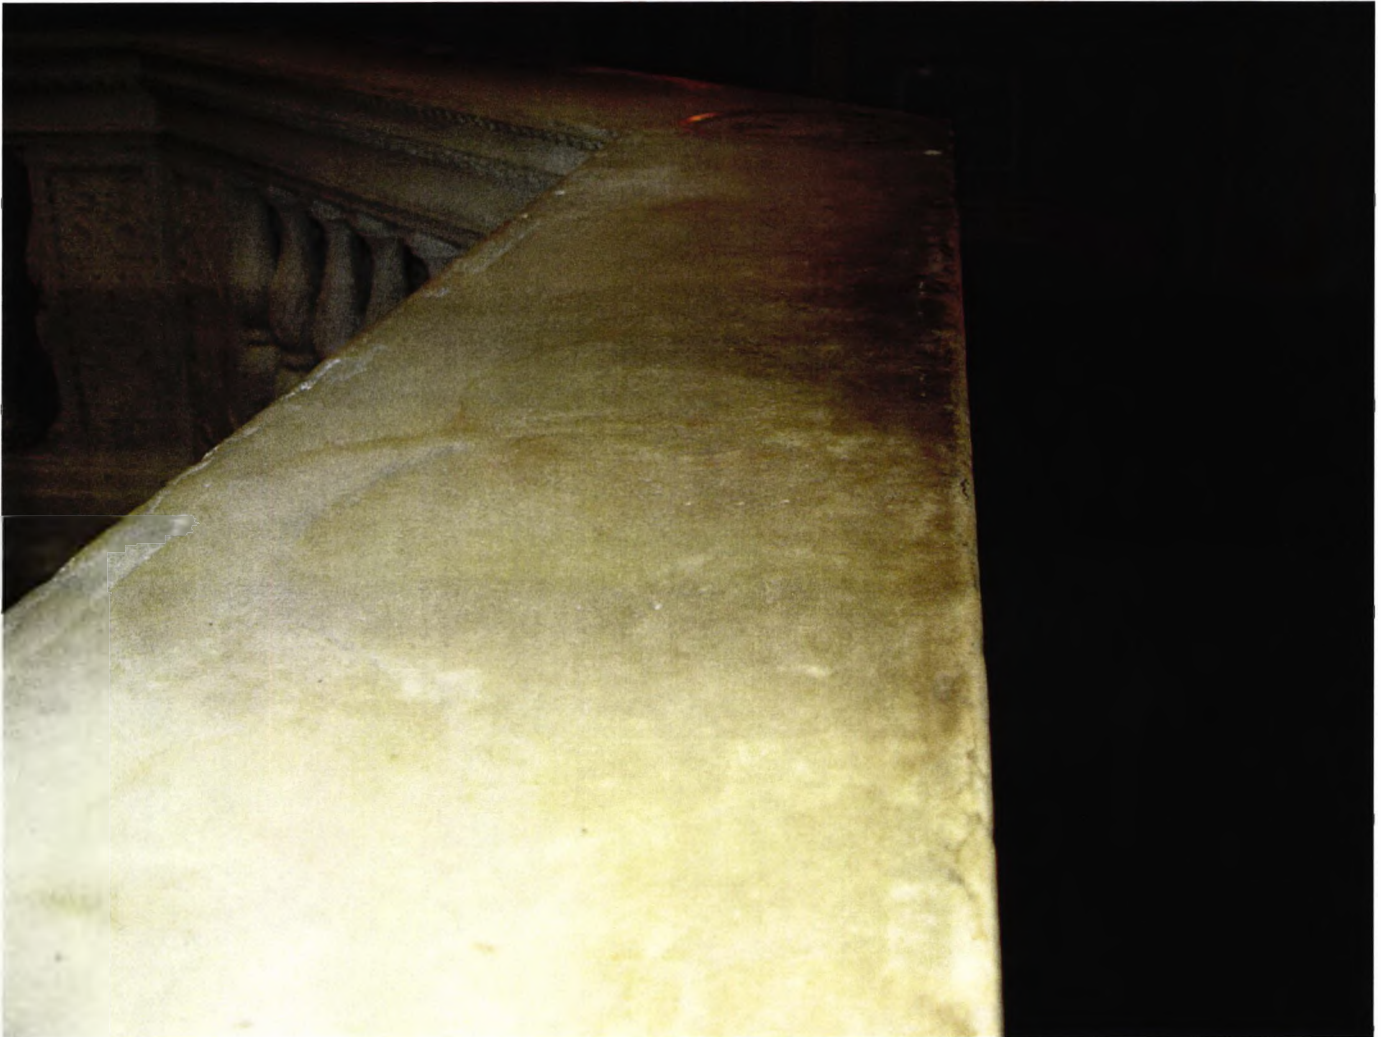
The balustrade has accumulated dirt/lipids and water staining due to use. In previous years, the Park placed potted plants on the railing which has left water ring stains. Visitors frequently lean on the railing leaving dirt and lipids from hands and arms.

**The top of the balustrade before treatment showing dirt and lipids from visitors.**

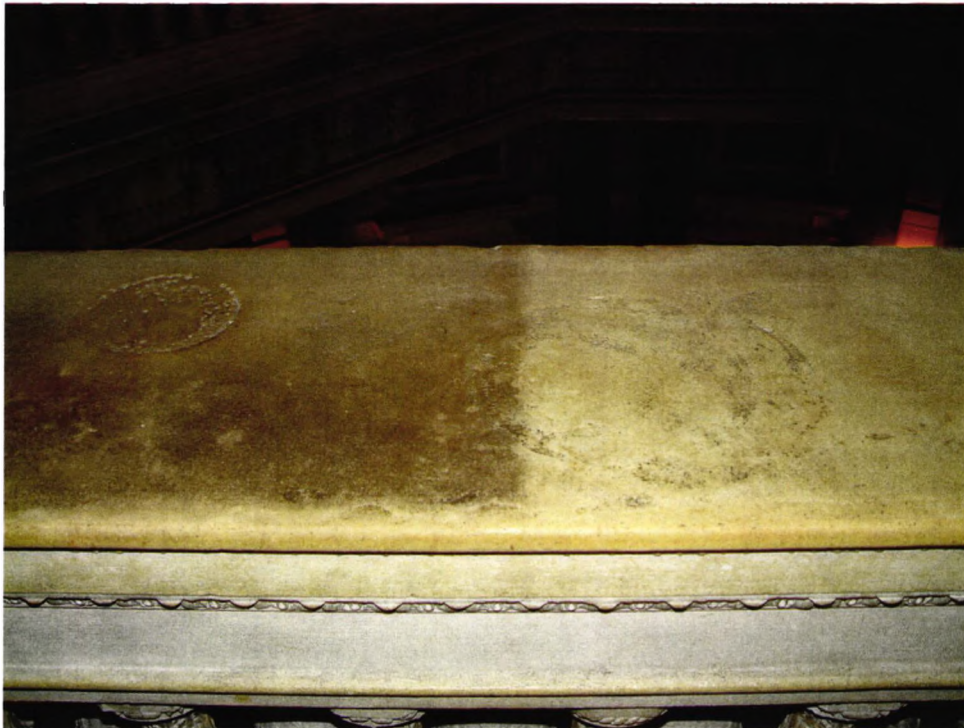
**During cleaning of balustrade showing significant dirt removal as well as plant vase/water staining.**

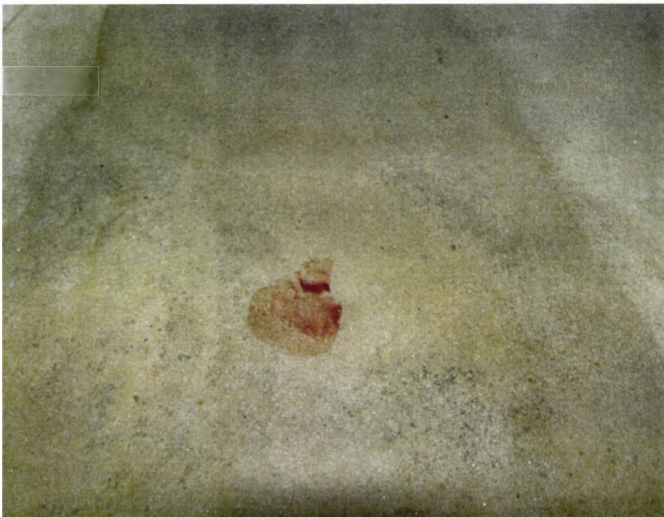
**Detail of blood stain from visitor nose bleed.**

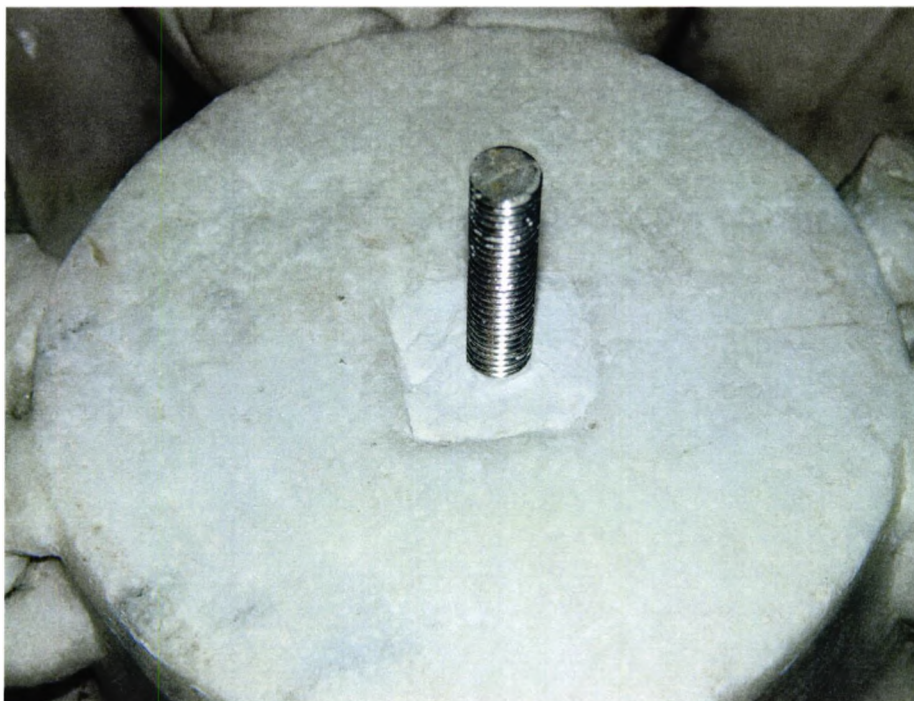
The capital was detached from the column. The capital had originally fallen off of the capital during transportation of the column to the Nassau County Museum of Art. Jerry Jiritano of Fine Art Conservation, Inc, repaired the column by placing a stainless steel pin in the capital that fits into a hole in the column. The pin was secured to the capital using an acrylic grout, and the capital was readhered to the column using the same acrylic grout (See Fine Art Conservation Treatment Report, 1999). During transportation back to the Park in February, 1999, the capital detached from the column once again, the repair failing at the same location.

**Detail of capital after grout was removed, and stainless steel pin inserted during previous treatment. Note grout left surrounding pin.**

- Old acrylic grout was removed from both the capital and the column surfaces using a scalpel, chisel and rubber mallet. The grout surrounding the stainless steel pin was not removed as it held the pin in place.
- 3% Acryloid B-72 (ethyl methacrylate, ethyl acrylate copolymer) in acetone was used as a barrier coat on both the cleaned column surface and the capital.
- "Premixed Tile Grout" (limestone, acrylic copolymer, and water by Custom Building Products, 800-272-8786), was placed into the hole and approximately 1 inch from the edge of the column and the capital was placed back on top of the column.

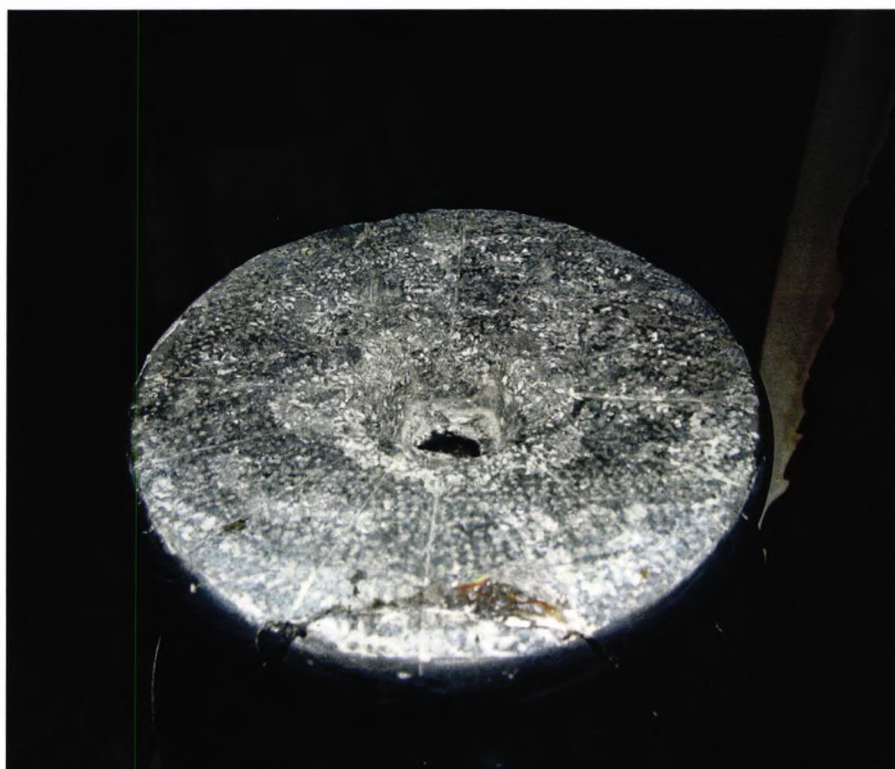
**Cleaned column surface showing hole for pin.**

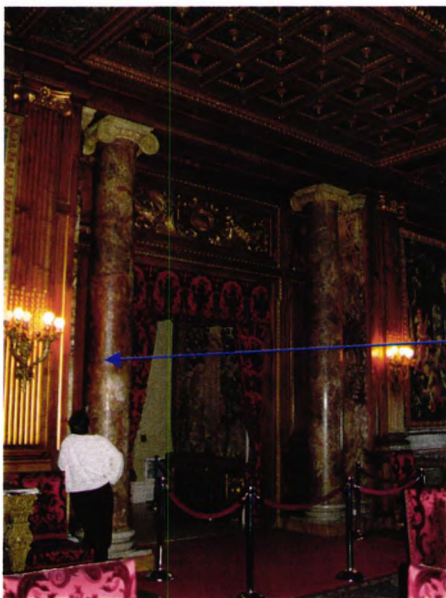
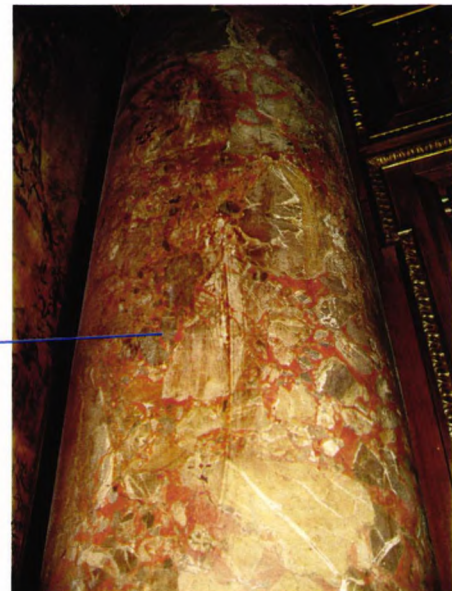
- Finally, avoid cleaning any areas that appear to have unusual coatings or stains. The columns and adjacent pilasters in the Dining Room and the pilasters in the reception Hall are examples of this. NMSC/CCB Conservators can address these concerns at a later date.

Detail of brown streaks on column.
