# Whiskeytown Visitor Center VOLUME 1

HISTORIC STRUCTURE REPORT | AUGUST 2022

Siegel & Strain Architects  
architecture + history, llc

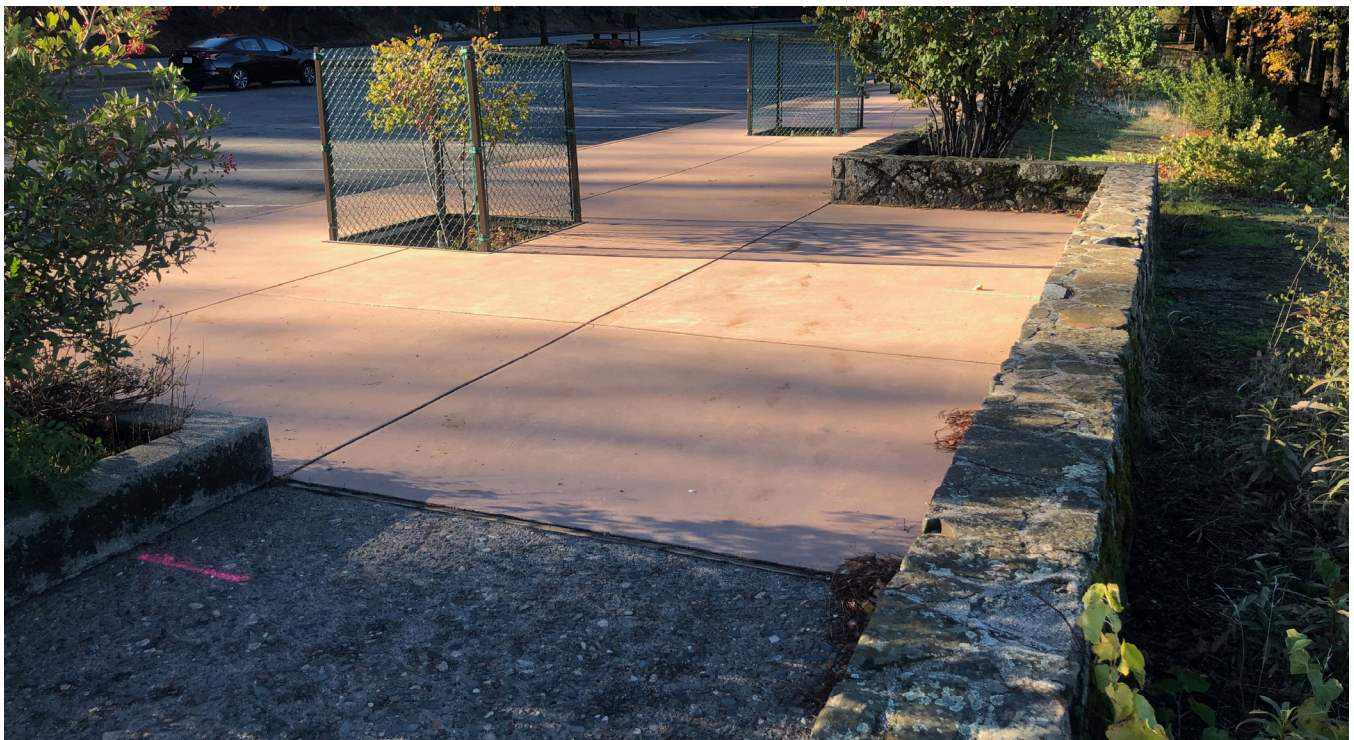
Figure 13  
Detail showing replacement integrally-colored concrete at south end of the promenade.

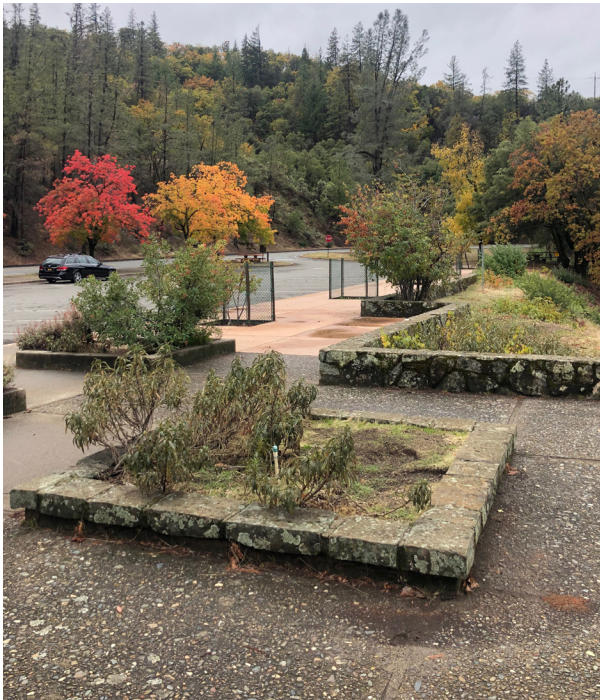
Figure 16  
The planting bed that was originally a pool and fountain. This photograph also illustrates the original concrete paving aggregate and the replacement paving that does not match the original, looking south.

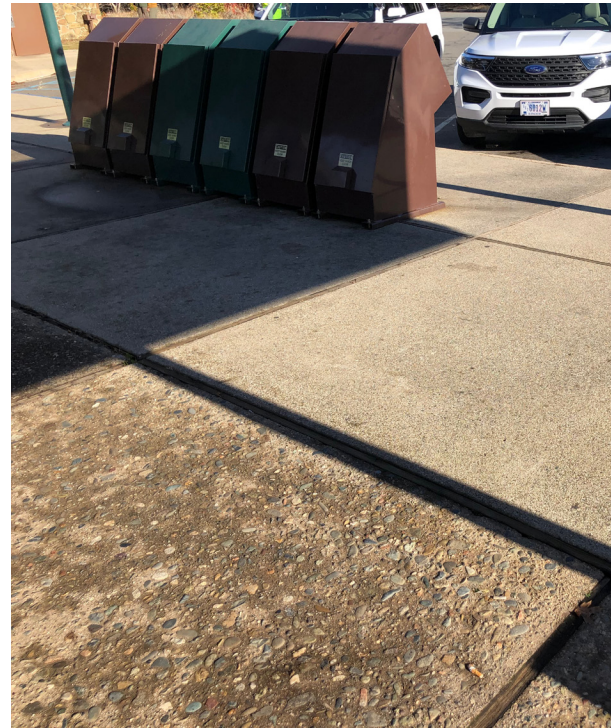
Figure 19  
The bear-proof garbage bins at the north end of the promenade and an example of the replacement concrete that does not match the original concrete aggregate used throughout the promenade.

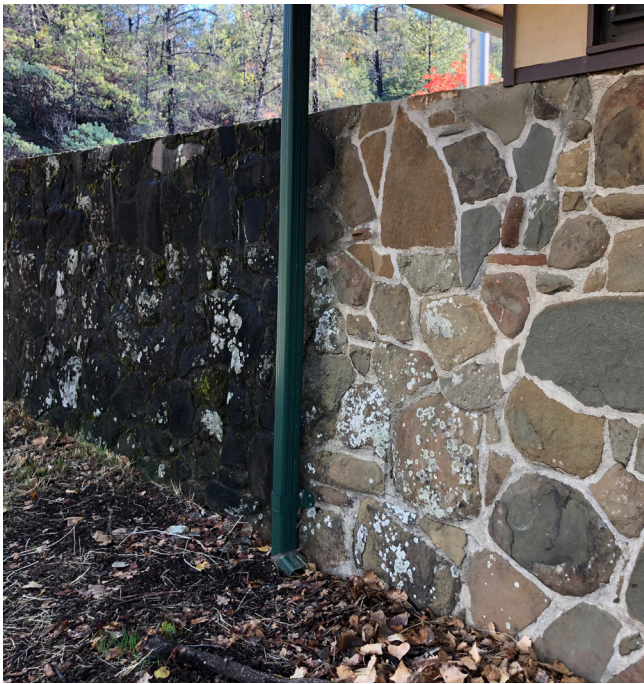
**Figure 42**  
The masonry wall extension at the east end of the north façade, looking southeast. This image also illustrates the mortar repairs and the biological growth on the east end of the north wall.

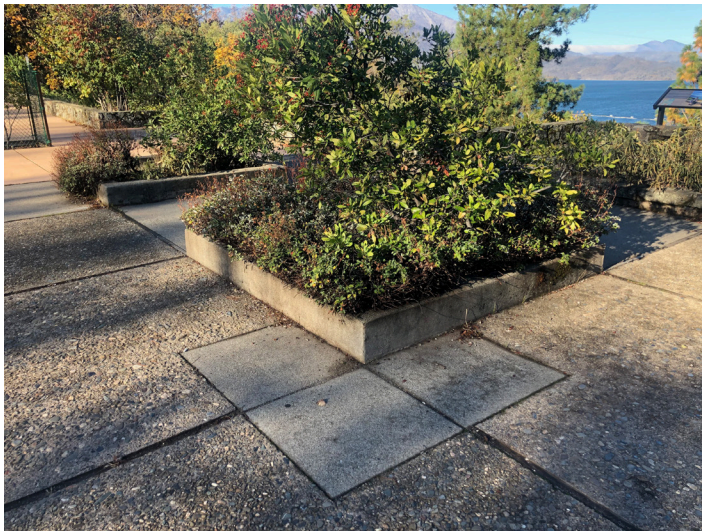
Figure 1  
Portions of the original exposed aggregate concrete have been replaced.

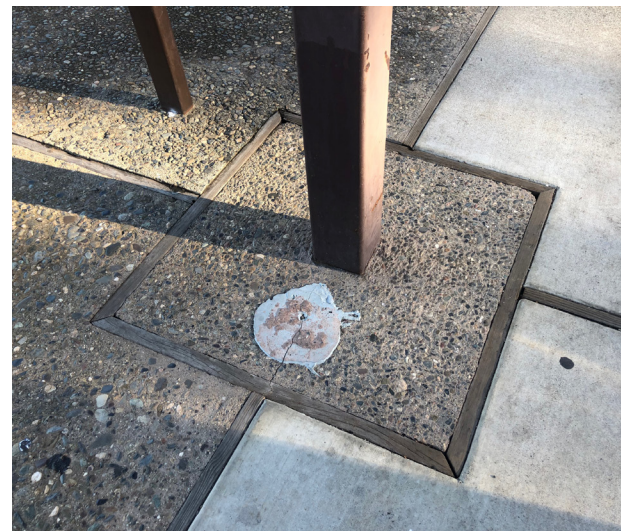
Figure 2  
Incompatible material was used to fill a previous post location.

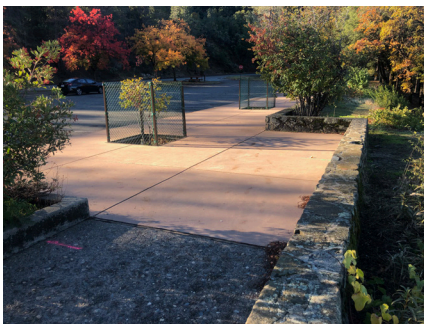
Figure 3  
The portion of concrete replaced south of the courtyard has a different texture and pinkish color.

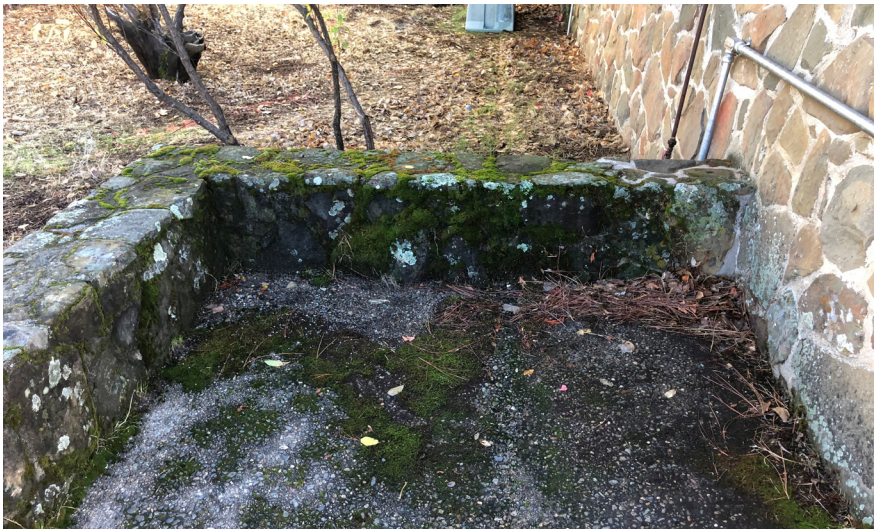
Figure 4  
At the shaded northern section of rubble wall, extensive bio growth is evident.

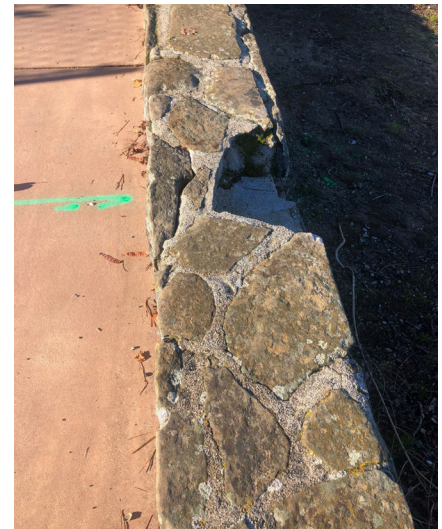
Figure 5  
A large stone is missing at the west side of the rubble wall.

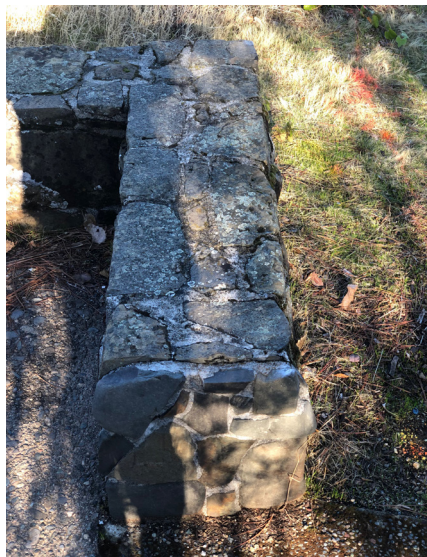
Figure 6  
Seen here, an opening resurfaced with differentiated stone and the typical light colored repair mortar

- As additional repointing is required at the site perimeter stone wall, install a mortar that more closely matches the original mortar color.
- As concrete plaza pavement and site curbing wears, replace these concrete features using an aggregate and color that more closely matches the historic.
- Create a cycle of maintenance of the following character-defining features and elements:
  - Wrap-around wood benches under the Plaza canopies
  - Plywood canopy soffits
  - Rubble stone walls at the site and the Visitor Center building
  - Redwood window trim

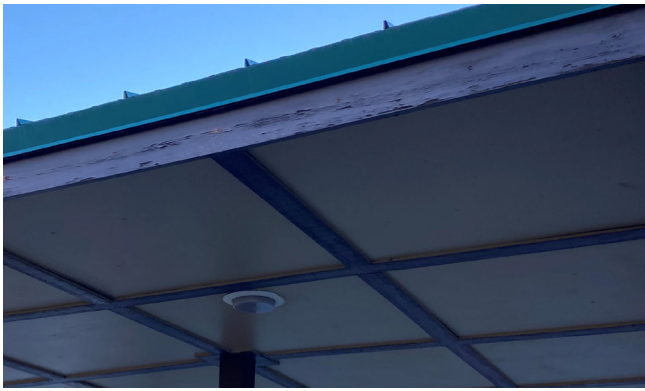
Figure 7  
Peeling paint at a typical redwood canopy fascia. Note that the original 1x4 redwood fascia trim is covered by the metal roofing.

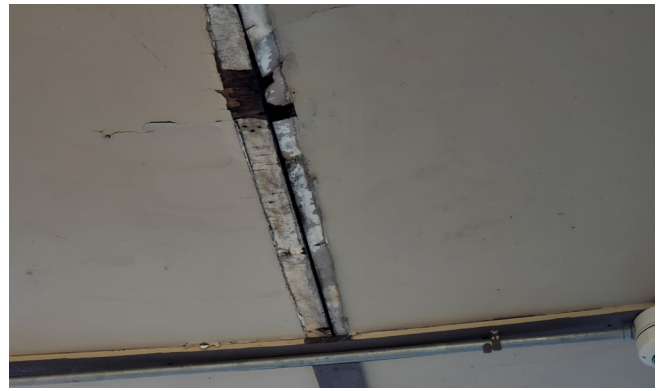
Figure 8  
Redwood trim is missing from this canopy soffit likely due to a water leak in the roof above

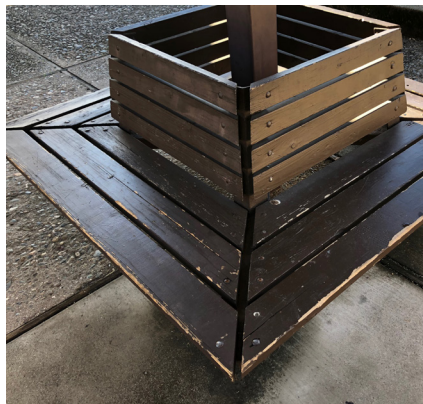
Figure 9  
Typical worn edges and paint at an original built-in redwood bench

- The original redwood benches are heavily worn with failed and scratched paint, worn wood edges, and missing slats (Figure 9). They are in fair condition.

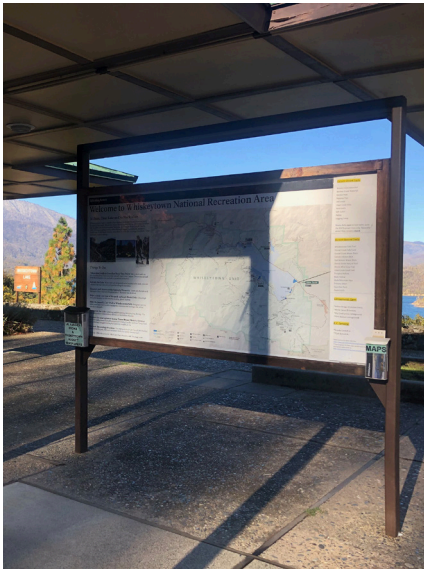
Figure 14  
The watershed view is blocked by inappropriately placed map, fee pay stations and trash receptacles.

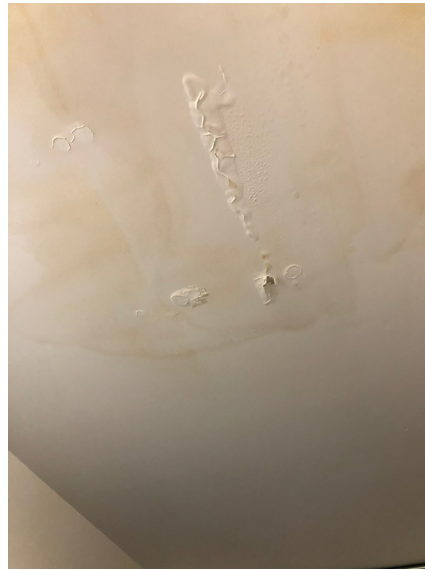
Figure 15  
Ceiling staining is indicative of water failure at converging roof valleys above.

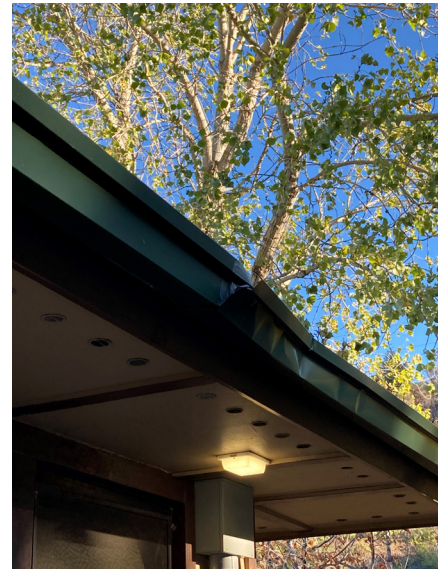
Figure 16  
Portions of gutter are damaged and require replacement.

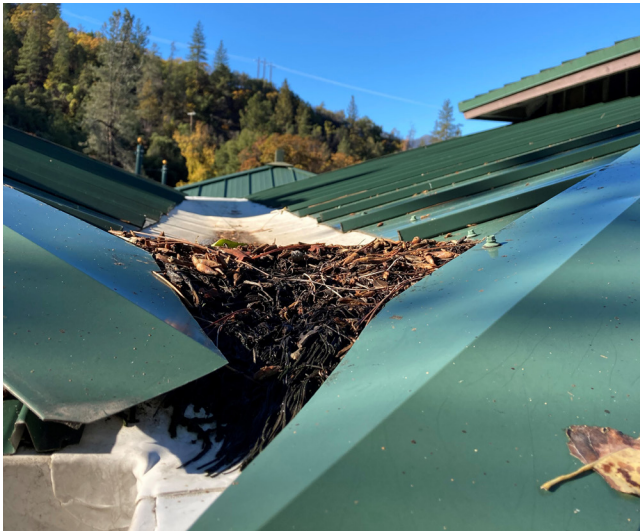
Figure 17  
Organic debris has built up at the valley gutter.

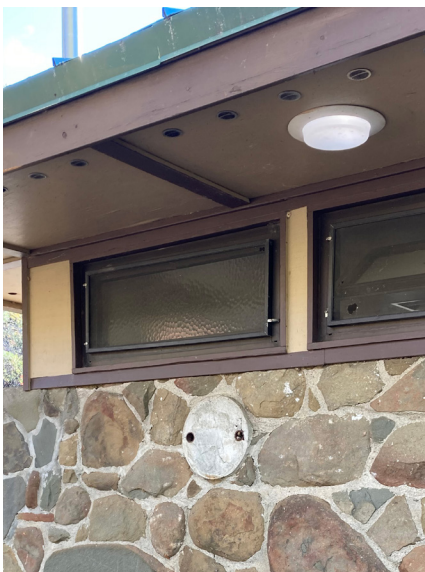
Figure 19  
Large grouted cylinders of wall with metal wall anchors exist where a flagpole was previously mounted.

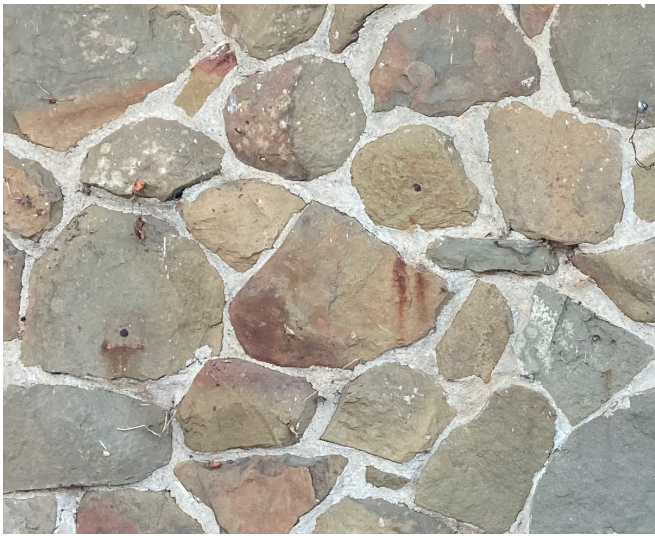
Figure 20  
Small holes remain where items were previously attached to the rubble stone wall.

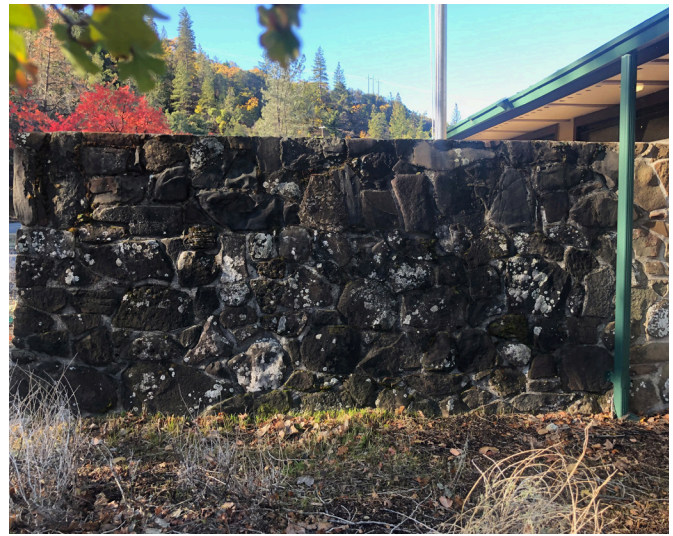
Figure 21  
The western portion of the northern rubble wall is very dirty with excessive bio growth.

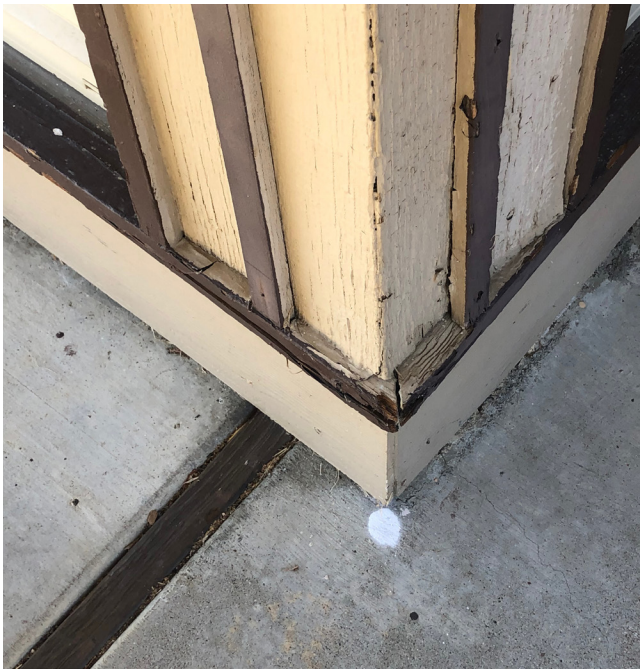
Figure 23  
Typical deteriorated redwood window trim.

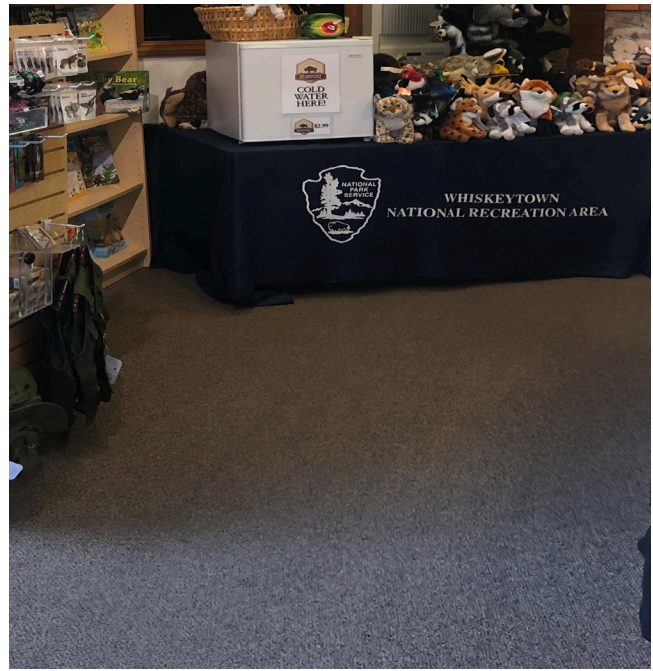
Figure 24  
The interior carpet is puckered and stained in locations.

- Reinstate the clerestory windows into the storage room to bring natural light into this space.
- Remove existing carpet and glue, and repair/refinish original integrally-colored concrete floor.

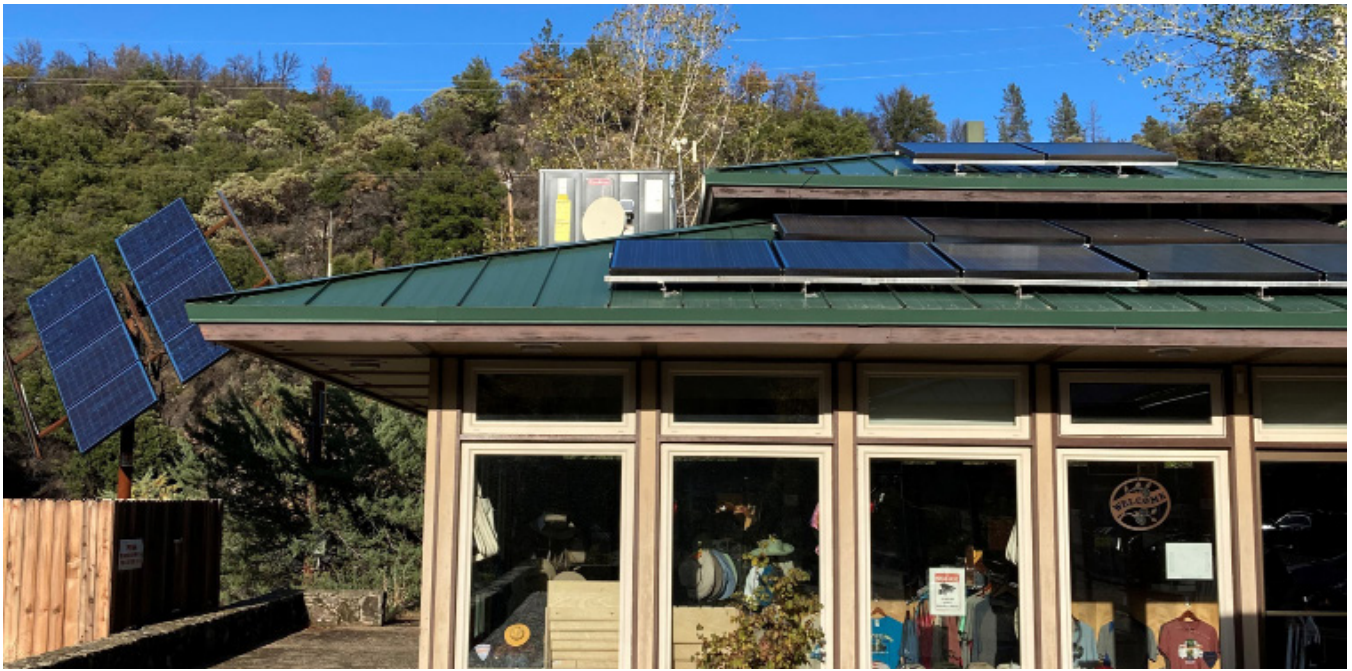
Figure 25  
The packaged mechanical unit and solar panels are poorly placed on the roof of the primary building elevation.
