Historic Structure Report  
**Wright Brothers Monument  
and Powerhouse**  
*100% FINAL*

# Wright Brothers Monument and Powerhouse

## Historic Structure Report

October 2022

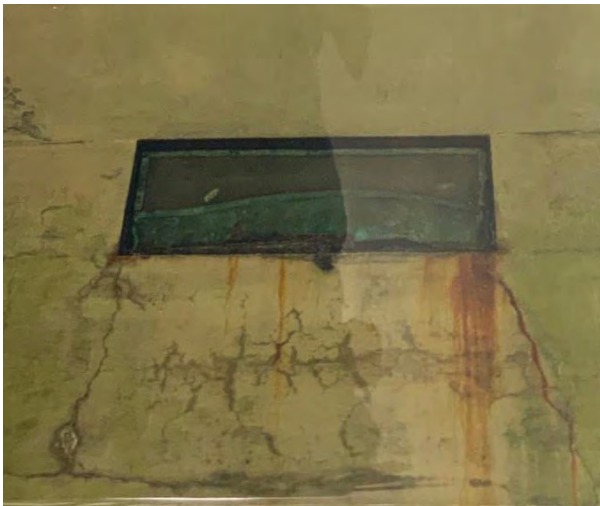
FIGURE 2-38. Condition of the Powerhouse interior vent opening prior to the stabilization, 2000. (WRBR Collection)

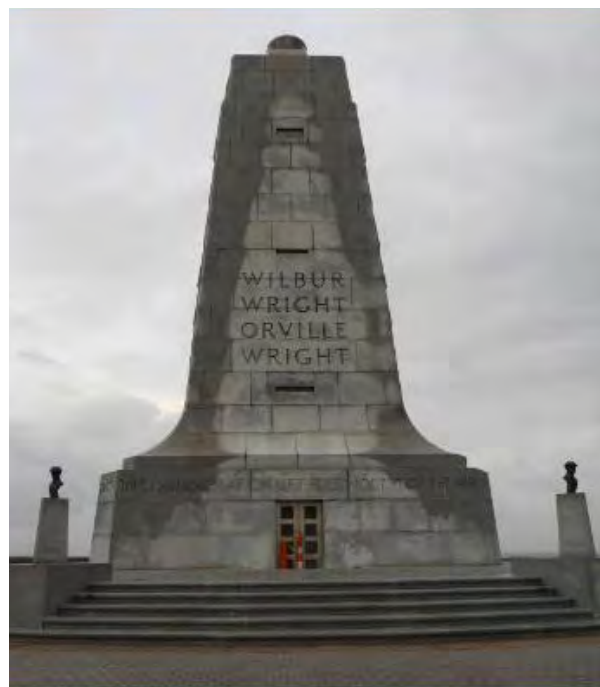
FIGURE 2–42. View of moisture at the exterior of the Monument during the moisture intrusion investigation, 2017. (Evaluation and Testing Report Wright Brothers National Memorial Monument prepared for Amidon, Inc.)

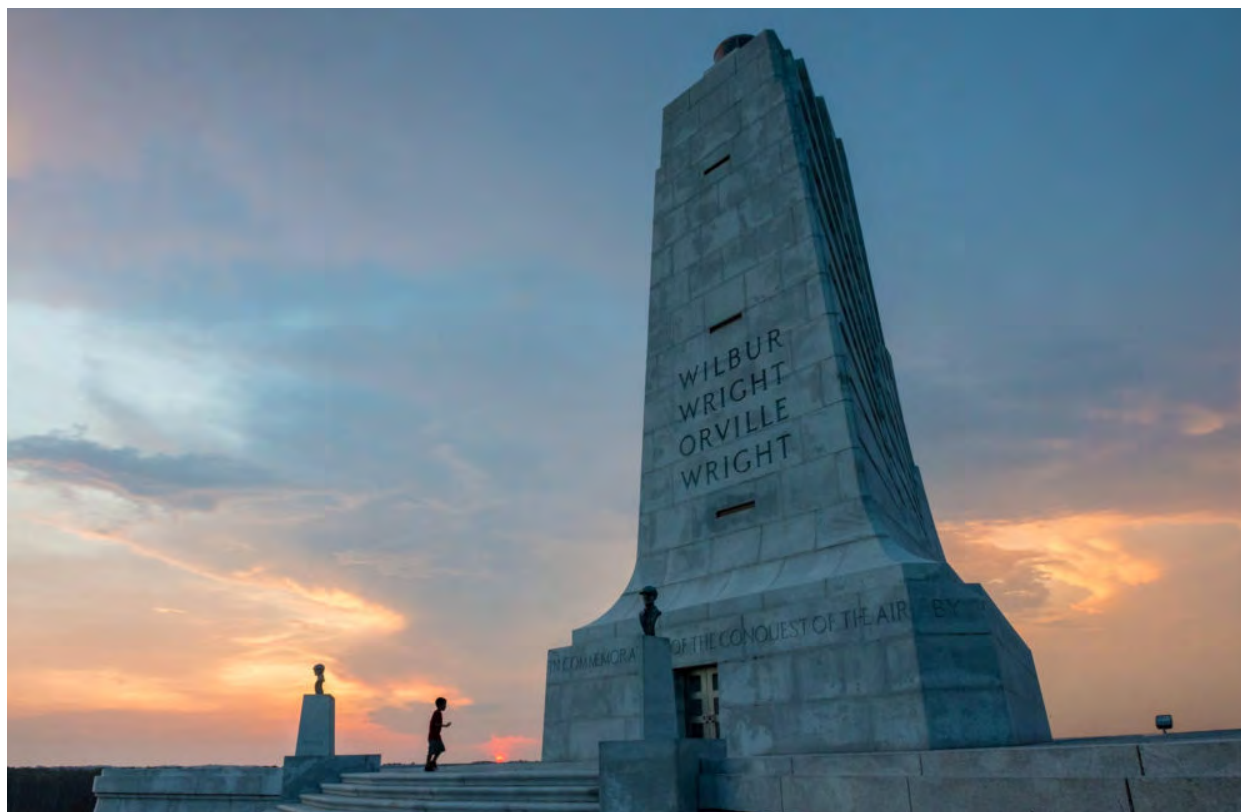
FIGURE 2–43. The Wright Brothers Monument showing signs of moisture penetration, three to four years after the 2014-15 masonry cleaning, 2018. (<https://ncseagrant.ncsu.edu/coastwatch/previous-issues/2018-2/winter-2018/bundle-up-and-explore-coastal-winter-adventures/>)

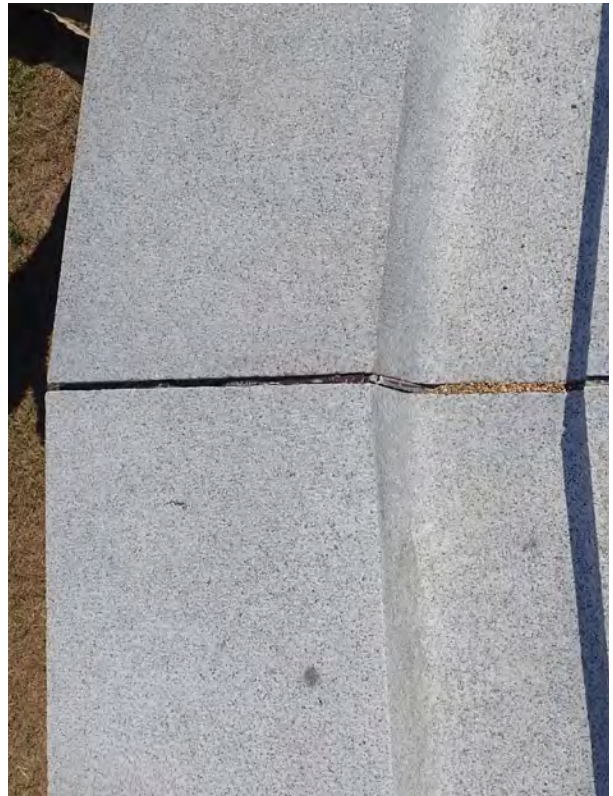
FIGURE 3–31. Typical condition of open top joints at terrace wall.

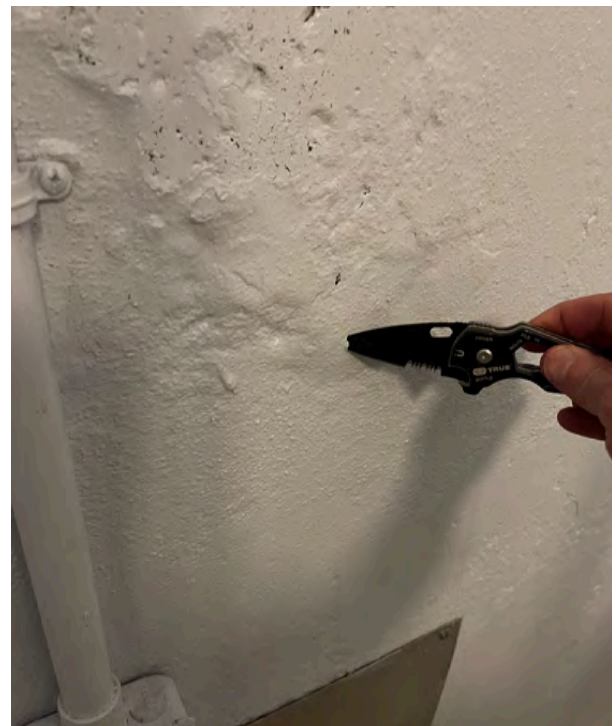
FIGURE 3-53. Bubbling paint at Level C.

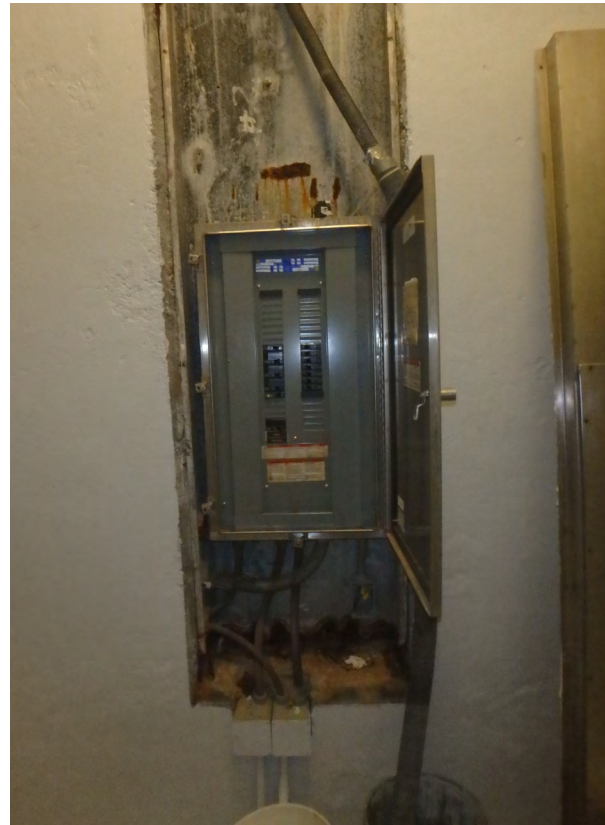
FIGURE 3–64. Old panel metal box, panel rust.

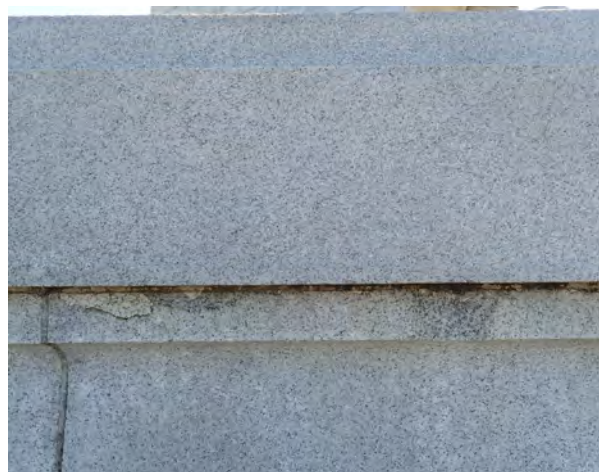
FIGURE 5-1. Typical spall condition at pedestal walls (QE 2021).

- Pedestal walls: Reset displaced stone units and repoint existing joints in stone masonry. Repair spalled granite stones with specialized stone patching mortar and provide matching dutchman's at previous conduit locations. Repoint sky-facing stone joints with urethane sealant with a custom color matched to pointing mortar and rub sand into the face of the sealant joints. Clean ferrous staining at one drain outlet location. Excavate and regrade slightly at the southeast corner of terrace base to expose partially covered drain outlet.
- Conduct topographic survey of terrace level from base of pylon to perimeter drainage channels.
- Terrace surface: Assuming topographic survey confirms inadequate positive slope away from pylon base, consider possible solutions to address surface storm water by

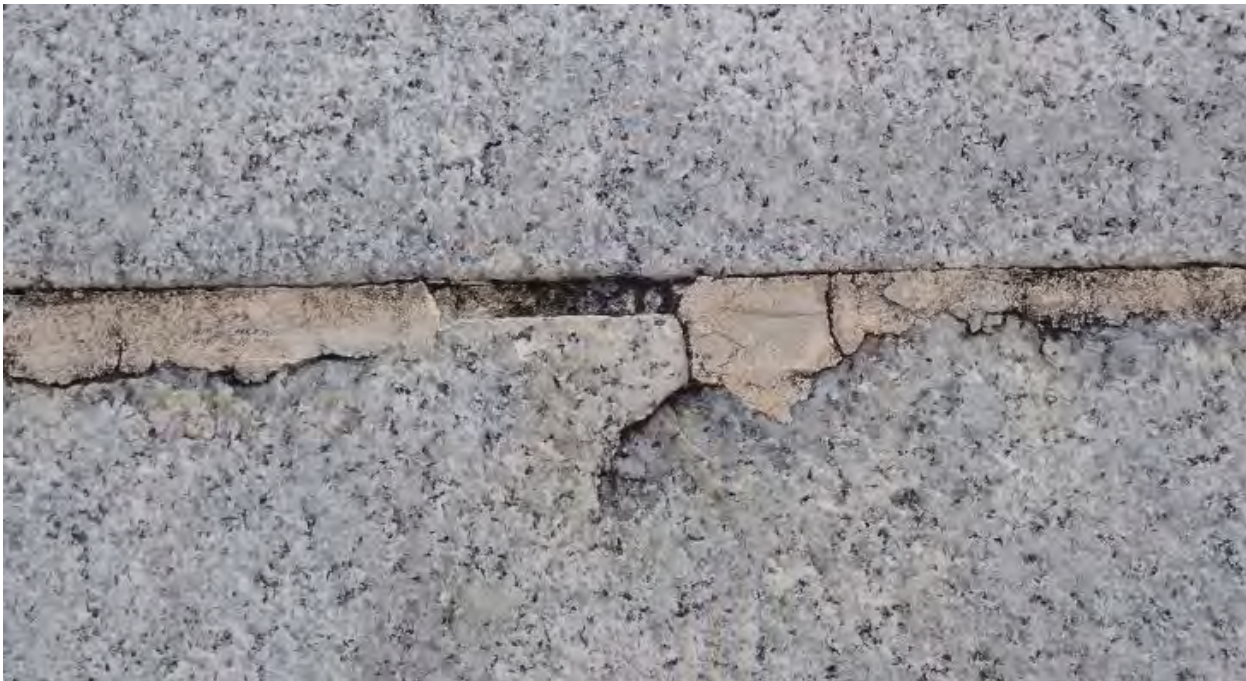
FIGURE 5-2. Typical condition of mortar joints at Monument, rake out and repoint (QE 2021).

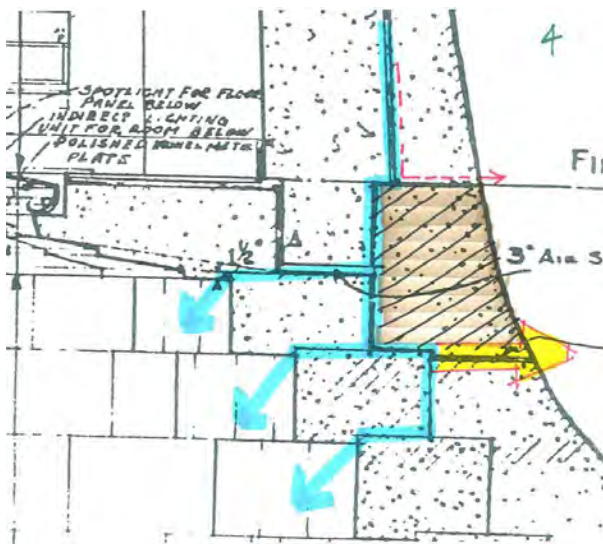
FIGURE 5-3. Moisture infiltration diagram (Moser Mayer Associates, Inc., 2009).

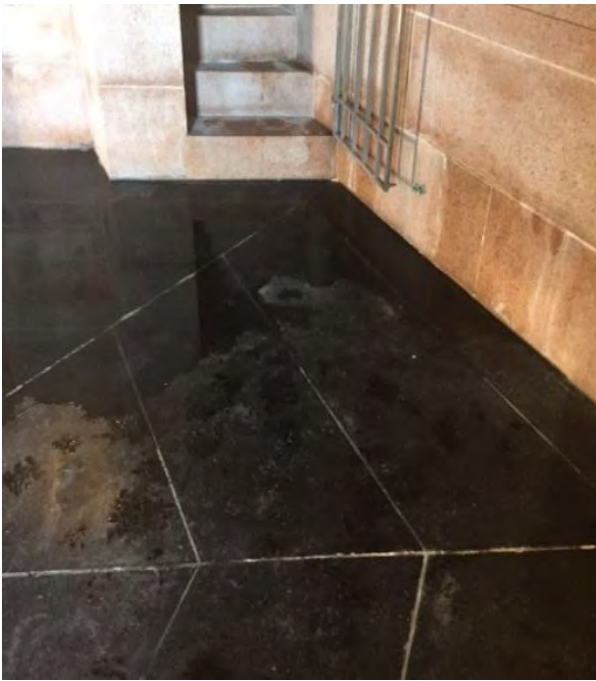
FIGURE 5-4. Moisture staining on the ground level floor (Atkinson-Noland & Associates, Inc. et al, 2017).

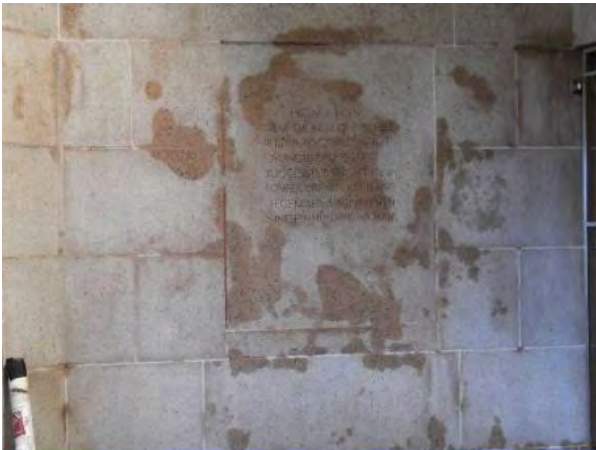
FIGURE 5-5. Moisture staining on the ground level walls (Atkinson-Noland & Associates, Inc. et al, 2017).

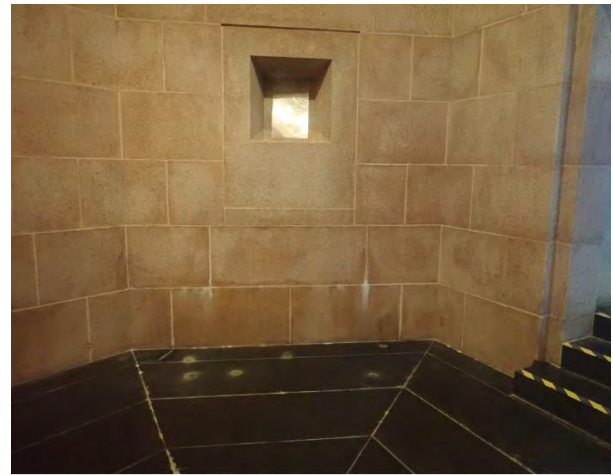
FIGURE 5-6. Ground level deposits (Atkinson-Noland & Associates, Inc. et al, 2017).

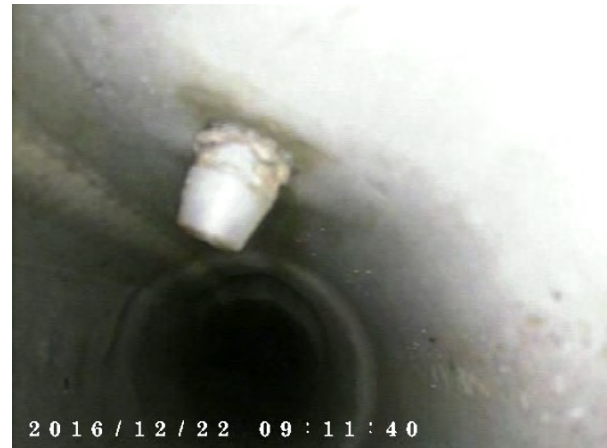
FIGURE 5-9. Bolt intrusion in roof drain pipe (Atkinson-Noland & Associates, Inc. et al, 2017).

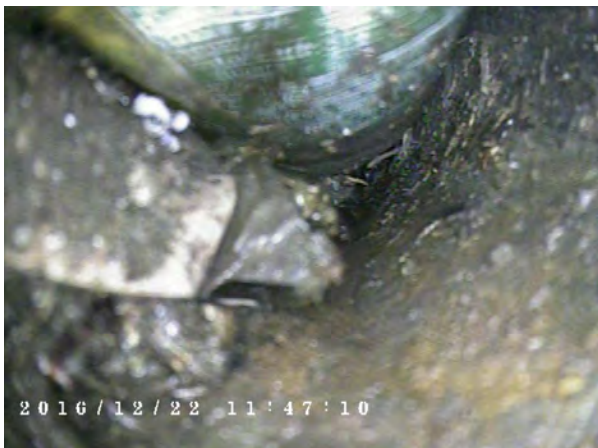
FIGURE 5-11. Drain line blockage (Atkinson-Noland & Associates, Inc. et al, 2017).

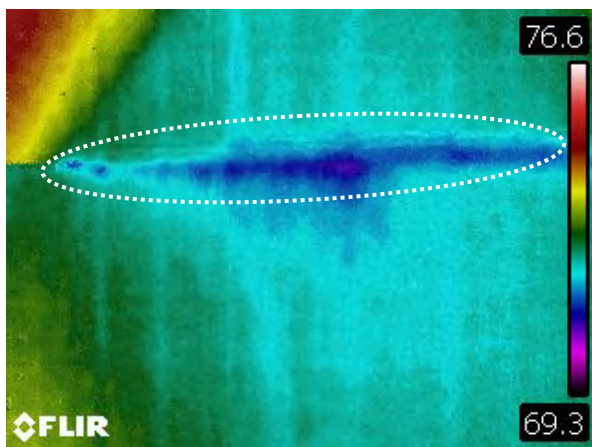
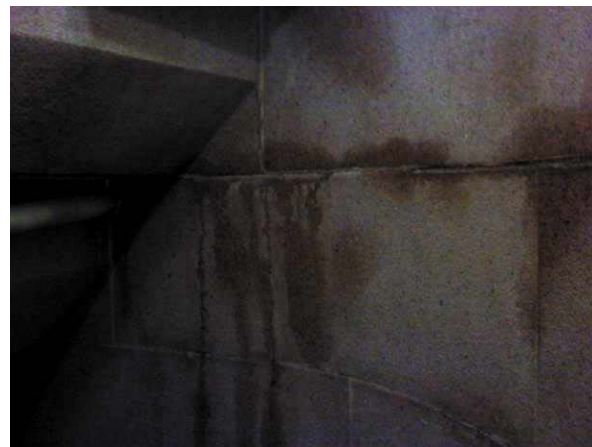
Figure 9. Interior lobby mortar joints. Water leak shows as coolness at mortar joint. Damp zones do not appear cooler indicating no evaporative cooling action.

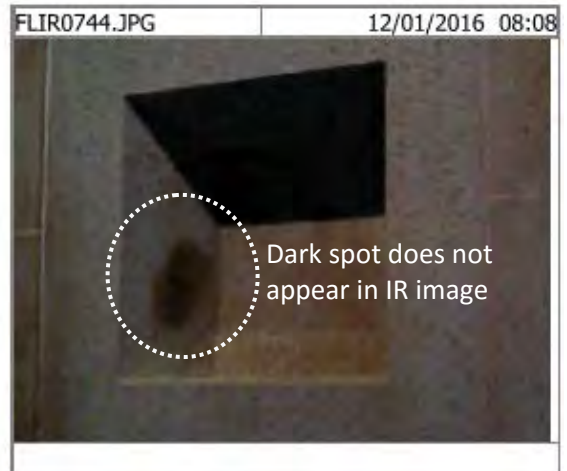
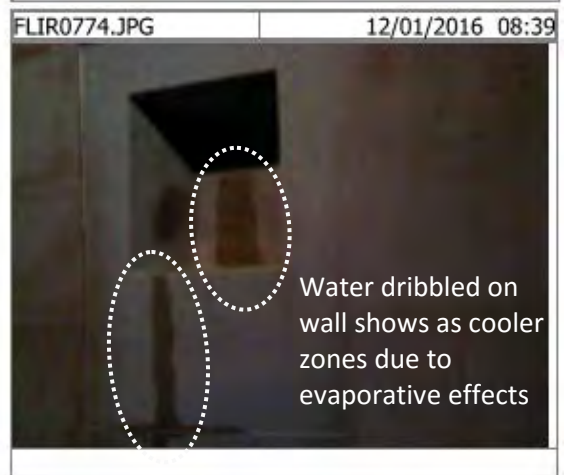
**Figure 10. Blotches on stone does not appear in infrared image (top images); water dribbled down stone face is cooler due to evaporation effects (bottom images).**

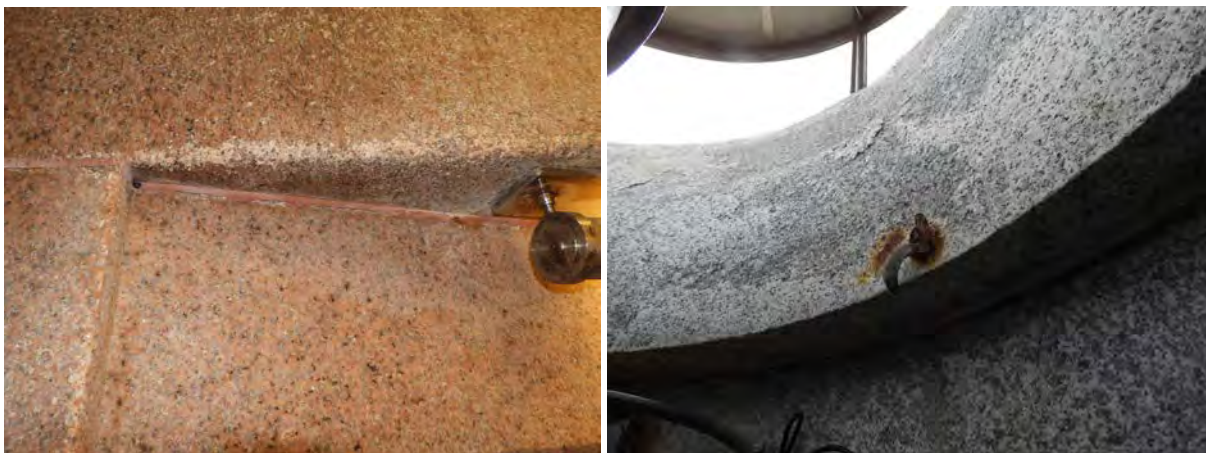
**Figure 14. Scrapings removed from deteriorating stone surfaces. Left: stone at interior stairs, 2<sup>nd</sup> level. Right: interior granite surface at top beneath beacon.**

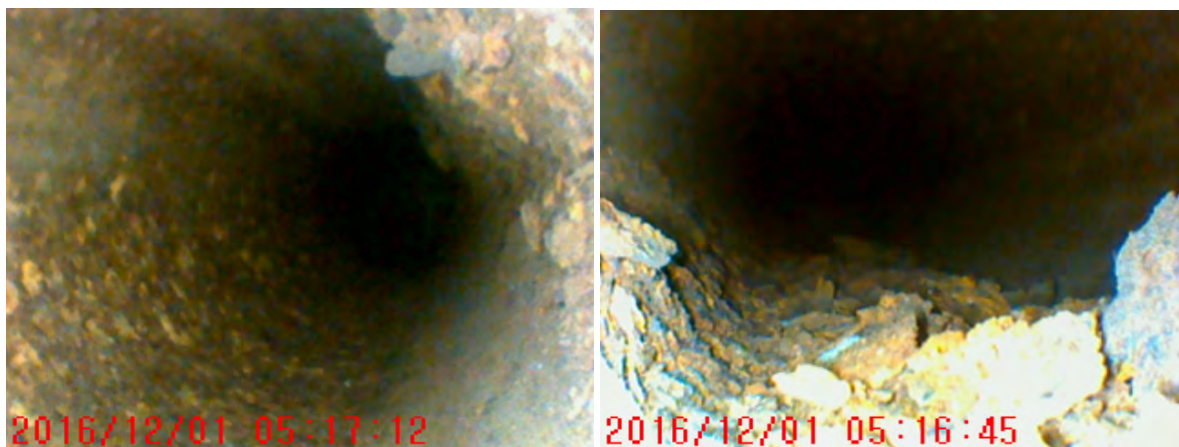
**Figure 22. Videoscope images at conduit to left of 3<sup>rd</sup> level electrical panel. Corrosion was moderate to severe with oxidation flakes collecting at the bottom of the conduit.**

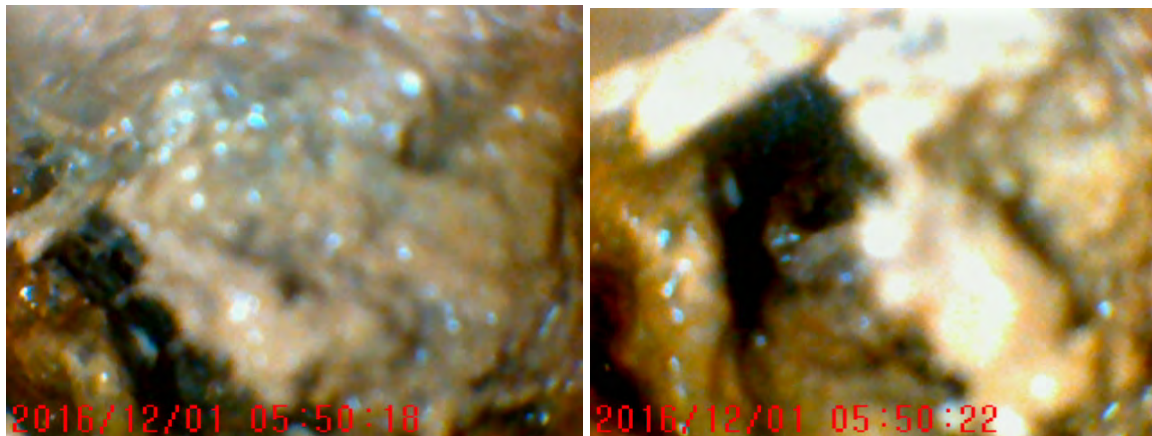
**Figure 23. Videoscope evaluation at conduit exiting top of 3<sup>rd</sup> level electrical panel; interior was very wet with water dripping from conduit.**

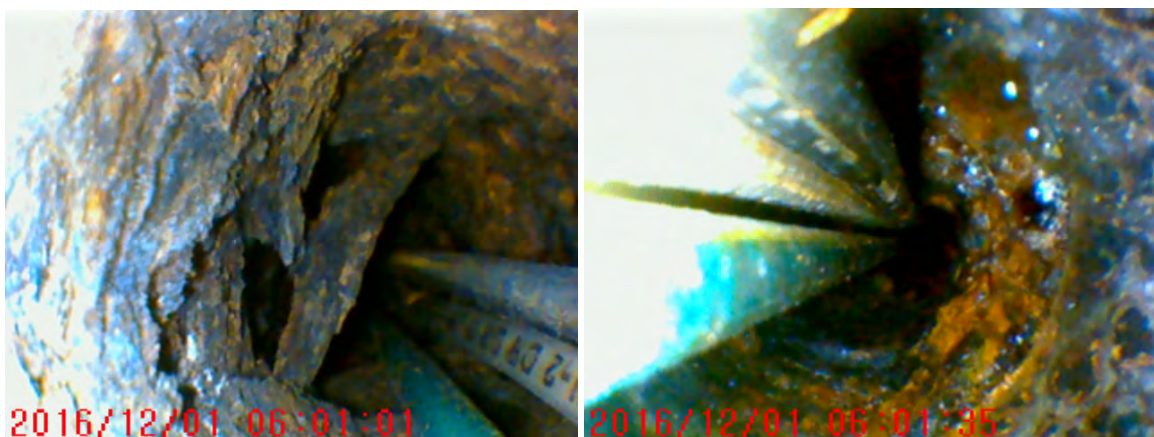
**Figure 24. Videoscope evaluation at 1<sup>st</sup> level conduit above removed light fixture. Severe corrosion and moisture noted.**

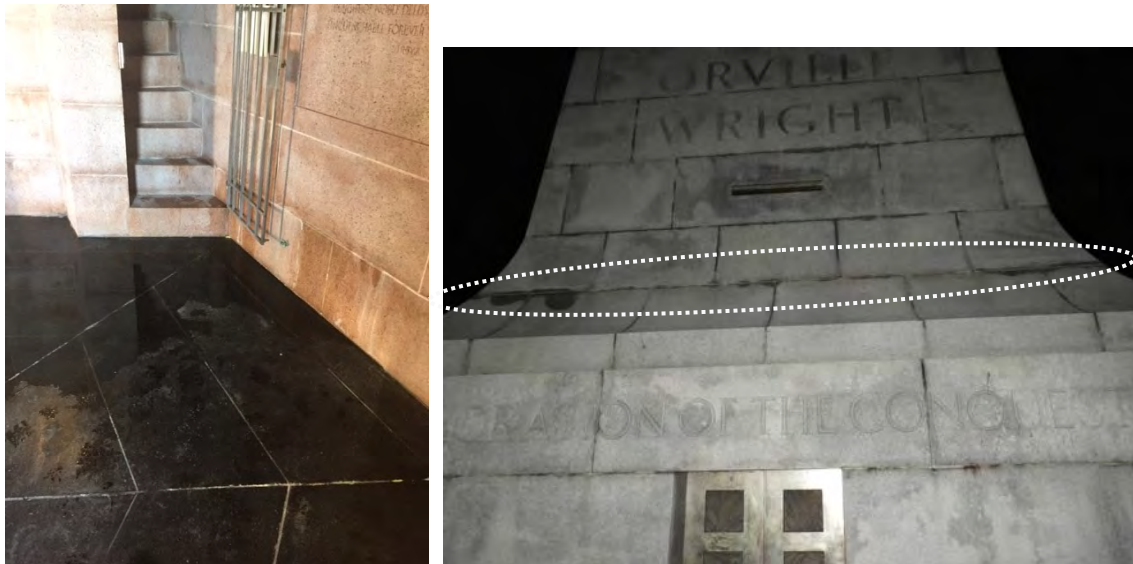
Figure 28. Water pooling in lobby (left) and exiting joint at flashing (right).

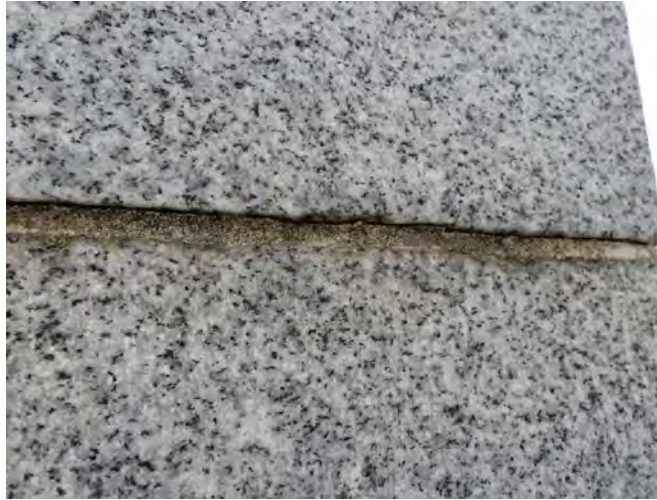
**Figure 29. Example of delaminated mortar joint; delaminations permit moisture ingress during rainstorms.**
