Historic Structures Report Fort Yellowstone Power House

Mammoth Hot Springs
Yellowstone National Park, Wyoming

1996

**Historic Structures Report
Fort Yellowstone Power House
Final Document**

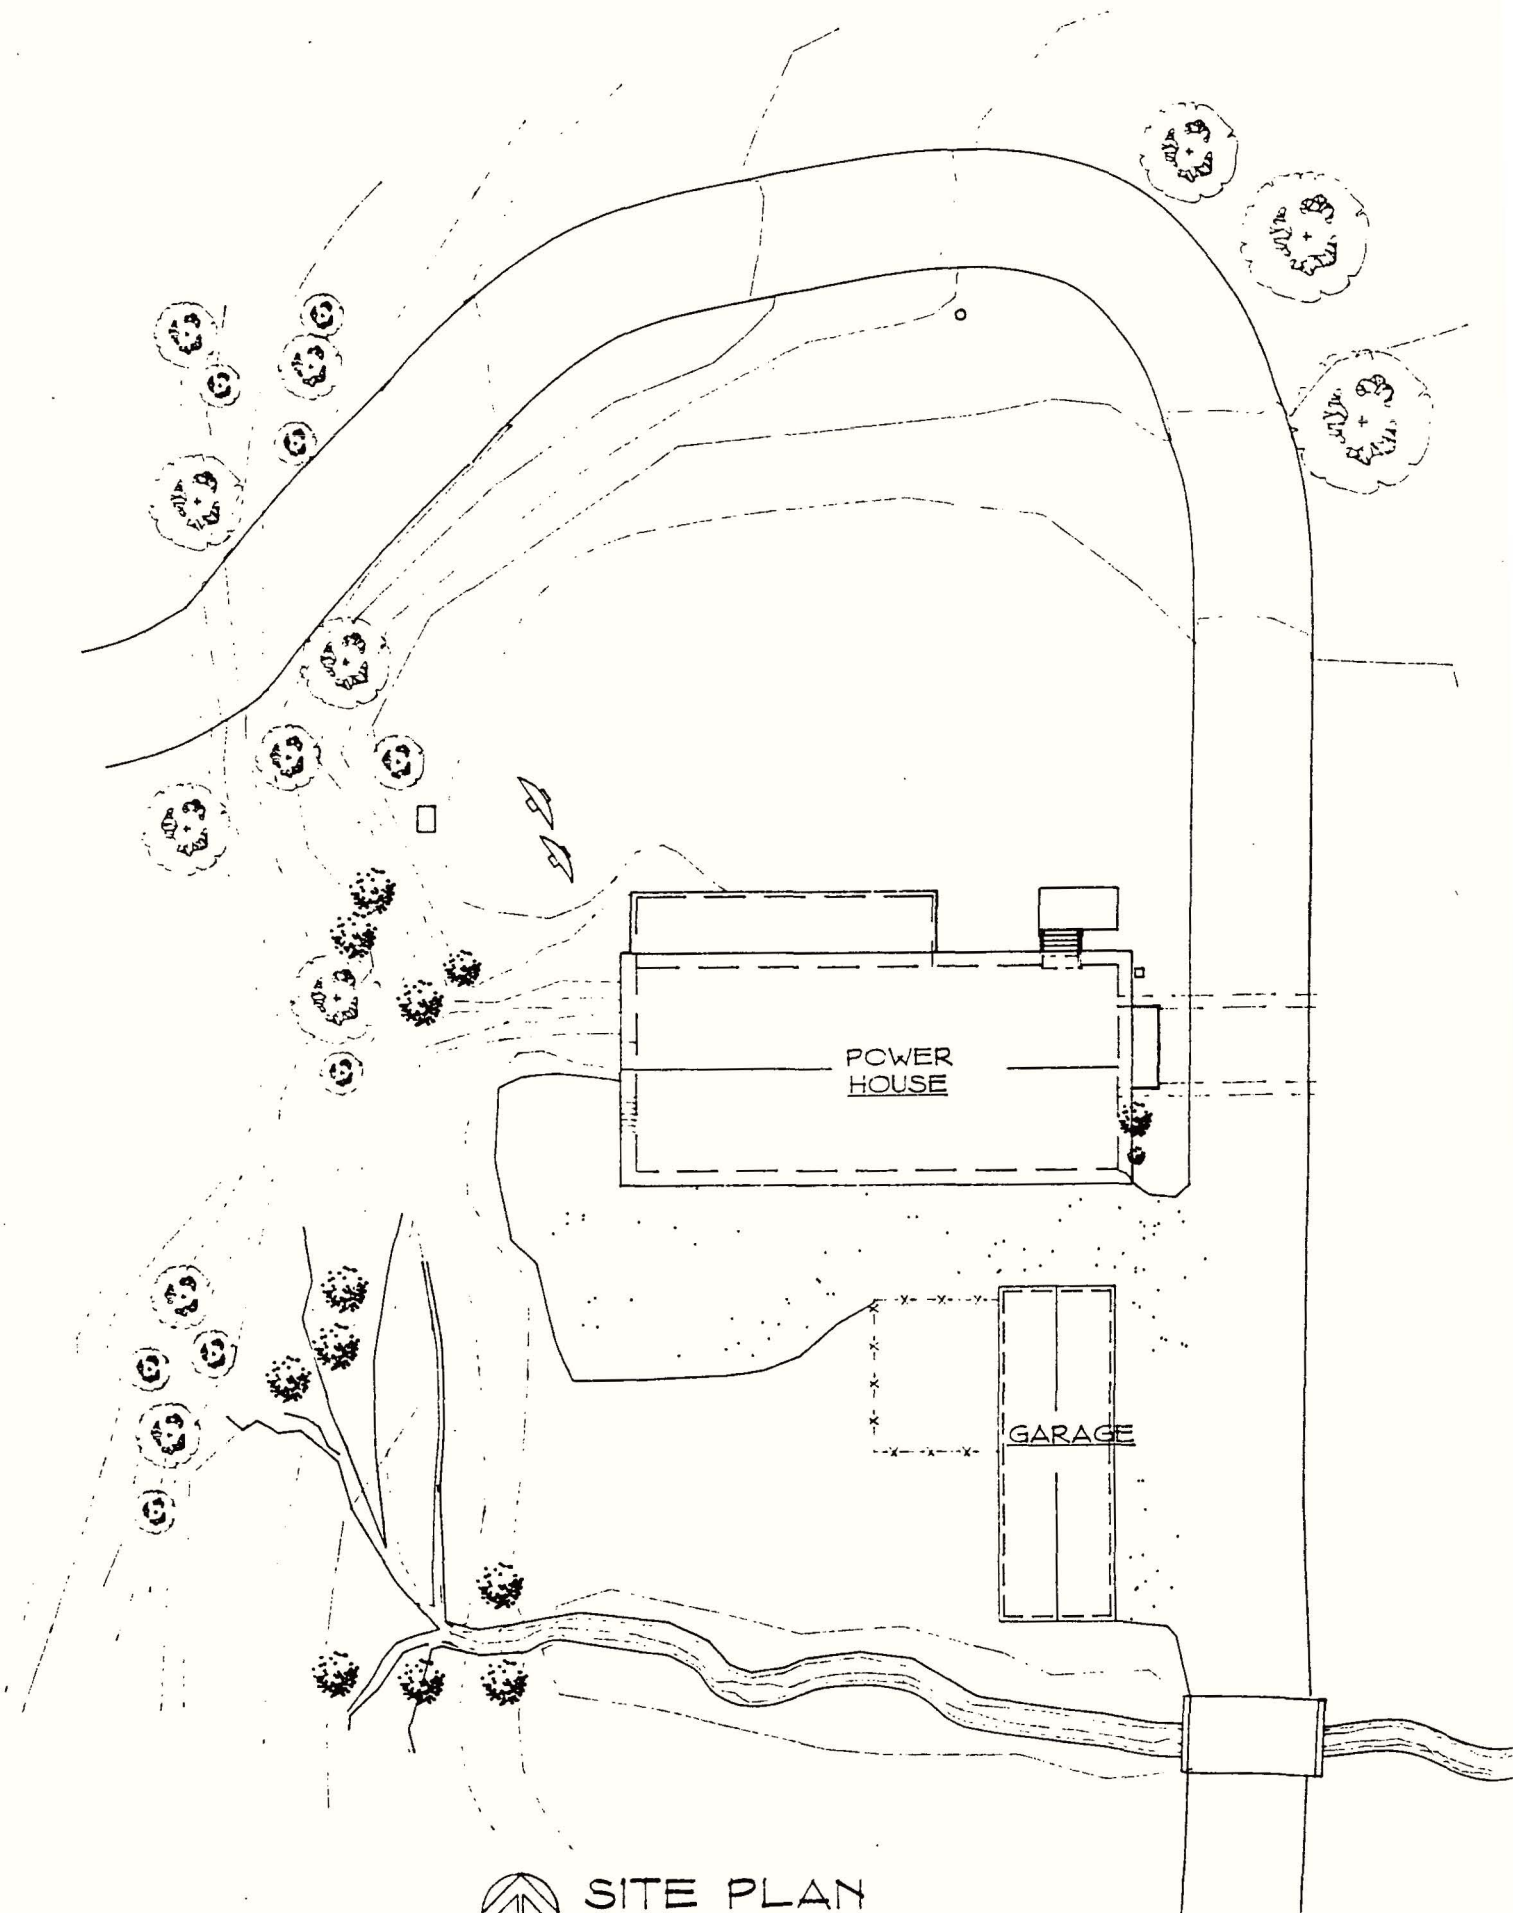
SITE PLAN
EXISTING POWER HOUSE

The power house site is in good condition; the only major problem being the lack of drainage on the north side of the building. Inadequate drainage of water flowing on the slope to the west may also be a problem in high water years. The site is maintained and the area around the building is kept in good condition.

1. Regrade the area around all sides of the building (especially on the north side) to provide positive drainage around the building thus eliminating the deterioration of the concrete base.
2. Define organized parking areas around the building; design a parking plan for the north side of the building that maintains the view of the historic building as much as possible.
3. Inspect the water entrance to the penstocks to make sure that the water source is closed off from the building.
4. Monitor and maintain the wet areas and streambed to make sure that the water continues to flow away from the building.
5. Maintain the wood structure that extends from the tail race over the discharge area to make sure that it is stable and does not become a potential hazard.

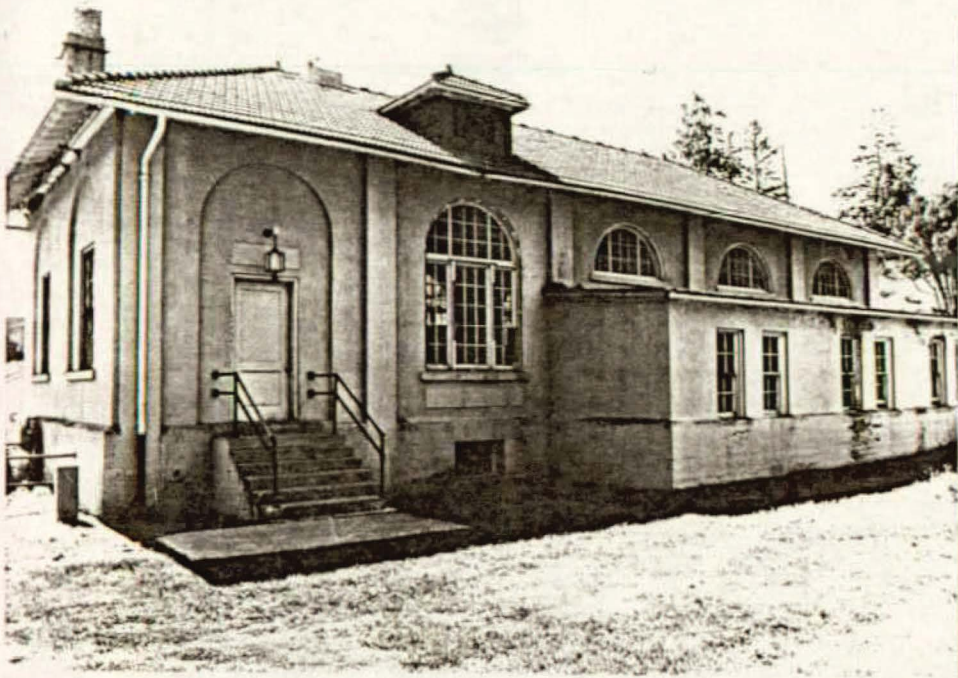
Figure 20. Looking southwest at the power house.

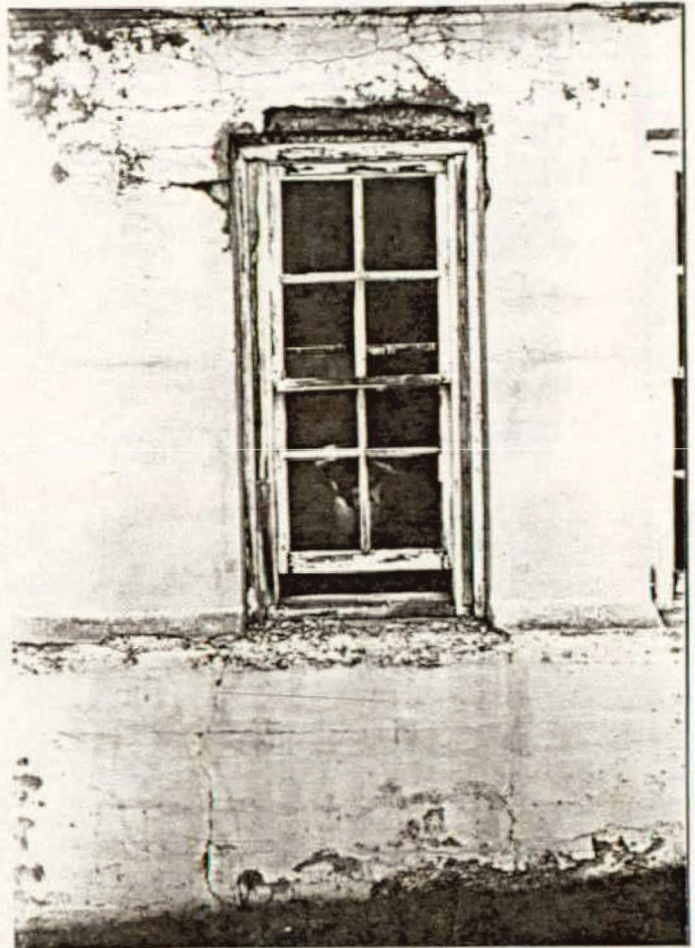
Figure 24.

Looking south at a window in the middle of the shed roof wing. This window is in very poor condition due to water coming off the roof above. The window is weathered and rotted in some areas and the concrete around the window is spalling due to the moisture.

2. Replace the roof on the wing with a single-ply roof membrane, and provide gutters to keep the water away from the surface of the concrete. Repair or replace gutters and flashing in-kind to existing, to prevent water damage to eaves and soffits.

3. All windows and doors need some degree of preservation maintenance including reglazing and painting of the frames, doors and sashes. All of the trim around the windows and doors needs to be sanded and repainted. All exterior doors need to be reworked with repair of weathered or worn wood, adjustment of hardware, and the refinishing of the wood.

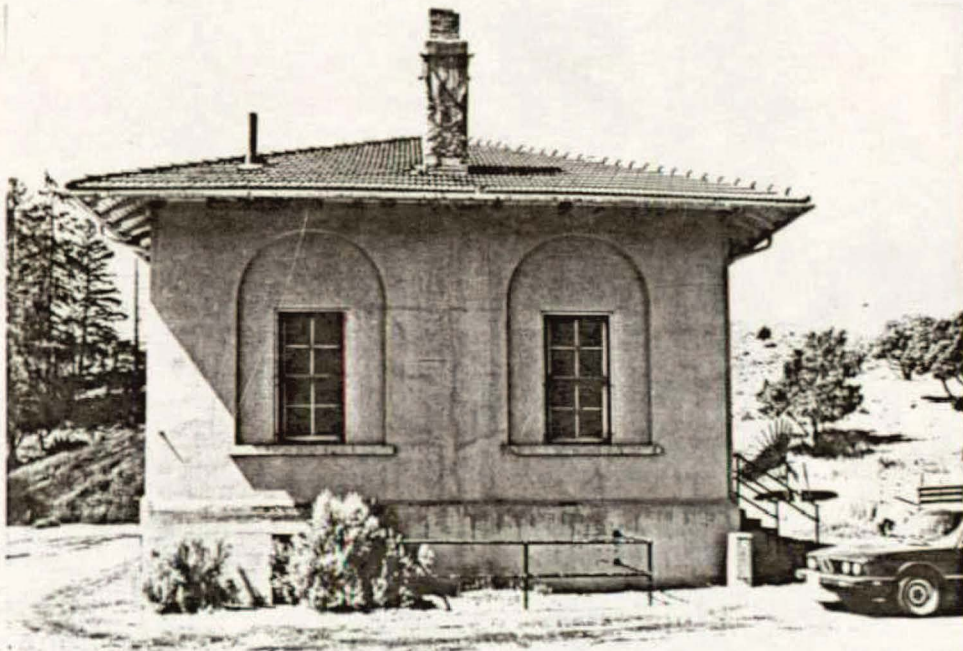
Figure 25.

Looking west at the power house. This elevation appears to be in good condition. Note some deterioration of the chimney that is cracked and spalling.

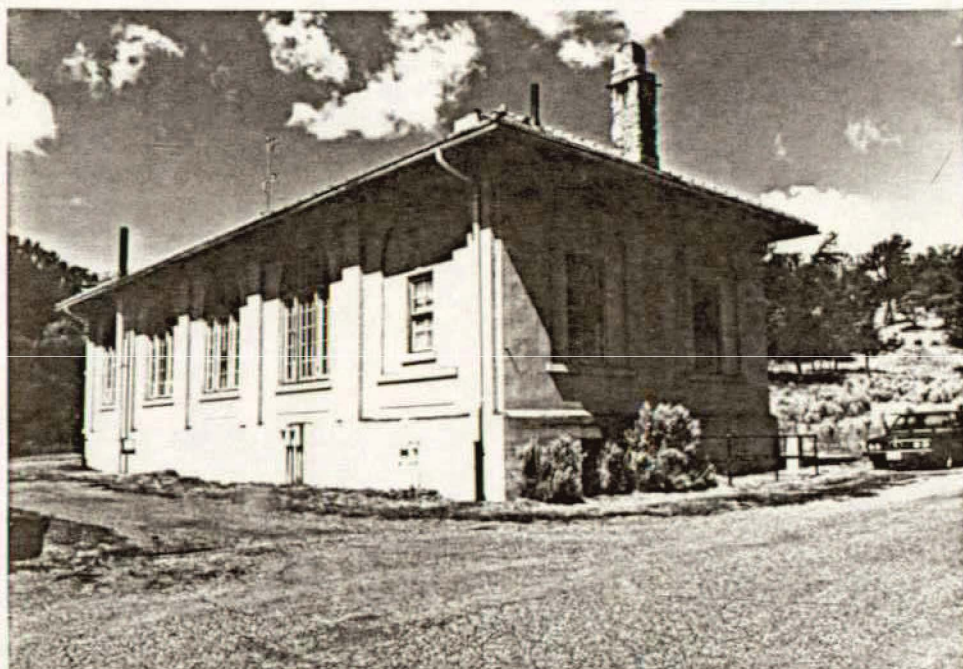
Figure 26. Looking northwest at the power house. Note the shrubbery up against the building. Most of the walls are in good condition.

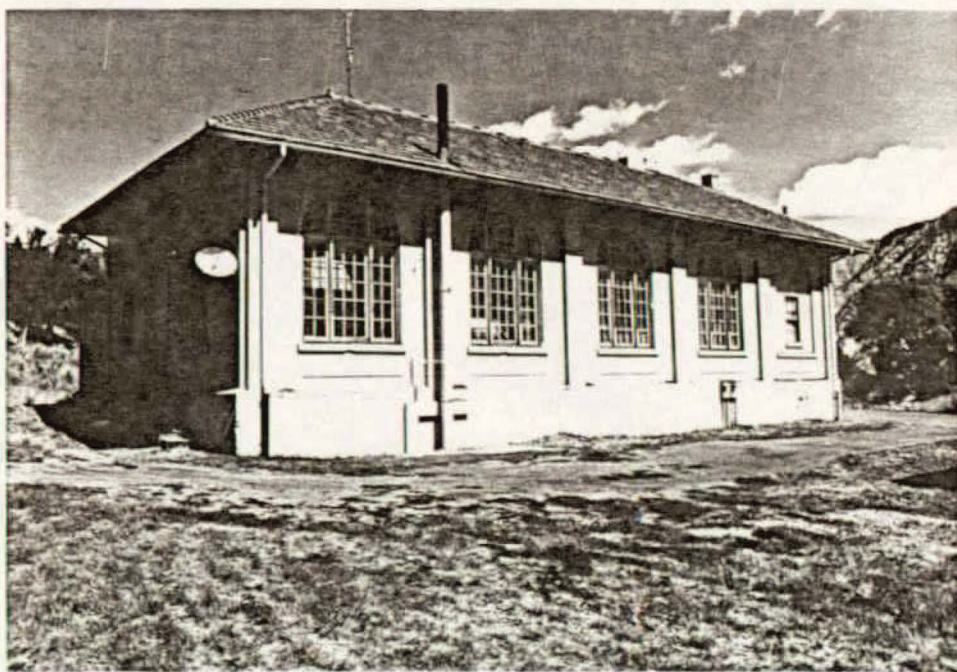
Figure 27. Looking northeast at the power house. Note the low area along the building where some of the site water drains into the foundation. There is minor concrete base deterioration at this point.

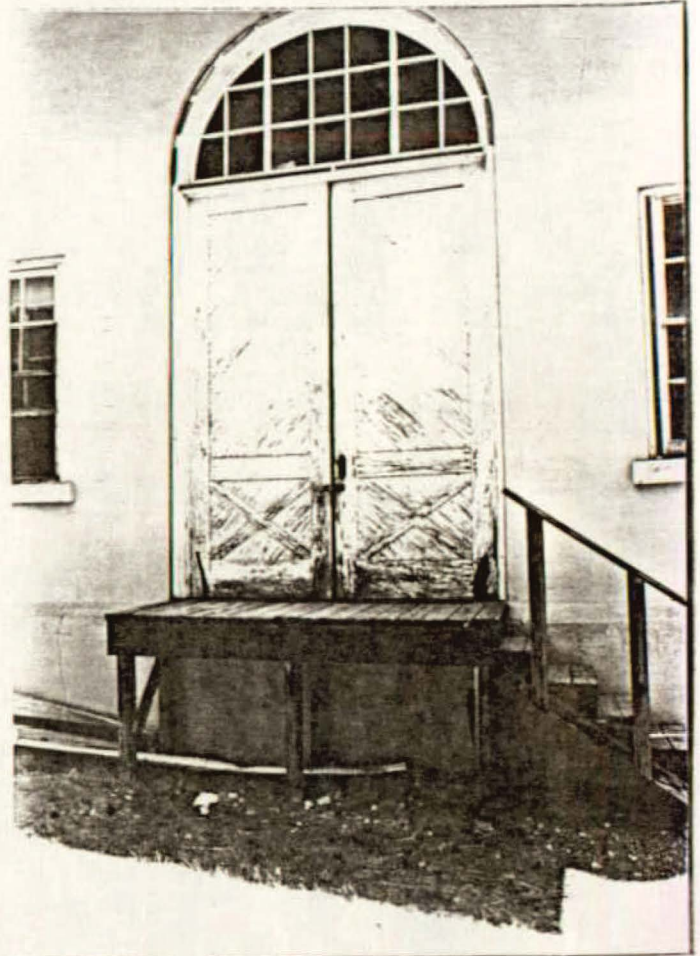
Figure 28.

Looking east at the loading dock and doors on the west side of the power house. The doors are slightly weathered.

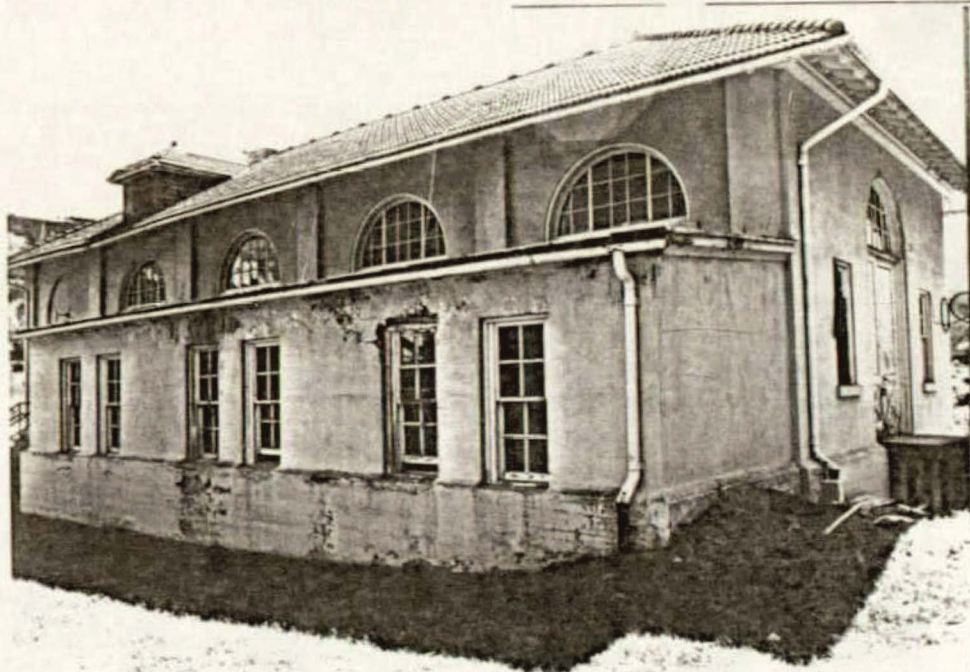
Figure 29.

Looking southeast at the power house and shed roof wing. This side appears to have the most deterioration including poor grade for drainage around the building, concrete spalling, weathered and rotted windows, broken glass, gutter leaks and downspout leaks and a poor roof on the wing.
