# ROOSEVELT LODGE HISTORIC STRUCTURES REPORT

**ROOSEVELT LODGE  
YELLOWSTONE NATIONAL PARK  
HISTORIC STRUCTURES REPORT**

**DECEMBER 1993**

**JAMES R. MCDONALD ARCHITECTS  
224 NORTH HIGGINS AVENUE  
P.O. BOX 8163  
MISSOULA, MONTANA 59807**

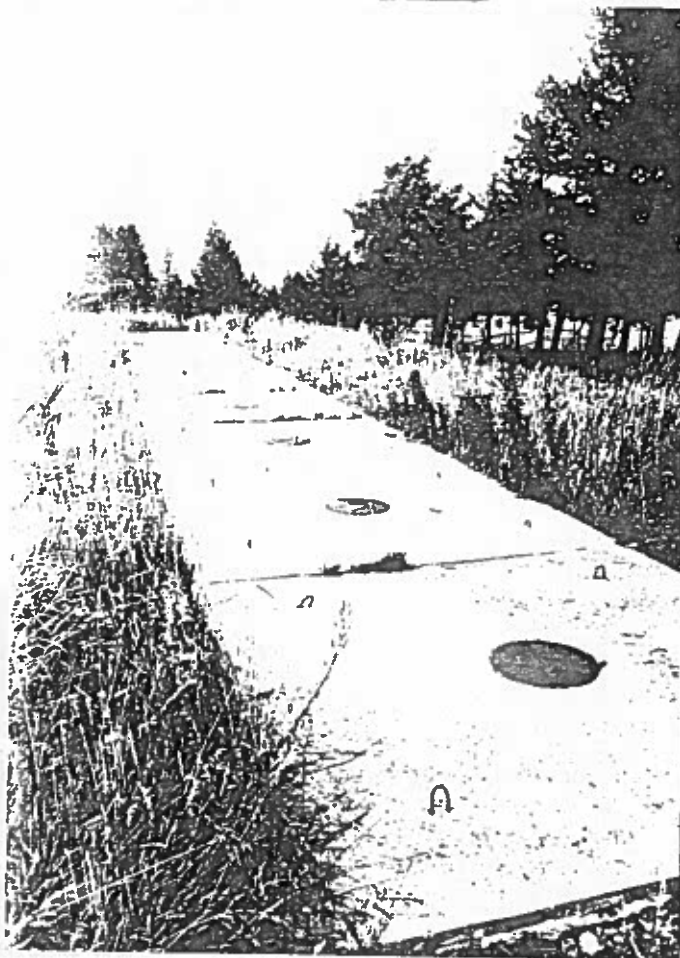
Figure 64: Looking north along the cesspool tanks down near the main highway on the north end of the site. These tanks are failing causing some sewage to leak out in other areas besides the drainfield.

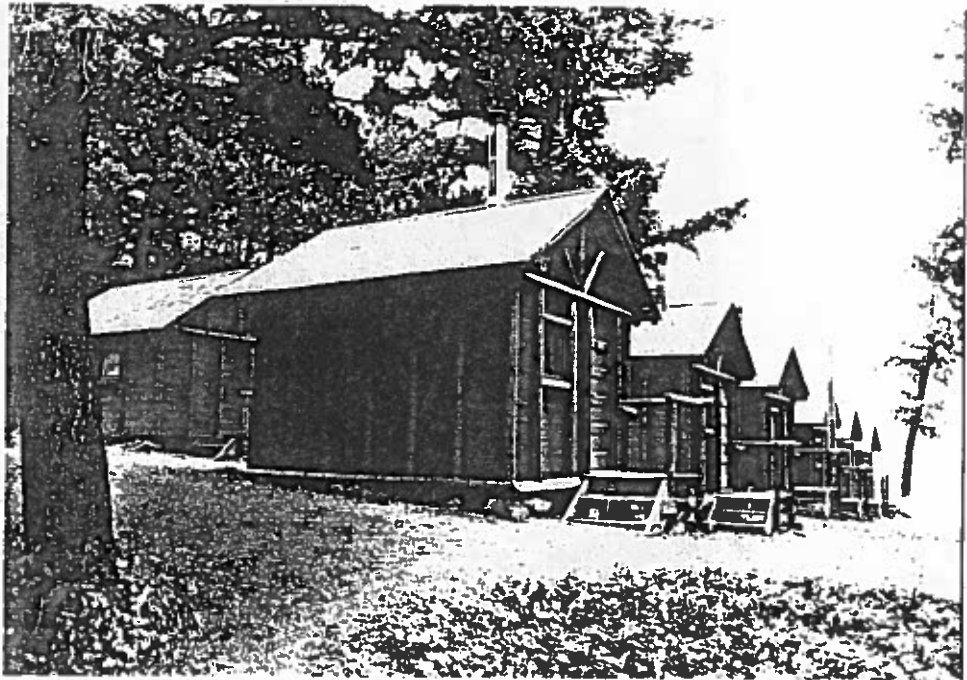
Figure 68: Looking north down a row of "log-out" cabins along the roadway to the Lodge. Generally these are in good condition with the only problems being sill logs that have rotted.

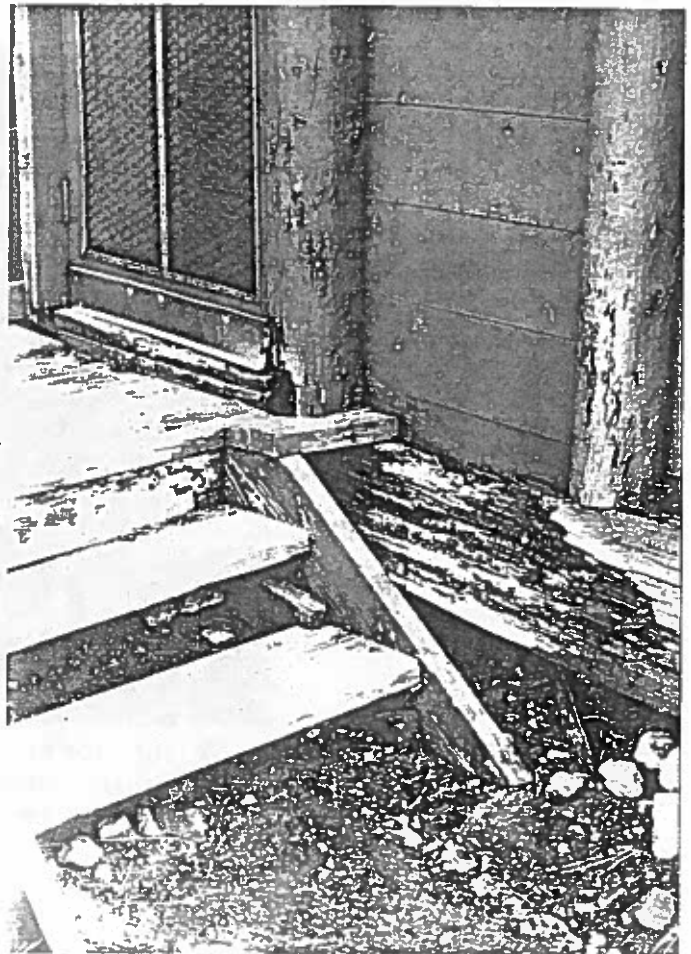
Figure 69: Typical rotted sill log next to and under the wood stoop. This seems to be a problem on all of the buildings because of the slope of the stoop.

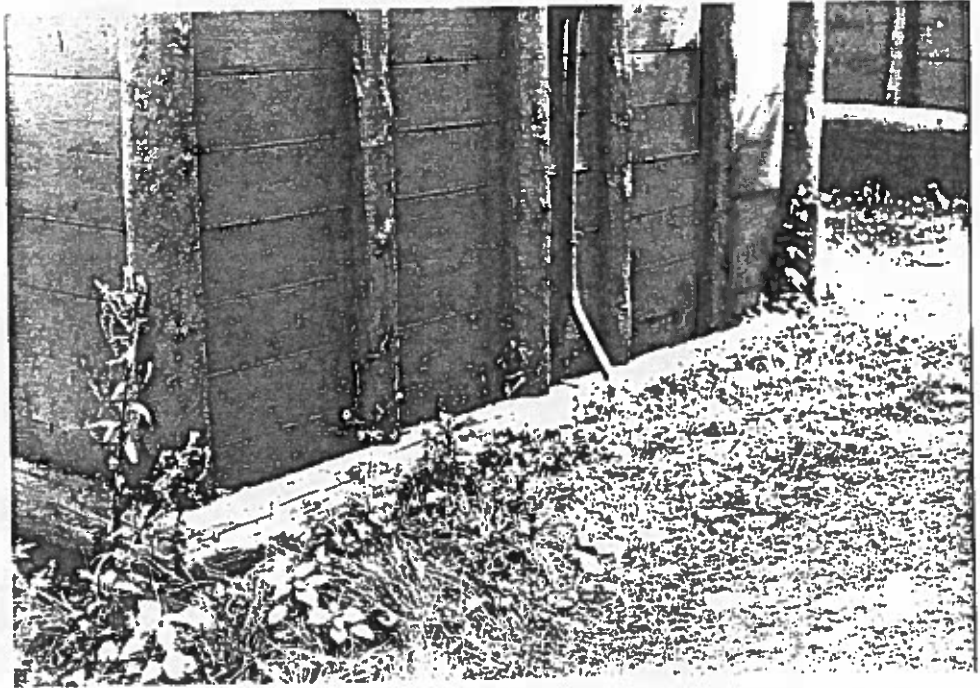
Figure 70: Typical problem where the ground is covering up a log and causing it to rot. About 20% of the cabins have this problem or could have the problem in the future.

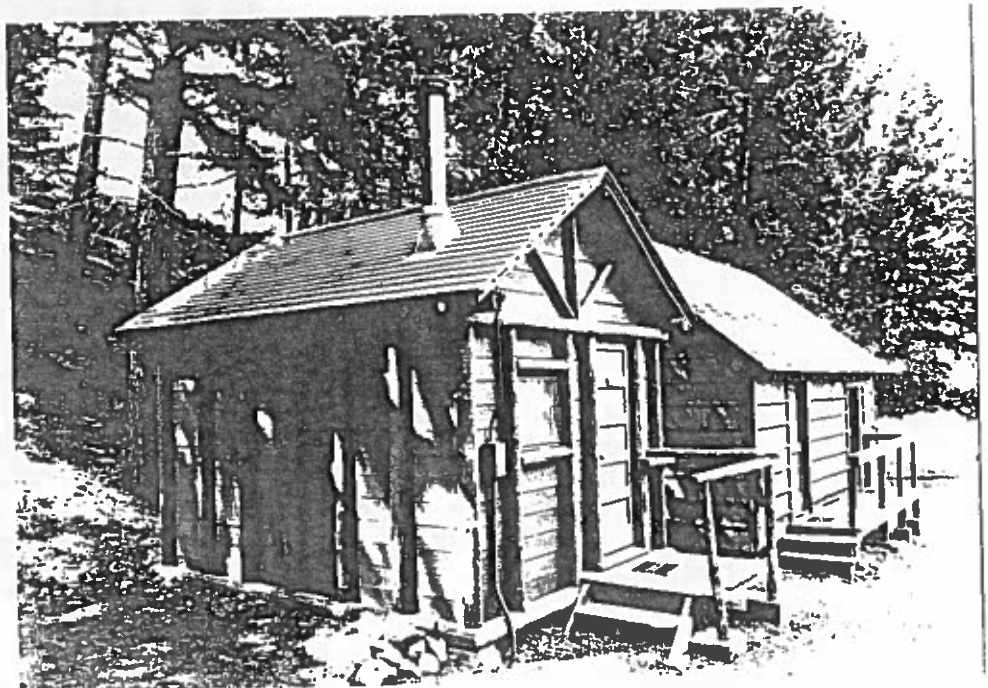
Figure 71: Looking north at cabin 4. Note the logs sitting on the ground where they are rotting. Also note the electrical conduit in the front of the building.

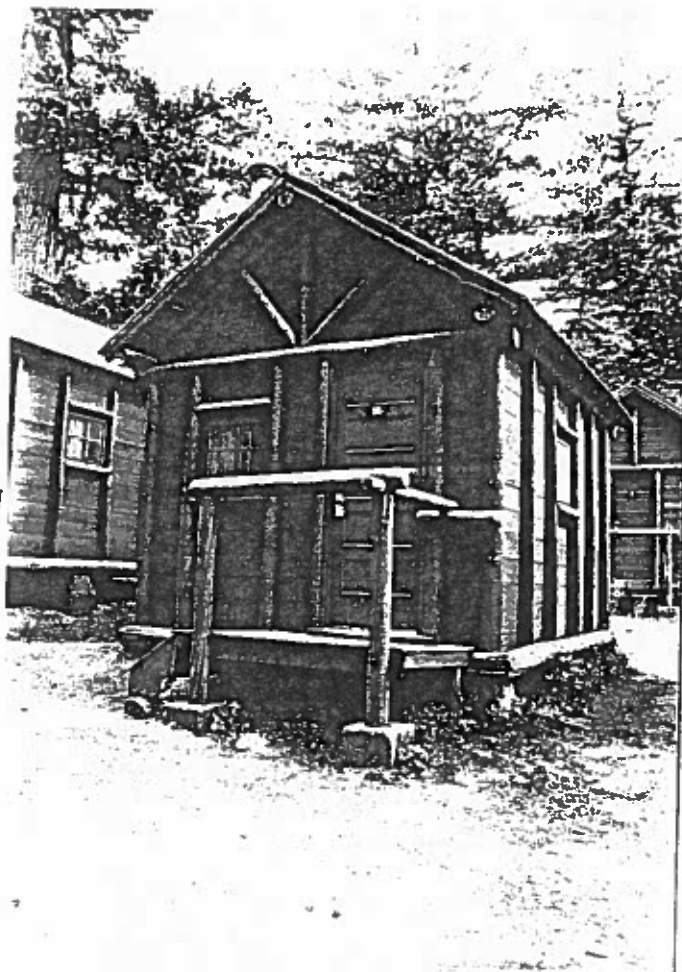
Figure 83: Looking southwest at the base detail on cabin 16. Note the poor condition of the stoop and the rotted sill log.

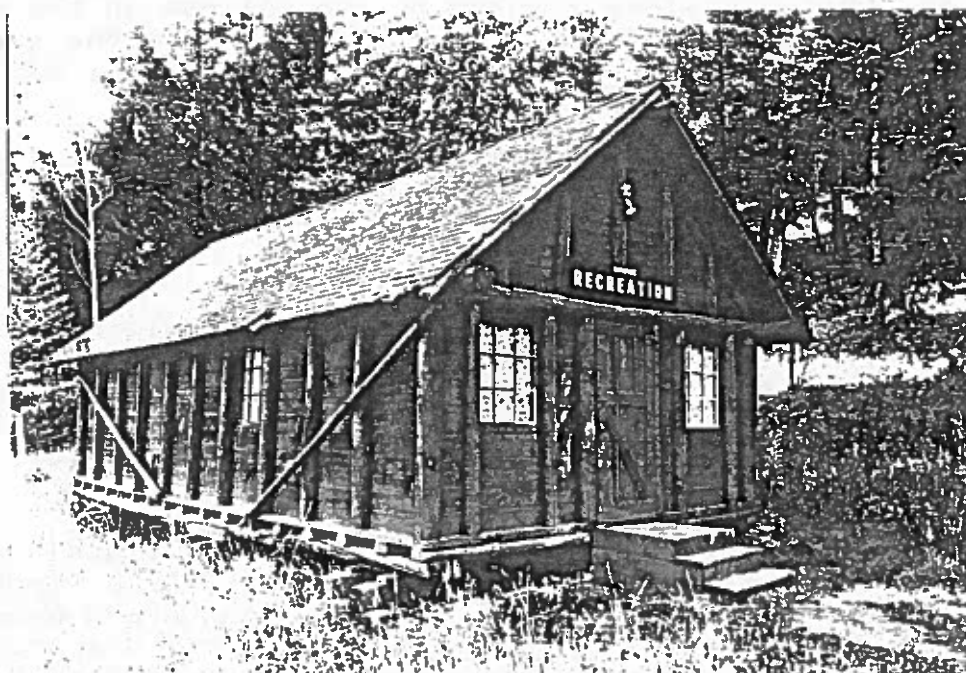
Figure 90: Looking east at the employee recreation hall. Note the poor roof, rot in some of the sill logs, and broken windows. The building was just set here temporarily; however, it has been here a long time and still sits on its moving blocks.

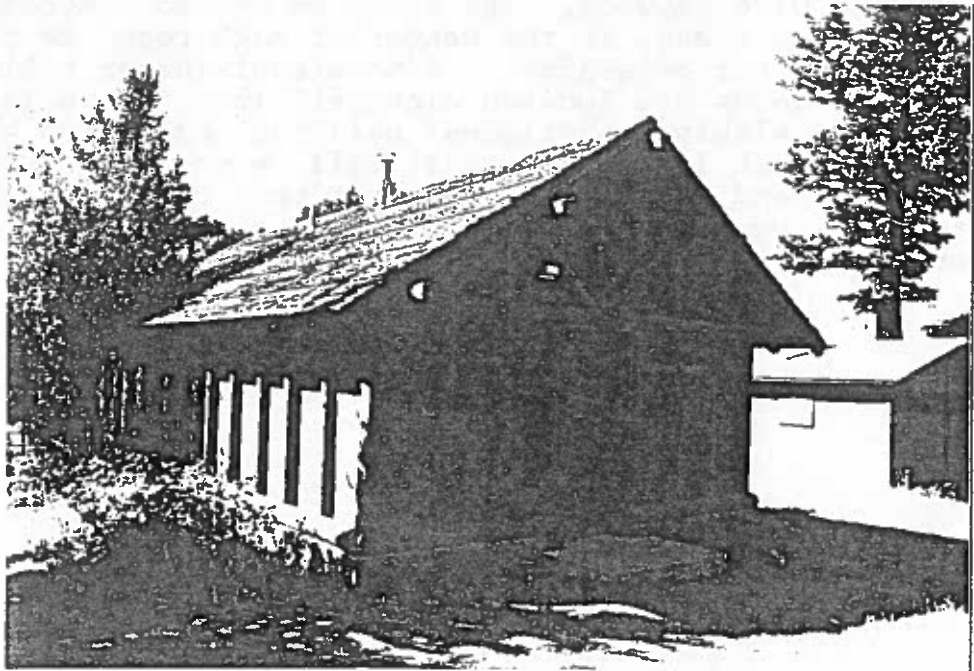
Figure 93: Looking northwest at the restroom structure on the northwest loop of the cabin area. The building is in good condition with the exception of the interior which does not ventilate well putting a lot of water on the walls causing deterioration.

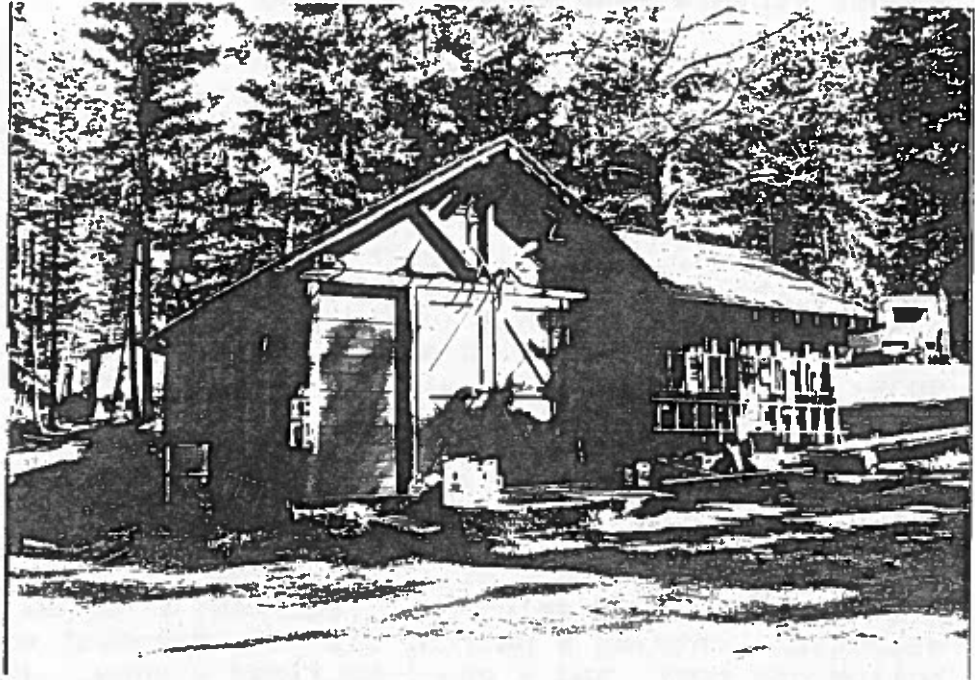
Figure 94: Looking southeast at the maintenance building. Note the deteriorated concrete along the base.

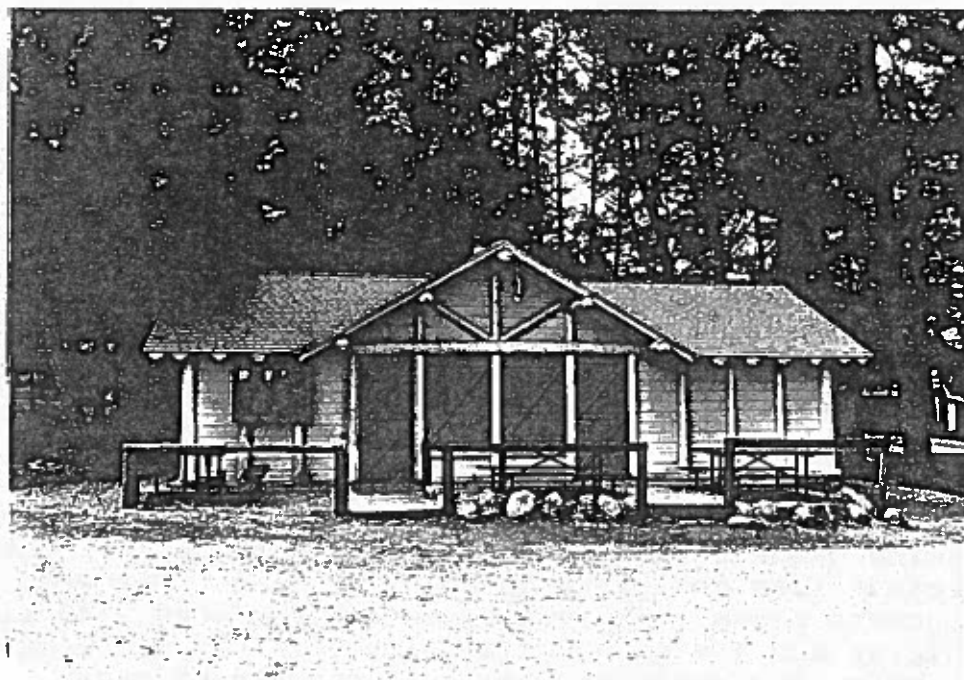
Figure 96: Looking west at the front of the Haynes Picture Shop (Hamilton Store). The building is in good condition generally; however, the white color is not appropriate with the rest of the buildings at Roosevelt.

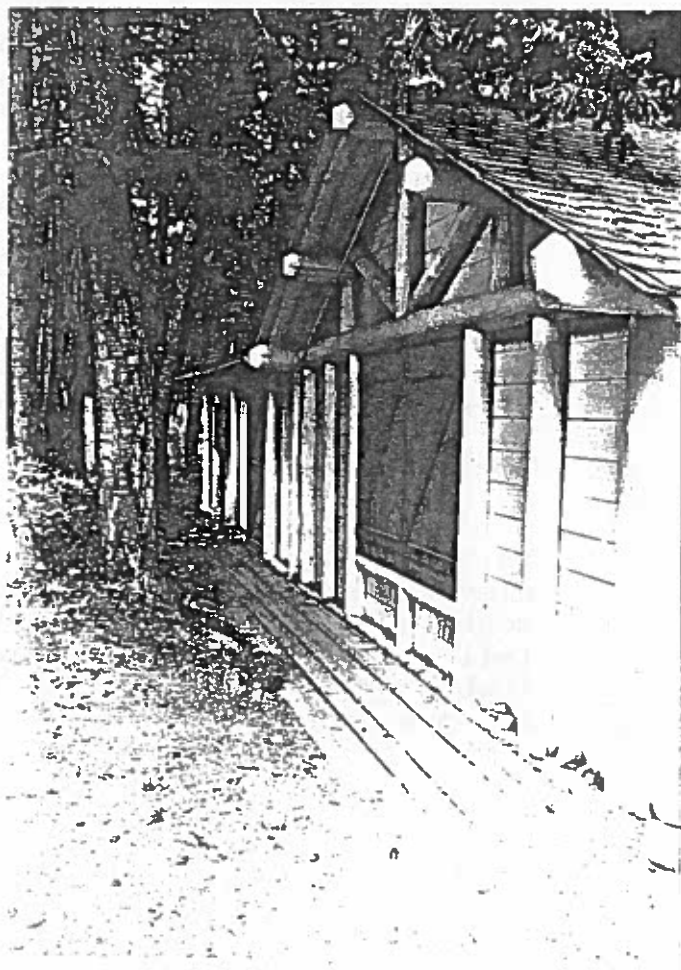
Figure 97: Looking northeast at the side of the Haynes Picture Shop. This side and the back of the building sit in the ground with the water rolling into the building causing rot on the sill logs.

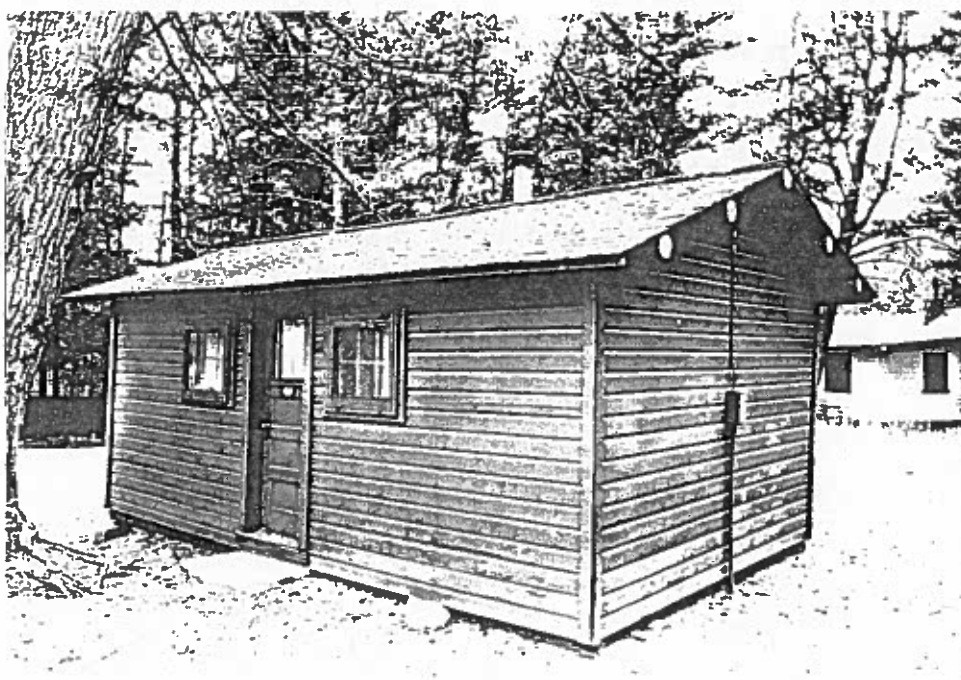
Figure 106: Looking east at cabin 50 in the west group of cabins. Note the electrical service on end of the building. Also, note the broken corner boards.

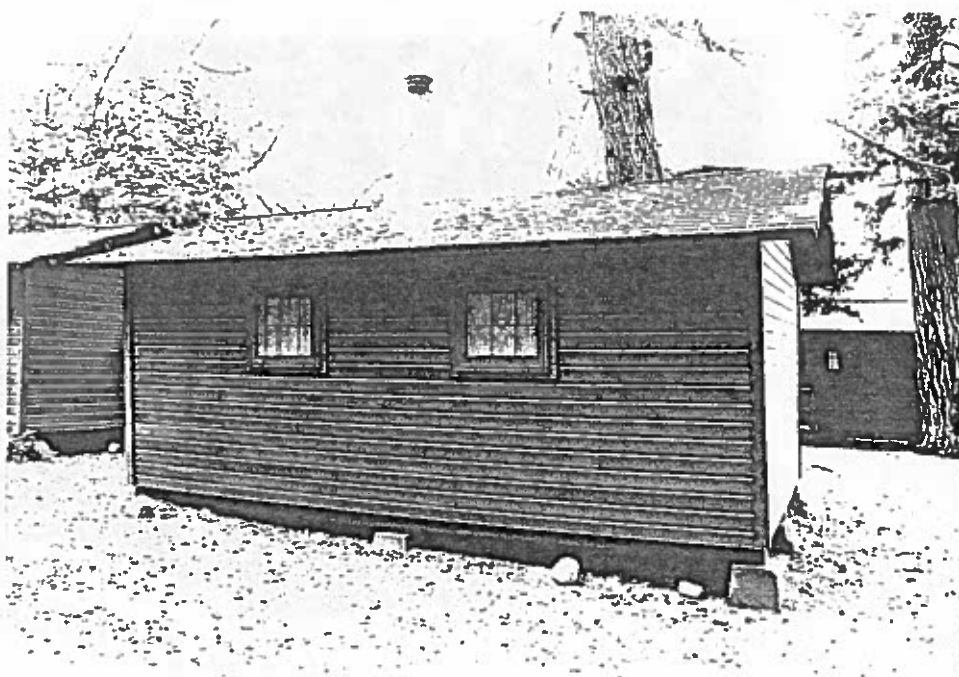
Figure 107: Looking west at the back of the "droplap" cabin 50. Windows and screens are typically in need of maintenance.

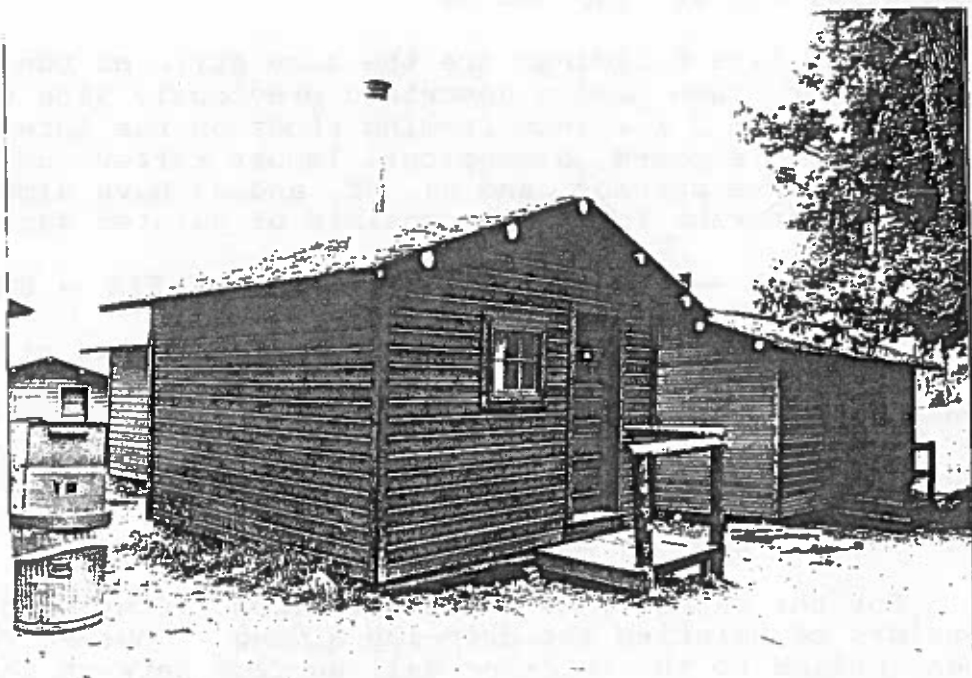
Figure 109: Looking north at cabin 61 a guest cabin in the west group of cabins. The roof is in poor condition, the porch needs work, and windows and doors need maintenance. Note the cracks in the corner boards.

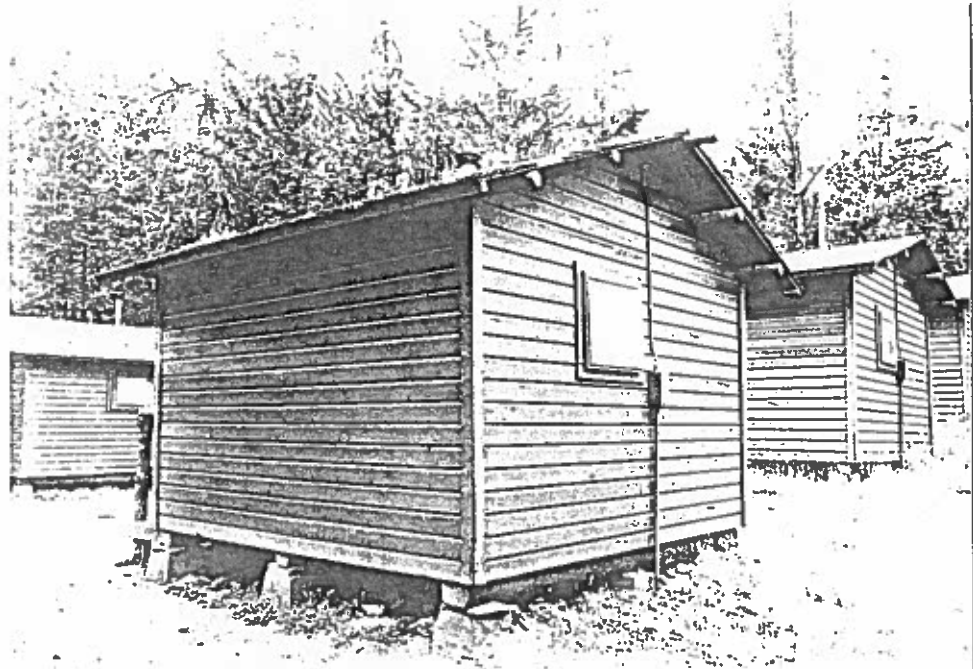
Figure 110: Looking south at cabin 61 which is generally in good condition. There are a few cracks in the drop-lap siding and the corner boards have come apart. Note the electrical conduit on the rear of the cabin.

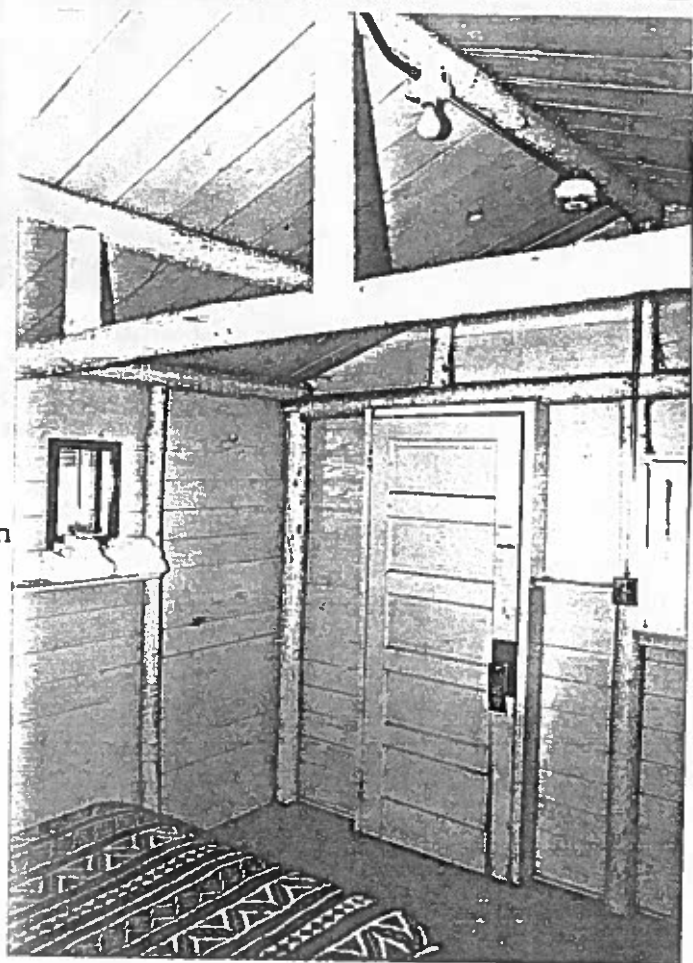
Figure 113: Looking south at the interior of cabin 61. Note the wood stove with the asbestos surround. Note the curtains. The door needs some work as there are some cracks on the inside.

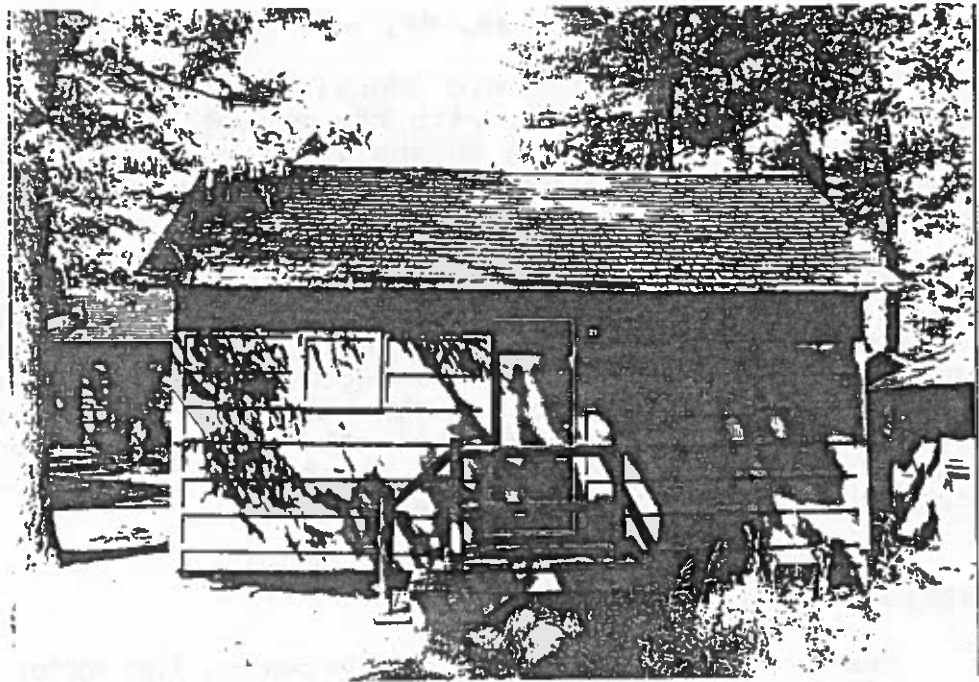
Figure 114: Looking north at a "board and batten" cabin 21. Note the flush wood door that was not part of the original building. The roof will need to be replaced in three to five years.

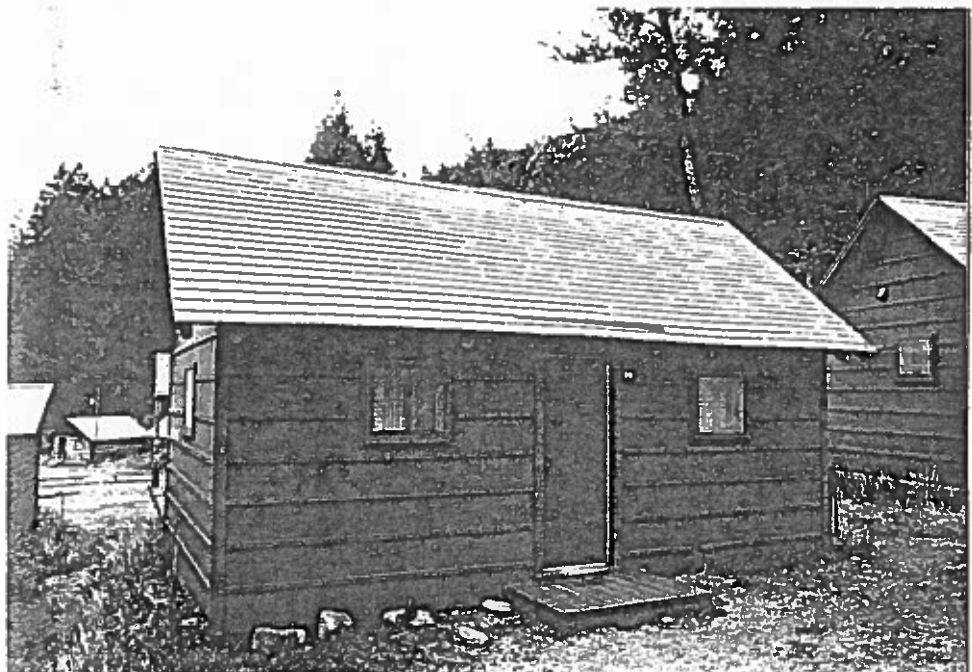
Figure 116: Looking east at a "board and batten" cabin 26. Note the flush door that was not part of the original design. Most of these types of buildings are in good condition, with some exceptions where some boards will have to be replaced and the walls tightened up.

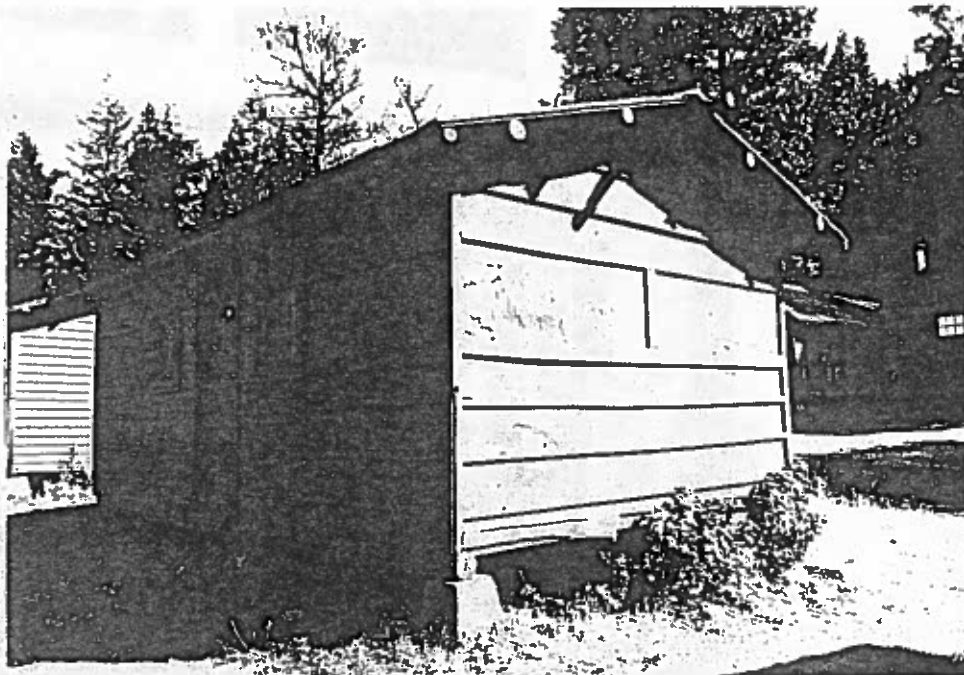
Figure 117: Looking south at cabin 79. Note the painted tarpaper on the window level. There is some rot in the sill plates. A new step is required into the front door.

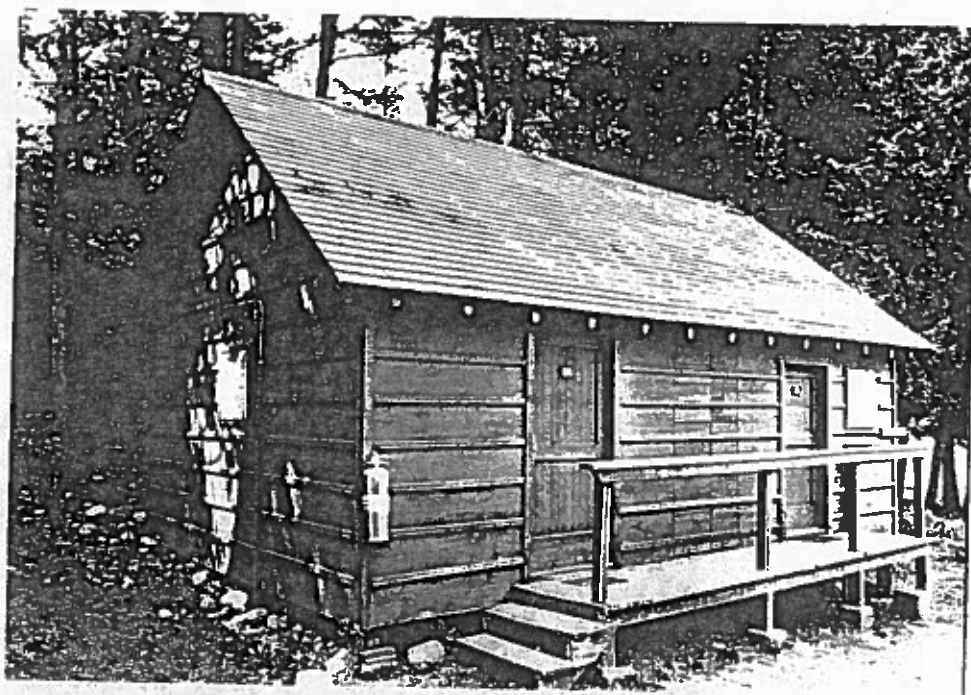
Figure 122: Looking north at a "board and batten" cabin 5A/5B on the front group of cabins near the entrance road. The cabin is generally in good condition with some minor wall settlement problems and a weathered and worn porch.

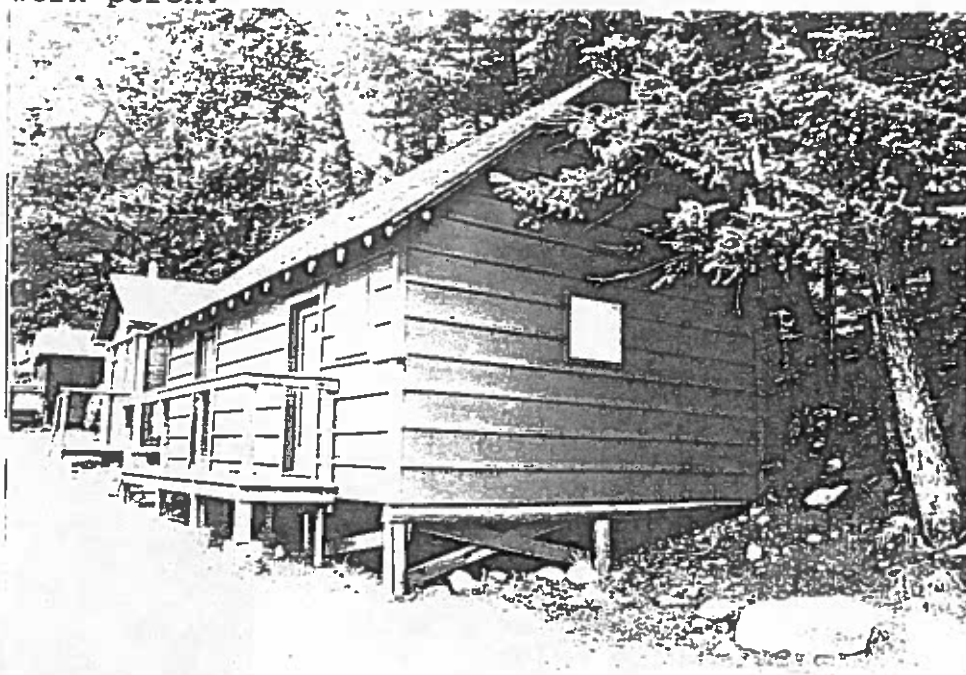
Figure 123: Looking south at cabin 5A/5B. Note the wood post piers on the ground. There is some rot in the bases as well as the sill log on the back where it sits in the ground.

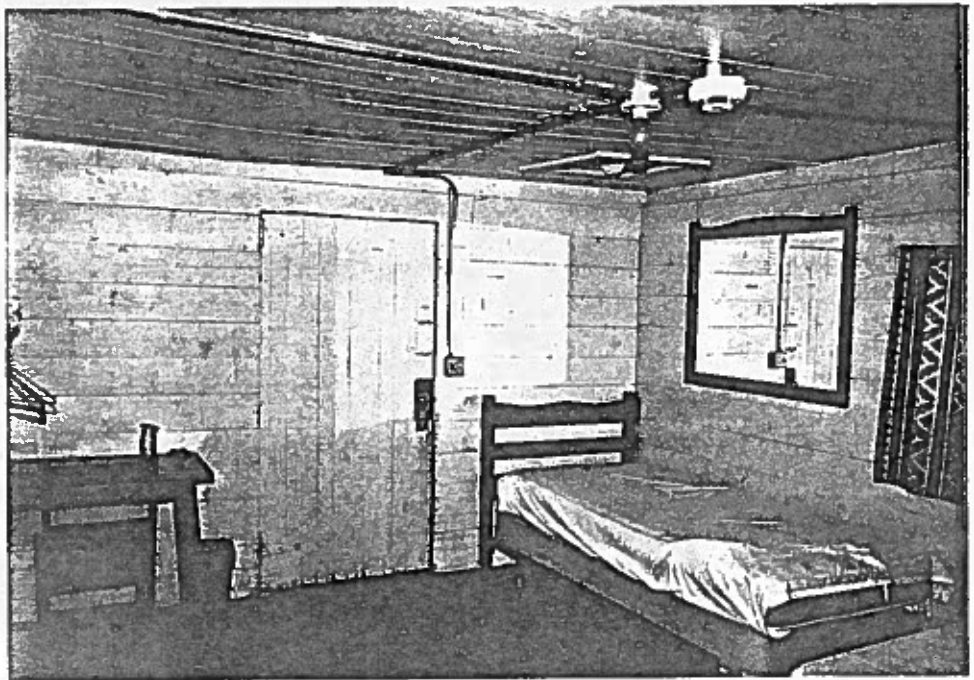
Figure 124: Looking northeast at the interior of cabin 5A. Note the electrical conduit run along the ceiling and walls, even though there is a full attic above.

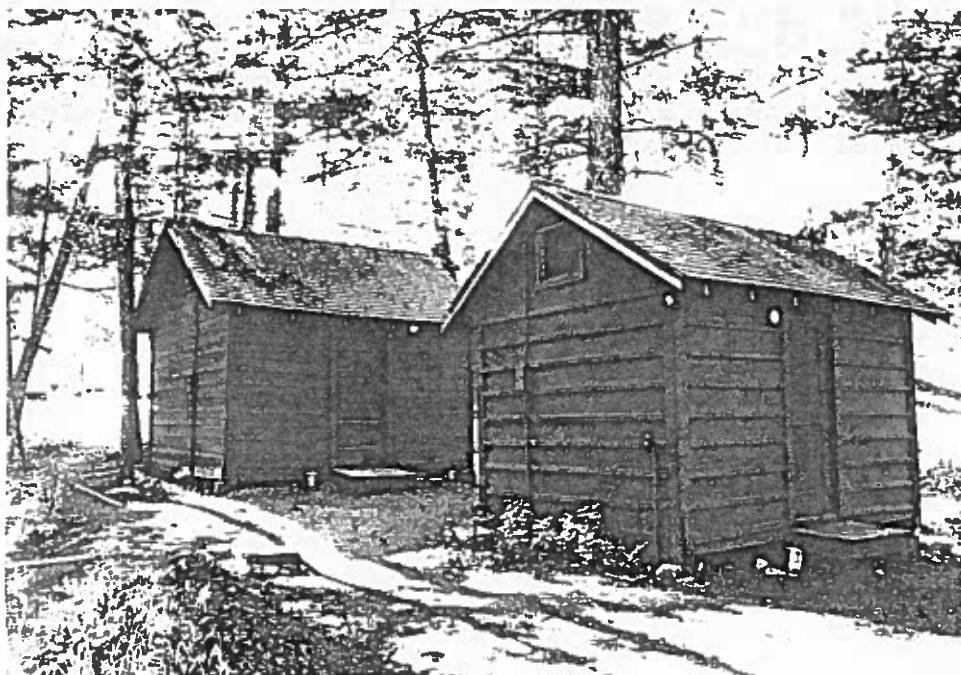
Figure 128: Looking west at the restrooms near cabins 1-18 along the entrance road to the Lodge. The buildings are in fair condition. The main problem is that there are no showers in this area and people have to go across the parking lot or around the hill to the west end to take a shower.

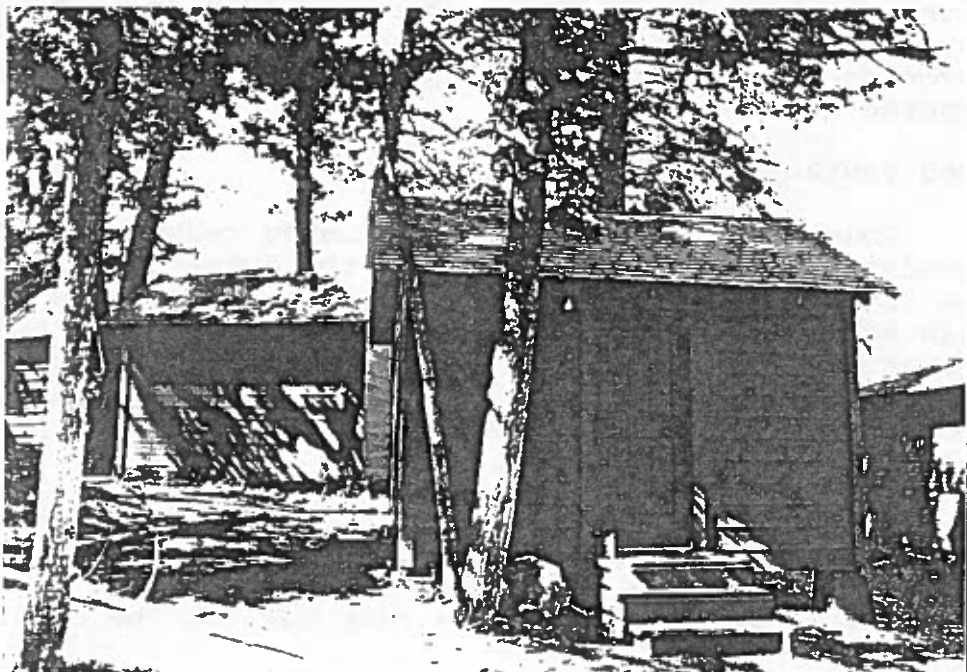
Figure 129: Looking west at the restrooms on the east side near the employee area. The buildings are in fair condition and need some work. The main problem again is the lack of showers.

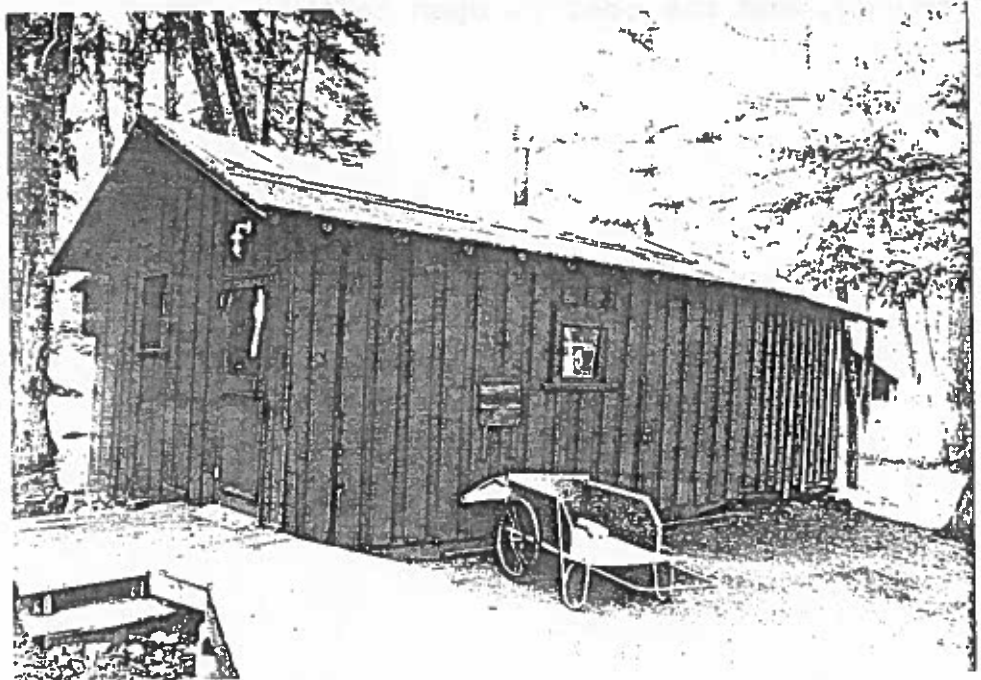
Figure 130: Looking southwest at the Linen building. It appears that this board and batten structure was two buildings that were connected together very poorly. The walls are coming apart and the roof has deteriorated to the point where it will have to be totally replaced.

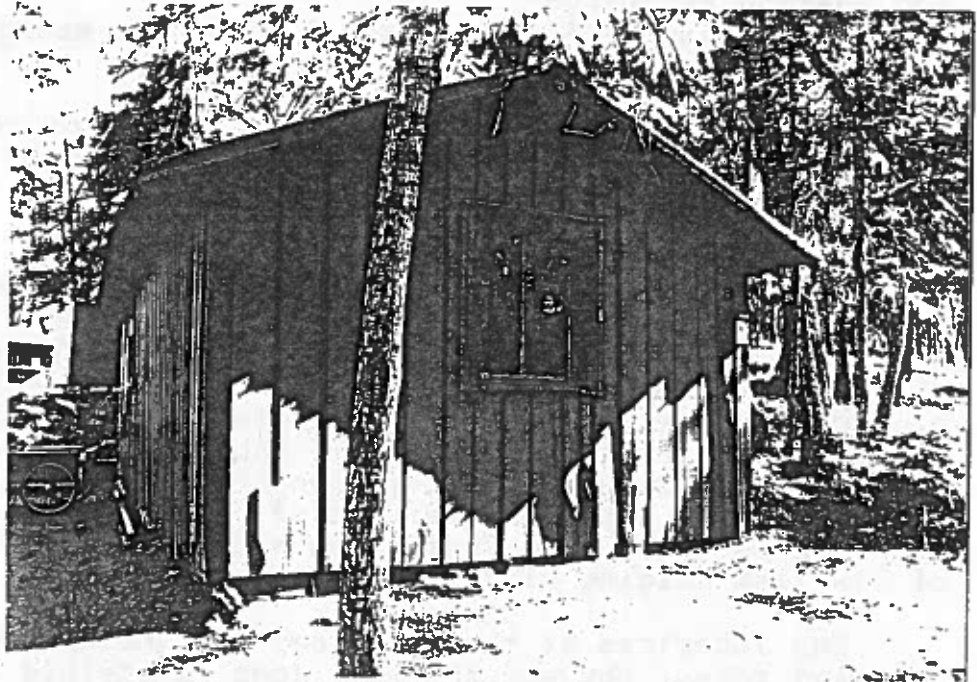
Figure 131: Looking east at the end of the Linen building. Note the rotted and cracked boards and battens. The windows are also in poor condition.

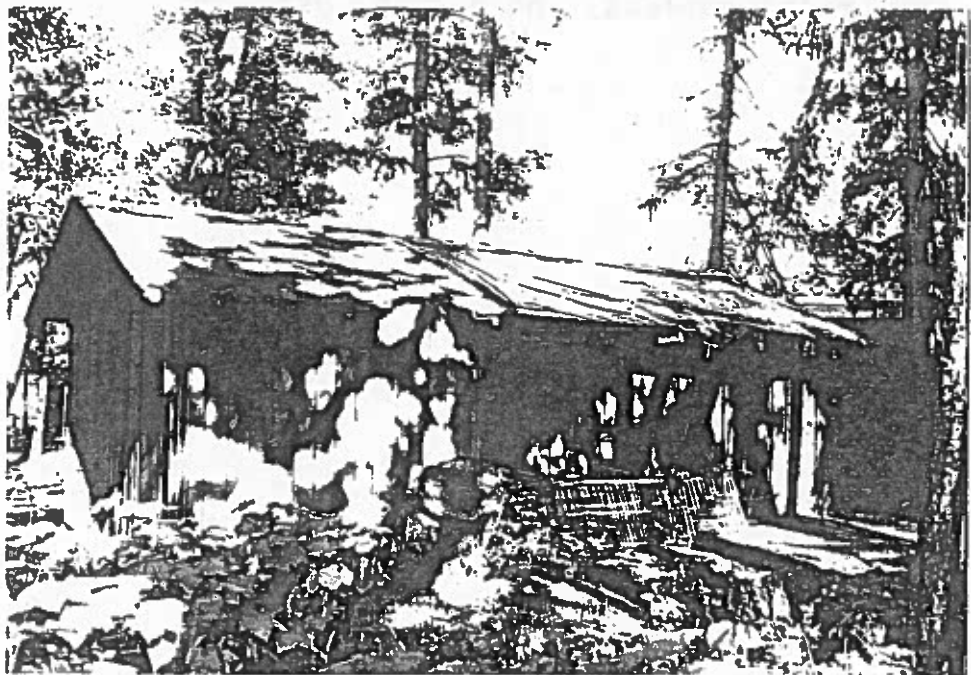
Figure 132: Looking northeast at the Linen building. The roof is in very bad condition on this side due to a tree that grew into the building and has since been removed. Most of the bottoms of the boards are rotted.

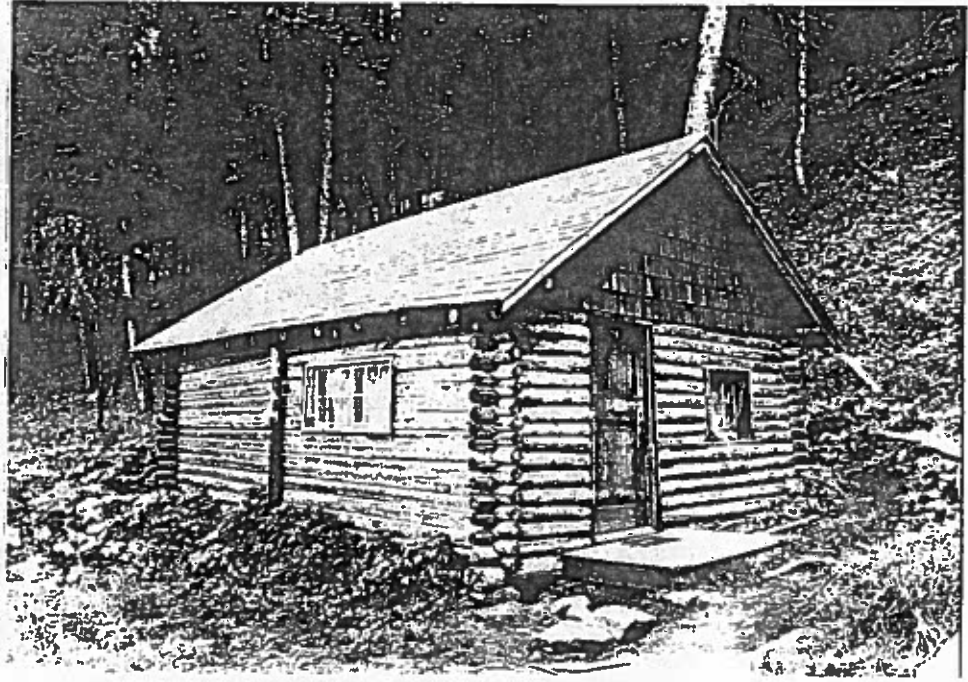
Figure 133: Looking southeast at cabin E9 an employee cabin and one of the original five log cabins. The roof is in good condition, but the logs and wood around the doors and windows need to be oiled. The daubing is coming out and the window glazing is deteriorating. The ground up around the logs and the shrubbery along the base are rotting the logs.

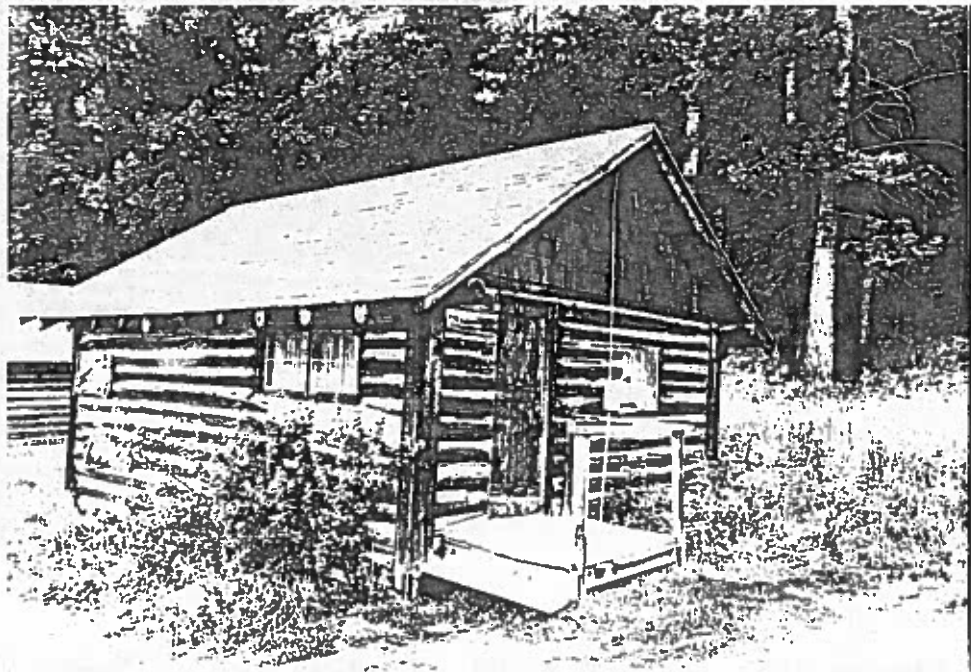
Figure 134: Looking southeast at cabin E6. Note the weathered wood and logs, the lack of daubing, and the poor porch.

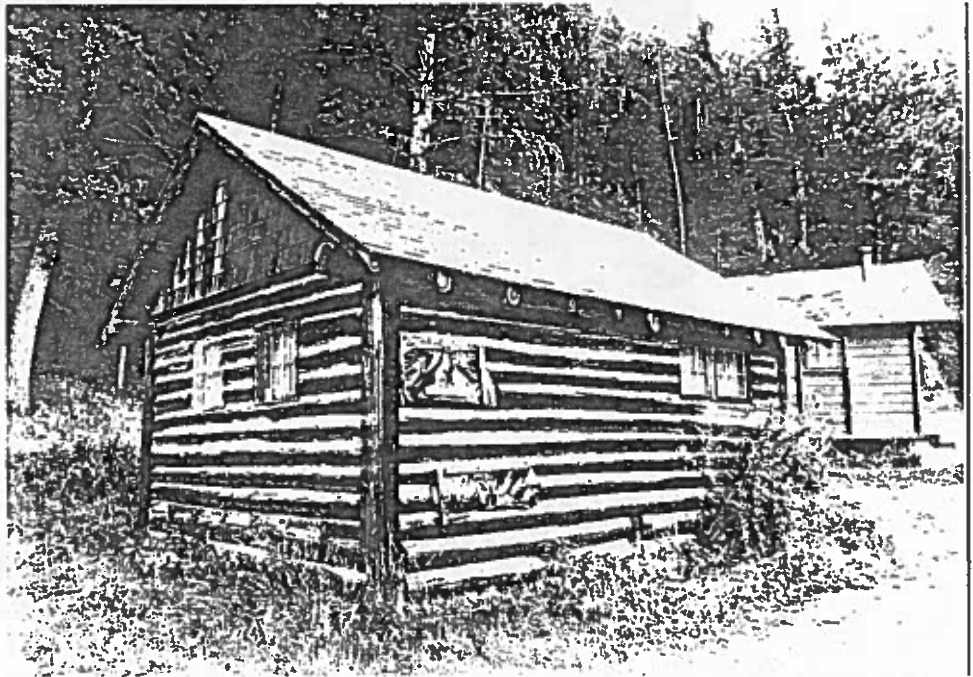
Figure 135: Looking south at cabin E6. Some of the holes in the walls have been covered up with plastic. Note the silt logs sitting on the ground which is deteriorating the wood.

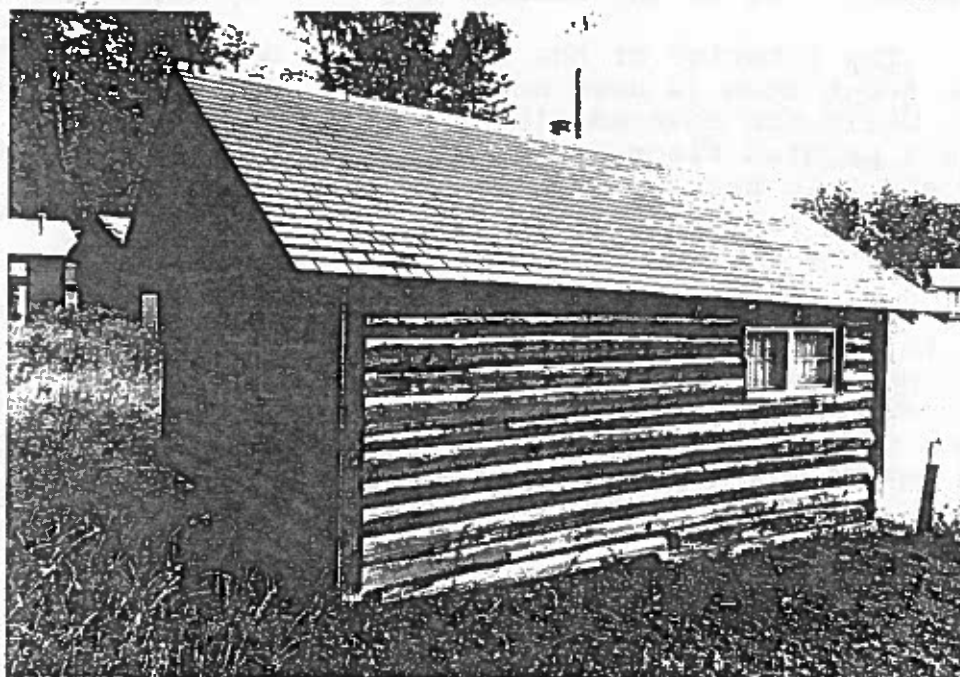
Figure 137: Looking west at cabin E5. Note the sill logs sitting on the ground where water runs up against the building causing the logs to rot. Also, note the missing daubing and the weathered wood.

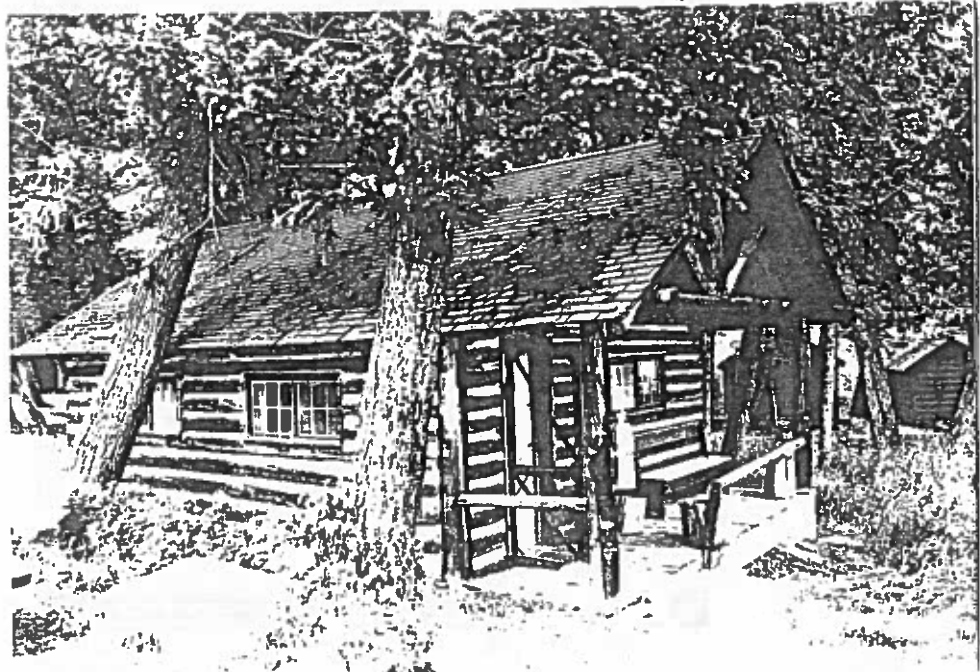
Figure 140: Looking west at the side of Miss North's cabin. Note the large tree leaning up against the roof of the cabin. There is another tree in the back pushing up against the ridge.
