# ROOSEVELT LODGE HISTORIC STRUCTURES REPORT

**ROOSEVELT LODGE  
YELLOWSTONE NATIONAL PARK  
HISTORIC STRUCTURES REPORT**

**DECEMBER 1993**

**JAMES R. MCDONALD ARCHITECTS  
224 NORTH HIGGINS AVENUE  
P.O. BOX 8163  
MISSOULA, MONTANA 59807**

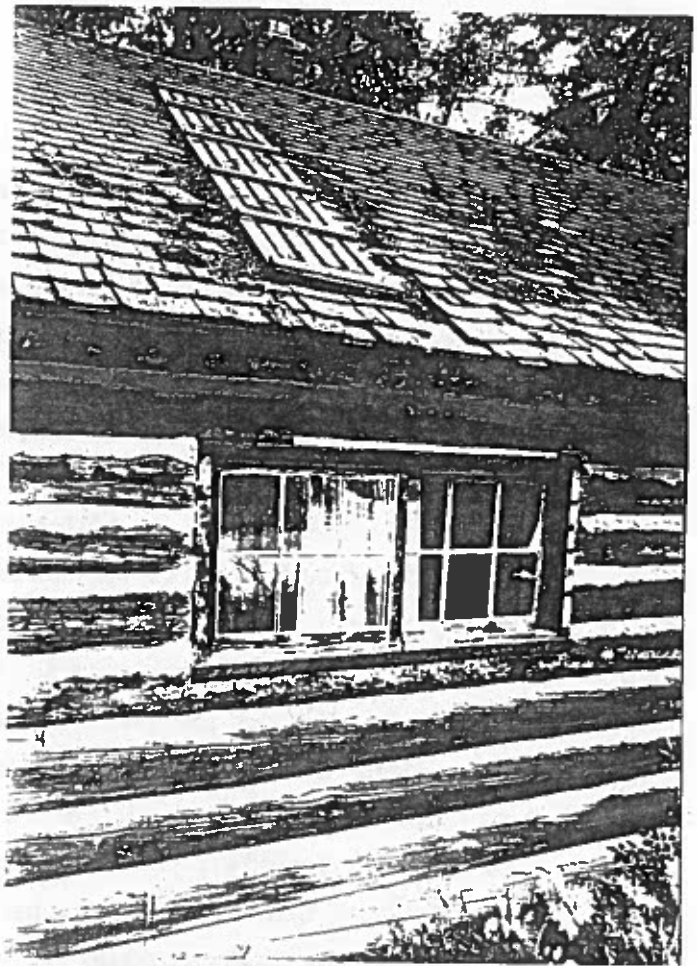
Figure 142: Looking at the southwest corner of Miss North's cabin. Note the missing daubing and also the rotted sill logs and corner post.

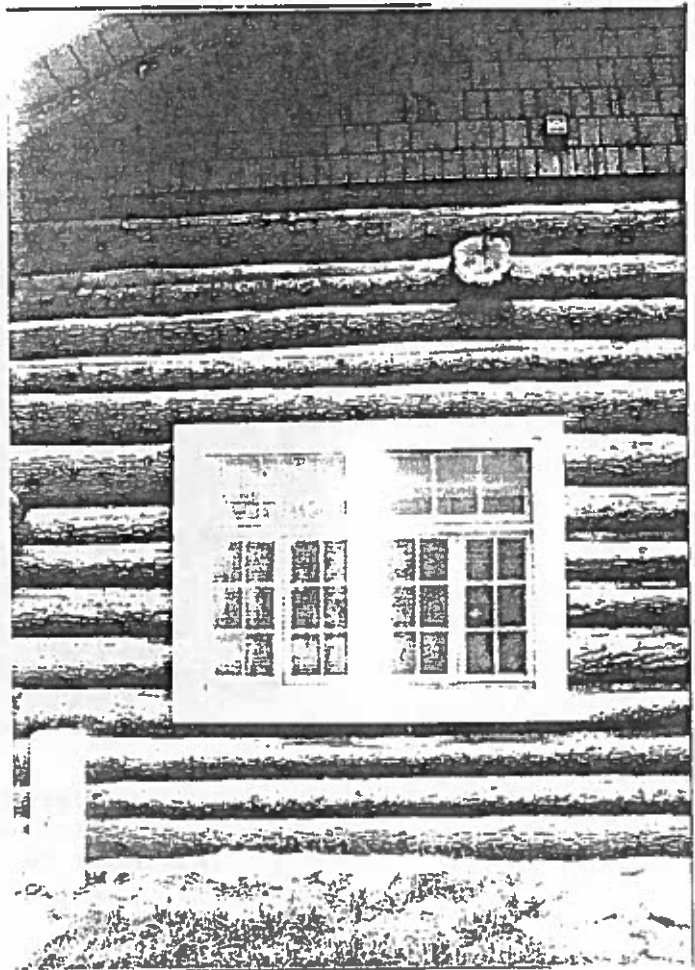
Figure 159: Looking east at the end of the Lodge. The logs on this side of the building appear to have a lot of rot and are deteriorating.

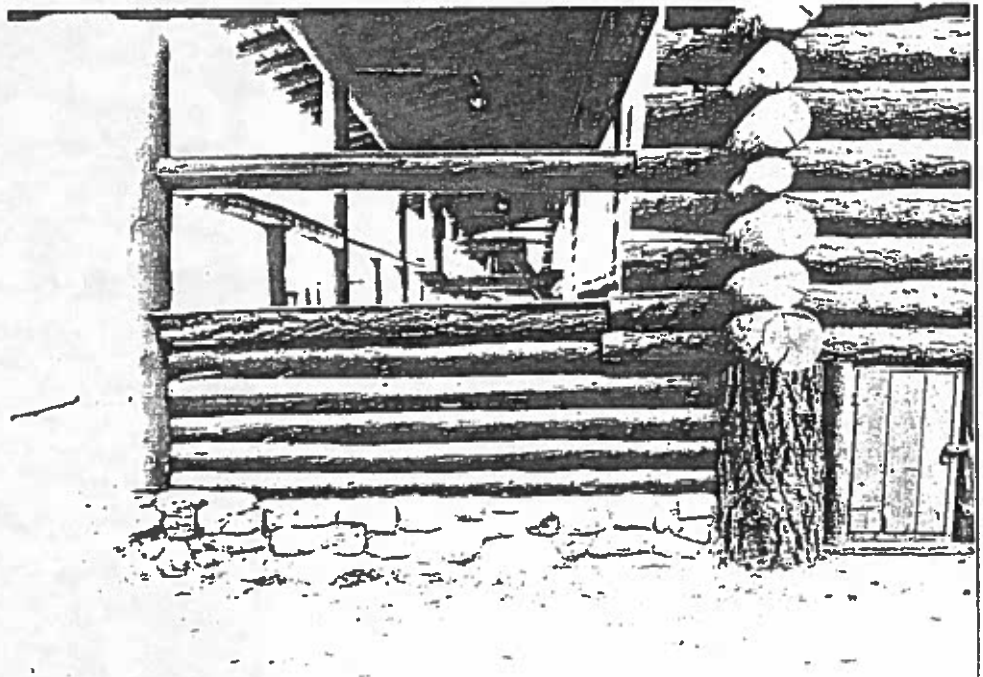
Figure 162: Looking at the west end of the porch. The corners are rotting at the base.

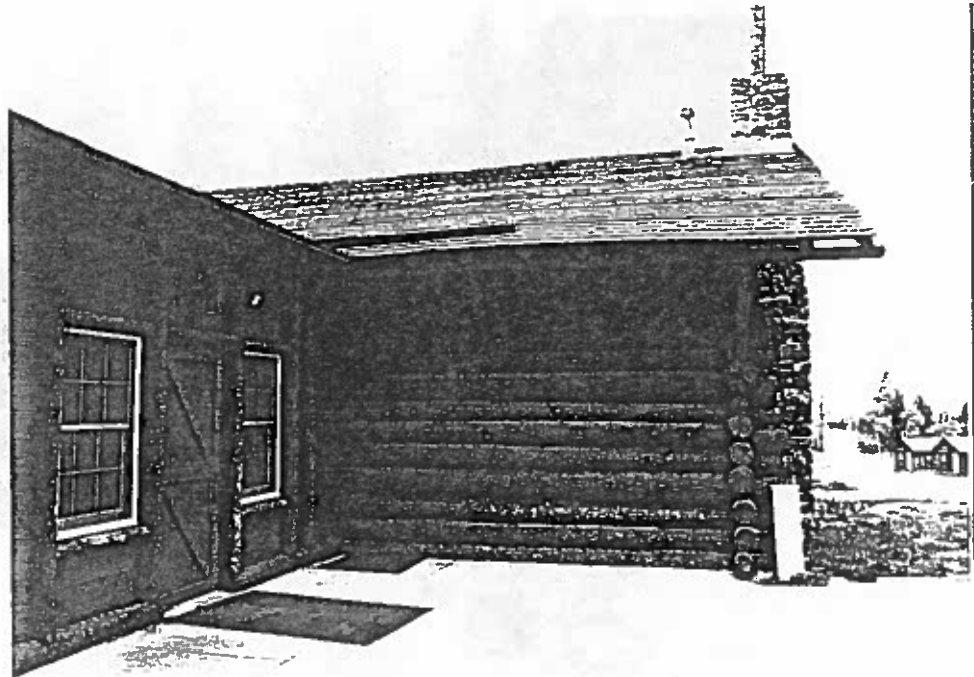
Figure 164: Looking north at the intersection of the Lodge and the new addition on the east side. There is some rot in the sill logs due to the concrete up against the logs causing water to flow up to or splash the logs.

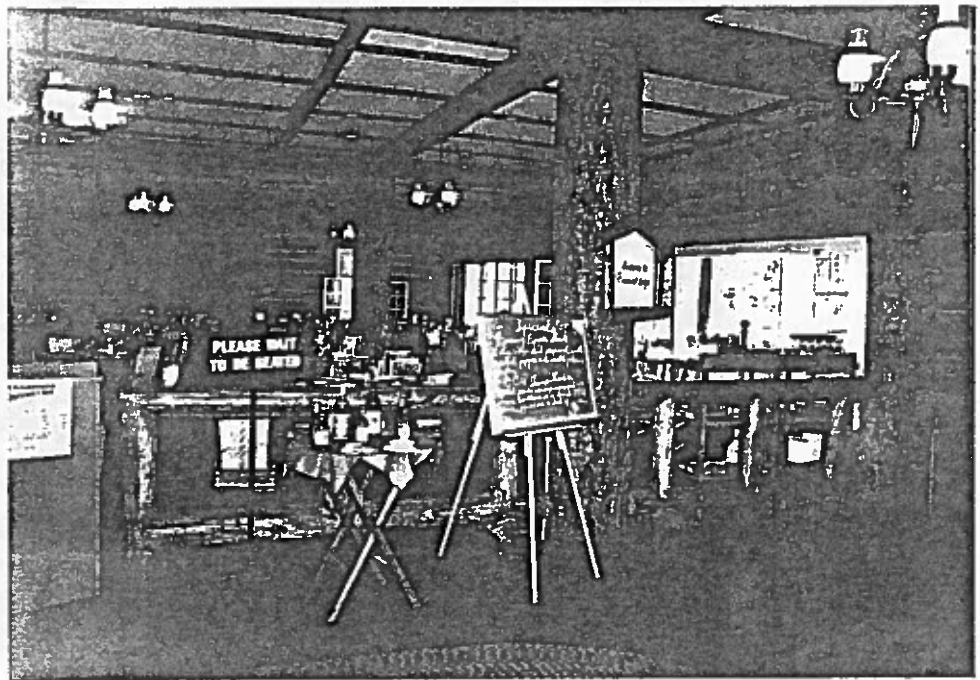
Figure 170: Looking at the log railing separating the dining area from the rest of the Lodge lobby. Note the signs and clutter that fill up the space.

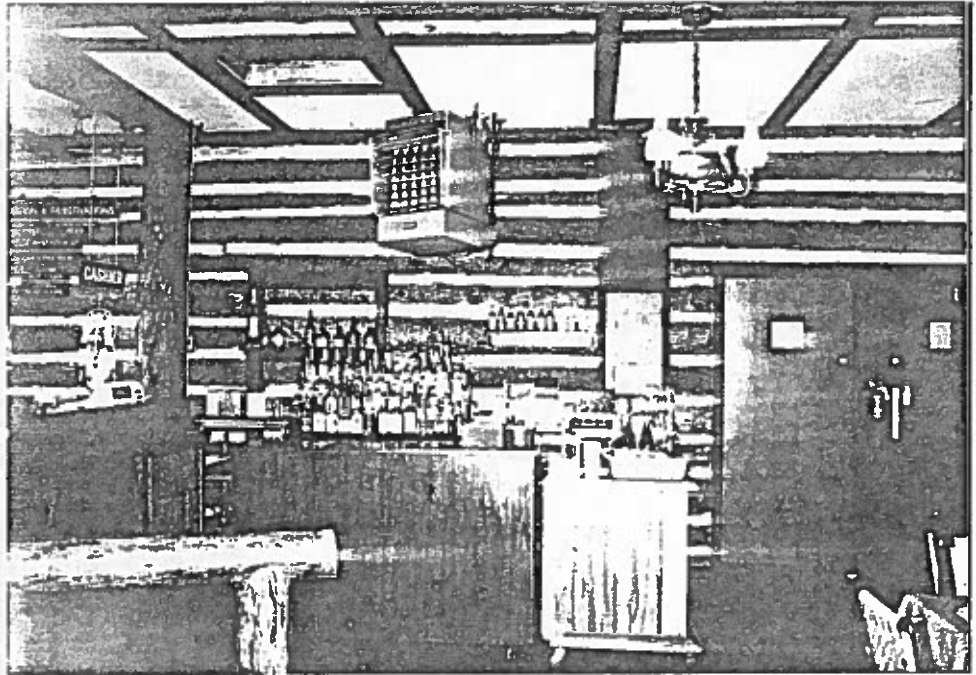
Figure 174: Looking at the bar area and entrance to the kitchen. There is a lot of clutter in this area because of the smallness of the space for the activities required.
