National Park Service  
Cultural Landscapes Inventory  
2004

South Entrance Station  
Yosemite National Park

CULTURAL LANDSCAPES INVENTORY (CLI) PROGRAM  
2009 Condition Assessment Update for:

Cultural Landscape Inventory Level II:  
South Entrance Station  
Yosemite National Park

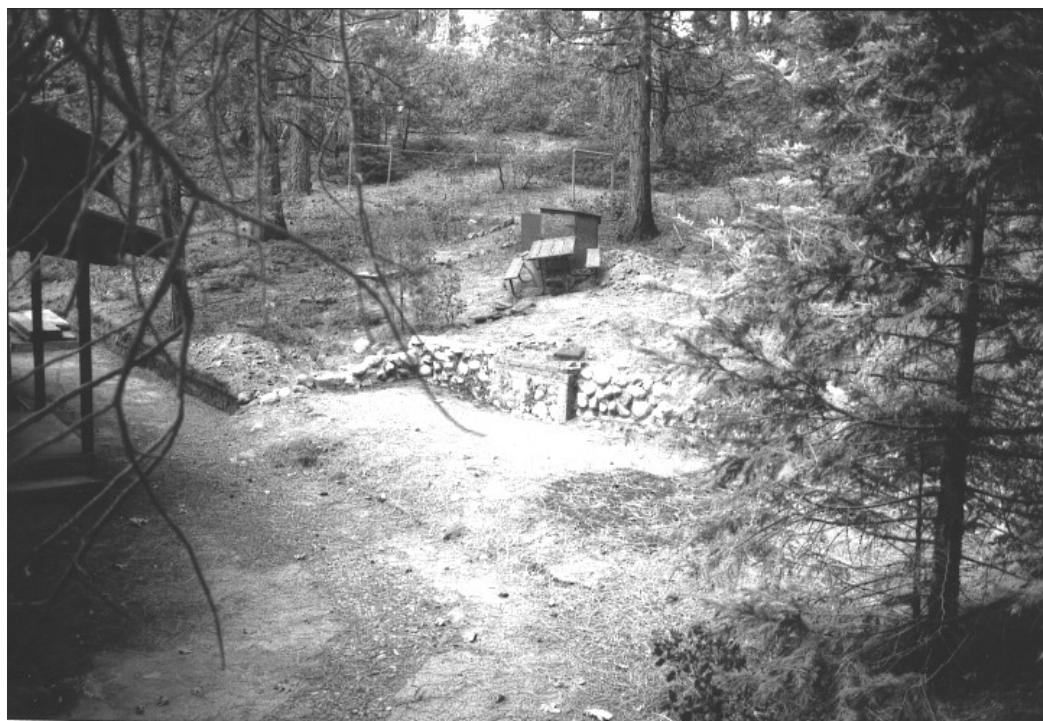
The area also contains one structure, a stone retaining wall at the rear of the ranger duplex, designed to stabilize the cut in the hill slope behind the building.

*Looking NW towards the cobblestone retaining wall at the rear of the rangers' duplex (WA04600). HRA, 1999.*

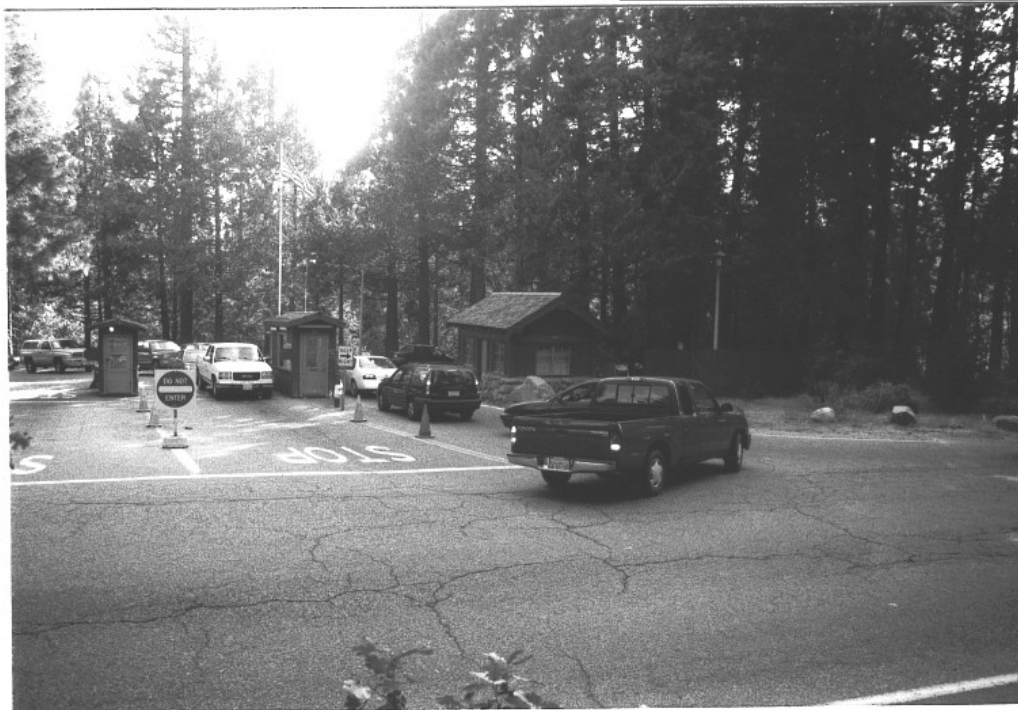
*Looking SSW to the existing intersection. Note the three lanes of traffic. HRA, 1999.*

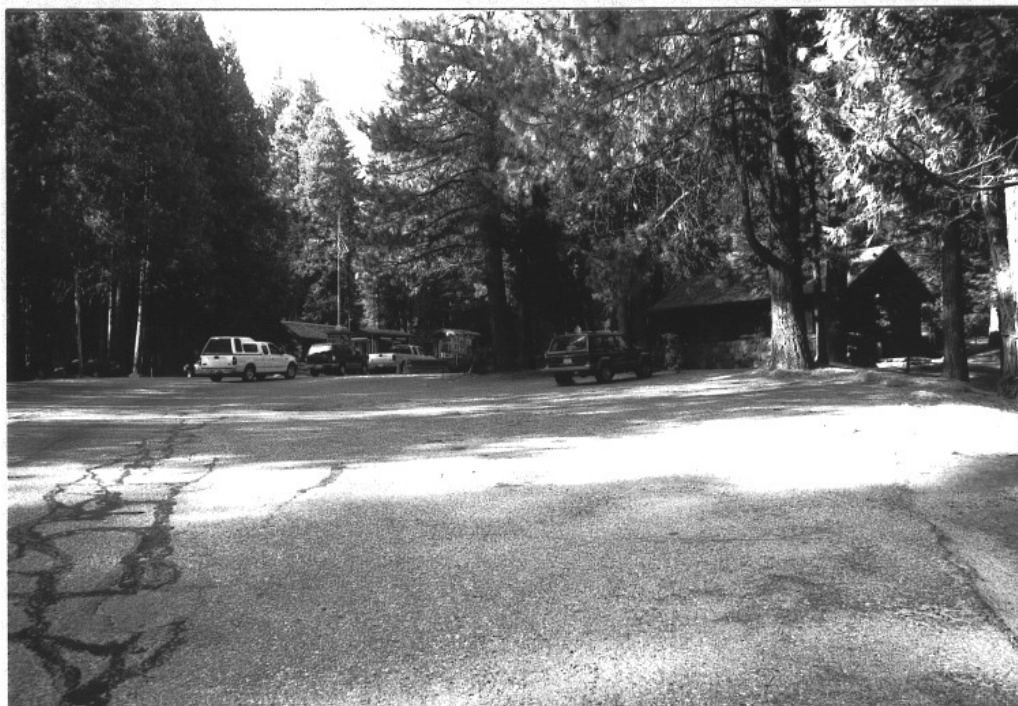
*Looking NNW to the entrance station. Note the continuous asphalt extending from the northbound driving lane through the parking area south of the comfort station. HRA, 1999*

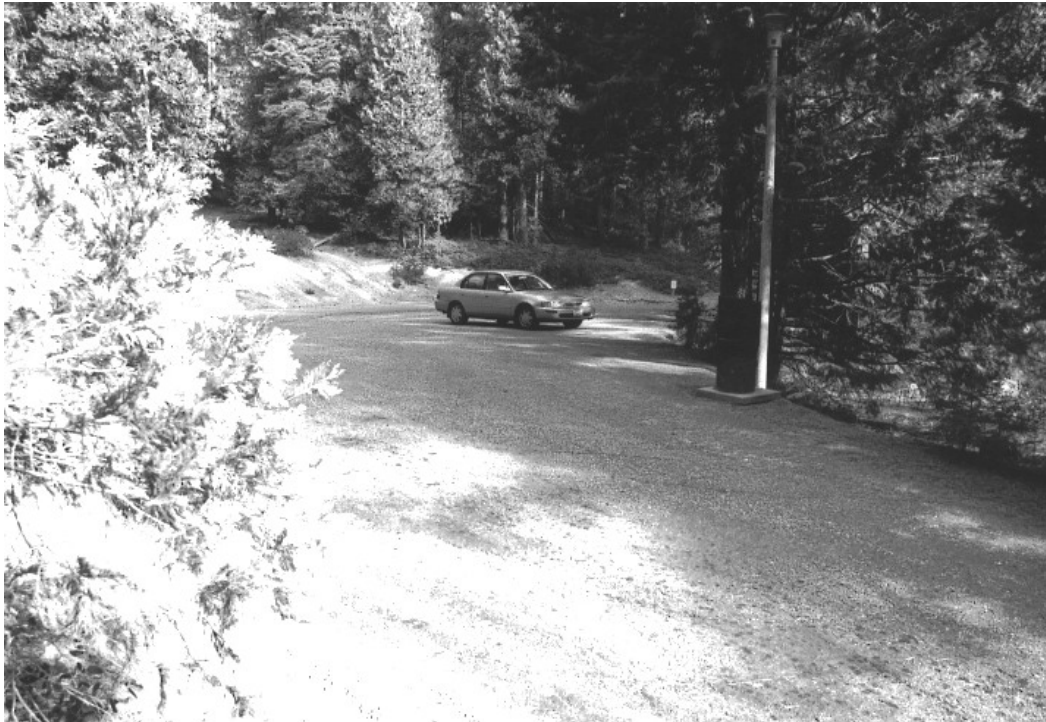
*Looking NE towards the modern parking area NE of the comfort station. HRA, 1999.*

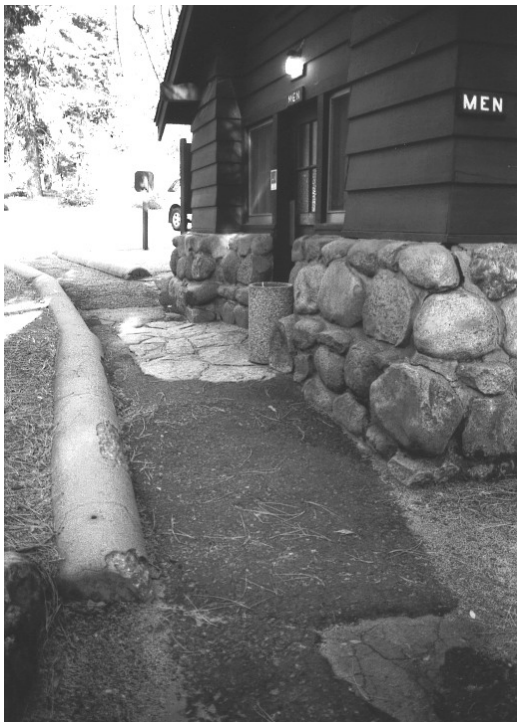
*Looking N along the asphalt path west of the comfort station (WA04606). HRA, 1999.*

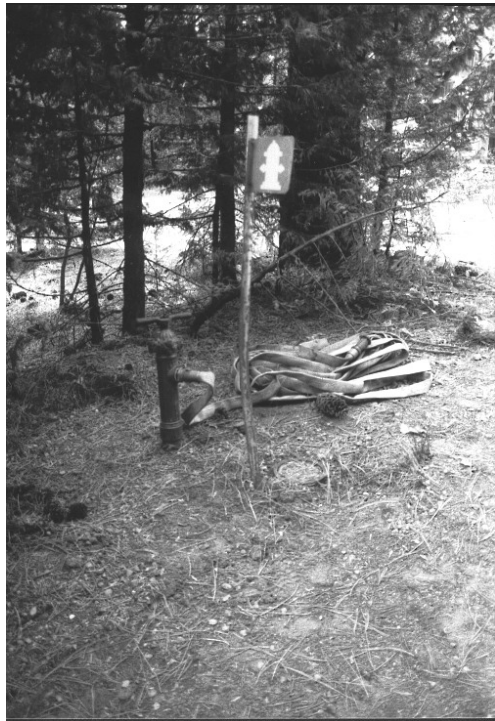
Housing Area: Historical small-scale features located in the vicinity of the housing area include a fire hydrant in the vicinity of the ranger duplex. This hydrant is still functional, and represents the only above-ground evidence of the south entrance water system in direct proximity to the buildings. (Another of these hydrants formerly was located west of the comfort station in the service area).

*Fire hydrant and hose in the vicinity of the rangers' dormitory. HRA, 1999.*

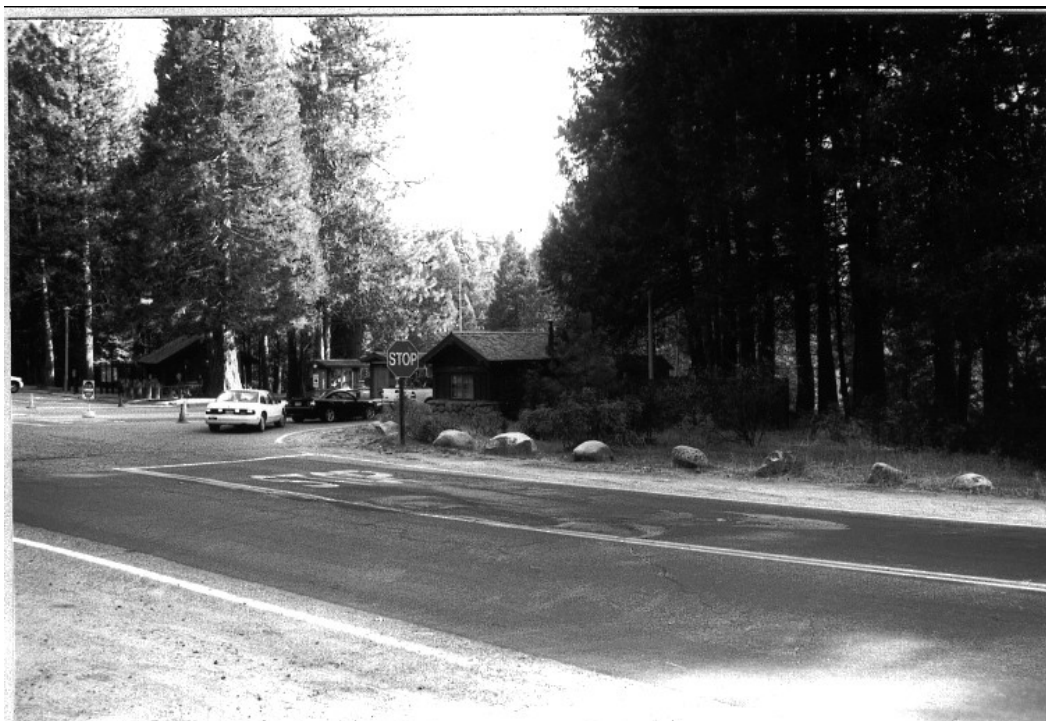
*Looking SE towards the existing intersection. Note the boulder barrier on the south shoulder of the eastbound lane. HRA, 1999.*
