# **Coal Creek Camp**

## **YUKON-CHARLEY RIVERS NATIONAL PRESERVE, ALASKA**

### **HISTORIC STRUCTURE REPORT**

**NPS Task Order #140P2021F0185**  
**April 2022**

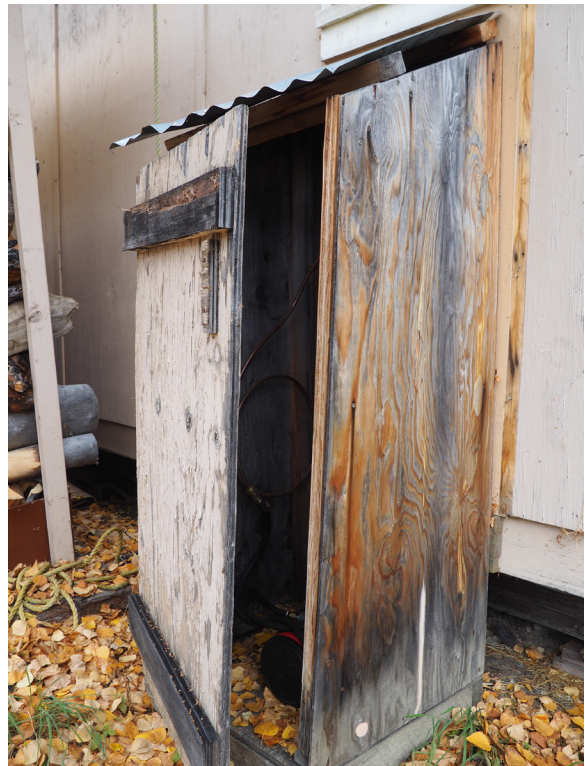
*Image 40: Severe plywood deterioration at the propane shed, west elevation.*

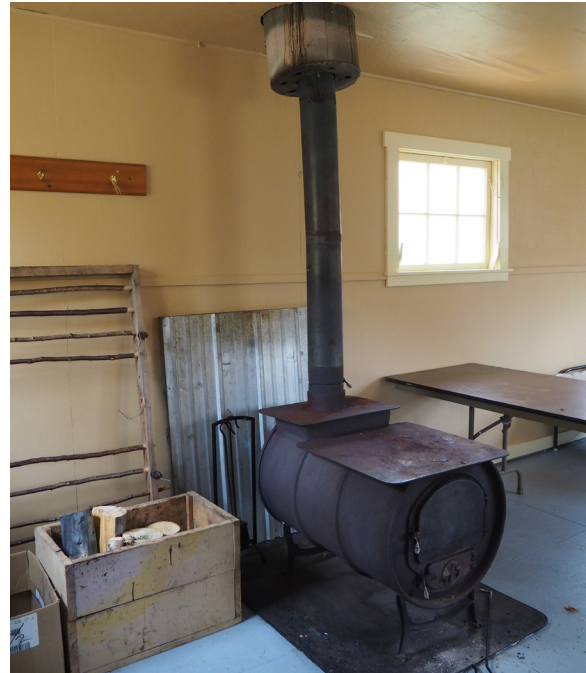
*Image 44: Wood barrel stove with surface corrosion and inadequate heat shielding at adjacent wall.*

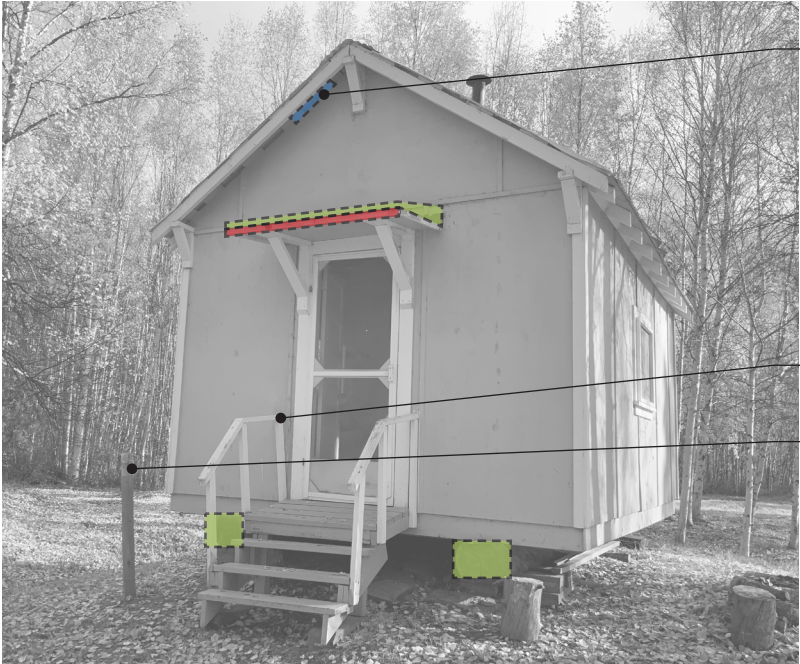
North Elevation

Metal holes

Loose rail

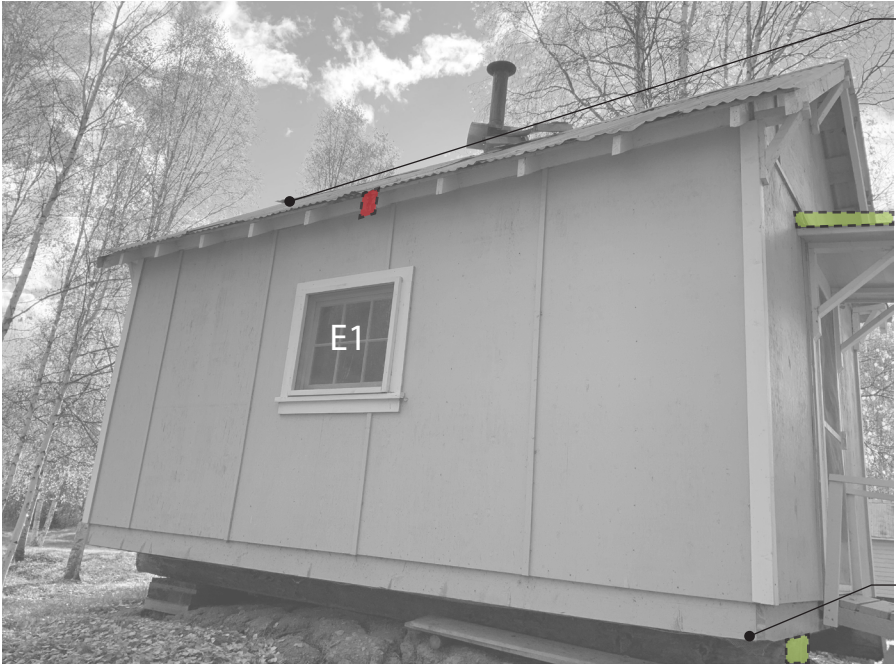
East Elevation

Loose flashing

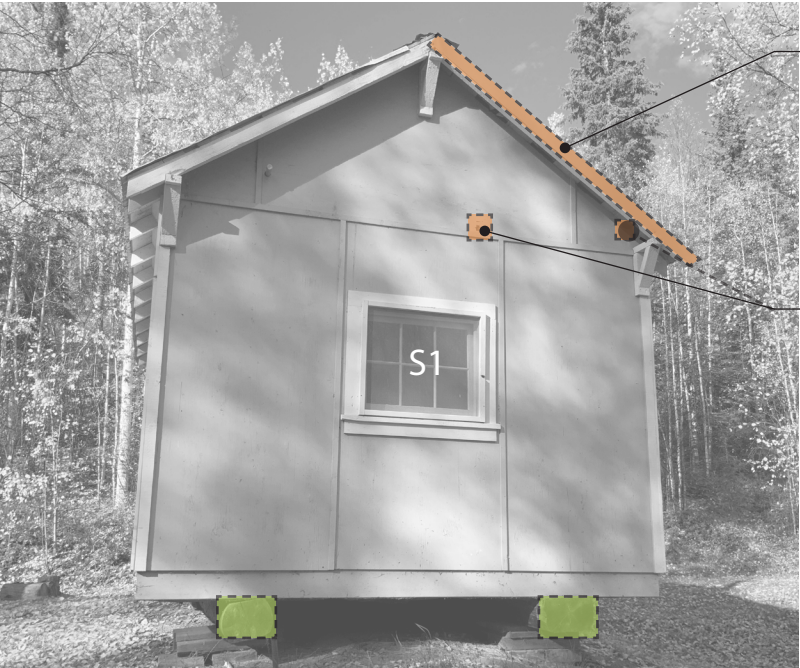
South Elevation

Galvanized flashing not original

Animal damage

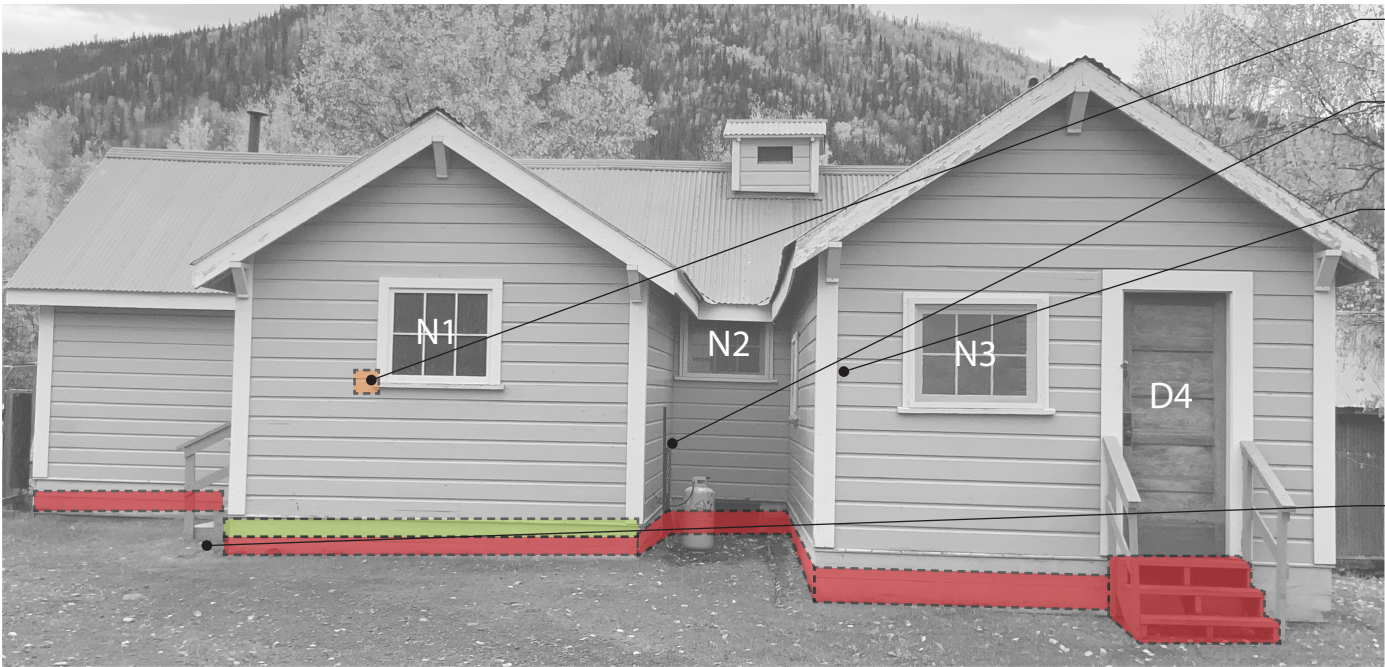
Animal damage

Gap

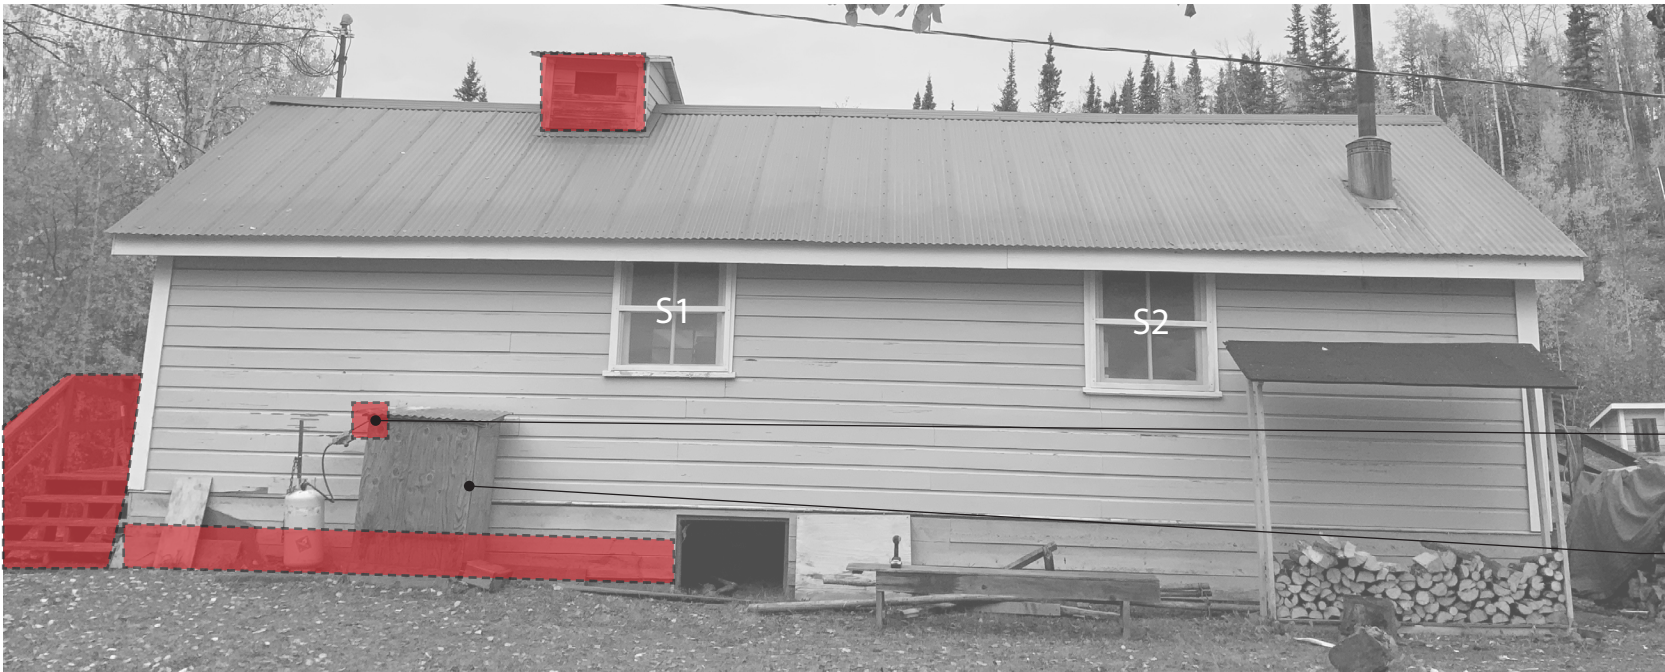
Surface rot at propane entry

Old propane shed, not used

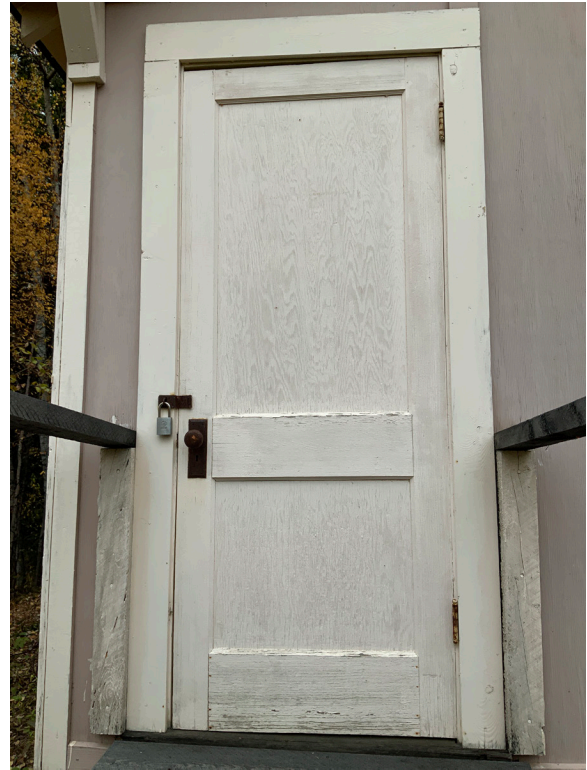
Image 239: Surface weathering at entry door.

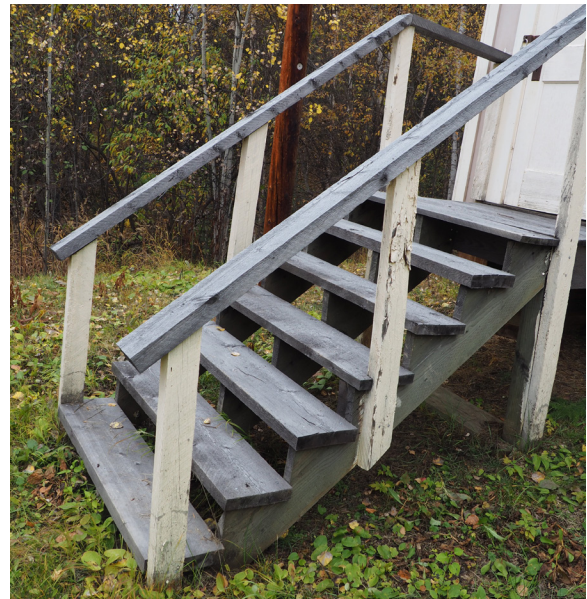
Entry stair and handrails do not meet code for landing requirements, tread or riser dimensions, and handrail heights and profiles. The stair and handrail are in poor condition with severe wood rot and unstable treads.

Image 240: Severe wood rot at entry stair.

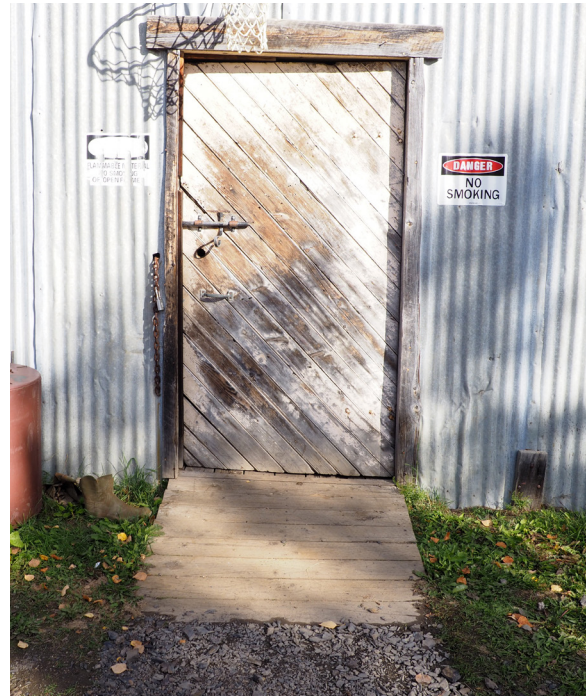
Image 248: West entry with surface deterioration at exterior.

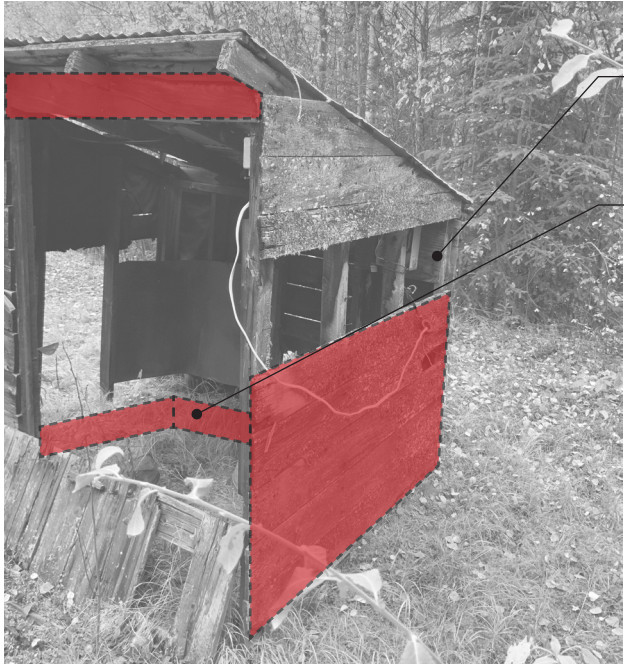
North Elevation

Two missing boards

Moderate rot at sill plate

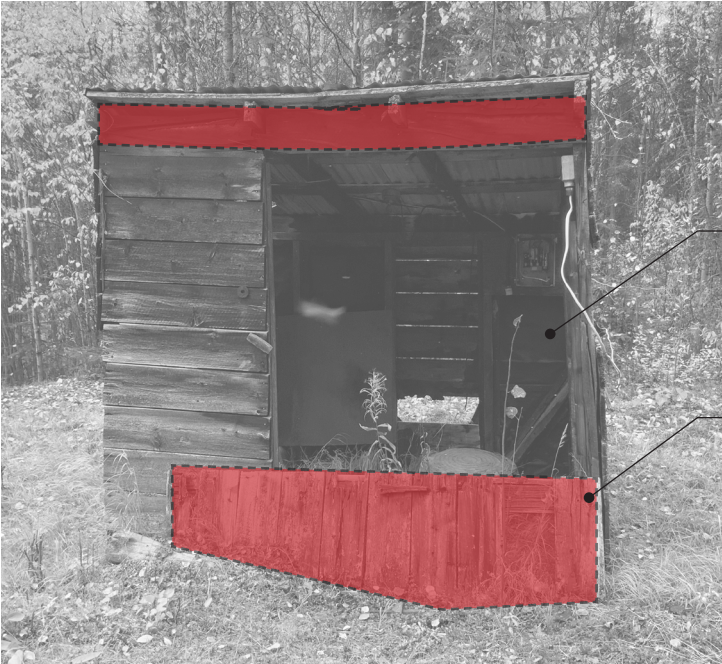
Missing door

Deteriorated door

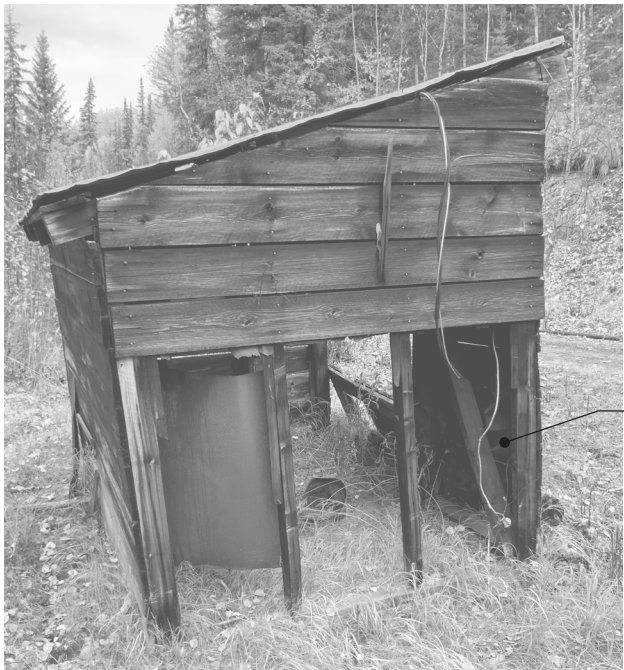
South Elevation

Six missing boards

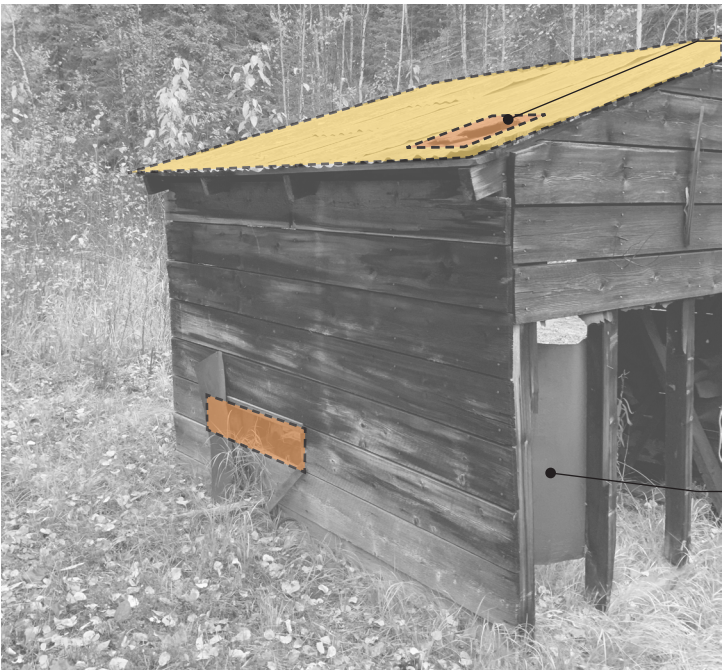
Hole

Abandoned stove insulation panel
