HISTORIC STRUCTURE REPORT

SOUTHWEST REGION HEADQUARTERS BUILDING
SANTA FE, NEW MEXICO

Southwest Cultural Resources Center Professional Paper No. 6
U.S. Department of the Interior
National Park Service
Santa Fe, New Mexico
March 1985

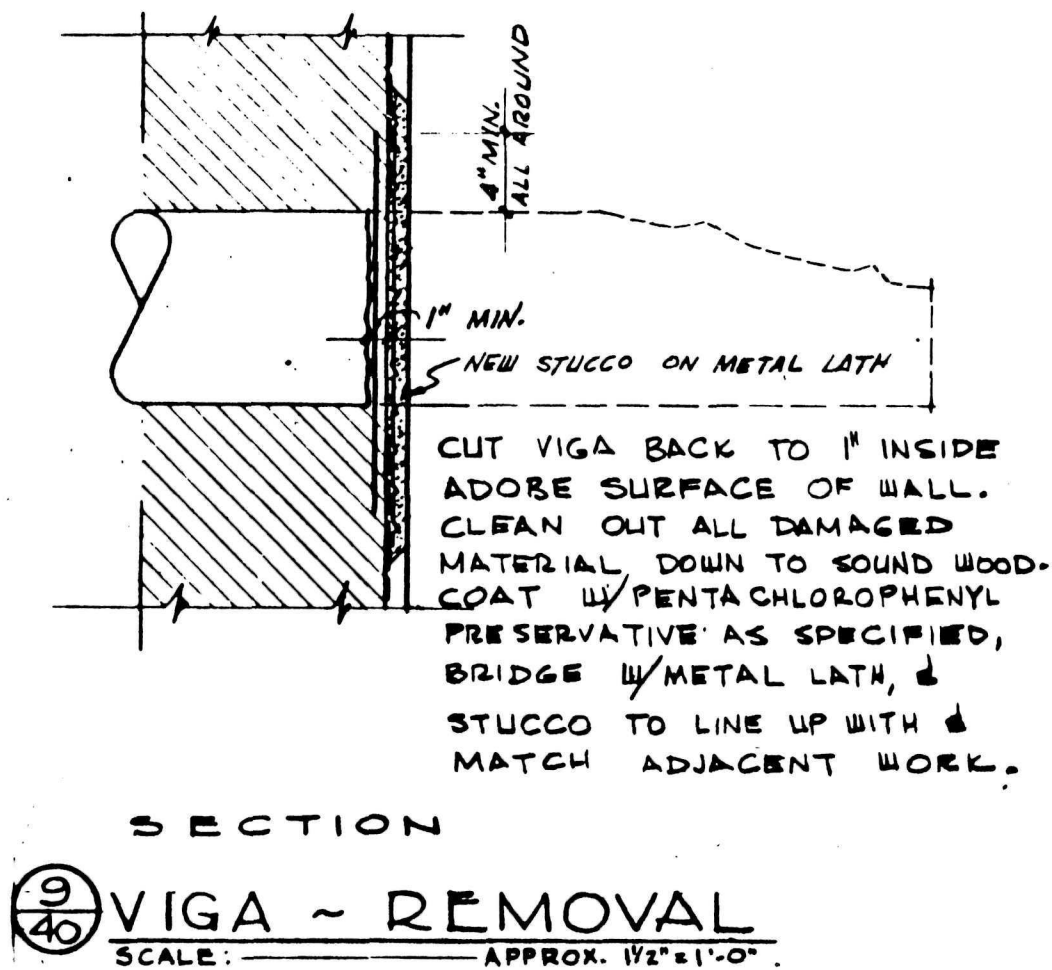
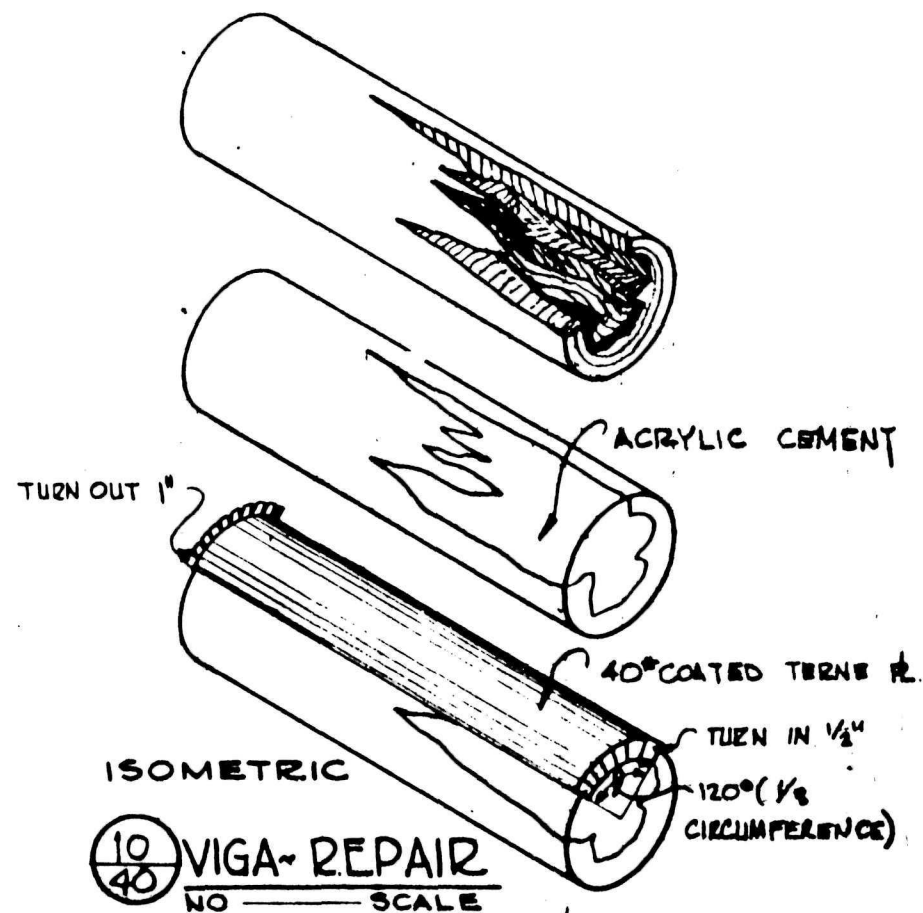
Figure 47.

The viga removal and repair plan shows many of the materials and techniques used when replacing vigas.

During the 1967 remodeling, half of the 209 vigas were in immediate need of repair or replacement. Where the exposed upper surfaces or ends of the vigas were in a severe state of decay, the rotted wood was removed and the viga was rebuilt to its original shape with an acrylic cement. After the cement had set, the viga tops were covered with a metalterne plate and cut back to a maximum projection of 2 feet. Of all the vigas repaired, only two were removed entirely. One of these was on the east side of the building and the other on the west side of the large patio. After the ends had been removed, the

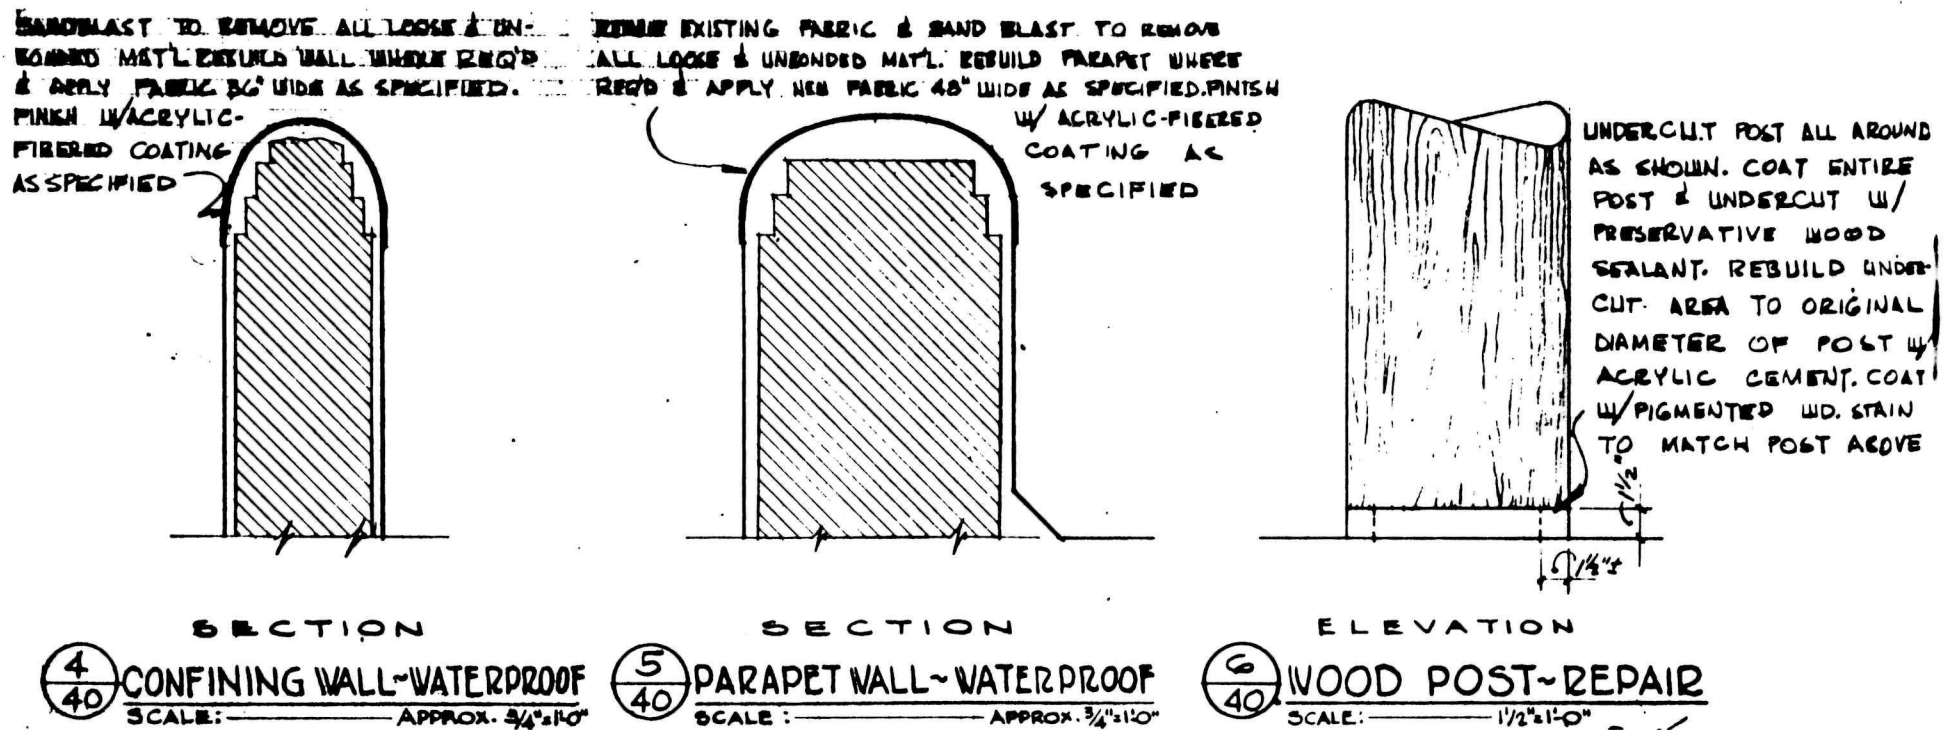
Figure 48.

Parapet and wood post details show how the wood posts were undercut and rebuilt with an acrylic cement. Waterproofing of parapet walls was also done at this time.

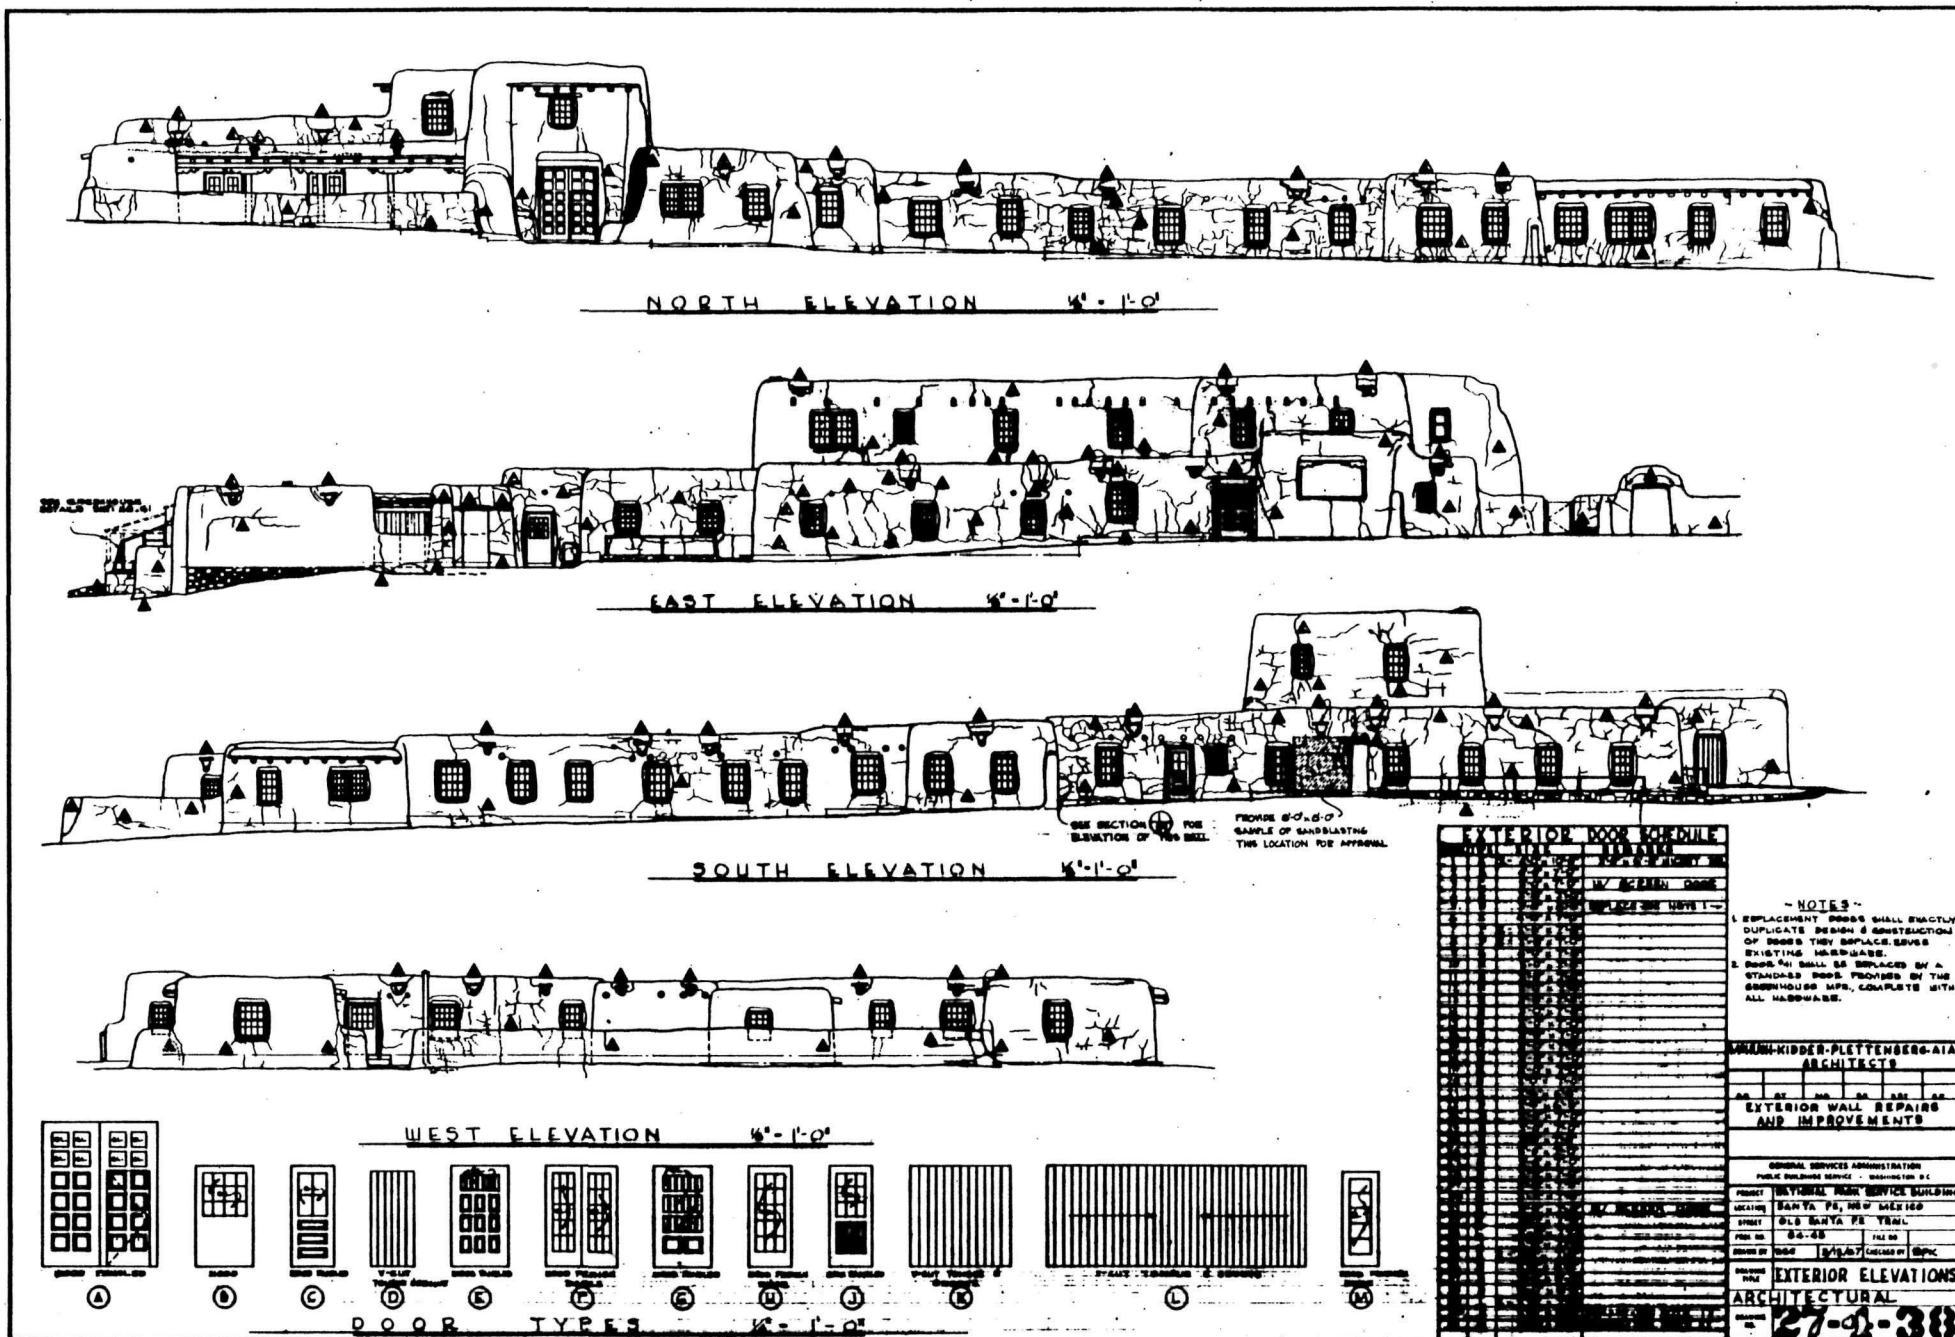
Figure 50.

Exterior elevation plans showing a number of exterior cracks. Also shown are a number of door types and an exterior door schedule.

After all the cracks and structural failures were repaired, the interior walls throughout the building were painted "cream," with the dado "terra cotta." Both colors were chosen to match the original paint. Also during the

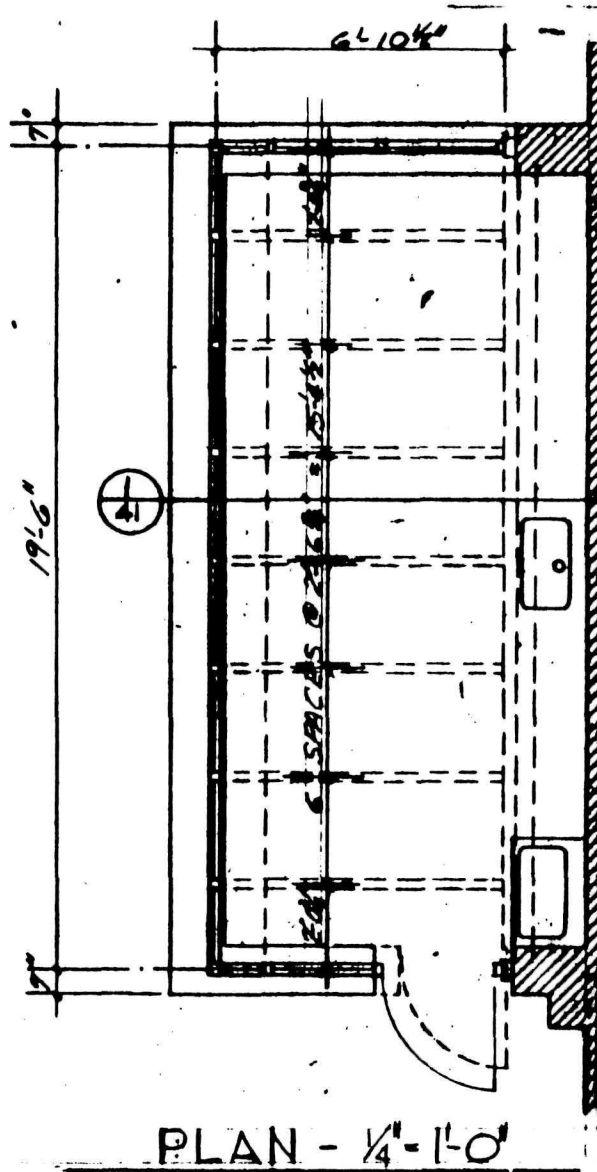
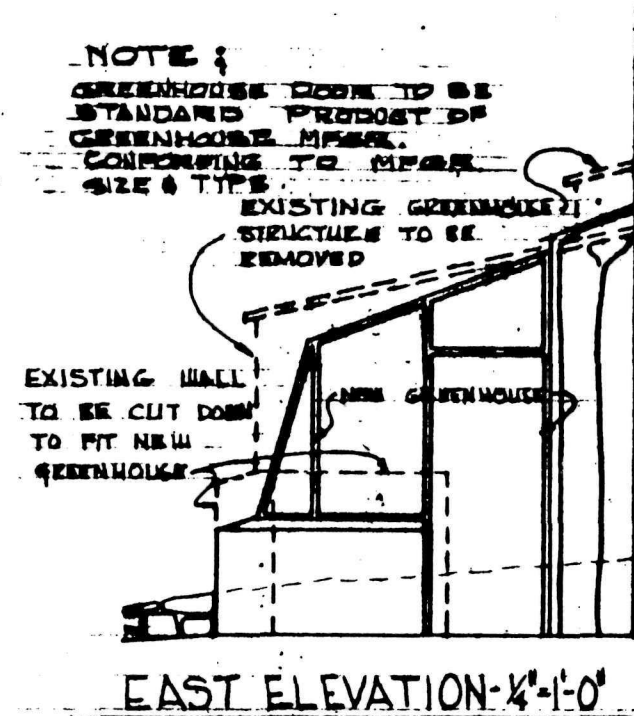
Figure 52.

Greenhouse details showing the existing greenhouse structure to be removed and replaced with a smaller more efficient one.
