RIPARIAN SYSTEM RECOVERY AFTER REMOVAL  
OF LIVESTOCK FROM SANTA ROSA ISLAND,  
CHANNEL ISLANDS NATIONAL PARK, CALIFORNIA

Technical Report NPS/NRWRD/NRTR-2004/324

December 2004

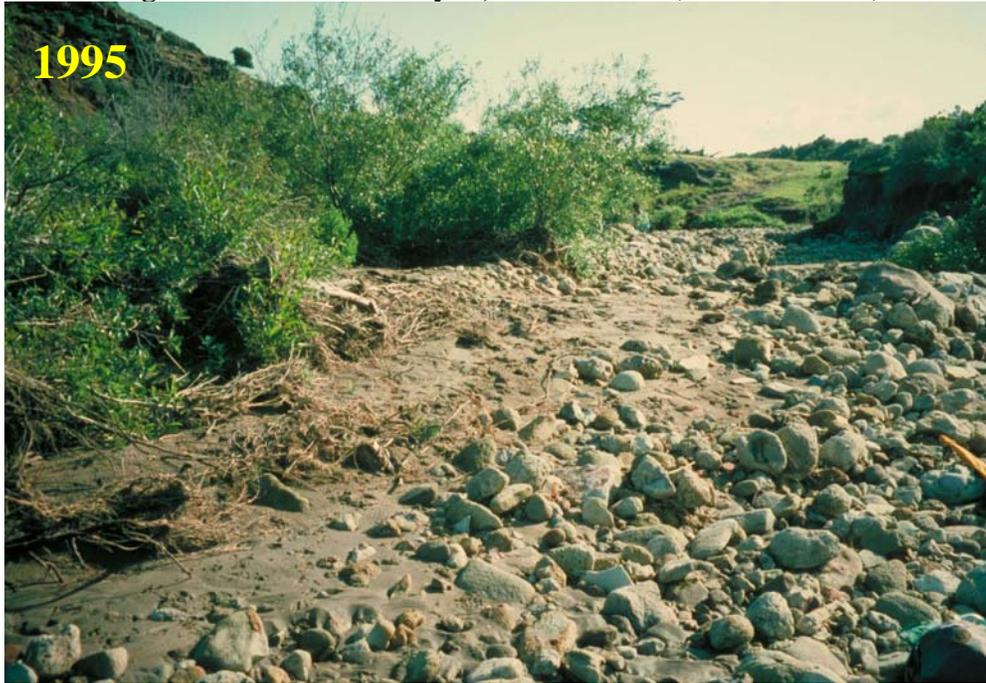
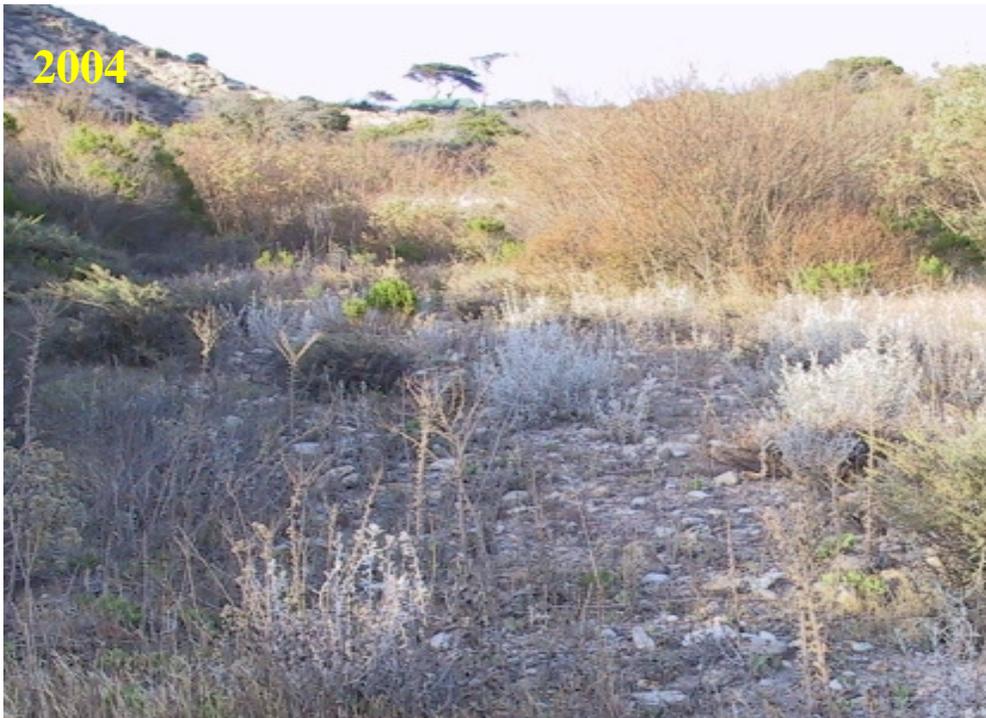
**Figure 2: Windmill Canyon, ID Reach #1 (1995 and 2004)**

Arroyo willow (*Salix lasiolepis*) is the dominant woody riparian species in this reach (several age classes are represented in the channel bottom and on the banks and bars). Mule fat (*Baccharis salicifolia*) is also present, but to a much lesser degree. As was the case in 1995, there is very little herbaceous wetland vegetation to help stabilize the system against erosion (Figure 2). The cobble and sand substrate may not retain moisture long enough near the surface in this intermittent drainage to support herbaceous wetland vegetation. The woody riparian species, which can tap into deeper water sources, are the critical factor in stabilizing this reach.

While this transitional channel form is out of balance with the landscape setting, the amount of flood energy it would take to significantly destabilize and “unravel” the system would be very high (though still possible). Our team judged the reach to be stable enough to handle a 20-year flow event or more, though some short stretches could incise as discussed above. But there are serious risk factors that could change this. The willows are highly stressed due to drought, insect damage, and severe deer and elk browsing in

the upper part of the reach. Continued willow decline could destabilize the system, allow excessive lateral erosion, and result in significant loss of wildlife value.

The team rated this reach **Functional – At Risk (High)**. The trend was rated “not apparent” because, although willows have spread substantially into the channel since 1995, all willows now appear highly stressed and may be lost. If the woody riparian community overcomes current stresses and is allowed to mature before being blown out by a large flood, and if deer and elk browsing in the watershed is brought under control (less runoff and sediment contribution), then a more efficient channel could eventually form with the stream power to move sediment through the system. Under those circumstances, the reach could eventually achieve PFC.

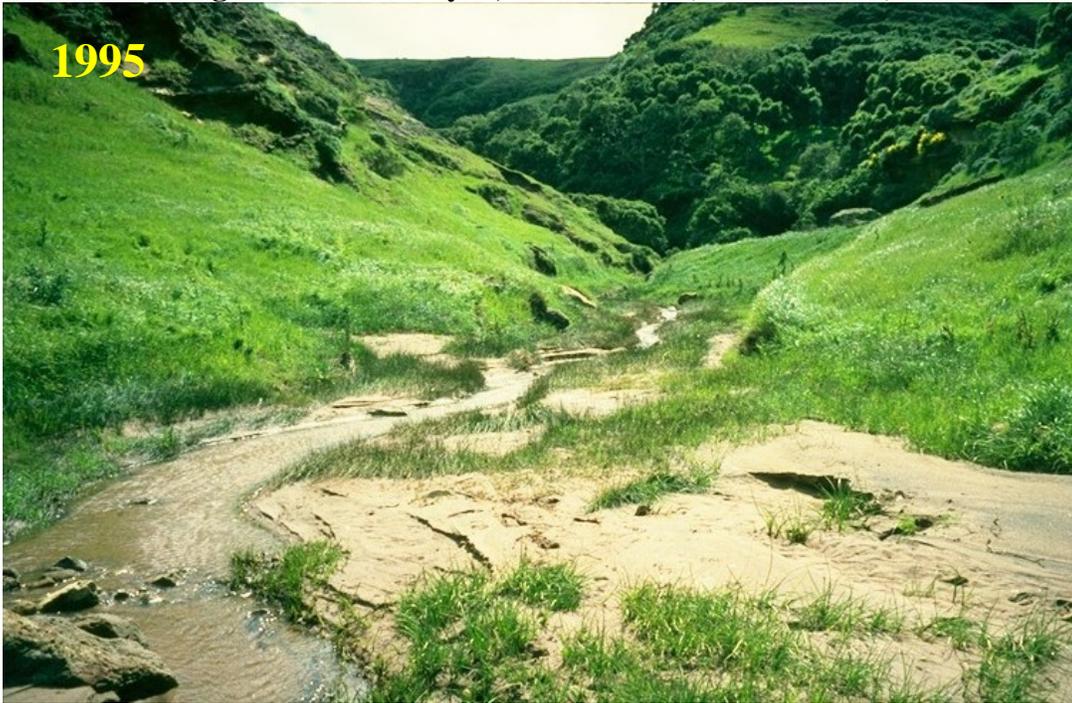
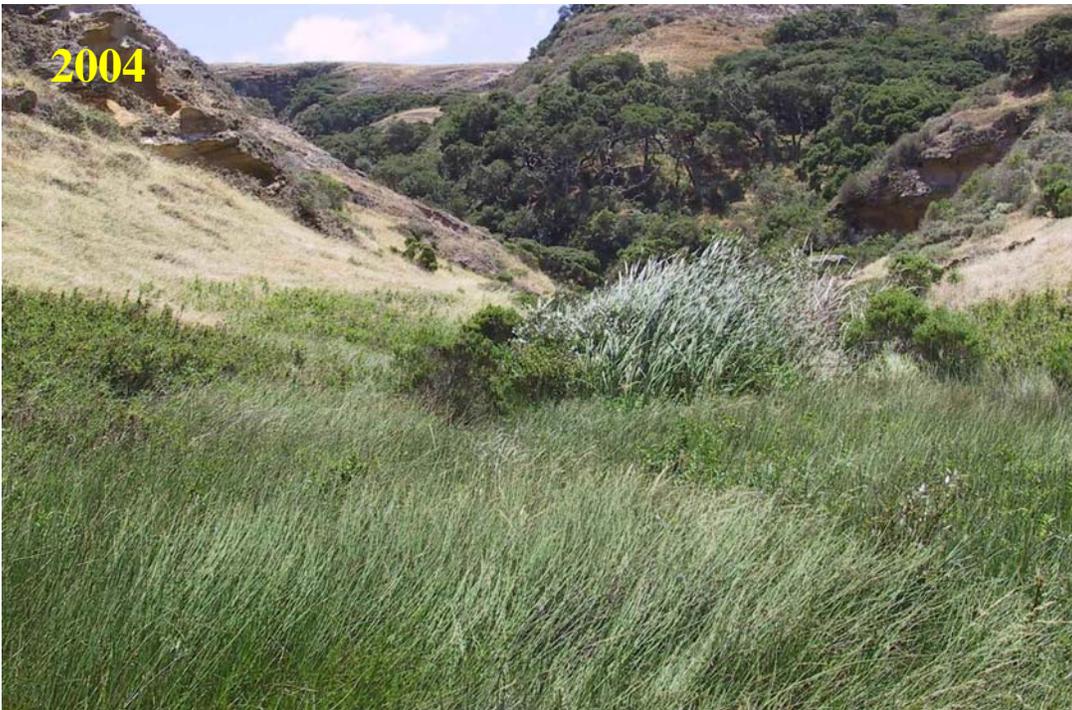
**Figure 3: Lobo Canyon, ID Reach #2 (1995 and 2004)**

1995 Assessment: Although this reach is outside of the enclosure fence that was built in 1993, the steepness of the canyon slopes discouraged cattle grazing. Therefore, it was treated as one of the three control or “reference reaches.” The 1995 team found that the riparian system was in **Proper Functioning Condition** based upon attributes such as appropriate channel and floodplain form and sufficient herbaceous vegetation to dissipate stream energies and maintain channel bank stability during large runoff events. The excessive sediment deposition evident in Figure 3 was probably derived from upland soil slips that occurred after recent heavy rains. Although somewhat out of balance with the sediment being supplied by the watershed, the riparian system was handling this excess sediment without undue changes in form or function. The team also noted that this reach was probably not at its potential relative to desired plant communities (note lack of woody riparian vegetation in Figure 3).

2004 Assessment: This reach is clearly still in **Proper Functioning Condition** based upon positive evaluations of its geomorphology, vegetation, and erosion/deposition characteristics. Channel sinuosity, width/depth ratio, and gradient are in balance with the landscape setting (i.e., landform, geology, valley slope, and bioclimatic region), and the channel is able to access the floodplain and dissipate energy in relatively frequent flow events. The stream is now in balance with the water and sediment being supplied by the watershed (no excessive erosion or deposition), which may be attributable to widespread recovery of vegetation since cattle were removed from the island.

One of the most significant changes in the reach is the strong recruitment and spread of herbaceous vegetation (see photo point comparison in Figure 3). Mexican rush (*Juncus mexicanus*), common threesquare (*Scirpus pungens*), smooth scouring rush (*Equisetum*

*laevigatum*), cattail (*Typha* sp.), and sticky Baccharis (*Baccharis douglasii*) are now the dominant species in a diverse community covering nearly 100% of the potential riparian-wetland zone. All of these native species have root masses capable of withstanding high stream flow events, providing strong protection against stream bank erosion.

Perhaps even more significant is the addition of a woody riparian component to the recovering vegetation community. Arroyo willow (*Salix lasiolepis*), which was absent in 1995, is now well-established in many areas and new recruitment was evident along much of the reach. This adds further stability to the riparian system and introduces a wildlife habitat component that was missing during the cattle grazing era. Mature willows within the former enclosure downstream (ID Reach #3) were the likely seed source for willow establishment in this reach.

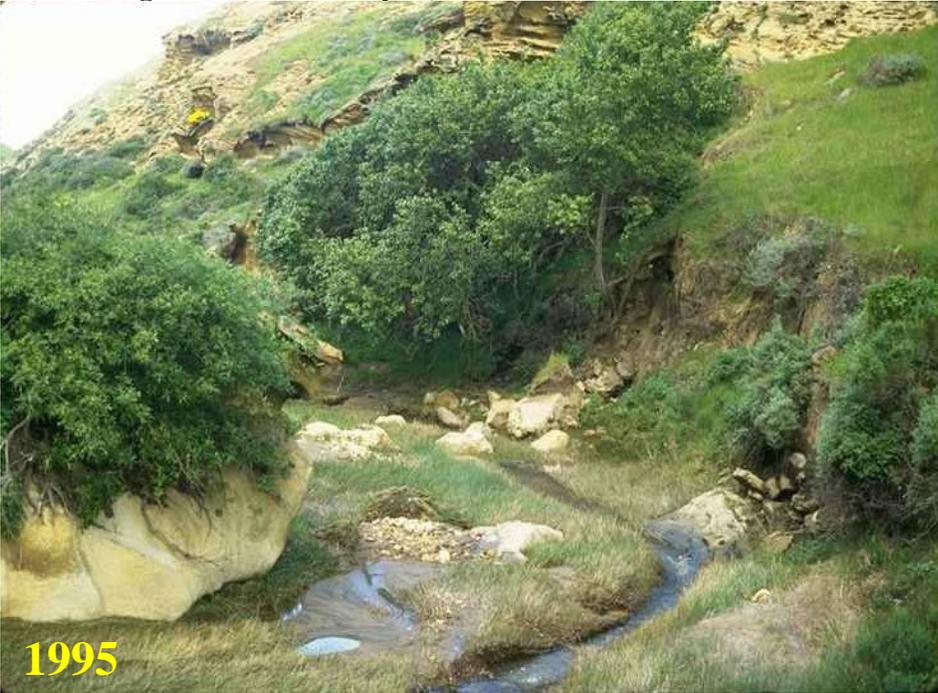
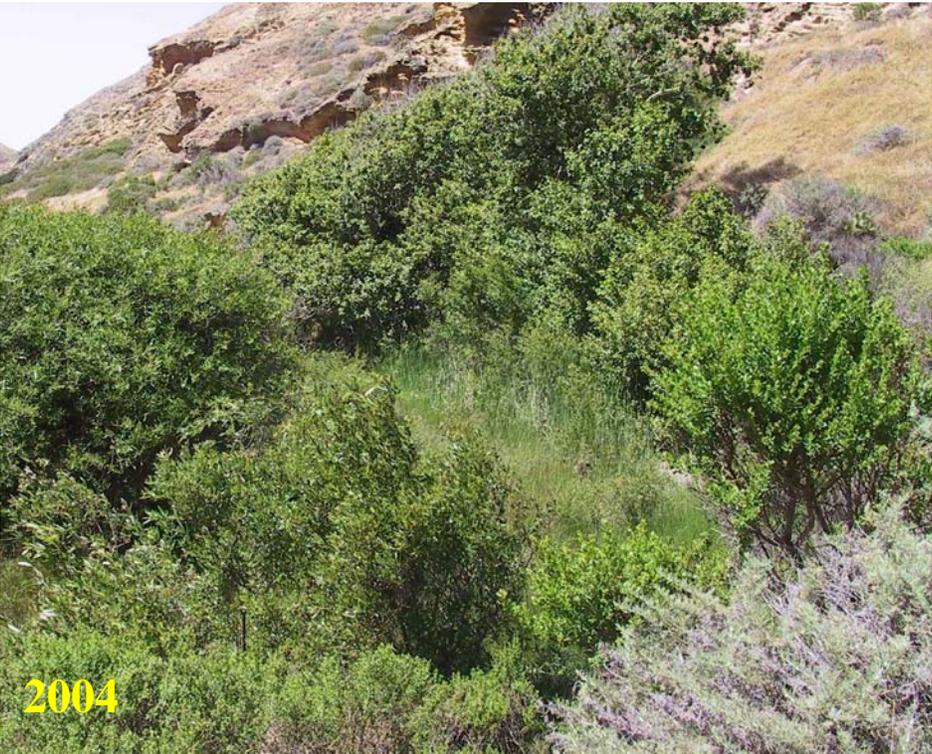
**Figure 4: Lobo Canyon, Reach ID #3 (1995 and 2004)**

Comparison of the 1995 and 2004 repeat photos (Figure 4) illustrates the striking growth, spread, and overall recovery of herbaceous and woody riparian-wetland vegetation. The dominant herbaceous plant species list expanded in 2004 to include common threesquare and smooth scouring rush. We observed very strong recruitment of arroyo willow

(several age classes represented), and the spread of native herbaceous wetland perennial species was remarkable (vegetative cover is virtually 100%). Black cottonwood is spreading vegetatively, though we did not observe recent recruitment from seed. Positive benefits from this vegetation recovery and development include more energy dissipation during flood events, increased channel bank and bed stabilization, and improved fish and wildlife habitat. Increased production and dispersal of arroyo willow and black cottonwood seeds is another important benefit, since this is one of the few healthy stands of willow and the only cottonwood stand on Santa Rosa Island.

Possible reasons for the significant vegetation recovery in this “control” reach include: 1) depending on the construction date for the fence, cattle were excluded for only 1-2 growing seasons prior to the 1995 assessment (limited time for vegetative recovery); and 2) deer/elk browsing pressure may have been significantly reduced in Lobo Canyon after cattle were removed from the island, deer numbers were greatly reduced, and vegetation recovery progressed island-wide (many more sources of riparian-wetland vegetation became available).

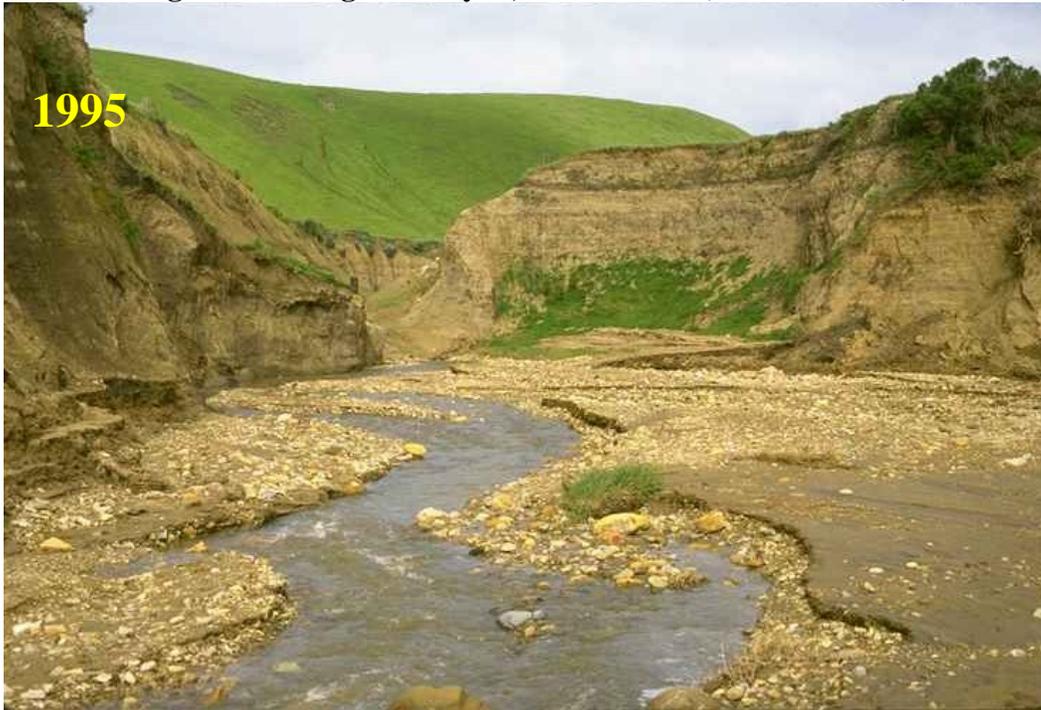
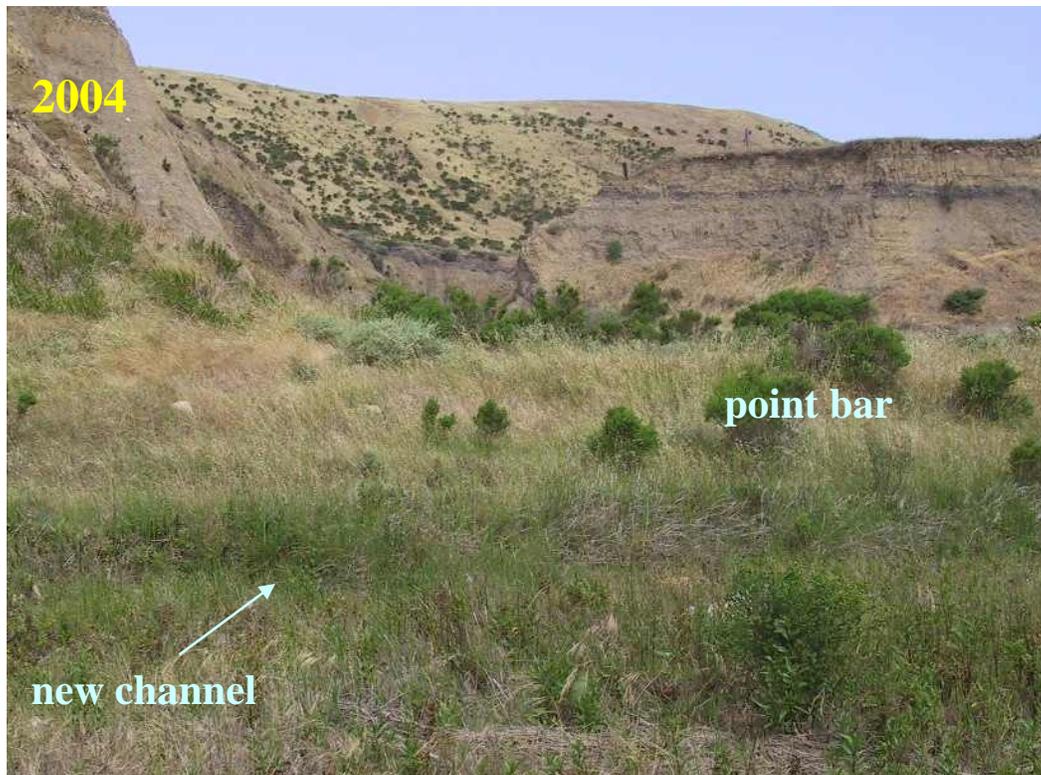
**Figure 5: Arlington Canyon, Reach ID #5 (1995 and 2004)**

1995 Assessment: The 1995 team conducted separate assessments on three contiguous reaches in Arlington Canyon, and all were rated **Nonfunctional**. Only subtle differences existed between their hydrologic, geomorphic, vegetation, and erosion/deposition attributes, so they were grouped together for analysis. These reaches were missing almost all of the components required for a properly functioning riparian area. An oversupply of sediment from upland and channel sources had exceeded the stream’s transport capability, resulting in a mostly braided channel form, high lateral instability, high width/depth ratios, and other characteristics that were out of balance with the landscape setting (Figure 5). Riparian-wetland vegetation was absent, exposing banks to excessive erosion in each flood event. Vertical stability due to bedrock control and low to moderate gradients led the team to conclude that Arlington Canyon had a high potential for natural riparian restoration if appropriate grazing management changes were made.

2004 Assessment: We walked the three reaches identified by the 1995 team and conducted PFC assessments on ID Reach #4 and on ID Reaches #5 and #6 (combined). Results of these assessments were very similar to each other in their hydrologic, geomorphic, vegetation, and erosion/deposition attributes (see PFC Checklist responses and notes in the Appendix), so they are grouped together here for comparison to the 1995 Arlington Canyon conditions. Based upon the team’s evaluation of these attributes, Reaches 4-6 have recovered to **Proper Functioning Condition** since 1995.

Arlington Canyon experienced what may be the most dramatic recovery of riparian systems on the island after removal of cattle. Repeat photography in Figure 5 shows such significant geomorphic and vegetative change that only canyon wall features and other upland reference points confirm that the photos were taken from the same location. The sediment-choked, braided channel evident in most stream segments in 1995 has progressed to a narrower, deeper, meandering channel with a well-developed floodplain and a gradient that is in balance with the landscape setting. Recovery of chaparral and riparian vegetation has apparently reduced excess runoff and erosion to the point where the stream is now in balance with the water and sediment being supplied by the watershed. Point bar development along the new meandering channel is one of the most striking geomorphic changes. For example, the large point bar at the center of the photo in Figure 5, which rises several feet above the current channel, did not exist in 1995.

In contrast to 1995 conditions when vegetation was largely absent, there has since been very strong establishment of bank-stabilizing herbaceous wetland vegetation along the channel. We observed >90% cover of such wetland species on >90% of the channel banks (except for the narrow shale bedrock segments where such cover is not possible and not necessary to maintain stability). The two most dominant wetland species, saltgrass (*Distichlis spicata*) and sticky Baccharis (*Baccharis douglasii*) are native perennials with root masses capable of withstanding high stream flow events, providing strong protection against stream bank erosion. The third dominant, water bent grass (*Agrostis viridis*), is non-native, but it is also a perennial wetland species with good soil stabilizing capability.

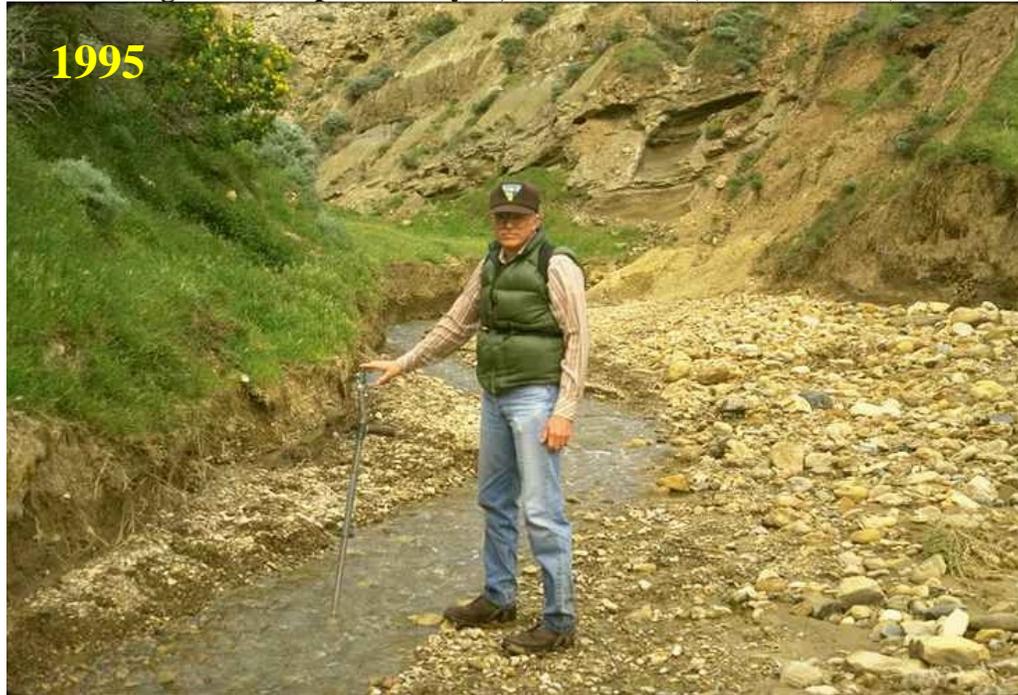
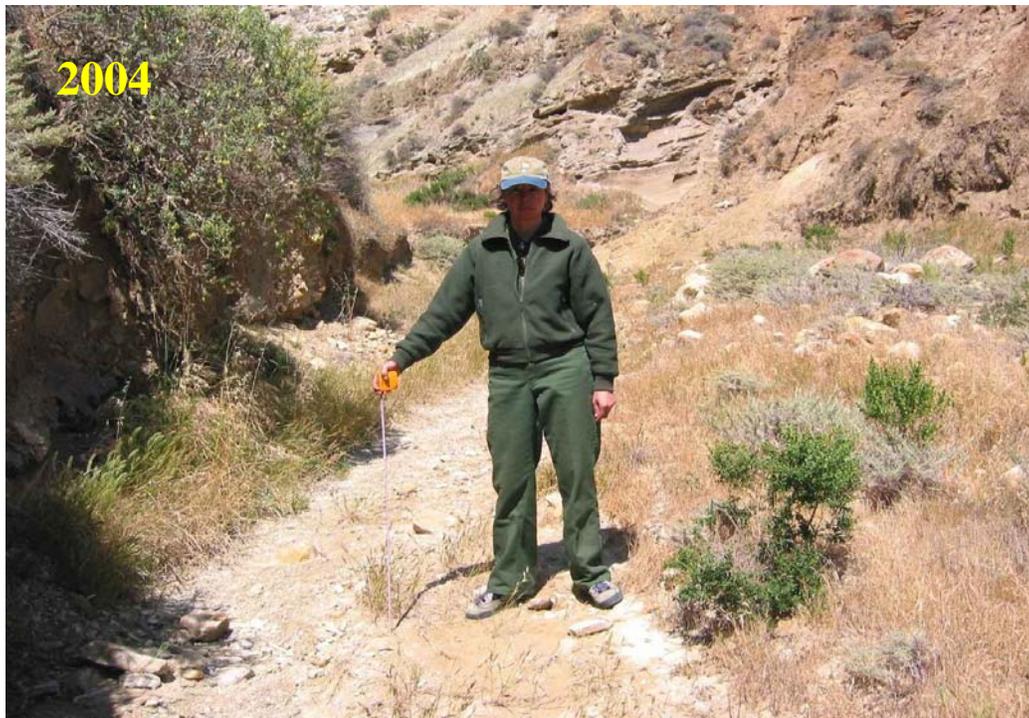
**Figure 6: Acapulco Canyon, Reach ID #7 (1995 and 2004)**

The most notable difference in the 2004 assessment is the establishment of limited herbaceous wetland vegetation on the channel banks and some stabilizing vegetation on the floodplain. The only two riparian-wetland species observed, saltgrass and water bent grass, have root masses capable of withstanding large flows. However, cover was much more patchy than in the other recovering watersheds we visited (<70% cover on <70% of the streambank area), diversity was obviously low, and there was no woody riparian component to the community.

Based upon the limited amount of stabilizing riparian-wetland vegetation recovery, the 2004 team determined that the riparian system in Acapulco Canyon is still **Functional At-Risk (Limited)**. At a minimum, the system could revert to 1995 conditions in a moderate to large runoff event, even if it doesn't come completely unraveled geomorphically. However, we rated the trend as "upward" (compared to "not apparent" in 1995) based on the establishment of bank-stabilizing and energy-dissipating vegetation in many channel bank and floodplain areas where it did not exist in 1995. Continued recovery of perennial herbaceous riparian-wetland vegetation along the channel banks and floodplain (more diverse communities with more complete cover) may bring this stream system into Proper Functioning Condition in the future.

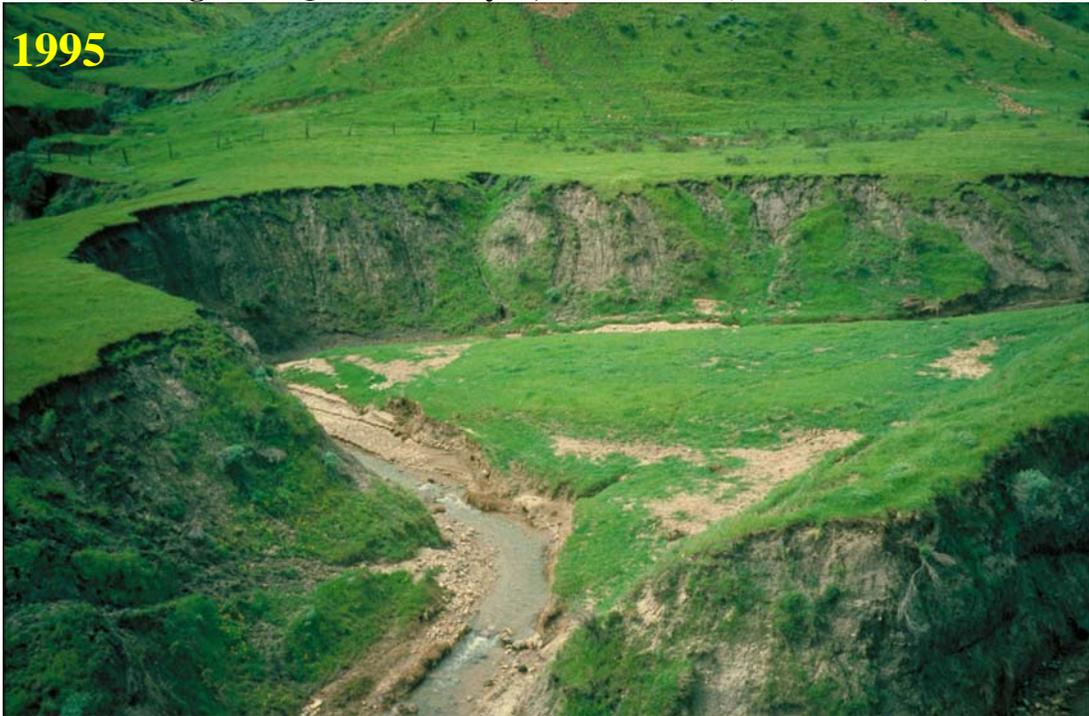
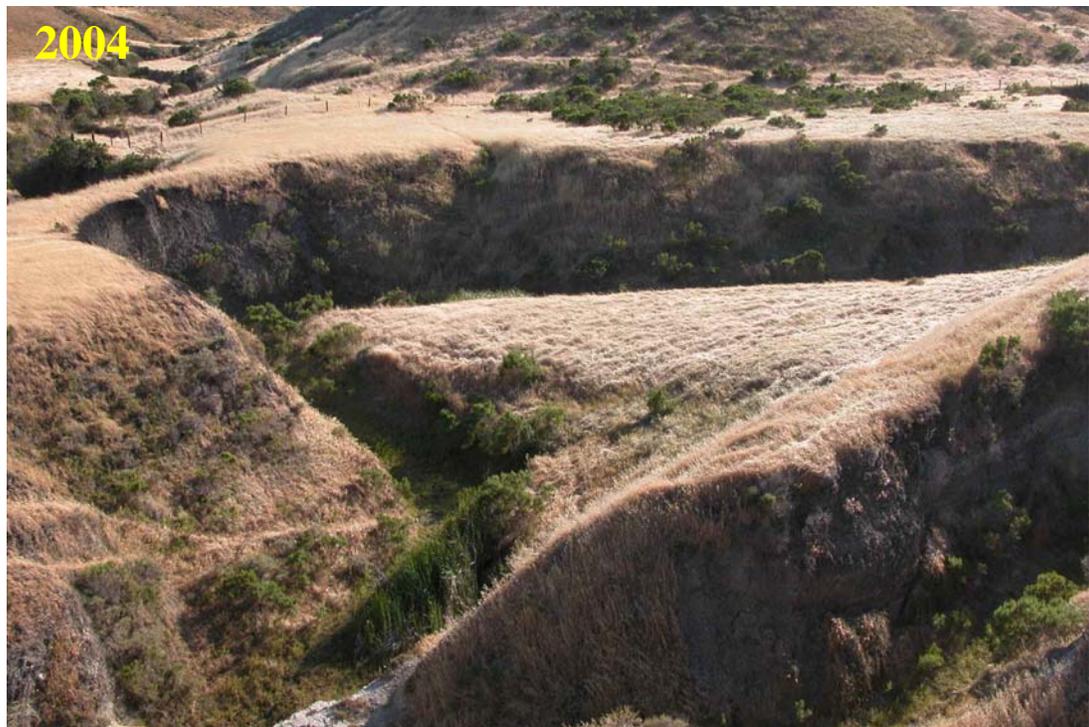
**Figure 7: Quemada Canyon, Reach ID #8 (1995 and 2004)**

1995 Assessment: Most of this reach had a deeply incised, relatively straight channel with bedrock control both vertically and laterally. In the few wider areas where point bars existed, the channel banks and bars were poorly vegetated and susceptible to erosion in large flood events (Figure 7). The high channel width/depth ratios and sediment loads in these areas (both negative attributes for fish habitat) were out of balance with the landscape setting. Without the establishment of adequate riparian-wetland vegetation and

reduced sediment and runoff from the watershed, there is little opportunity for recovery of proper channel form and desirable habitat attributes in the channel or on the associated floodplain.

2004 Assessment: The step pool channel form in the bedrock controlled segments and the sinuous channel in the wider valley bottom areas now have sinuosity, width/depth ratios, and gradients in balance with their landscape settings. In most areas the riparian-wetland zone has achieved its maximum potential extent, primarily through channel narrowing and deepening (note new channel and bank vegetation in Figure 7 that did not exist in 1995).

The dominant riparian-wetland plant species are now cattails, saltgrass, and water bent grass. Although herbaceous wetland plant diversity was relatively low, the species observed do have root masses capable of stabilizing and maintaining channel bank integrity during large flows. Heavy use by deer in the narrow riparian corridor was evident, and hoof action and browsing are leaving some channel bank areas bare. However, the team agreed that the bedrock control in the straight segments and the remaining riparian-wetland vegetation in the sinuous segments were sufficient to withstand the erosive effects of moderate to larger floods. Willows and cottonwoods were absent, which again may be due to limited seed sources and preferential feeding on any newly established plants by deer and elk.

Based upon the bedrock control in most of the reach, the recovery of appropriate channel forms throughout the reach, and development of an herbaceous community that is adequate to maintain channel and floodplain integrity in larger flow events, the team gave this reach a **Proper Functioning Condition** rating. However, the addition of a woody riparian component would further enhance stability, help dissipate flood energy and trap sediment, and provide valuable wildlife habitat that would likely have occurred historically in the canyon. This may not be possible until deer and elk populations are brought under control.

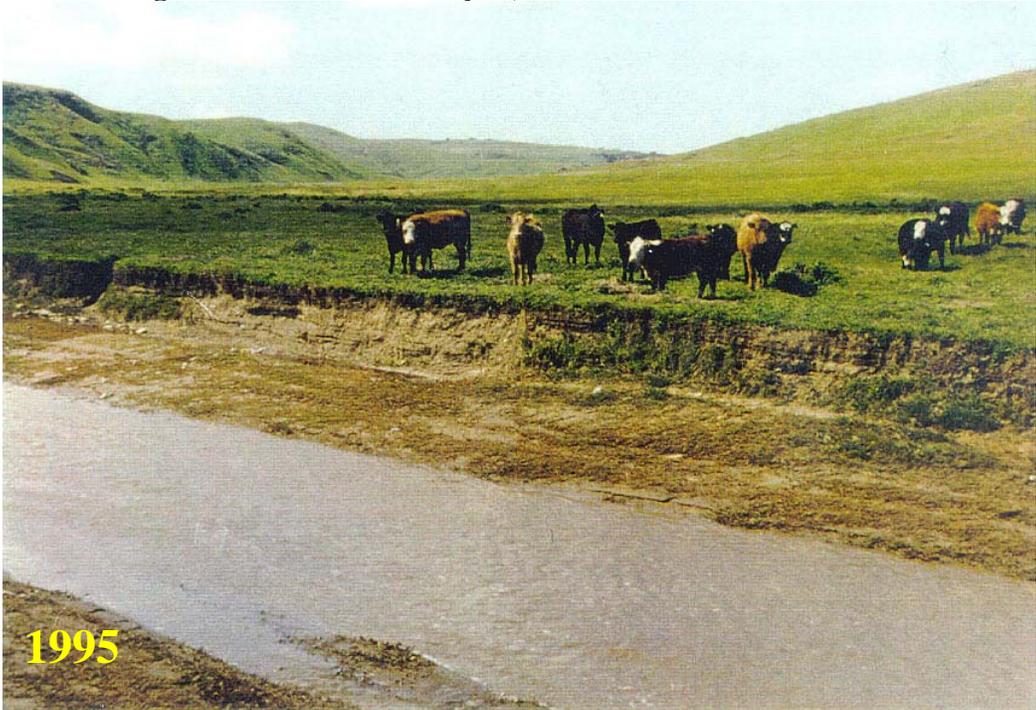
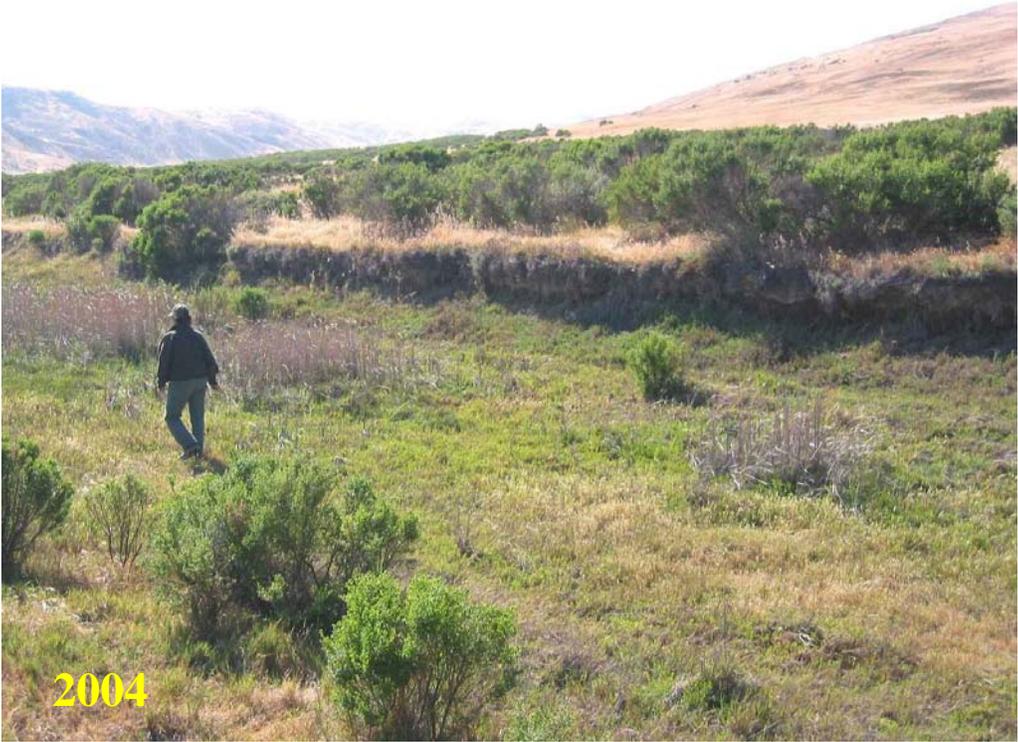
**Figure 8: Old Ranch Canyon, Reach ID #9 (1995 and 2004)**

The team found this reach to be in **Proper Functioning Condition** based upon the stable channel and floodplain forms, the predominance of stabilizing wetland vegetation, and other positive characteristics indicated on the PFC Checklist form in the Appendix. Although it appears that a woody riparian community component is not necessary to maintain a basic functional riparian condition in Old Ranch Canyon, reintroduction of willows and other woody species would bring increased stability and important wildlife habitat components to this riparian ecosystem.

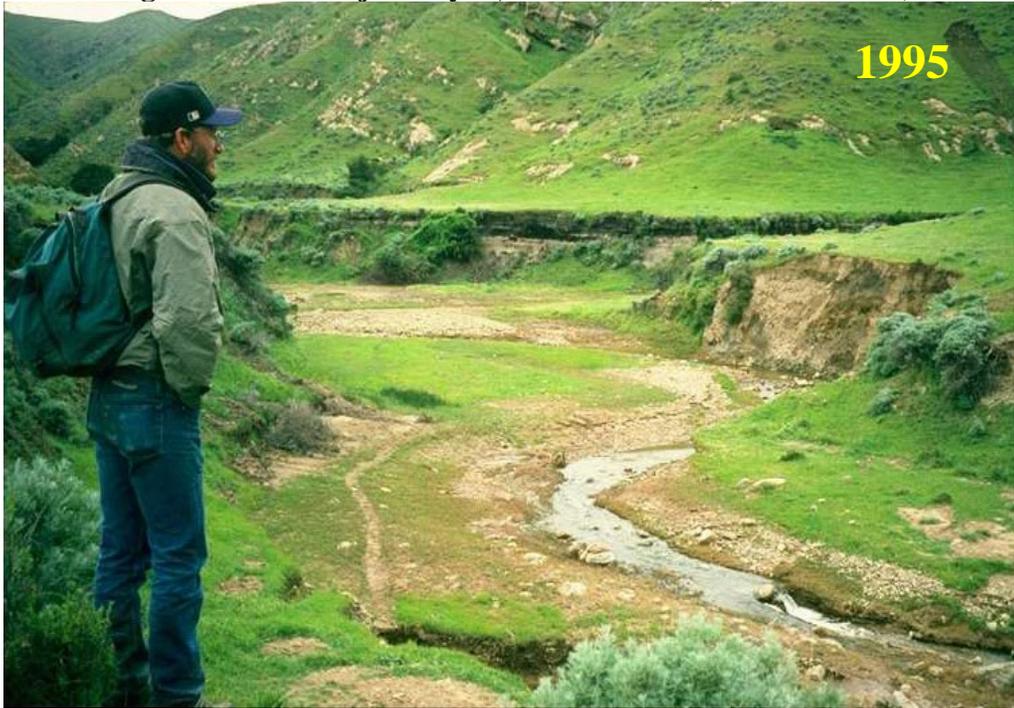
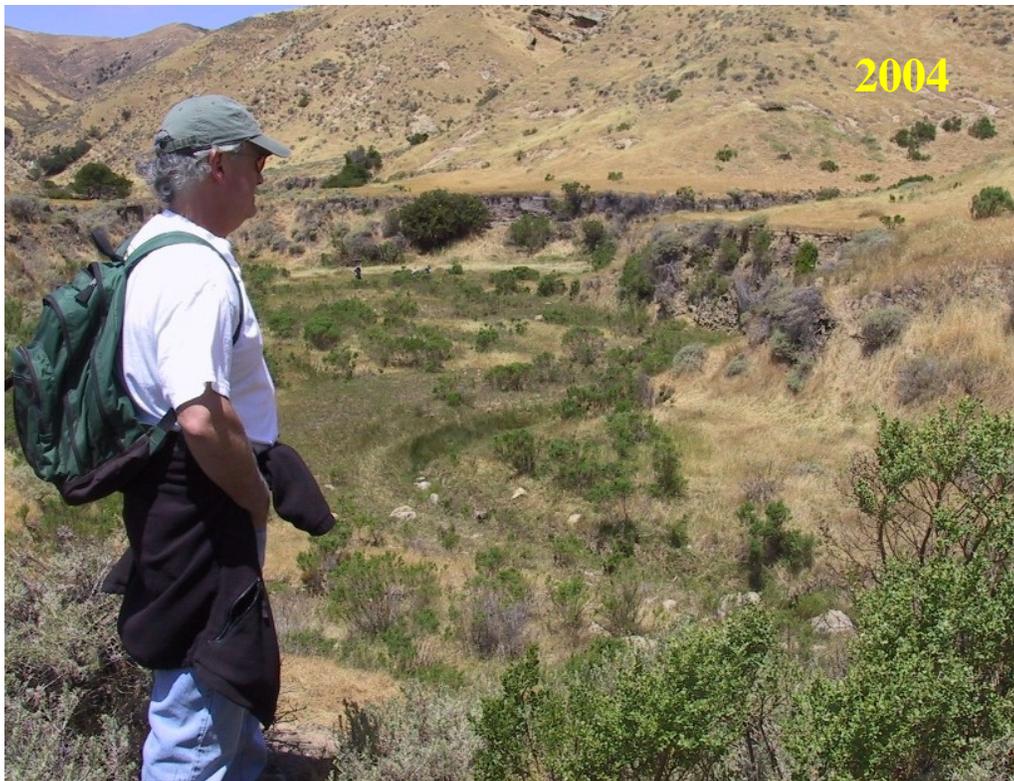
**Figure 9: Jolla Vieja Canyon, Reach ID #10 (1995 and 2004)**

Herbaceous wetland species found along this reach, including water bent grass, saltgrass, cattails, California bulrush (*Scirpus californicus*), brown-head rush (*Juncus phaeocephalus*), and Mexican rush, are all perennials with well-developed root masses that can withstand large flood flows and stabilize channel banks.

Deer and elk browsing appear to be strongly limiting the re-establishment of arroyo willows. Only two small willows were observed on the assessment reach, but they are plentiful in upstream locations where deer and elk can't reach them. However, like most other riparian areas we evaluated, the herbaceous vegetation seems to adequately protect banks and point bars from erosion (channel shows no evidence of degradation after recent flood events). Absence of willows may be more an issue of lost habitat structure and supplemental energy dissipation and bank stabilization than a problem for basic geomorphic stability.

Based upon observations of channel and floodplain morphology appropriate to the landscape setting, adequate vegetation to protect channel banks and point bars against erosion, and other positive attributes listed on the 2004 PFC Checklist (Appendix), this riparian system has recovered to **Proper Functioning Condition**.

1. Consistent with management constraints such as the Court Settlement Agreement and the park's enabling legislation, reduce or eliminate deer and elk from Santa Rosa Island.
2. As soon as possible, plant locally-derived willow and cottonwood cuttings at strategic locations in watersheds where existing seed sources are inadequate to support natural re-establishment. (Simple seed rain traps can be constructed and monitored to evaluate the need for the cuttings, if desired.) These cuttings would need to be protected from browsing and allowed to mature so they can serve as seed sources for re-populating these watersheds once deer and elk are removed from the island.
3. Consider growing and planting plugs of perennial herbaceous wetland vegetation in watersheds with particularly depauperate communities, especially if the opportunity for passive seed re-introductions is low.
